**Heritage Impact Assessment,
4243 Sixth Line, Town of Oakville,
Ontario**

FINAL REPORT

October 21, 2021

Project Number: 160940563

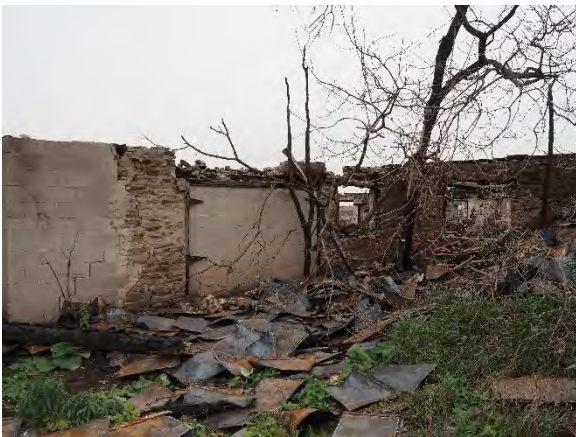
The barn, driveshed, chicken coop and silos were burned by a fire in July 2020. The barn foundation and silo ruins were subject to an assessment completed by Stantec in August 2020 (see Appendix E), which found that the timber part of the barn building, including roof, siding, floor, and structure of the second story, was completely burned beyond the possibility of repair. The ground floor perimeter walls of the barn were severely affected, including the complete collapse of some segments due to the disintegration of the mortar. The sections of the wall above the window/door's openings are in poor condition, some of them had already collapsed due to lack of support, since the wooden lintels were significantly affected or completely burned in some cases.

Plate 20: Barn foundation following fire damage, November 2020

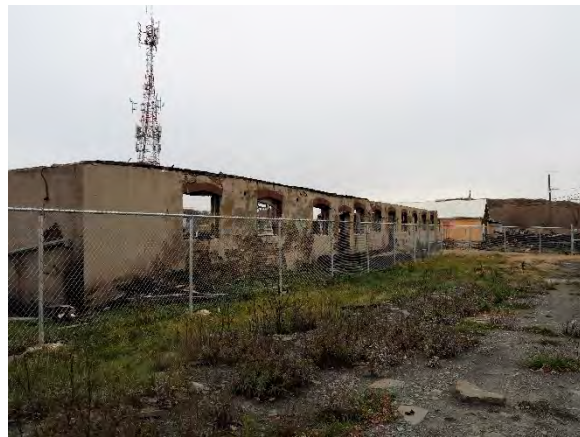
Plate 21: Barn window and door openings following fire damage, November 2020

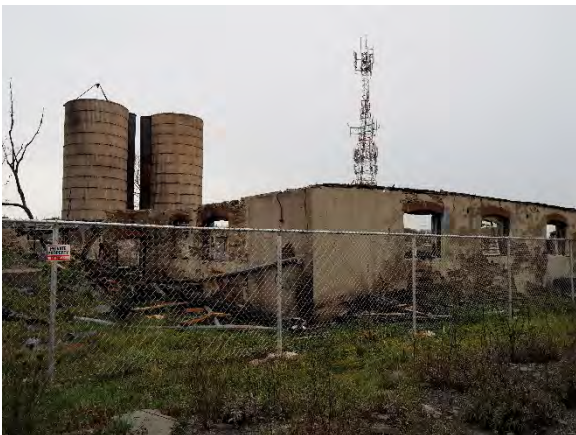
Plate 22: Barn and silos following fire, November 2020

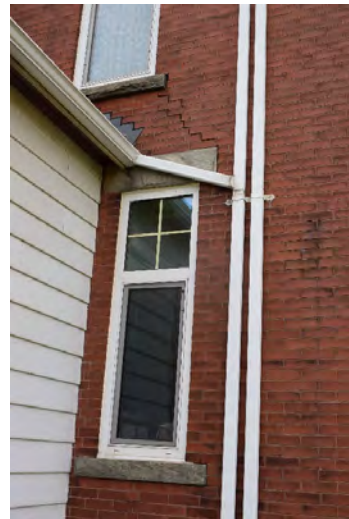
Plate 35: East elevation brick cracking above window, October 2018

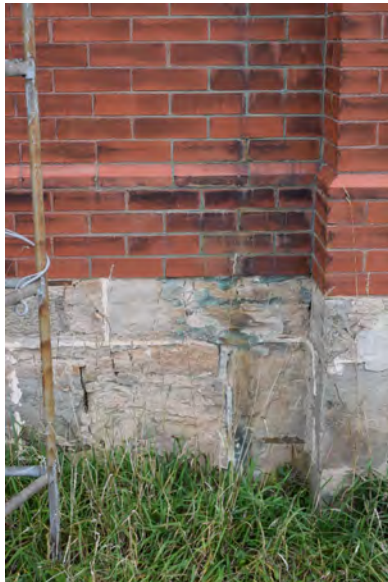
Plate 36: North elevation cracking and water stains, October 2018

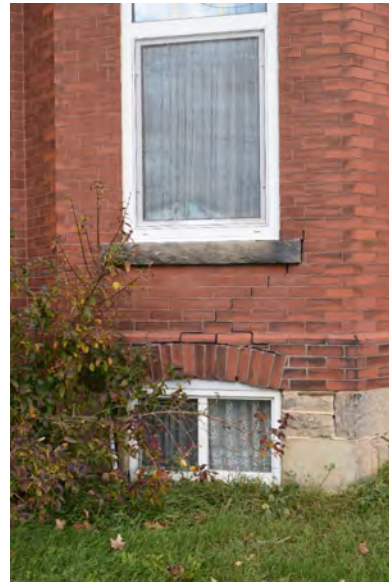
Plate 37: South elevation bay window brick cracking, October 2018

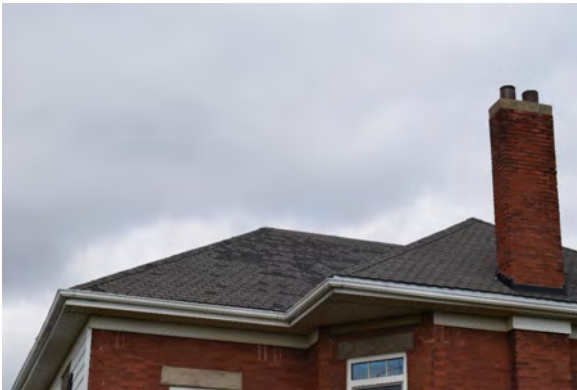
Plate 38: Weathered shingles at southwest corner of roof, October 2018

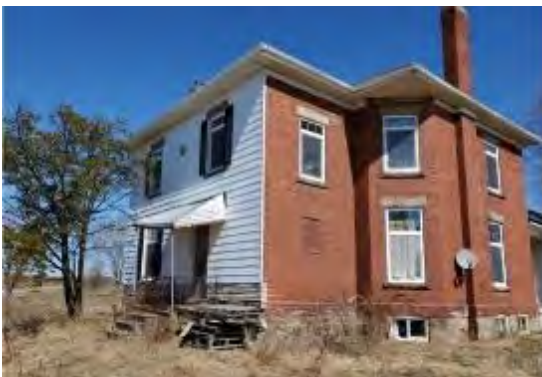
During a break-in in Spring 2020, a second storey window, basement windows, and doors off the south porch elevation were broken and damaged (Plate 41 and Plate 42). Additional exterior damage has not been noted, and the building's windows and doors have since been boarded up by Bell Mobility.

Plate 42: View of south elevation showing second storey window damage. Photo courtesy of Bell Mobility, 2020

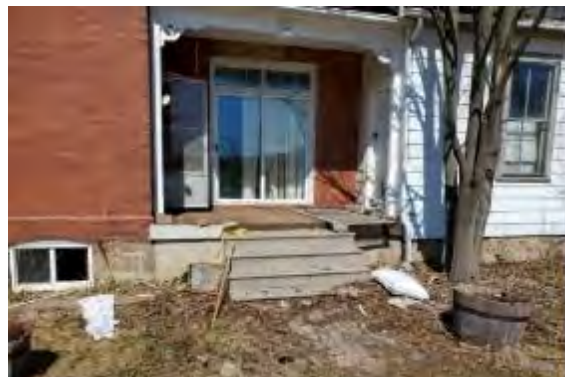
Plate 43: Vandalism damage of porch area on south elevation.

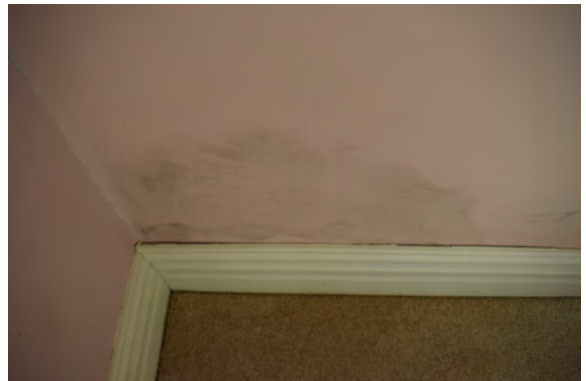
Plate 51: Close-up of water damage and mould on staircase landing, October 2018

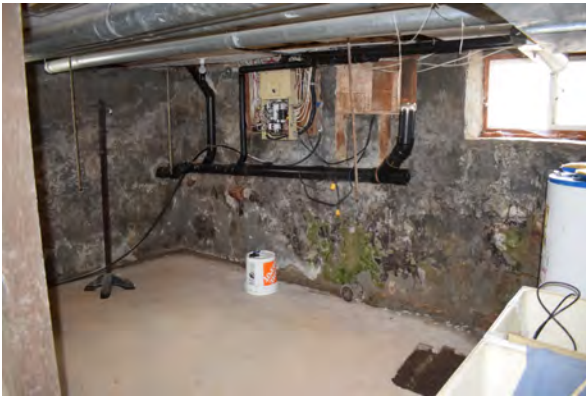
Plate 71: Stains on basement wall looking northeast, October 2018

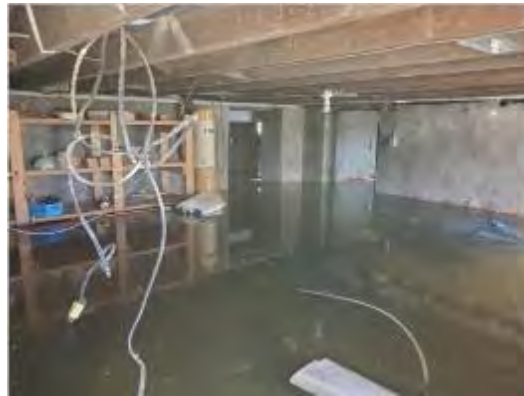
Plate 72: Interior basement flooding/standing water. Photo courtesy of Bell Mobility, September 2020

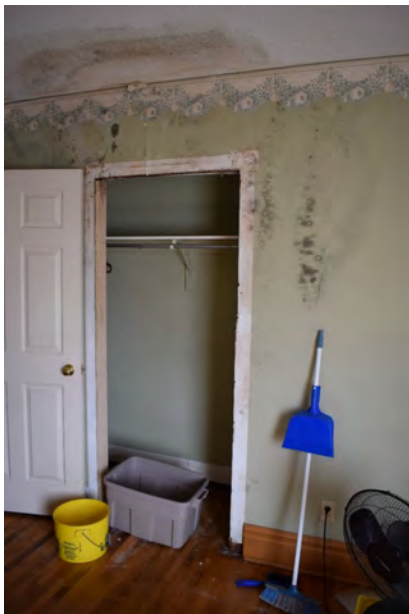
Plate 75: Water damage in bedroom, October 2018

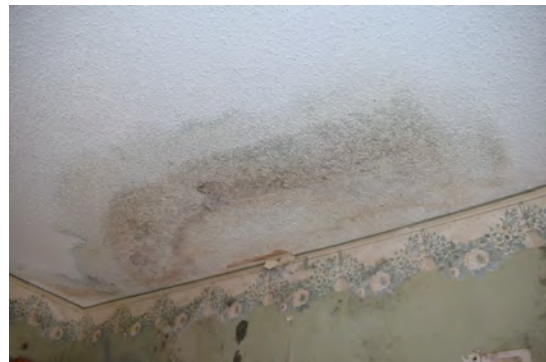
Plate 76: Close-up of water damage in bedroom, October 2018

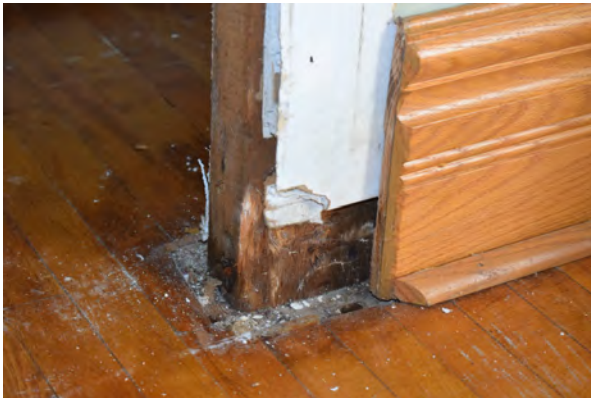
Plate 77: Close-up of water damage, October 2018

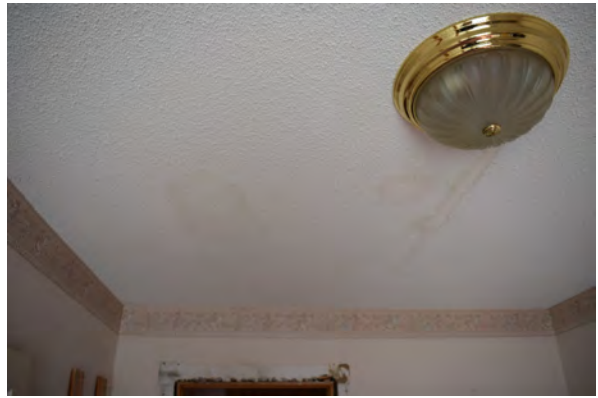
Plate 78: Water stains on bedroom ceiling, October 2018

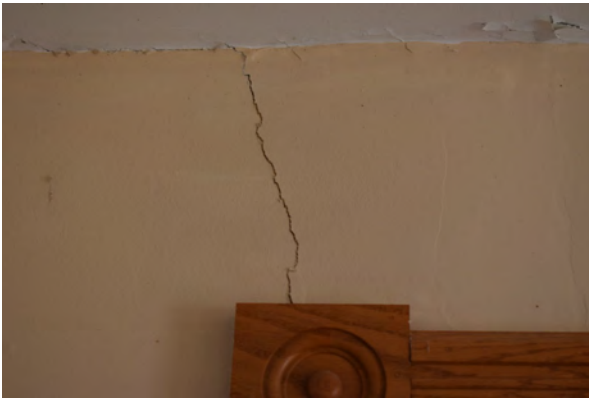
Plate 79: Cracking above bathroom window, October 2018

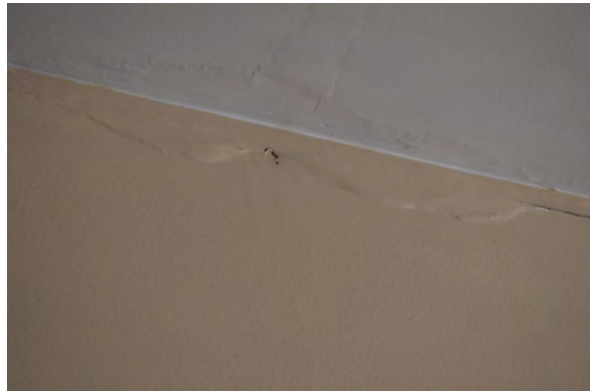
Plate 80: Water damage on bathroom wall and ceiling, October 2018

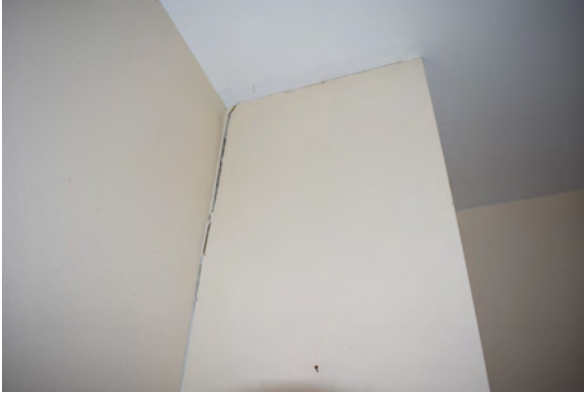
Plate 81: Crack on laundry room wall, October 2018

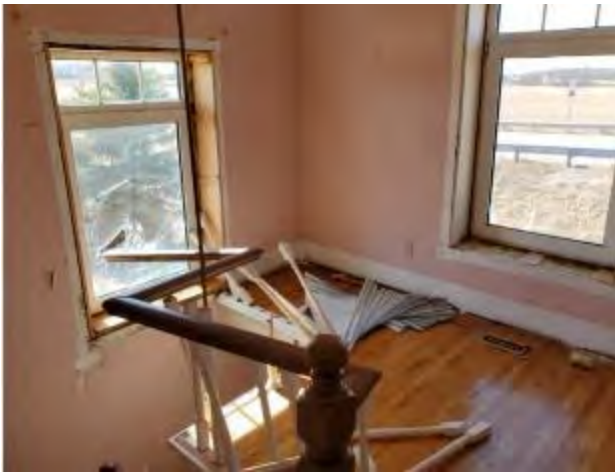
Plate 83: Interior trim removal and railing damage. Photo courtesy of Bell Mobility, September 2020

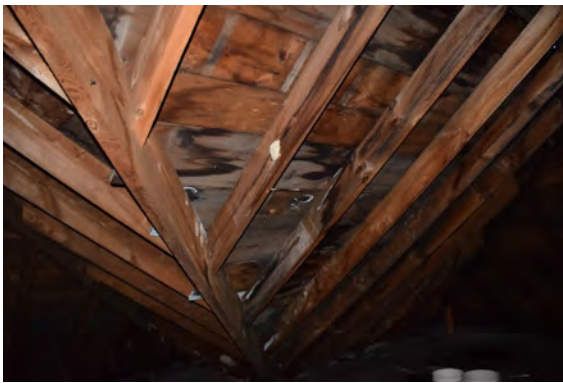
Plate 86: Water damage in attic looking southwest, October 2018

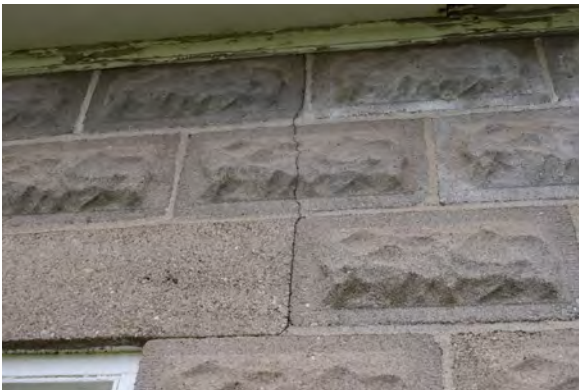
Plate 94: Concrete crack on south elevation, October 2018

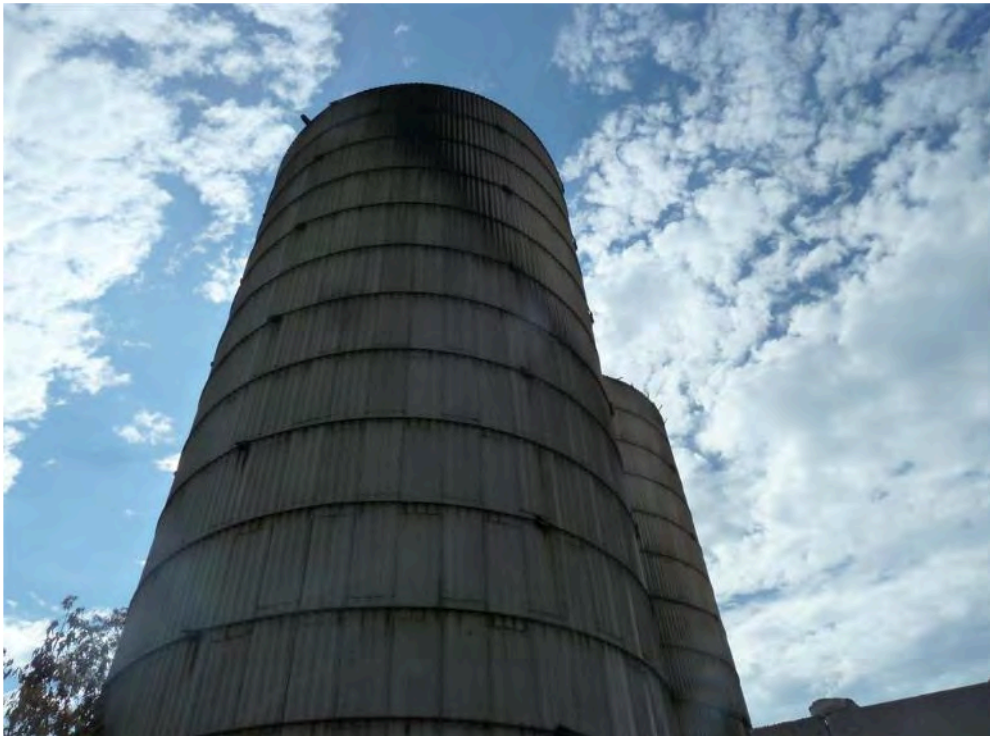
Photo 19 – West Silo - Staining

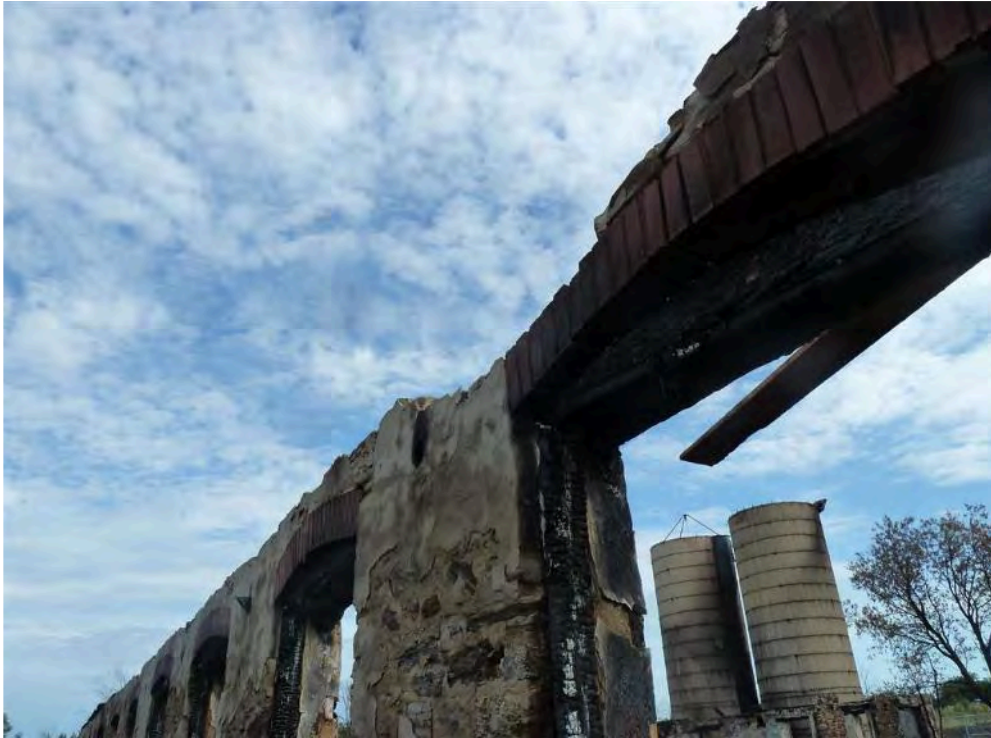
Photo 21 – Barn – South Side Opening Condition

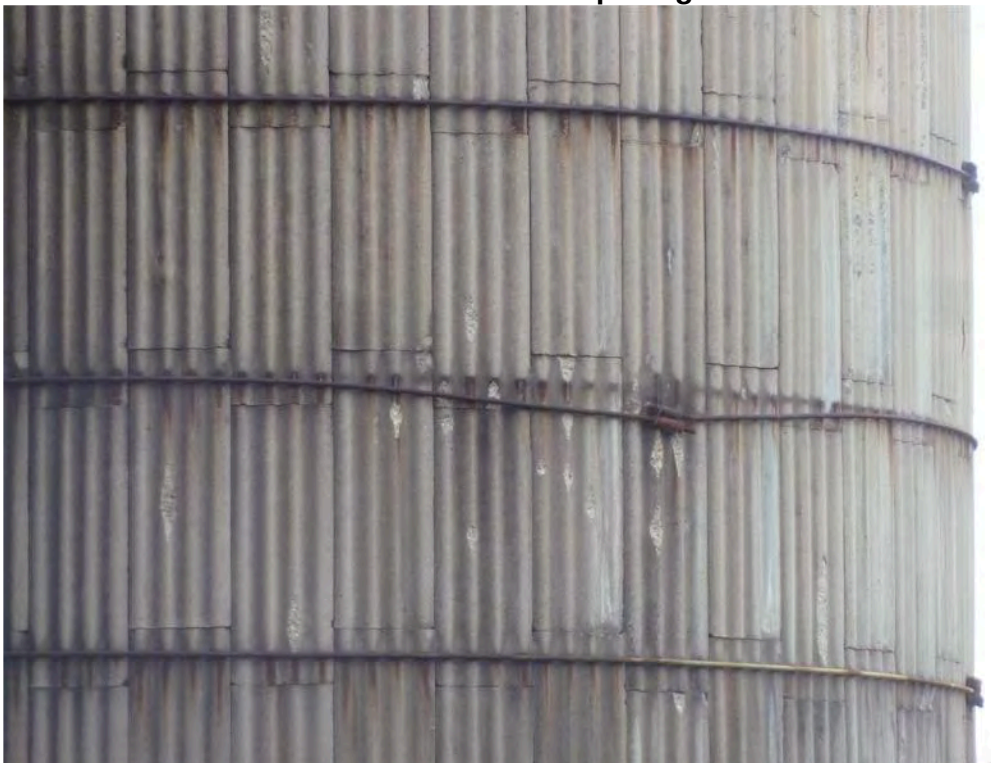
Photo 22 – East Silo – Steel Hoop Loose
