REVIVE
STRUCTURAL ENGINEERING

Structural Assessment Report

Site Address: 3017 Old Bronte Rd, Oakville
Description: Existing heritage building
Project No: 000-22-030
Visit Date: July 13, 2022
Site Rep: Boland Mohamed, B. Eng, E.I.T., Azad Kalemkarian, B. Eng, E.I.T.
Sent To: Mark Tribble Shelley Abair

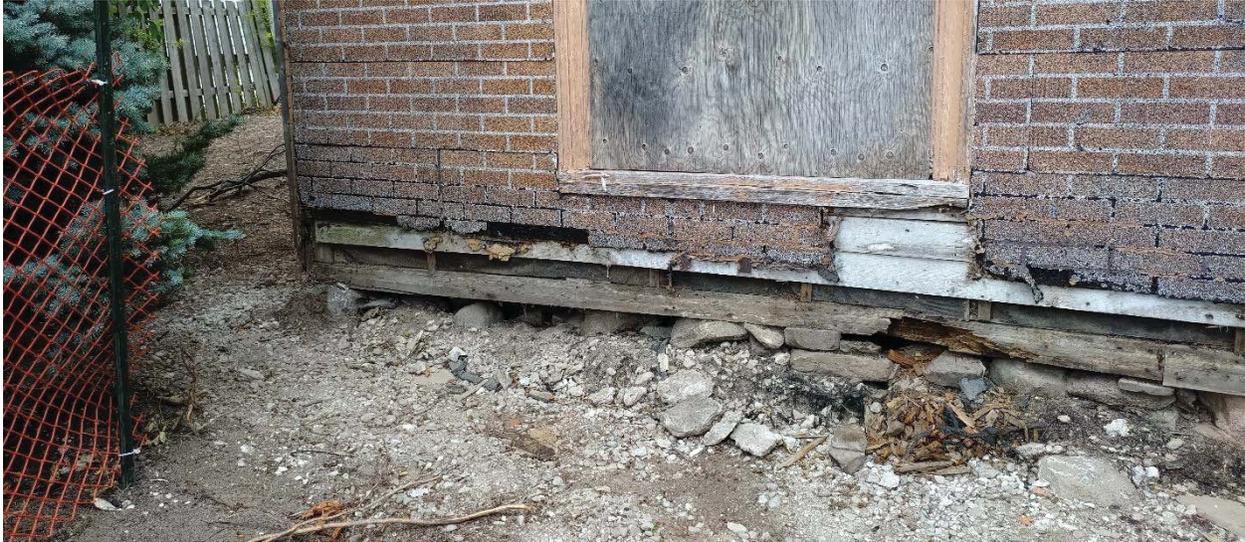
- 2) The original historical house foundation consisted of fieldstone, that supported a heavy timber plate beam. Today the fieldstone is loose with missing sections and the timber plate beam is rotten with loss of section.

Photo 9: Wood sill on field stone.

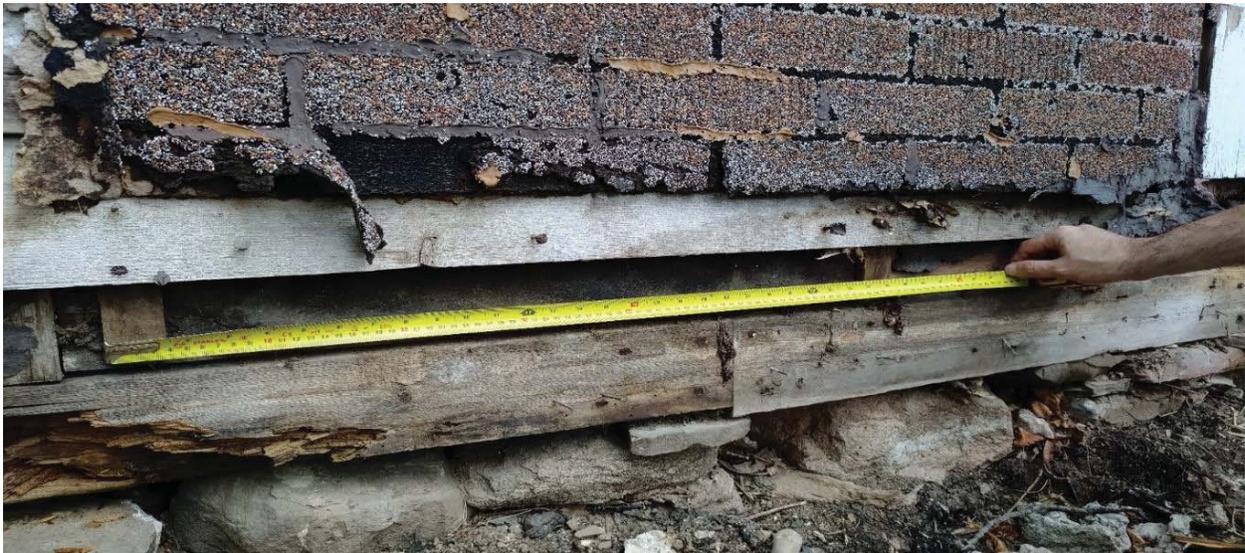
- 4) The exterior face of the perimeter walls was sheathed with wood plank boards and clad with asphalt type siding (no brick) and vinyl siding on the addition. The above grade vertical support consists of load bearing 2x wood studs. We observed areas where the walls appear to be hanging with loss of support below.

Photo 10: Front side, stud walls are resting on a deteriorated sill plate.

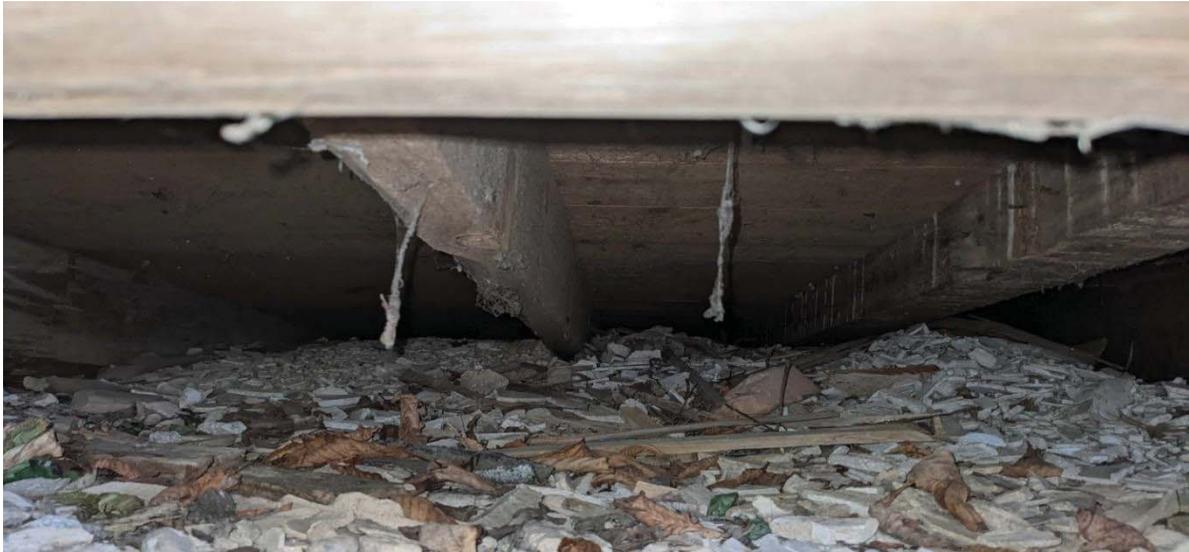
- 5) The main floor support system consists of 2x lumber joists with loss of support and acting like sleepers on grade in areas. We observed areas with complete loss of cross-sectional area and loss of strength due to rot.

Photo 11: Under the main floor framing.

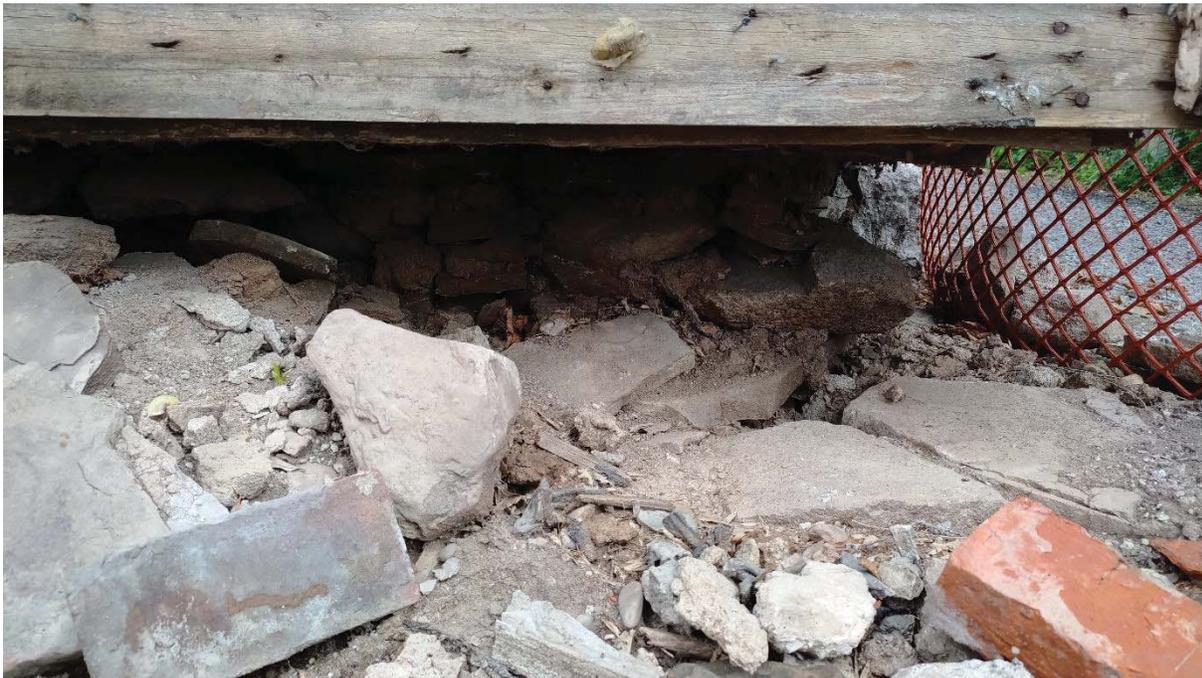
Photo 12: South-West corner at grade under the main floor framing.

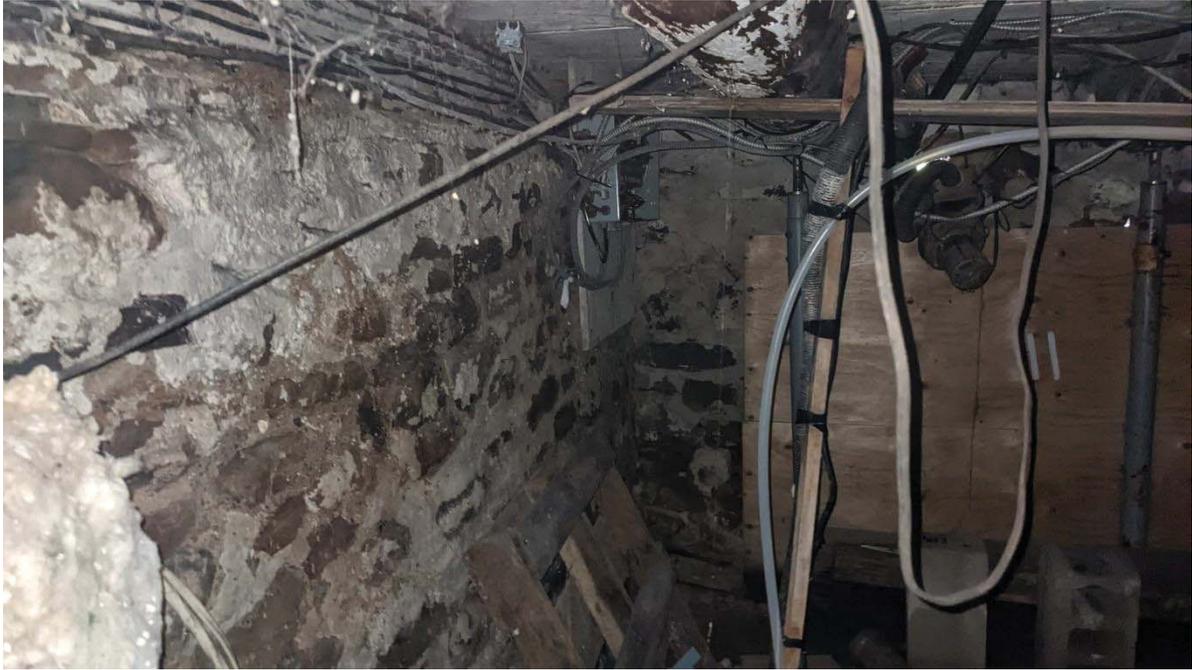
- 3) There is a partial cellar basement area that extends approximately 5ft below grade on the south side with a dirt floor. There are no signs of distress to these cellar walls. The instability of the surrounding main floor framing to the partial basement has caused the house to slant (lean) with a 25cm (10") drop vertically.

Photo 13: View of partial cellar.

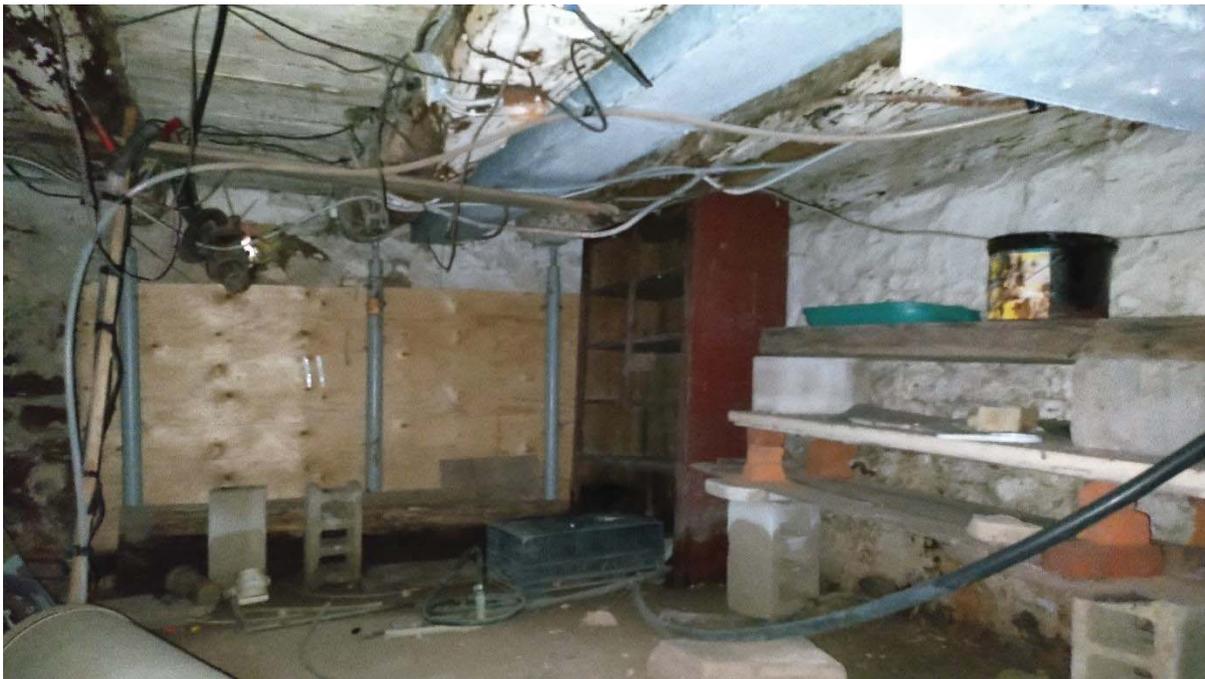
Photo 14: View of cellar.

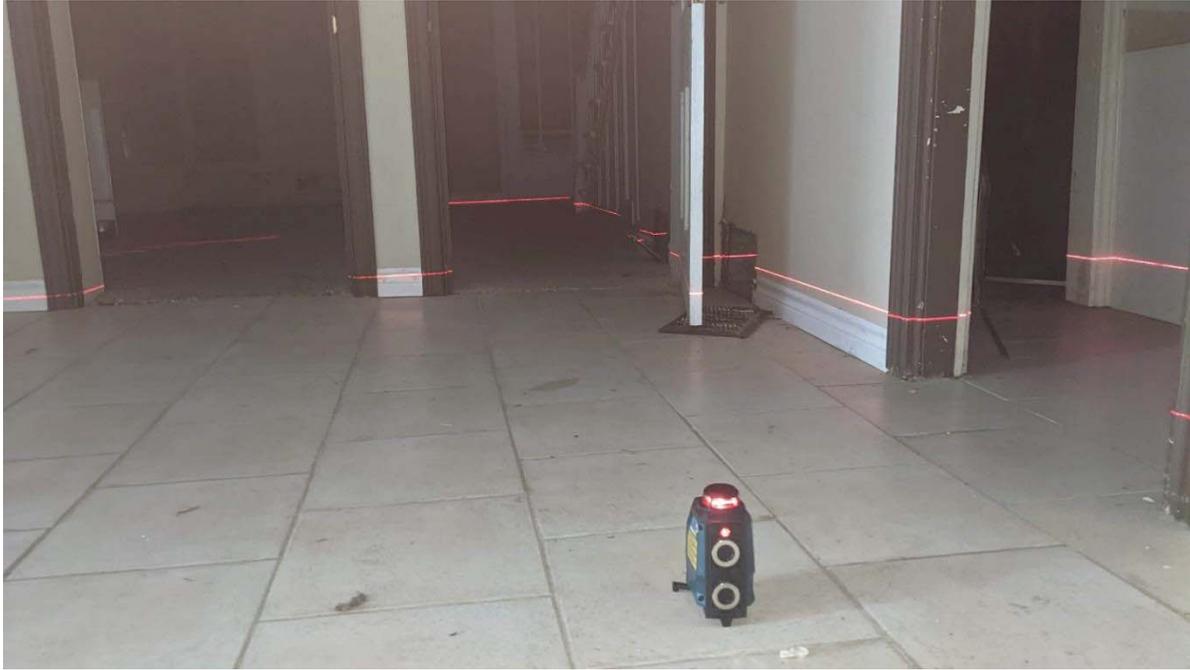
Photo 15: Ground floor showing excessive differential settlements.

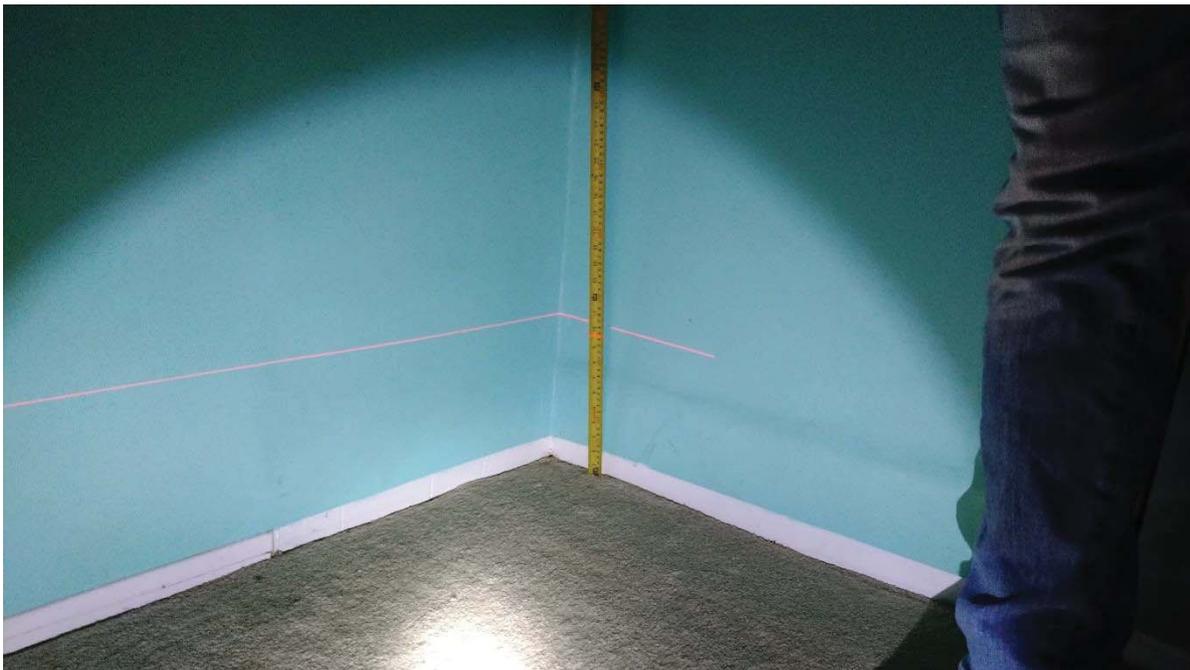
Photo 16: The second-floor slopes toward the back with roughly a 10" drop.

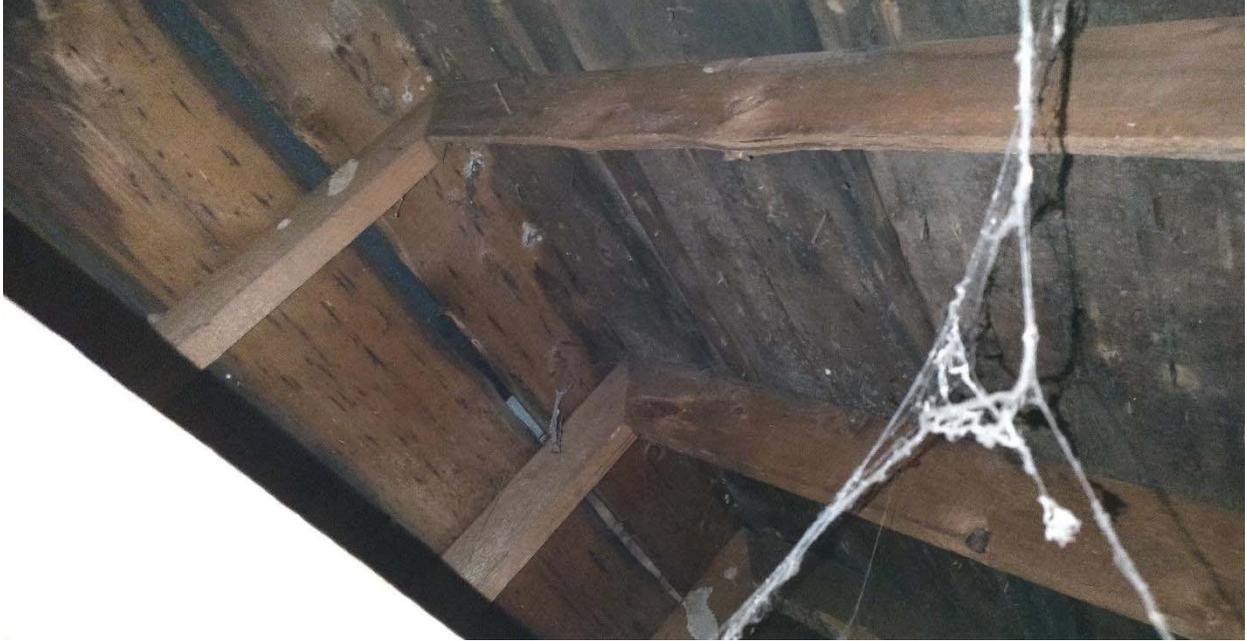
Photo 17: View of roof ridge

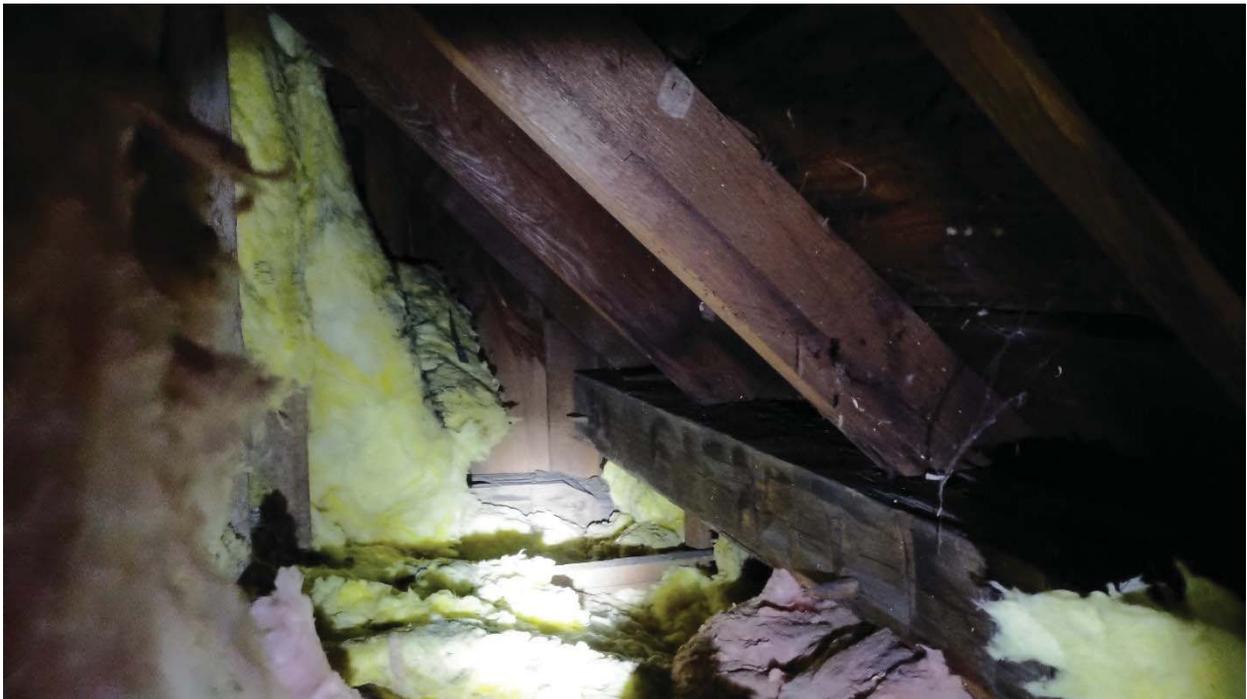
Photo 18: View of Eave beam

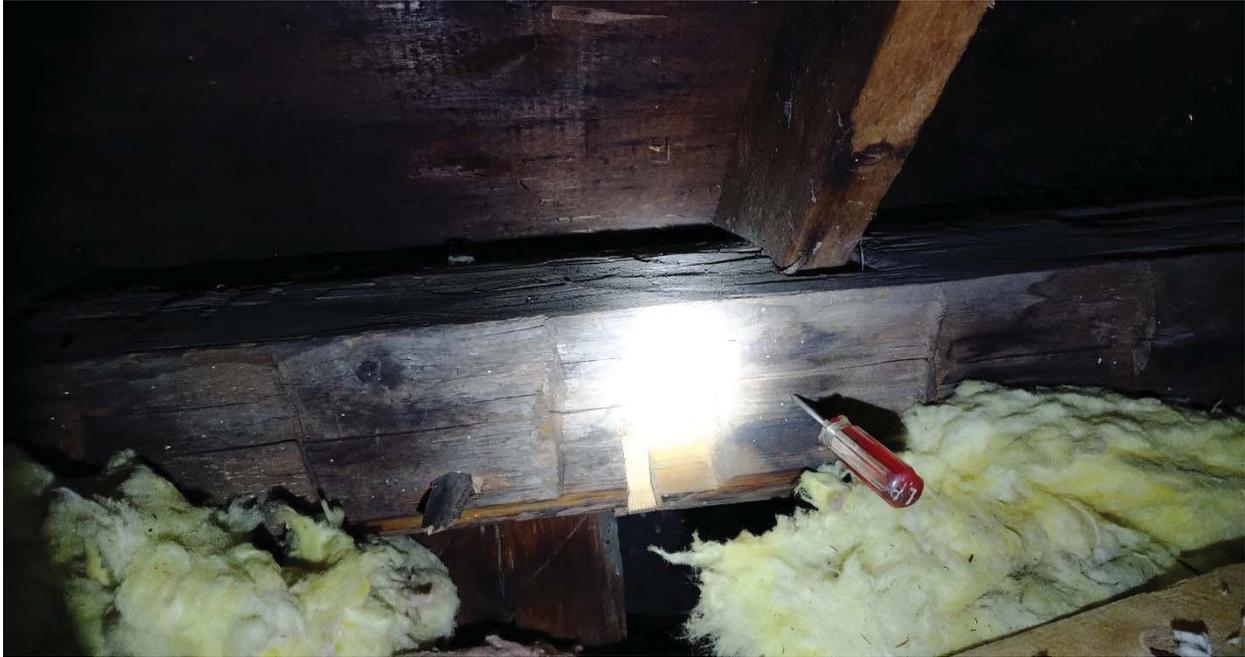
- 7) The roof was constructed in two tiers (upper and lower), both tiers were constructed in a gable configuration. The roof was sheathed with plank board and surfaced with asphalt shingles. The roof framing consists of 2x rafters and heavy timber eave beams, with signs of rot and loss of strength.

- 6) In a wood framed historical building that needs to be saved and restored, the structural members of significance are typically the heavy timber beams. The heavy timber beams reviewed during our assessment were rotten with loss strength and loss of material.

Photo 19: Eave beam has loss of strength due to rot.

- 4) Rotten wood needs to be removed and replaced with either new wood or resin epoxy. When load bearing lumber is rotten resulting in a loss of strength and cross-sectional area, repairing rotten wood become impractical and not possible.

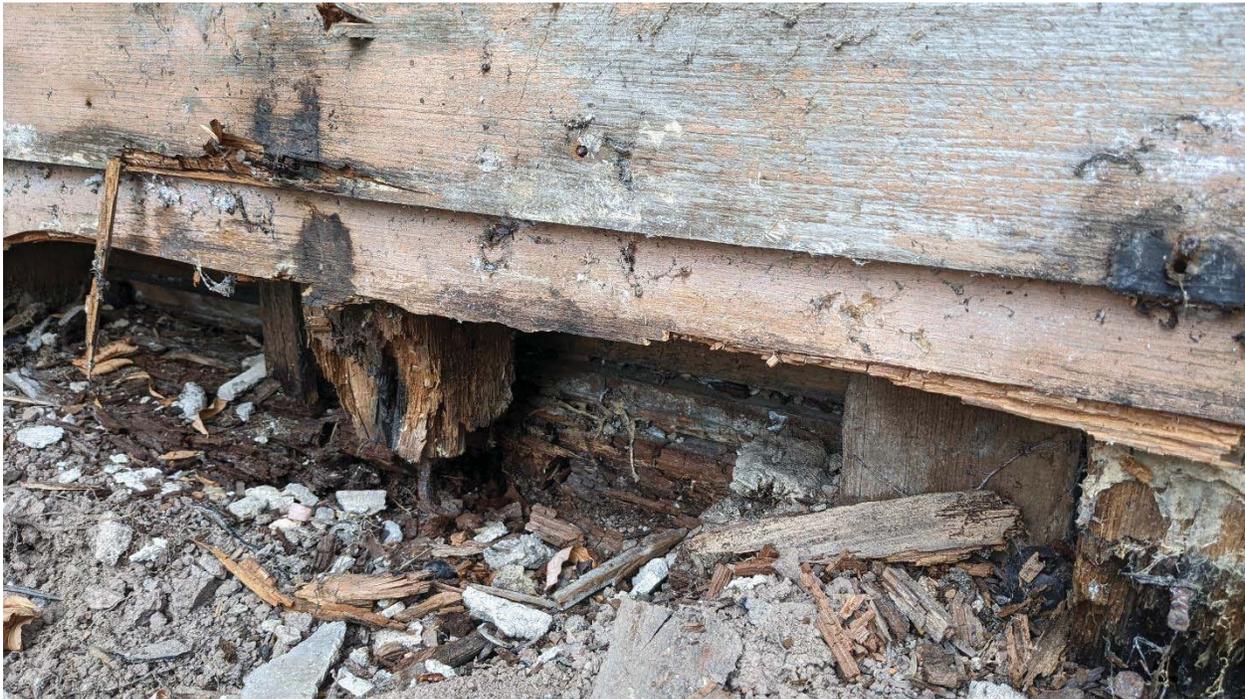
Photo 20: Rot of the exterior studs.

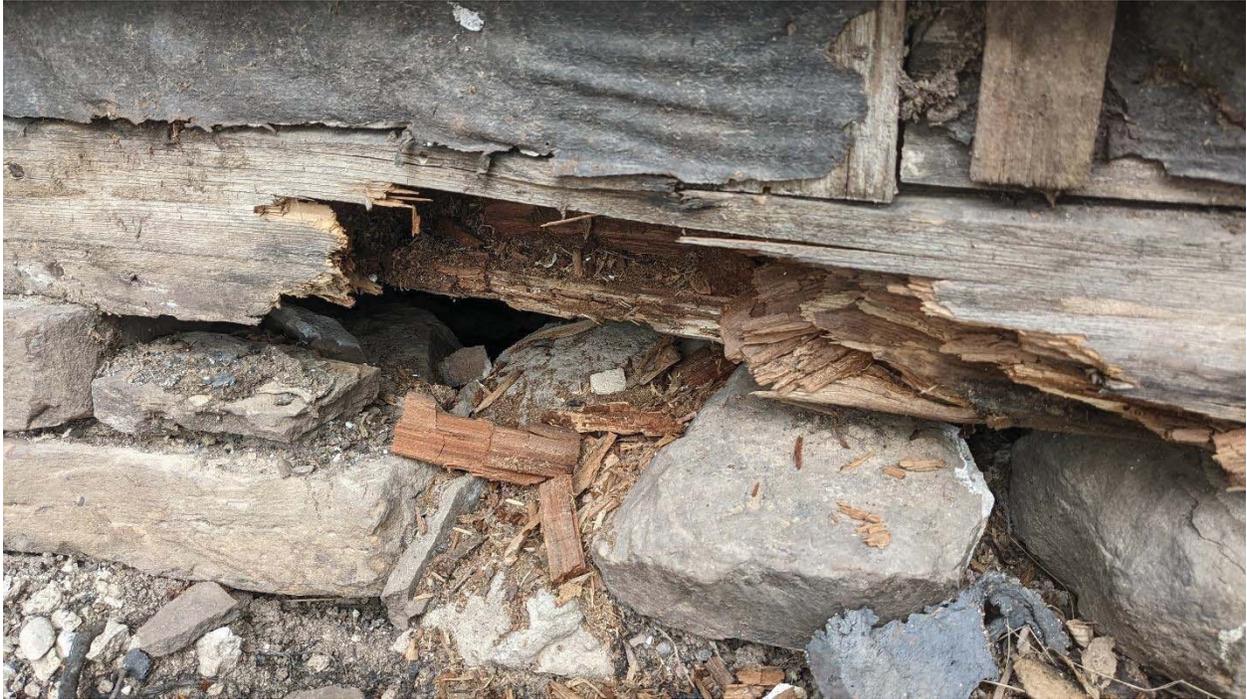
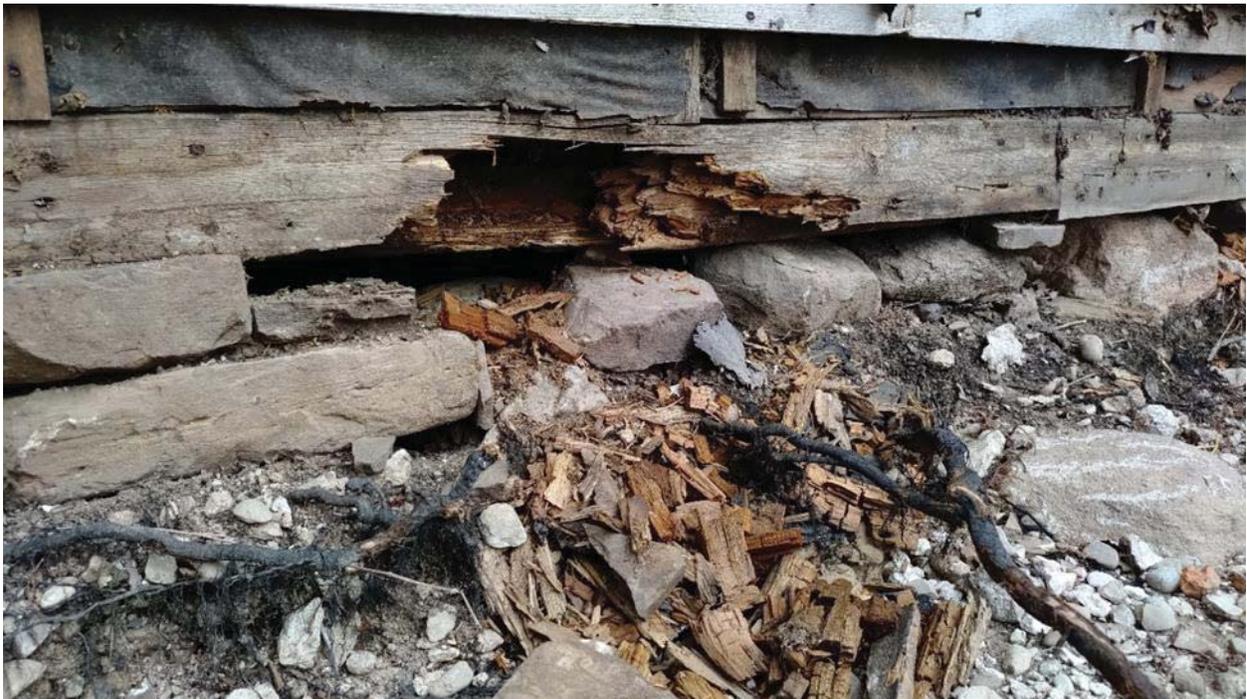
- 1) The perimeter soil grade was pulled back to expose the house foundation at the time of our arrival. The entire perimeter wood sills had signs of being in direct contact with organic soil.

Photo 21: Rot of the perimeter sill beams.

Photo 22: Rot of the perimeter sill beams.
