# Structural Assessment Report

Site Address: 3017 Old Bronte Rd, Oakville  
Description: Existing heritage building  
Project No: 000-22-030  
Visit Date: July 13, 2022  
Site Rep: Boland Mohamed, B. Eng, E.I.T., Azad Kalemkarian, B. Eng, E.I.T.  
Sent To: Mark Tribble Shelley Abair

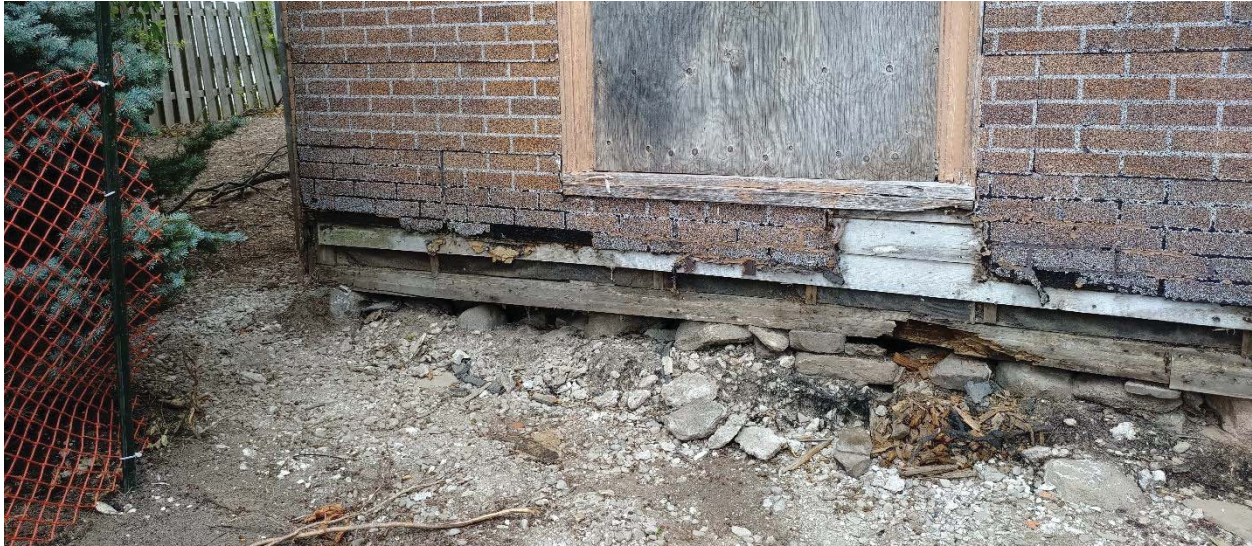
- 2) The original historical house foundation consisted of fieldstone, that supported a heavy timber plate beam. Today the fieldstone is loose with missing sections and the timber plate beam is rotten with loss of section.

Photo 9: Wood sill on field stone.

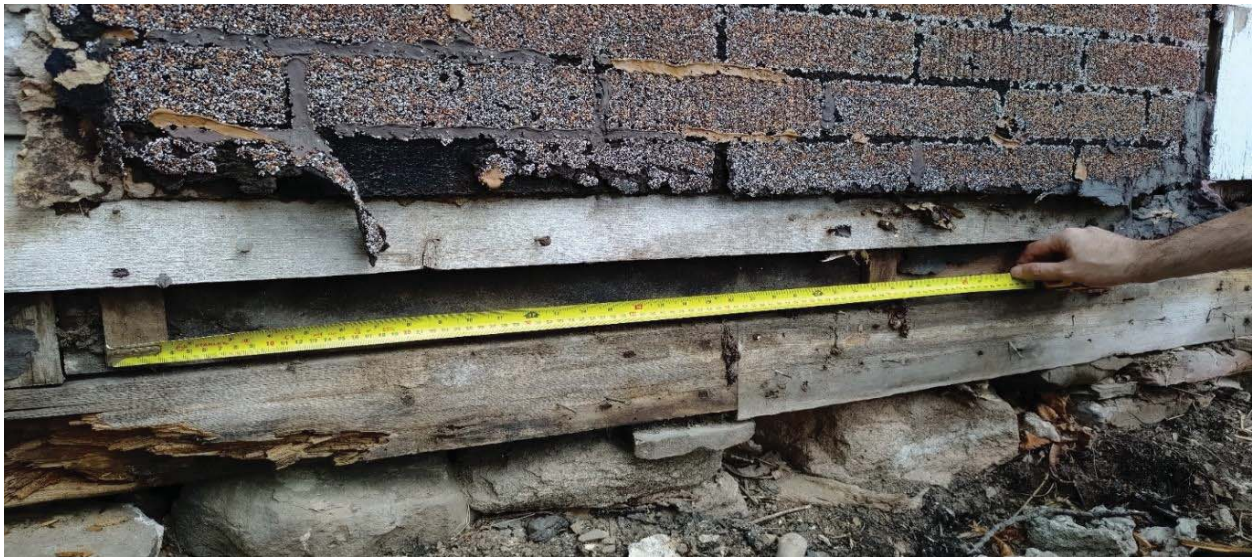
- 4) The exterior face of the perimeter walls was sheathed with wood plank boards and clad with asphalt type siding (no brick) and vinyl siding on the addition. The above grade vertical support consists of load bearing 2x wood studs. We observed areas where the walls appear to be hanging with loss of support below.

Photo 10: Front side, stud walls are resting on a deteriorated sill plate.

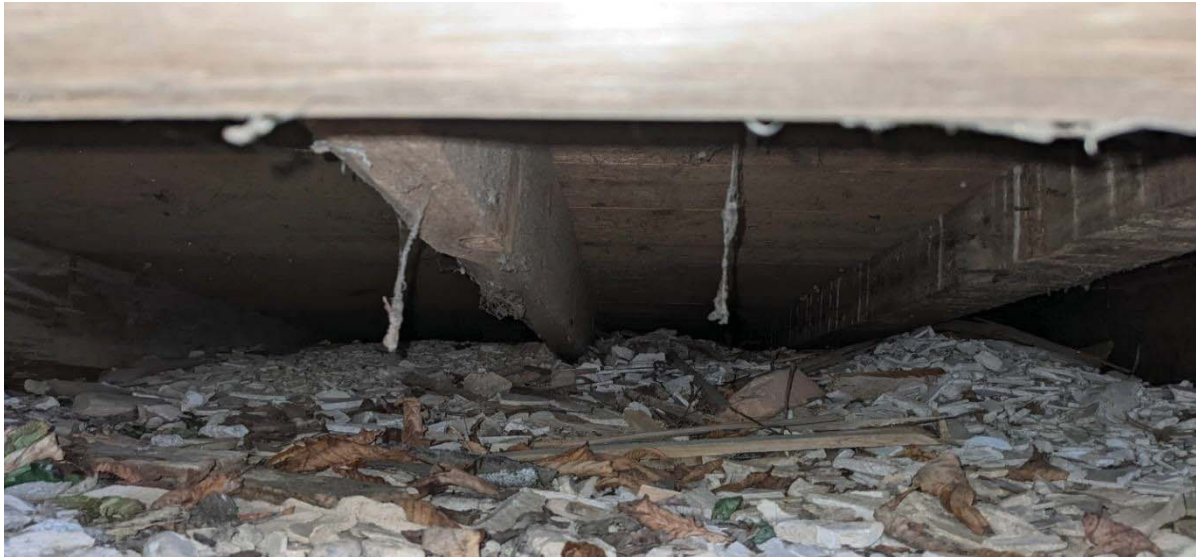
- 5) The main floor support system consists of 2x lumber joists with loss of support and acting like sleepers on grade in areas. We observed areas with complete loss of cross-sectional area and loss of strength due to rot.

Photo 11: Under the main floor framing.

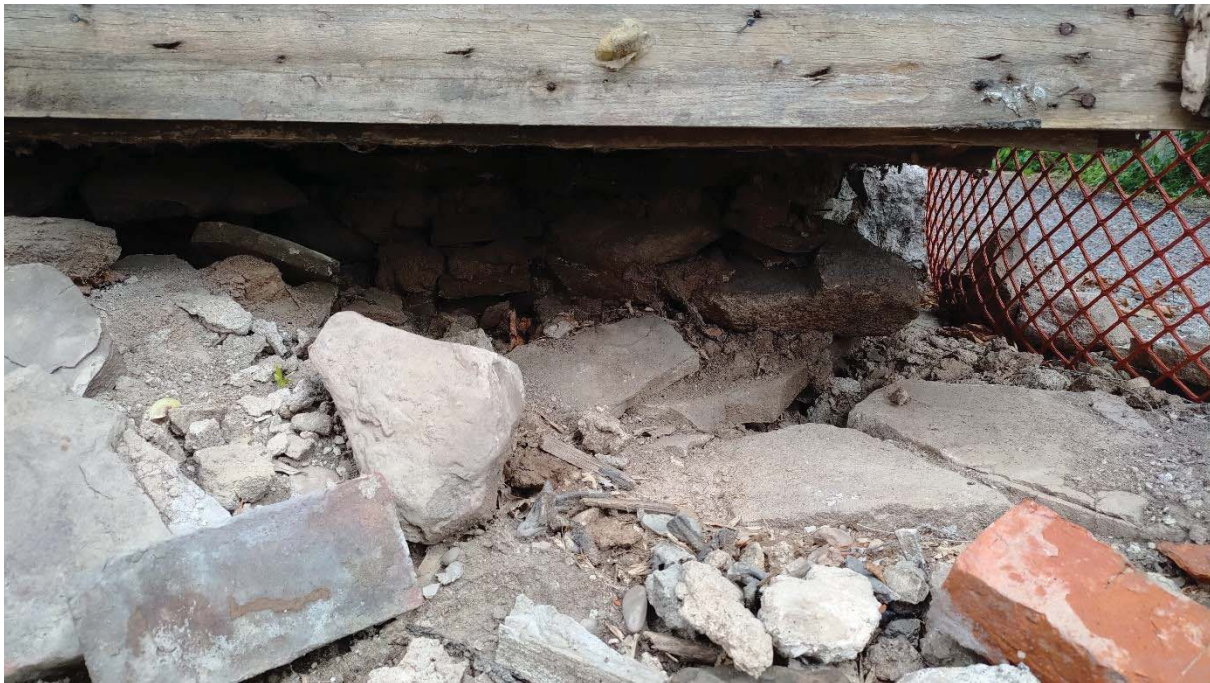
Photo 12: South-West corner at grade under the main floor framing.

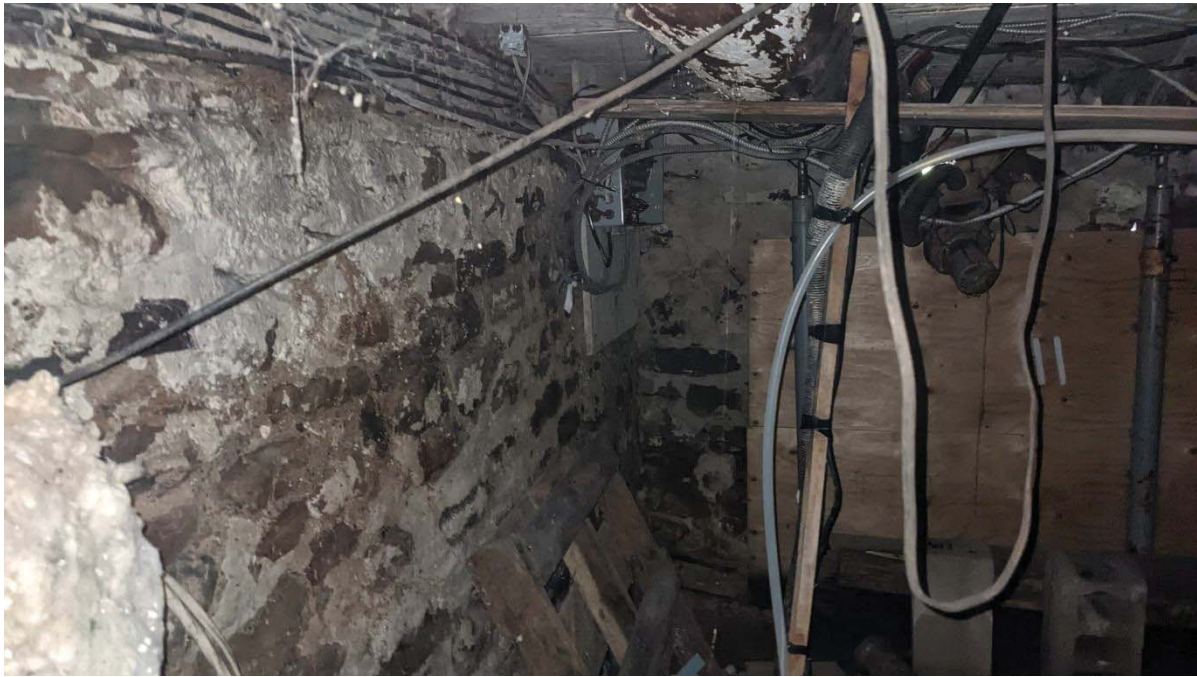
- 3) There is a partial cellar basement area that extends approximately 5ft below grade on the south side with a dirt floor. There are no signs of distress to these cellar walls. The instability of the surrounding main floor framing to the partial basement has caused the house to slant (lean) with a 25cm (10") drop vertically.

Photo 13: View of partial cellar.

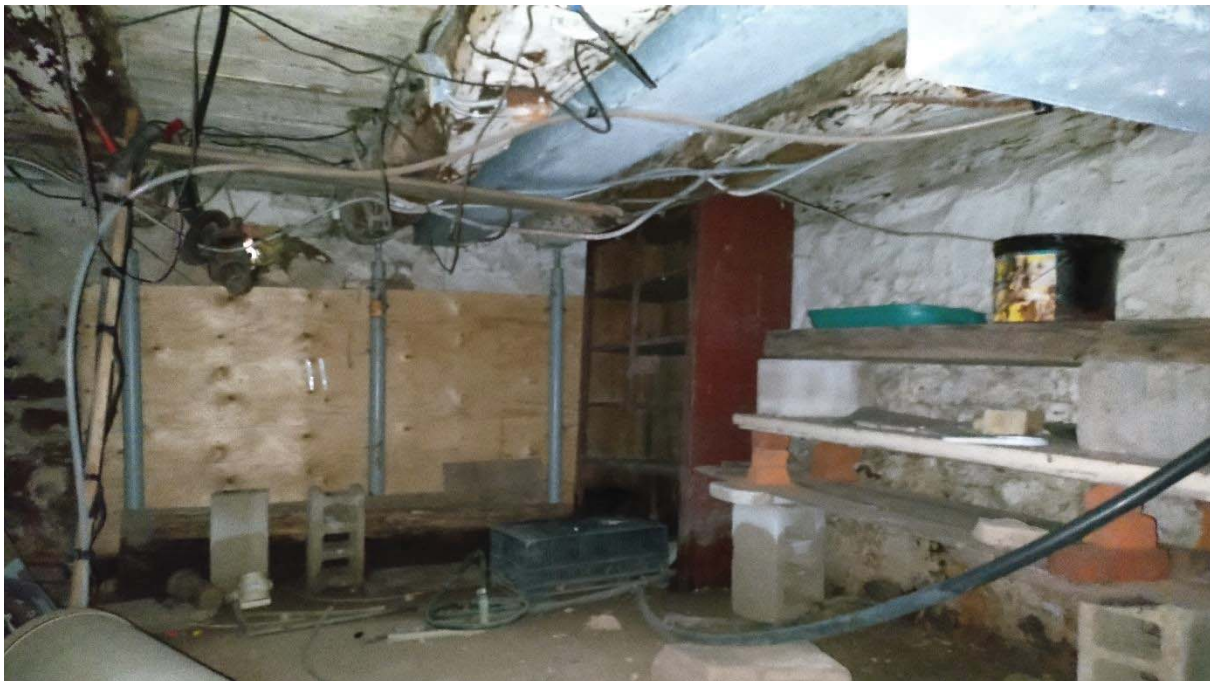
Photo 14: View of cellar.

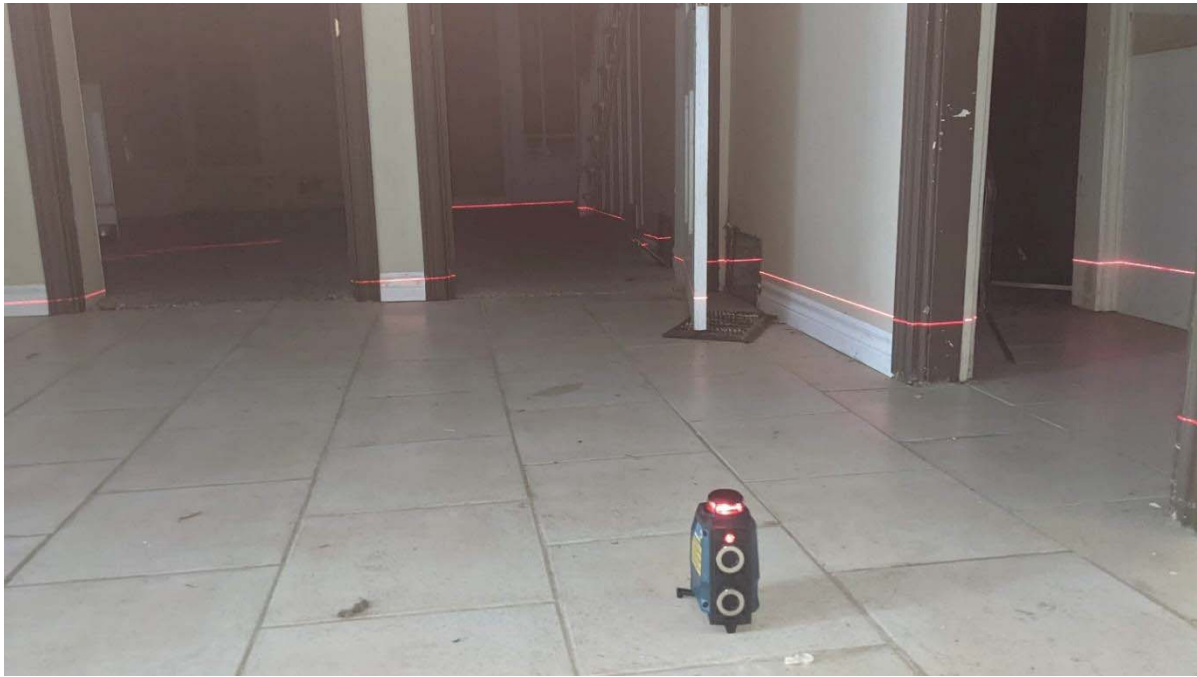
Photo 15: Ground floor showing excessive differential settlements.

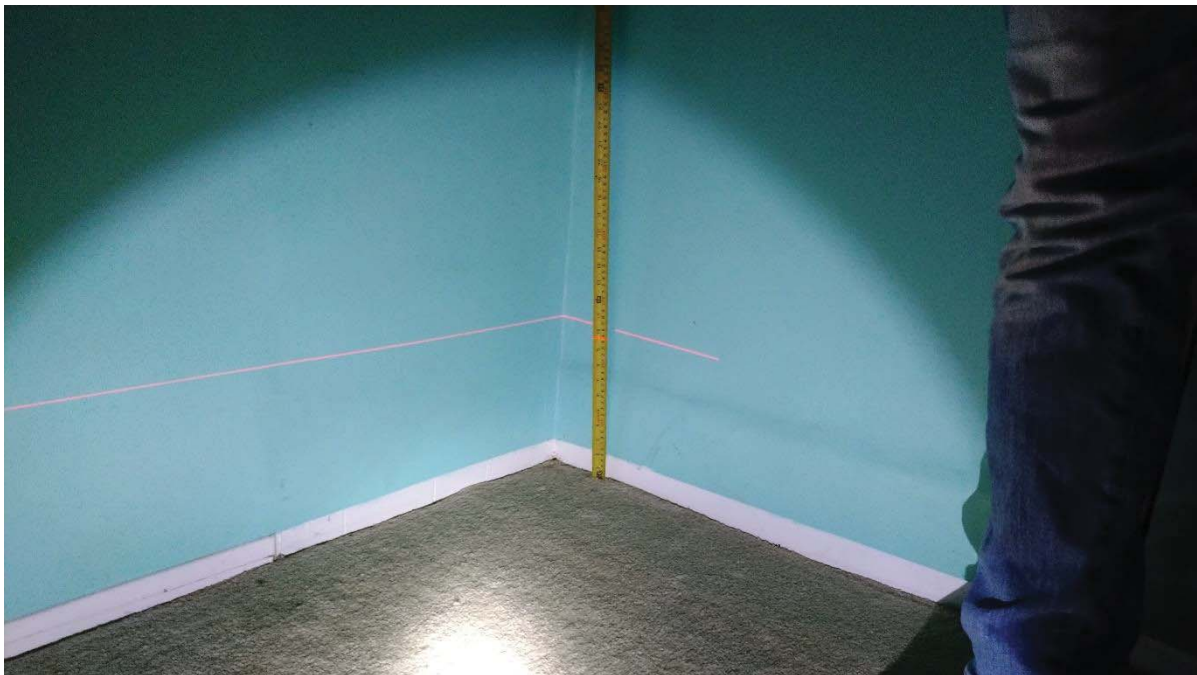
Photo 16: The second-floor slopes toward the back with roughly a 10" drop.

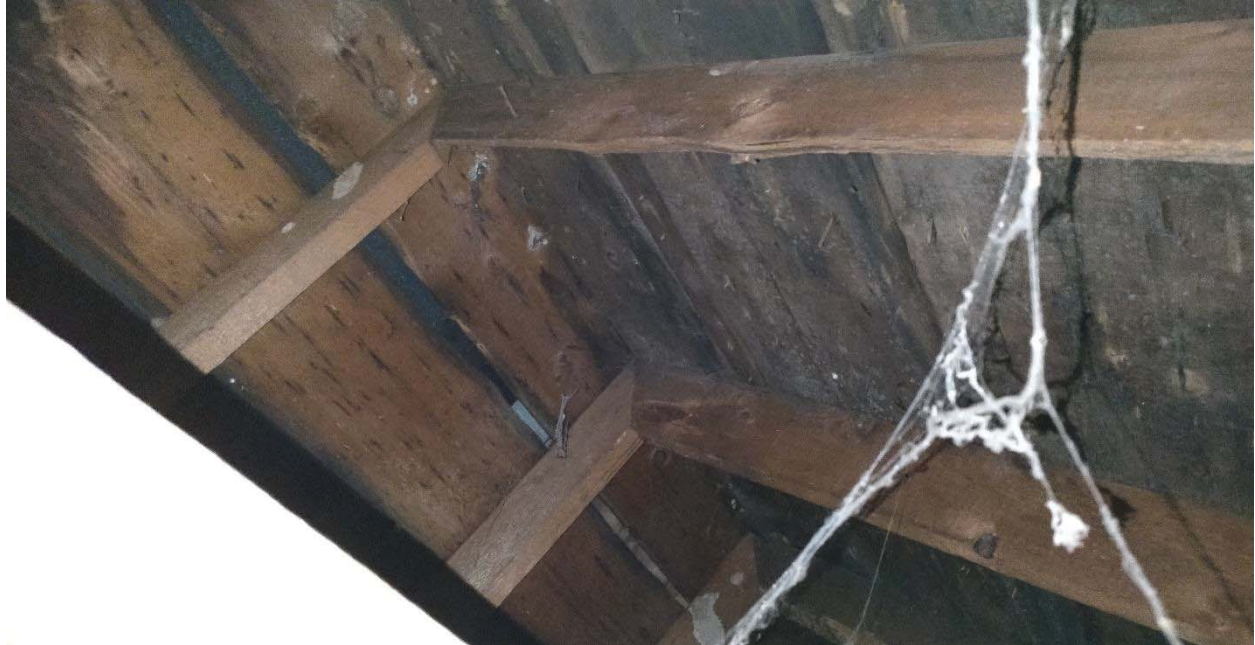
Photo 17: View of roof ridge

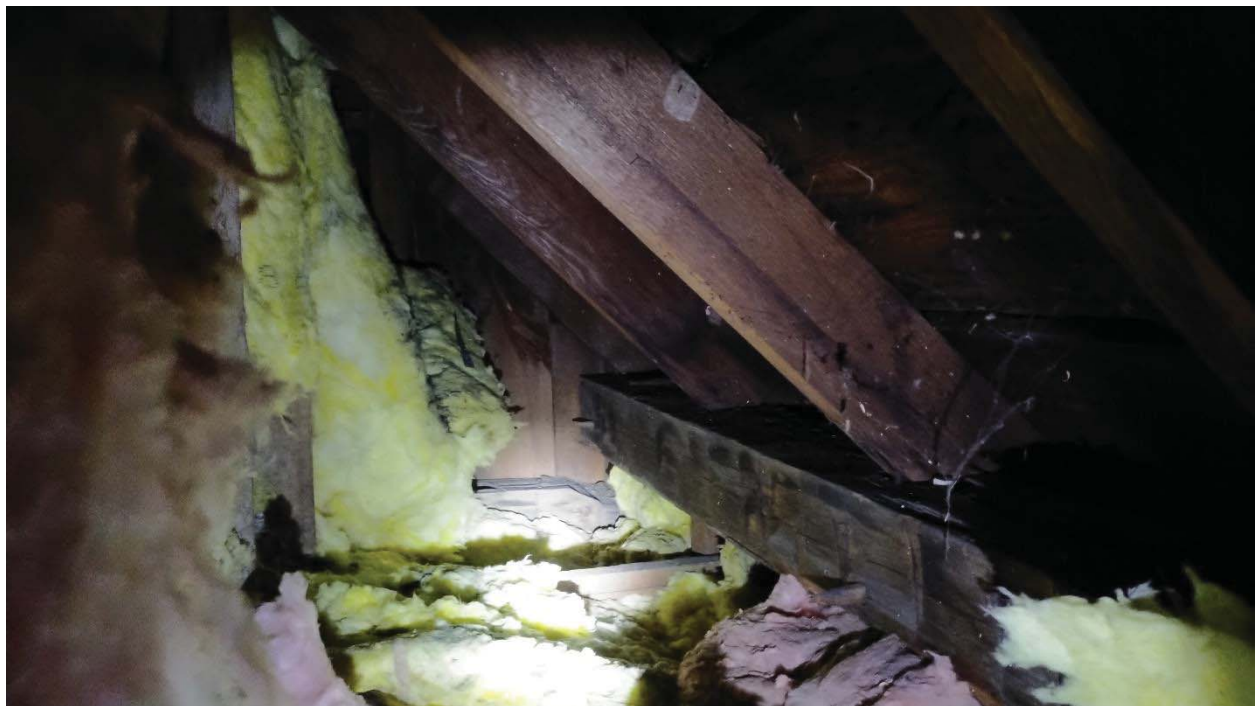
Photo 18: View of Eave beam

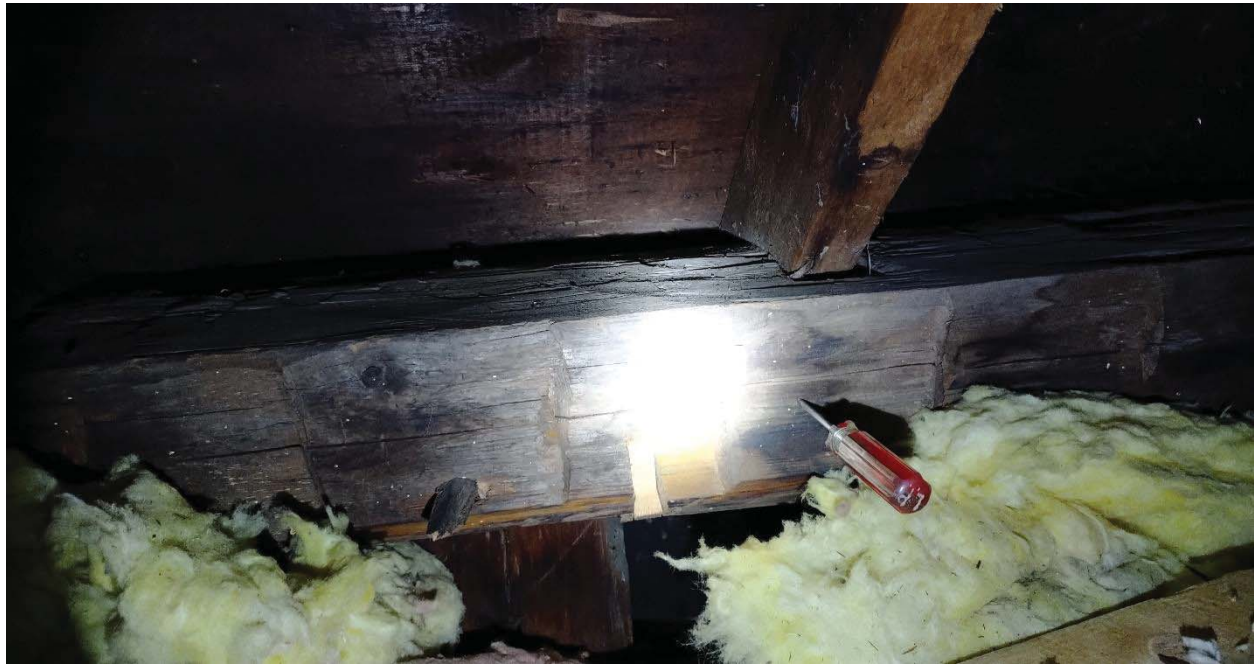
- 7) The roof was constructed in two tiers (upper and lower), both tiers were constructed in a gable configuration. The roof was sheathed with plank board and surfaced with asphalt shingles. The roof framing consists of 2x rafters and heavy timber eave beams, with signs of rot and loss of strength.

- 6) In a wood framed historical building that needs to be saved and restored, the structural members of significance are typically the heavy timber beams. The heavy timber beams reviewed during our assessment were rotten with loss strength and loss of material.

Photo 19: Eave beam has loss of strength due to rot.

- 4) Rotten wood needs to be removed and replaced with either new wood or resin epoxy. When load bearing lumber is rotten resulting in a loss of strength and cross-sectional area, repairing rotten wood become impractical and not possible.

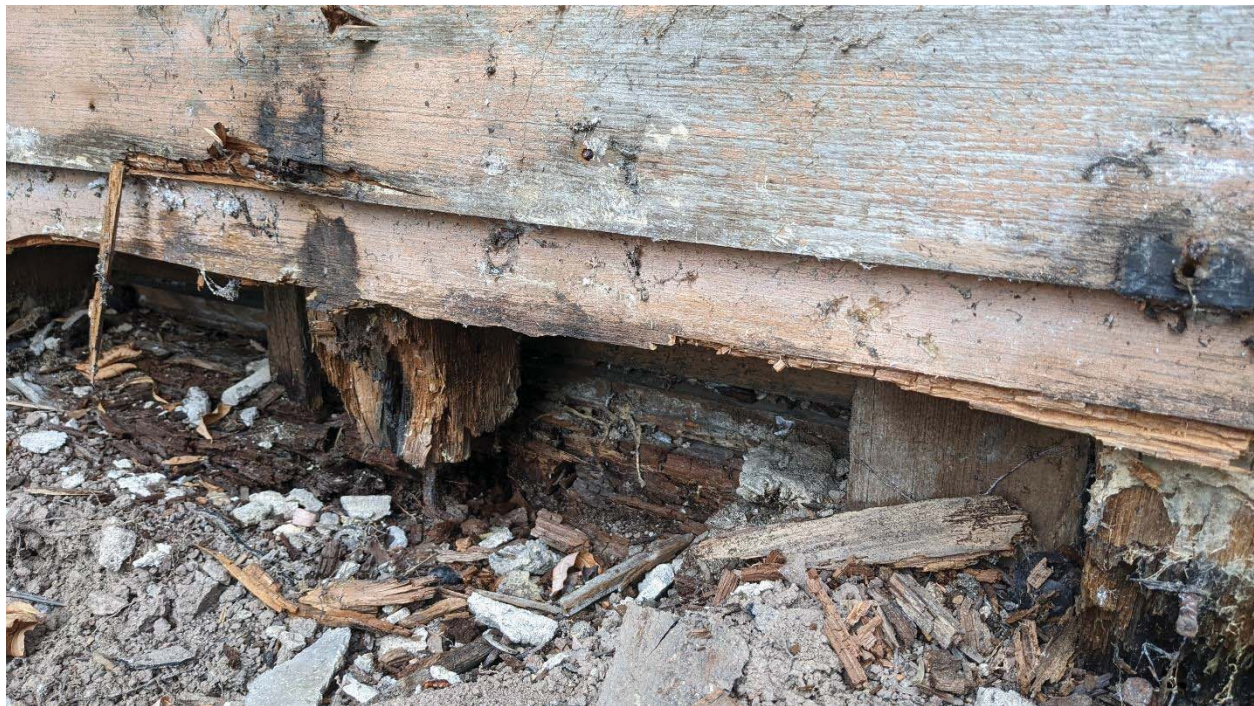
Photo 20: Rot of the exterior studs.

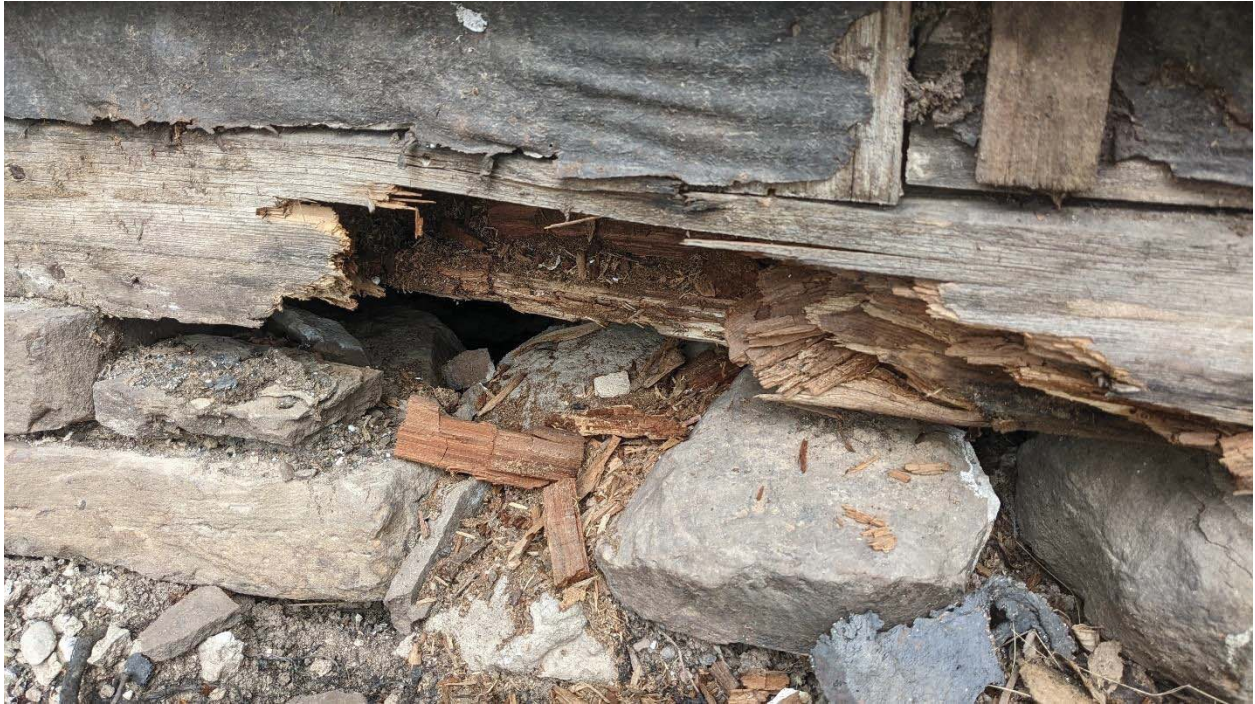
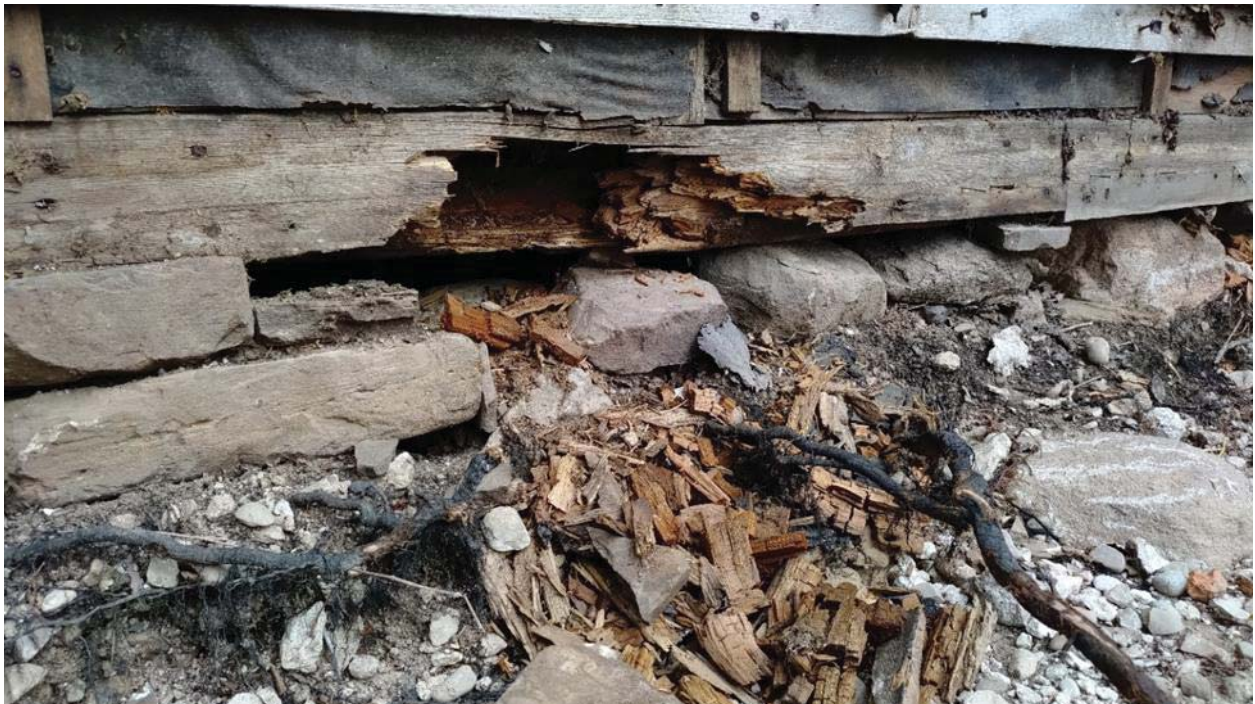
- 1) The perimeter soil grade was pulled back to expose the house foundation at the time of our arrival. The entire perimeter wood sills had signs of being in direct contact with organic soil.

Photo 21: Rot of the perimeter sill beams.

Photo 22: Rot of the perimeter sill beams.
