2108 Lakeshore Road East, Oakville ON

Building 1 Structural Assessment

February 21, 2023

MTE File No.: 51975-200

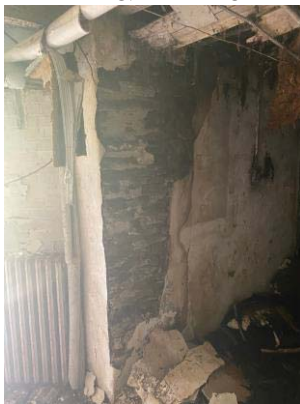
Photo 11

1. The existing building consists of a 1-storey small timber house, on a raised concrete (rubble / brick) foundation (Photo 11). There is a 1-storey garage to the north and to the east. The home is shown in Photo 2 & Photo 6.

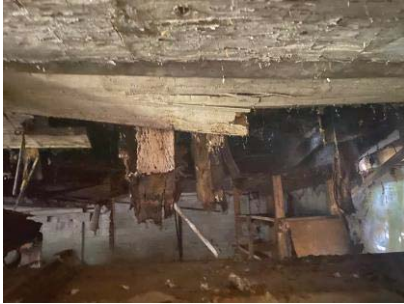
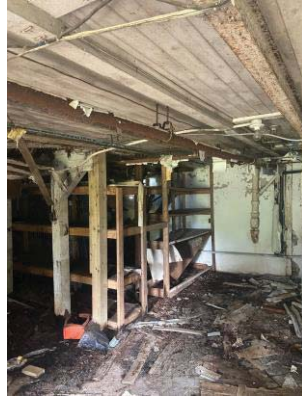
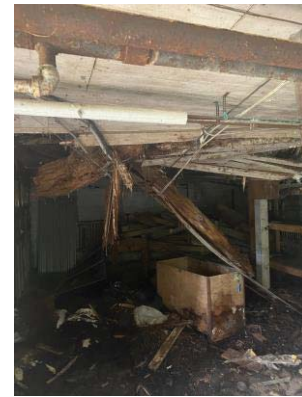
2. The building is only accessible at the basement level. The ground floor framing of the home is collapsing (Photos 10, 12, 13).

Building 1 could be lifted above the first floor framing and rebuilt onto a new foundation and ground floor framing. We would require a review of the roof and wall structure, but the existing framing could be strengthened to meet the structural requirements of the Ontario Building Code (OBC).

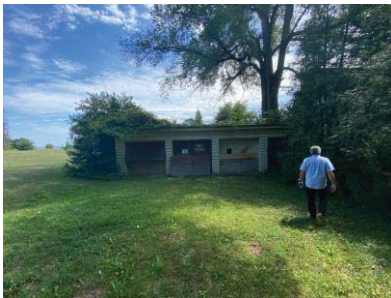
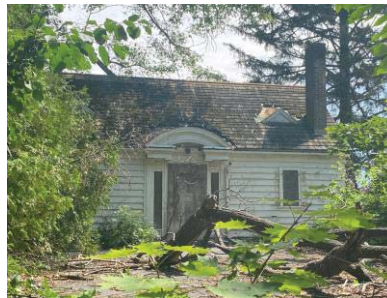
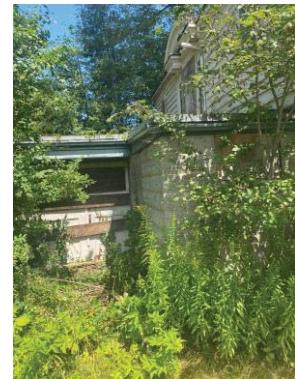
3. The flat roof over the garage has also collapsed (Photos 7, 8, 14).

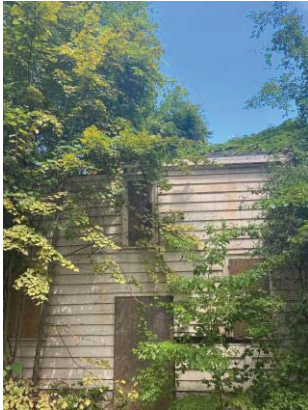
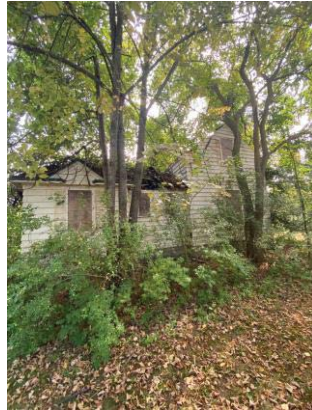
1. The building closer to Lakeshore Blvd. consists of a 1-½ storey timber building. This building was not accessible on the inside (Photos 3, 4).

2. Building 2 is dilapidated and is currently collapsing. This building is currently and unsafe and should be demolished. A demolition procedure should be submitted for review, and a demolition permit should be obtained.

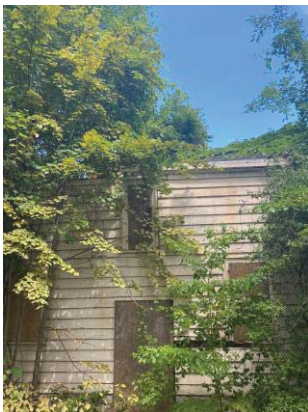
Photo 3

2. The west wall of the building is bowed by approximately 8”.
3. The roof behind the flat façade has completely collapsed and is overgrown (Photo 3).

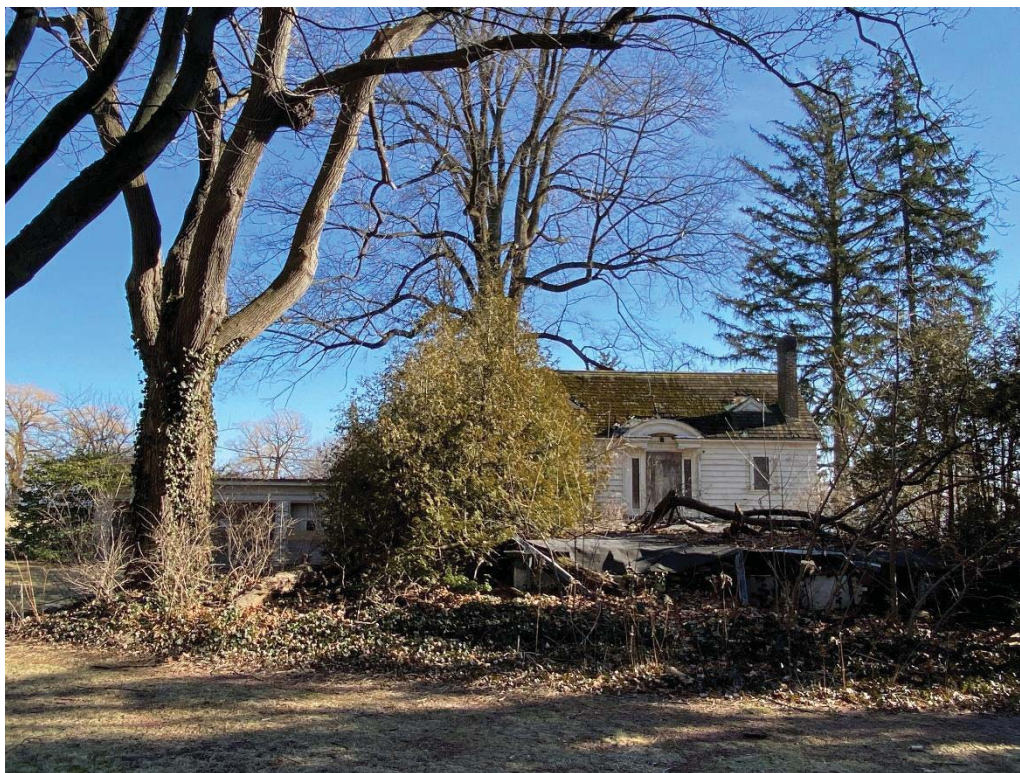
- The residential house and garage are vacant. They appear to have been abandoned for a while (Photograph No. 1);
- The house and garage superstructure is generally concealed by architectural finishes to the exception of one ceiling location in the garage. The house roof and building envelope is deteriorated. There is vegetation growth on the roof. The wood siding is stained and paint peeled off at various locations. The main door and windows are missing; they are boarded up. The basement roof has collapsed at the front door (Photographs No. 2, 5, 12 and 13);

Photograph No. 1 – Building 1 – House and Garage Front (North) Elevation

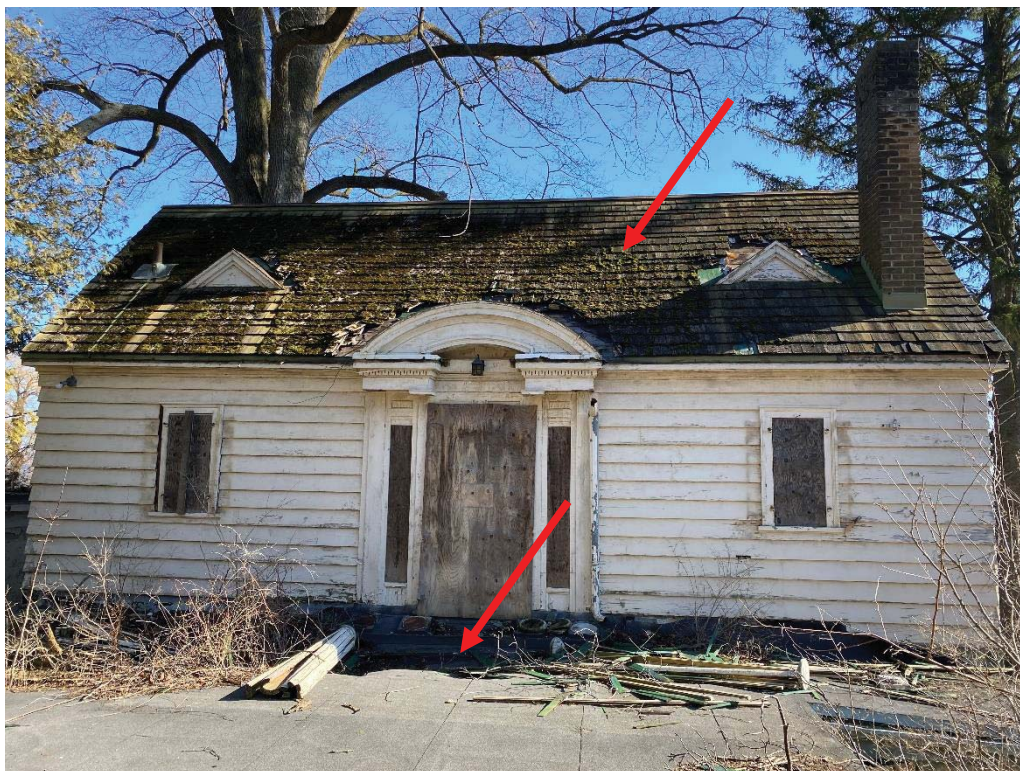
**Photograph No. 2 – House Front Elevation; Deteriorated Roof and Building Envelope
Collapsed Basement Roof at Front Door**

Based on the age of the building and its observed condition, we recommend demolishing the building and its building systems as they have reached the end of their service life. It is our opinion that the building is unsafe and hazardous to occupy.

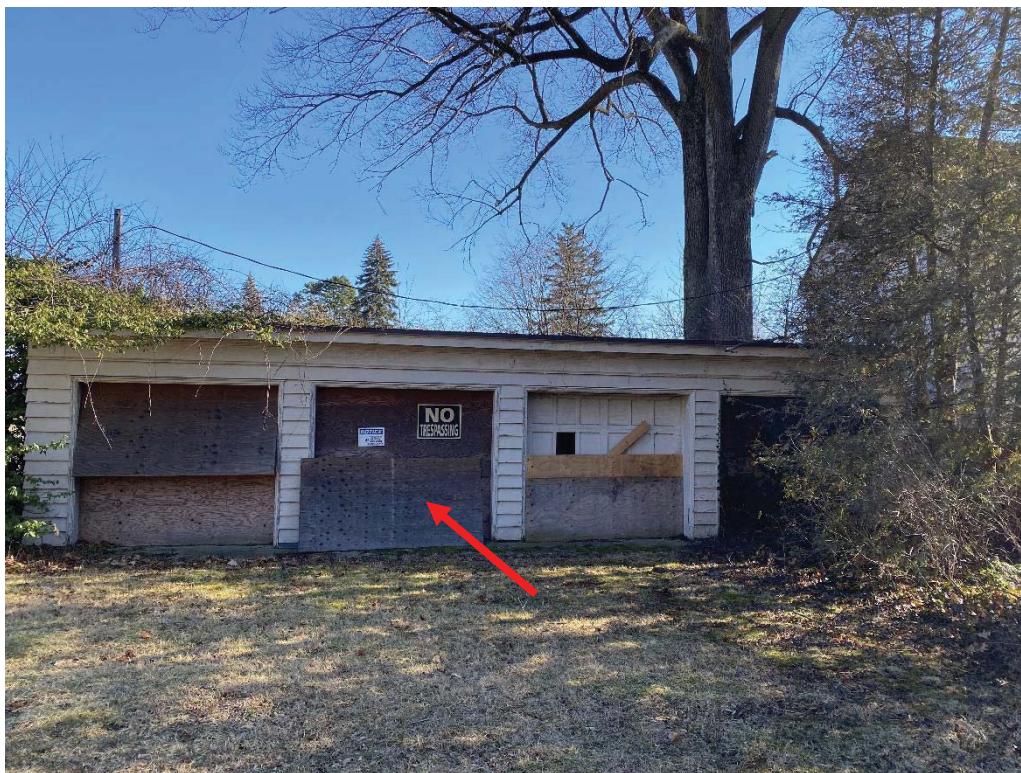
- The garage overhead doors are in poor condition. The windows openings and some of the doors have been boarded up with plywood. The exterior walls are stained and the paint peeled off at some locations (Photographs No. 3 and 4);

Photograph No. 3 – Garage Front Elevation – Deteriorated Building Envelope and Boarded Up Doors

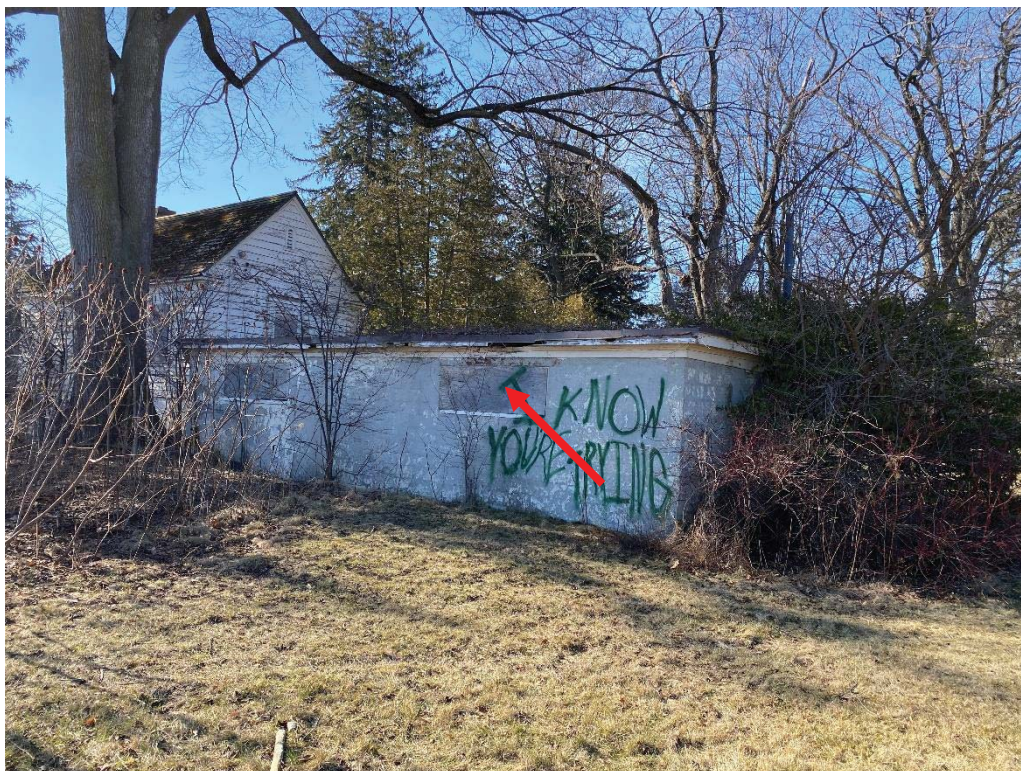
Photograph No. 4 – Garage Rear (South) Elevation; Boarded Up Windows

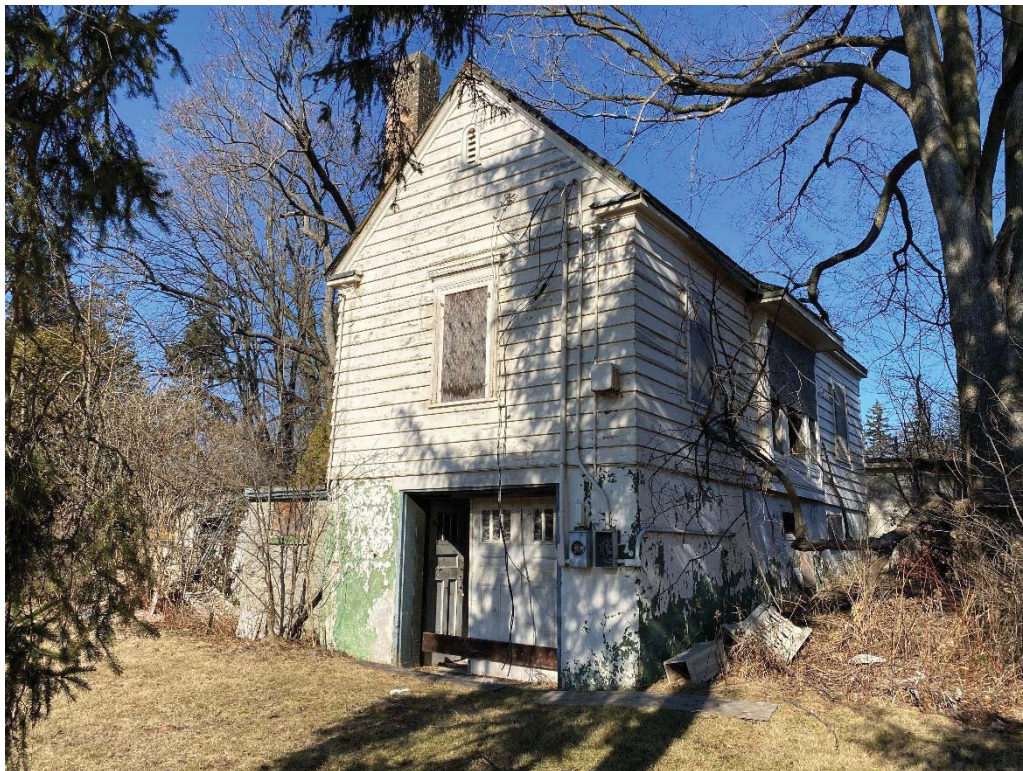
Photograph No. 5 – House Side (West) and Rear (South) Elevations

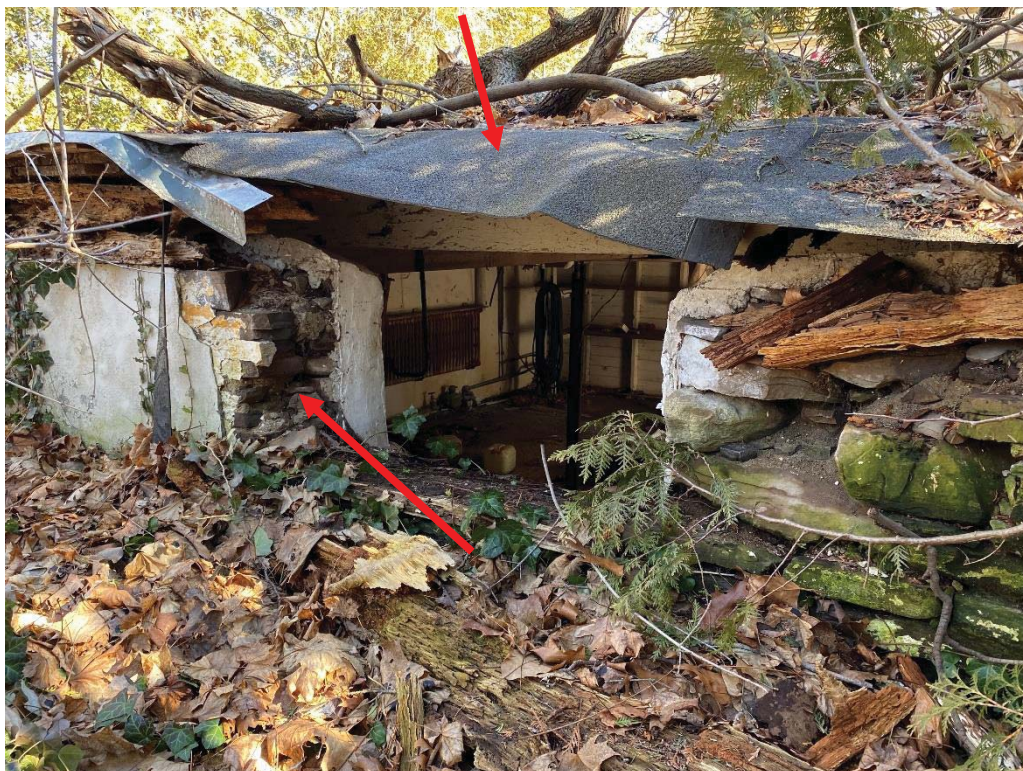
- The modified bitumen roof membrane over the basement is in poor condition. The basement roof has collapsed at various locations. The basement stone foundation walls are in poor condition (Photograph No. 6);

Photograph No. 6 – Deteriorated Basement Roof and Stone Foundation Walls

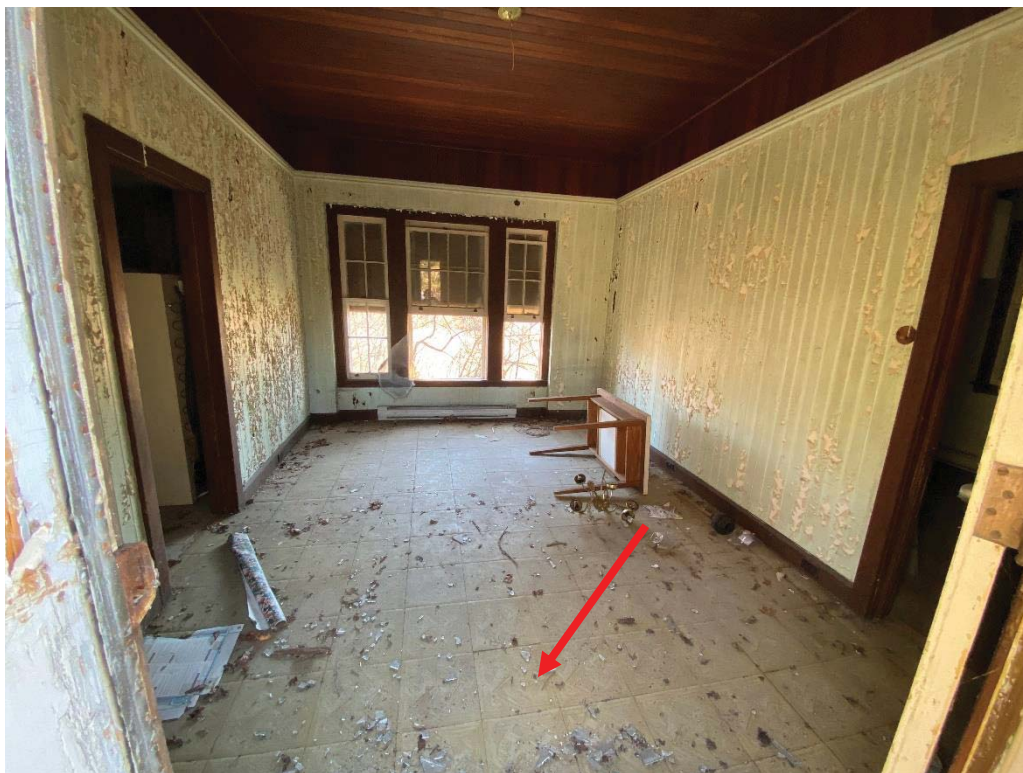
- The house main architectural finishes show evidence of moisture exposure. Roof leakage may have occurred. There is debris, including glass, on the living room floor (Photographs No. 7 and 8);

Photograph No. 7 – House Living Room; Concealed Roof and Wall Framing, Debris on Floor

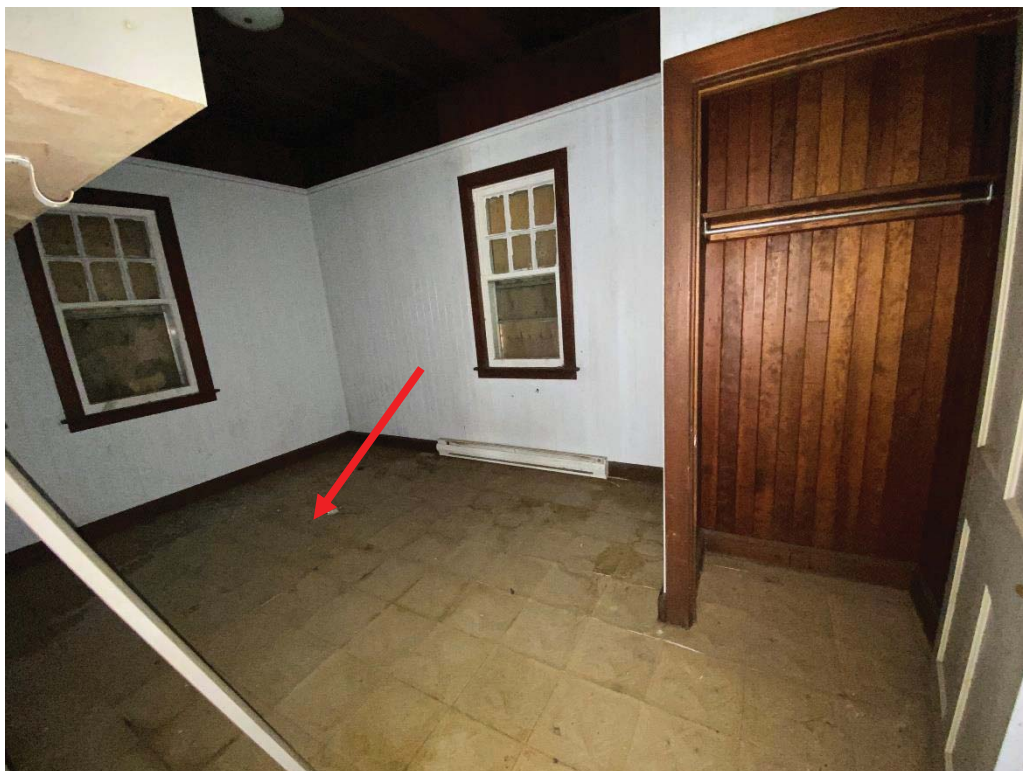
Photograph No. 8 – House Bedroom; Concealed Roof and Wall Framing; Stains on Floor Finishes

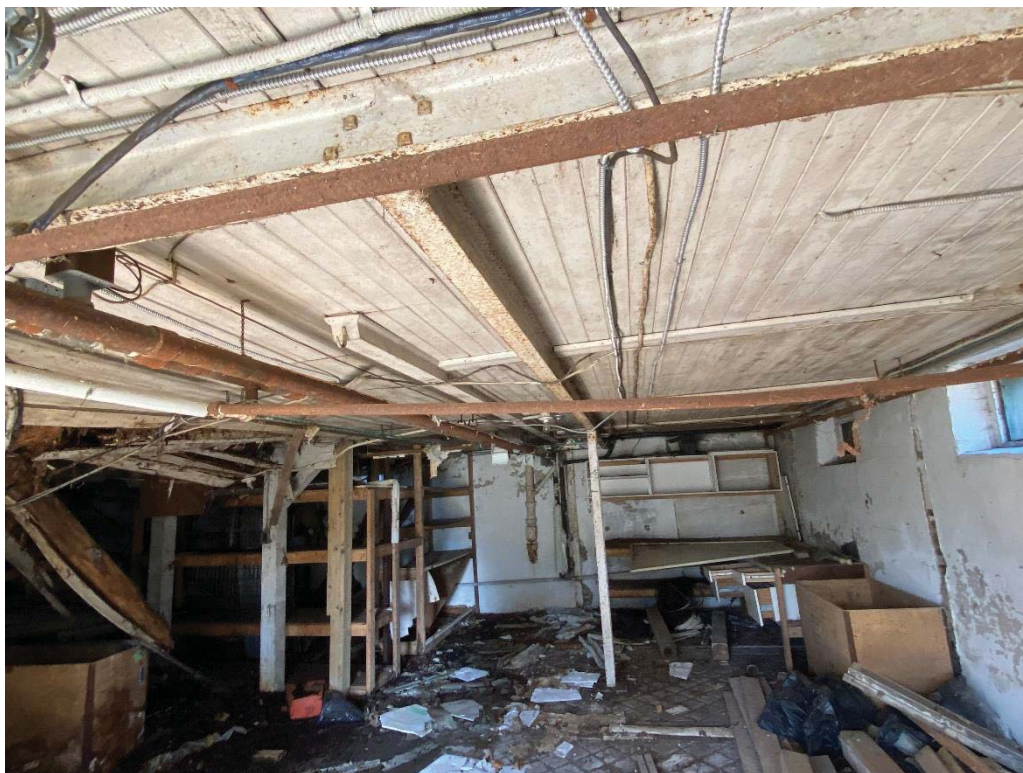
- The house supporting steel beams and columns are corroded. The steel post baseplate rests on the basement concrete slab-on-grade. There is water stains on the basement walls and floor (Photographs No. 9 to 11);

Photograph No. 9 – Basement Structural Steel Framing supporting House Main Floor

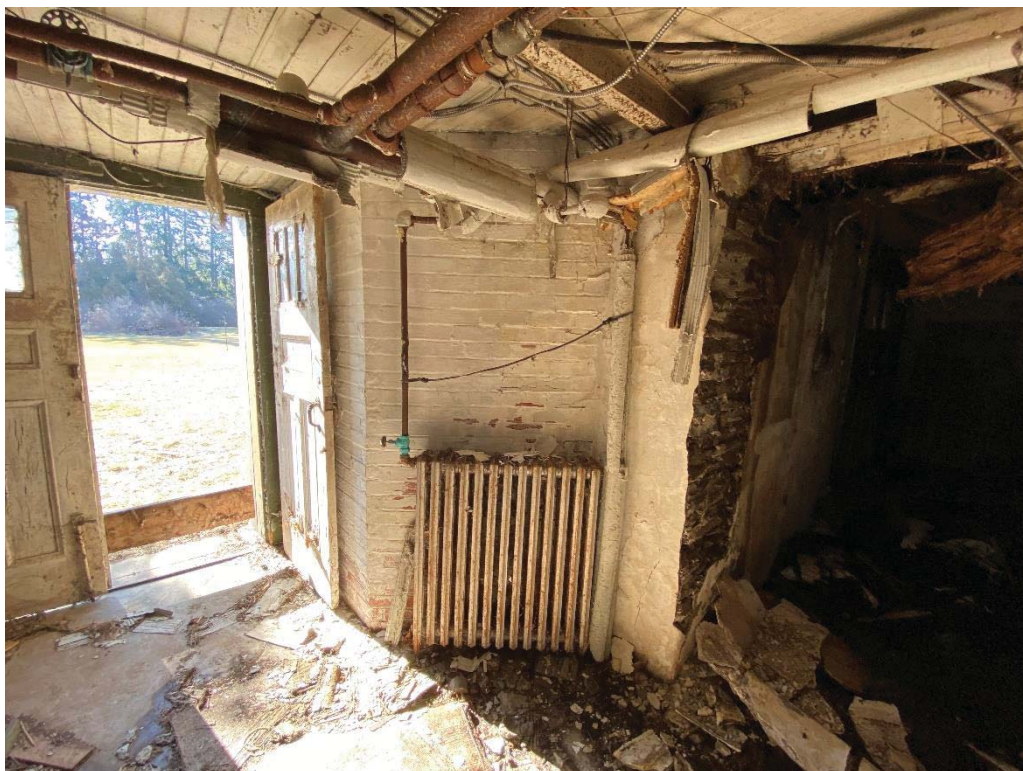
Photograph No. 10 – Basement Stone and Brick Foundation Walls

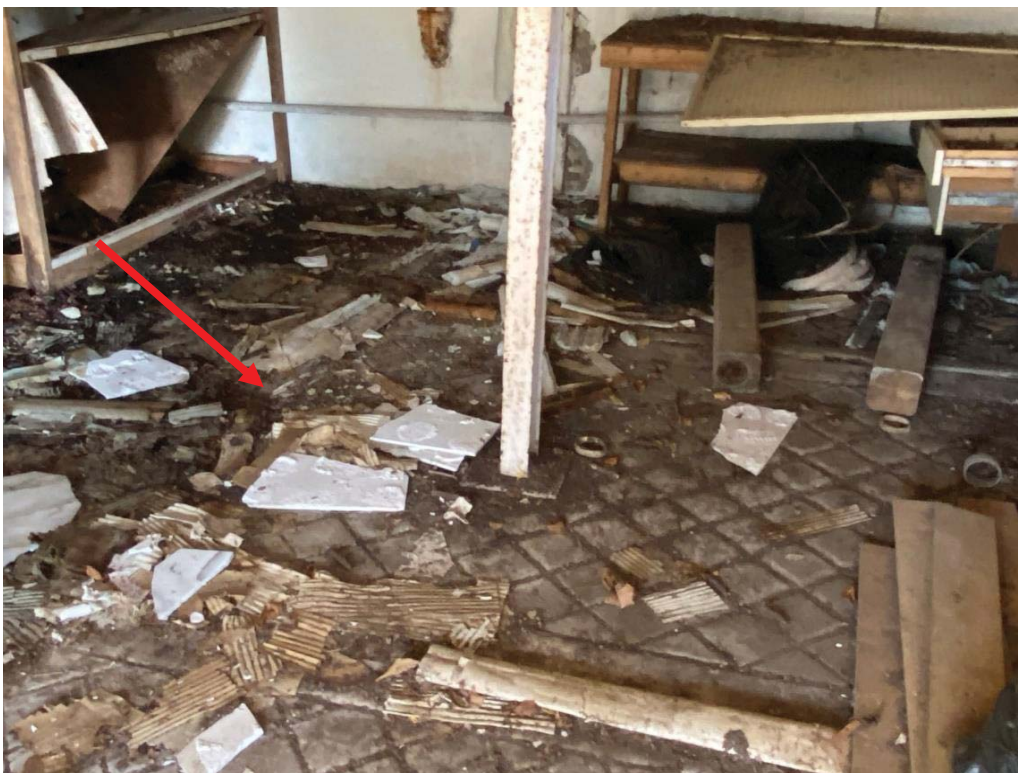
Photograph No. 11 – Basement Steel Column supporting House Main Floor; Stains and Debris on Floor

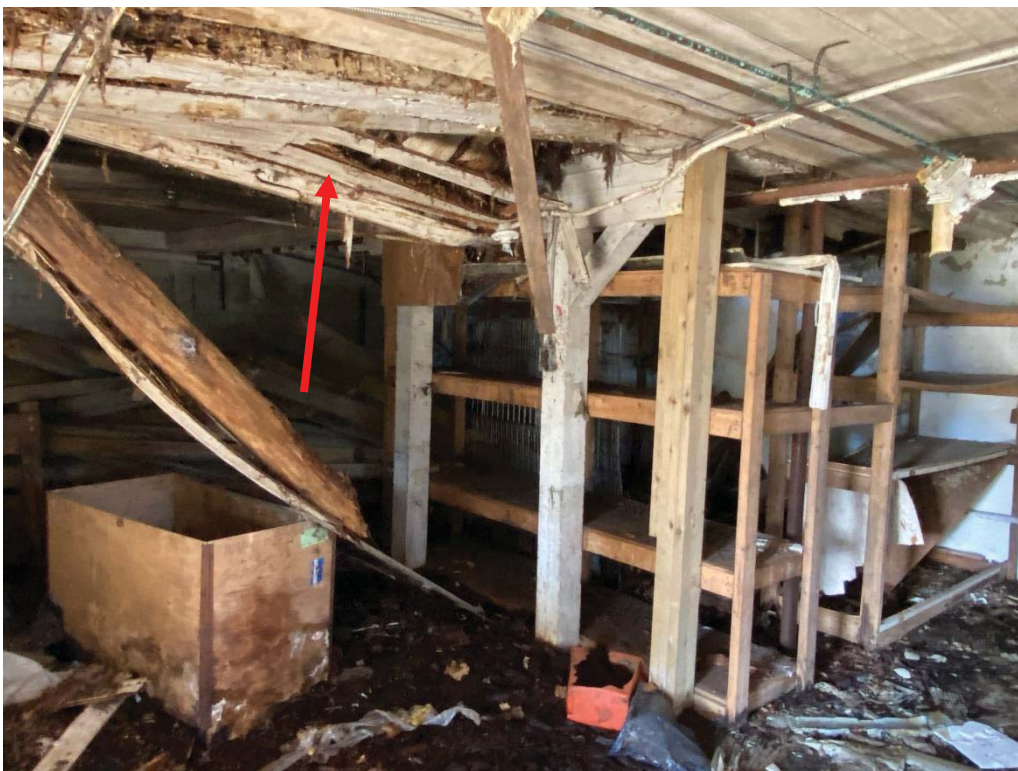
Photograph No. 12 – Collapsed Basement Roof Structure

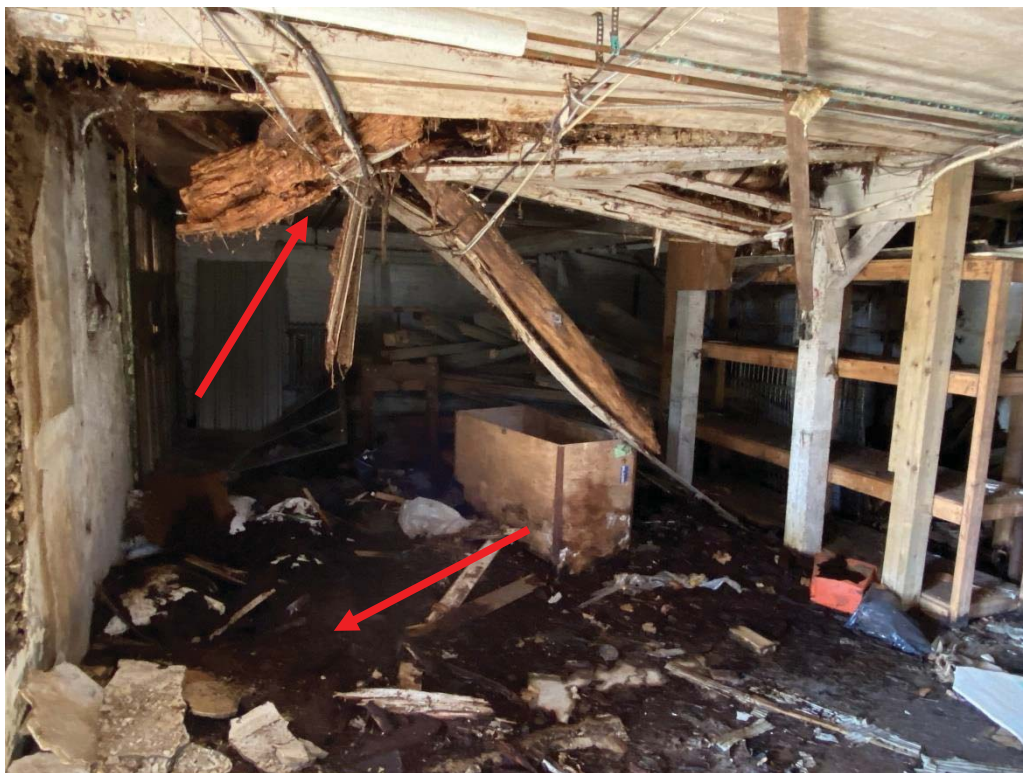
Photograph No. 13 – Evidence of Water in Basement; Collapsed Basement Roof

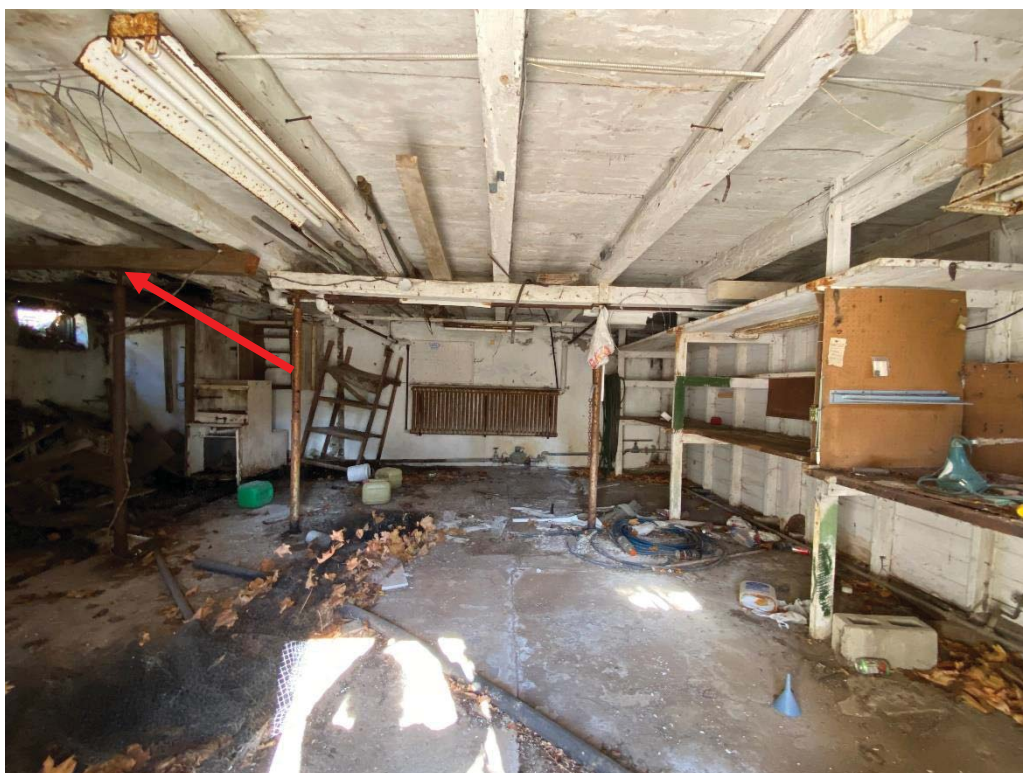
- The basement roof wood beams are generally cracked and rot where they have been exposed to water. The roof wood decking is stained at various locations. There are additional wood beams and steel jacks that appeared to have been installed as shoring of the roof structure. The concrete slab-on-grade is cracked at various locations (Photographs 14 to 16); and,

Photograph No. 14 – Basement Roof Structural Framing; Shoring

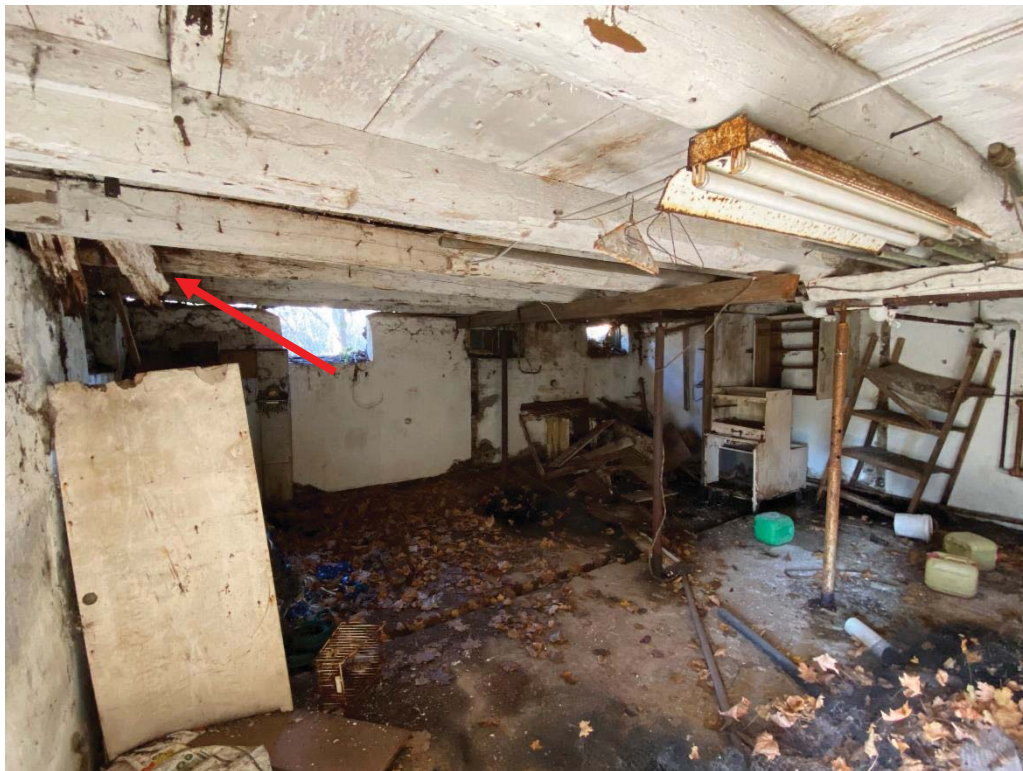
The house substructure and the basement roof wood framing are in poor condition. Many of the structural members have been exposed to moisture and are deteriorated. The wood beams are cracked, rot and have collapsed at some locations. The steel beams and posts are corroded. The interior posts are not bearing on a dedicated concrete footing. The stone foundation wall is deteriorated, and some stones are misplaced or missing. The concrete slab-on-grade is cracked at various locations. Furthermore, it appears that temporary shoring was installed to support the basement roof structure and prevent the roof from further collapse.

Photograph No. 15 – Stained and Rot Basement Roof Wood Beams

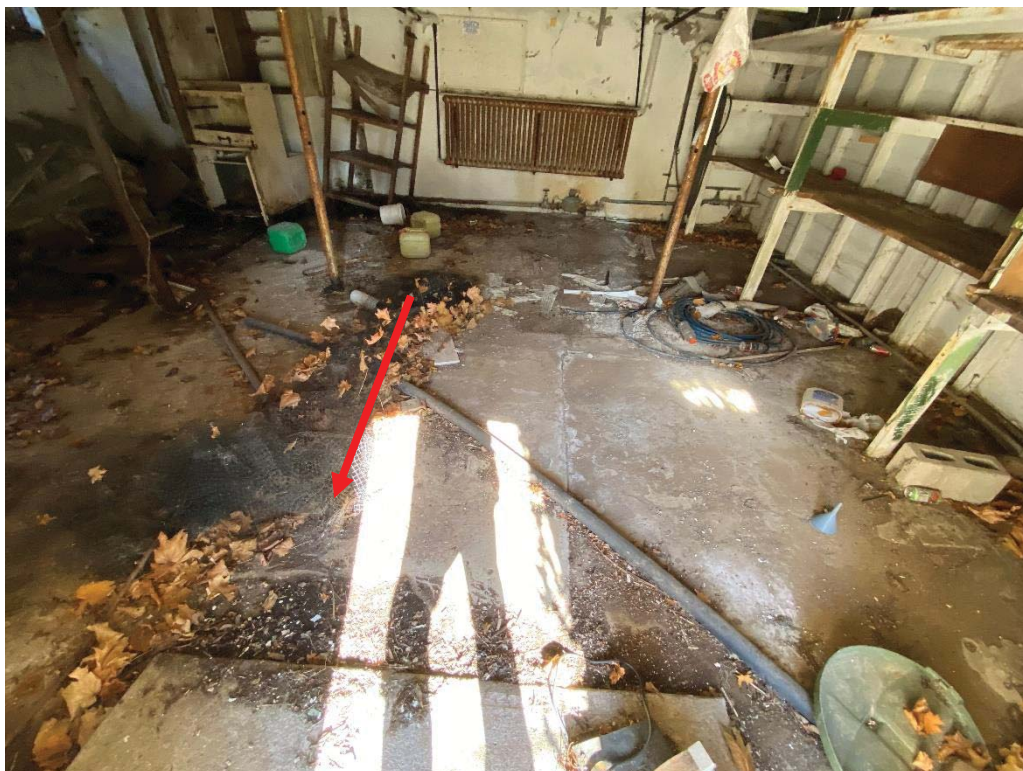
Photograph No. 16 – Cracked Basement Concrete Slab-on-Grade

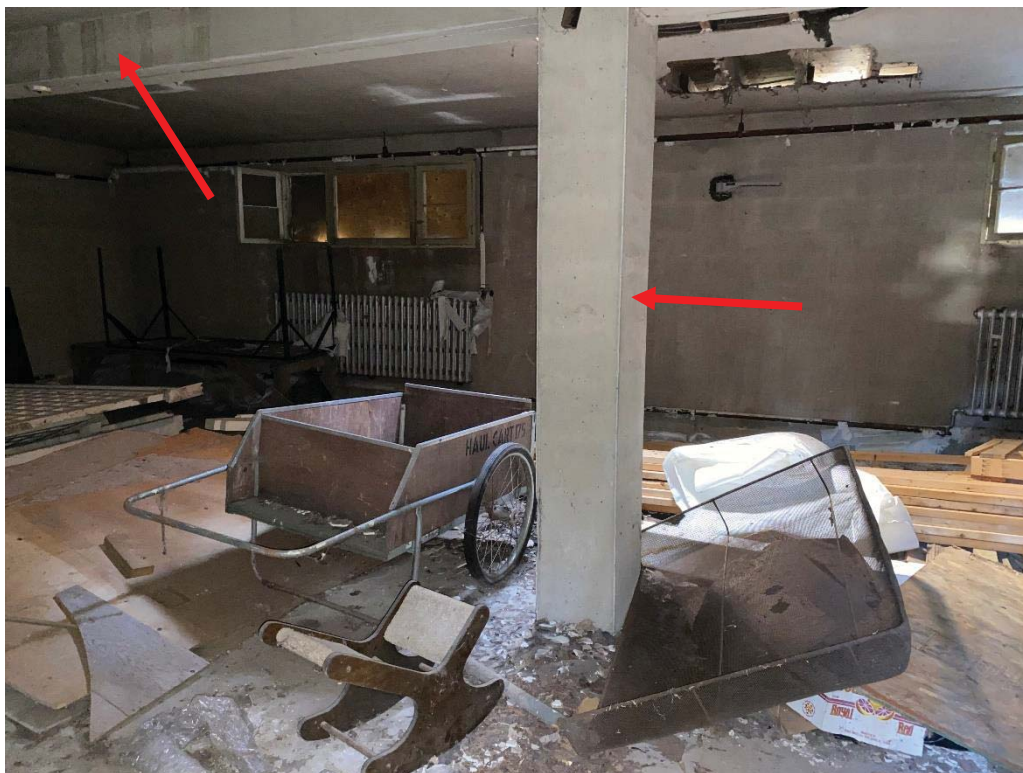
- The garage roof ceiling is stained, and the roof contains vegetation (Photographs No. 17 and 20).

Photograph No. 17 – Concealed Garage Roof Supporting Column; Stained Ceiling

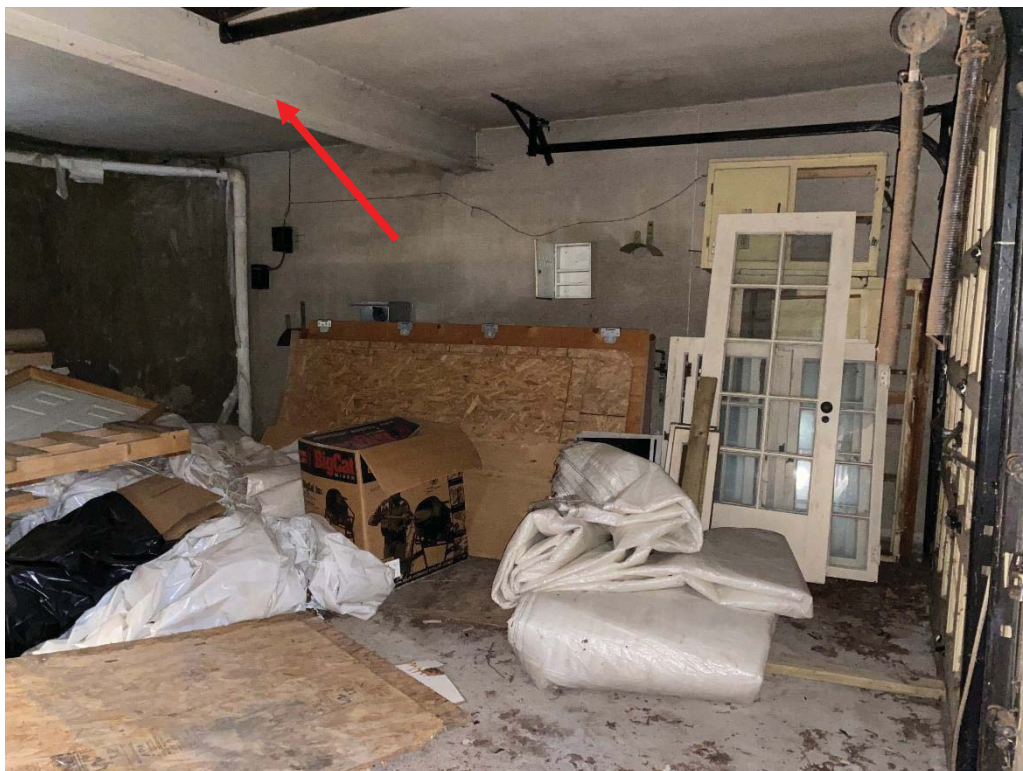
Photograph No. 18 – Concealed Garage Roof Beam

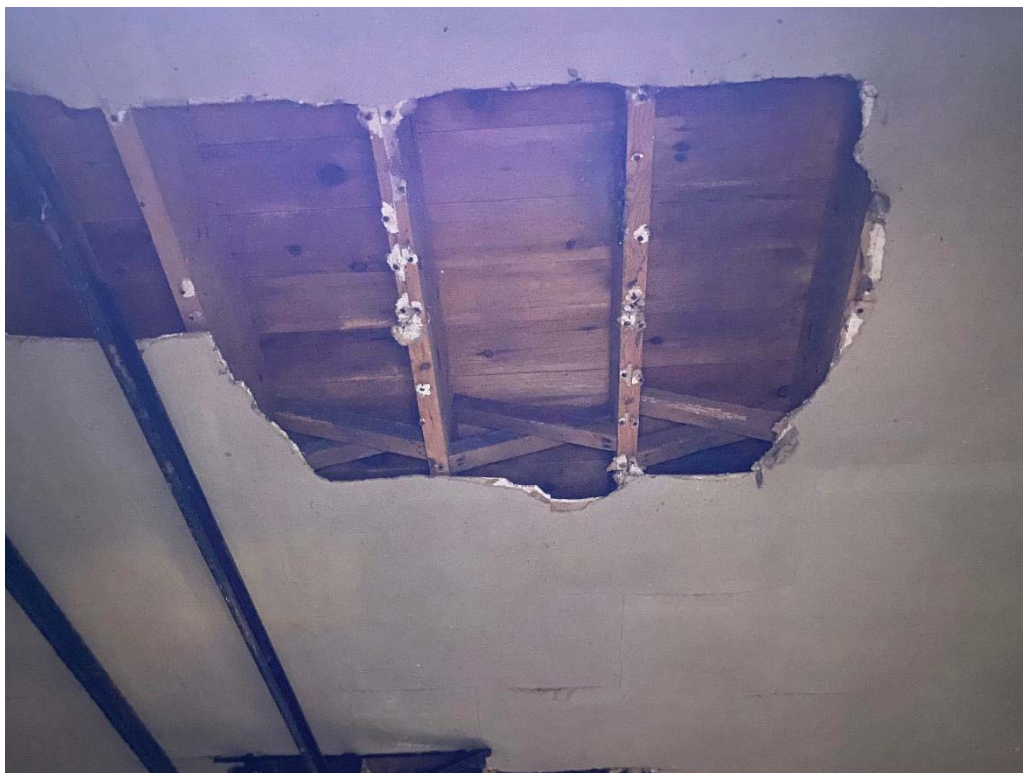
Photograph No. 19 – Garage Wood Roof Joists

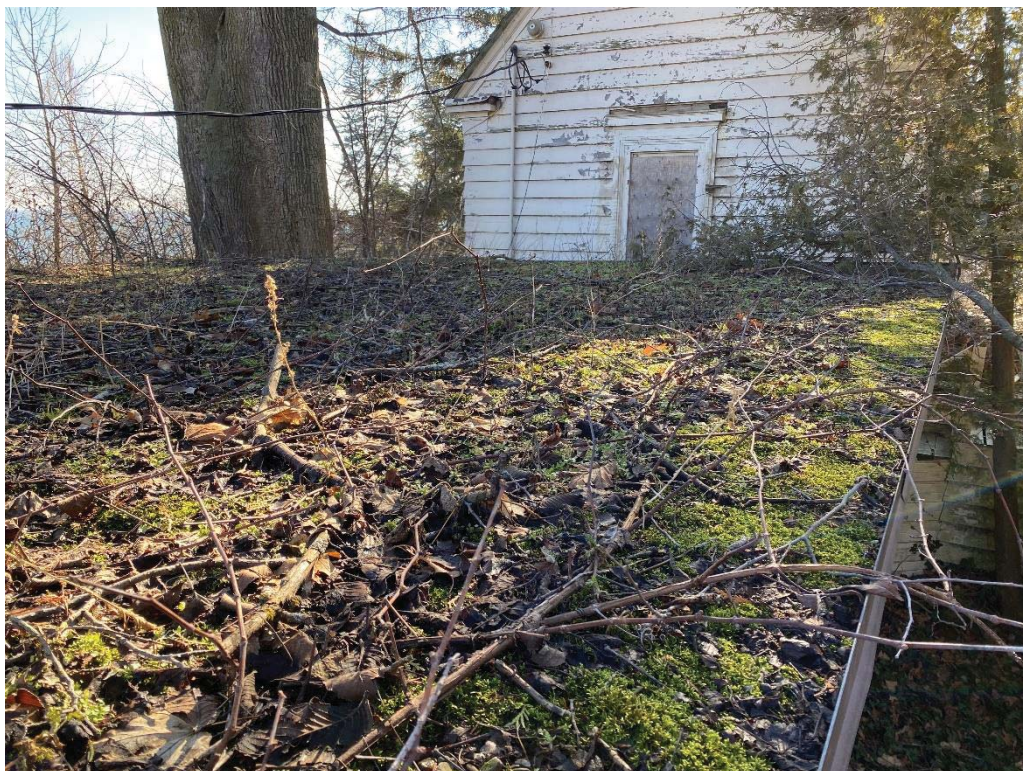
Photograph No. 20 – Garage Roof; Vegetation Growth
