HERITAGE MEMORANDUM

Subject: DEMOLITION PERMIT APPLICATION

Project: 42 Lakeshore Road West

Reference: Structural Assessment Report – 42 Lakeshore Rd. West, Oakville

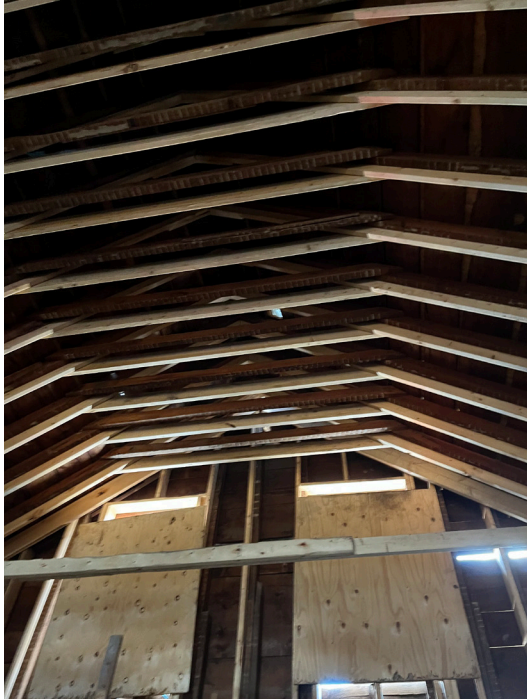
Structural reinforcement along roofline (ERA, 2023).

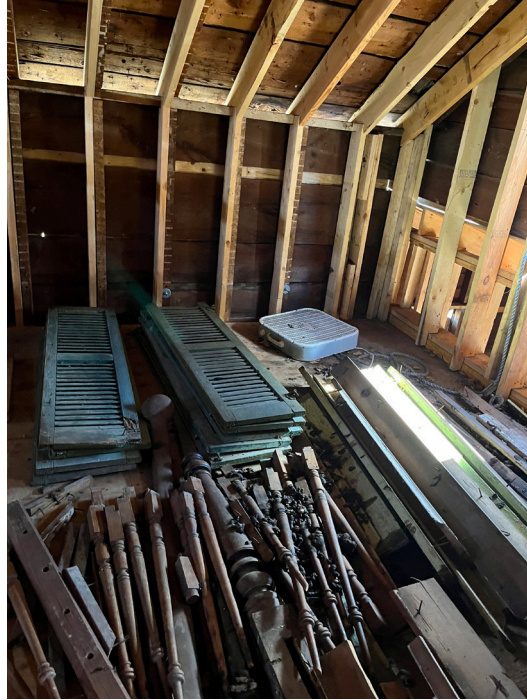
ERA’s analysis further concludes salvaged exterior wooden elements currently stored within the building would require replacement, as follows: 100% of window trim; and at least 90% of wooden shutters.

Salvaged items on second floor (ERA, 2023).

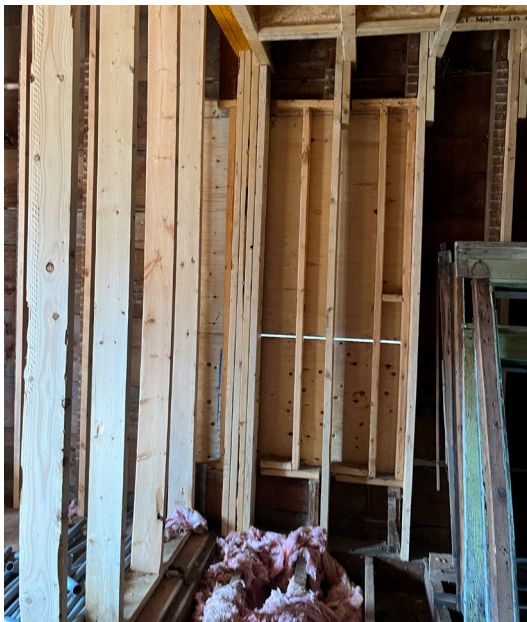
Structural reinforcement on first floor (ERA, 2023).

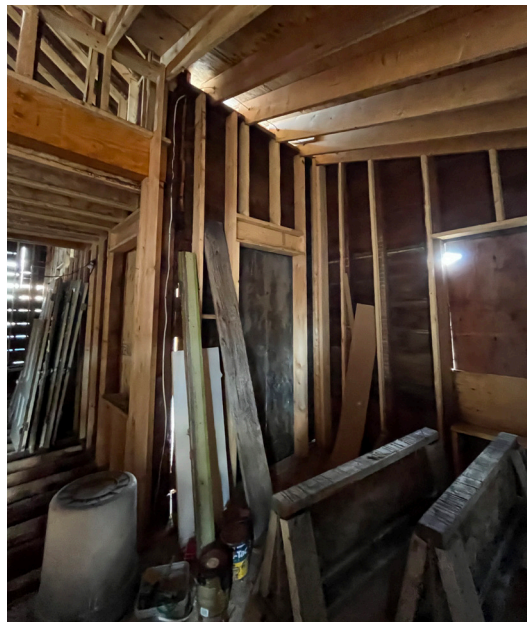
Structural reinforcement on first floor (ERA, 2023).

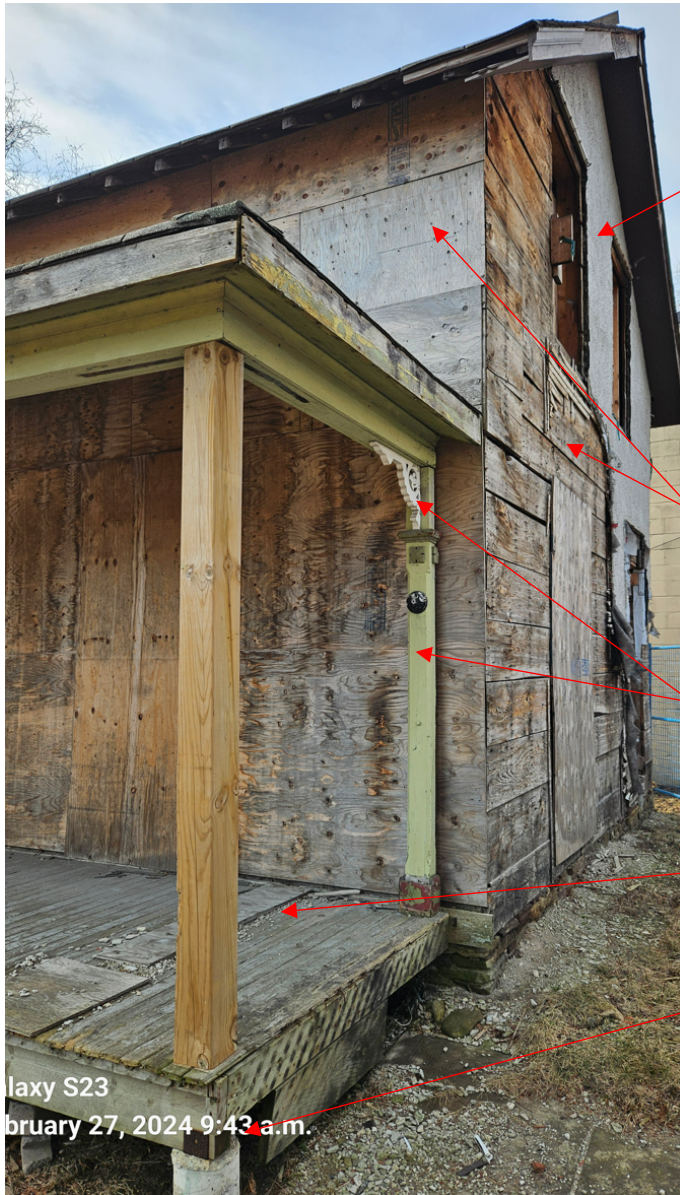
Picture #1

We observed that the original and non-original stucco finishing has been removed and only a small part of the non-original stucco remains at the front elevation. Due to this, the exterior materials that conform the facades exhibit a high level of environmental deterioration. Even the new plywood installed on all the wall elevations, in previous effort to conserve or repair the building, is in a defective condition.

Only one original pilaster of the existing observed posts and the roof framing (side porch) have been preserved. The rest of the structural members including the Sonotubes are new construction. Note that the existing subfloor has a high level of decay and due to this, I suspect a deterioration between the subflooring damaged planks and existing new wood floor beams.

Only part of the non-original stucco that remains.

Existing wood siding and new sheathing plywood that are damaged for weather exposure.

Architectural fixture, one post and bracket (from the original construction) that remain.

Existing side porch subflooring in defective conditions.

New Sonotube from previous rehabilitation.

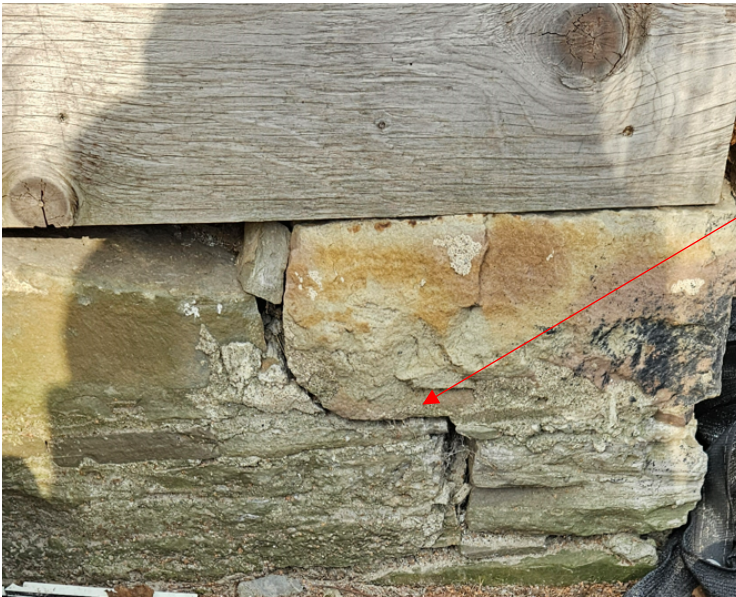
Picture #2

The masonry parging that once provided uniformity and strength to the exterior foundation walls has been largely gone. We observed cracks on the south-east corner of the building as well as material delamination and loose stones. The foundation walls are faulty and in very poor condition.

Please note that the depth of foundation is unknown and hasn't been addressed in this report, however, we suspect the footings are not protected against frost action or designed to prevent damage resulting from adfreezing and frost jacking.

Crack on the south-east corner of the rubble foundation wall.

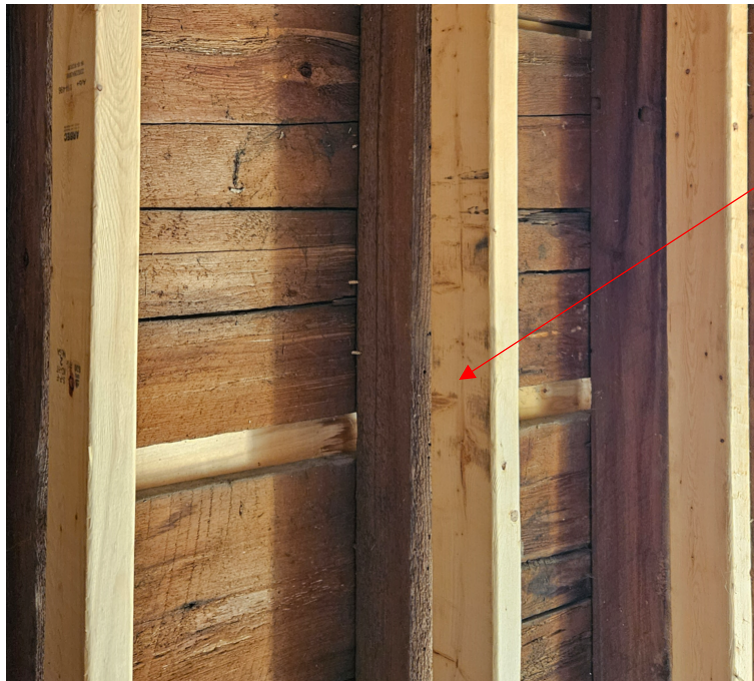
Picture #3

It appears to be a discrepancy when we mentioned that there are existing and new exterior wall studs, but there isn't. The entire rear part of the building was framed with new 2x4's wood studs but these new walls were never properly connected or fastened to the existing wood studs. The new stud walls were built in front of the existing studs. Because this, the lateral loads such as the wind load cannot be transferred under these conditions to the other structural members if the path load is discontinuous or interrupted. It is probable that the new wall was constructed due to the defective condition of the existing studs.

New stud wall at rear addition that is not fastened to the existing studs.

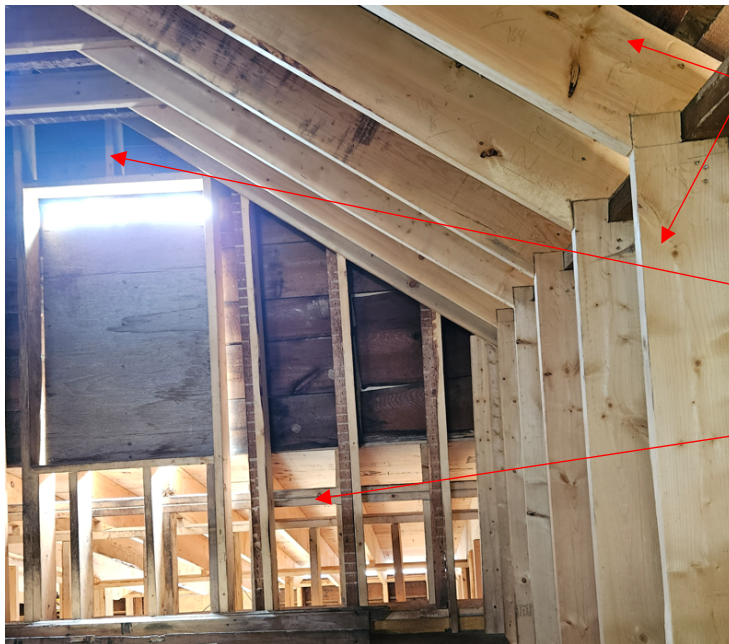
Picture #4

Except on the front main door, no structural lintels were observed during this structural assessment.

New lumber used to reinforce the existing roof joists.

Opening with no lintel.

Knee wall constructed to support the new roof joists at rear addition. A hinge point created that is not ideal.

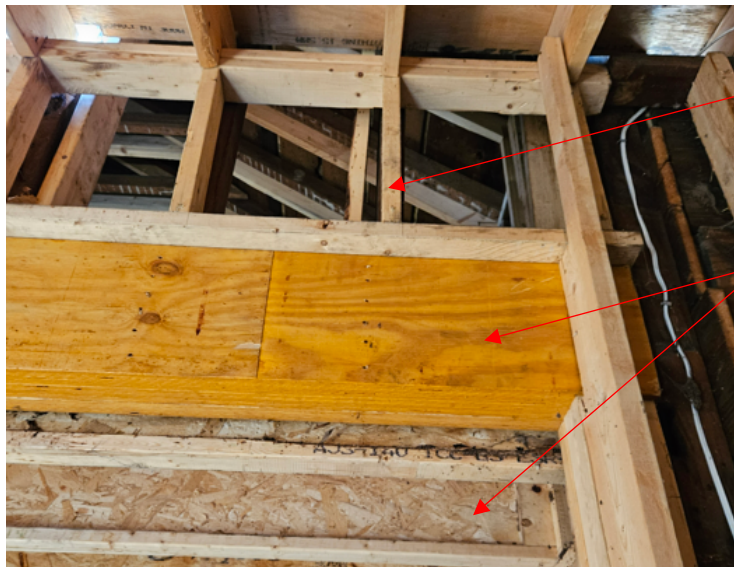
Picture #5

Half of the existing floor joists in this part of the building have been removed to create a vaulted ceiling. In the other half, new engineered floor joists, spanning from side to side, have been installed.

New knee wall.

New LVL and engineered joists.
