Re. Structural and building engineering assessment at 324 Spruce Street, Oakville, Ontario

Date: March 5, 2024

Expert Report

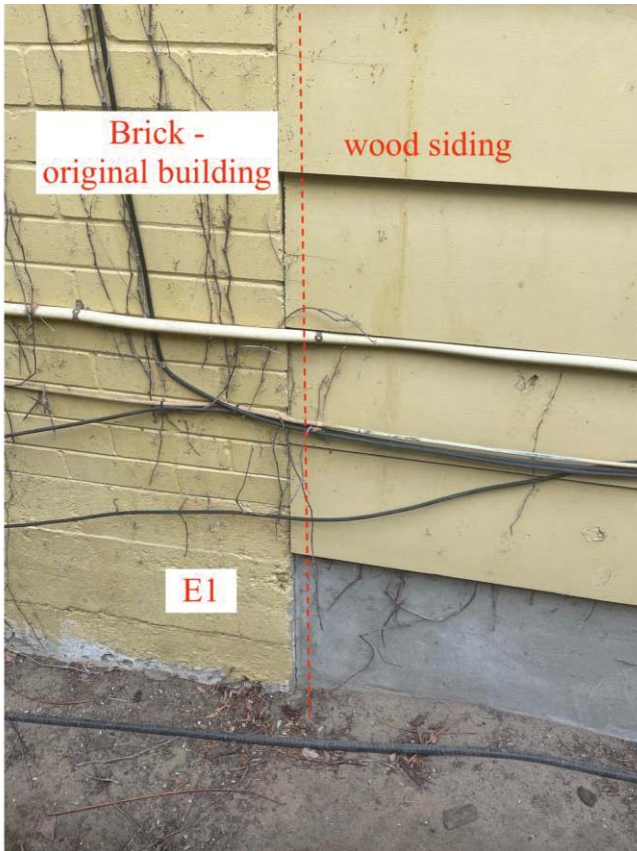
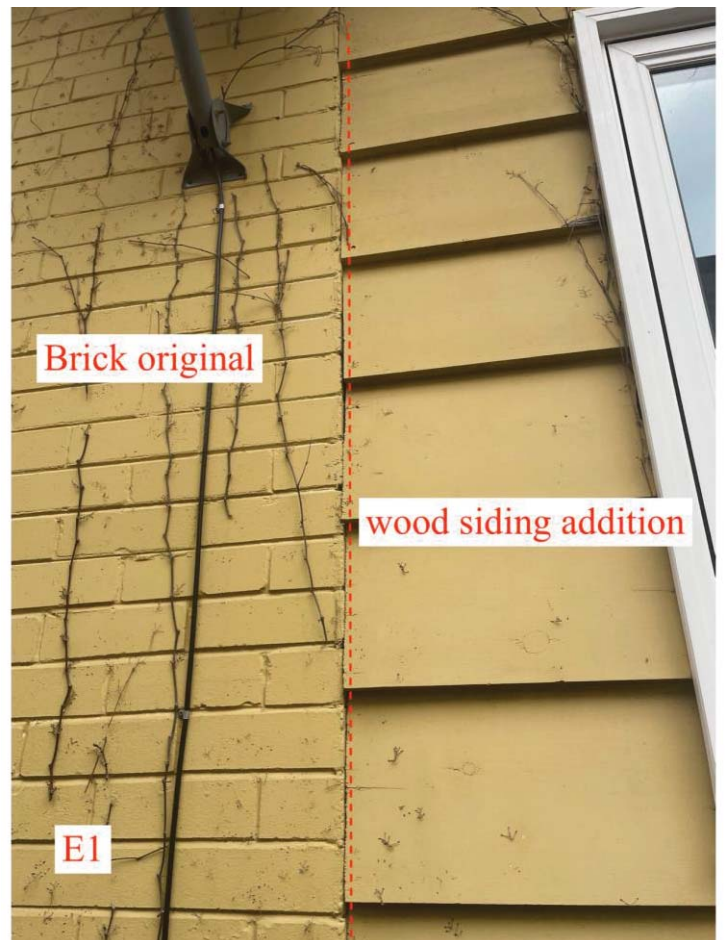
Demarcation lines - original additions

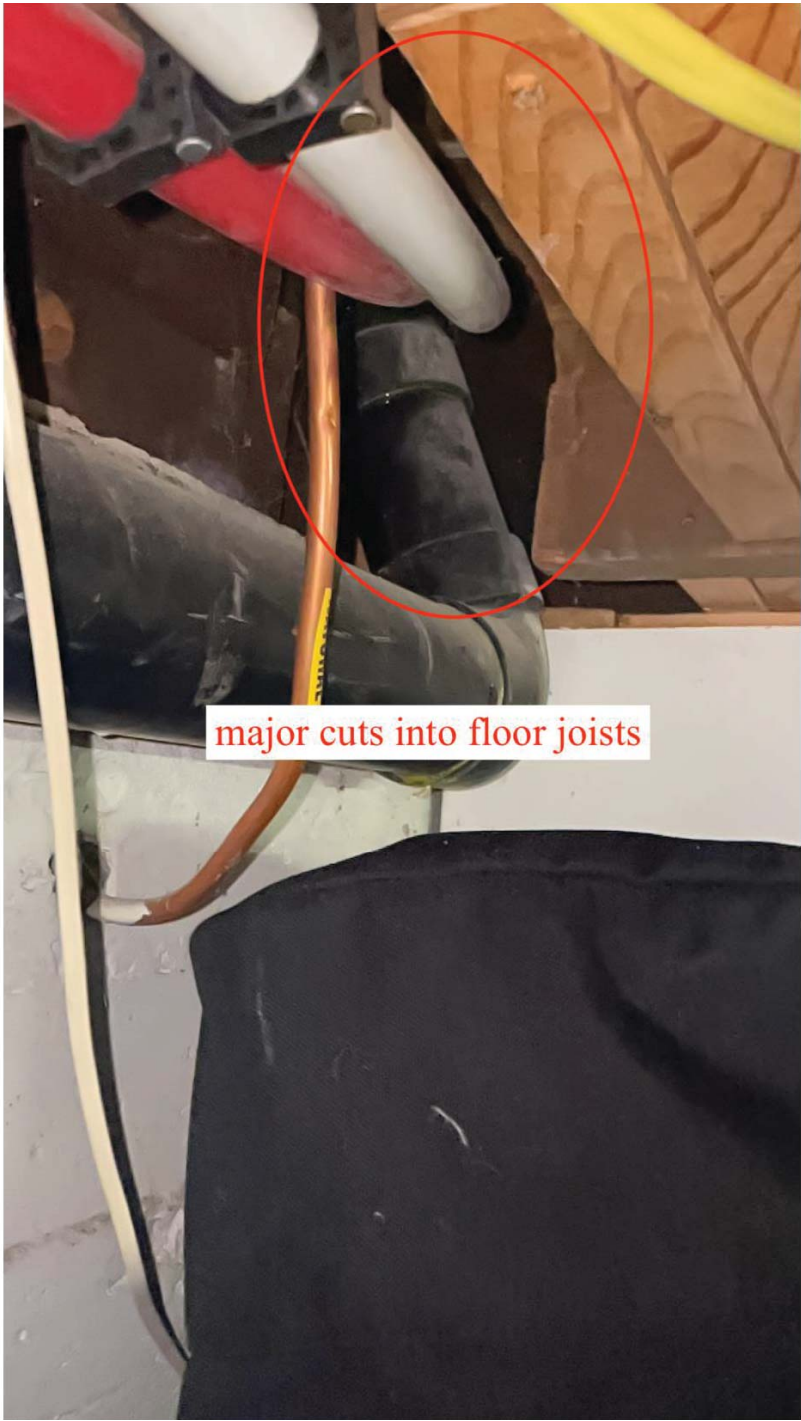
Some joists were observed cut, to allow mechanical installation (plumbing or heating).

major cuts into floor joists

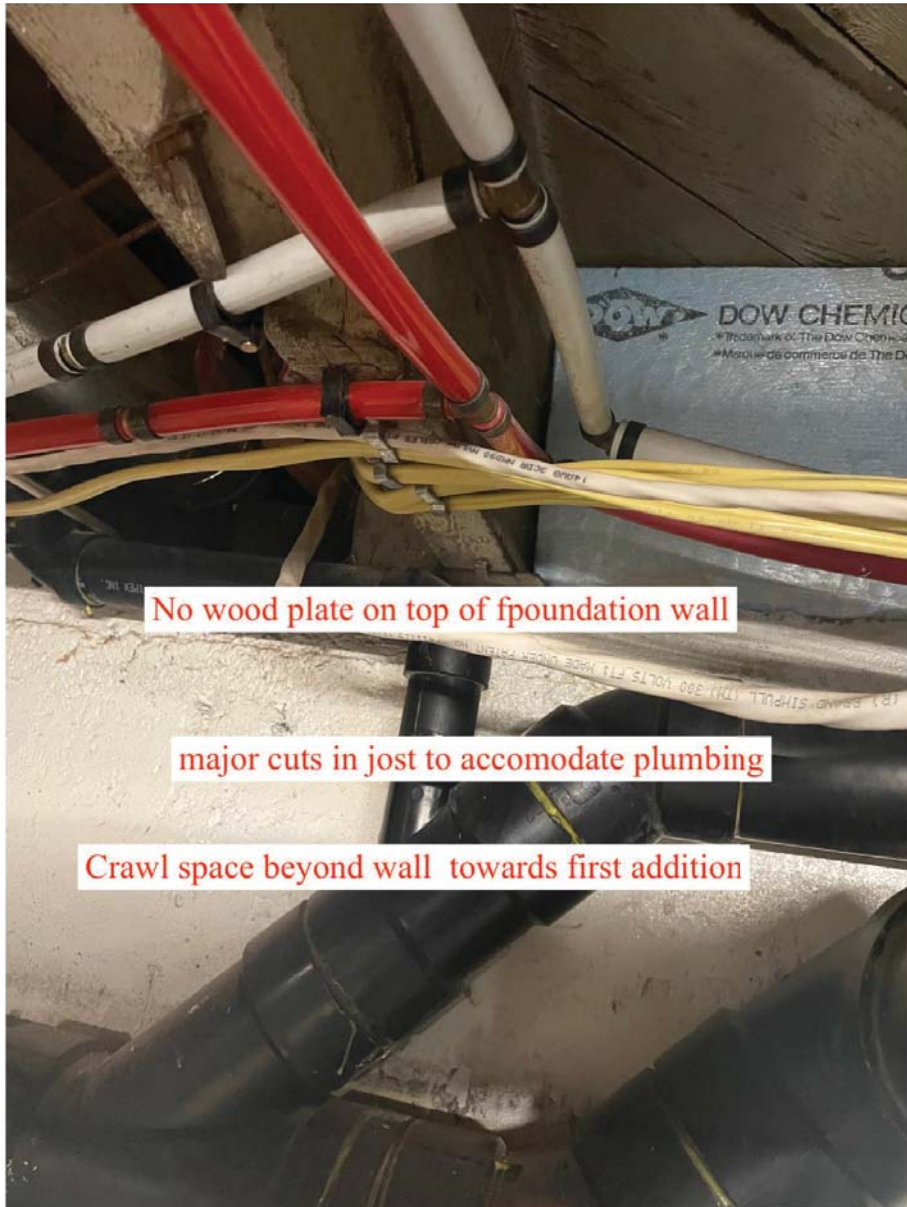
Floor joists were observed bearing on bare concrete and not on a typical wood plate. The lack of a wood plate indicates the probability of no anchorage to the foundation walls and no connection joist to concrete walls.

No wood plate on top of foundation wall

major cuts in jost to accomodate plumbing

Crawl space beyond wall towards first addition

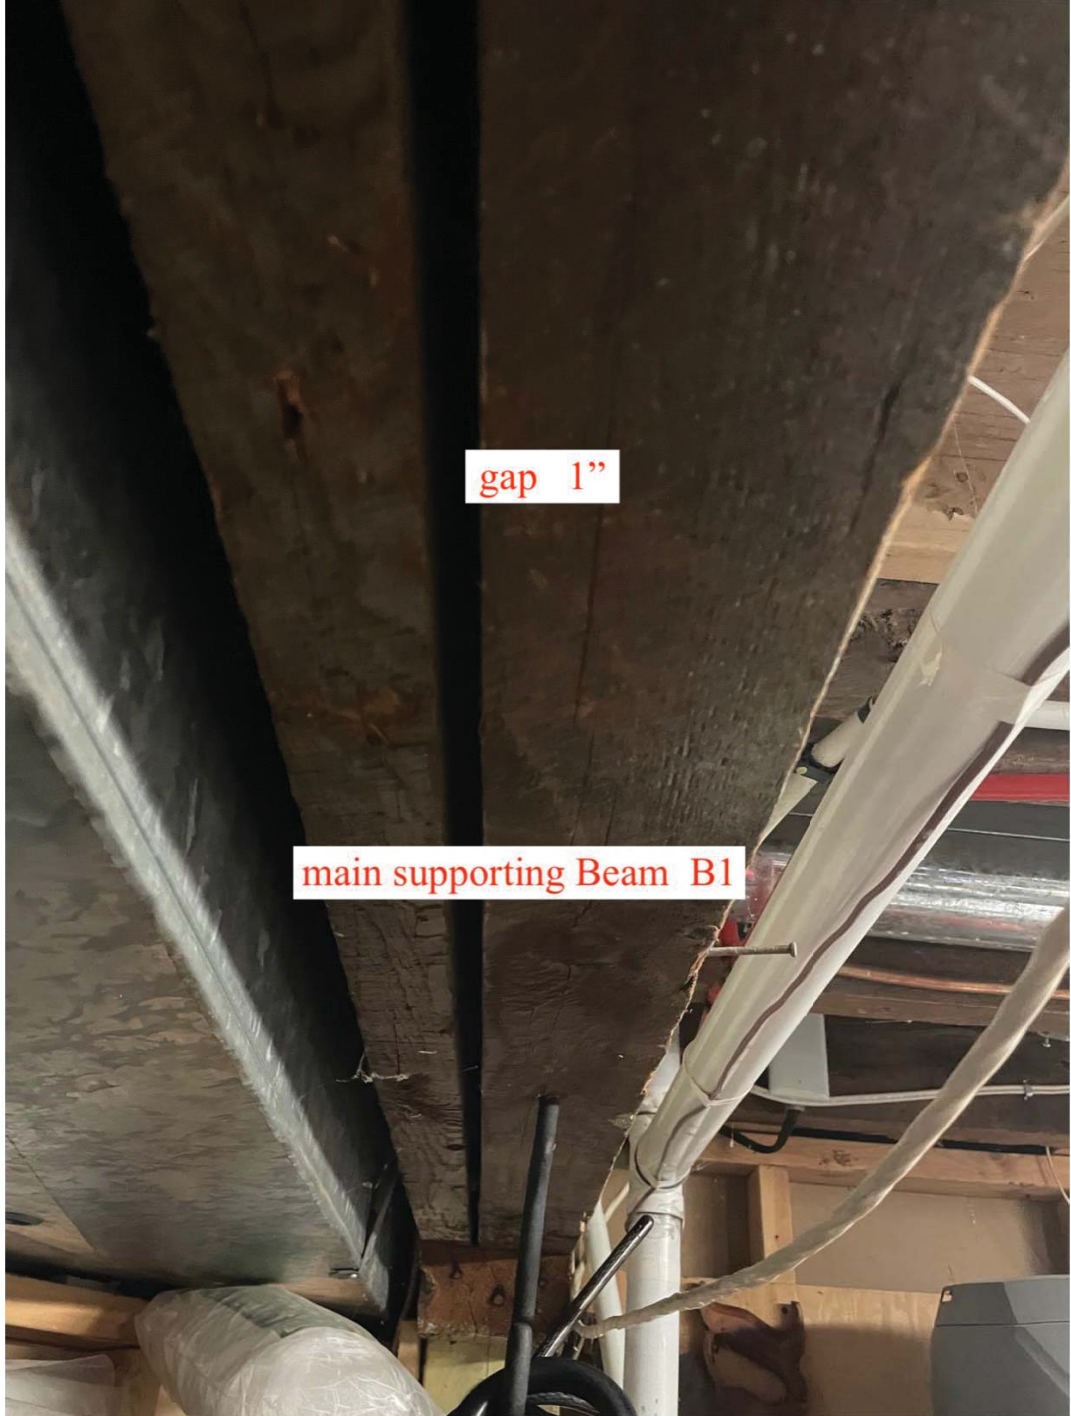
Wood beam B1 was observed as a timber cut 3.5”x8” with one piece of 2”x8” beside it.

No connection, nailing or bolting between the two. We observed a gap of an approximate 0.25” between the timber cut beam (3.5”x8”) and the 2”x8” added.

Main supporting wood beam (B1) is supporting main floor and second floor so it is the structural core of the building. The beam is undersized and we consider it a possible structural hazard. After loading the beam according to latest building code requirements, with 1.9 Kpa life load the beam failed in all areas.

Failed shear (197%), failed moment (500%), and failed live load deflection (360%). We understand that standards at the time of construction of the original home were different than today, but the excess of maximum allowable is to be considered serious and hazardous.

gap 1"

main supporting Beam B1

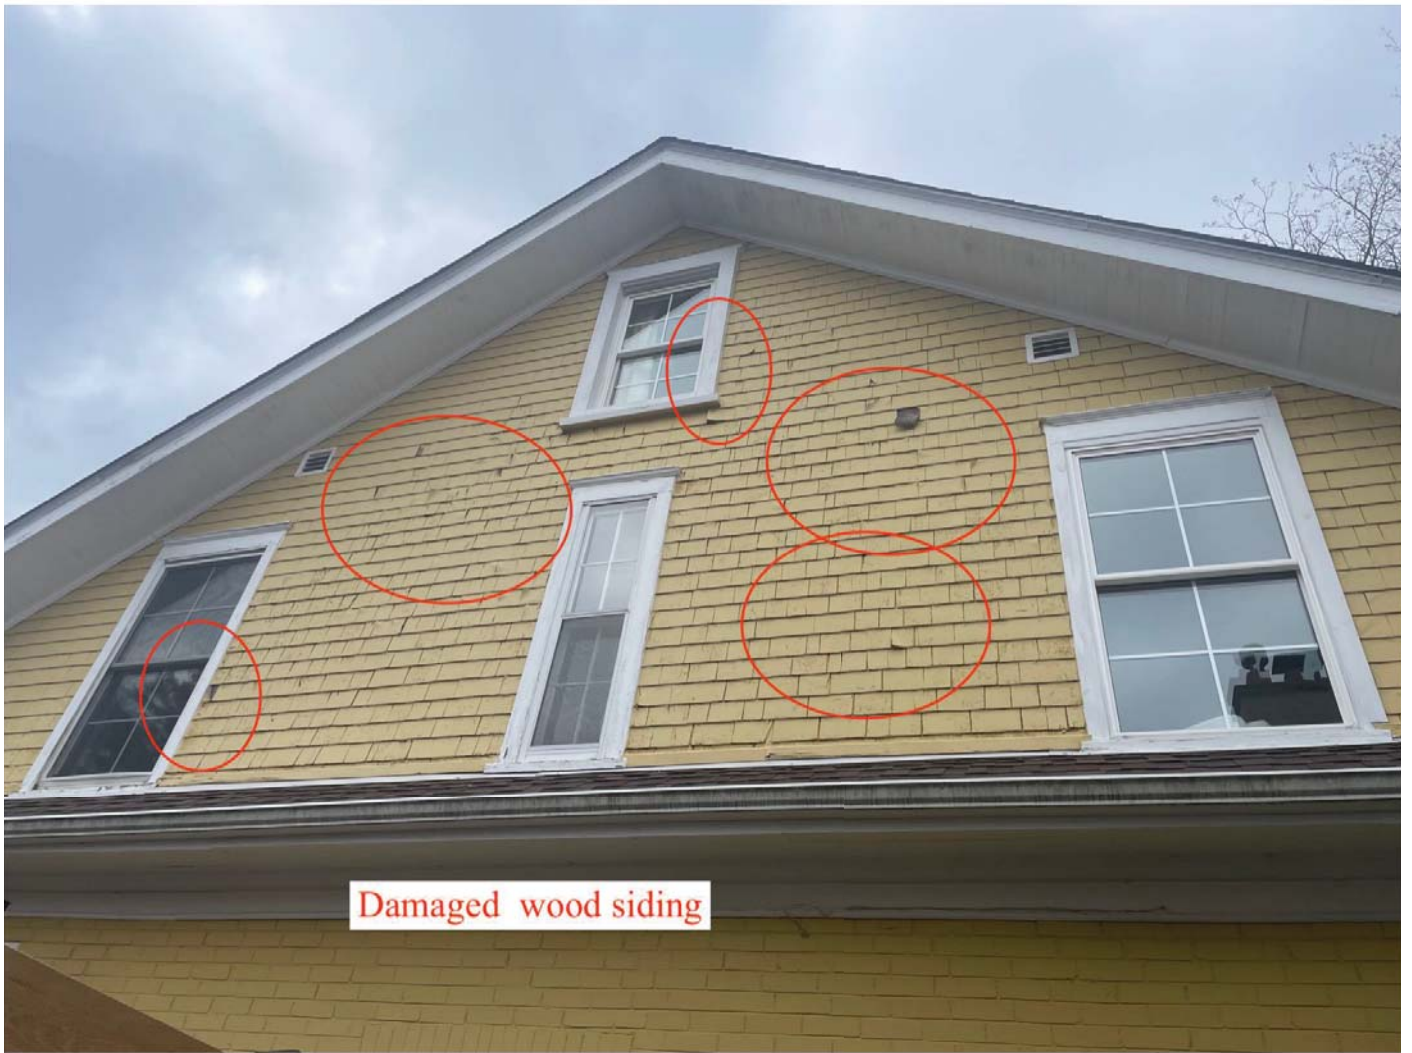
Original building exterior cladding is brick at main floor and wood siding at second and third floor (Attic level). The wood siding was observed to be in very bad shape with need of replacement. (see pictures attached)

Damaged wood siding

Overall exterior cladding brick and siding will need repairs and replacement.

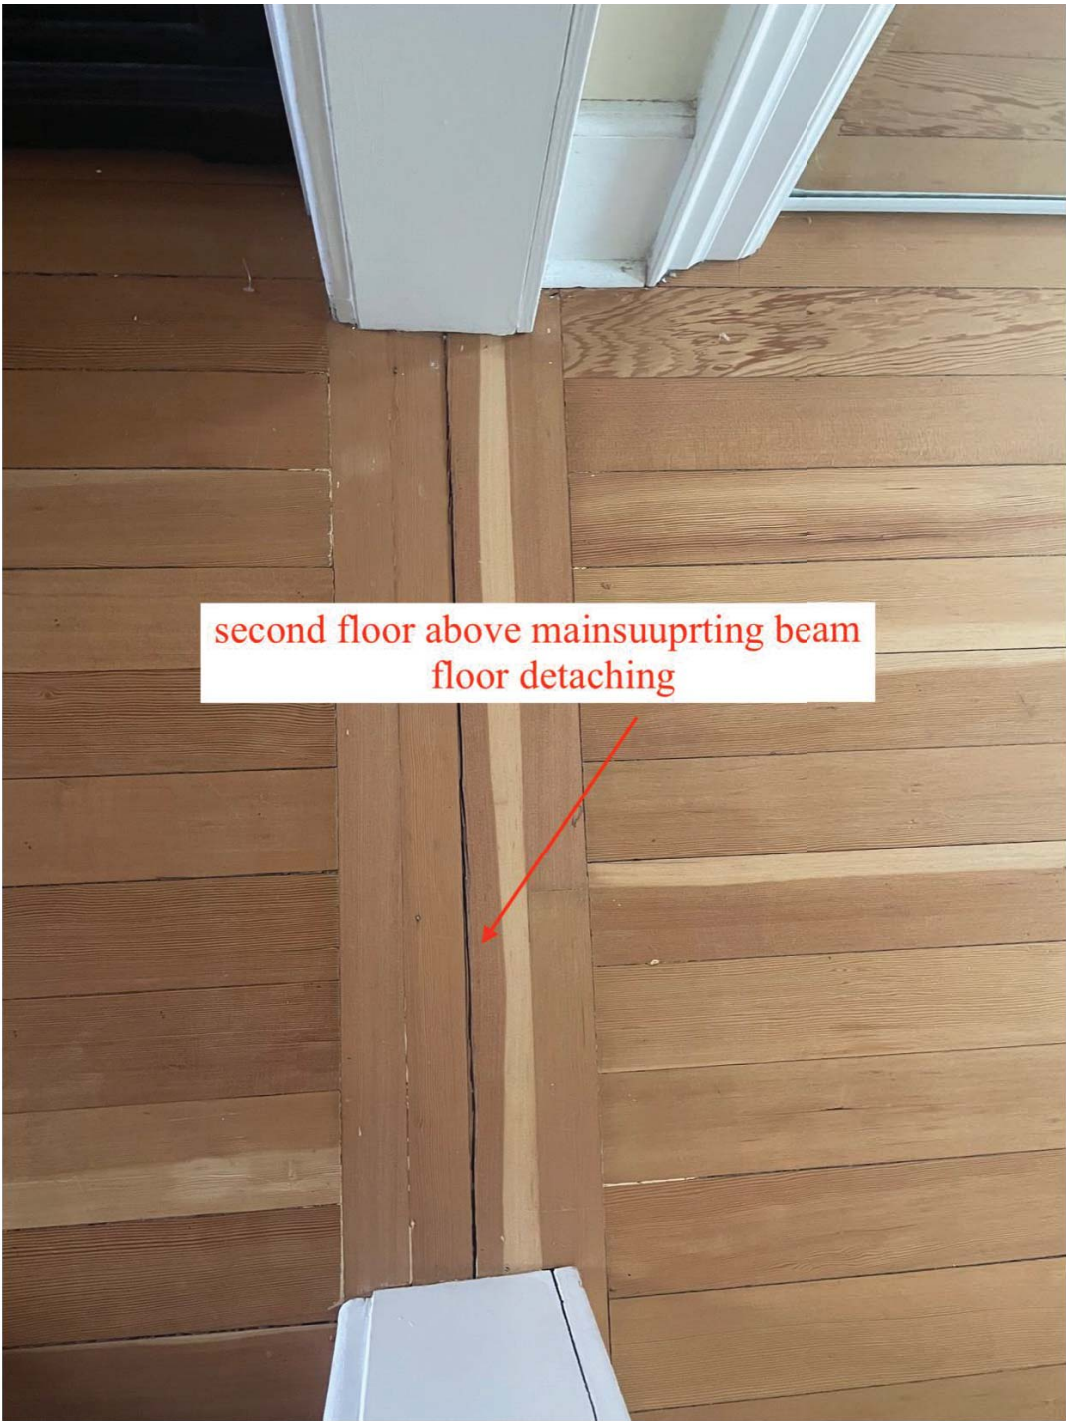
Second floor is also sagging. Values of depressions marked as F3 0.75" over 4' and F4 1.5" over 4' are both unacceptable. The direction of depression as marked on attached plans is towards the main supporting beam.

second floor above mainsuuprting beam  
floor detaching

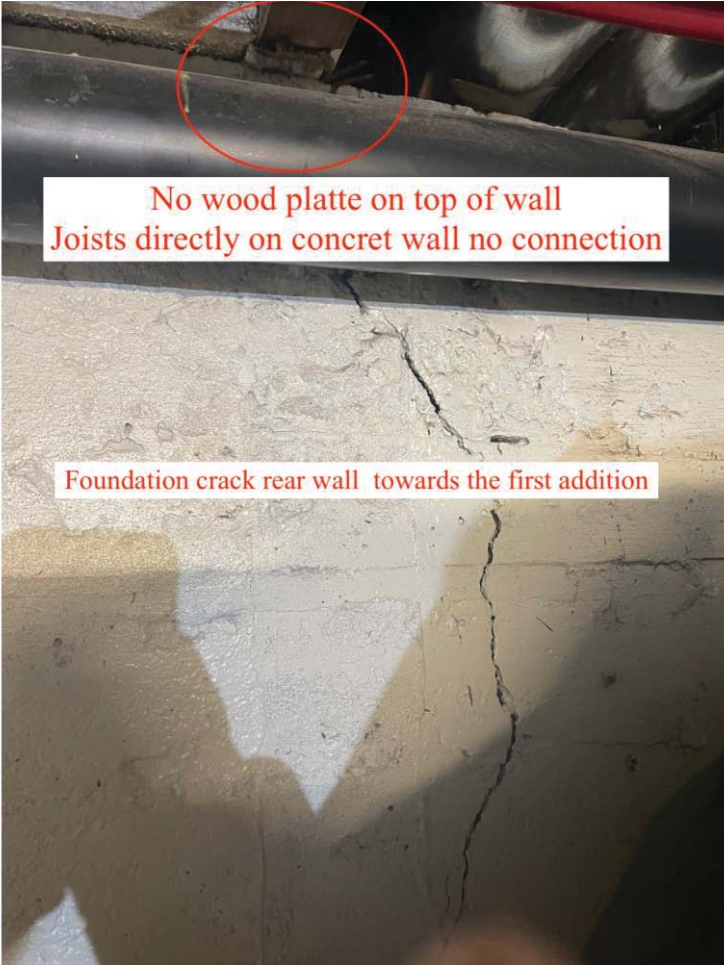
No wood platte on top of wall  
Joists directly on concret wall no connection

Foundation crack rear wall towards the first addition

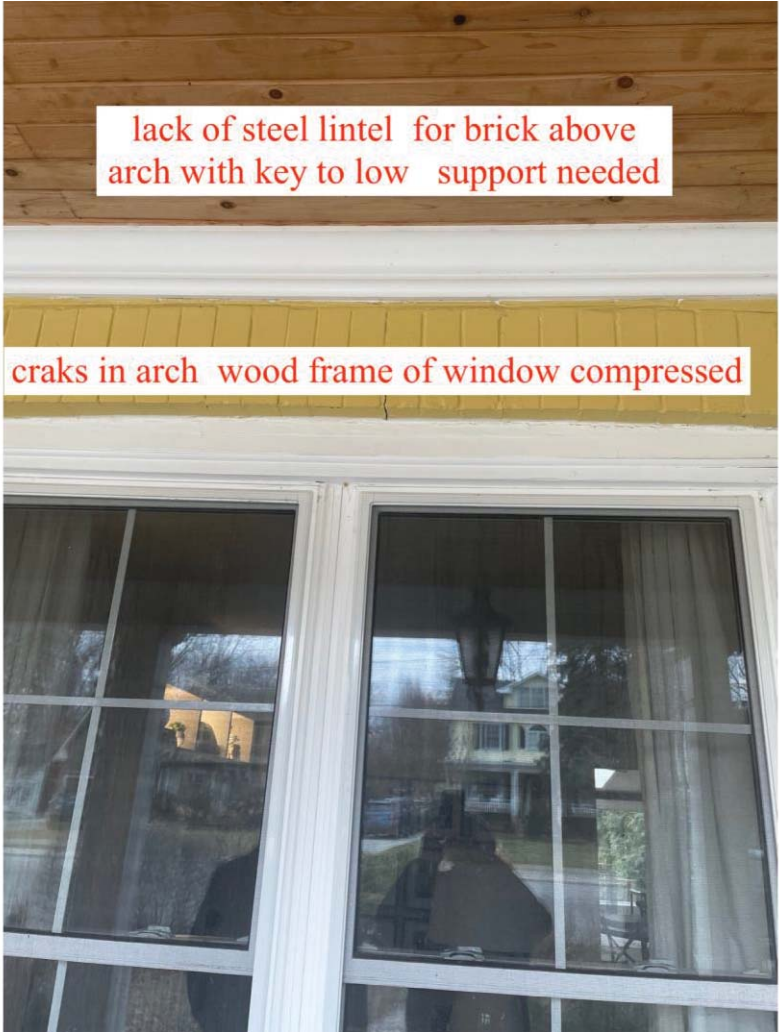
lack of steel lintel for brick above  
arch with key to low support needed

craks in arch wood frame of window compressed

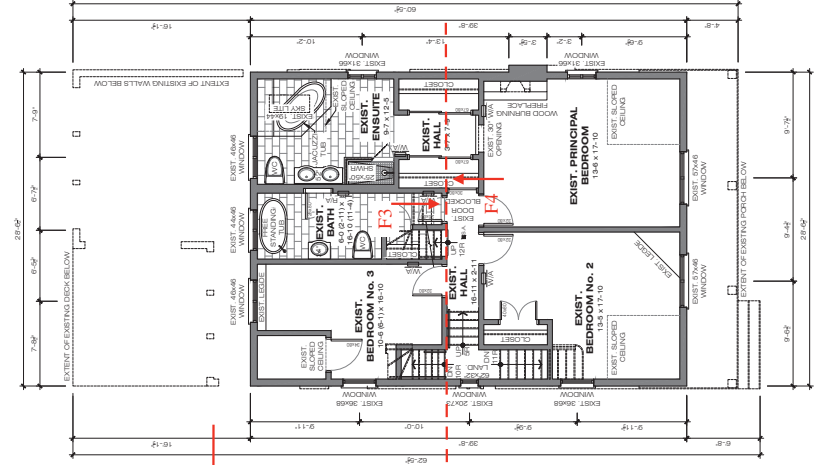
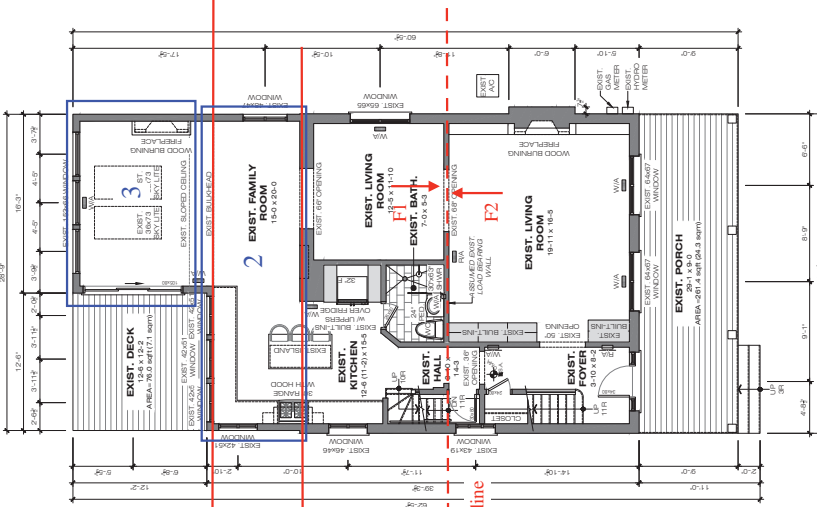
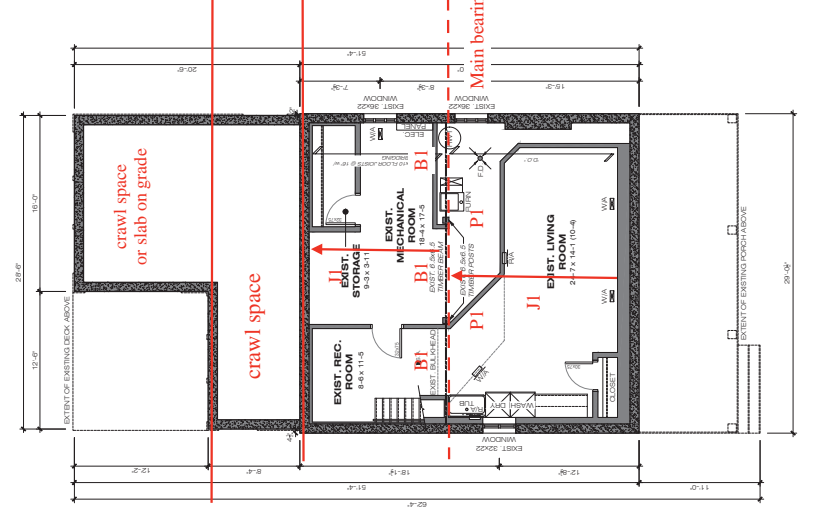
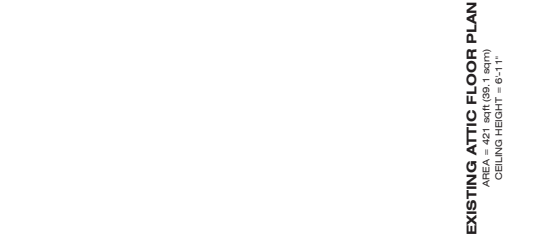
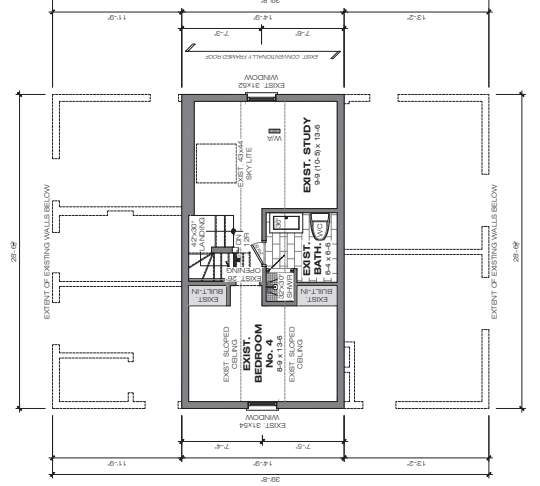
Project Name:  
 Sheet Title:  
**EXIST. FLOOR PLANS (FOR REF. ONLY)**

Due to the above structural deficiencies the floor is sagging. We marked areas of depression in the floor with F1 and F2 at main floor. Values as indicated for F1 0.5” over 4’ and F2 1” over 4’ are both unacceptable. The direction of the depression is indicated on attached plans towards the main supporting beam below.

The largest depression in floor was observed in the stairs landing F5 2" over 4' which is also unacceptable and a hazard (structurally and as an eventual fire exit) due its steep angle.

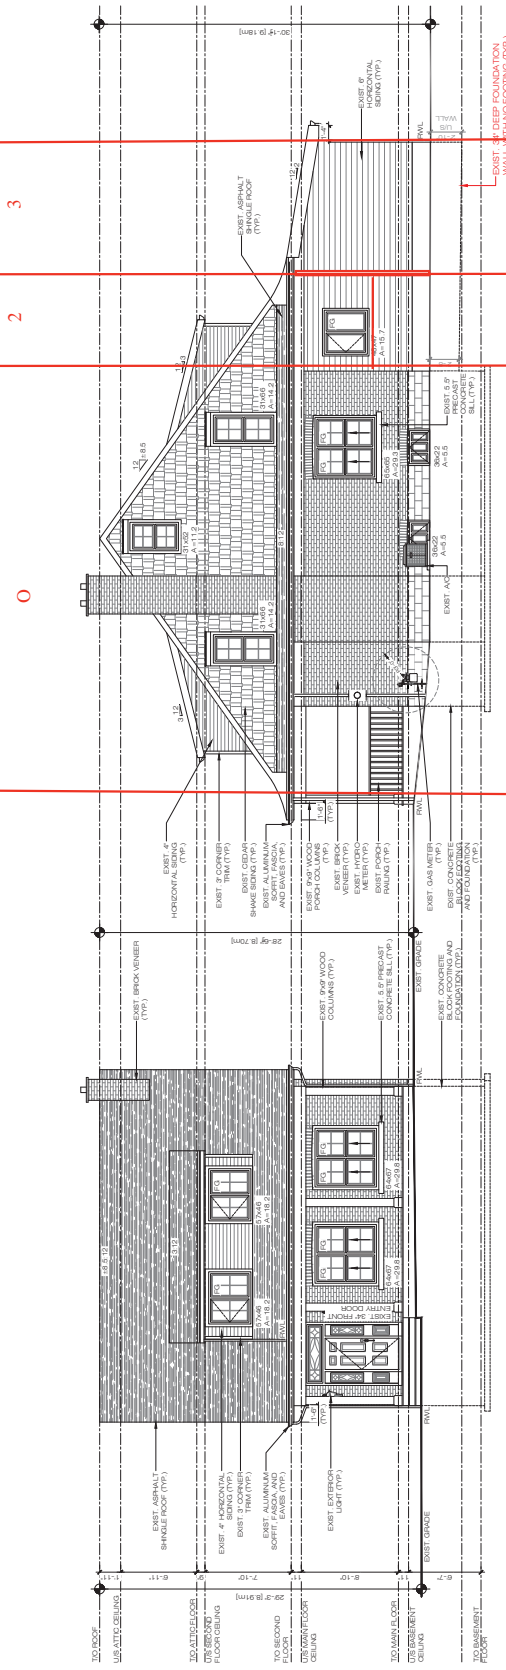
EXISTING FRONT ELEVATION

original Home  
 porch - front and rear  
 rear was changed with addition 1

line of demarcation  
 addition 1  
 addition 2

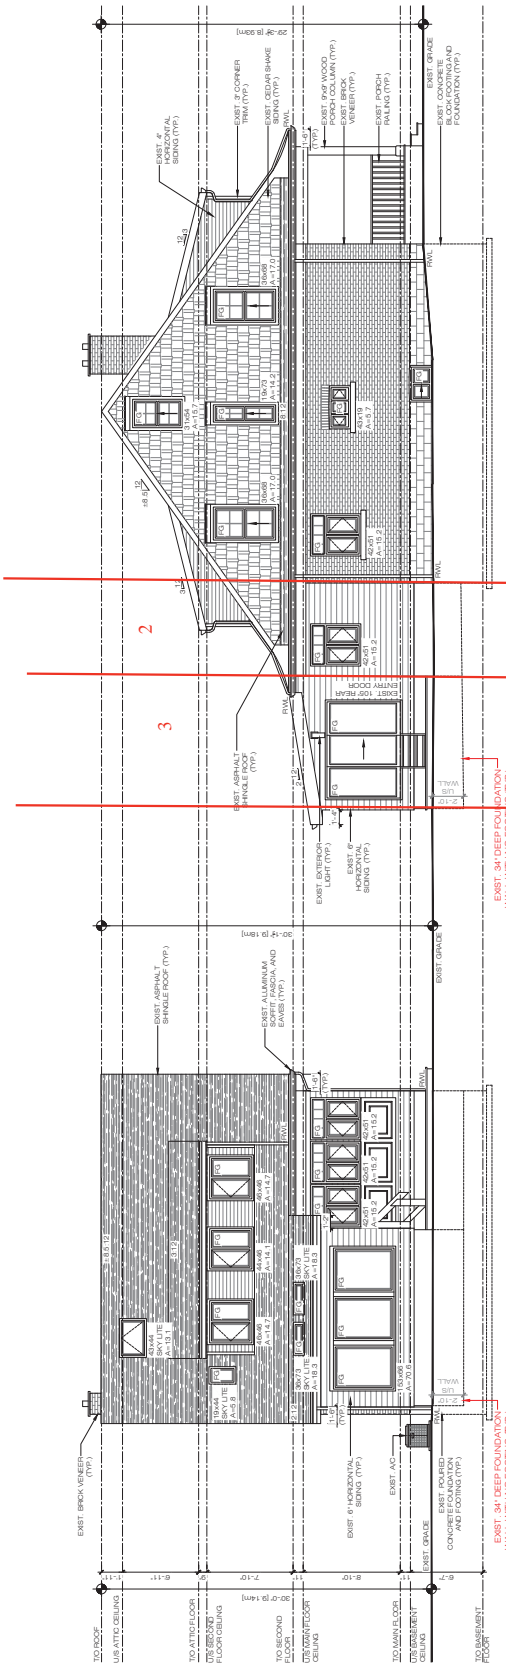
EXISTING REAR ELEVATION

line of demarcation  
 addition 1  
 addition 2
