**320 Maple Avenue, Oakville**

**BUILDING ASSESSMENT REPORT:**

**February 7, 2018**

**Prepared by: T. Murison**

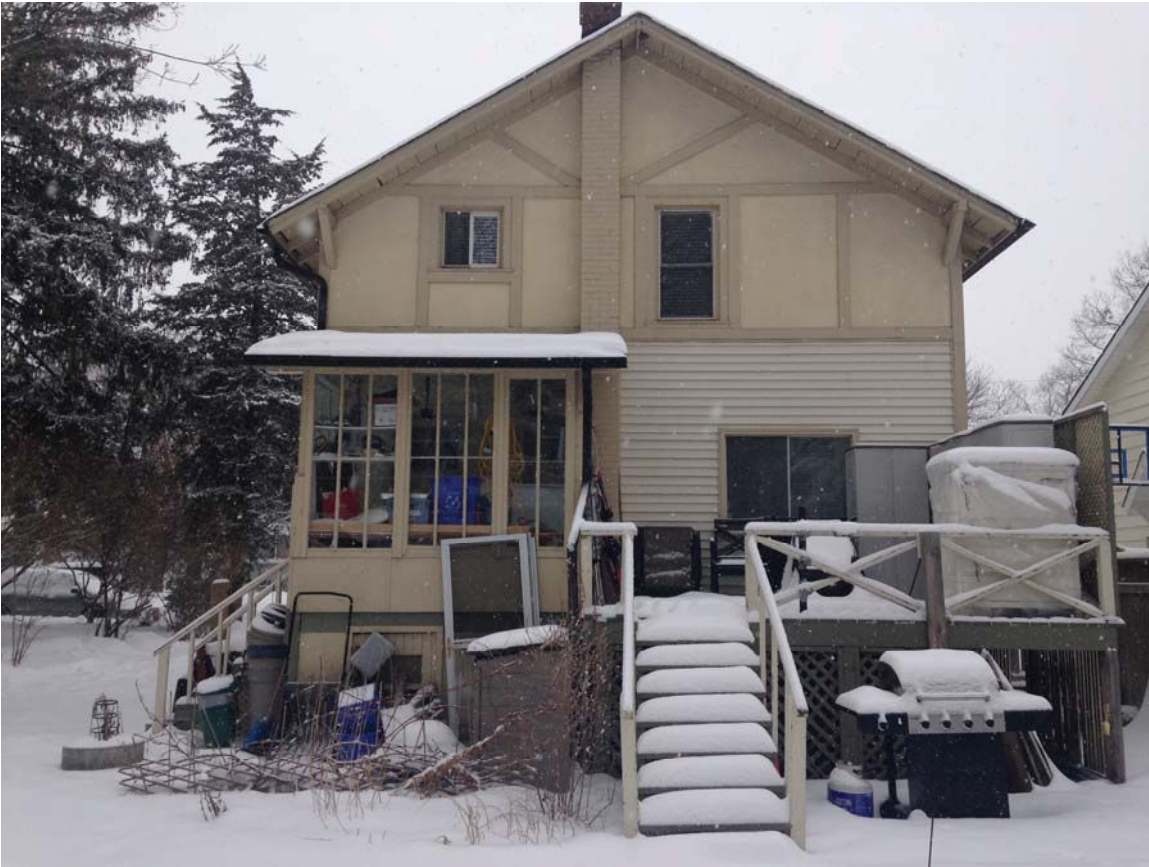
**2.01** South Elevation of 320 Maple Avenue. Porch and deck have been added at various times to the original house. Arbitrary decisions have been made throughout the history of the building.. The brick chimney was added externally and off the centerline of the roof. A porch was added with mismatched salvaged windows and doors. An exterior deck was then added but not completed approximately 35 years ago. Narrow clapboard, which may be the original wall surface of the ground floor is visible to just below the second floor window, beside the porch. A sliding aluminum window which does not relate to any other opening in the house, was inserted in this wall approximately 40 years ago. The center bracket on gable was omitted at the ridge, perhaps because the chimney was so close by or because the builder wanted to save a few more dollars than on the opposite elevation. The original bedroom window on the second floor does not match the modern bathroom window which was added in the past twenty years. The synthetic stucco and highly arbitrary placement of the wood trim complete the chaotic collection of features which the neighboring houses view every day. This elevation is not an exemplary Arts and Crafts house by any measure. This side shows the poor quality of the house better than the north (street) elevation, which is hidden by trees and shrubs.

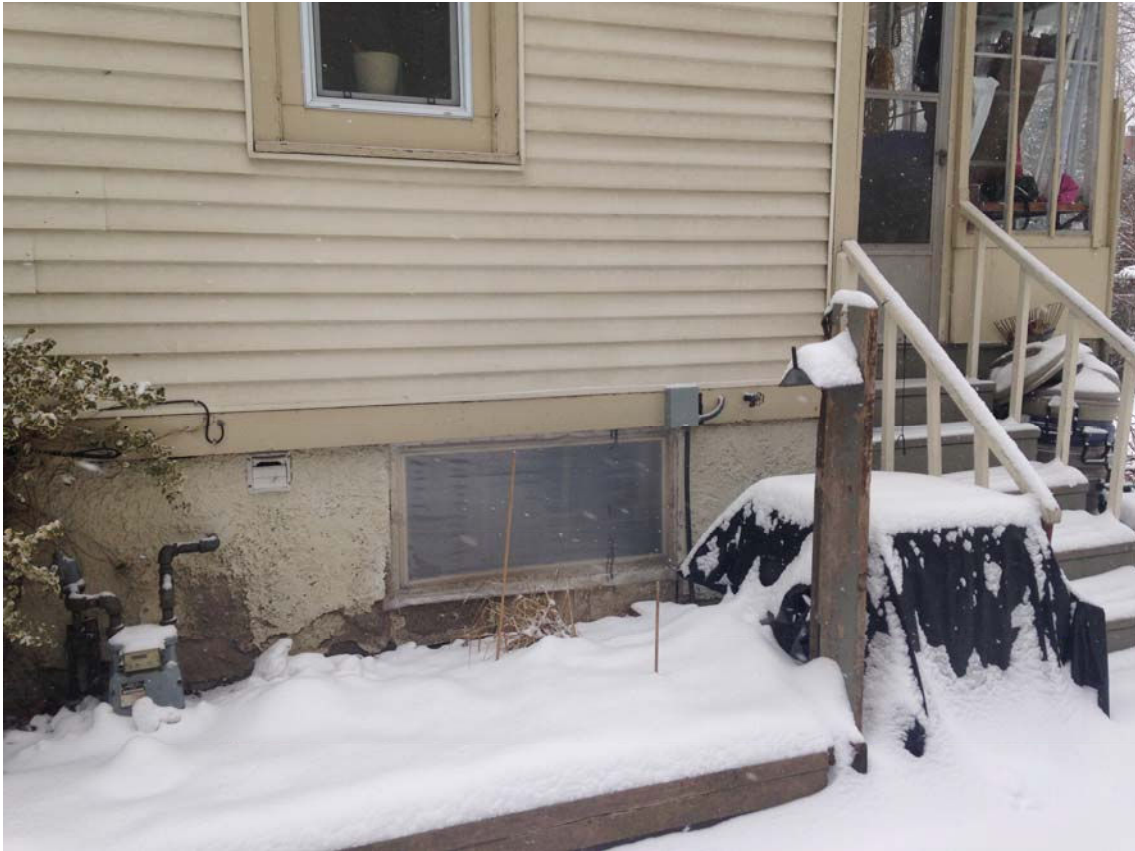
**2.09** West wall with vinyl siding applied over old sheathing. Note the use of standard vinyl trim edge moulding to secure siding at corners and old window trim. This vinyl 'outline' or 'border' emphasizes the width and imperfections of the old material, degrading the appearance of the house. In this elevation the spalling cementitious parging also shows the blockwork foundation below. Various holes & service connections through the wall form a random pattern of aging structure along the wall. The original wood windows have been covered with plastic to try to protect them from further weathering and decay. While this is not unusual for a 90 year old house, it detracts from appearance and would require replacement for improvement. All four of the original basement windows appear to be the same condition.

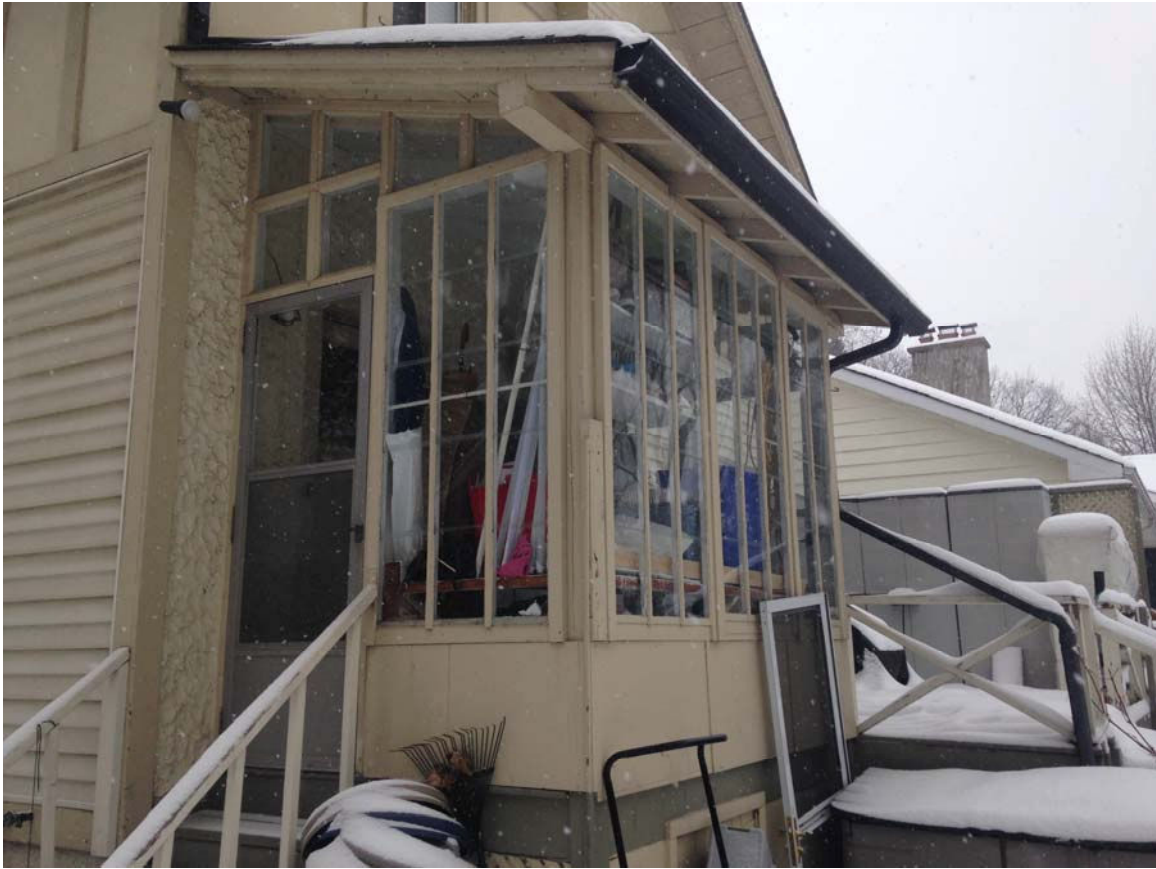
**2.11** Random collection of recycled windows used to close in porch. Railings and decks were added variously with low quality materials & workmanship.

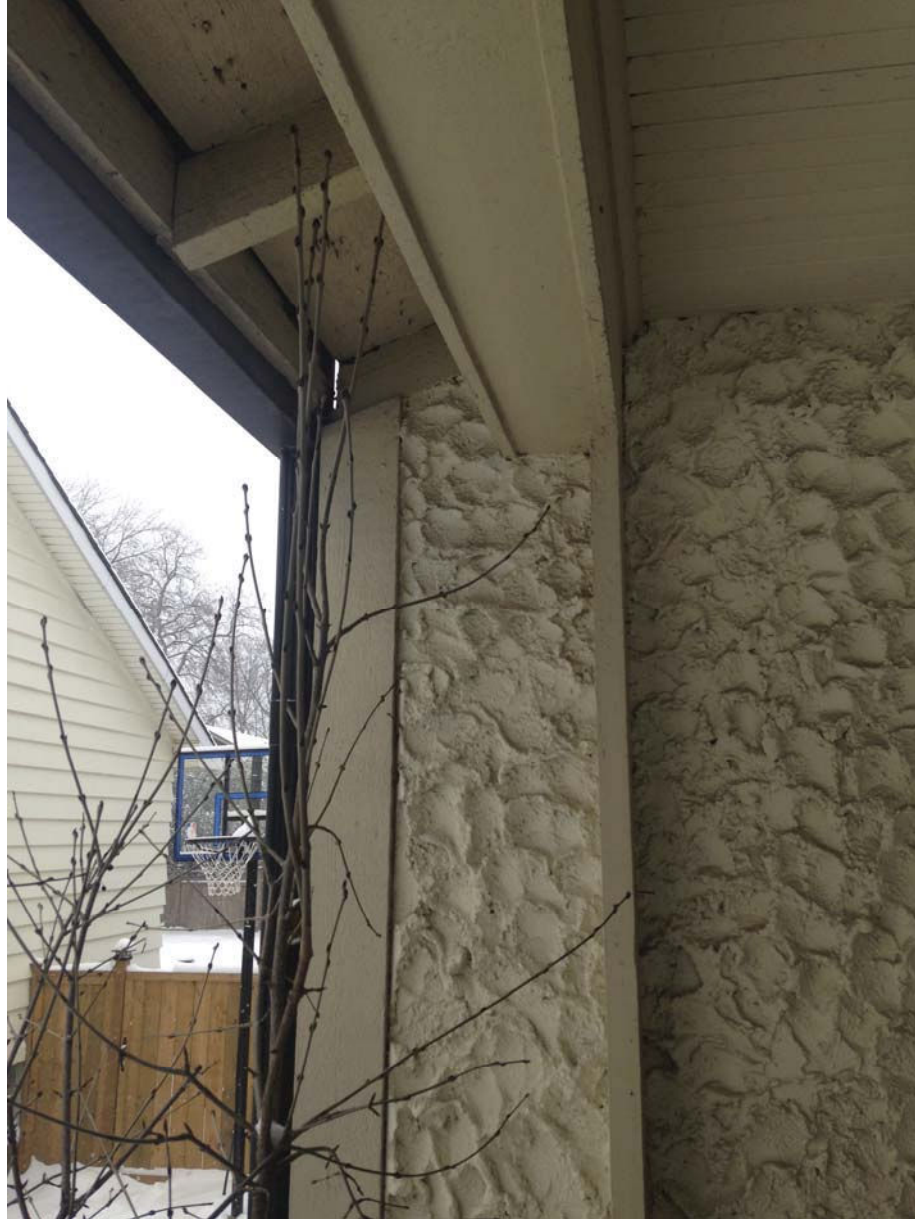
**2.22** The stucco at 320 Maple is similar to #38 Second Street circa 1970, but does not match other houses built in the 1920s. The stucco was not applied against frieze or barge boards at the soffit and floor, but was applied against corner boards, door and window trim. Was this vertical trim installed for wood siding first? This is a strong possibility, since narrow clapboard survives on part of the south wall. On the north side it would weather faster and be a candidate for replacement by stucco. In the 1920's a few, rare examples "International Style" houses were built, but they invariably used a thin, lightly textured stucco similar to that found on the foundation wall of this house. The coarse dimpled texture of the front wall is not seen until after WW2. A few rare houses used Spanish Mission Style, with very coarse and theatrical stucco, but these houses invariably have exposed parapets, "Spanish tile rooflets" and ornamental scuppers. This house is not Mission Style, International style or Arts and Crafts, and does not retain typical details of other significant Oakville examples.

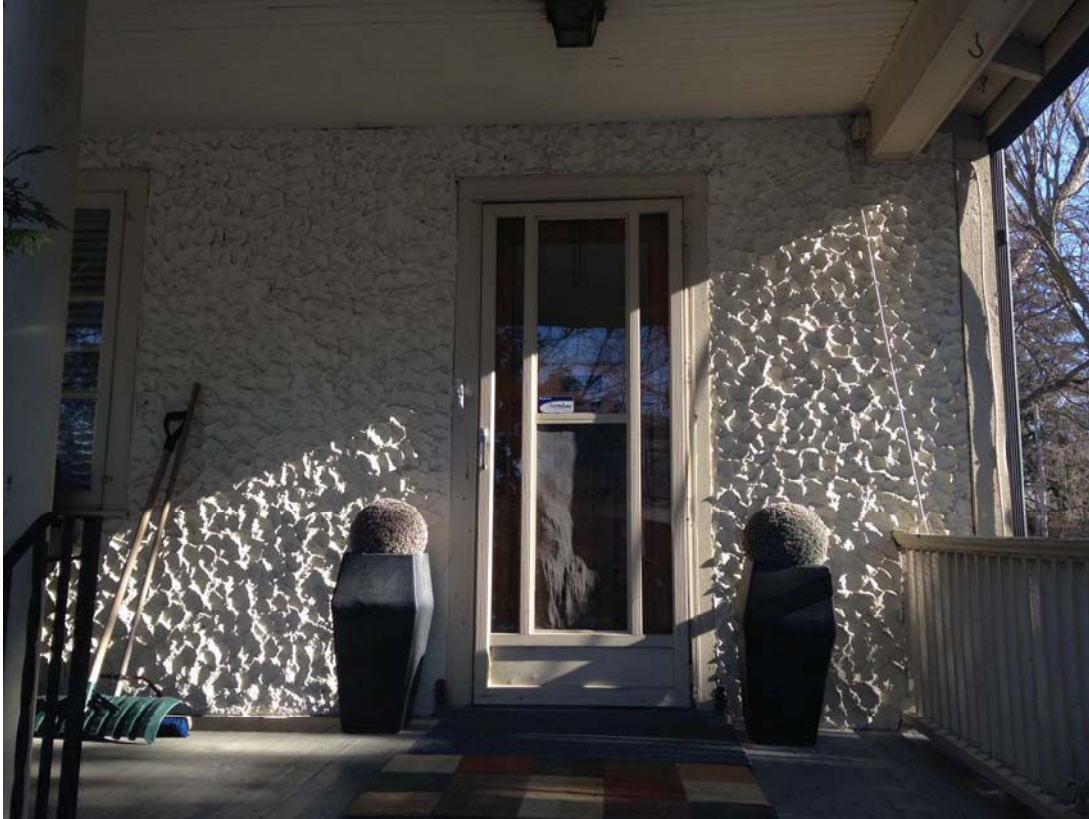
**2.23** Another clue to the age of the stucco is seen at the vertical cleat, east end of the verandah which was probably installed to support insect screens. The stucco has been applied against the girder and out to the face of the corner trim. This suggests that siding or shingles were removed from the wall before the screen porch was contemplated, and stucco was added to the wall at the same time the cleat was nailed into it. The other end of the verandah does not have a similar cleat so makes it more likely that the stucco was not an original finish. Since verandahs offer protection from weather, mechanical damage from chairs and tables, or even hockey sticks may be may have caused siding replacement.

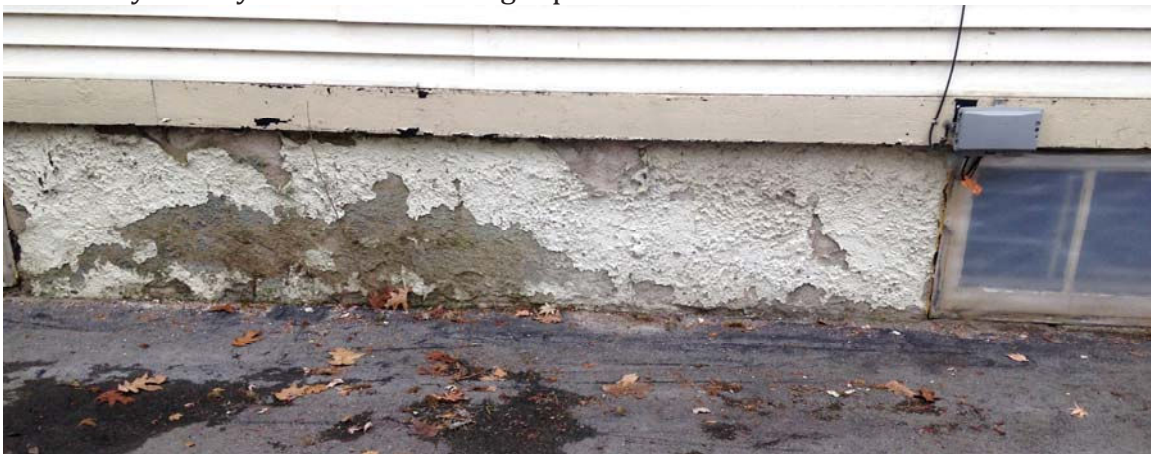
**2.24** “Smooth” stucco, without rustication, on west foundation wall, probably original. Note the deterioration of the stucco indicating insufficient binder in the mix. The block foundation is highly permeable and allows chronic dampness.

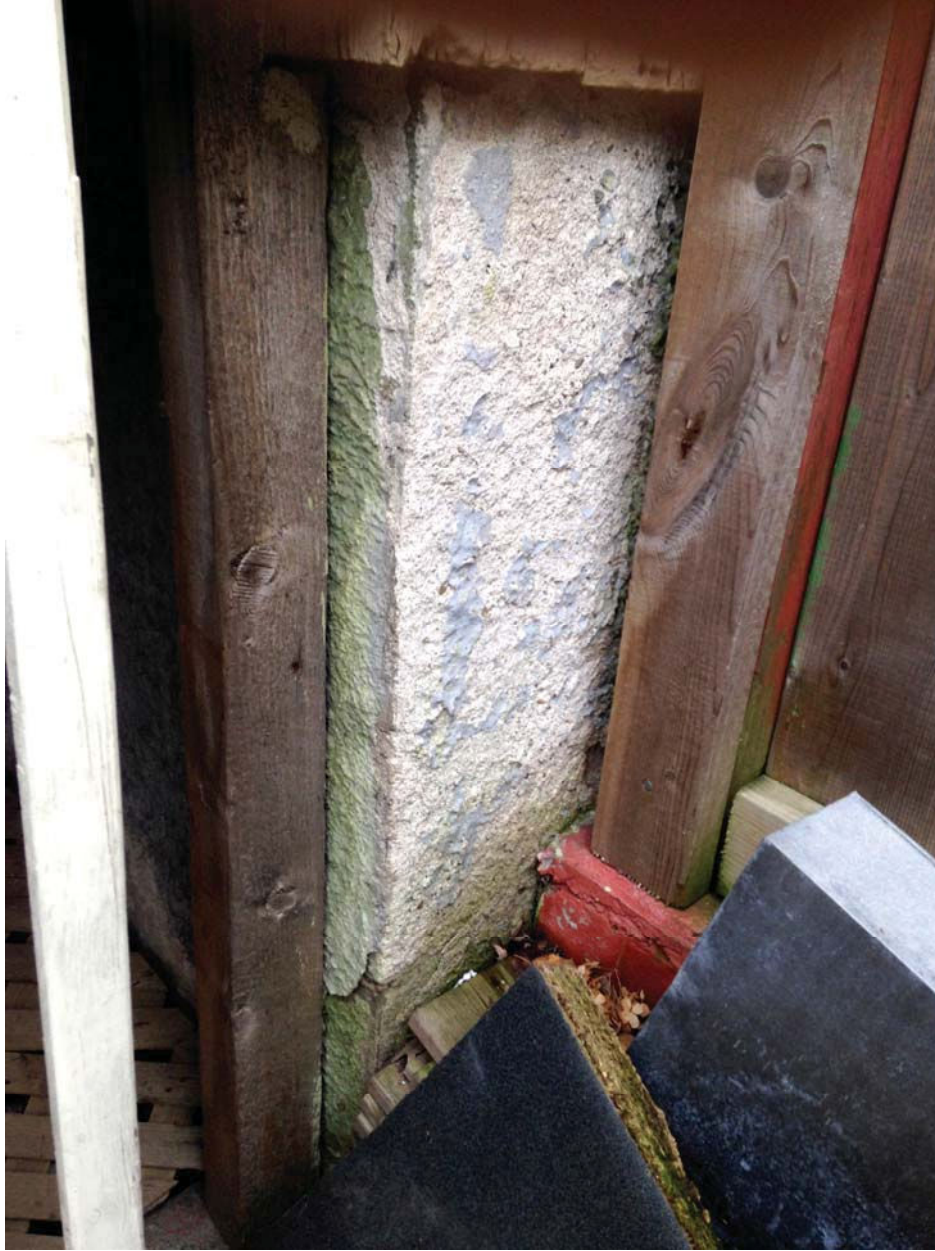
**2.25** Stucco finish at south-east corner. This was also applied directly to the substrate without strapping. There was no corner board below the first floor. If stucco was intended for the entire house as a cheaper alternative to siding it is unlikely that they would have used corner boards on the upper walls but omitted them below the first floor. The stucco was applied directly to the foundation wall in a very thin coat. A plasterer would usually apply a scratch coat, and a bond coat before the finish stucco. This single coat is another indication of a poor construction by a speculative builder.

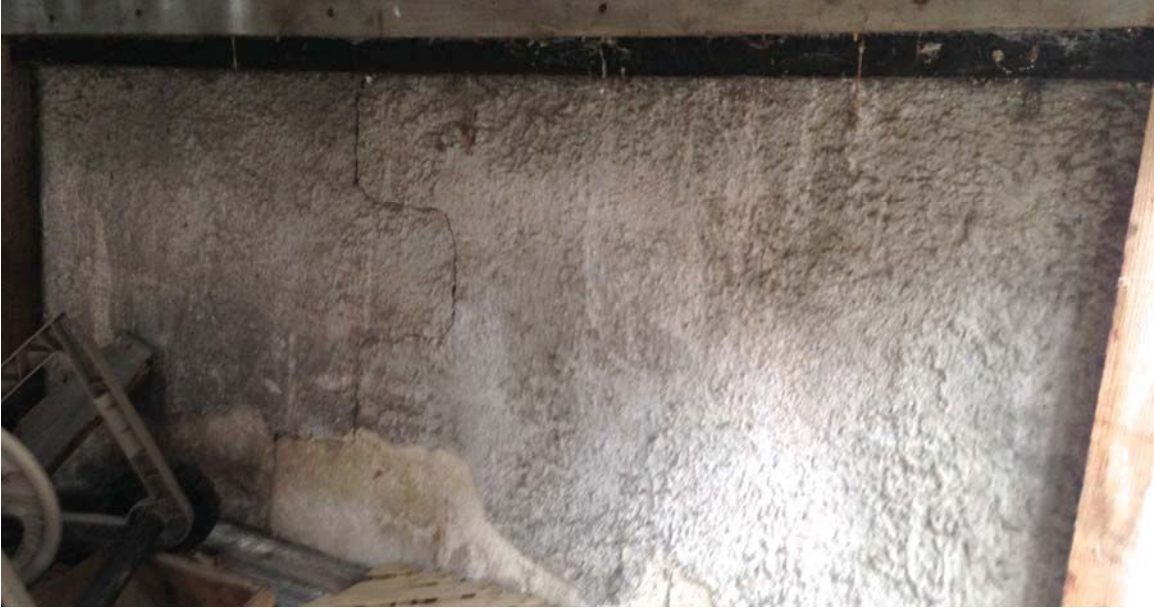
**2.26** Stucco on smooth block foundation at south wall. Texture is similar on west side and north side under the deck. The quality of stucco is uneven suggesting that the plasterer had not done an apprenticeship and was not a tradesman. Textured concrete block with a “stone face” were developed for better quality walls and exposed foundations in the early 20<sup>th</sup>. Century. They could have been used here but would have required more expense, and the goal was the cheapest construction possible. The parging stucco is the original finish, and is unlike that of the north wall.

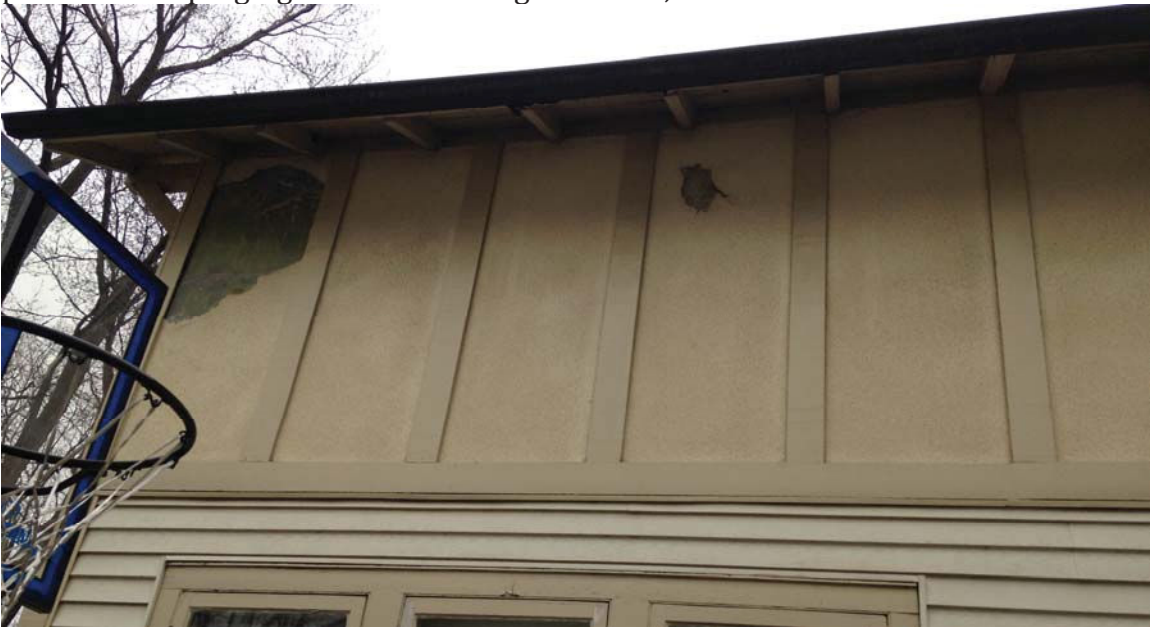
**2.27** Stucco at upper east wall is failing near the corner and soffit in mid-wall. This is a modern synthetic stucco applied recently, as part of a third or fourth refinishing of the walls. This application above first floor siding seems very arbitrary and poorly executed. Patches of the finish are peeling off the substrate under the soffit where the finish should have been protected from weather. This indicates poor preparation, rather than excessive deterioration.

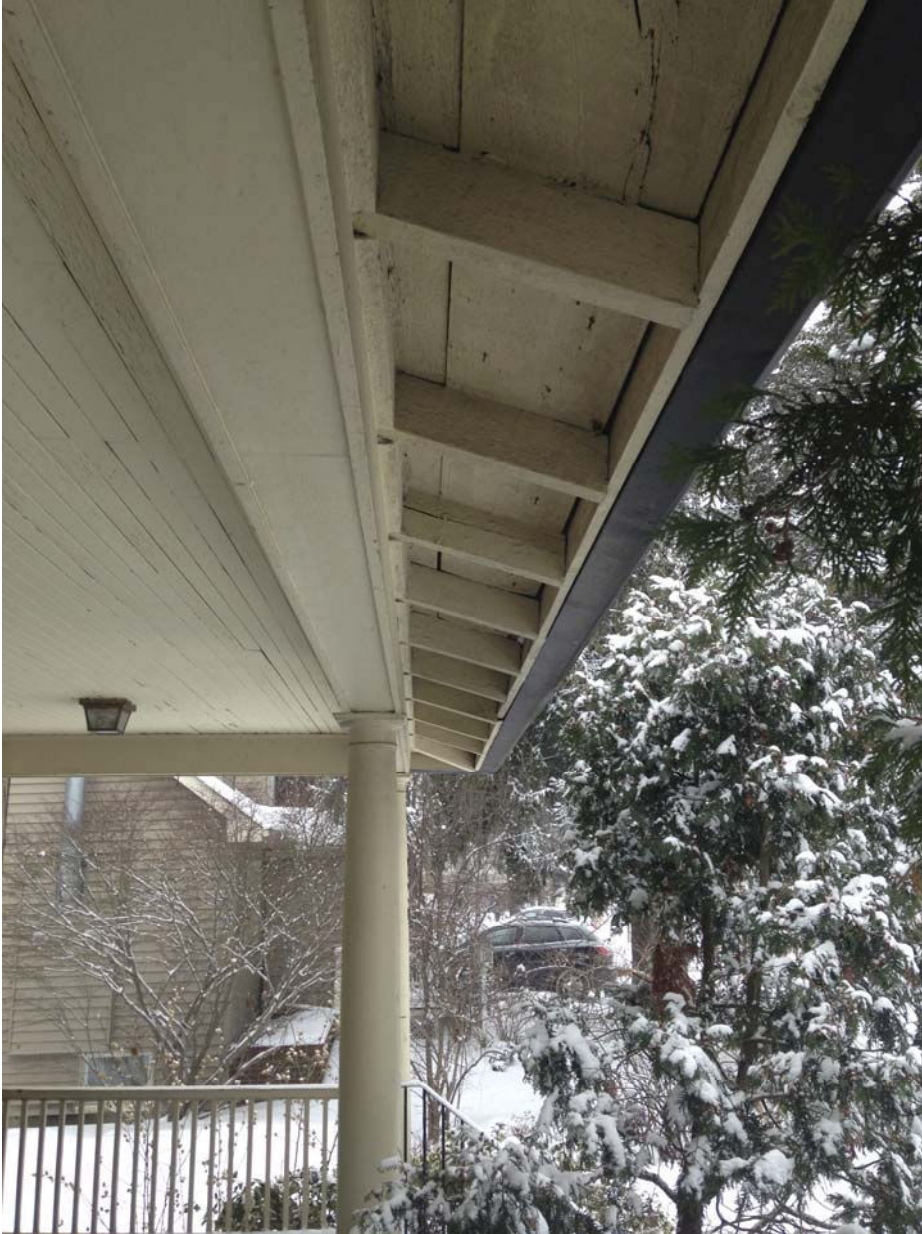
**2.28** View of the exposed rough sawn rafters & roof sheathing. The sheathing has long checks (splits), wane, missing knots and gaps between boards. In high quality Arts & Crafts cottages, the exposed roof sheathing would use clear or #1 grade tongue & groove V-joint pine with the finished side down, visible where exposed to below. This is a poor imitation. The rafter tails of Arts & Crafts buildings were also meant to be seen as finished details. The rafters would be planed, sanded and either profiled with a radius on the bottom edge, or a sculpted termination. These details can be seen in many houses & railway stations built between 1890 and 1914. The rafters here are simply rough sawn sticks of wood that are too deep to match the fascia board. Arts and Crafts Houses aspired to bring the quality workmanship of carpentry back as simple and honest decoration of modest houses. There is none of the quality of workmanship that would qualify this as real Arts and Crafts building.

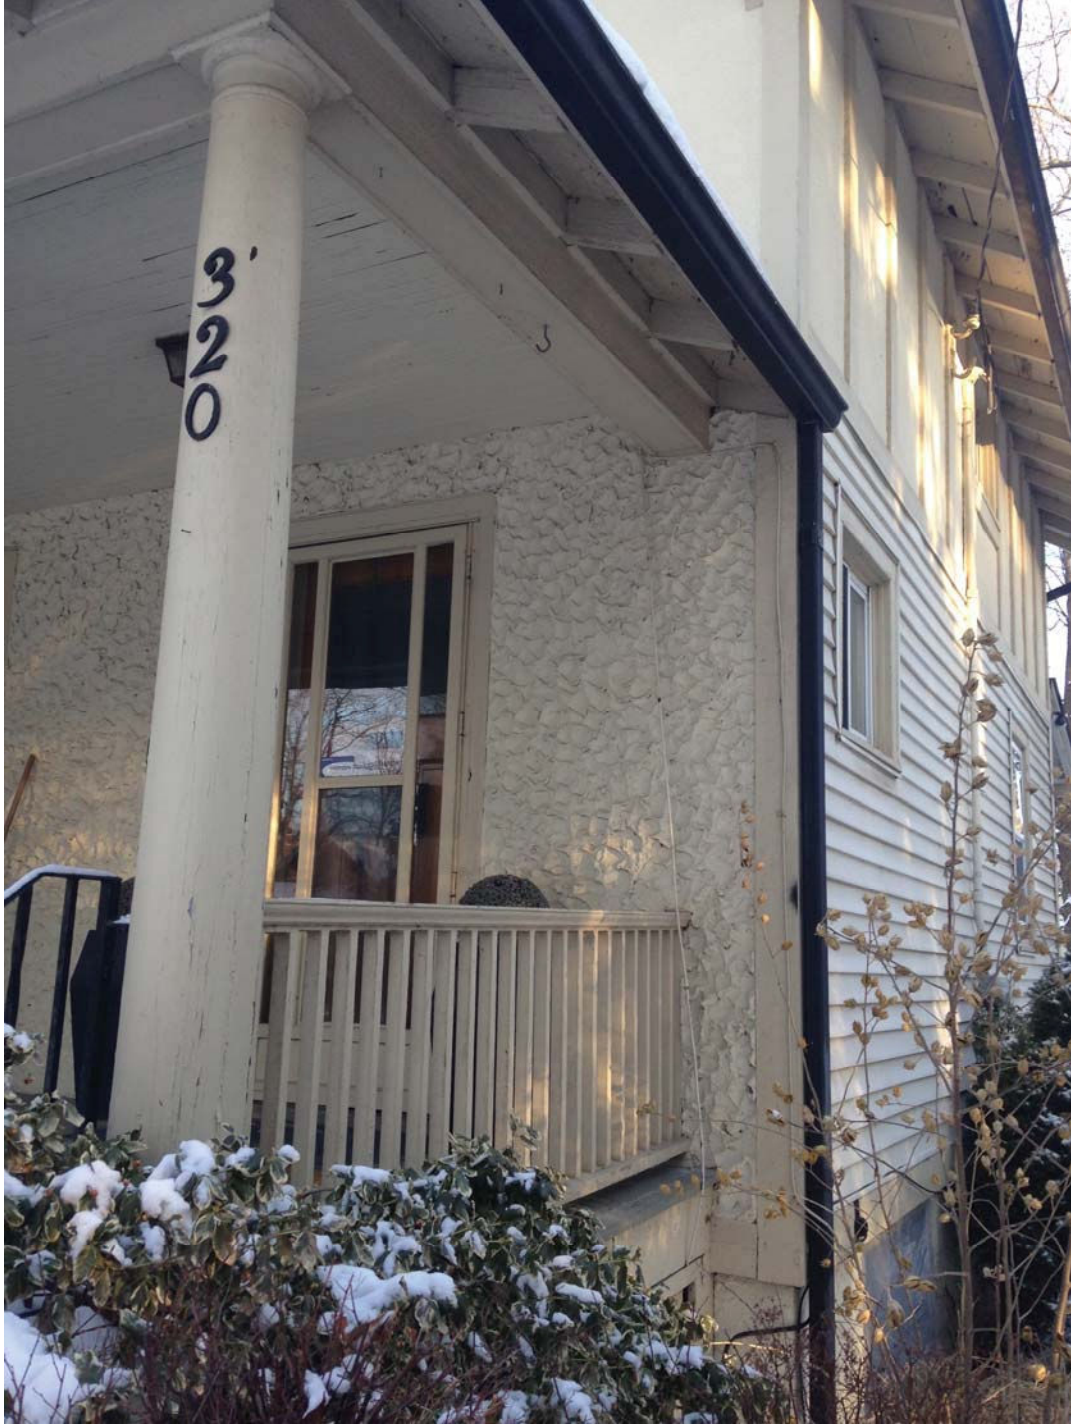
**2.29** View of North West corner of verandah with vinyl siding, modern synthetic stucco and faux Tudor half-timber, concrete block foundation, and repaired stucco under the soffit. The Porch railing can be seen here, preceded the stucco. A wall cleat was installed to support the railing. This detail is often used where clapboard is installed after the railings, but also where stucco was applied up to the railing, so provides no conclusive proof that siding was or was not used originally.

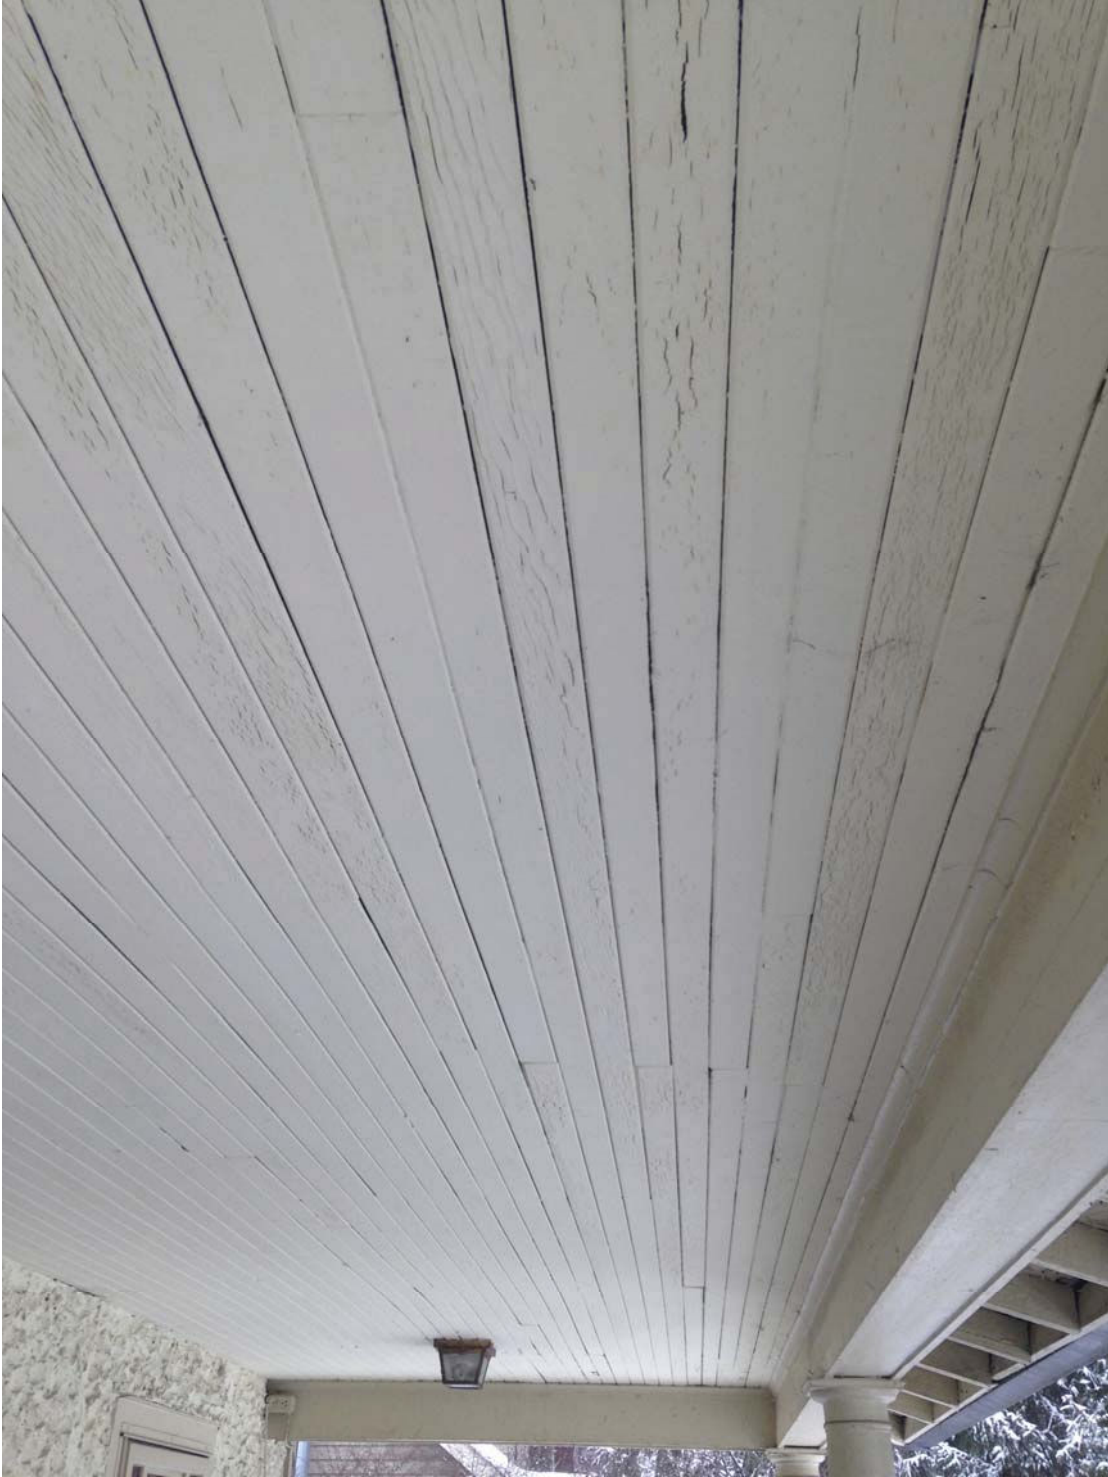
**2.33** View of ceiling with visible shrinkage of the tongue and groove V-match material. Note the heavy checking in the paint which indicates that much of it will have to be removed to bare wood before repainting. The material was not kiln dried when installed. The stucco was applied up to the existing ceiling on the left side. Changes to replace the existing knob and tube connections in the ceiling would be best done from above by removing the roof, a pretty serious intervention.

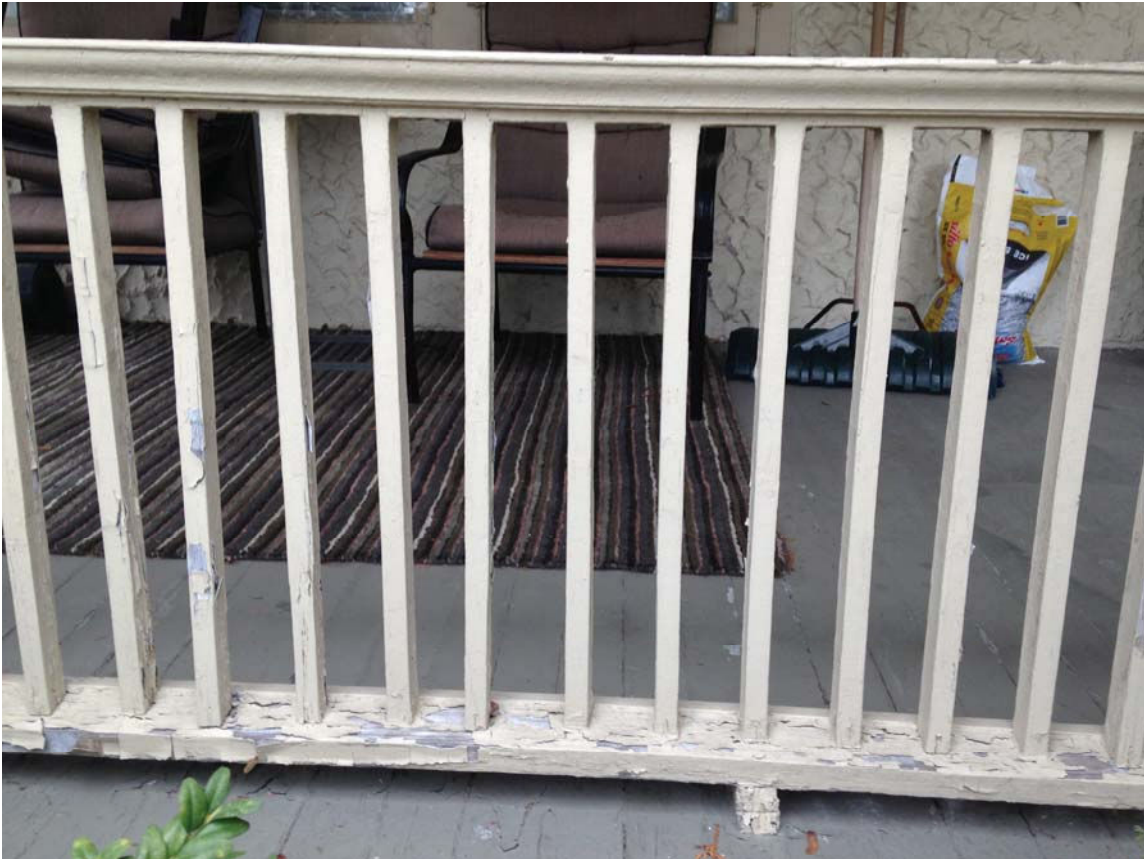
**2.34** A “floating” rail with moulded hand and foot rails and square pickets was installed between columns. The foot rail is supported at mid span with blocks nailed to the deck to prevent sagging, and allow leaves to be swept clear. The crude blocking of the foot rail telegraphed the subsidence of the corners through the deck to the railing which has a bow of at least 2” along the front rail.

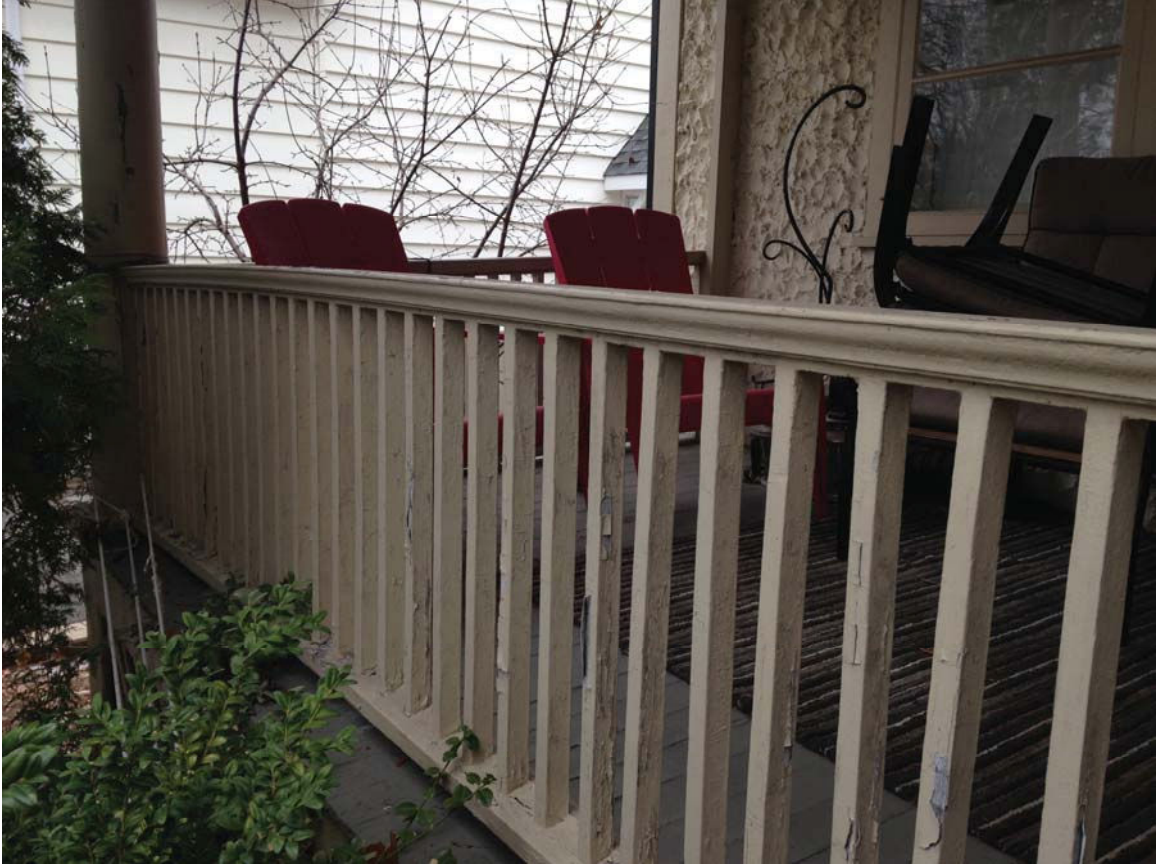
**2.35** The substantial bow in the railing near the north-east corner indicates that more movement is occurring at this corner than across the rest of the verandah. The middle column is higher than both corners.

**2.37** The verandah deck has tilted downwards at the edge by nearly 3". The porch columns may have had minimal foundations. They were frequently constructed on a couple of concrete blocks set two or three courses below grade. One would not expect a poured concrete foundation since concrete block was used for the house foundation. Subsidence of the footings in the top soil would have allowed the piers to sink resulting in the current slope.

**2.38** If the foundation piers have not subsided, decay at the bottom of the wooden post would allow compression of the structure and subsidence. The wooden "skirt" of trim & ventilation panels are almost flush with the soil. Chronic dampness and rot from the soil will cause rot in the posts or be exacerbated by carpenter ants which

require wood in close proximity to damp soil as a habitat. Damage from the ants is not restricted to their tunnels. The mould spores that they carry into the wood cause the worst decay.

**2.39** Repairing the columns would require shoring the porch and cutting the bottoms off the posts before fitting new scarfed extensions. This would also require raising the deck with jacks to reduce the slope. The problem with lifting the porch is that the nails that held the roof framing tight to the wall, have been pulled away from the sheathing. This can be seen in the gap along the ceiling. Because the nails were driven diagonally into the sheathing (toe-nailing) it is never possible to push them back while the full weight of the roof resists. Nails will have to be sawn off where there is room to insert a saw blade, or the stucco will have to be removed to allow the nails to be cut. Realistically this means pulling the verandah roof far enough away from the wall to work behind it. The top row of sheathing and all of the soffit would need to be removed as well to gain access to the nails & substrate. If the verandah was of a high quality, this would be worth doing.

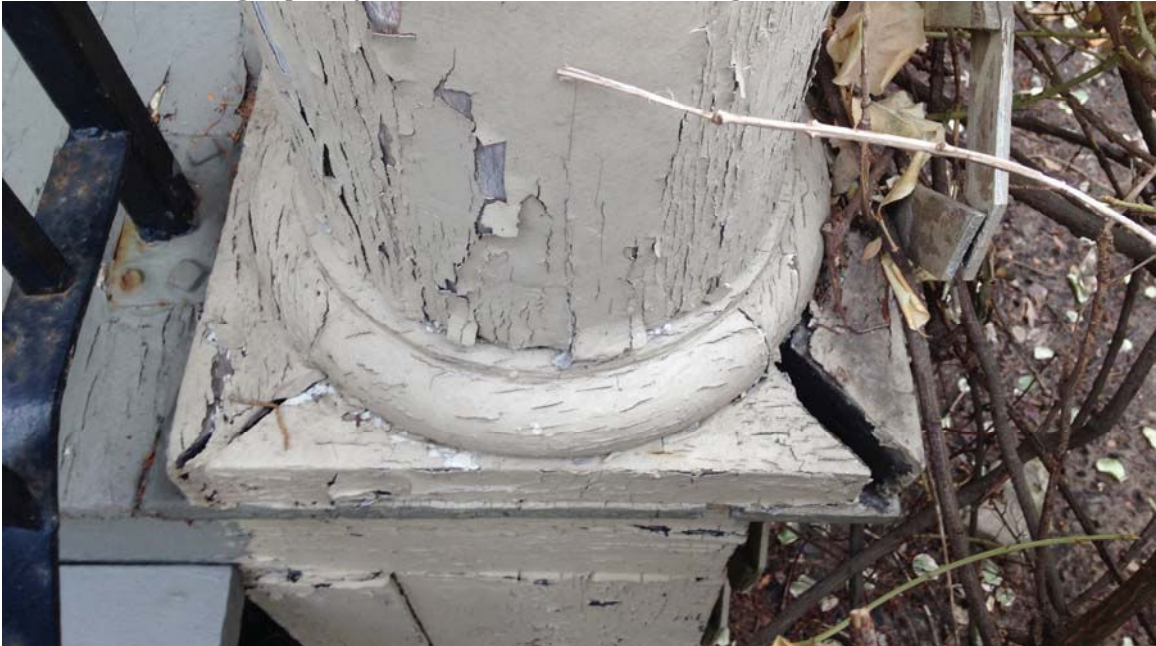
**2.40** The porch columns are also rotting at their bases and will require removal to replace the base blocks and undertake repairs to the column shafts. Decayed column and rotted base block which does not align with porch wall.

**2.41** The poor quality of the existing structure means that almost anything done to repair it will be of higher quality than what is existing. It makes more sense to replace the porch with a consistently better quality one, than to try to preserve it.

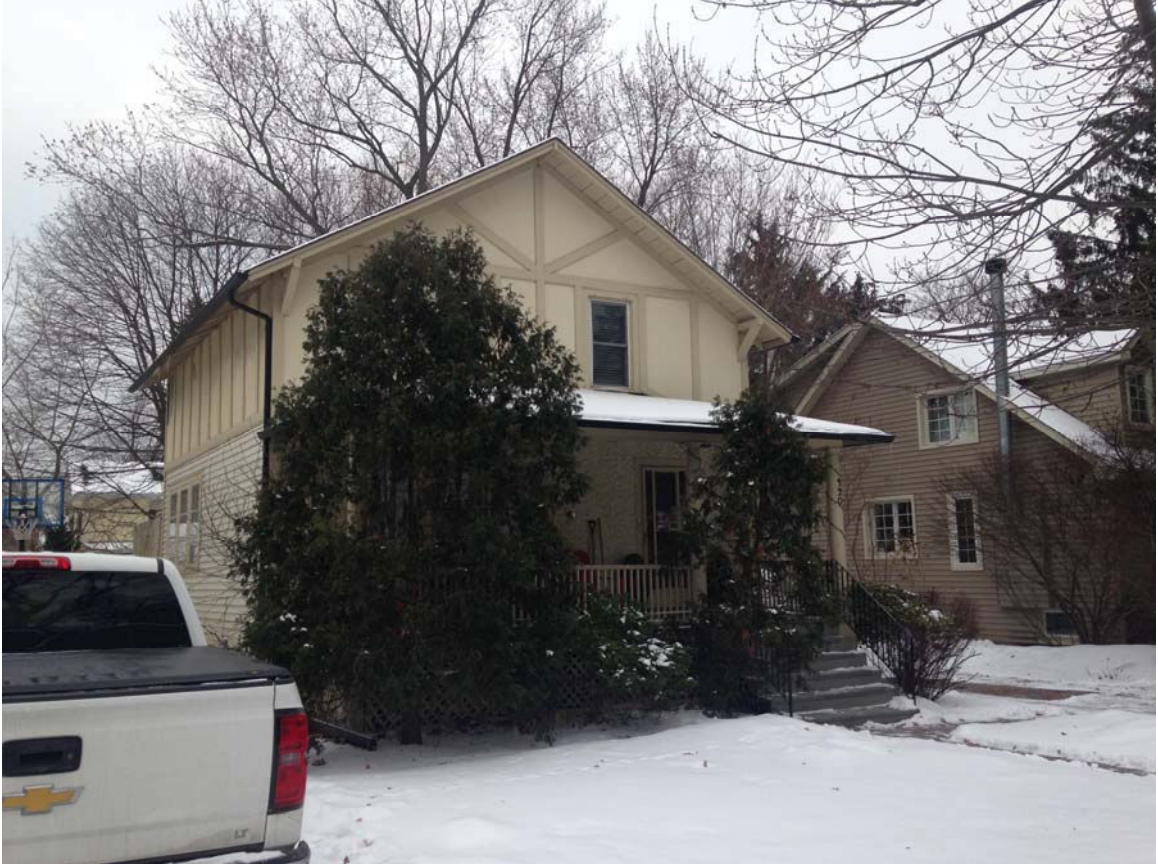
**2.42** Street Elevation. The recent addition of “half timber” detail with synthetic stucco does not convince one that this is an early 20<sup>th</sup>. century house. The “half timber motif” with several “timbers” radiating from the center point is more suggestive of an exposed roof truss. Diagonal braces were used sparingly even in authentic Arts and Crafts revival houses, and never in this manner. Rather than create the impression of medieval “Wattle and Daub” construction with compartmentalized structure, this gable is high, with arbitrary positioning of the diagonals, and a generally “blank” presentation to the street, quite unlike other houses all around it. The little 2” x 4” brackets under the eaves & porch columns are the only features that suggest structural connection between the verge of the roof and the wall. Since this is the principle elevation of the house, and the view that has triggered concern about the appearance of an Arts and Crafts structure, the several failures of detail are evidence that it is not worthy of designation and preservation.

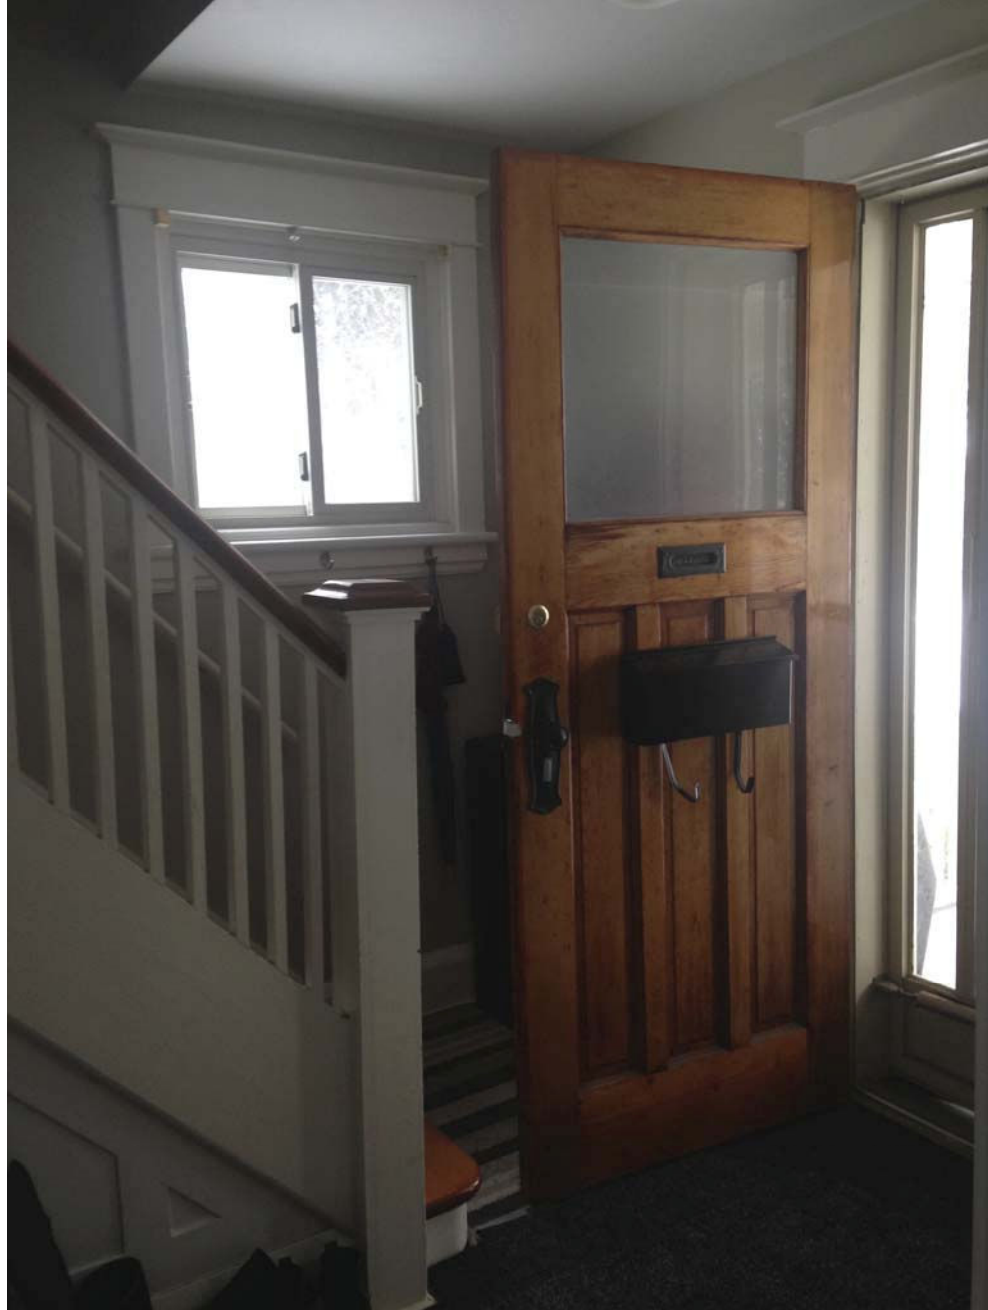
**2.43** Entry door with exterior aluminum storm door. The Pine door is probably contemporary with the construction of the house, but has a single large pane of glass and three narrow panels below. It does not have the detail of an Arts and Crafts house which would have expressed craftsmanship in details such as the window, center rail, the width, quality of the wood used, and panel details. This door is only 1-3/8" thick so is an interior door used where a 1-3/4" or 2-1/4" door should have been placed. The latch set is original but supplemented with a modern deadbolt, letter slot and surface mounted mail box. The window on the stair is a modern vinyl sliding window replacement. Ceiling height is only 92". Once again, the inappropriate use of cheaper materials and poor execution must be understood as a substitution for the qualities of Arts and Crafts Houses that it was trying to emulate.

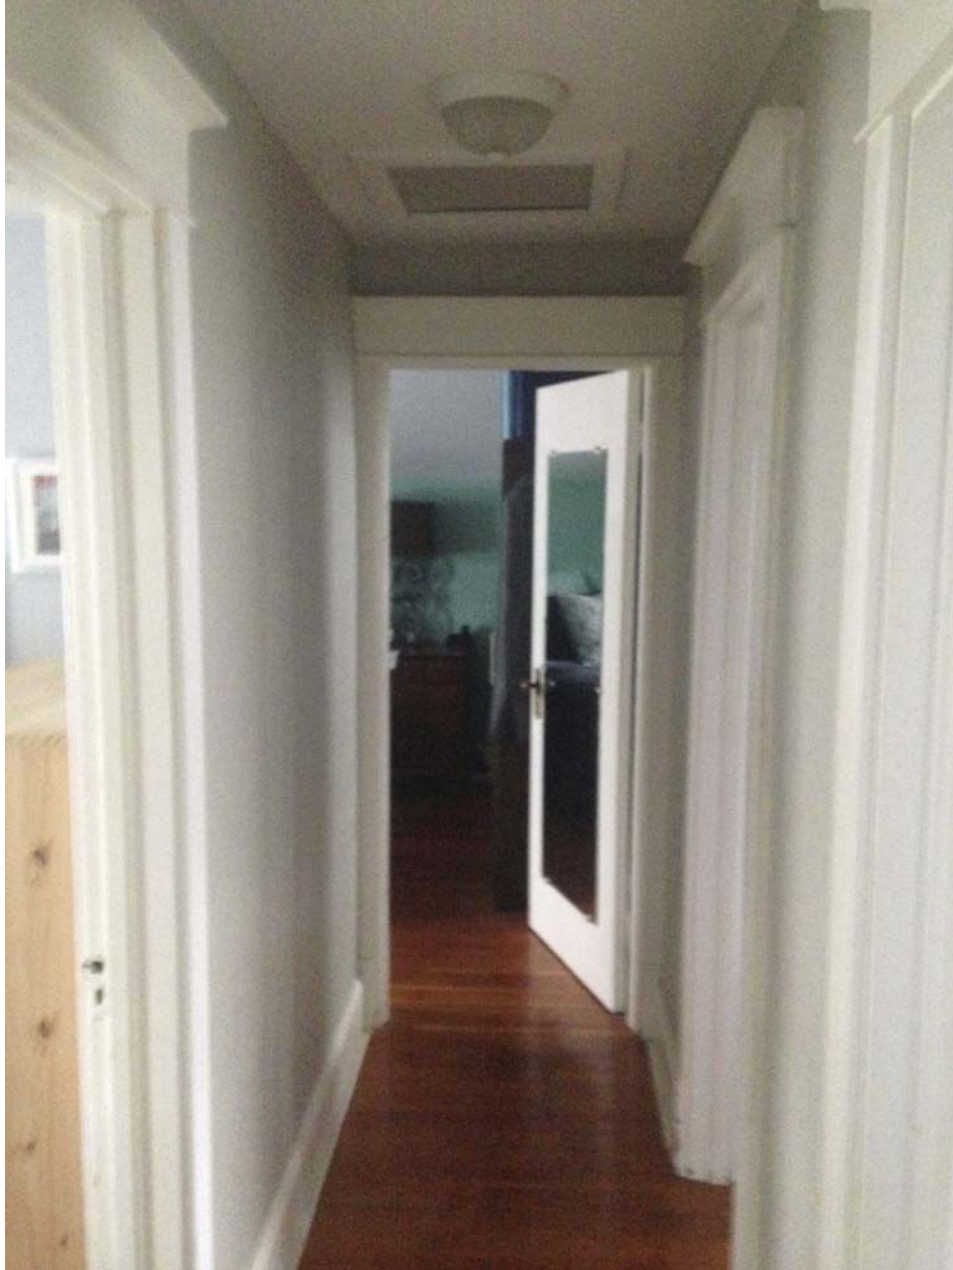
**2.53** Second floor hallway is less than 36" wide. Attic hatch beyond light.
