**320 Maple Avenue, Oakville**

**BUILDING ASSESSMENT REPORT:**

**February 7, 2018**

**Prepared by: T. Murison**

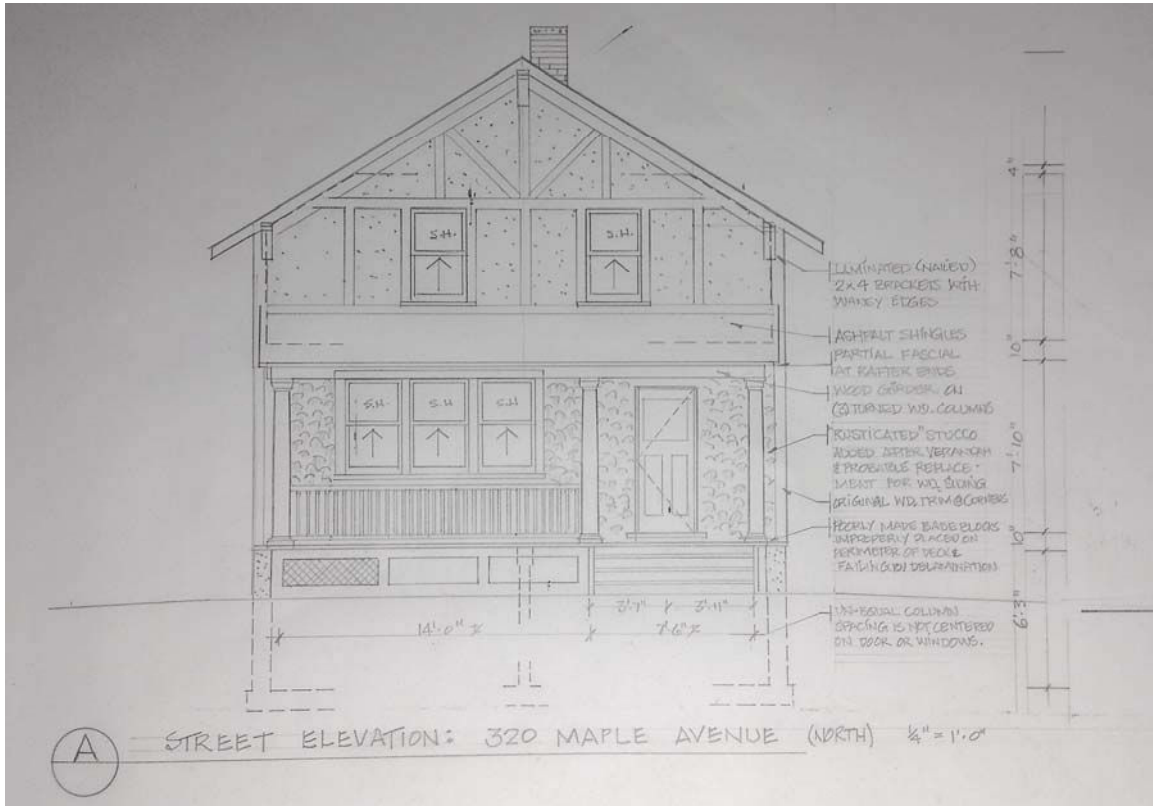
**3.12 North Elevation facing Maple Avenue. Trees & shrubs removed for clarity.** Almost all of the finishes including the stucco is not original. The porch and brackets are probably original, but are were installed without an understanding of Arts and Crafts buildings or even Classical Revival traditions.

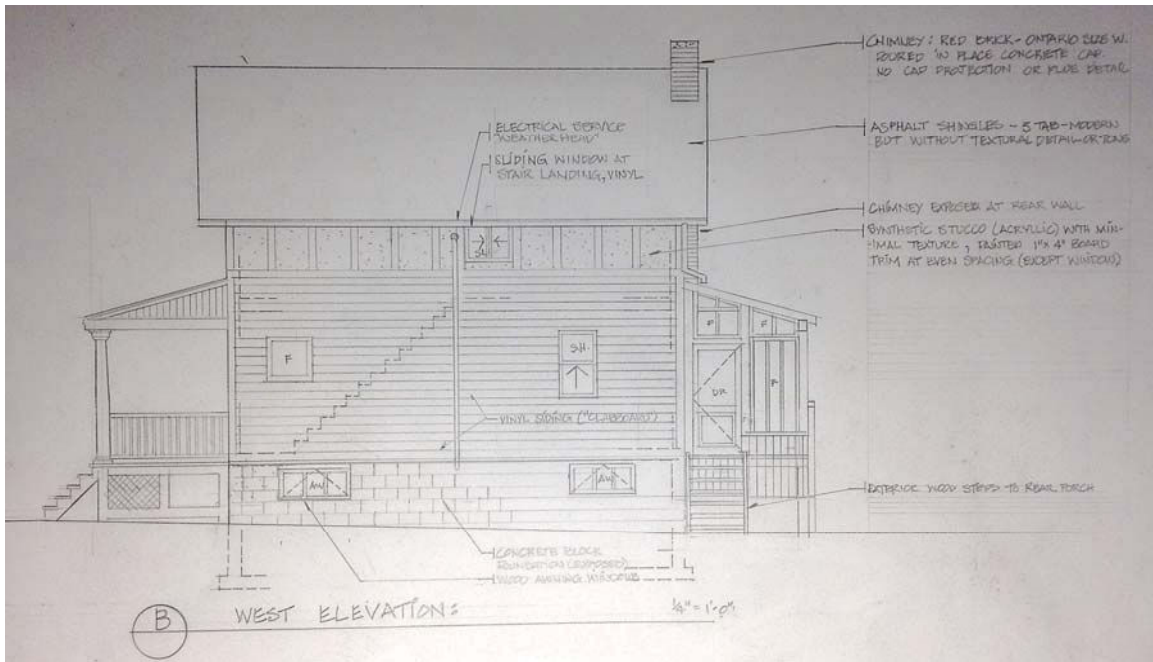
**3.13 West elevation along driveway to rear garage.** Note steady slope of grade towards the back wall which is near the lowest point of the lot and surrounding properties. This causes chronic flooding of the basement.

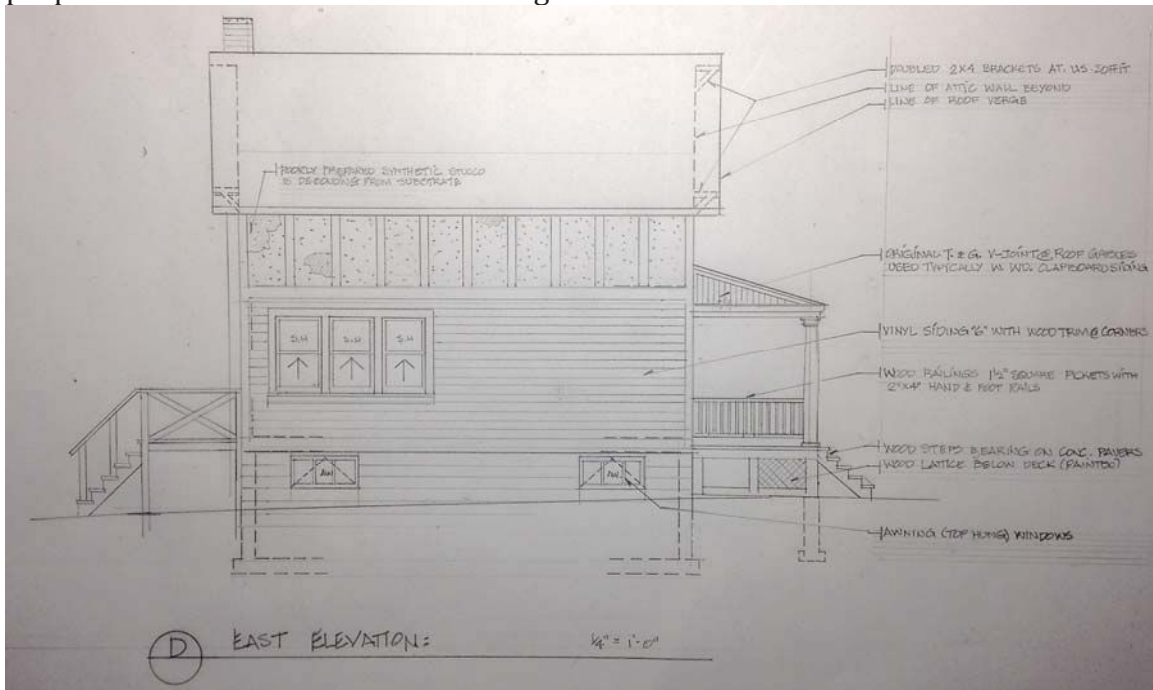
**3.14 East Elevation with rear porch and front verandah.** Note original dining room window and deteriorating modern trim & synthetic stucco at second floor.

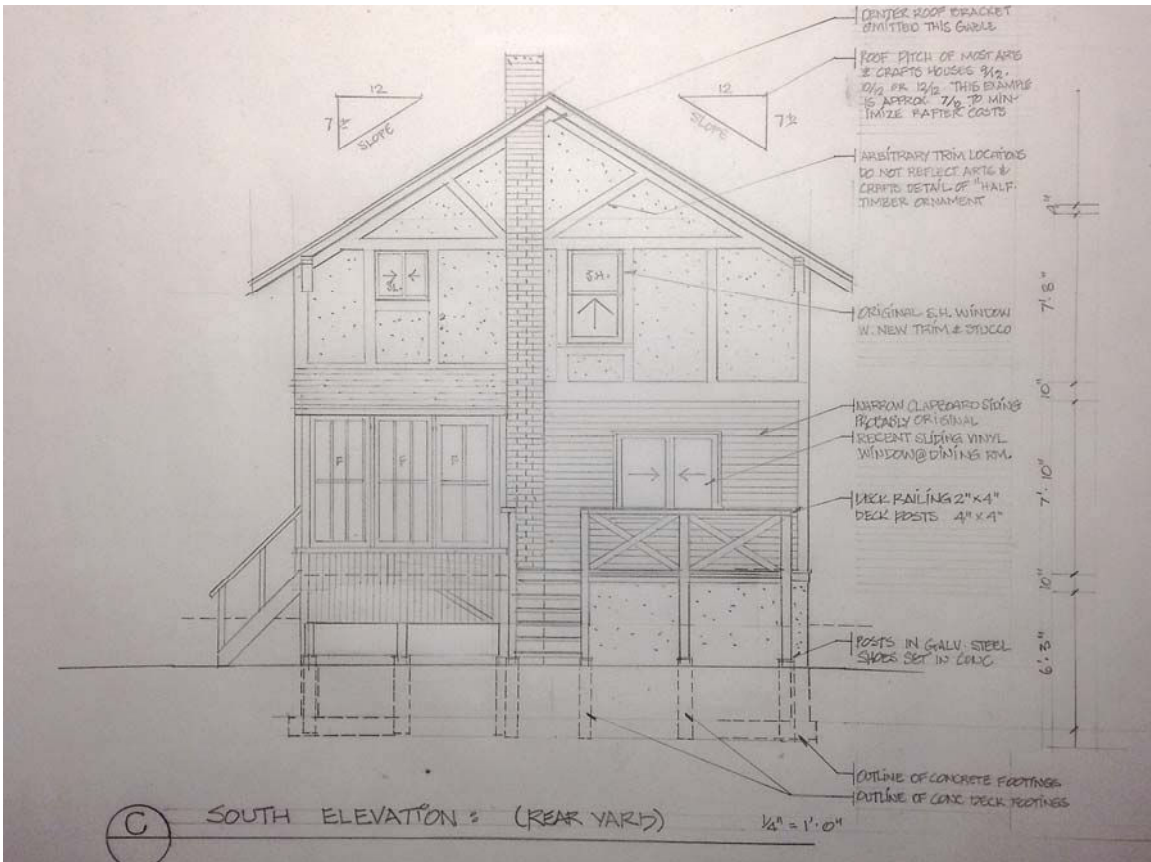
3.15 South elevation (visible to several neighbours), with external chimney, various additions and changes with salvaged & new materials at several times.

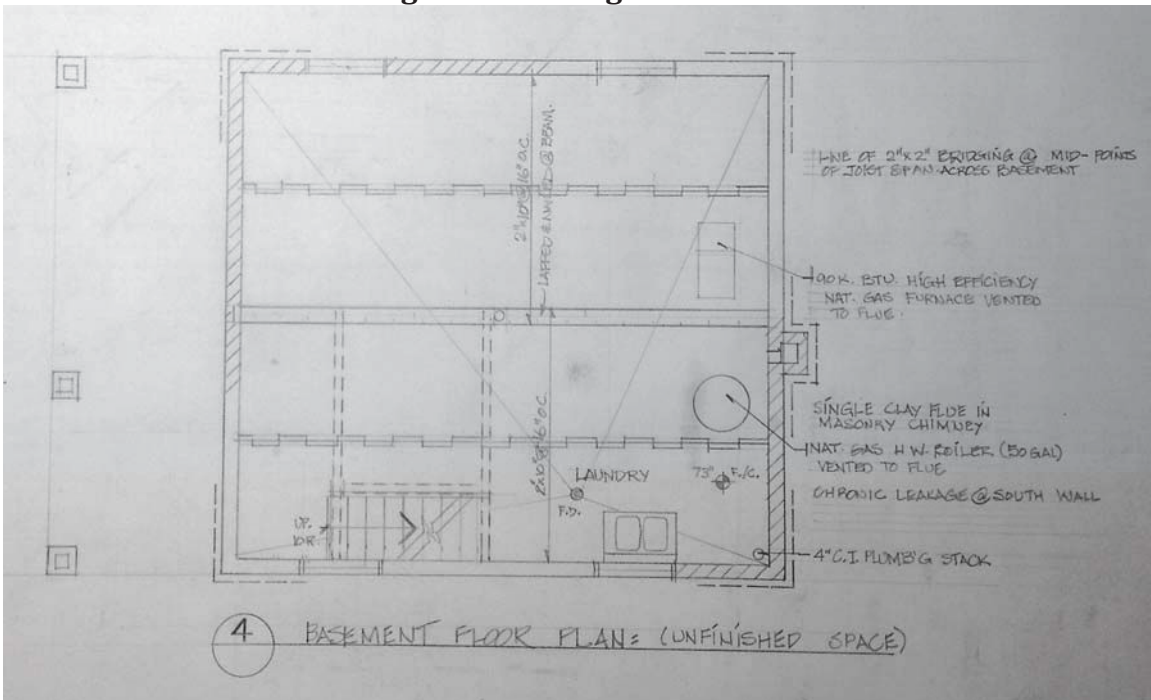
3.16 Basement plan with notations of framing & foundations. Ceiling height is only 6' 3". Chronic flooding brings water through the block wall at the rear.

Staircase cracks in the block foundation also indicate movement of the foundation. Vertical movement will occur if frozen soil adhering to the block lifts a portion of the wall relative to an adjoining section. Since more heat escapes through the middle of a wall than at the corners, frost adhesion is usually worse at the corners. This is seen in the basement corners. The block walls have been "jacked" vertically by the outside soil, resulting in structural failure of the foundation and leakage through the block. The furnace is located at the middle of the south

foundation wall below the back porch, which keeps the soil outside thawed in colder weather than the soil at the corners. Repairs would require excavating the entire foundation to the footings, to allow repointing, parging, installation of weeping tile and a drainage layer. This is an expensive repair that will add not space and no increase in value to the house.
