Building Condition Assessment
and Recommendations for Moving a Dwelling at
1158 Burnhamthorpe Road, Oakville

1.1 Executive Summary

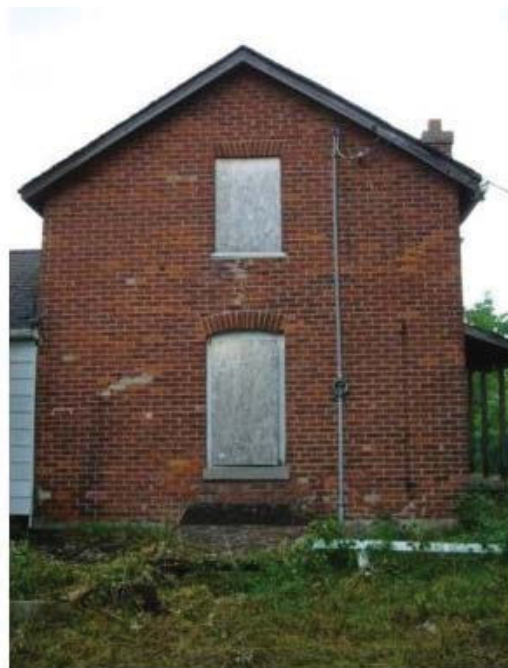
South elevation, 2017 (David Cuming)

A single window in the first-floor south end is balanced by an anomalous door in the north end, seemingly superfluous to the front and rear doors in the same room. The crude masonry work and finishing details, lack of windows, and added door give the north end of

the building the distinct appearance of a poorly-executed repair to a catastrophic event in the life of the house. More will be said later about the brickwork.

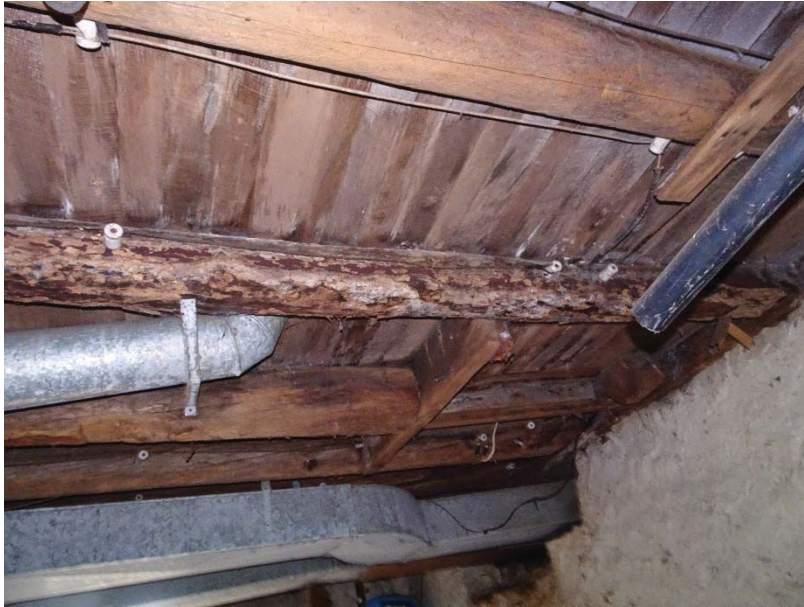
Cut off timber joist & filled-in floor

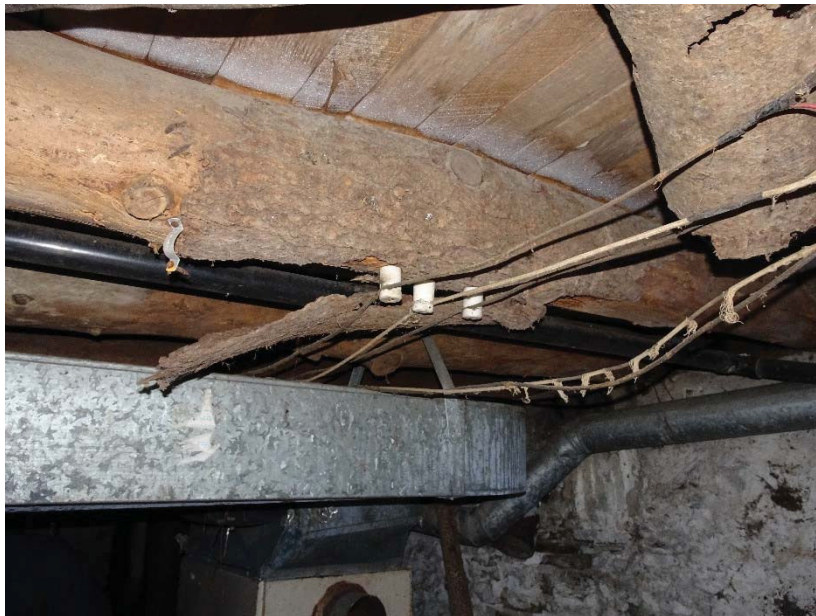
The south end of the main floor has its original round pine timber joists, some with the bark still clinging to them, flattened on top to receive the flooring.

Round pine timber joists with bark attached

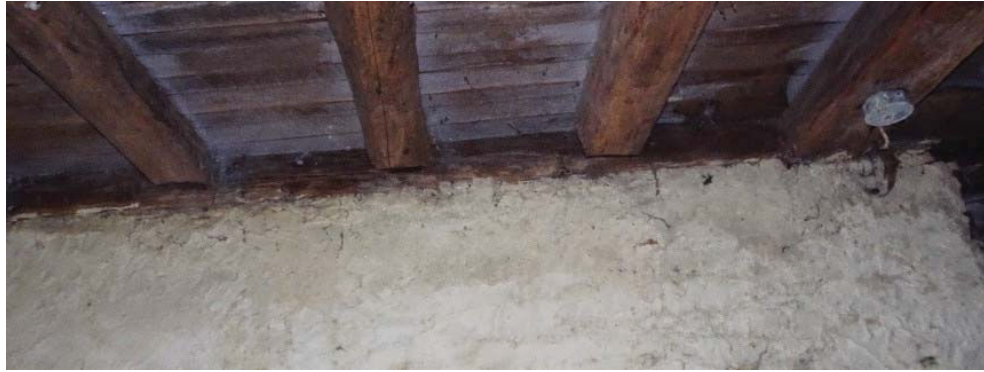
By 1858 this would be considered somewhat crude, but it is not that unusual. The joists are framed into a timber sill plate that has been flattened top and bottom by broad-axe and rests on the stone foundation.

Timber sill plate on stone foundation

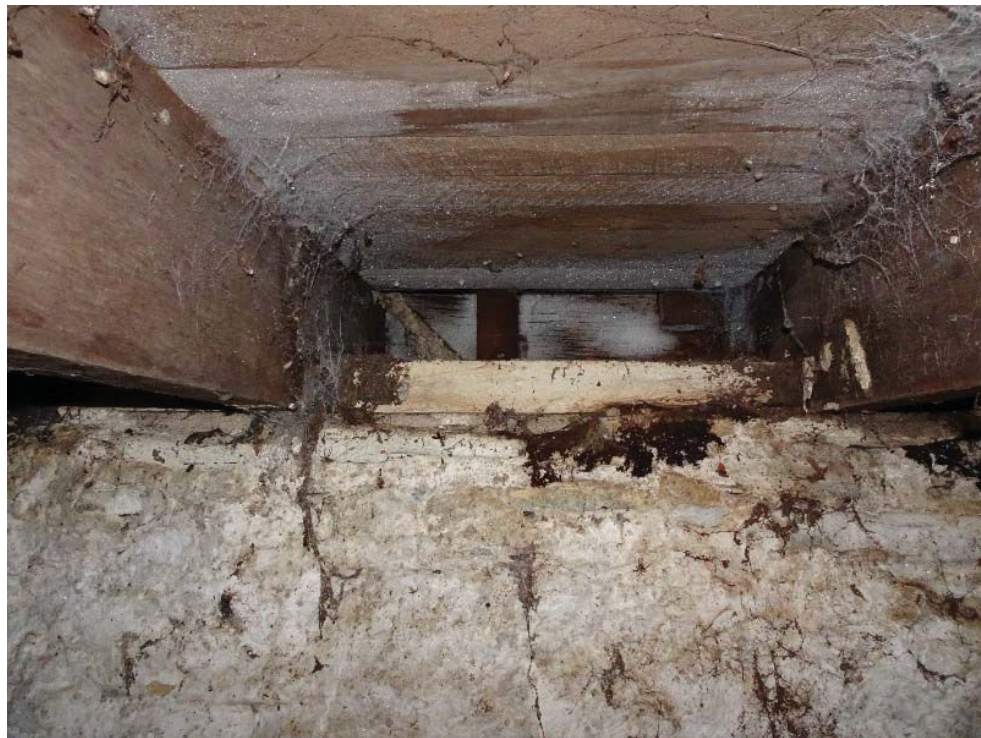
This original hewn floor structure has been replaced with sawn members in the north end of the house. 2x8 joists sit on a 2x8 plate on the stone wall, and sawn studs can be seen sitting on the plate in the style of late 19th or early 20th century balloon framing.

Replaced wood plate and joists in north end with balloon studs

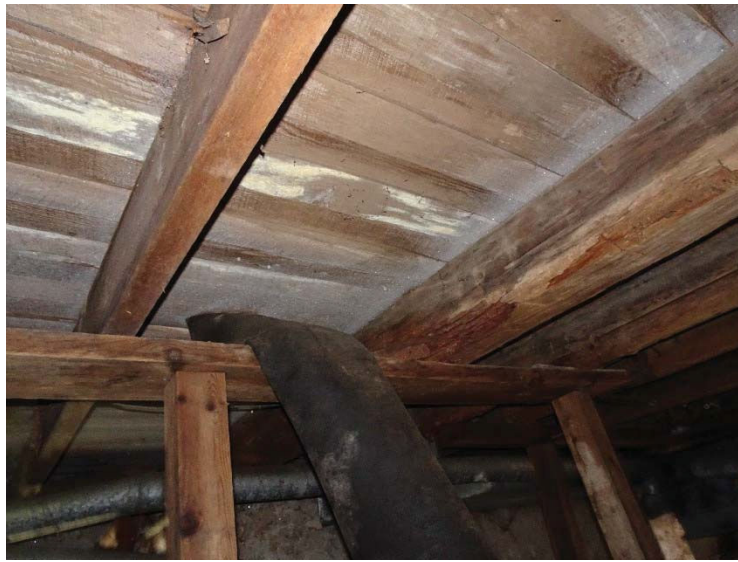
Both the timber joists and the lumber joists exhibit decay in various stages, and have been supported at intermediate points by a range of wooden posts, beams, and bolsters.

Sawn and hewn joists decayed & with mid-support

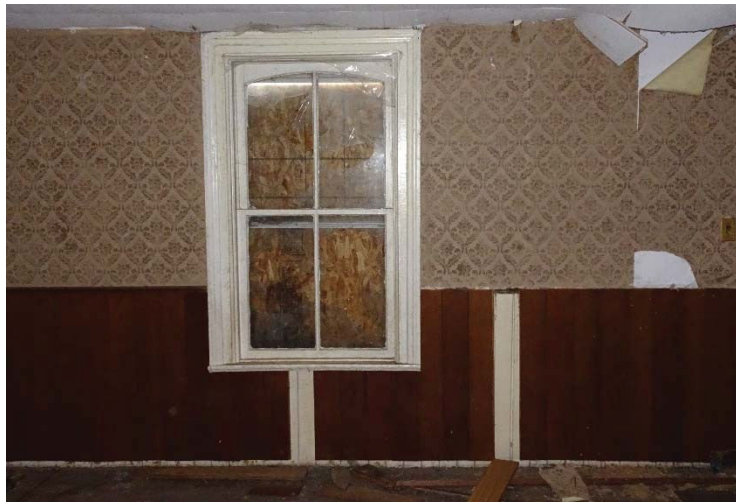
The interior main floor of the house remains as the original two rooms, with little architectural distinction. The main room has vertical T&G wood wainscoting over an older, vertical T&G wood wainscoting unlikely original in a front room but possible in a kitchen wing. The casing on the doors and windows and the window sash are typical of a somewhat later period than 1858, more like 1870s or 80s.

2 layers of wood wainscoting, later style window and casing

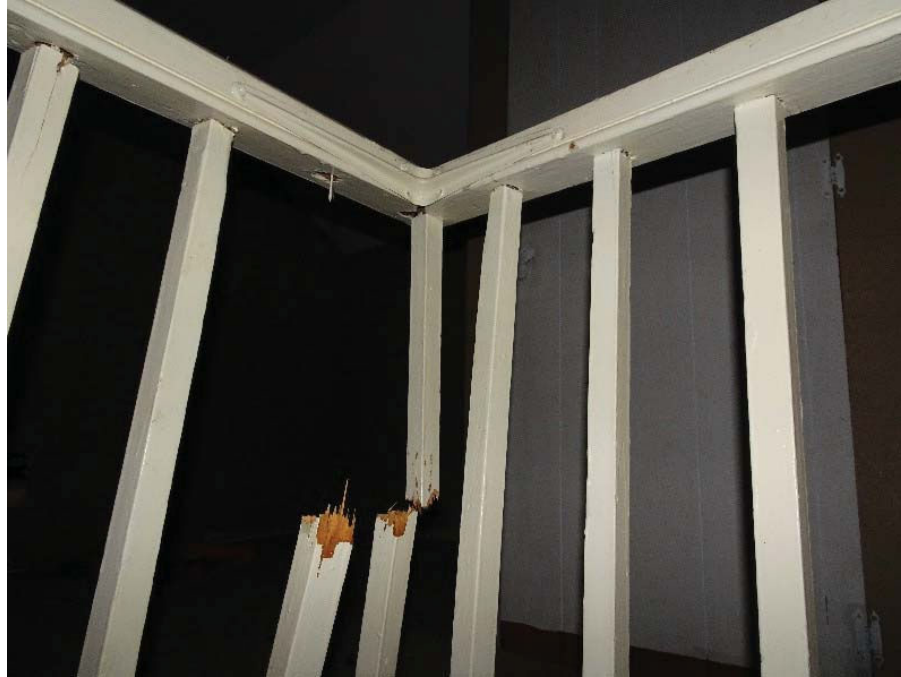
Damaged plain pine balustrade

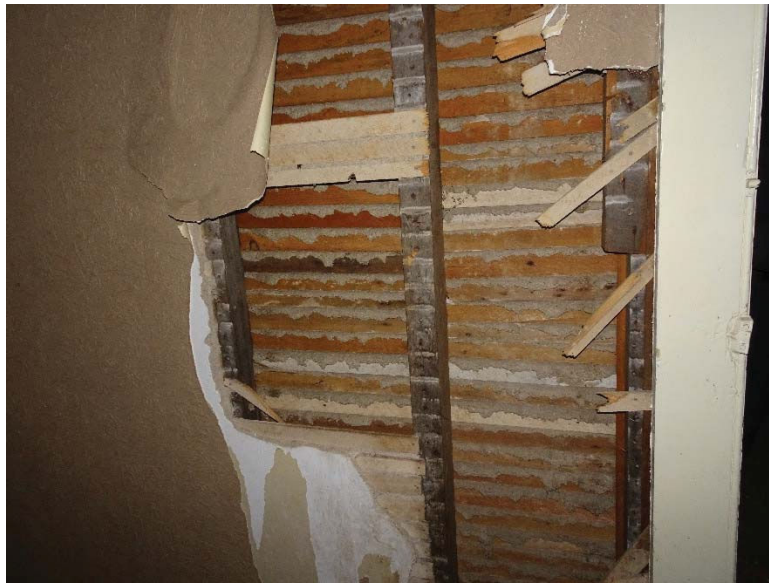
Vandals have knocked some holes in some walls, and the circular-sawn wood lath is indicative of a much later date than 1858. It is also curious that the studs carrying this lath appear to be somewhat weathered, which is distinctly unusual, indicative of a fairly lengthy period of exposure between framing and lathing.

Circular sawn wood lath on weathered studs

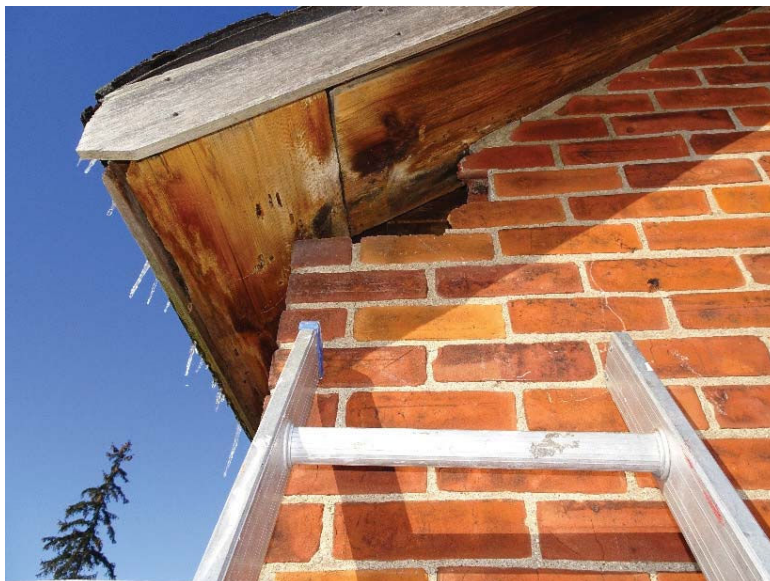
There are numerous indicators that point strongly to this conclusion. The wood soffit was installed before the brick was laid, which would not be done if the brick was original. The author removed a brick at the soffit, and the concealed wood exhibited a fair degree of weathering, which would not be the case if the brick were original. There is no frieze or even a small moulding to finish the joint between the brick and the soffit; mortar was used to fill the gap. This lack of finishing detail is unheard of even in the simplest carpenter-built house.

Brick laid over finished soffit

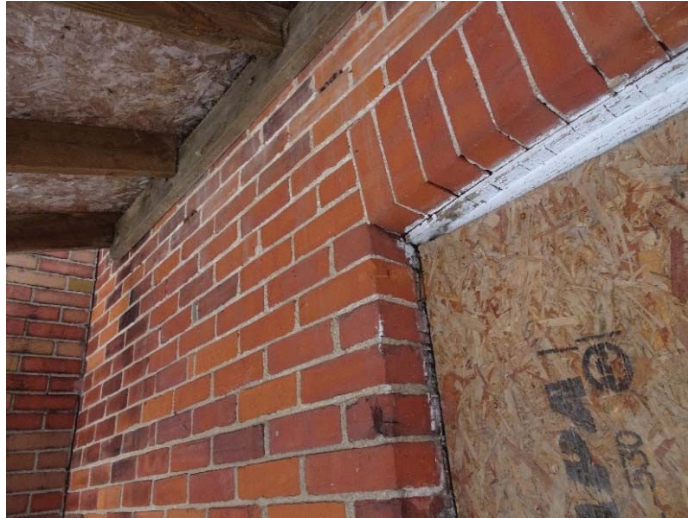
The exterior casing on the windows and doors did not cover the gap behind the brick, and a small wood trim was installed after the original trim to close it off.

Kerfed trim to cover the gap at the door head

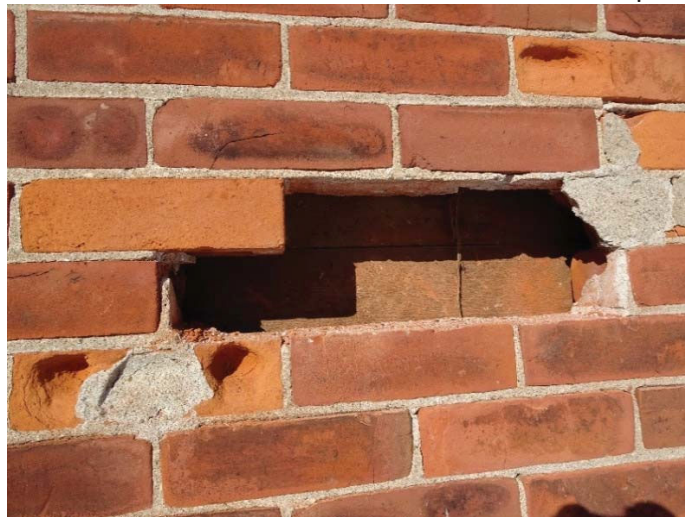
The brick overhangs the foundation in places. The bricks themselves are a consistently-made product with a deep frog typical of a brick manufacturer, not the more irregularly moulded flat bricks typical of site-produced bricks in the mid-century, again indicating a later date than 1858 for the brick. Unfortunately many of the bricks appear to have been under-fired and are failing. Some of these failed bricks were removed by the author to view the back-up. There are cut nails used as brick ties to hold the veneer to the back-up.

Failed bricks, mortar patching, and cut nails for brick ties

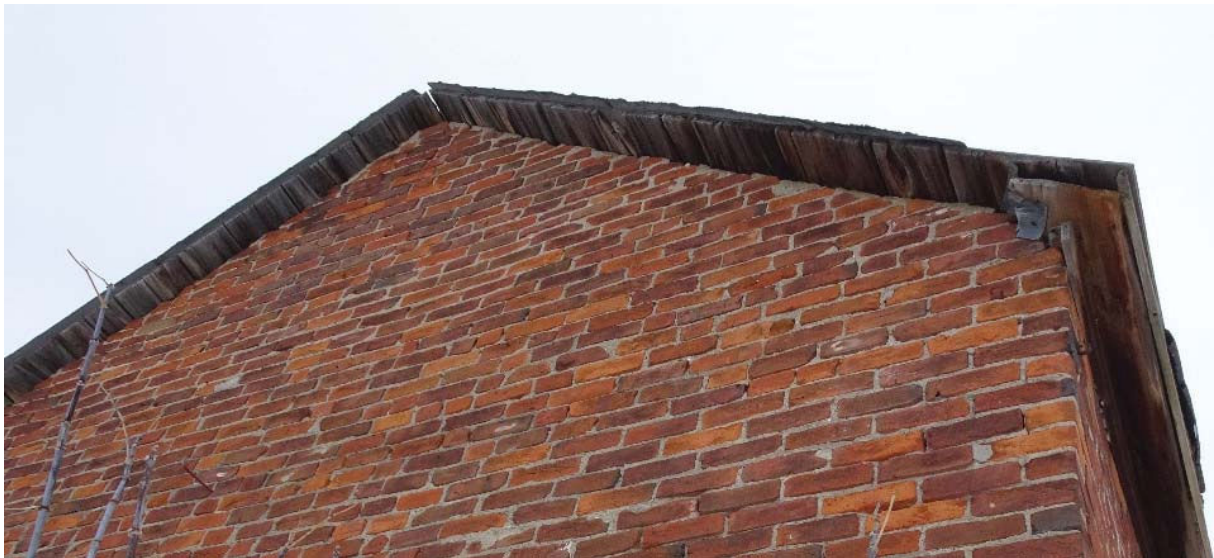
Brick laid against sheathing boards, no soffit or fascia

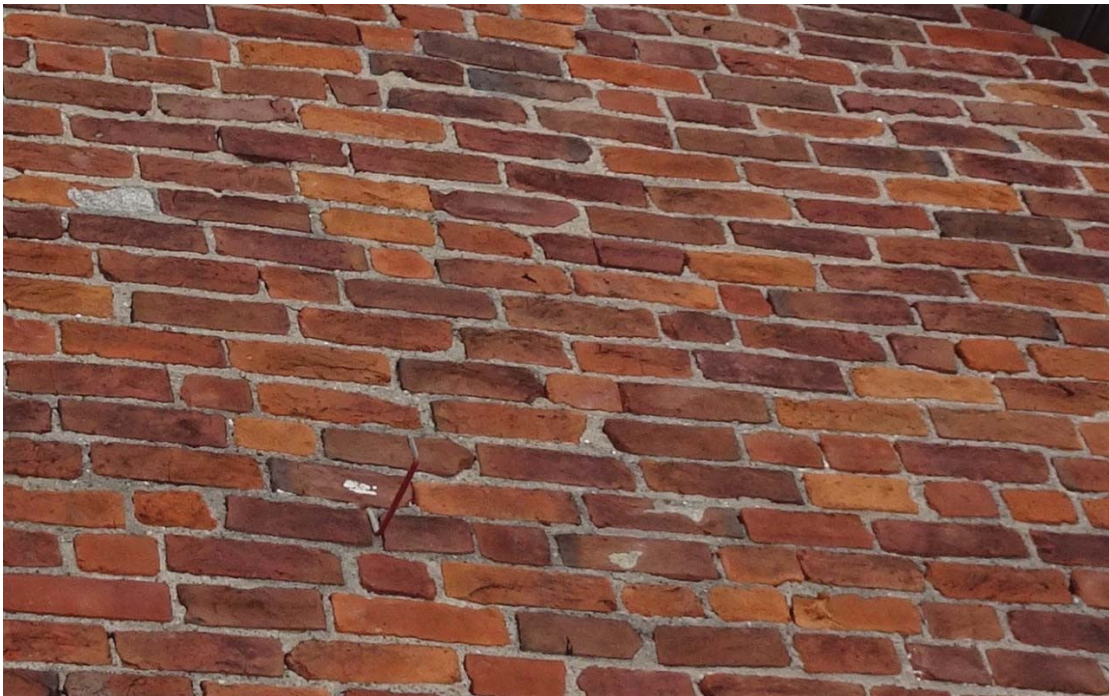
The assumed catastrophic event that necessitated reframing much of the main floor and relathing and plastering some interior partitions also clearly affected the north wall of the house. The east and west walls are bearing, so the north wall could be removed without seriously harming the structure or losing support of the roof. As earlier indicated, the presence of a single door on the ground floor and no windows up or down in the wall is distinctly odd and may have been an alteration done for a specific purpose when the wall was rebuilt. There is no soffit or fascia on the north gable end and the bricks were laid right up to the roof sheathing, however the eave soffit was in place before the brick was laid. While one could assume that a frieze and soffit were intended to be installed, and indeed should have been installed after the brick, the gaps at the roof sheathing were filled with mortar indicating that it was intended to be and has been the finished product. The bricks on the north end do not match the rest of the house, and in fact they appear to be salvaged. Many bricks are chipped and broken and were laid that way.

Chipped and broken brick laid into the north wall

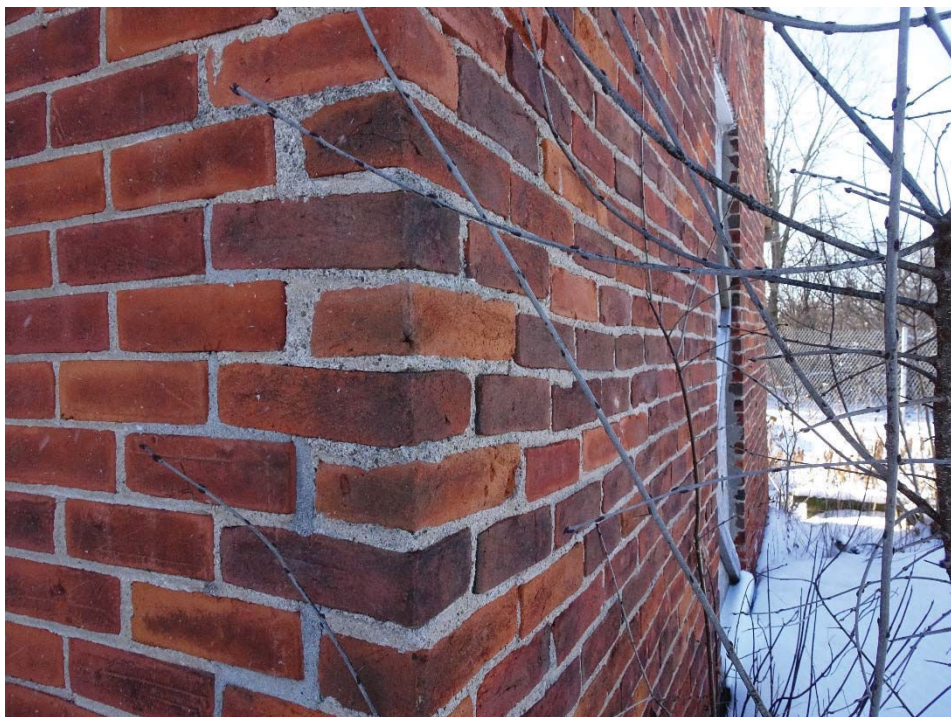
The mortar used in the north wall has much coarser aggregate than the rest of the house; the tothing-in at the corners is poor, and the general line of the bricks is crooked. The workmanship is clearly inferior to the rest of the house. The repair gives every appearance of a job done with few resources or access to skilled labour.

Crooked coursing, salvaged bricks, poor tothing-in, and coarse mortar
