FINAL REPORT

Cultural Heritage Evaluation Report

1297 Dundas Street East, Formerly Lot 8, Concession 1 North of Dundas Street, Trafalgar Township, Now Town of Oakville, Regional Municipality of Halton, Ontario

20141025-1000-R01

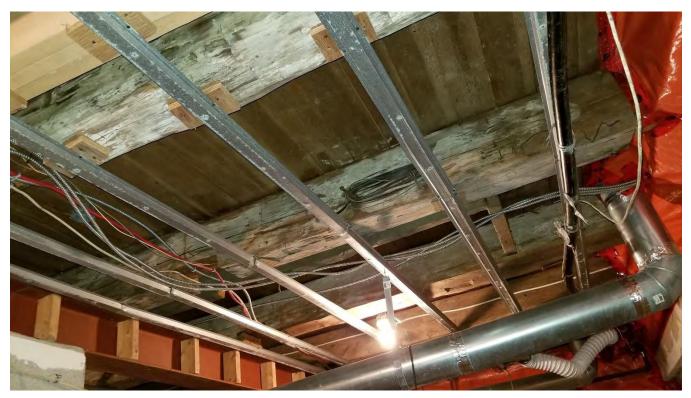
The main block is supported by eight hand hewn beams and reinforced by two steel I-beams and CMU posts (Figure 40). The majority of the northwest wall of the main block foundation was cut and removed to join the basement of the rear extension.

Figure 40 Hand hewn joists and steel I-beam reinforcement.

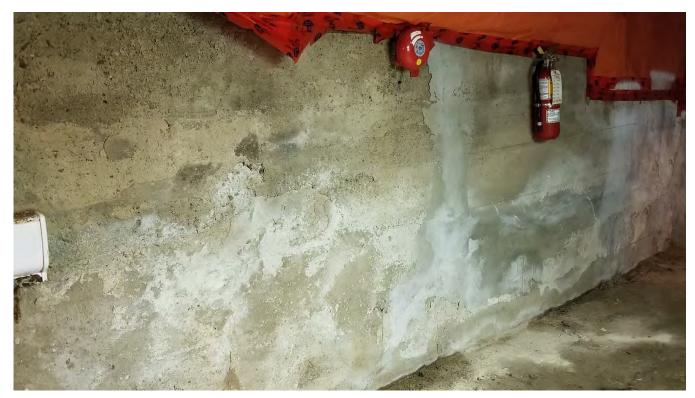
Figure 52 Southwest basement wall showing evidence of form boards.

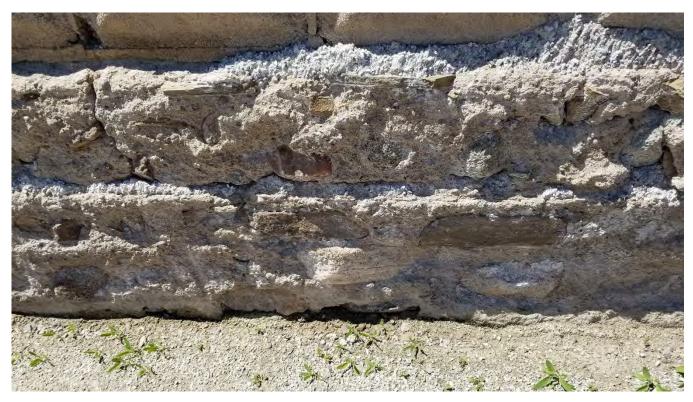
Figure 70 Coursed rubble stone foundation of the barn.

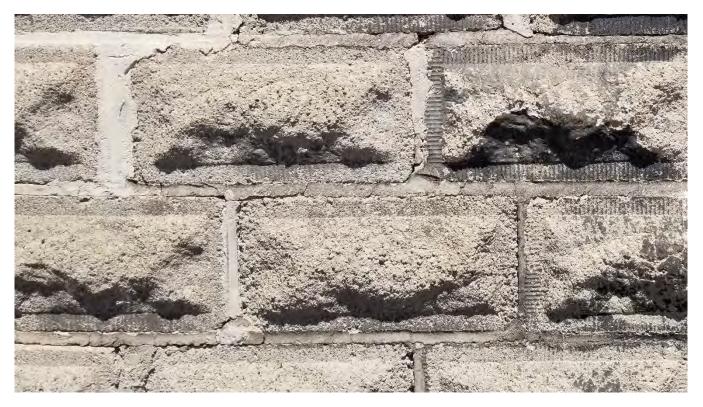
Figure 71 Rock-face CMUs with tooled edge

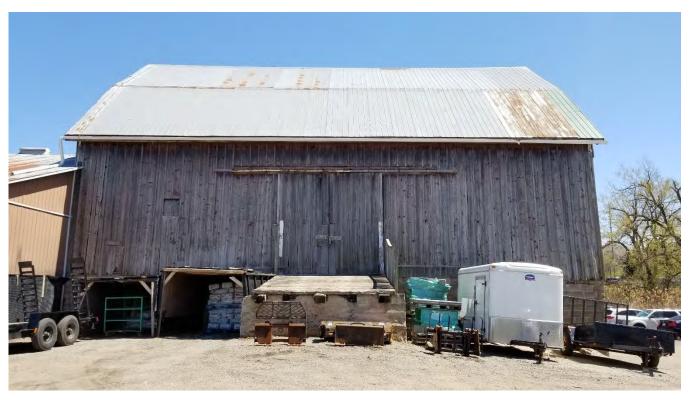
A partial wooden ramp supported by wood beams and concrete on the northeast elevation provides access to the second storey through a large central double sliding door (Figure 75). Its associated dirt ramp has been removed.

Figure 75 Partial wooden ramp and large central double sliding door on northwest elevation of the barn.

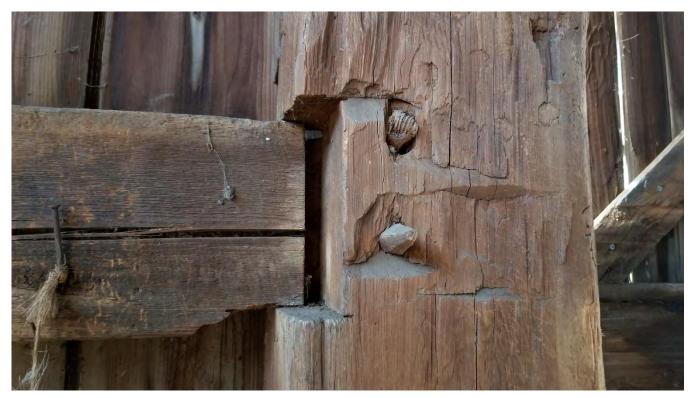
Figure 91 Detail of mortice and tenon joinery pinned with treenail.

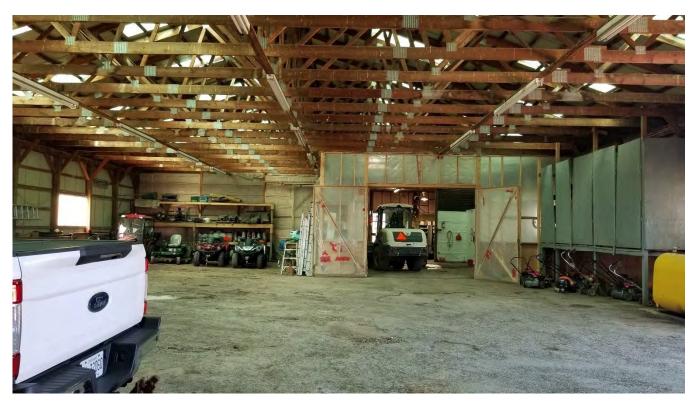
The board and batten section of the extension has two floors with office space on the second floor and storage and rooms on the ground floor (Figure 93). The aluminium clad section of the extension is a dimensional lumber framed large open space. The floor is asphalt, cracked and uneven (Figure 94).

Figure 94 Aluminum extension, looking northeast.
