APPENDIX B

HERITAGE CONSERVATION STATEMENT

**William Perkins House
41 Dundas Street East
Part of Lot 15, Concession 1 North
Former Trafalgar Township
Town of Oakville, Halton Region, Ontario**

Report Number: 1529982-R01

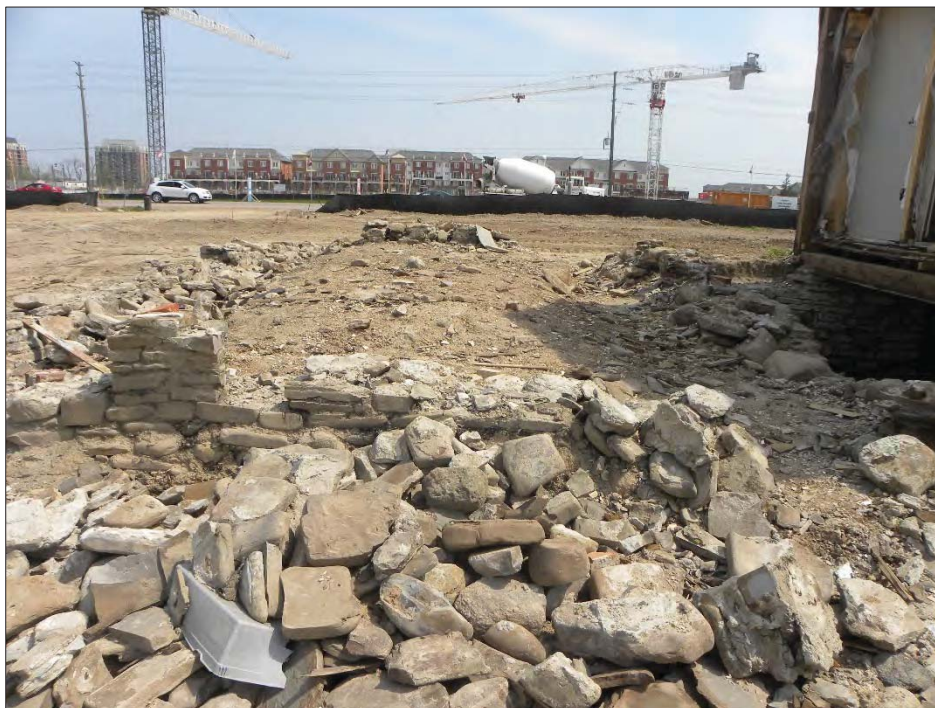
Figure 5: The partially demolished foundation of the brick section (centre) and timber-frame section (right), 2015.

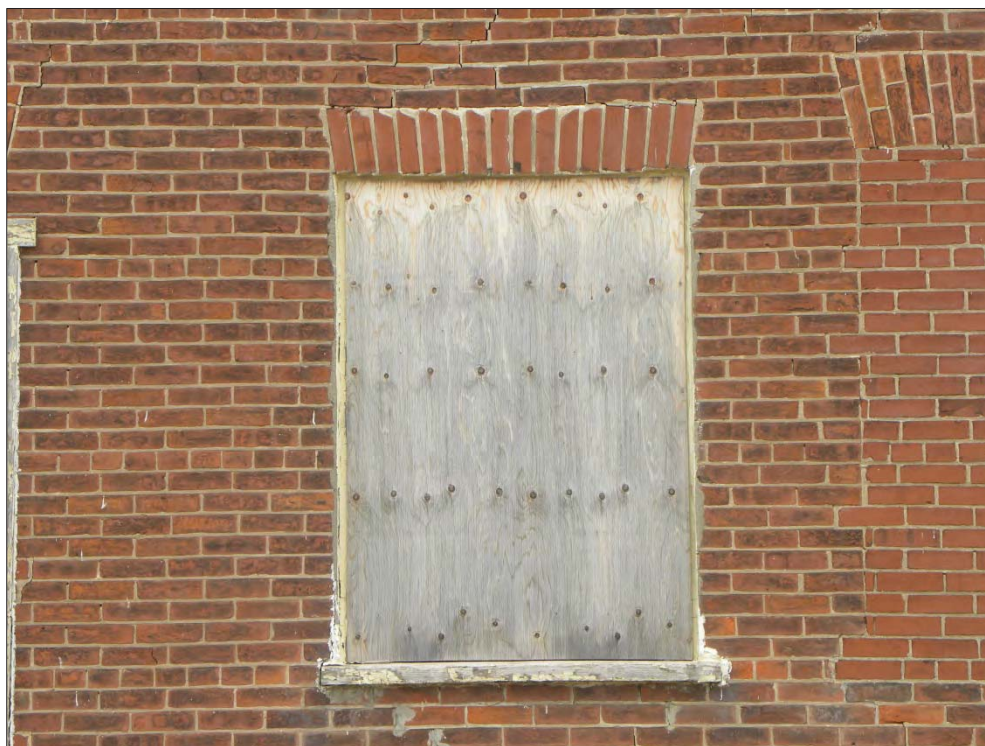
Figure 10: Detail of the later window cut on the south façade.

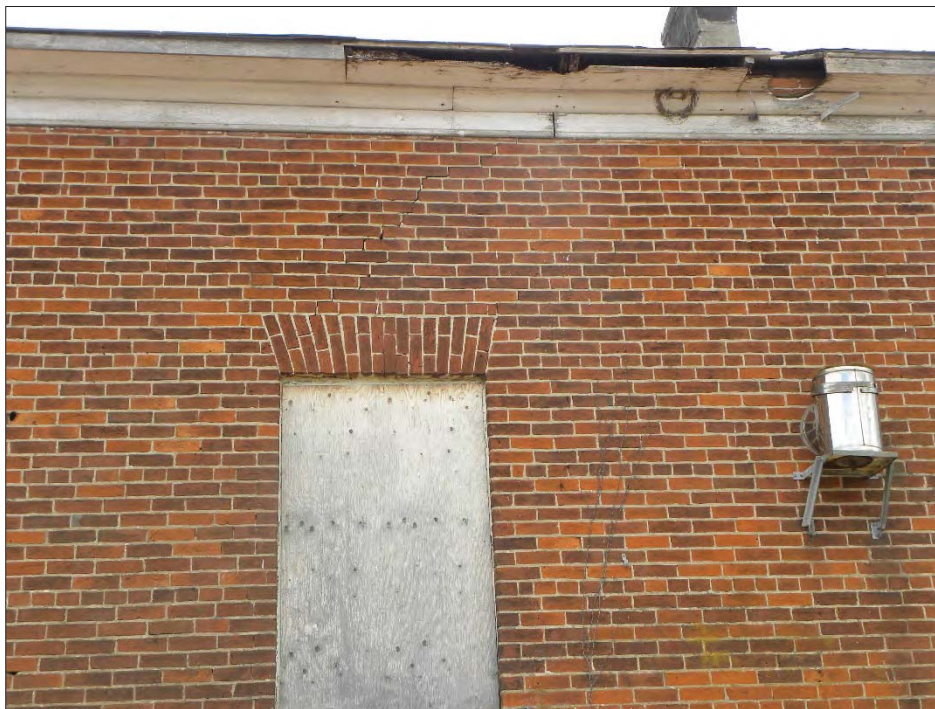
Figure 18: Section of missing fascia, soffit, and bedmould near the northeast corner. A crack in the masonry can also be seen.

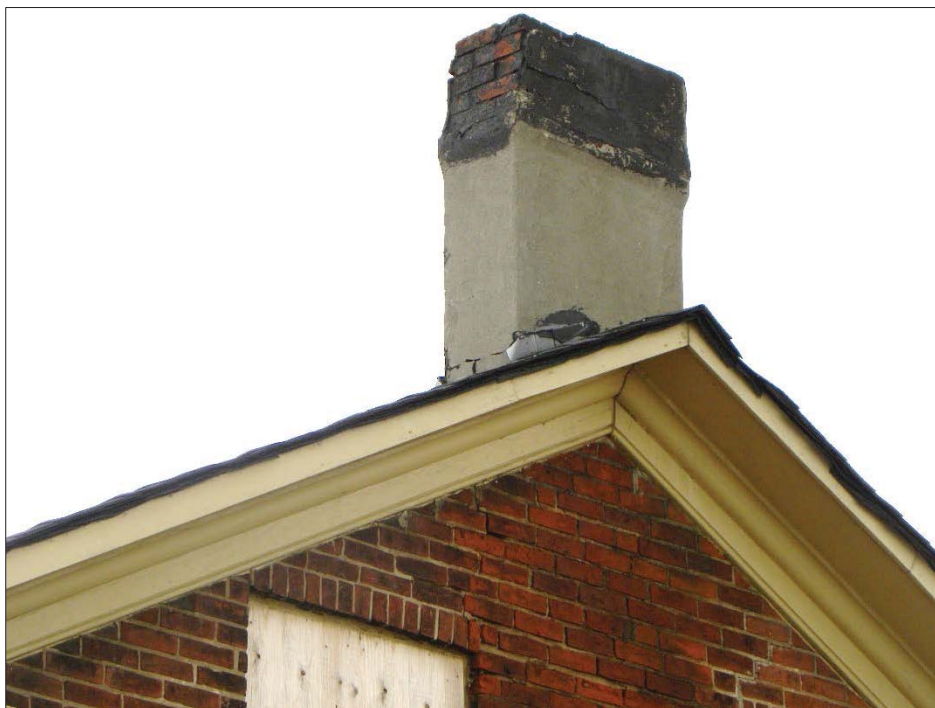
Figure 19: Lifted or missing flashing and mortar loss on the south chimney.

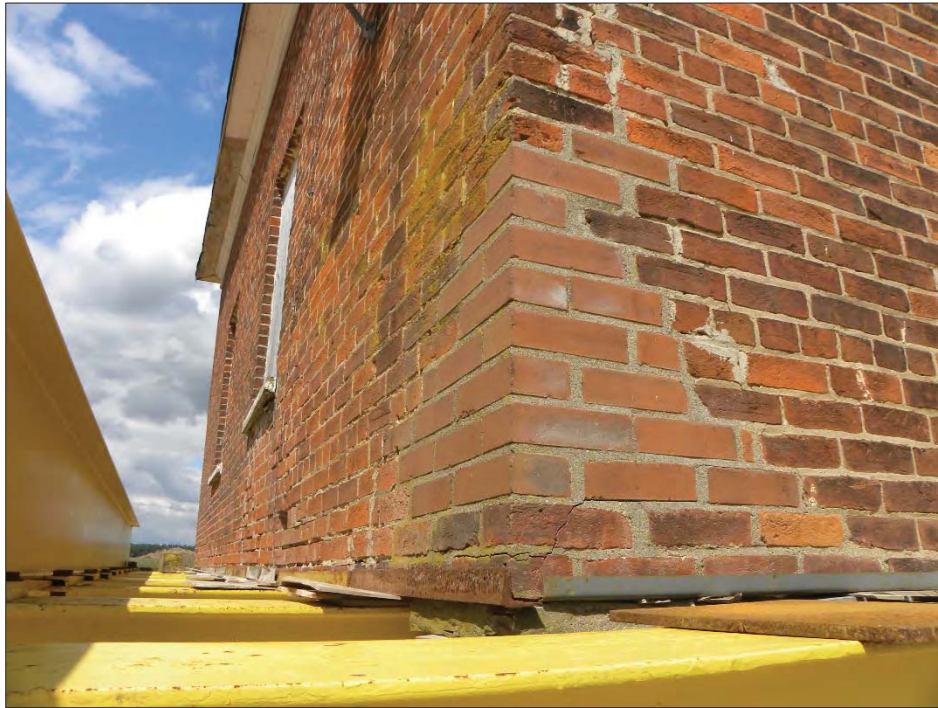
Figure 20: Masonry repair in new brick and Portland cement at the northeast corner. Missing brick and cracks can also be seen.

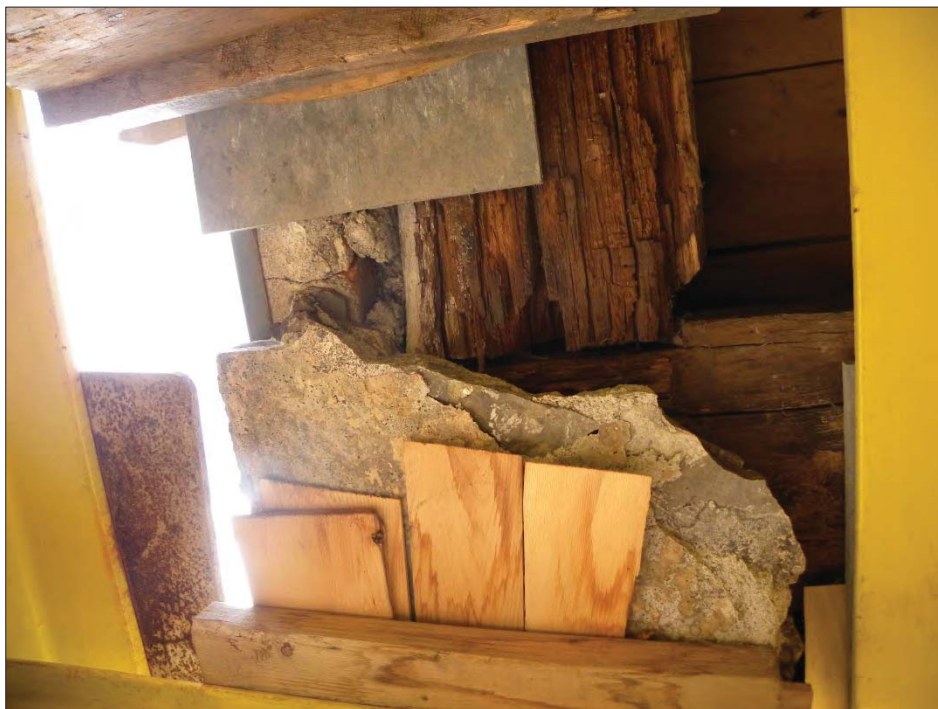
Figure 21: Rot in the end section of the sill plate

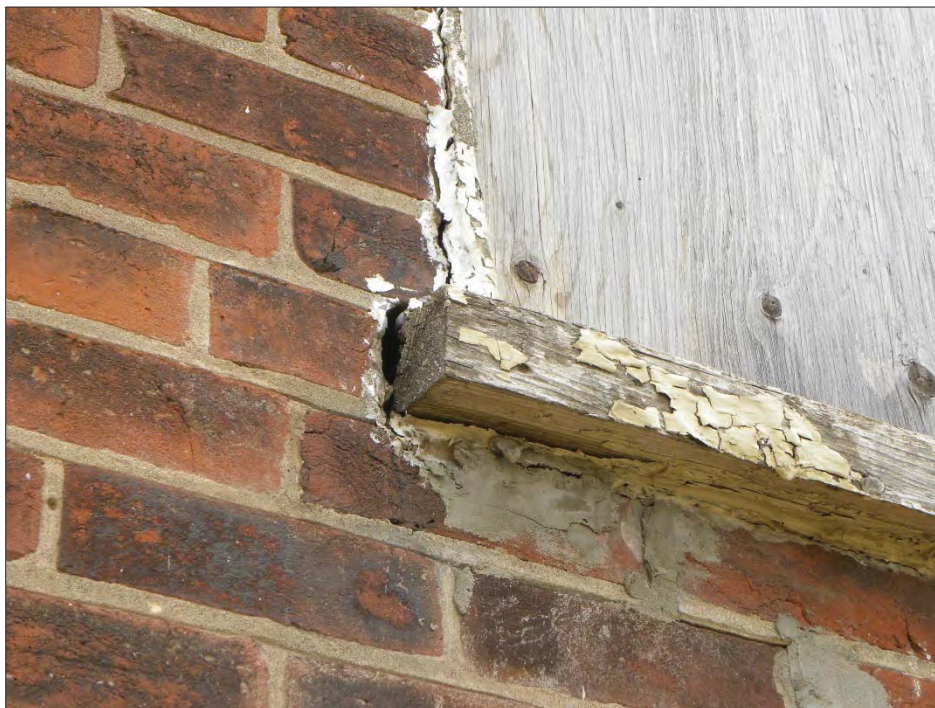
Foundations	N/A	<ul style="list-style-type: none">■ N/A
Windows and Doors	Good to Fair	<ul style="list-style-type: none">■ All windows are covered in plywood but the framing as seen from the interior appears sound (good)■ Many exterior wood sills partially rotted and paint has exfoliated (poor) (Figure 22)

Figure 22: Rot and peeling paint in the wood window sills.

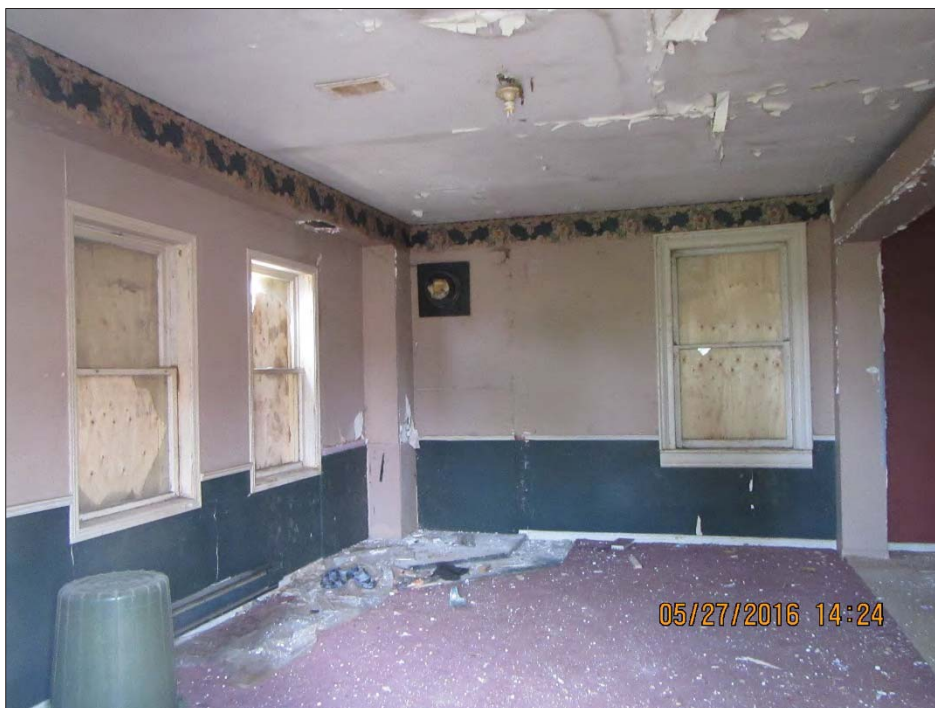
Element	Overall condition	Observations
		<ul style="list-style-type: none">■ Many panes completely broken or smashed (none are original) (very bad) (Figure 23)■ Original brick voussoirs intact; later voussoir and masonry above door on south façade poorly executed (very good to poor)
Porches and Extensions	N/A	<ul style="list-style-type: none">■ Removed prior to 2011 assessment
Basements	N/A	<ul style="list-style-type: none">■ N/A
Living and working spaces	Fair to poor	<ul style="list-style-type: none">■ Damage from partial demolition, vandalism, and neglect (fair)■ Peeling paint and trim damaged or removed (no original finishes-fair to poor) (Figure 23)■ Plasterboard damage when services removed (fair) (Figure 24)■ Sections of bird stencil now on exterior have exfoliated, cracked or been lost (very bad)
Attics, shafts, and concealed spaces	Not accessed	<ul style="list-style-type: none">■ Not accessed

Figure 23: Interior view showing peeling paint and broken window glass.

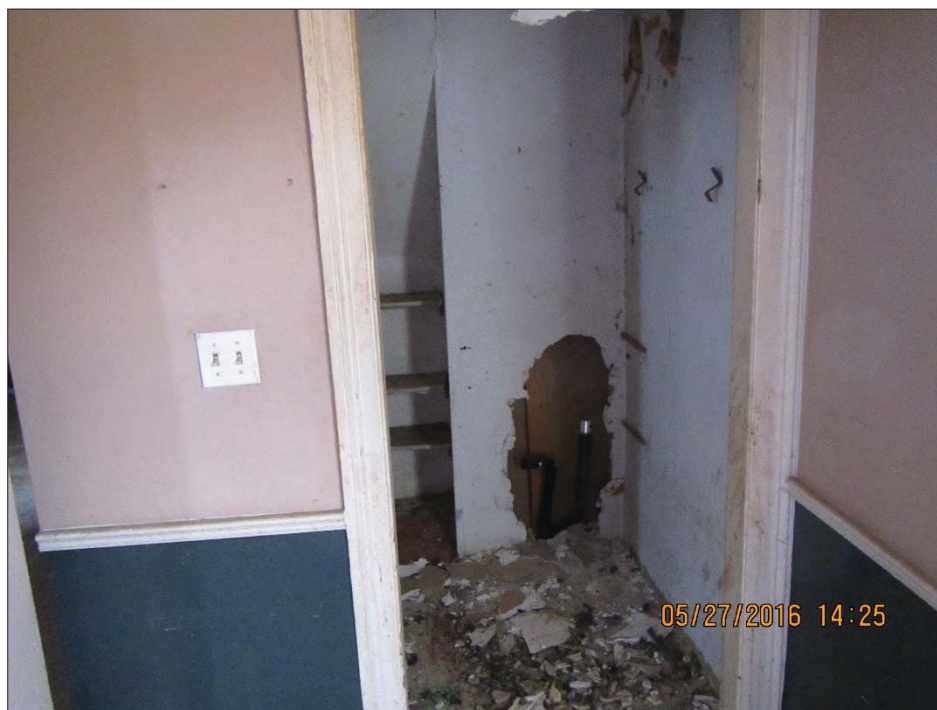
Figure 24: Plaster damage where services were removed.
