**LEONARD KALISHENKO & ASSOCIATES
LIMITED**

**RE: 2480-2496 Old Bronte Road
Oakville, Ontario**

At your request, Leonard Kalishenko and Associates Ltd. performed a visual inspection on the storage facility located at 2480 Old Bronte Road in Oakville. The purpose of this investigation was to determine the structural adequacy of the building. The investigation was performed on November 27th, the results of which are presented below.

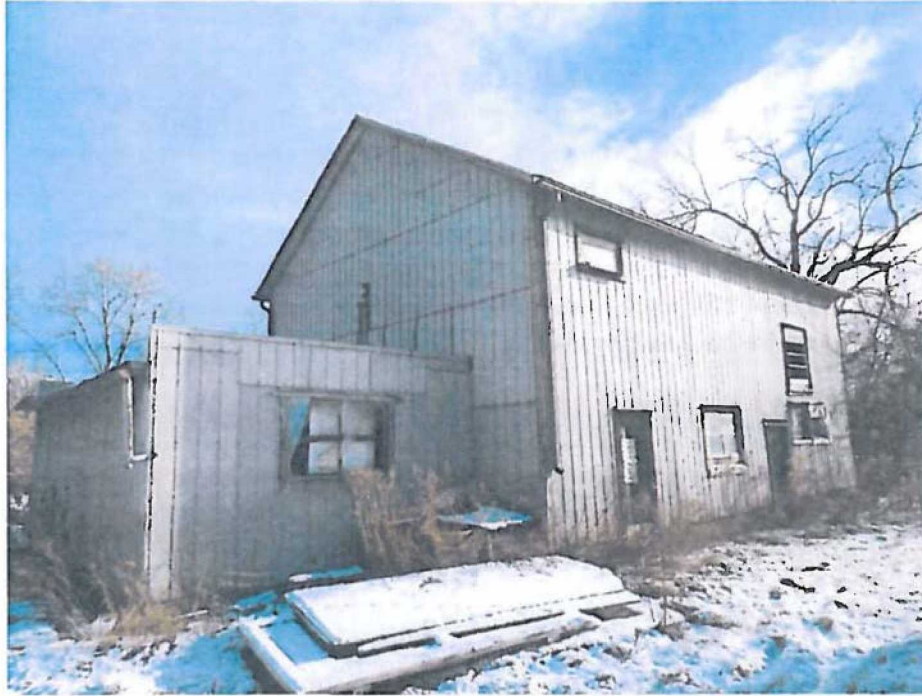
The building is located at the South-East side of the property at 2480 Old Bronte Road in Oakville. It consists of a two storey wood structure approximately 24 feet wide by 36 feet long with metal cladding covering the exterior walls of the building and the roof (see Picture 1). The foundations walls are built out of masonry units which extend above the grade by 3 courses. It looks to have functioned mainly as a storage facility. A smaller one storey portion, 24 feet by 12 feet, is attached to the main structure on the North-West of the building. This addition was not accessible at the time of the visit.

Picture 1: Barn Exterior

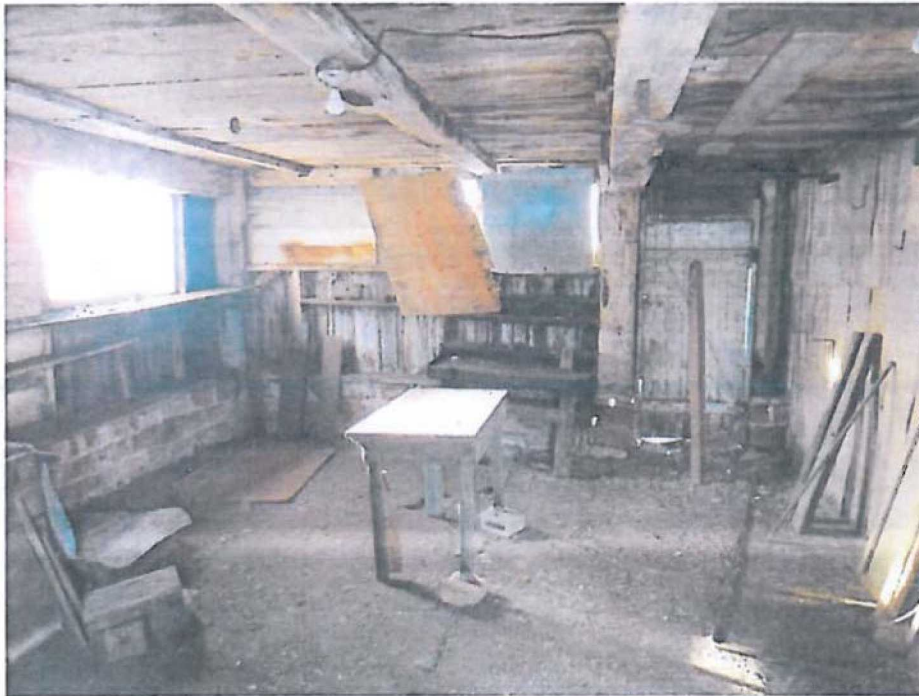
The building is supported by 8 large wood columns varying 8"x8" to 12"x12" posts. These columns are spaced at 12'-0" on centre along the two longer sides of the structure and are sitting directly on the masonry foundation wall. The second floor structure consists of 2" deep planks of varying width spanning between large wood beams approximately 8" wide x 10" deep spaced at 12'-0" and connecting to the main building columns (see Picture 2). Due to the unsafe and unstable nature of the second floor

Picture 2: Barn Ground Floor

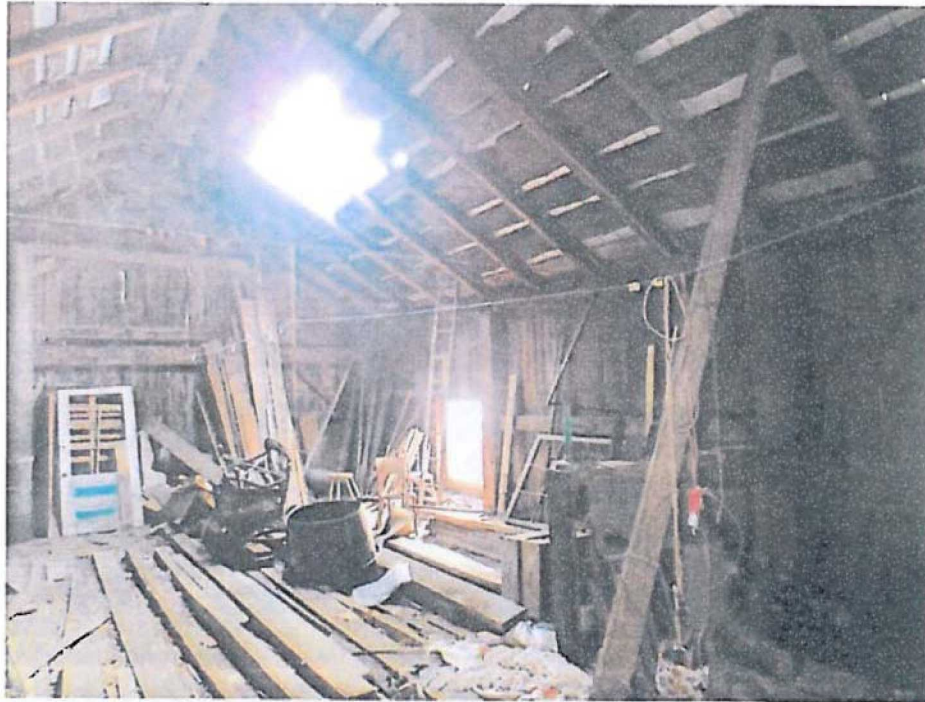
Picture 3: Barn Second Floor

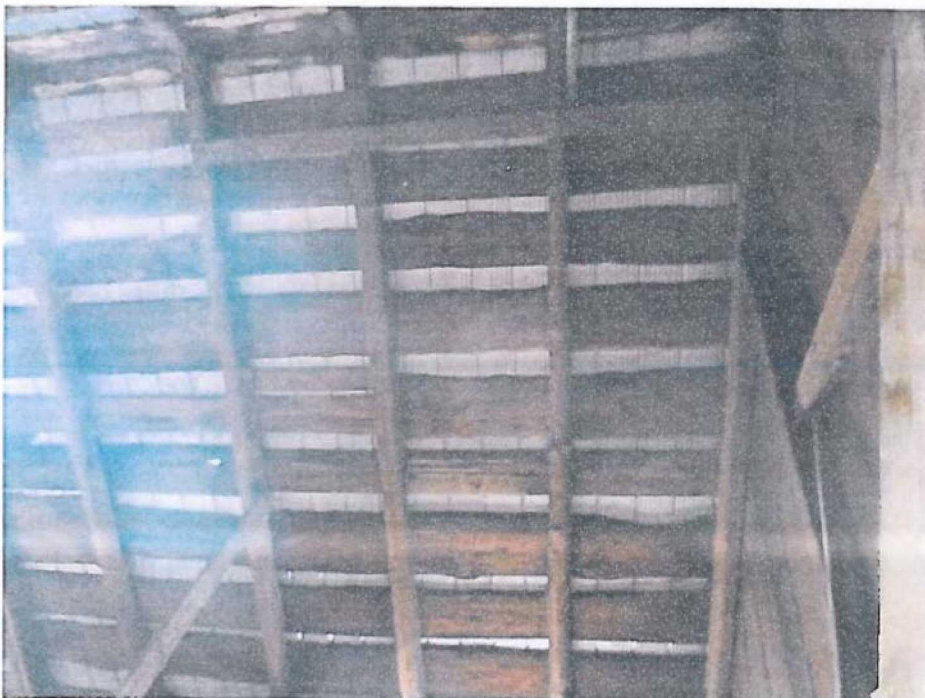
As indicated above, the roof structure could not be examined closely, as the second floor was deemed unsafe. A visual inspection from below led to the following conclusions. The roof structure does not have rafter ties or ceiling joist to provide integrity to the roof framing, preventing it from spreading the walls when loaded (see Picture 3). A single steel wire connected the two walls but this cable is not sufficient to assure the stability of the roof. Diagonal members were provided to brace the walls, The rafters were not noticed to be mechanically fastened to their supporting beams, and no uplift resistance system was noticed to tie down the roof. In the event of a large snow storm or heavy winds, there is a significant chance of the roof structure failing and either dislodging itself or failing and spreading the walls. These items are of significant concern and the roof structure is considered to be unsafe.

Picture 4: Barn Roof Structure

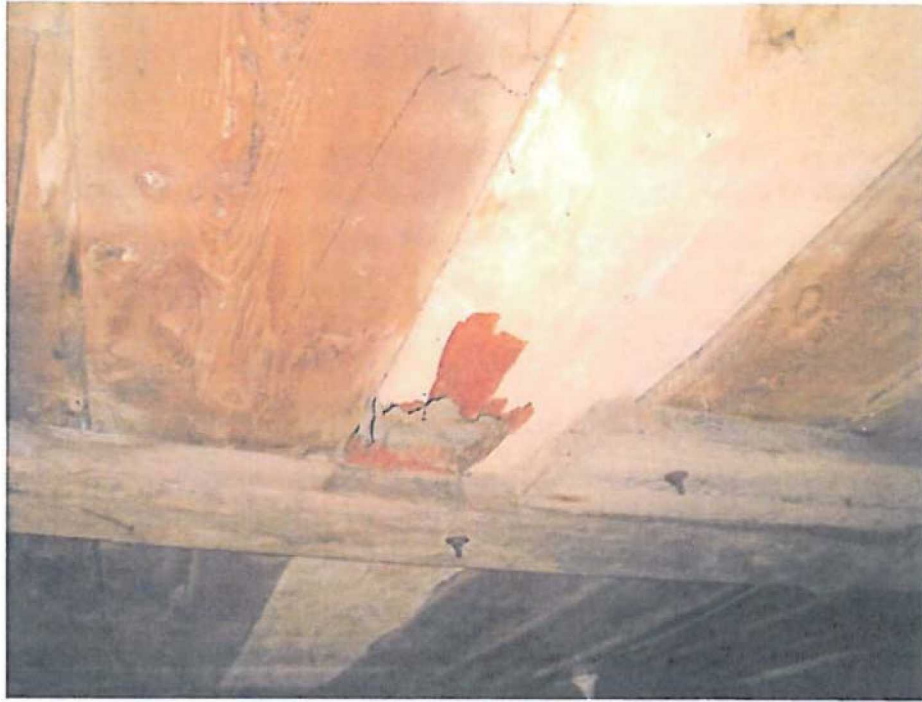
The floor structure is significantly under-strength. The floor planks are only 2" deep and are not sufficient to span between the supporting beams and significant sagging was noticed. In addition, a number of the planks are damaged or poorly supported and have lost a majority of their strength (see Pictures 5, 6). No structural framing of any significance is provided around the stair opening. An opening is provided for the brick oven vent and the cut joist is currently supported on a brick which has been loosely laid diagonally on the brick structure below (see Picture 7). The large wood beams have minimal bearing on the perimeter columns, sometimes as little as 1/4" and at one location the beam was propped up by a shim, leaving only a 2" x 1/4" bearing area (see Pictures 8, 9). These deficiencies represent a very significant threat to human safety. If someone were to step on the second floor, there is a high chance of the floor failing resulting in severe injury.

Picture 5: Damaged Floor Planks

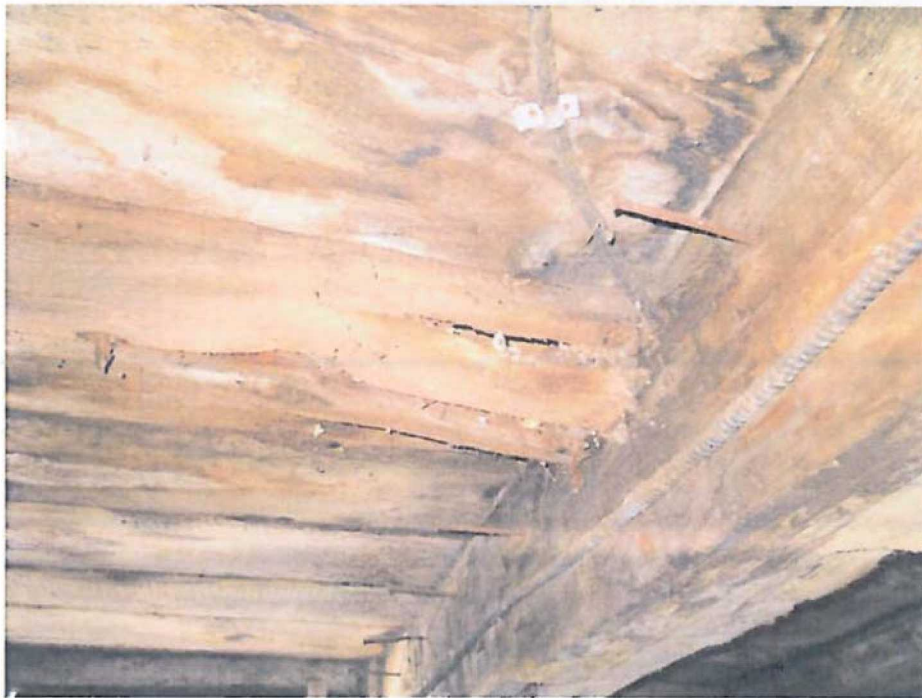
Picture 6: Damaged Floor Planks

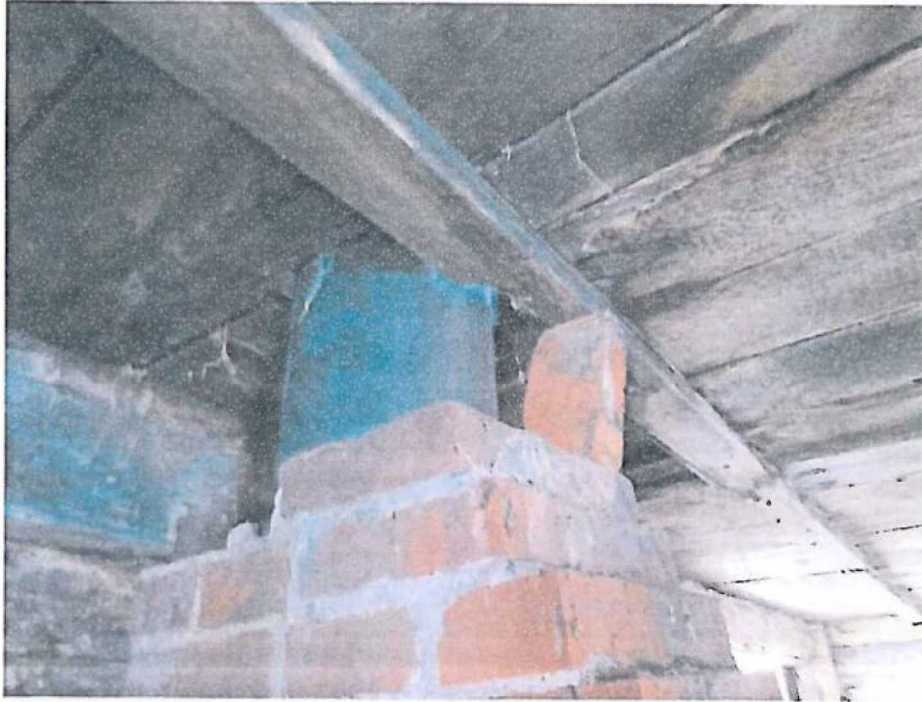
Picture 7: Floor Opening Improperly Re-Supported

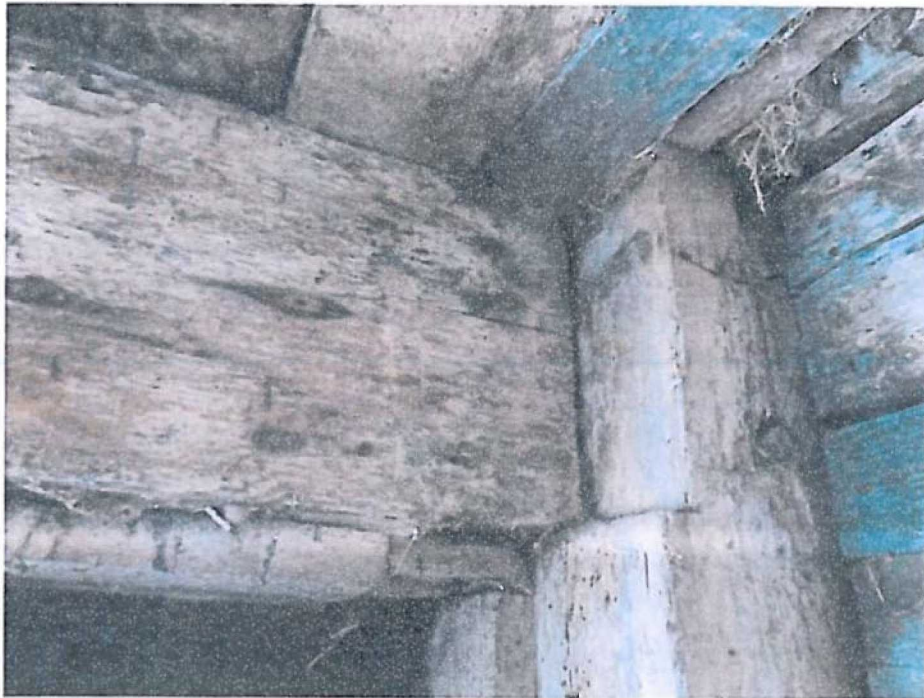
Picture 8: Improper Beam Bearing

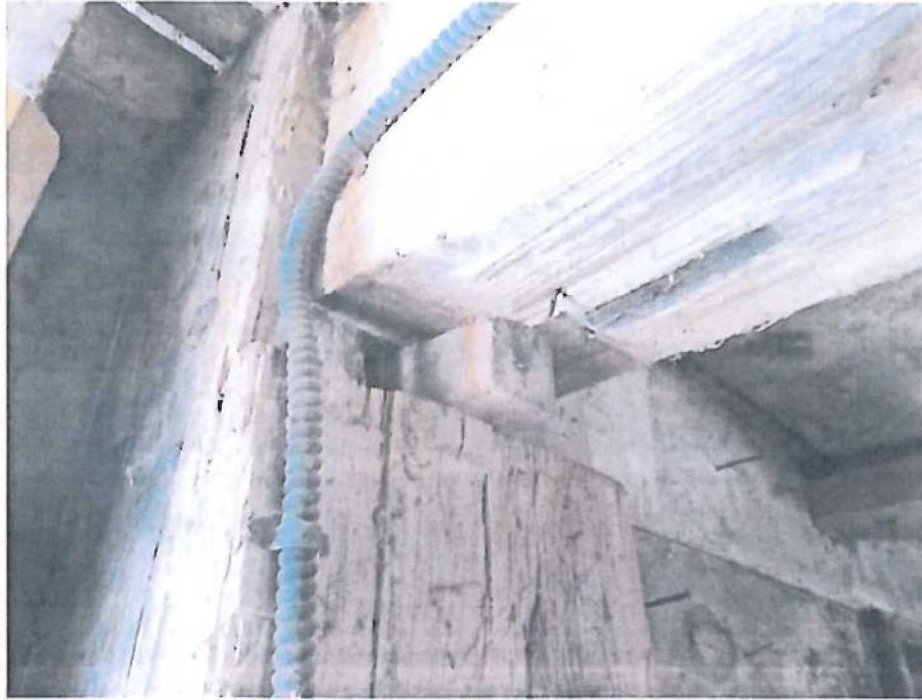
Picture 9: Improper Beam Bearing

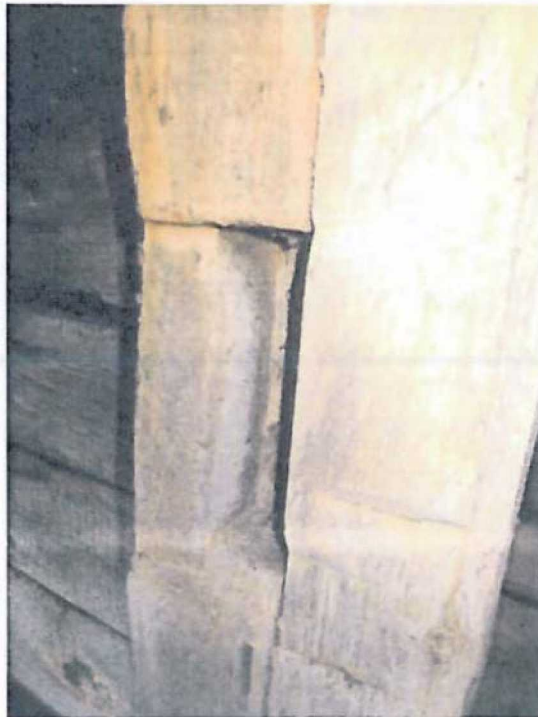
The building columns consisted of very large wood posts, however, numerous holes have been created in these posts (see Picture 10), compromising their strength. The columns are resting directly on the foundation walls, with no shoe or mechanical connection provided to hold down the structure. The foundation wall, especially at the column bearings, was noticed to be in extremely poor condition (see Pictures 11, 12, 13). Severe damage was noticed at 6 of the 8 main building conditions. Although the column section may be strong enough to support the applied loads, the very poor connections to the floor beam and extremely deteriorated bearing conditions create an unsafe condition which, under regular loading conditions, could lead to a sudden and overall failure of the structure.

Picture 10: Hole in Column

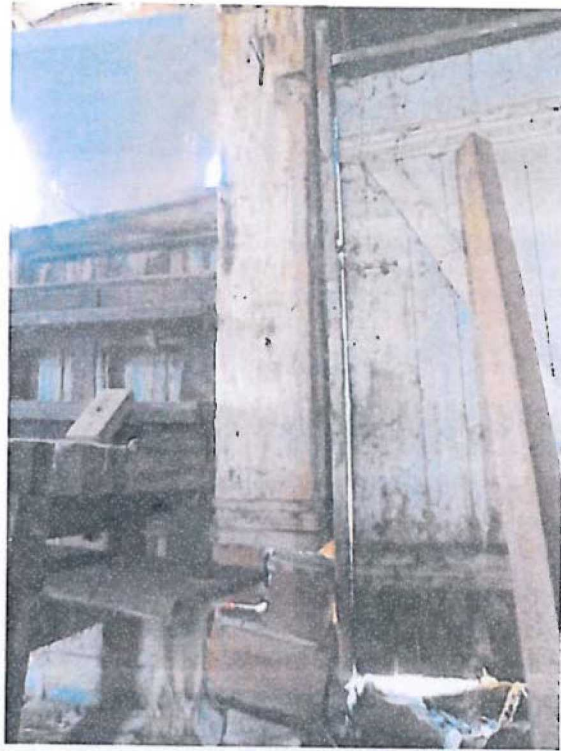
Picture 11: Damaged Foundation Wall at Column

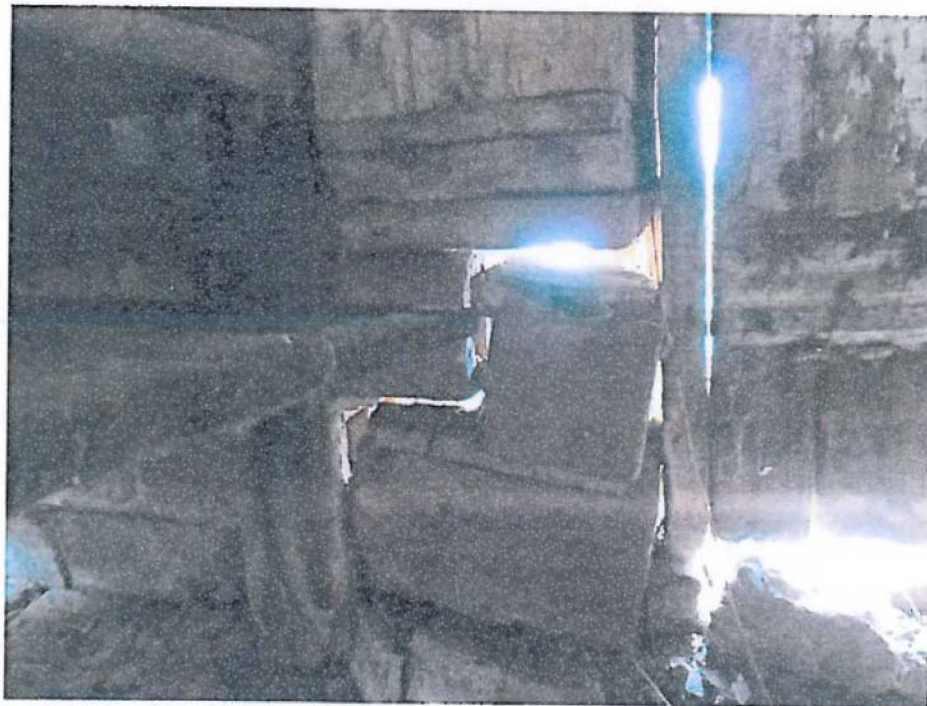
Picture 12: Damaged Foundation Wall at Column

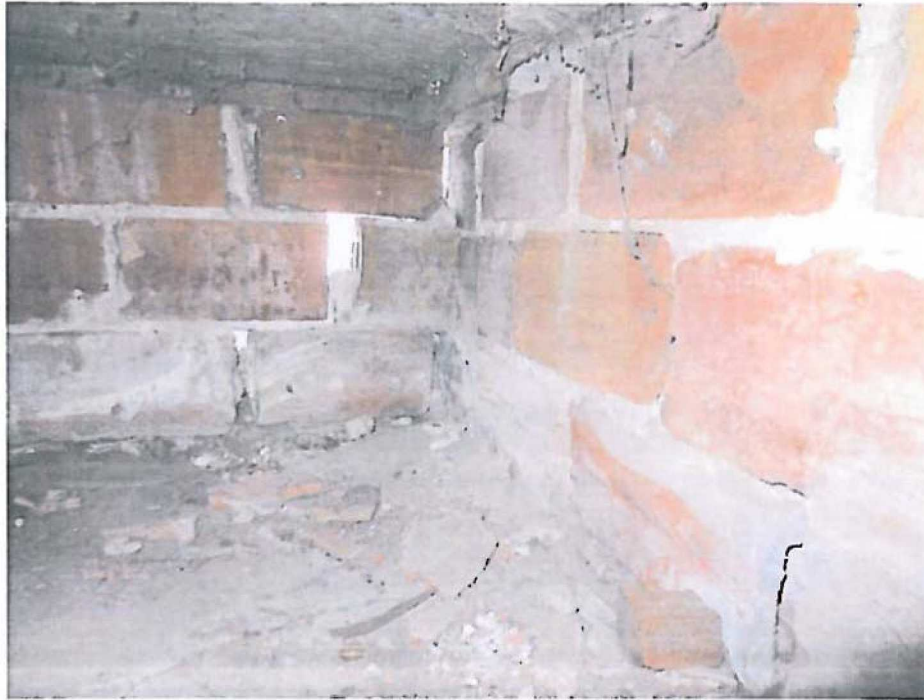
Picture 12: Damaged Foundation Wall at Corner Column
