**HERITAGE ASSESSMENT REPORT:
CULTURAL HERITAGE, LISTED STRUCTURES REPORT**

September 25, 2020

**Doug R. Barker, P. Eng.
110 Chisholm Street,
Oakville, Ontario
L6K - 3H9**

**T. Murison Restoration Consultant
288 Woodale Avenue,
Oakville, Ontario
L6K - 2N6**

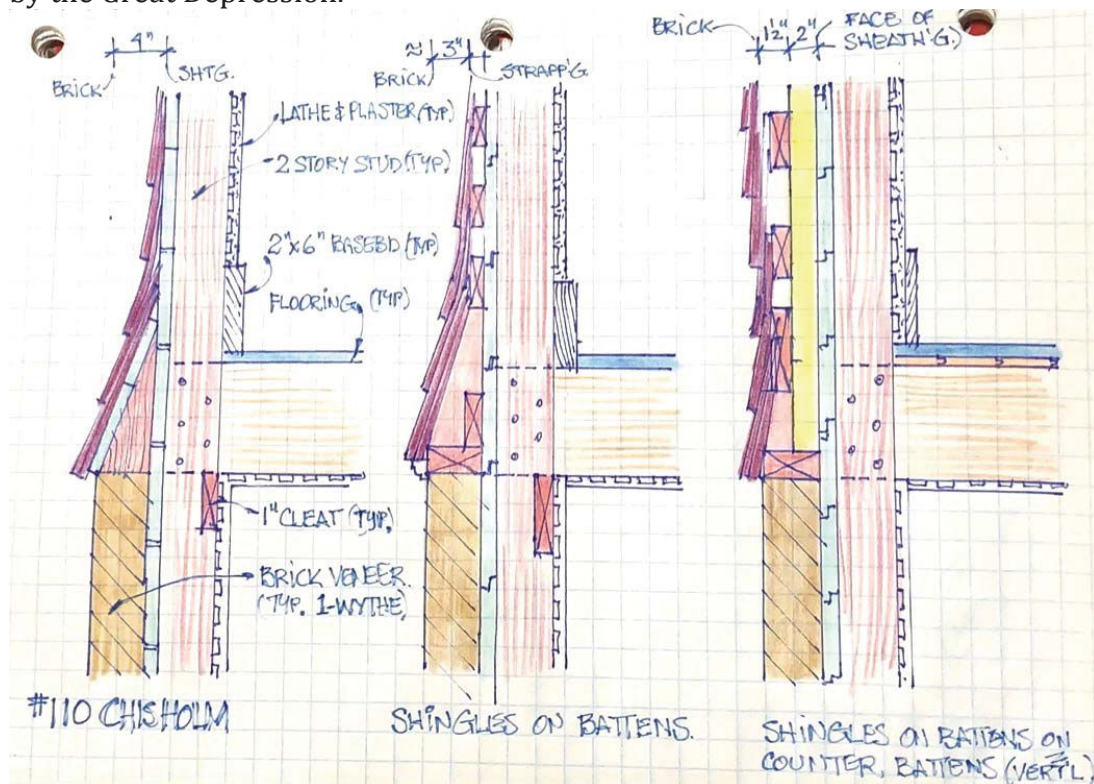
3.0.10.1 Three shingle wall types. Simple, battened and strapped on counter battens.

3.0.11 Shingle installation above brickwork veneer at #110 Chisholm, shows the shingles nailed directly to the board sheathing. Tar-paper was used to provide some waterproofing and air barrier behind the shingles. This is the simplest method and the one most likely to fail over time. Squirrels have subsequently chewed through the lowest shingles and fillet that tilts the first couple of courses of shingle to extend beyond the brick.

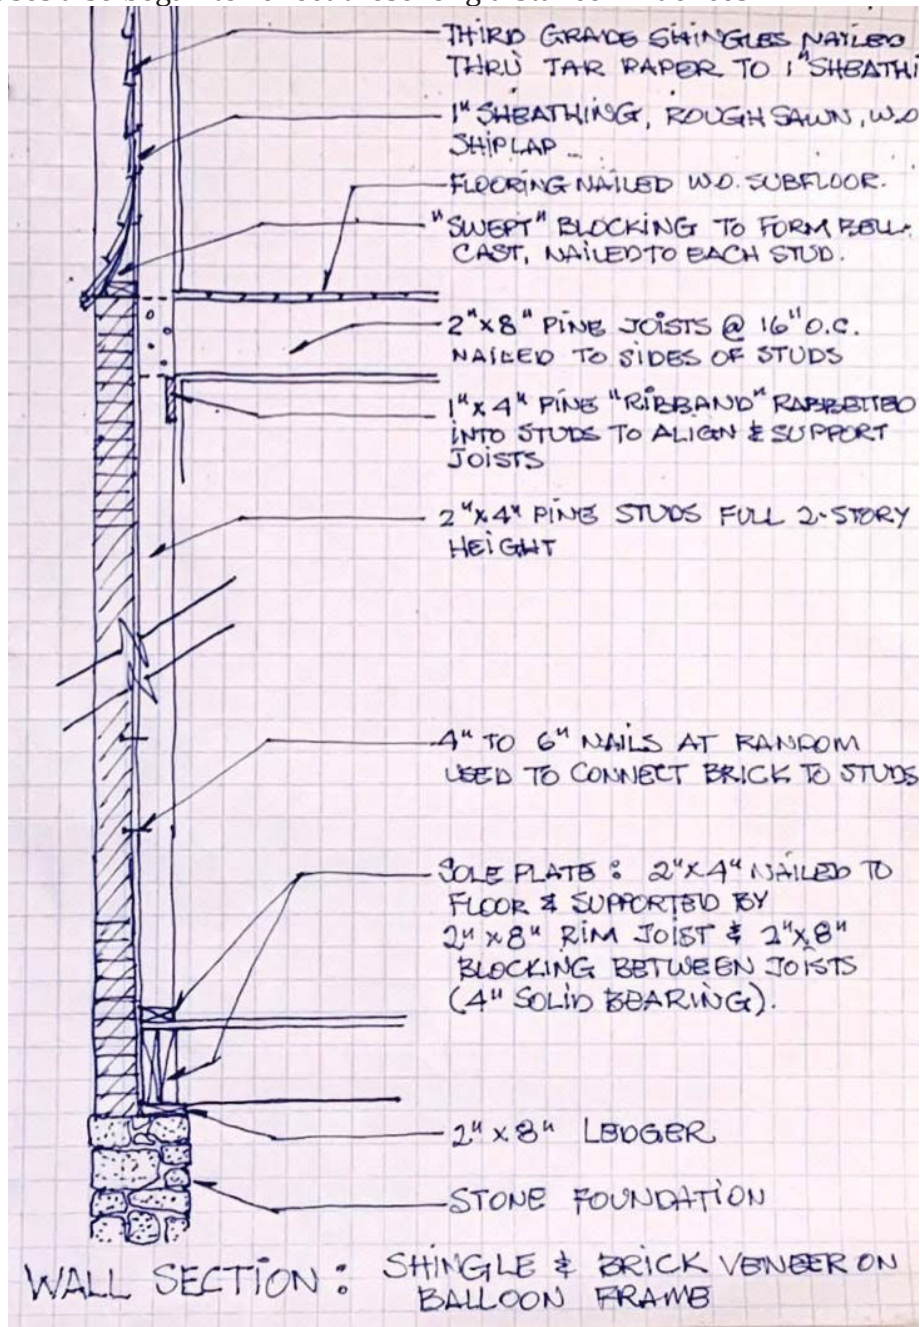
3.0.16 Wall Section of # 110 Chisholm Street. While the floors and framing are well built, the masonry foundation and walls are prone to deterioration from ground water and corrosion of nails used to attach the brick to the sheathing. The brickwork is beginning to show signs of separation from the wall.

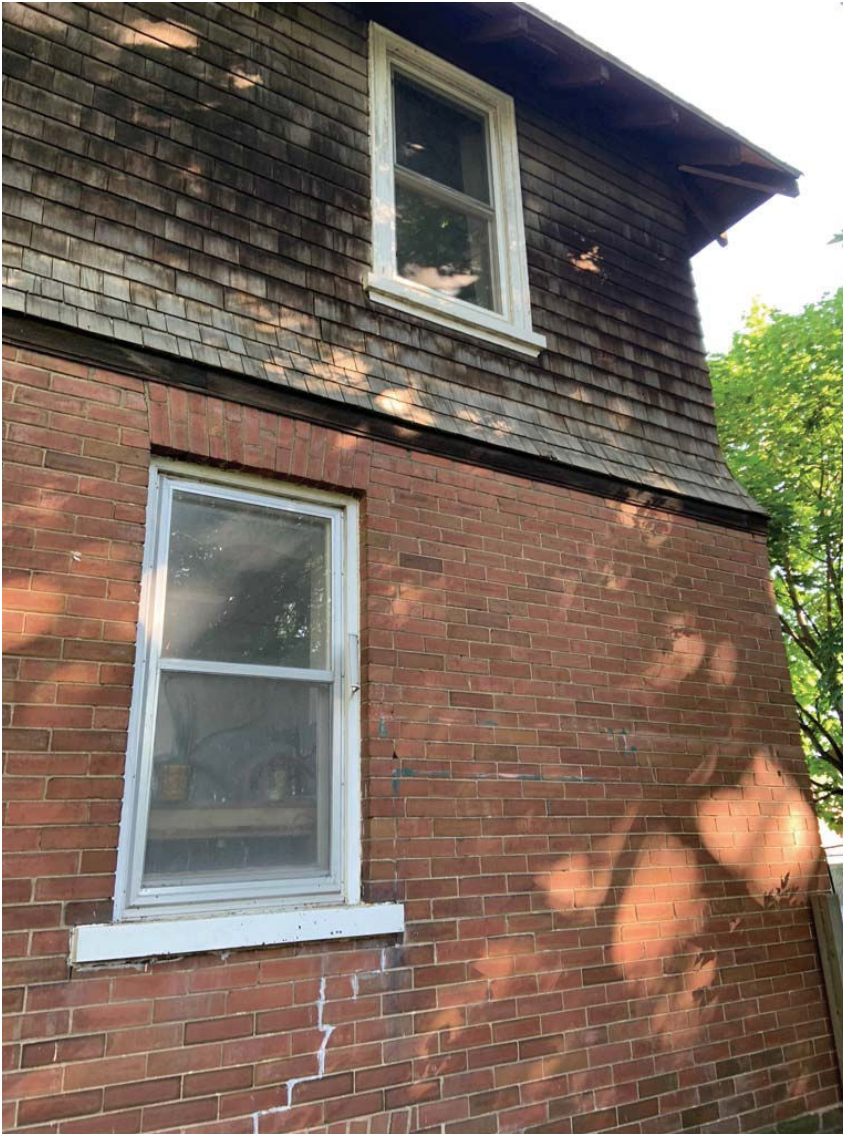
3.0.22 Several areas of exterior brickwork required repointing in the past; at the north wall of the kitchen above the basement window, and at the brick arches of several windows. These "staircase" cracks and slipped "voussoirs" in the brick arches, indicate that the foundation has moved slightly causing stress in the masonry higher up in the building. The repointing was done with strong modern mortar mixes (high proportion of cement), but the effect produces a poor match to the original, weathered, mortar. Several voussoirs have slipped and are now loose, relying on the window frames for stability. These slipped brick are hazardous to anyone outside so should be removed and re-laid in new mortar to restore the integrity of their respective arches.

3.0.23 Recent repointing of “staircase” cracks in the brick wall.

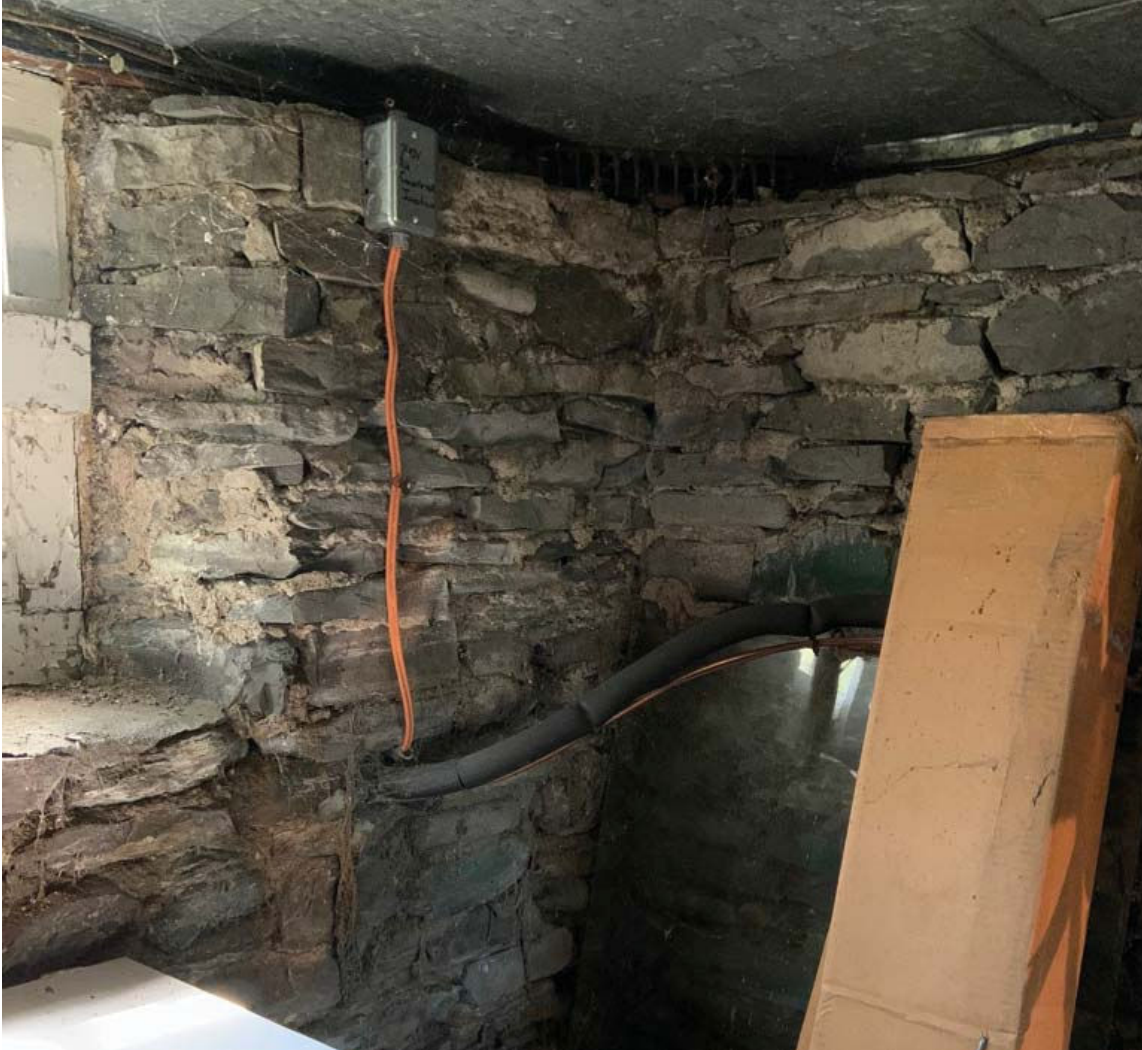
3.0.25 Many areas were not readily visible due to storage in the basement. A general pattern of water infiltration through the mortar joints, efflorescence, was noted at several locations where the walls were exposed from the floor, up. The gradient of moisture from exterior to interior, fluctuates seasonally, being higher in late fall, and lower in late summer. Efflorescence, was observed almost to the level of exterior grade. Since grade (and the street) slopes from north to south along Chisholm, it is not surprising to see the highest “tide lines” of salt, are along the north wall, at 50” above the floor slab. Efflorescence in itself, does not cause damage to the interior of the basement. Efflorescence is the accumulation of dried salts on the interior face of the wall where moisture evaporates to the circulating air in the room. It represents the gradual loss of binder in the mortar as the alkaline mortar mix is reacted and neutralized by acidic ground water.

3.0.26 View of south west corner of the main cellar next to the high efficiency gas furnace. The insulated line to the exterior is connected to the HVAC unit outside.

3.0.27 The resulting salt that is left by evaporation on the “drying face” at the interior is a result of the perpetual gradient from high (90 – 100%) to low (50 – 80%) moisture surfaces on the exterior and interior sides of the wall. In soft lime mortars like those used in the 1870s (before the introduction of Portland cement as a common building material), the eventual loss of lime binder leaves only sand behind in the mortar joints.

3.0.28 The loss of mortar allows the foundation stones to shift and increases the speed of moisture infiltration. The only real remedy for foundations that are approaching the complete loss of mortar is to excavate the exterior to the depth of the footing, repoint the wall and waterproof with a modern bituminous sealant to prevent further infiltration. In places with hydrostatic pressure caused by a high water table, it is also recommended that a permeable barrier (like the proprietary product Enka-Drain) be used to remove water pressure from the waterproofing membrane. Groundwater is allowed to weep through the protective barrier but it

drains down to a weeping tile for removal, leaving an airspace against the wall. In the case of 110 Chisholm this would require excavation of the entire perimeter of the foundation at considerable expense.

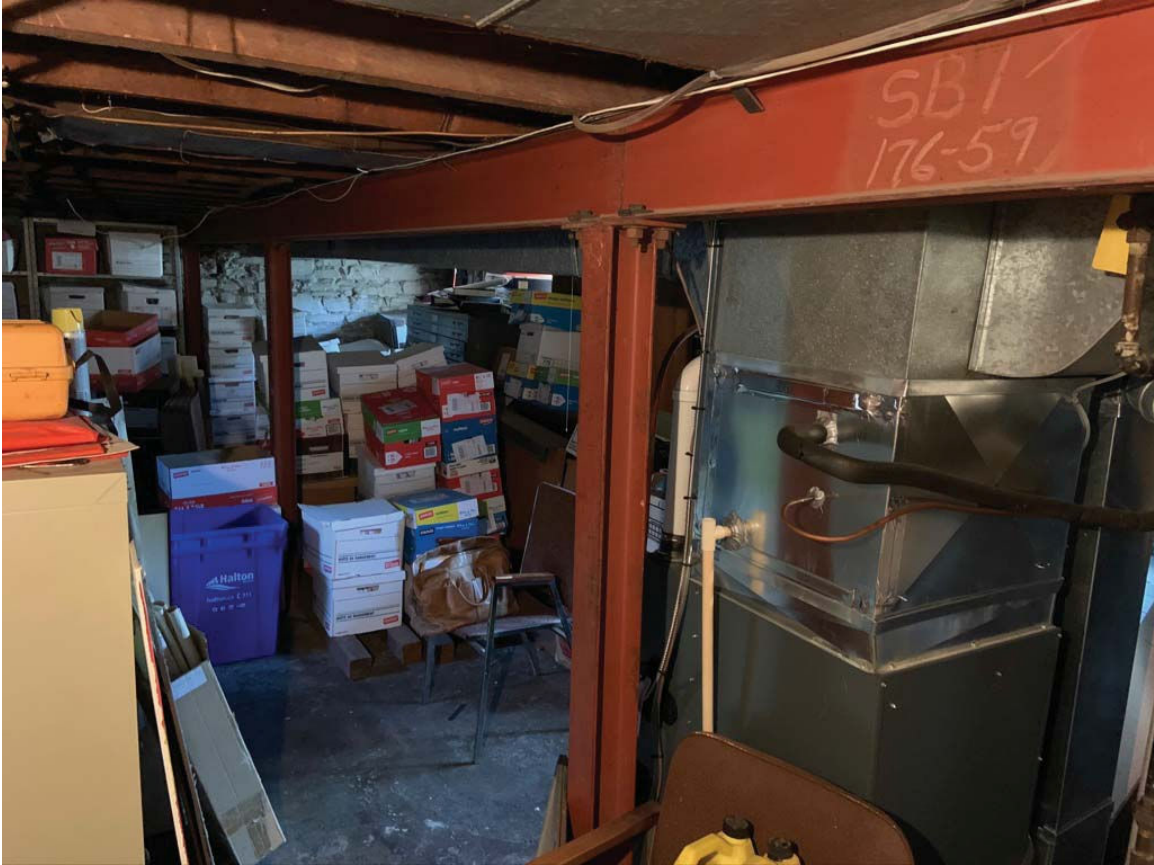
3.0.29 A “new” structural steel I-beam and stanchions was installed to carry the first floor. The steel I-section, stanchion were installed, presumably, with large steel base plates on new concrete footings, now buried below the repaired concrete floor slab.

3.0.30 As a solid wood beam would be expected in a house of this age, we may surmise that solid wood posts were also used to carry the center beam off the floor. It is likely that these posts rotted due to excessive moisture at the floor. This would have compromised their capacity to carry the beam, and caused downward deflection of the floors. The new steel beam appears to have been very well designed and professionally installed as the floors above are quite level and sound. The process of installation may, however, have caused some adjustment of the ends of the floor joists which may partially explain the structural cracks in the exterior brickwork.

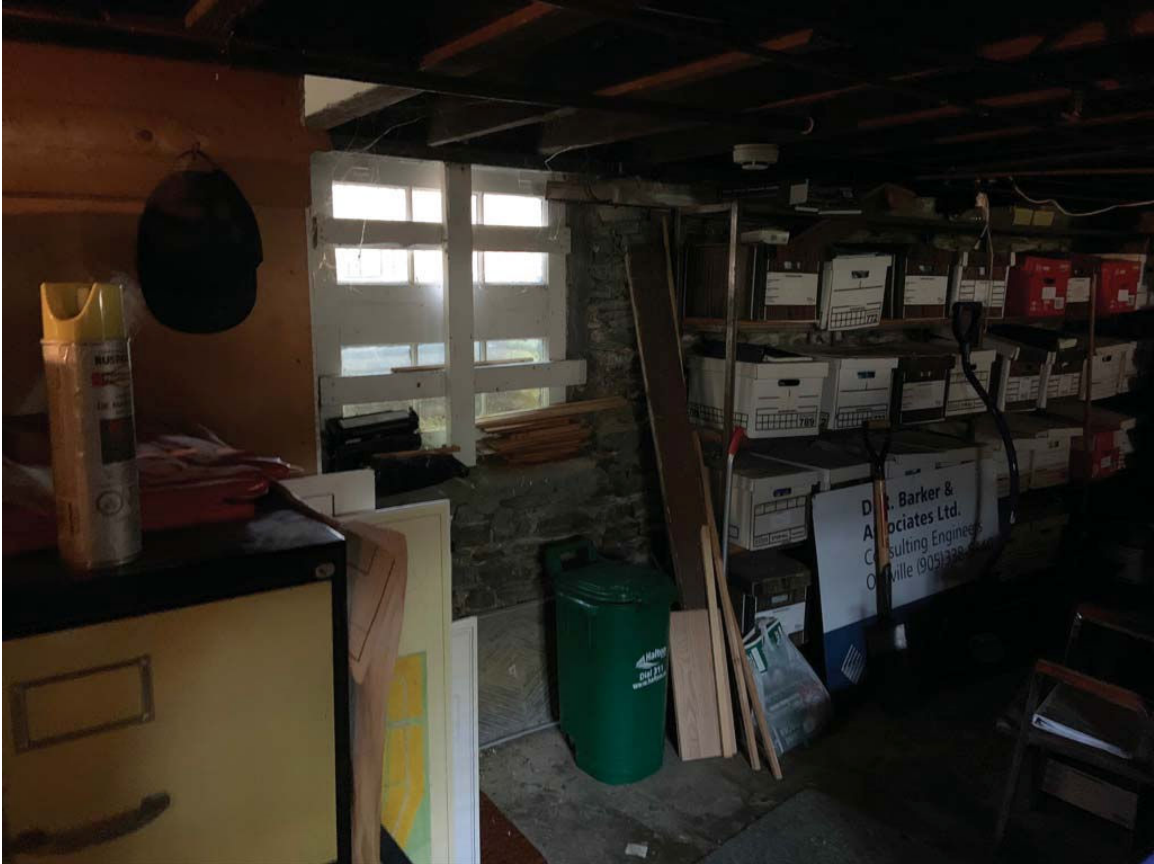
3.0.32 The basement windows are wide and shallow, typically 35” wide by 15” high, except for the window near the foot of the stairs which has a deep “window well” on the exterior. This anomalous window may have been used as a coal port, to allow loose coal to be shoveled or sacks of fuel to be tossed down to the furnace without being carried through the house. This would suggest that the driveway along the north side of the house was present from the original construction of the house as a service access. It also suggest that the coal cellar was stockpiled for the winter months, and that the original solid fuel furnace was located near the current high efficiency gas furnace and chimney flue on the south-west corner of the basement. The mason “battered” the basement window openings, making the inside opening wider than that where the window frame was built in. This extra 8 to 10 inches allows more light into the basement than if the opening was square to the frame. The frame is set out 8” from the inside face of the masonry. The special window has a deep exterior window well to allow more access for sacks of coal presumably. The window sill is at 3 feet or so, a nice height if grabbing a 100 pound sack of coal to carry across the room. Or perhaps they just shoveled a ton of coal from the back of the wagon, down to the floor. From there it could be shoveled to the bunker against the other wall.

3.0.33 Basement window that provided access for solid fuel (coal) to the cellar.

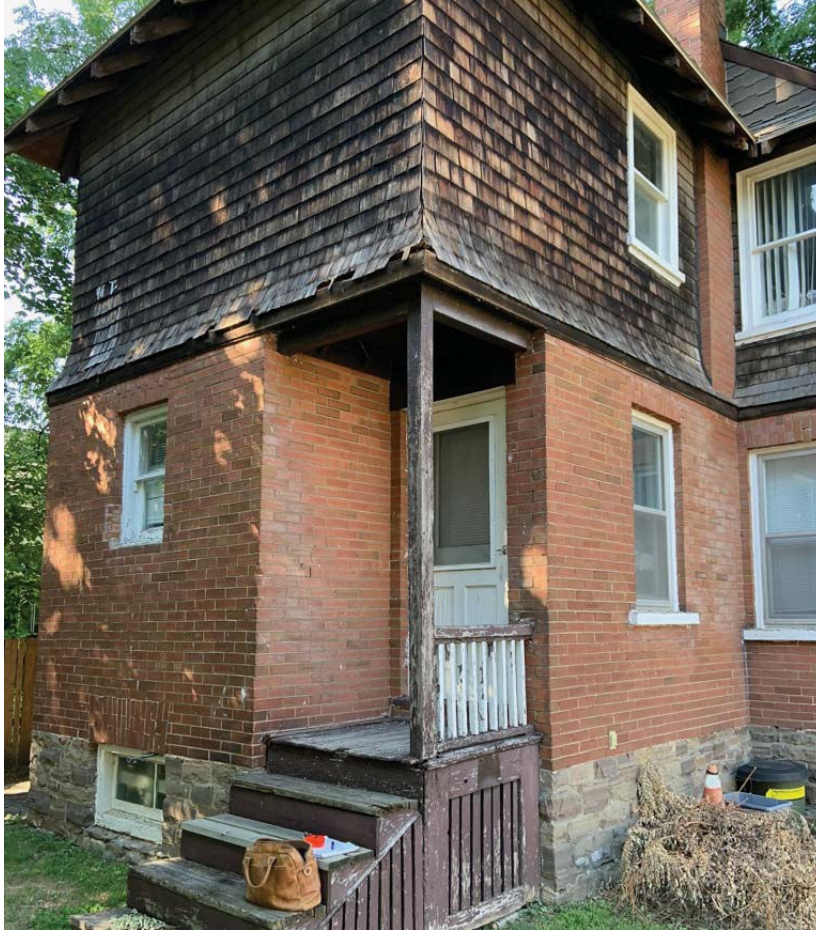
3.0.43 Kitchen porch covered by second floor overhang.

3.0.44 The rafter ends and paint finish are in very poor condition now. It appears that the house has had little exterior maintenance over the past 110 years. The brown trim paint was applied over white paint. No other colour or layer was observed on the substrate. The extreme loss of paint suggests that the last re-painting occurred between thirty and fifty years ago. As a result much of the trim has weathered irretrievably. Very deep checks have penetrated the mouldings allowing water and algae inside the material. The surface fibers have greyed from Ultraviolet sunlight, and then delaminated creating a soft fuzzy representation of the original profiles. Restoration requirements will be discussed later in the Report.

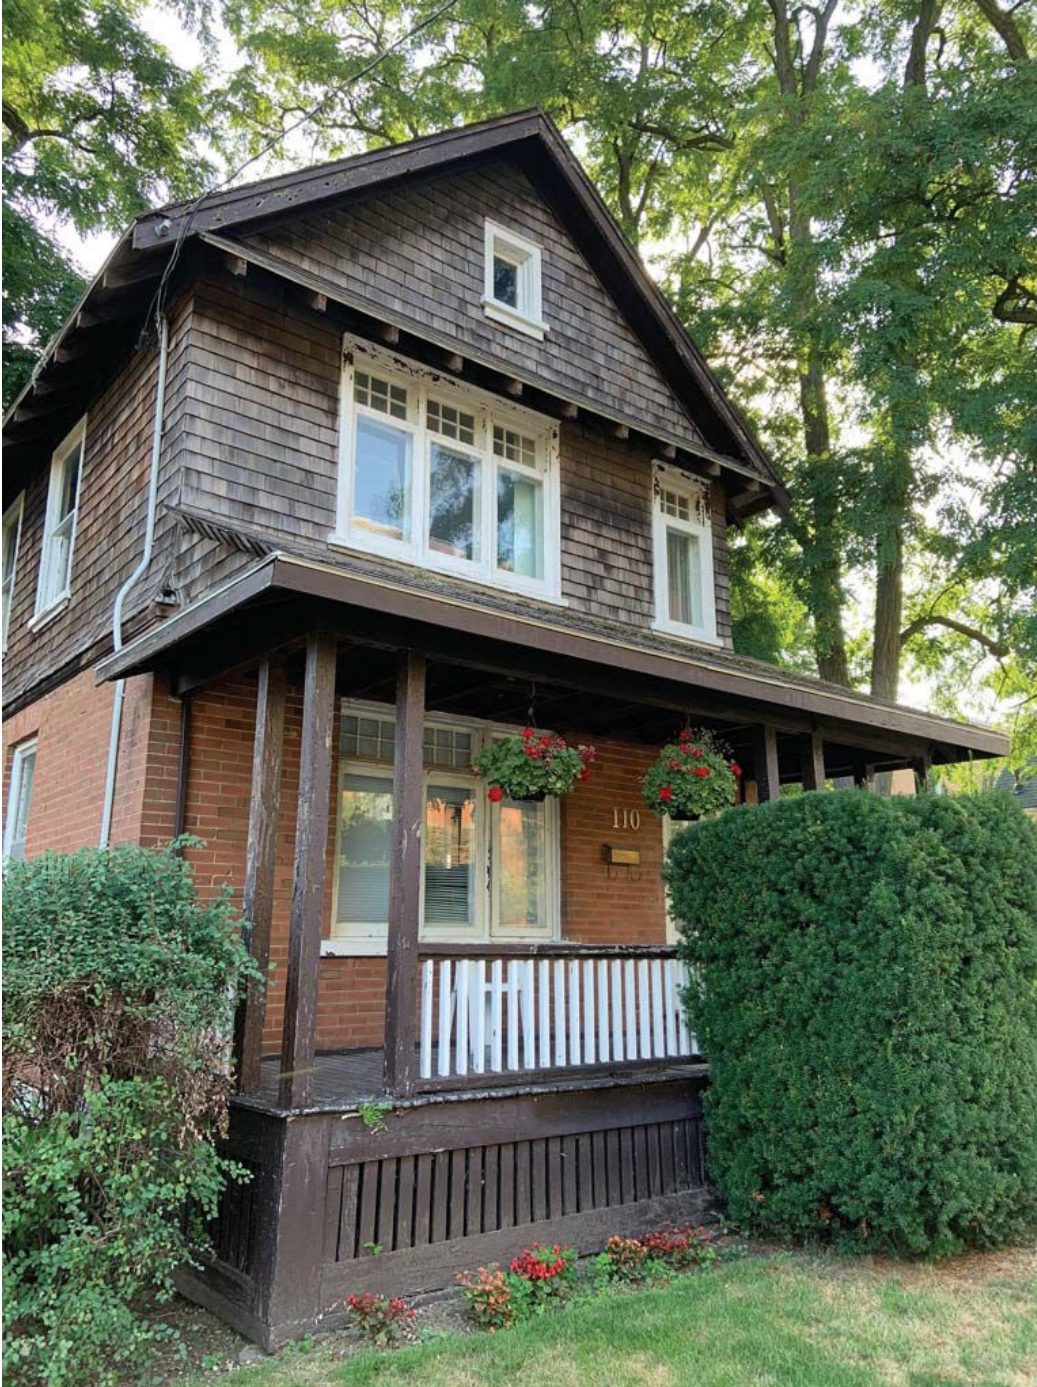
3.0.48 The roof returns at the porch and rear gable of the house were finished in an unusual way. The porch returns were shingled on the underside, an especially rustic detail that was usually reserved for the most rustic houses with “boulder” style masonry.

3.0.49 Porch roof and half gable shingled on the underside. Note that the fascia board along the perimeter of the porch is a modern replacement with a prefinished aluminum drip edge inserted under the replacement shingles. Originally these rafter tails would have been open to the weather like the gable above. There is an awkward transition between the bell-cast at the house wall and the slightly lower half gable.

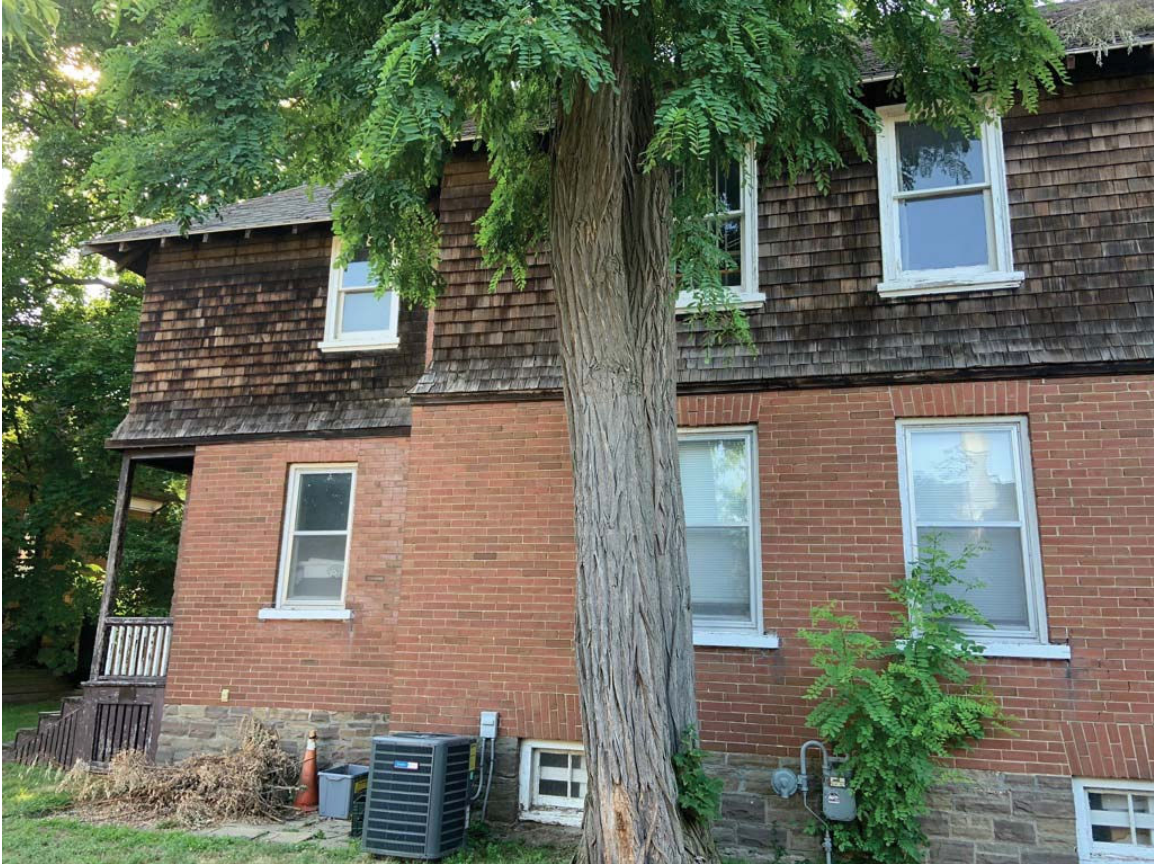
3.0.50 South elevation of house. The window sills are over 2" thick at the second floor and 3" at the first floor. The trim board below the second floor sills is unusually narrow. The reason for this is unclear, except that it may have been seen as only necessary to cover the irregular gap between the shingles and the sill.

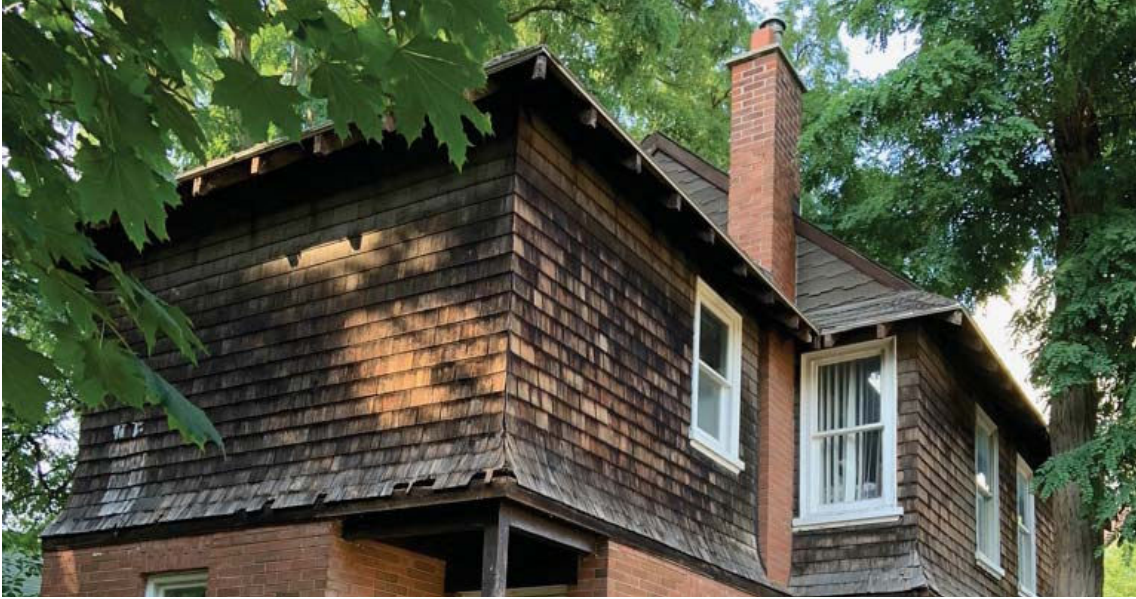
3.0.51 The rear roof soffit was clad with a tilted soffit board that met the outside verge of the shingles without an additional moulding. This is a poor detail as it leads rainwater back towards the wall behind the soffit, often causing leakage where flashings were insufficient.

3.0.54 Note the roof soffit at the rear gable is finished with a board nailed to the underside of the roof overhang as a tapered fillet, instead of as a shingled soffit at the front porch half gables. Also note that the roof of the rear wing was built as a hipped roof with rafter tails visible on all three sides. This de-emphasized the height (and therefore narrowness) of the rear wing.
