SURVEYOR'S REAL PROPERTY REPORT OF
PART 1:
PLAN OF LOT 29
REGISTERED PLAN 544
TOWN OF OAKVILLE
(REGIONAL MUNICIPALITY OF HALTON)

NEW INFILL SINGLE-FAMILY DWELLING, DETACHED HOUSE

ADDRESS OF PROPERTY:
189 Weybourne Road, Oakville

Section 6: Photo Documentation

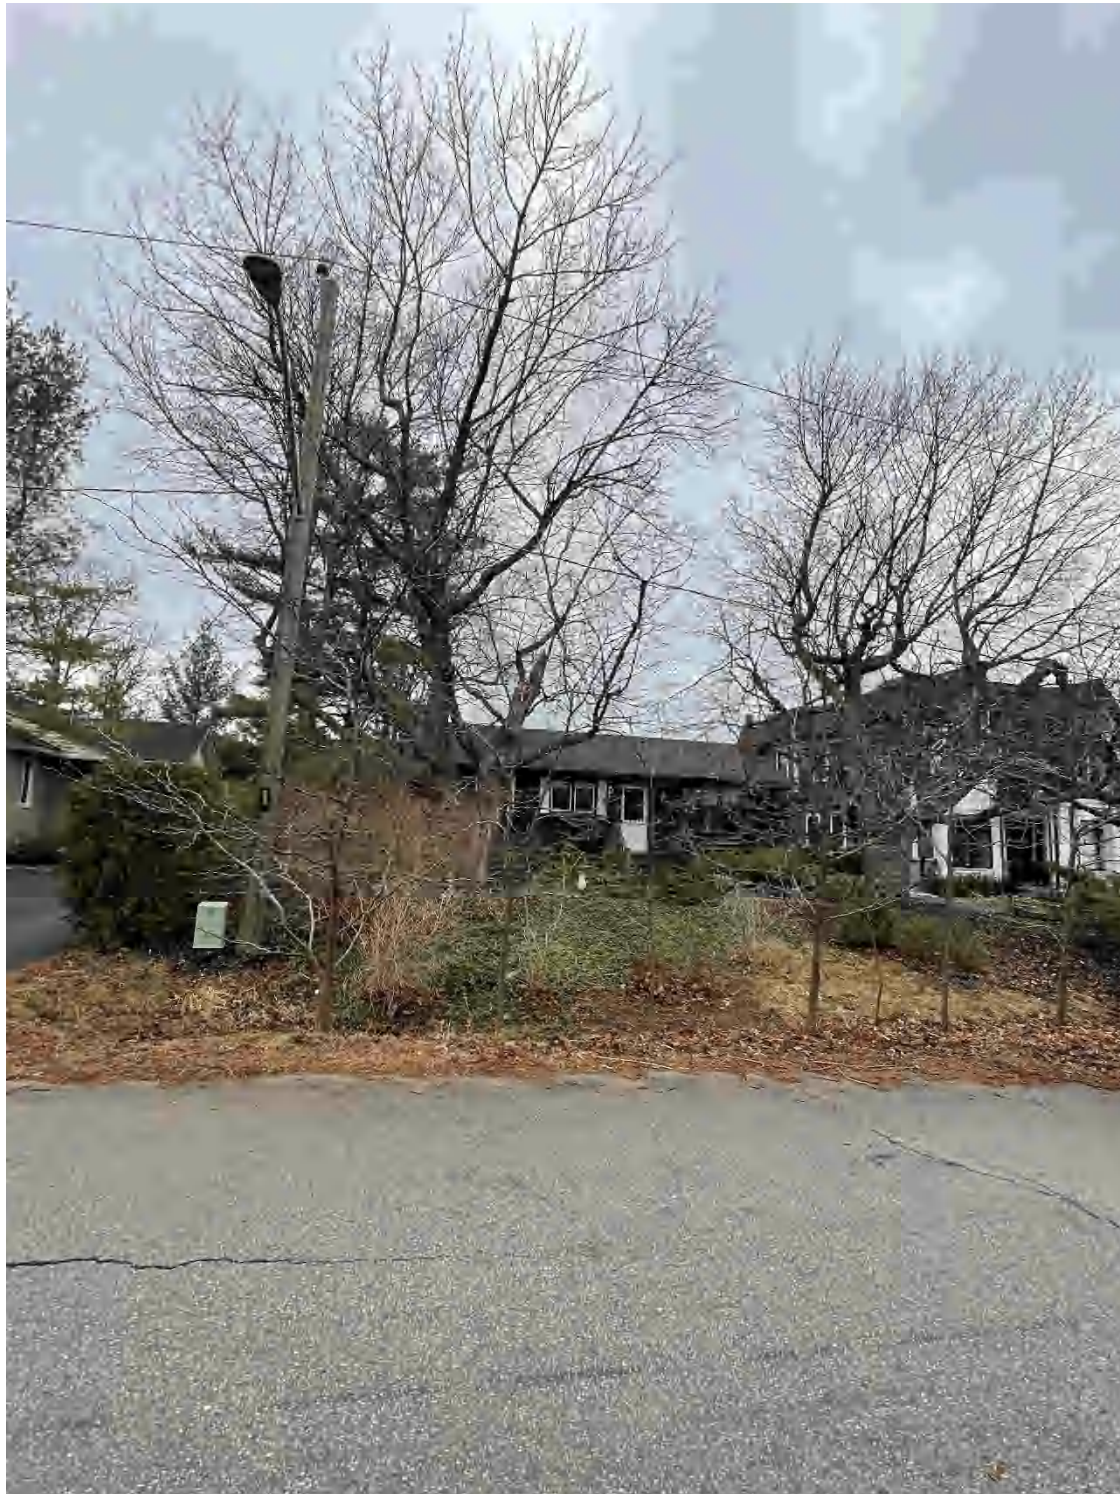
Picture 1: Trees 1 and 2

Tree #1 is an 84cm mature Norway Maple in Private ownership, located in front yard of the property. The tree is in Fair botanical and structural condition, with several flaws and signs of health decline noted during the latest on-site inspection. There is a minor to moderate amount of deadwood present in the crown of the tree, small cavities are forming, the overall form is poor and it is in fair health with declining tendency.

Tree #2 is an 89cm mature Norway Maple in Private ownership, located in front yard of the property. The tree is in Poor botanical and structural condition, with numerous flaws and signs of health decline noted during the latest on-site inspection. There is a moderate to significant amount of deadwood present in the crown of the tree, cracks

Finding and pruning of minor to moderate amount of small and medium diameter roots is expected to have no effect on the structural integrity of the tree and its botanical condition, however if large diameter roots are uncovered they shall be preserved. Removal of roots larger than 5cm in diameter is forbidden, and if such root is uncovered, the envelope should be immediately back filled, and the footprints of the driveway reduced.

Finding and pruning of minor amount of small and medium diameter roots is expected to have no effect on the structural integrity of the tree and its botanical condition, however if large diameter roots are uncovered they shall be preserved. Removal of roots larger than 5cm in diameter is forbidden, and if such root is uncovered, the envelope should be immediately back filled, and the footprints of the driveway reduced.

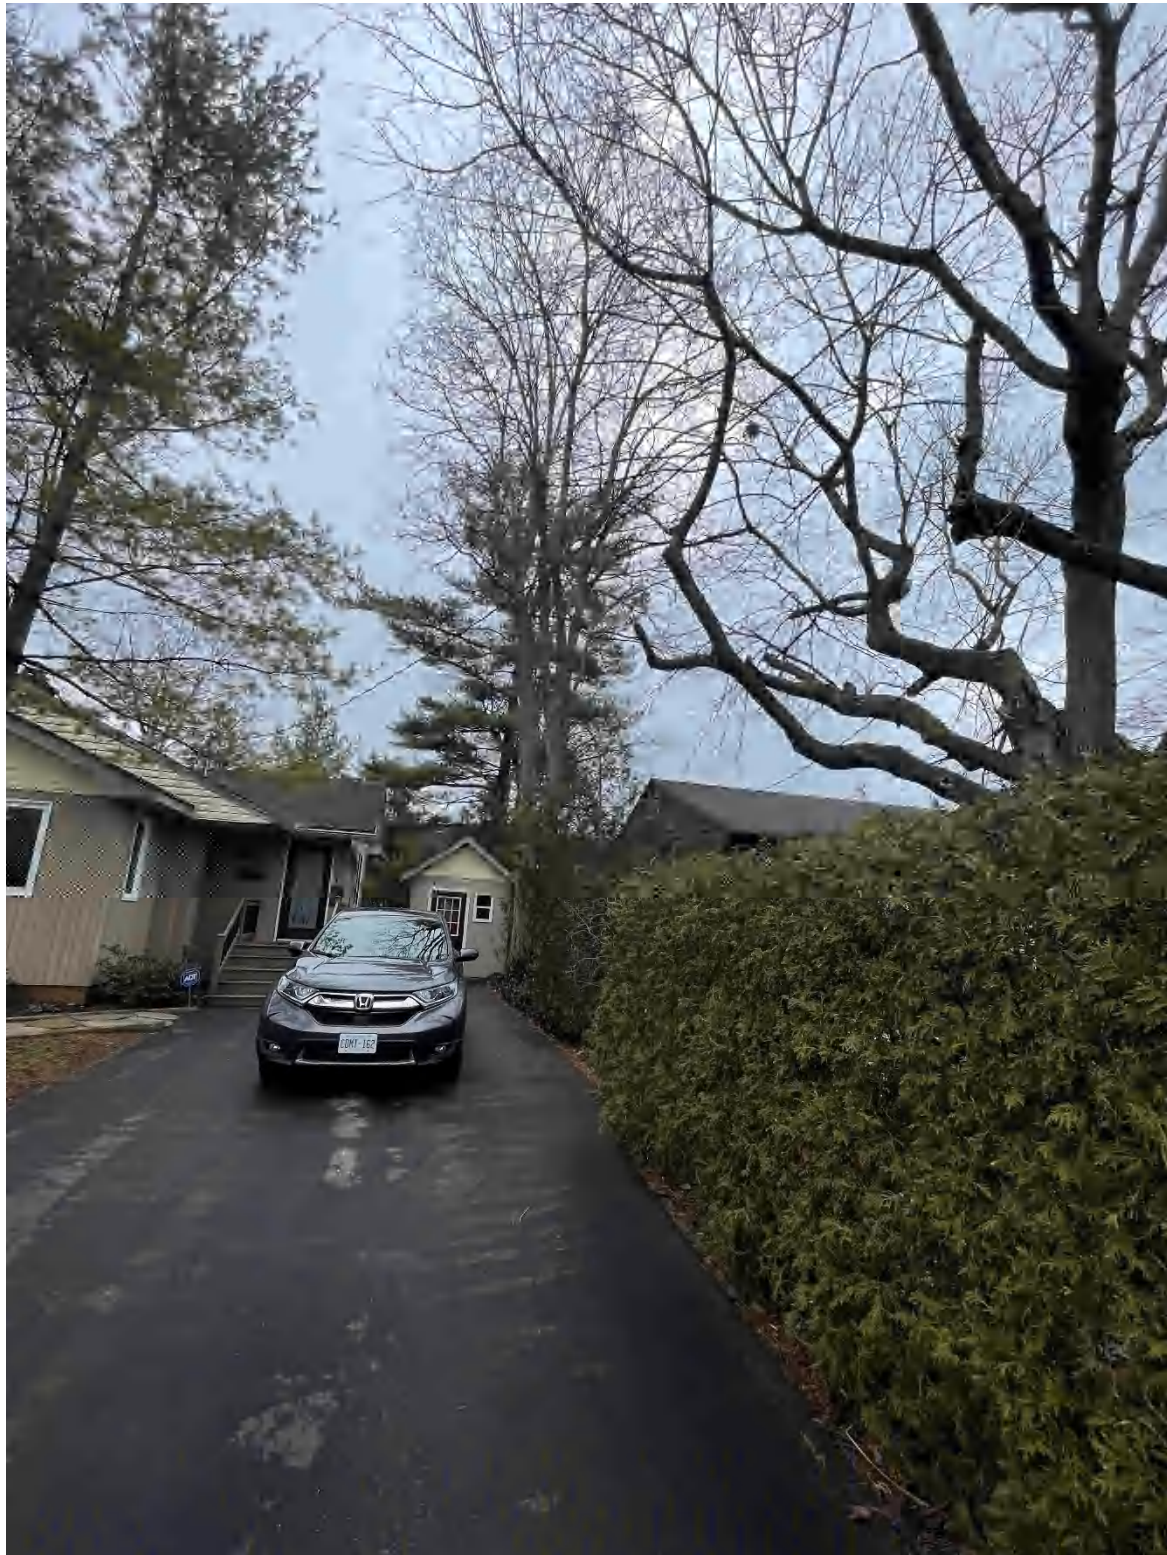
Picture 2: Trees 3 and 4

Tree #3 is a 32,33cm semi-mature Black Locust in Neighbouring ownership, located in back yard of the adjacent property. The tree is in Good botanical and structural condition, with no significant flaws noted during the latest site visit. There is

Proposed work will be brought 1m closer to the tree considering that the house is to be constructed traditionally and will include 1m over-dig. Waiving over-dig within the TPZ of the tree is recommended however can't be mandatory considering the scope of work. The construction of the house is expected to have moderate effect on the tree in question.

Tree #4 is a 44cm semi-mature Black Locust in Neighbouring ownership, located in back yard of the adjacent property. The tree is in Good botanical and structural condition, with no significant flaws noted during the latest site visit.

Every effort for preservation as many large diameter roots as possible should be made. Exploratory excavation trench should be opened to assess root distribution and provide clearer picture of the damage that construction will be causing to the roots.

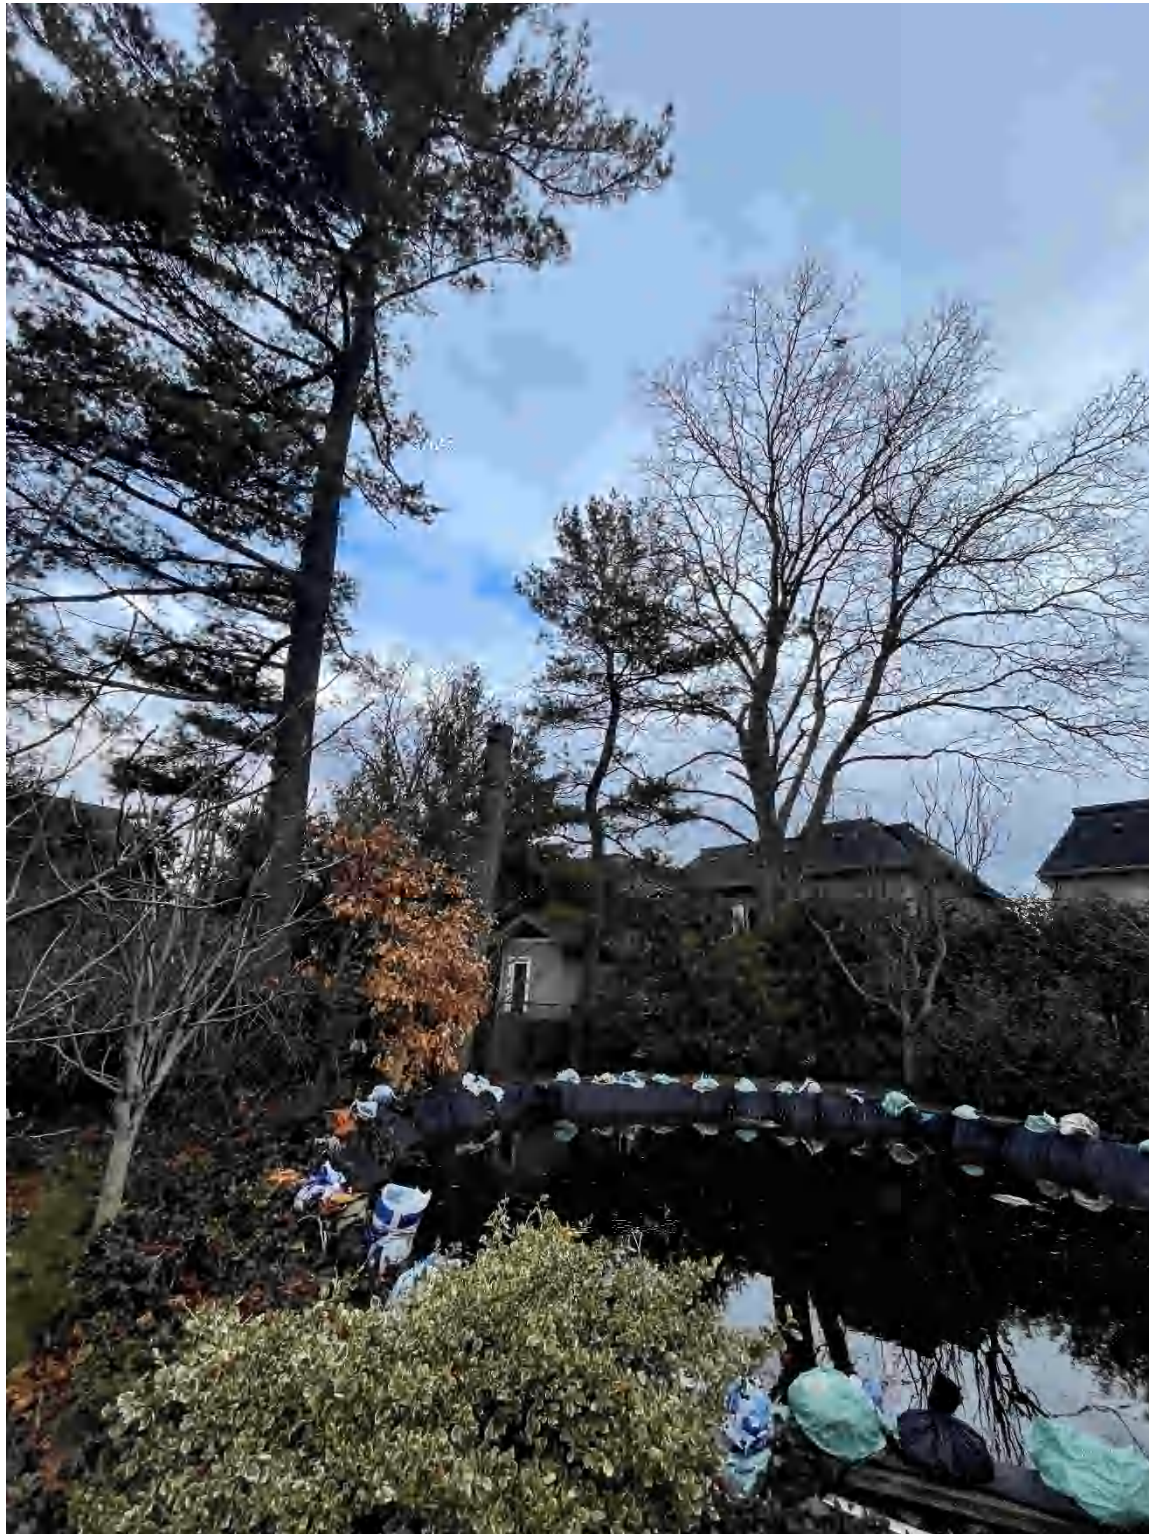
Picture 3: Trees 5-8

Tree #5 is a 60cm mature White Pine in Neighbouring ownership, located in back yard of the adjacent property. The tree is in Good botanical and structural condition, with no significant flaws noted during the latest site visit. There is a minor amount of small diameter deadwood present in the crown however, this flaw is not of immediate concern and do not affect tree's overall well-being and longevity.

Proposed work will be brought 1m closer to the tree considering that the house is to be constructed traditionally and will include 1m over-dig. Waiving over-dig within the TPZ of the tree is recommended however can't be mandatory considering the scope of work. The construction of the house is expected to have moderate effect on the tree in question.

Tree #7 is a 27cm semi-mature White Pine in Private ownership, located in back yard of the property. The tree is in Fair botanical and structural condition, with several flaws and signs of health decline noted during the latest on-site inspection. There is a minor to moderate amount of deadwood present in the crown of the tree, the trunk of the tree is bent and it is in fair health with declining tendency.

Tree #6 is a 52cm mature White Pine in Private ownership, located in back yard of the property. The tree is in Poor botanical and structural condition, with numerous flaws and signs of health decline noted during the latest on-site inspection. There is a moderate to significant amount of deadwood present in the crown of the tree, cracks significant in size and abundance are visible on the main trunk, and there are barkless patches on the tree. Due to poor health and structure, retention of this tree wouldn't be recommended regardless of the proposed construction activities.

The tree in question will require removal in order to allow removal of the existing pool and pool patio from the back yard of the property. The tree is in a very poor condition and will likely die within the next growing season, and removal of these features will loosen up the soil adjacent to it and could lead to its failure. In order to prevent a potentially hazardous situation pre-emptive removal of this tree is recommended.

Every effort for preservation as many large diameter roots as possible should be made. Exploratory excavation trench should be opened to assess root distribution and provide clearer picture of the damage that construction will be causing to the roots.

Total number of replacement is to be determined considering that removal of tree #6 might qualify for exemption. In case the tree is exempted from standard tree removal procedure and fees, no replacement trees should be compensated as cash in lieu payment.

Following the removal of 1 tree (present location marked on the site plan), 2 replacement trees will be planted in the back yard of 189 Weybourne Road (planned location marked in green on the site plan). There are no remaining trees to be paid as cash in lieu payments.

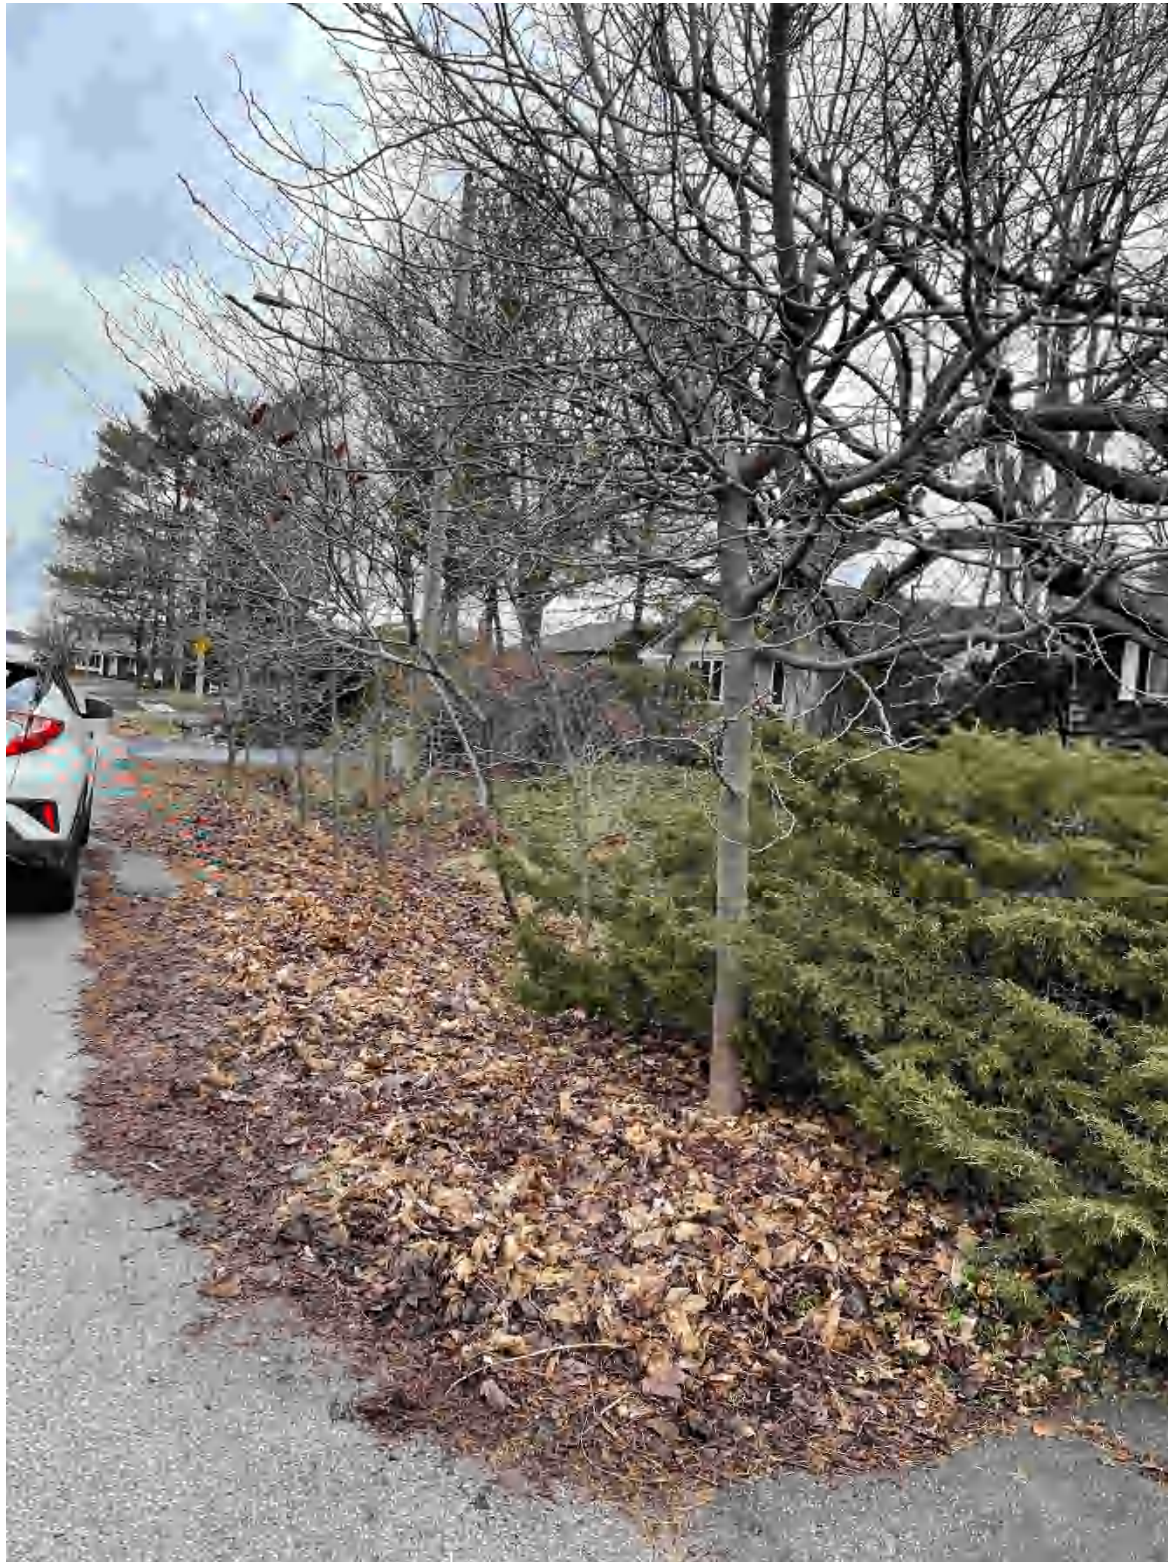
Picture 5: Trees 10-18

17	Honey Locust	Gleditsia triacanthos	4	Protect	1.8	Good	City	Botanically and structurally tree is in good condition
18	Honey Locust	Gleditsia triacanthos	7	Protect	1.8	Good	City	Botanically and structurally tree is in good condition

11	Honey Locust	Gleditsia triacanthos	3	1.5	Injury	1.8	Fair	City	Slight lean, bent trunk, fair health and structure
12	Sumac	Rhus species	5	1.5	Protect	1.8	Fair-Poor	City	Tree with poor health and structure, wounds
13	Honey Locust	Gleditsia triacanthos	4	1.5	Protect	1.8	Good	City	Bent trunk, fair health and structure
14	Honey Locust	Gleditsia triacanthos	5	1.5	Protect	1.8	Good	City	Small tree with good health and structure
15	Honey Locust	Gleditsia triacanthos	6	1.5	Protect	1.8	Good	City	Botanically and structurally tree is in good condition
16	Honey Locust	Gleditsia triacanthos	2	1.5	Protect	1.8	Fair	City	Small tree with fair health and structure
17	Honey Locust	Gleditsia triacanthos	4	1.5	Protect	1.8	Good	City	Botanically and structurally tree is in good condition
18	Honey Locust	Gleditsia triacanthos	7	1.5	Protect	1.8	Good	City	Botanically and structurally tree is in good condition

Tree #10 is a 10cm juvenile Honey Locust in City ownership, located in front yard of the property. The tree is in Good botanical and structural condition, with no significant flaws noted during the latest site visit. There is a minor amount of small diameter deadwood present in the crown however, this flaw is not of immediate concern and do not affect tree's overall well-being and longevity.

Tree #11 is a 3cm juvenile Honey Locust in City ownership, located in front yard of the property. The tree is in Good botanical and Fair structural condition, with no significant flaws noted during the latest site visit. The trunk of the tree is bent however, this flaw is not of immediate concern and do not affect tree’s overall well-being and longevity.

Finding and pruning of minor to moderate amount of small and medium diameter roots is expected to have no effect on the structural integrity of the tree and its botanical condition, however if large diameter roots are uncovered they shall be preserved. Removal of roots larger than 5cm in diameter is forbidden, and if such root is uncovered, the envelope should be immediately back filled, and the footprints of the driveway reduced.
