# 43: 2165 Dundas St. West, Smith-Carrique Barn and Shed

# 1. Description of Property

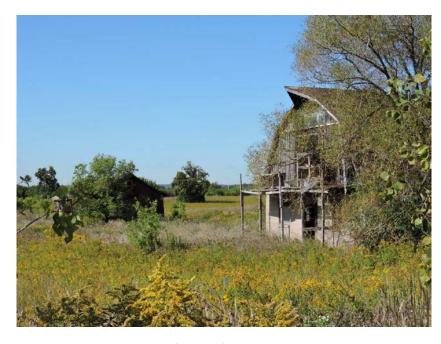
Figure 1: 2615 Dundas St. West. (AB, 2015)

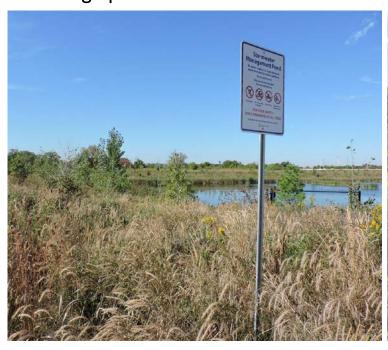
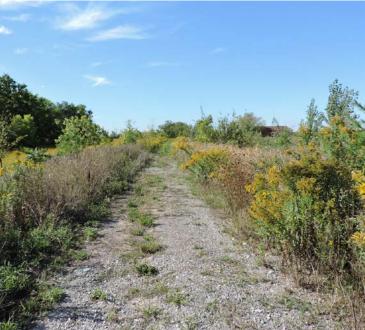
Figure 5: Storm water management pond (left) and public trail on south side (right) barn in background on both. (AB, 2015)

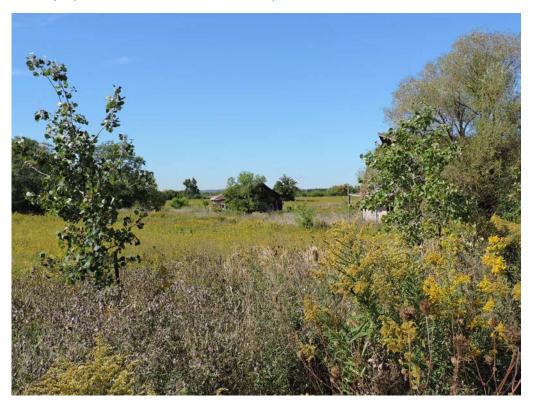
Figure 6: View of shed with surrounding open fields. (AB, 2015)

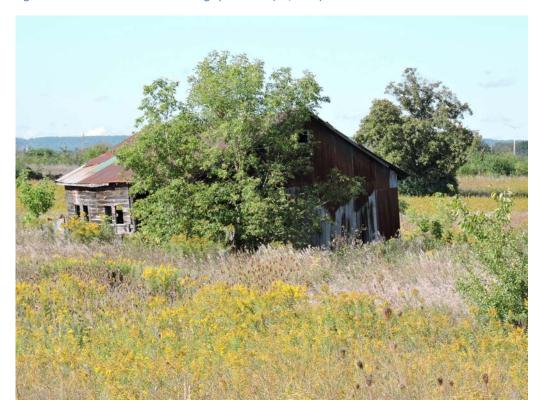
- Barn- gambrel style metal roof, it appears to be built with cinderblock, with a vertical plank wood second storey. Windows are missing, but openings remain. Modifications to openings on southern exterior second storey.
- Shed-gable style metal roof made with flush board exterior. Windows are missing, but square openings remain.
- Large rectangular storm water management pond located directly east.
- Gravel path surrounding storm water management pond.
- Gravel laneway runs north from Dundas St. West to the outbuildings.

Figure 7: Detailed view of shed. (AB, 2015)

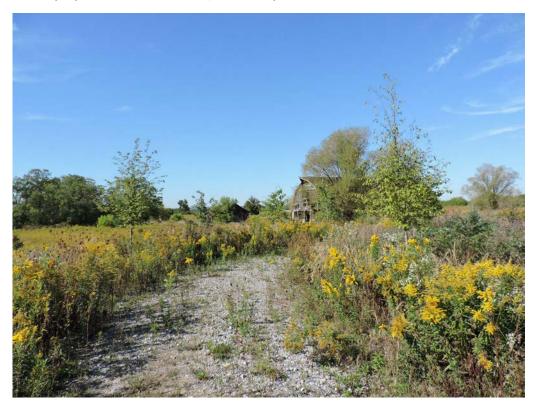
Figure 8: View of barn from pathway on south west corner of storm water pond. (AB, 2015)

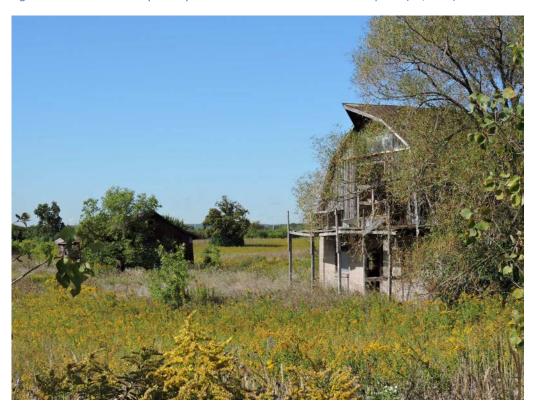
Figure 9: View of barn with shed in background. (AB, 2015)

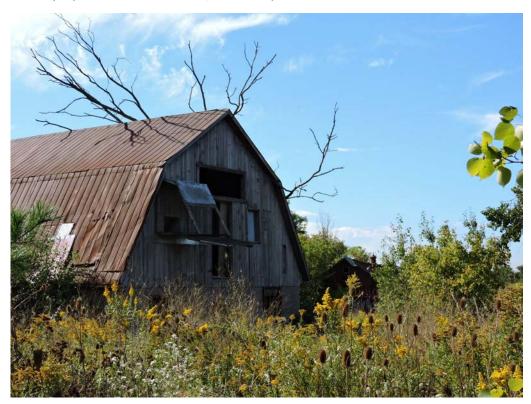
Figure 10: Rear (north elevation) of barn with shed in background. (AB, 2015)

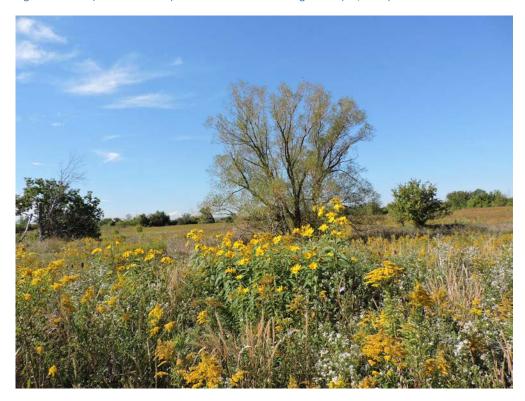
Figure 11: View of open fields to the north of property. (AB, 2015)

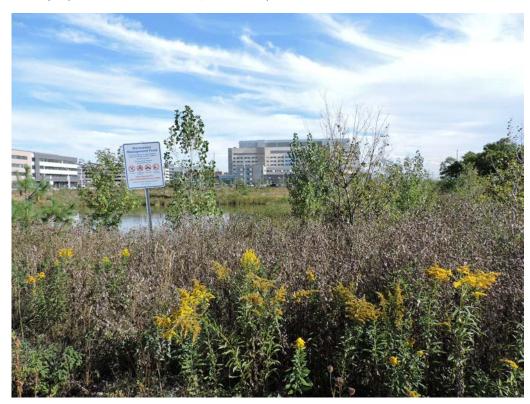
Figure 12: View of new Oakville Hospital and research buildings to the east, with storm water pond in foreground. (AB, 2015)
