250 FORESTWOOD DRIVE

Arborist Report and Tree Preservation Plan for:

250 Forestwood Dr.
Oakville, Ontario

23 March 2021

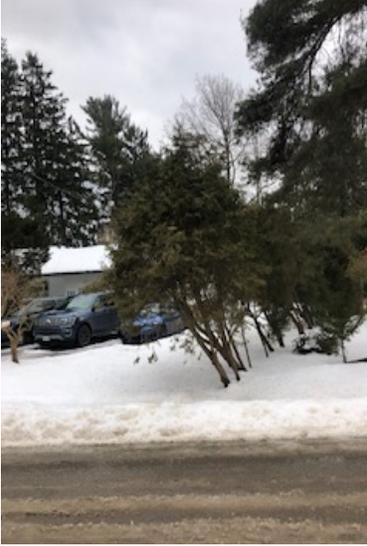
Tree#1

Tree number one (1) is a 5-14cm dbh White Cedar Hedge that is located on the property line of 250 Forestwood Dr and 236 Forestwood Dr. This tree is in fair condition and protective measures have been recommended.

Trees numbered one (1) through six (6) and eighteen (18) through twenty-two (22) shall have protective tree hoarding erected on the subject property as a one piece unit adhering to the guidelines set out in Appendix 1.

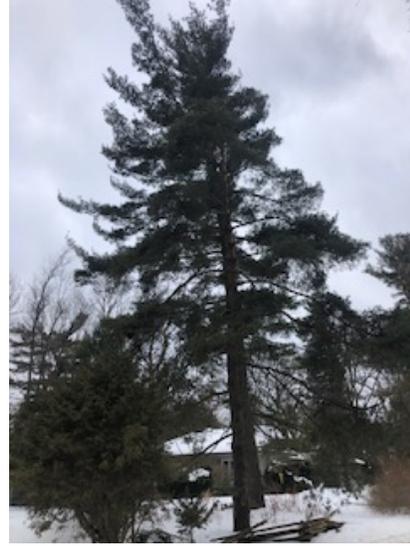
Tree#2

Tree number two (2) is a 45cm dbh Scots Pine that is located at 250 Forestwood Dr. This tree is in good condition and protective measures have been recommended.

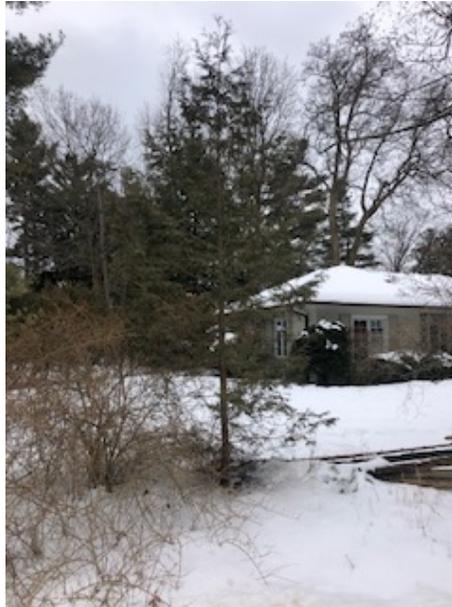
Tree #3

Tree number three (3) is an 8cm dbh White Cedar that is located at 250 Forestwood Dr. This tree is in good condition and protective measures have been recommended.

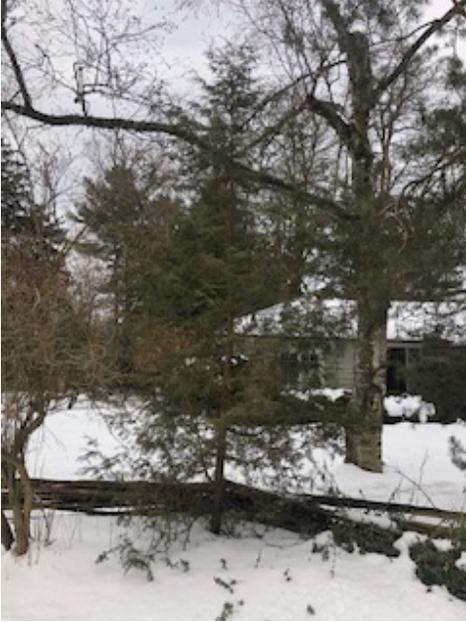
Tree #4

Tree number four (4) is an 8cm dbh White Cedar that is located at 250 Forestwood Dr. This tree is in good condition and protective measures have been recommended.

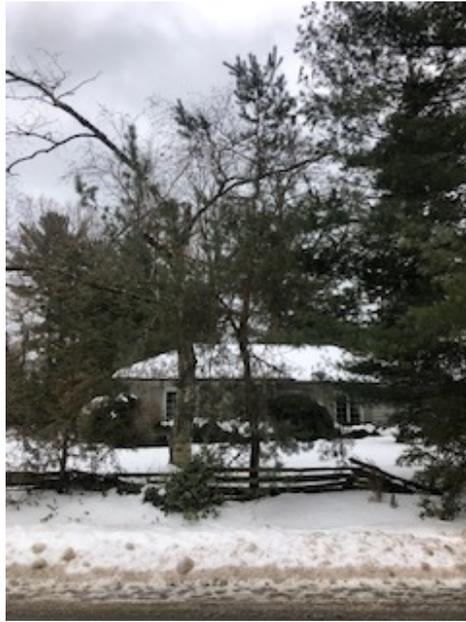
Tree #5

Tree number five (5) is an 8cm dbh Scots Pine that is located at 250 Forestwood Dr. This tree is in good condition and protective measures have been recommended.

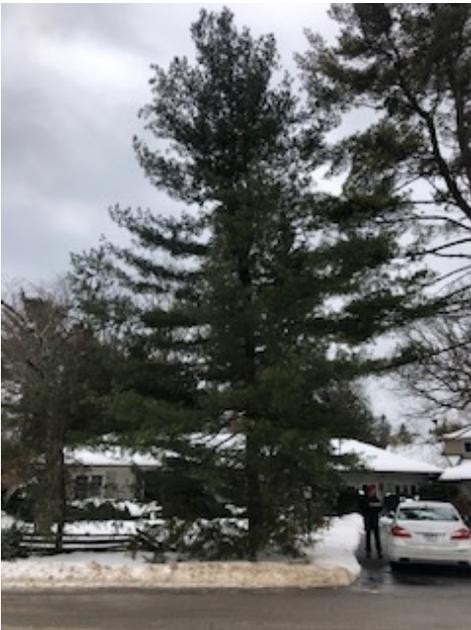
Tree #6

Tree number six (6) is a 39cm dbh White Pine that is located at 250 Forestwood Dr. This tree is in good condition and protective measures have been recommended.

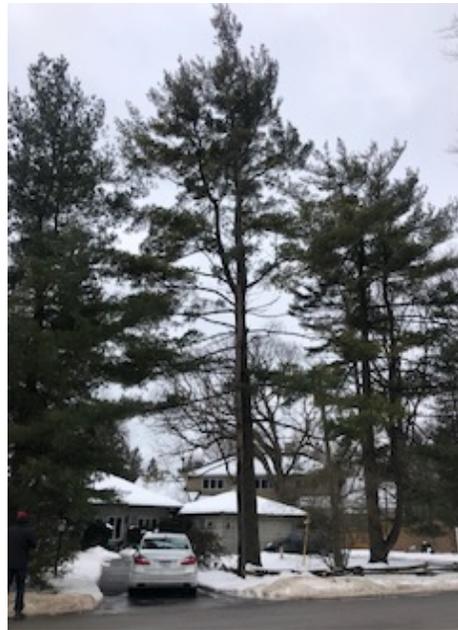
Tree #7 & #8

Tree number seven (7) is a 20cm dbh Scots Pine that is located at 250 Forestwood Dr. This tree is in fair condition and protective measures have been recommended.

Tree number eight (8) is a 56cm dbh White Pine that is located at 250 Forestwood Dr. This tree is in fair condition and protective measures have been recommended.

An encroachment is expected into the recommended TPZ of trees number seven (7), eight (8), nine (9) and ten (10) to allow for the installation of the new driveway. Ground protection shall be installed for the duration of the construction over the entire area of encroachment. Ground protection shall consist of solid steel plates no less than one half inch thick and a permeable surface shall be used in the areas of encroachment. All excavation shall either be hand dug or excavated utilizing low pressure hydro-vac technology. A qualified member of Arborcorp's staff shall be present during the excavation process to direct, monitor and inspect any excavation activity inside the TPZ.

Trees numbered seven (7) through ten (10) shall have protective tree hoarding erected on the subject property as a one piece unit adhering to the guidelines set out in Appendix 1.

Post construction, the base of the driveway will be backfilled with permeable aggregate and permeable pavers within the encroached area.

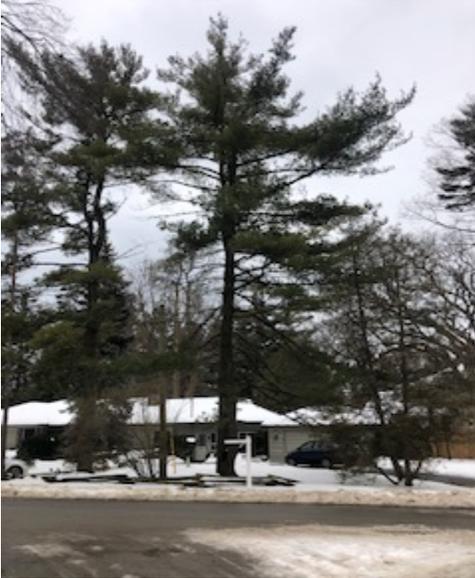
Tree #9

Tree number nine (9) is a 59/30cm dbh split stem White Pine that is located at 250 Forestwood Dr. This tree is in fair condition and protective measures have been recommended.

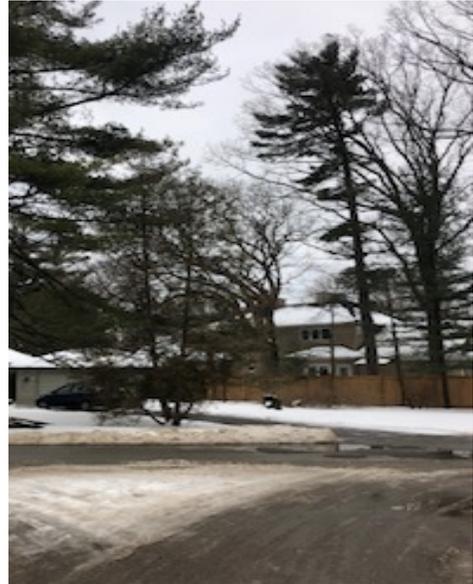
Tree #10

Tree number ten (10) is a 19/18/5/5cm dbh split stem White Cedar that is located at 250 Forestwood Dr. This tree is in fair condition and protective measures have been recommended.

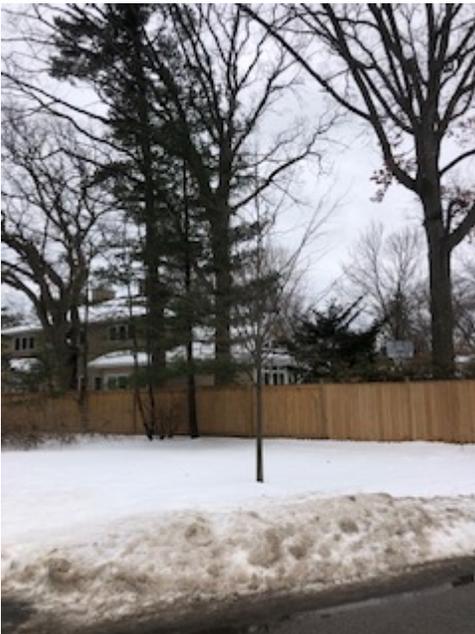
Tree #11

Tree number eleven (11) is a 10cm dbh Linden that is located at 250 Forestwood Dr. This tree is in good condition and protective measures have been recommended.

Tree number eleven (11) shall have protective tree hoarding erected on the subject property no closer than 1.8m from the base of the tree.

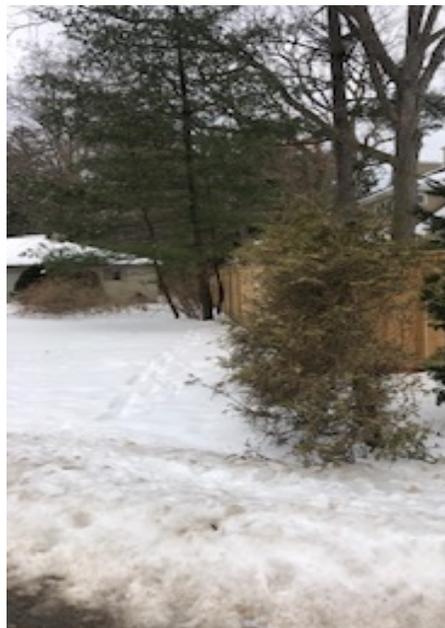
Tree #12

Tree number twelve (12) is a 5-8cm dbh White Cedar Hedge that is located at 249 Poplar Dr. This tree is in poor condition and protective measures have been recommended.

Trees numbered twelve (12) through sixteen (16) shall have protective tree hoarding erected on the subject property no closer than 2.4m from the base of the tree.
