496 CHARTWELL ROAD

ARBORIST REPORT & TREE PROTECTION PLAN

Project Address: 496 Chartwell Road Oakville, ON L6J 4A5

ARBORIST REPORT & TREE PROTECTION PLAN 496 CHARTWELL ROAD, (WARD 3) OAKVILLE, ON L6J 4A5

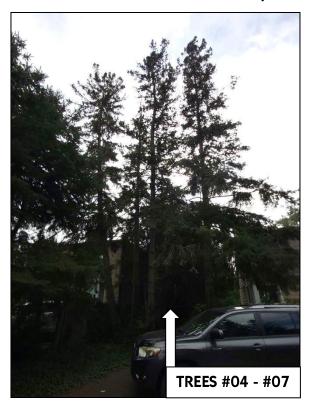
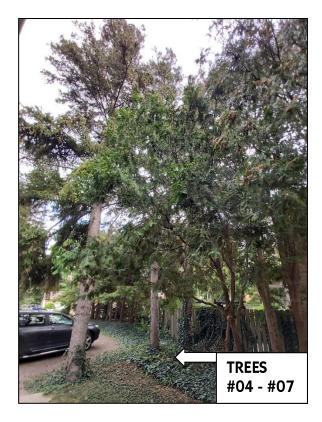
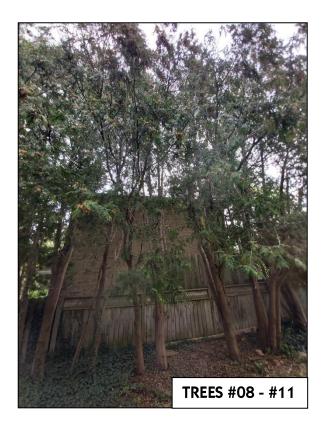
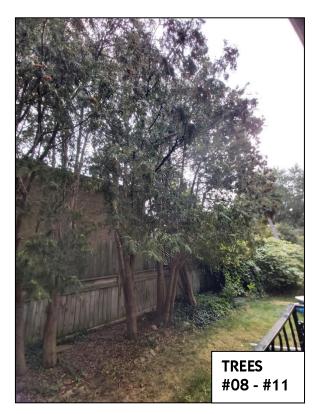
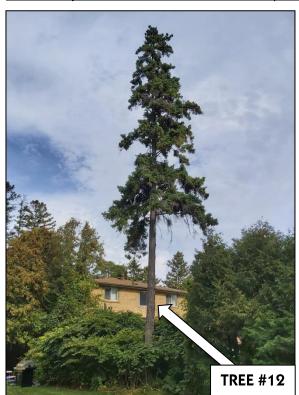
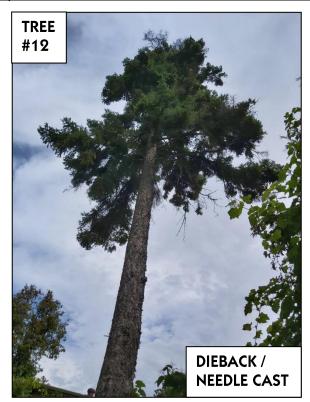
Trees #04 - #12 & #13 - Permits Required

Tree #04, a 38cm dia. Norway Spruce (*Picea abies*) is a privately-owned evergreen tree growing at the front of the subject property at 496 Chartwell Road. Tree #04 is slightly overhanging the existing dwelling. Overall the canopy of this tree is considered to be asymmetrical as it is being suppressed by the adjacent vegetation. Due to this tree being located within the footprint of the proposed new driveway, my client is looking to remove this tree at this time. Therefore an application to remove this tree will be submitted to Oakville Urban Forestry.

Tree #05, a 32cm dia. Norway Spruce (*Picea abies*) is a privately-owned evergreen tree growing at the front of the subject property at 496 Chartwell Road. Overall the canopy of this tree is considered to be sparse as it is being suppressed by the adjacent vegetation. Due to this tree being located within the footprint of the proposed new driveway, my client is looking to remove this tree at this time. Therefore an application to remove this tree will be submitted to Oakville Urban Forestry.

Tree #06, a 32cm dia. Norway Spruce (*Picea abies*) is a privately-owned evergreen tree growing at the front of the subject property at 496 Chartwell Road. Tree #06 is leaning. Overall the canopy of this tree is considered to be sparse as it is being suppressed by the adjacent vegetation. Due to this tree being located within the footprint of the proposed new driveway, my client is looking to remove this tree at this time. Therefore an application to remove this tree will be submitted to Oakville Urban Forestry.

Tree #07, a 27cm dia. Norway Spruce (*Picea abies*) is a privately-owned evergreen tree growing at the front of the subject property at 496 Chartwell Road. Tree #07 is leaning. Overall the canopy of this tree is considered to be asymmetrical as it is being suppressed by the adjacent vegetation. Due to this tree being located within the footprint of the proposed new driveway,

Tree #08, a 32cm dia. Cedar (*Thuja occidentalis*) is a privately-owned evergreen tree growing at the side of the subject property at 496 Chartwell Road. Tree #08 is codominant at its base, with leaning leaders. Overall this tree is being suppressed by the adjacent vegetation. Due to this tree being located within the footprint of the proposed new dwelling, my client is looking to remove this tree at this time. Therefore an application to remove this tree will be submitted to Oakville Urban Forestry.

Tree #09, a 28cm dia. Cedar (*Thuja occidentalis*) is a privately-owned evergreen tree growing at the side of the subject property at 496 Chartwell Road. Tree #09 is codominant and is considered to be multi stemmed, with leaning leaders. Overall this tree is being suppressed by the adjacent vegetation. Due to this tree being located within the footprint of the proposed new dwelling, my client is looking to remove this tree at this time. Therefore an application to remove this tree will be submitted to Oakville Urban Forestry.

Tree #10, a 37cm dia. Cedar (*Thuja occidentalis*) is a privately-owned evergreen tree growing at the side of the subject property at 496 Chartwell Road. Overall this tree has an asymmetrical canopy as it is being suppressed by the adjacent vegetation. Due to this tree being located within the footprint of the proposed new dwelling, my client is looking to remove this tree at this time. Therefore an application to remove this tree will be submitted to Oakville Urban Forestry.

Tree #11, a 28cm dia. Cedar (*Thuja occidentalis*) is a privately-owned evergreen tree growing at the side of the subject property at 496 Chartwell Road. Tree #11 has an asymmetrical canopy. Overall this tree is being suppressed by the adjacent vegetation. Due to this tree being located within the footprint of the proposed new dwelling, my client is looking to remove this tree at this time. Therefore an application to remove this tree will be submitted to Oakville Urban Forestry.

Tree #12, a 32cm dia. White Spruce (*Picea glauca*) is a privately-owned evergreen tree growing at the back of the subject property at 496 Chartwell Road. Tree #12 has unhealed pruning cuts and a sparse canopy, with dieback present. Overall the canopy of this tree is considered to be sparse due to the presence of needle cast. Due to this tree being located within the footprint of the proposed new dwelling, my client is looking to remove this tree at this time. Therefore an application to remove this tree will be submitted to Oakville Urban Forestry. The condition of this tree should be taken into account when determining the compensation required for its proposed removal.

my client is looking to remove this tree at this time. Therefore an application to remove this tree will be submitted to Oakville Urban Forestry.

As a result of the non-hazardous private tree removals, my client is required to plant tree(s) on private property as compensation. The number of compensation trees, the species and planting location of the compensation trees is to be determined in conjunction with the Oakville Urban Forestry department. My client may wish to exercise their option of paying Oakville Urban Forestry the sum of \$300.00 as cash-in-lieu for any of the compensation trees not planted on their property. Tree protection hoarding/fencing should be installed prior to any demolition or construction activities as outlined on sheets T1- T3.

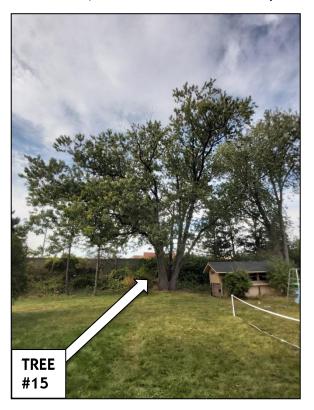
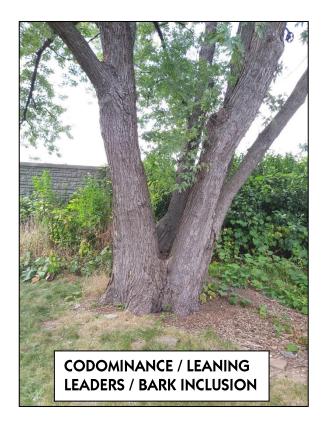
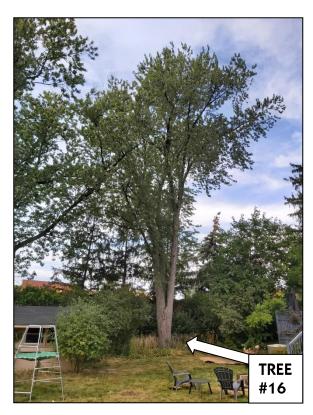
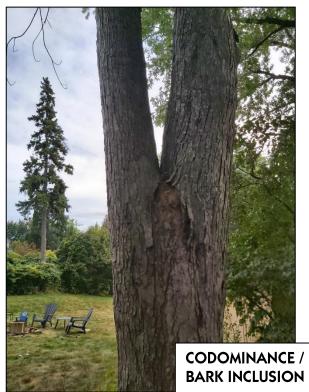
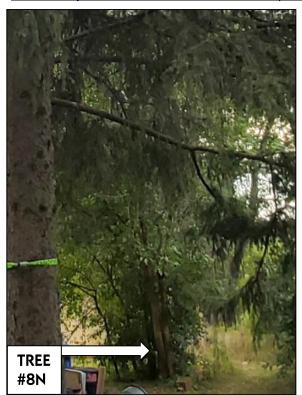
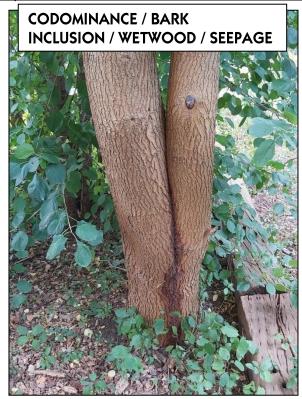
Trees #15, #16 & #8N - Permits Required

Tree #15, a 135cm Dia. Silver Maple (*Acer saccharinum*), is a jointly-owned deciduous tree growing at the back of the subject property at 496 Chartwell Road. Tree #15 is growing along my client's Northern property line and is considered to be partially on town property. This tree is codominant at its base, and is considered to be multi stemmed. These leaders are leaning, with bark inclusion present at this union. This is considered to be a potential water trap. Due to the TPZ of this tree being located within the footprint of the proposed pool and rear yard landscape elements, my client is looking to remove this tree at this time. Therefore an application to remove this tree will be submitted to Oakville Urban Forestry.

Tree #16, an 83cm Dia. Silver Maple (*Acer saccharinum*), is a jointly-owned deciduous tree growing at the back of the subject property at 496 Chartwell Road. Tree #16 is growing along my client's Northern property line and is considered to be partially on town property. This tree is codominant, with bark inclusion noted. This is considered to be a potentially weak union. Due to this tree being located within the footprint of the proposed dwelling and the excavation required to construct it, my client is looking to remove this tree at this time. Therefore an application to remove this tree will be submitted to Oakville Urban Forestry.

It is important to note that Silver Maples (also known as Soft Maples) as a species pose problems as they mature. According to woody plant specialist Michael A. Dirr, Silver Maples, due to their fast growing weak wooded nature become "...a liability with age" (Dirr; 1998, 52). According to Gary Hightshoe Silver Maples have a "frequent" rating with regards to susceptibility to wind/ice damage due to their "very weak, brittle branches." They are also considered a short-lived tree species "reaching maturity at 50-75 years, rarely beyond 125 years" (1988, 126). Silver Maple trees do not compartmentalize wounds well and future pruning wounds will be vectors for Anthracnose, Verticillium wilt, and Nectria canker. Silver Maple are susceptible to all three.

Tree #8N, an 18,12cm Dia. White Mullberry (Morus alba), is a jointly-owned deciduous tree growing near the side of the property at 496 Chartwell Road. Tree #8N is growing along my client's Northern property line and is considered to be partially on my client's private property. This tree is codominant, with bark inclusion, seepage and wetwood noted at this union. Therefore this is considered to be a weak union and a structurally compromised point in the tree. In addition, due to the TPZ of this tree being located within the footprint of the excavation required to construct the proposed dwelling and in order to facilitate the proposed works, my client is looking to remove this tree at this time. Therefore an application to remove this tree will be submitted to Oakville Urban Forestry.

An application to remove these trees will be submitted to Oakville Urban Forestry. As a result of these non-hazardous private tree removals, my client is required to plant trees on private and public property as compensation. The number of compensation trees, the species and planting location of the compensation trees is to be determined in conjunction with the Oakville Urban Forestry department. My client may wish to exercise their option of paying Oakville Urban Forestry cash-in-lieu for any of the compensation trees not planted on their property.

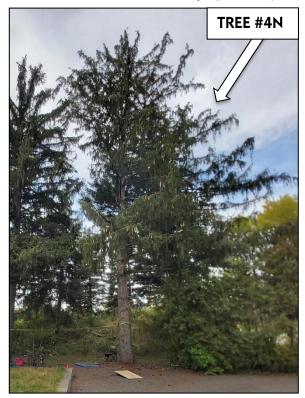
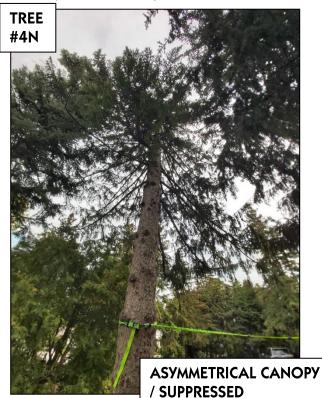
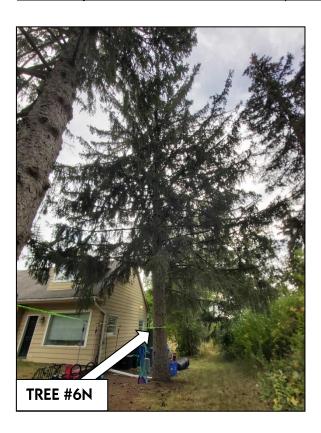
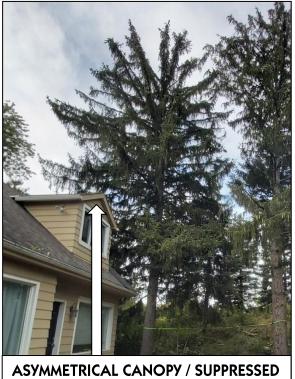
Trees #4N & #6N – Norway Spruces (64 & 58cm Dia.) - Permits Required

ASYMMETRICAL CANOPY / SUPPRESSED / OVERHANGING DWELLING

Tree #4N, a 64cm dia. Norway Spruce (Picea abies) is a jointly-owned evergreen tree growing at the front of the subject property at 496 Chartwell Road. Tree #4N is growing along my client's Northern property line and is considered to be partially on town and private property. Therefore this is considered to be a boundary tree. This tree is considered to have an asymmetrical canopy as it is being suppressed by Tree #6N.

The proposed construction and demolition activities will infringe upon the 4.2m Tree Protection Zone (TPZ) of Tree #4N. Due to the TPZ of this tree being located within the footprint of the proposed front yard landscape elements, my client is looking to injure this tree at this time. Therefore an application to injure this tree will be submitted to Oakville Urban Forestry.

Specifically, a section of the proposed front yard elements will occur within the TPZ, with the intrusion proposed at a distance of 3.9m. The encroachment is along the Southwestern section of the TPZ of this tree, consisting of the construction of the proposed water feature. It is important to note that the proposed dwelling and the excavation required to construct it will not occur within the footprint of the TPZ in this area.

Tree #6N, a 58cm dia. Norway Spruce (Picea abies) is a jointly-owned evergreen tree growing at the front of the subject property at 496 Chartwell Road. Tree #6N is growing along my client's Northern property line and is considered to be partially on town and private property. Therefore this is considered to be a boundary tree. This tree is considered to have an asymmetrical canopy as it is being suppressed by the nearby dwelling.

The proposed construction and demolition activities will infringe upon the 3.6m Tree Protection Zone (TPZ) of Tree #6N. Due to the TPZ of this tree being located within the footprint of the proposed dwelling and front yard landscape elements, my client is looking to injure this tree at this time. Therefore an application to injure Tree #6N will be submitted to Oakville Urban Forestry.

Specifically, a section of the proposed dwelling and walkway will occur within the TPZ, with the intrusion proposed at a distance of 3.6m. The encroachment is along the Southwestern section of the TPZ of this tree.

Root protection is proposed within the TPZ, in order to limit compaction in this immediate section as this area will provide access to the rear of the property. Lakeshore Tree Services Inc. recommends root and canopy pruning prior to construction along the edge of the disturbance required to facilitate the dwelling and proposed landscape elements.

Root protection is proposed within the TPZ, in order to limit compaction in this immediate section as this area will provide access to the rear of the property. Lakeshore Tree Services Inc. recommends root and canopy pruning prior to construction along the edge of the disturbance required to facilitate the dwelling and proposed landscape elements

Overall, to limit the impact that this proposed work will have on Trees #4N & #6N, Lakeshore Tree Services Inc. recommends that the proposed work be conducted utilizing hand tools, and under arborist supervision whenever possible.

Furthermore, Lakeshore Tree Services Inc. recommends "deep root feeding" fertilization in as large an area as possible within the TPZ of Trees #4N & #6N. The fertilizer should be low in nitrogen and high in phosphorous in order to promote new root growth to compensate for any root loss during construction.

Overall, to limit the impact that this proposed work will have on these trees, Lakeshore Tree Services Inc. recommends that hoarding be installed as outlined on sheet T1, and that the driveway removal work in this section be conducted last, once materials, personnel and waste due to the construction of the proposed dwelling is concluded. This work should be conducted utilizing hand tools, and under arborist supervision.
