SITE and GRADING PLAN of PROPOSED 2 STOREY SINGLE FAMILY DWELLING 2042 SALVATOR BOULEVARD OAKVILLE, ON L6L 1M7

CUSTOM 2 STOREY DWELLING
2042 SALVATOR BLVD., OAKVILLE, ON

ARBORIST REPORT

2042 Salvator Blvd.
Oakville, ON
L6L 1M7

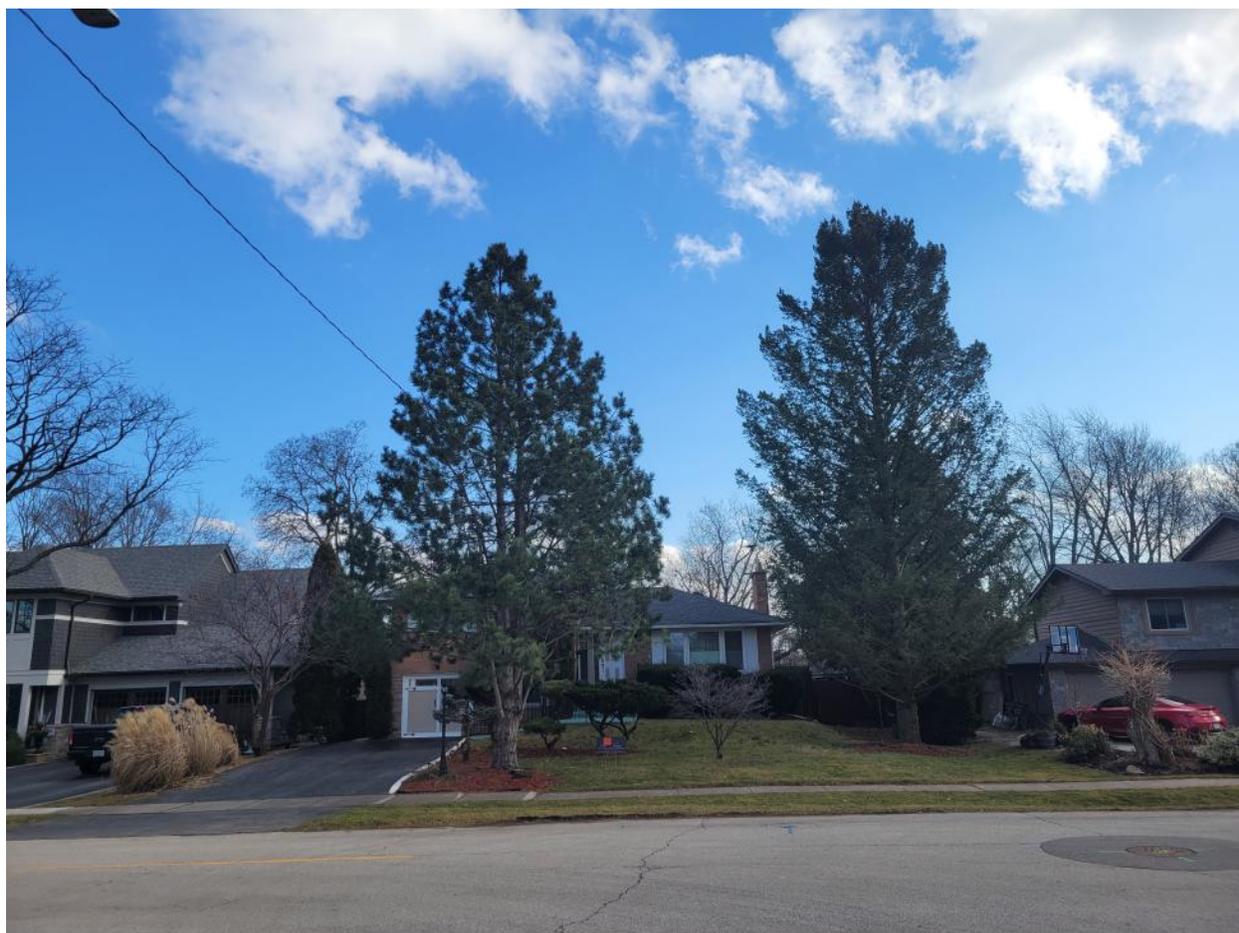
Photo 1. Trees 1-5.

Tree #	Species	DBH (cm)	Crown Radius (m)	Biological Condition	Structural Condition	Condition Comments	Min TPZ (m)	Ownership Category	Recommended Action & Details
1	<i>Thuja occidentalis</i> (white cedar)	15	1	Good	Good	Full crown.	2.4	Private	Remove - due to proposed walkway.
2	<i>Cercis canadensis</i> (Eastern redbud)	23	2	Fair	Poor	Three main stems (18, 9 & 12cm DBH); main stem has a split included union.	2.4	Potential Boundary	Injure - due to proposed walkway and driveway. Moderate impacts expected.
3	<i>Pinus nigra</i> (Austrian pine)	54	4.5	Good	Poor	Three main stems; good new growth.	3.6	Private	Remove - due to proposed driveway widening.

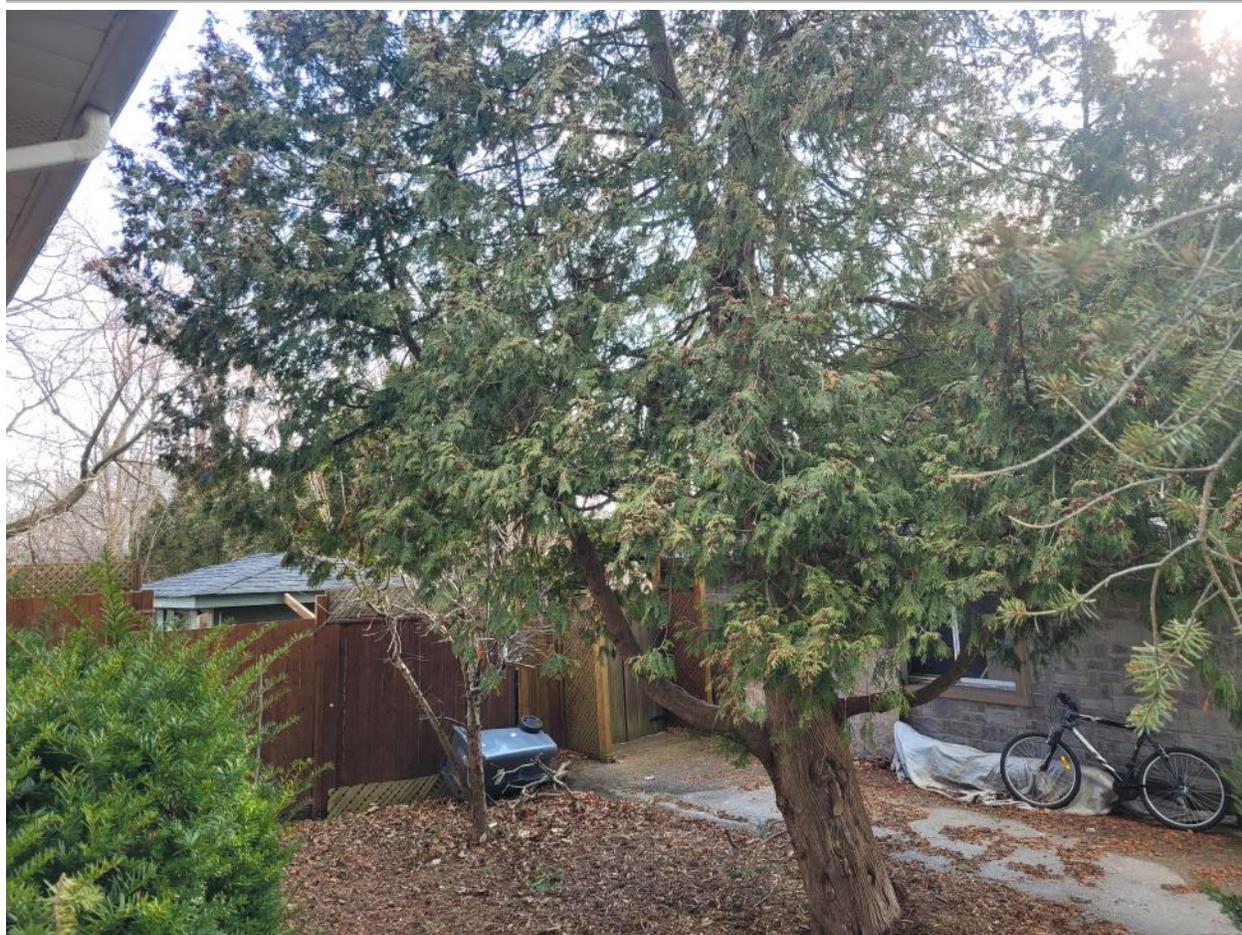
Photo 2. Tree 5.

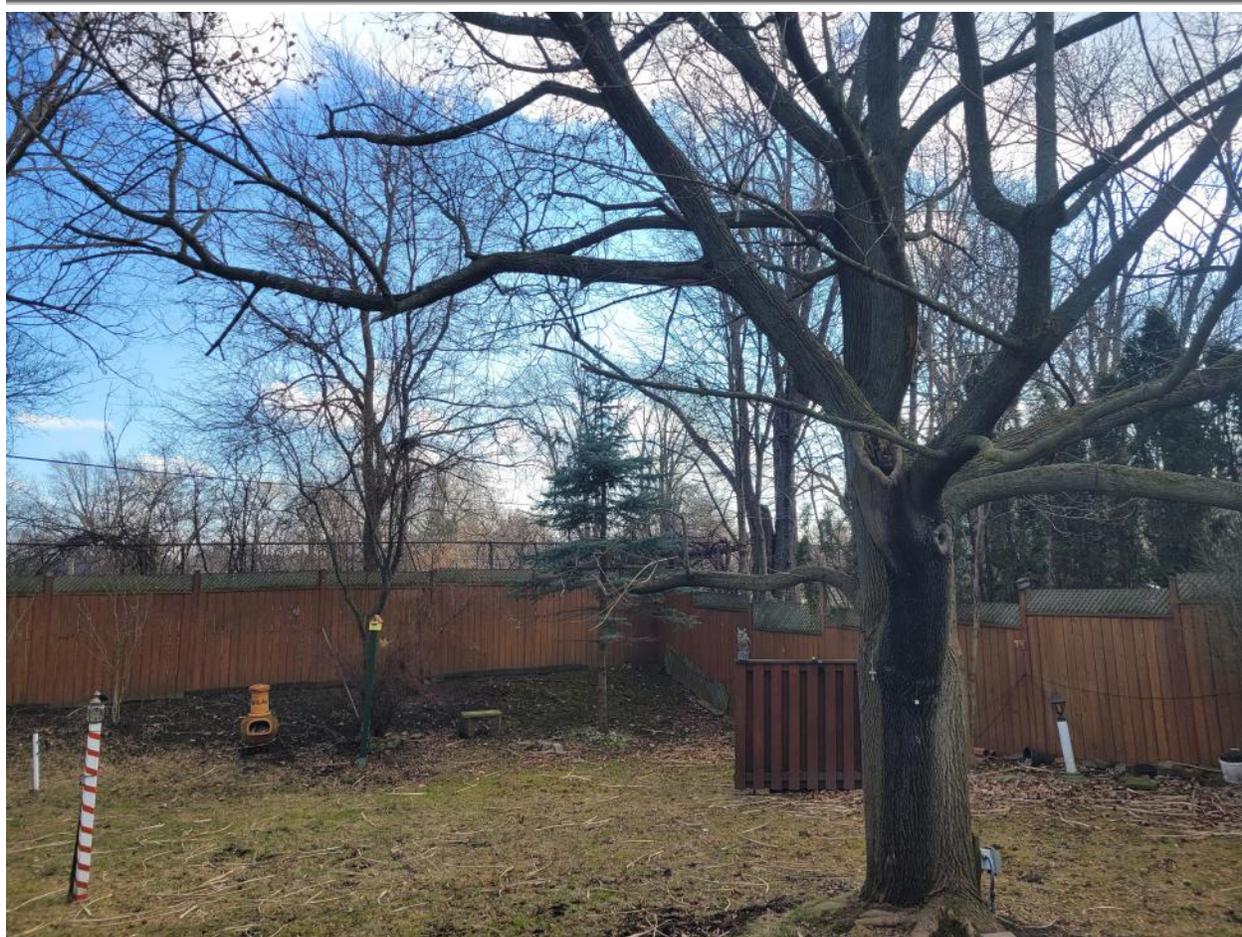
Photo 3. Trees 6-10.

6	<i>Acer platanoides</i> (Norway maple)	59	5	Fair	Fair	Decurrent habit; fair shoot extension; decent dieback.	3.6	Private	Remove - due to proposed pool and stairs.
7	<i>Fraxinus pennsylvanica</i> (green ash)	15	1.5	Good	Fair	Codominant stems; good shoot extension.	2.4	Private	Injure - due to proposed pool excavation. Minor impacts expected.
8	<i>Fraxinus pennsylvanica</i> (green ash)	16	1.5	Poor	Poor	Significant Emerald Ash Borer infestation.	2.4	Neighbor	Preserve - tree protection fence.
9	<i>Acer saccharinum</i> (silver maple)	78	8	Good	Fair	Multi-stem (~65, 30 & 30cm DBH); good bud set.	4.8	Neighbor	Preserve - tree protection fence.
10	<i>Morus alba</i> (white mulberry)	30	3.5	Good	Fair	Good bud set; decurrent habit.	2.4	Neighbor	Preserve - tree protection fence.
11	<i>Salix fragilis</i> (crack willow)	54	5	Fair	Fair	Bifurcates at ~1m (46 & 29cm DBH) with a fair union; minor deadwood.	3.6	Private	Preserve - tree protection fence.

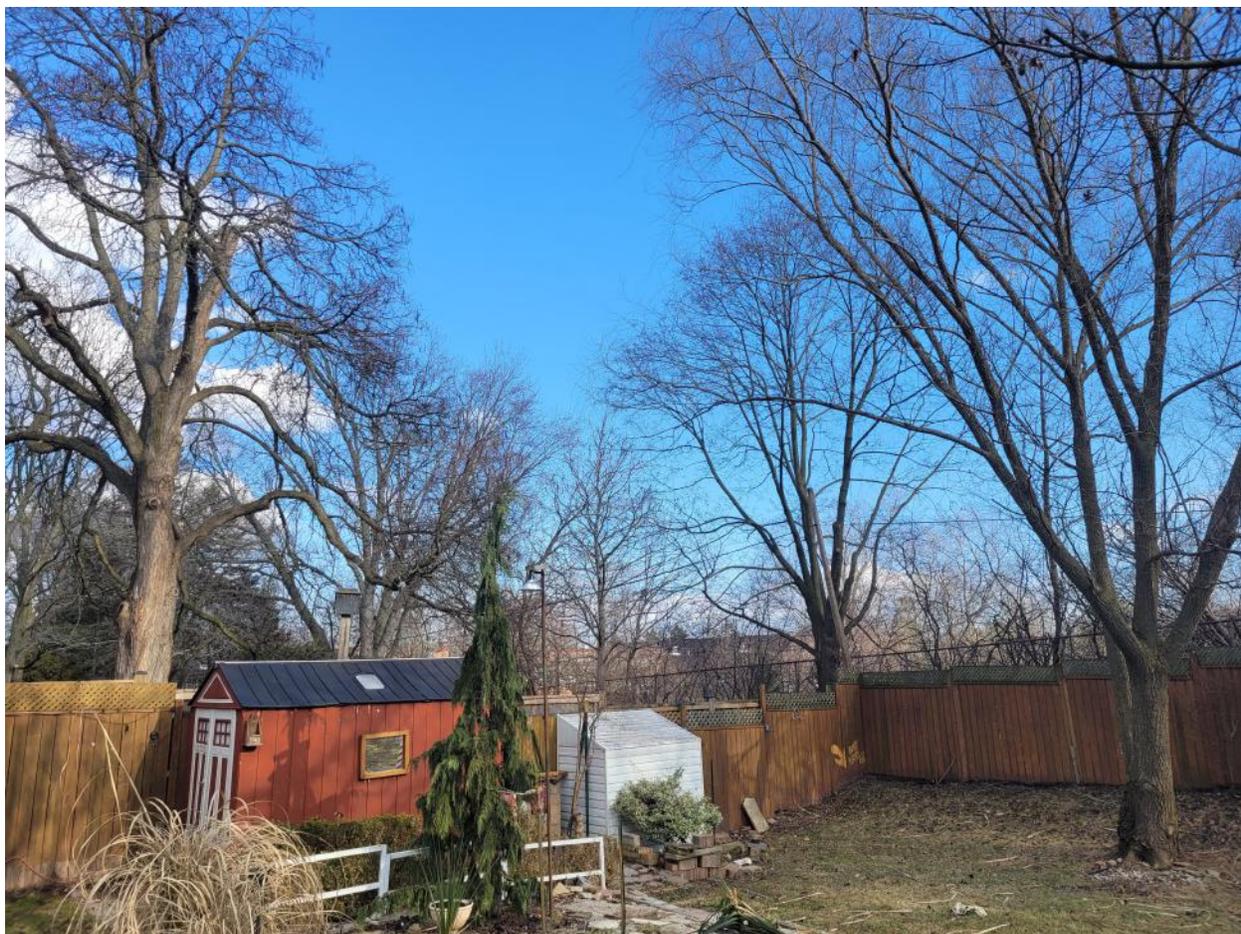
Photo 4. Trees 11-13.

12	<i>Acer platanoides</i> (Norway maple)	45	5	Fair	Poor	Decurrent habit; fair shoot extension; included main union.	3	Neighbor	Preserve - tree protection fence.
13	<i>Catalpa speciosa</i> (Northern catalpa)	100	8	Fair	Poor	Decurrent habit; major past stem damage; fair shoot extension.	6	Neighbor	Preserve - tree protection fence. Existing shed to be removed prior to installing tree protection fence.
