2375 Carrington Place
 Lot 40
 Registered Plan 1522
 Town of Oakville,
 Regional Municipality of Halton

Drawing:
Site Plan

TREE AND SHRUB SERVICES

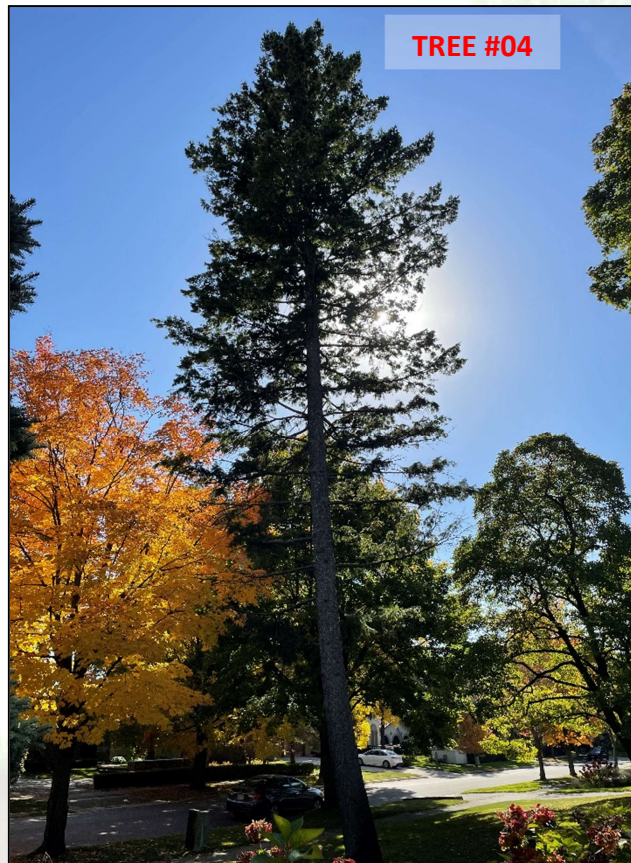
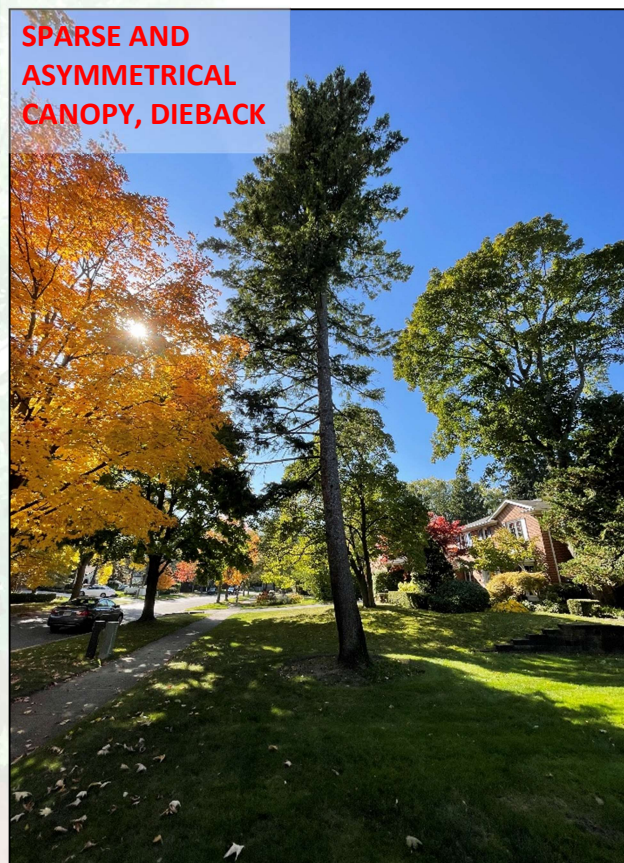
Tree #04 – PHOTOS

Tree	Tree Species	Botanical Name	DBH (cm)	Root Zone	Trunk Integrity	Crown Structure	Crown Vitality	Overall Condition	TPZ (m)
04	White Spruce	<i>Picea glauca</i>	55	Fair	Fair	Fair	Fair	Fair	3.6

Tree #04, a 55cm DBH White Spruce (*Picea glauca*) is a privately owned evergreen tree growing at the front of the property at 2375 Carrington Place. This tree is leaning and has an asymmetrical and sparse canopy, with dieback noted as well. Overall, this tree is considered to be in fair condition.

Due to the proposed regrading measures and the excavation required to facilitate this work occurring within the 3.6m TPZ of this tree, my client is looking to remove this tree at this time. Therefore, a removal permit is required for the removal of Tree #04. Replacement trees chosen from a list of town approved species are required on private property as compensation for the removal of Tree #04. Tree Protection Hoarding/Fencing should be installed prior to any demolition or construction activities as outlined on Tree Protection Plan TPP-1.

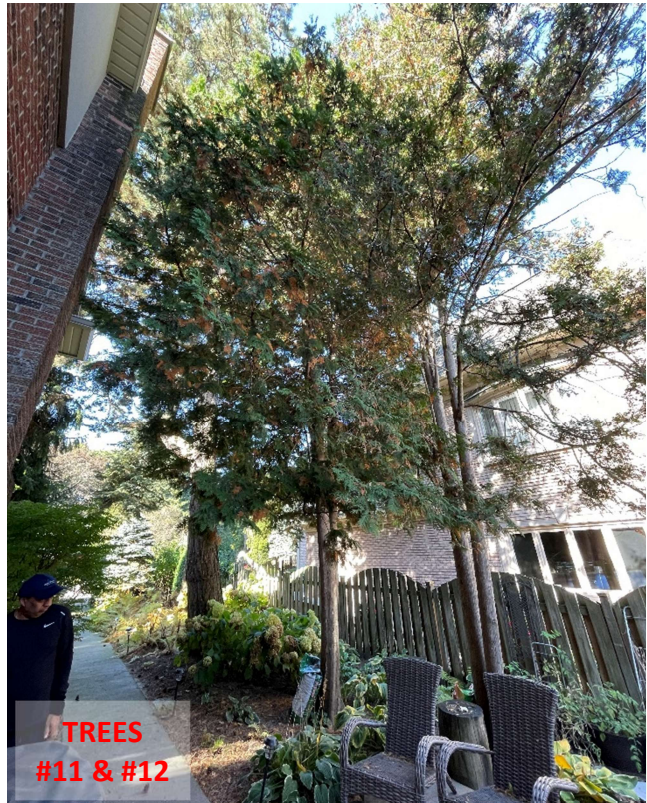
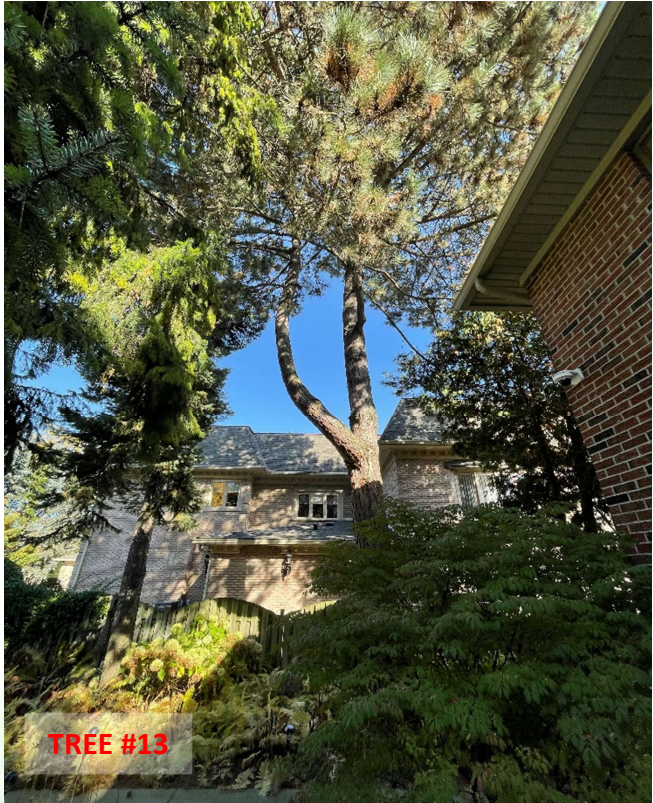
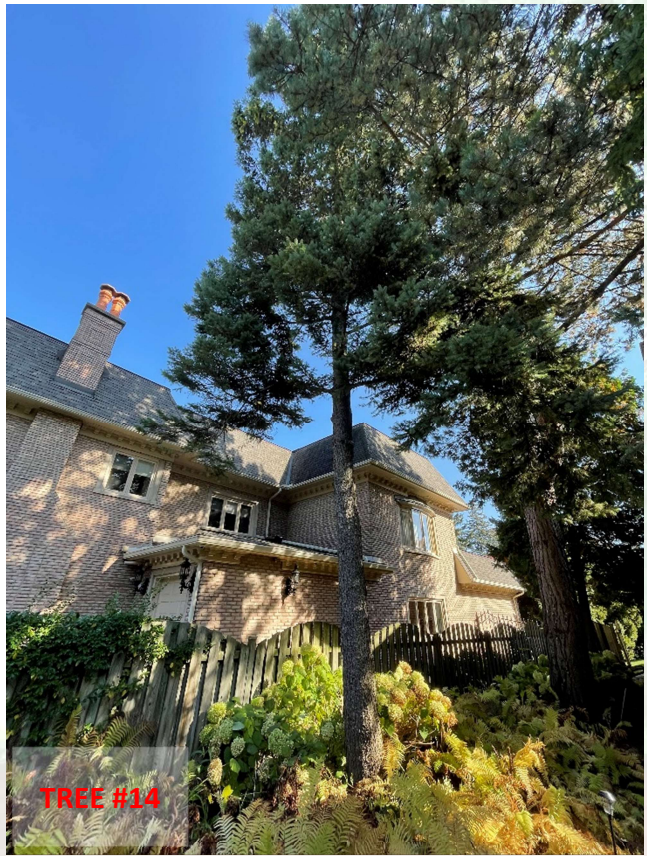
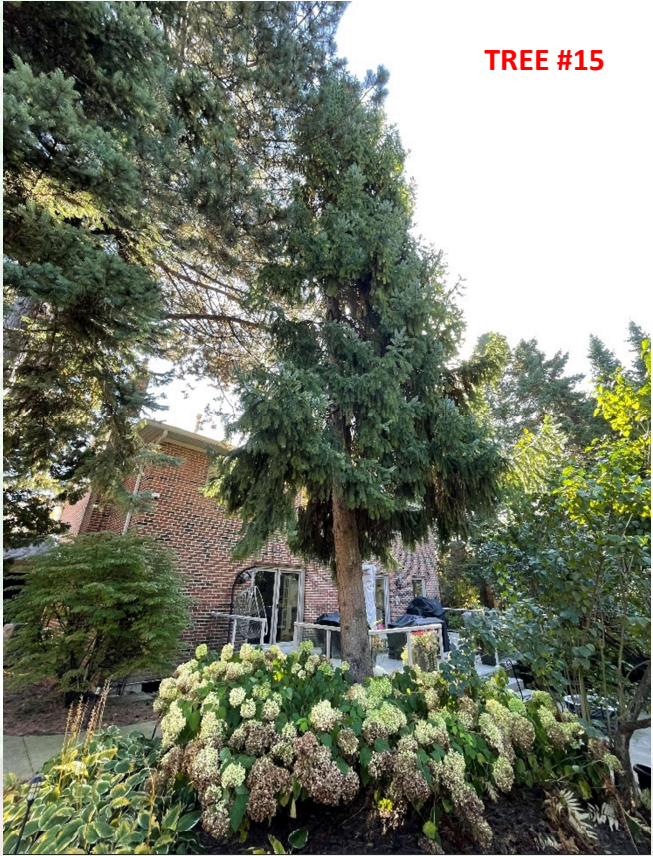
Trees #11 – #15 PHOTOS

Tree	Tree Species	Botanical Name	DBH (cm)	Root Zone	Trunk Integrity	Crown Structure	Crown Vitality	Overall Condition	TPZ (m)
11	White Cedar	<i>Thuja occidentalis</i>	25	Fair	Fair	Fair	Fair	Fair	2.4
12	White Cedar	<i>Thuja occidentalis</i>	26	Fair	Fair	Fair	Fair	Fair	2.4
13	Austrian Pine	<i>Pinus nigra</i>	62	Fair	Fair	Fair	Fair	Fair	4.2
14	White Spruce	<i>Picea glauca</i>	34	Fair	Good	Fair	Fair	Good/Fair	3.0
15	Norway Spruce	<i>Picea abies</i>	38	Fair	Good	Fair	Fair	Good/fair	3.0

Due to the excavation required for the proposed demolition and construction activities, along with construction access, these trees require removal in order to facilitate the proposed works. It is important to note that these are shallow rooted trees, and due to the one metre minimum required foundational overdig occurring in close proximity to the base of these trees, there is no possibility of retaining these trees, post construction.

Removal permits are required for the removal of Tree #11-#15. Replacement trees chosen from a list of town approved species are required on private property as compensation.

Tree Protection Hoarding/Fencing should be installed prior to any demolition or construction activities as outlined on Tree Protection Plan TPP-1.

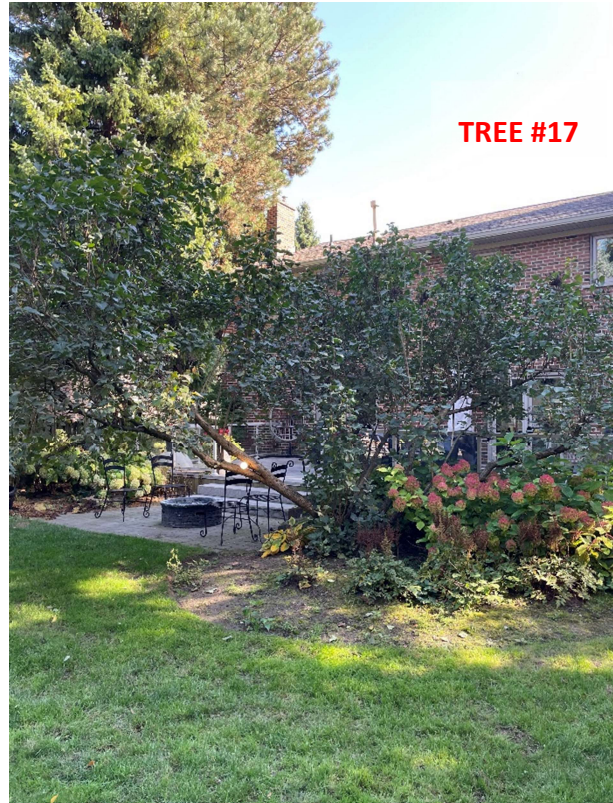
TREE #17

Tree	Tree Species	Botanical Name	DBH (cm)	Root Zone	Trunk Integrity	Crown Structure	Crown Vitality	Overall Condition	TPZ (m)
17	Red Bud	<i>Cercis canadensis</i>	25	Fair	Fair	Fair	Fair	Fair	2.4
18	White Cedar	<i>Thuja occidentalis</i>	26	Fair	Good	Fair	Fair	Good/Fair	2.4
19	Austrian Pine	<i>Pinus nigra</i>	62	Fair	Good	Fair	Fair	Good/Fair	4.2
20	White Spruce	<i>Picea glauca</i>	34	Fair	Good	Fair	Fair	Good/Fair	3.0
22	Norway Spruce	<i>Picea abies</i>	38	Fair	Good	Fair	Fair	Good/Fair	3.0
23	White Spruce	<i>Picea glauca</i>	20	Fair	Good	Fair	Fair	Good/Fair	2.4
24	White Spruce	<i>Picea glauca</i>	21	Fair	Good	Fair	Fair	Good/Fair	2.4
25	White Spruce	<i>Picea glauca</i>	25	Fair	Good	Fair	Fair	Good/Fair	2.4

Due to the excavation required for the proposed demolition and construction activities, along with construction access, these trees require removal in order to facilitate the proposed works. It is important to note that these are shallow rooted trees, and due to the one metre minimum required foundational overdig occurring in close proximity to the base of these trees, there is no possibility of retaining these trees, post construction.

Removal permits are required for the removal of Tree #17 - #20, #22- #25 Replacement trees chosen from a list of town approved species are required on private property as compensation.

Tree Protection Hoarding/Fencing should be installed prior to any demolition or construction activities as outlined on Tree Protection Plan TPP-1.

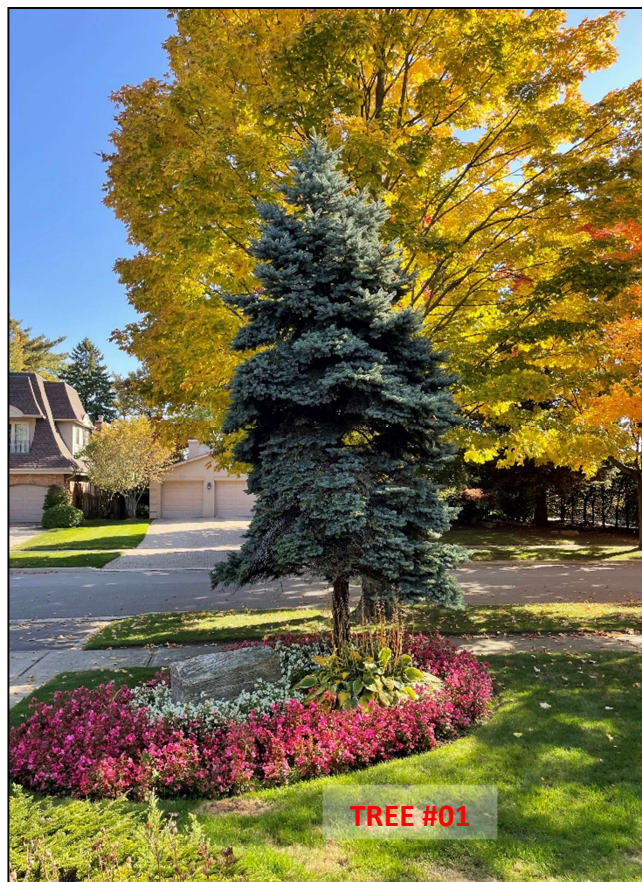
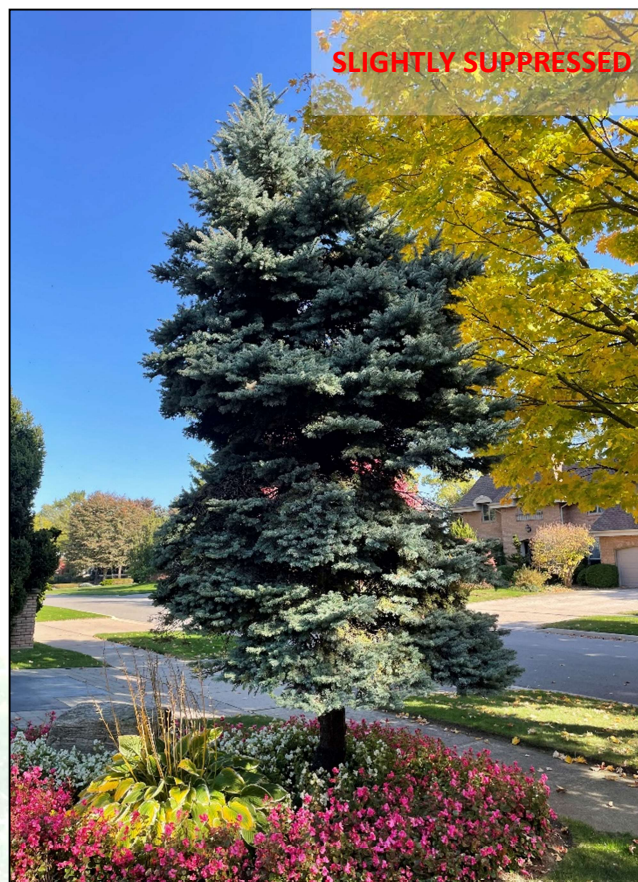
Tree #01 – PHOTOS

Tree	Tree Species	Botanical Name	DBH (cm)	Root Zone	Trunk Integrity	Crown Structure	Crown Vitality	Overall Condition	TPZ (m)
01	Colorado Blue Spruce	<i>Picea pungens</i>	18	Fair	Good	Good	Good	Good	2.4

This tree is being slightly suppressed by the adjacent vegetation and shows signs of minor needle cast affliction. Overall this tree is considered to be in fair to good condition. Due to the proposed removal of the front yard landscape elements along with excavation required for the proposed reconfigured driveway, there will be an encroachment into the Northern portion of the 2.4m TPZ of this tree.

All work within the TPZ is to be done by hand and in the presence and under the supervision of an ISA Certified Arborist. Within the limits of any proposed excavation, the Best Management Practice of day-lighting the tree roots using the Air Spade system is recommended. It is our preferred method to daylight roots without causing damage to the bark of the roots.

Typically for an Air Spade excavation around tree roots, a maximum air stream pressure of 100 pounds per square inch (PSI) is utilized to minimize damage to the root bark. If a dense mat of roots is encountered, a large number of smaller feeder roots, or significant roots larger than 5cm diameter are encountered, no roots larger than 5cm in diameter are to be cut. Any root pruning requires approval from Oakville Urban Forestry and should follow ISA Best Management Practices.

The 2.4m TPZ of this tree will be protected with 1.2m high orange snow tree protection hoarding on 2 x 4" wood frame. Tree Protection should be installed prior to any demolition or construction activities as outlined on the Tree Protection Plan.
