**LUCID HOMES** SITE PLAN  
DRAWN BY: PR CHECKED BY: -  
ADDRESS: 150 DIANNE AVE, OAKVILLE  
PROJECT NO: 2024-049 SCALE: 1:150  
SHEET NO. **SP**

# ARBORIST REPORT AND TREE PRESERVATION PLAN

**150 Dianne Ave  
Oakville, Ontario  
L6J 4H1**

PP-1: Tree Preservation Plan

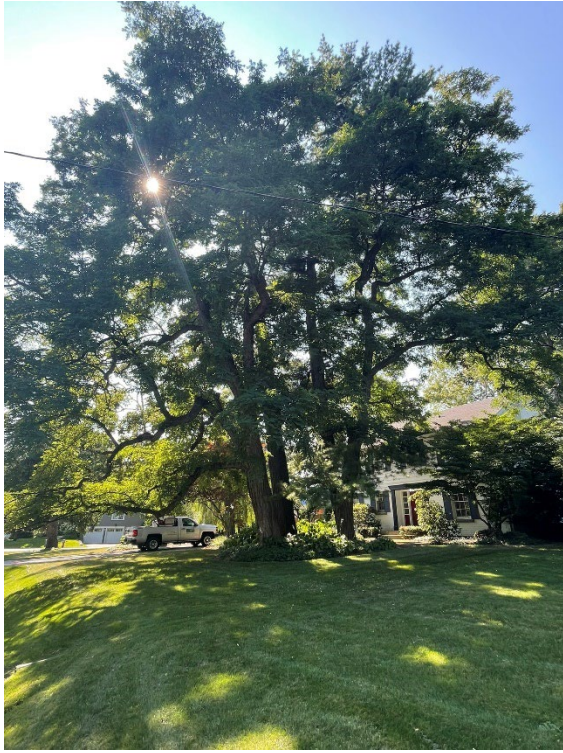
**Image 1.** Trees 1 – 4 (right to left).

Based on the currently proposed Site Plan, seven (7) private trees (Trees 1 – 4, 8, 9, and 18) are recommended for removal. Private tree removal permits will need to be secured prior to the commencement of tree removal work.

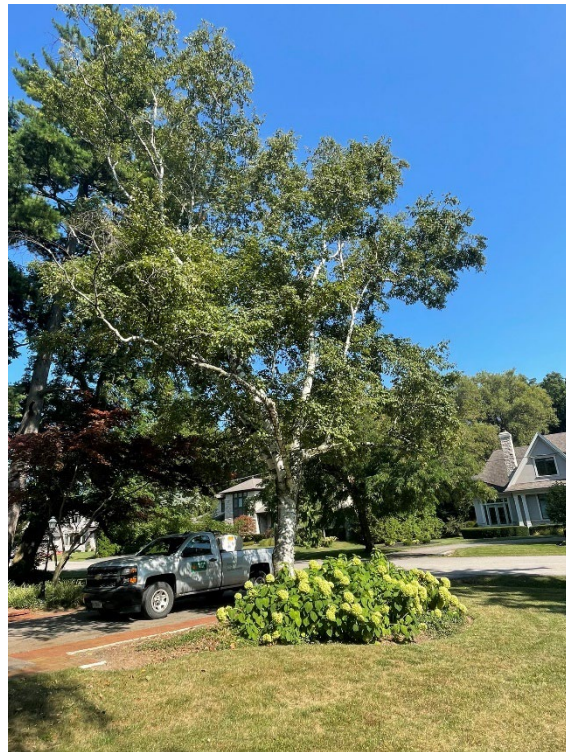
**Image 4.** Tree 6.

Trees 5 and 6 flank the existing driveway, which is to be removed and relocated. If the existing driveway will aid the construction contractors with accessing the site, then its removal should be delayed until construction work is completed. Tree protection fencing should be installed as per **PP-1**, along the edges of the existing driveway. When it is time to remove the existing driveway, the following recommendations should be observed:

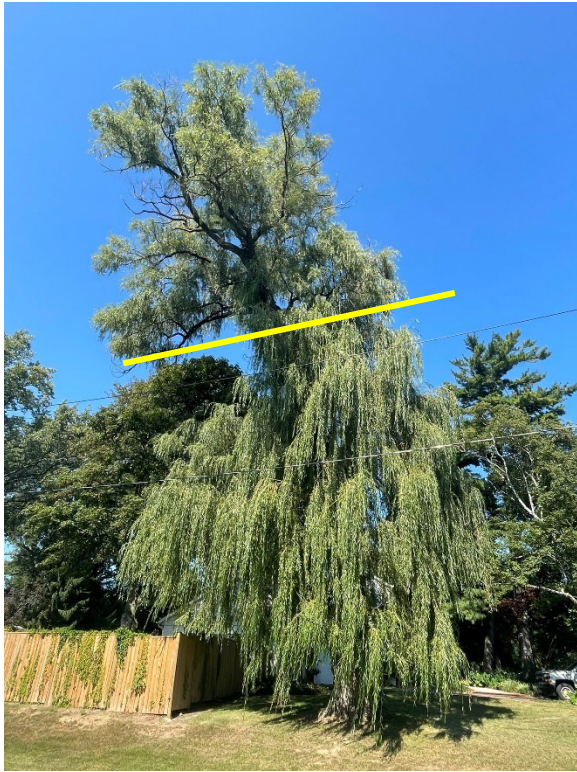
7	Weeping Willow	<i>Salix babylonica</i>	111	5	7.1	F	P	Subject Site	Deadwood (H), Severe cavity @ ~1.5 m, Advanced decay in trunk	Injure
8	Dogwood	<i>Cornus spp.</i>	6, 10, 12	3.5	2.4	F	F	Subject Site	<b>Calculated DBH = 17 cm</b> , Asymmetrical crown (M), Codominant @ ground, Epicormic branches (M)	Remove
9	Norway Maple	<i>Acer platanoides</i>	55	5	3.6	F	F	Subject Site	Defoliation (M), Stem seam (M), Pruning wounds (H), Girdling root (L), Trunk has been bolted	Remove
10	White Spruce	<i>Picea glauca</i>	18	1.5	2.4	G	G	Subject Site	Pruning wounds (L), Raised canopy (L)	Preserve
11	White Spruce	<i>Picea glauca</i>	25	1.5	2.4	G	G	Subject Site	Defect-free	Preserve
12	White Spruce	<i>Picea glauca</i>	21	1.5	2.4	G	G	Subject Site	Defect-free	Preserve
13	Norway Spruce	<i>Picea abies</i>	23	2	2.4	G	G	Subject Site	Pruning wounds (L), Raised canopy (L)	Preserve
14	Norway Spruce	<i>Picea abies</i>	19	2	2.4	G	G	Subject Site	Defect-free	Preserve

Image 5. Tree 7 (with recommended pruning line).

Tree 7 is a large weeping willow (*Salix babylonica*) with a trunk cavity, evident decay, and dead branches in its canopy. Despite these defects, the preservation of Tree 7 is recommended. In order to reduce the likelihood of future tree failure, it is recommended that the height of this tree be reduced; this will not only accomplish the removal of dead branches, thereby improving site safety, but also reduce the forces exerted on the weakened trunk during wind events. See **Image 5** for the approximate recommended pruning line.

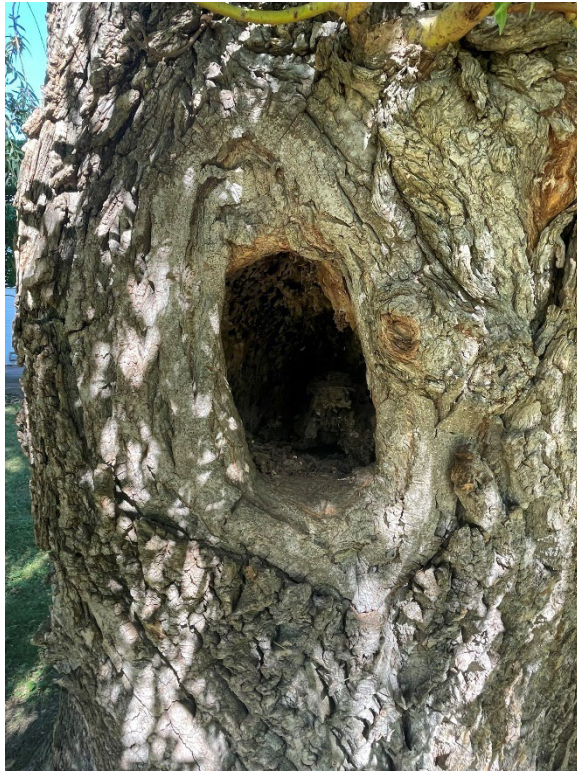
Image 6. Cavity in Tree 7.

The proposed excavation will occur within the TPZ of Tree 7; therefore, trenches to assess the amount of root damage necessary are recommended:

- Trenches should be excavated using an AirSpade pneumatic tool
- The AirSpade should be operated, or supervised, by a Certified Arborist
- Trenches should be located as prescribed on **PP-1**, just beyond excavation limits
- Trenches should be between 20-30 cm wide, and 30-40 cm deep
- Roots encountered in the trench should be assessed for removal viability by a Certified Arborist
- If it is determined that Tree 7 will not be compromised by the root loss, then all roots within the trench should be severed cleanly
- If required root loss will compromise the tree, tree removal is recommended
- Once root pruning is complete, the trench should be backfilled with clean topsoil
- All work should be documented, photographed, and reported for submission to the Town

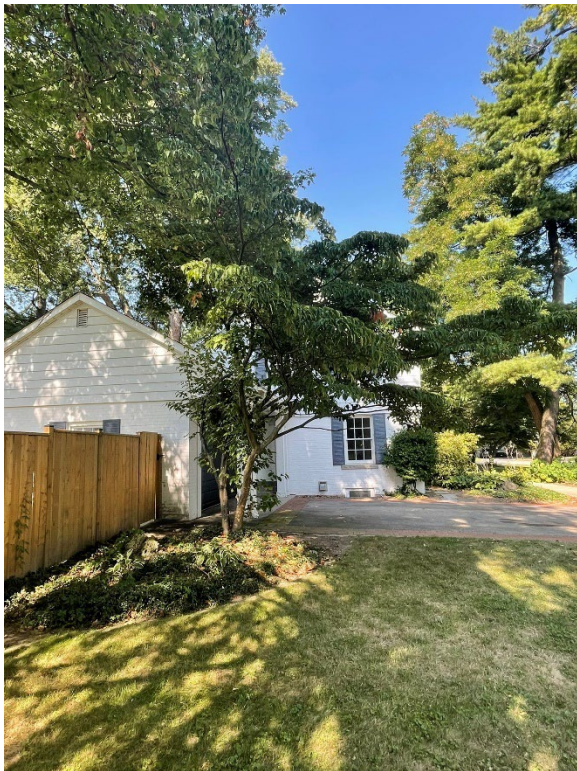
Image 7. Tree 8.

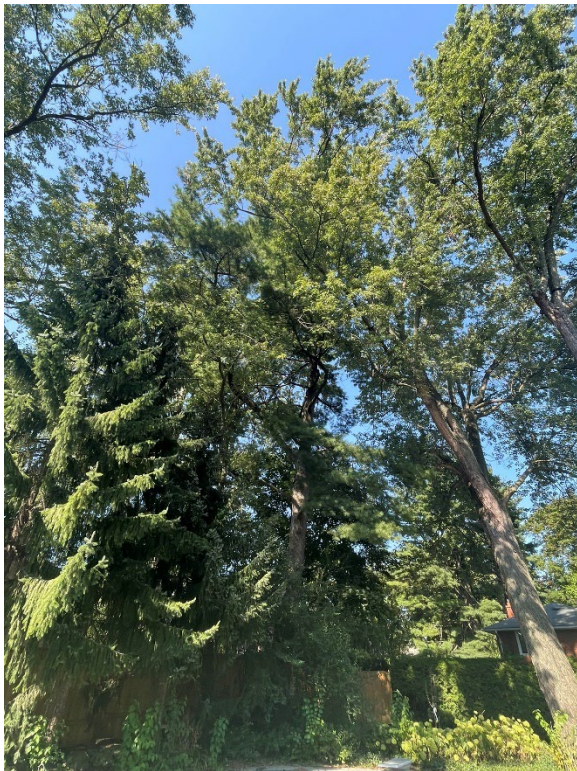
15	Norway Spruce	<i>Picea abies</i>	18	2	2.4	G	G	Subject Site	Defect-free	Preserve
16	Silver Maple	<i>Acer saccharinum</i>	37	5	3	G	G	Subject Site	Asymmetrical crown (M), Pruning wounds (M)	Preserve
17	White Pine	<i>Pinus strobus</i>	84	6	5.4	G	F	Subject Site	Pruning wounds (H), Dead branches (M)	Preserve

**Image 11.** Tree 17 (center of frame).

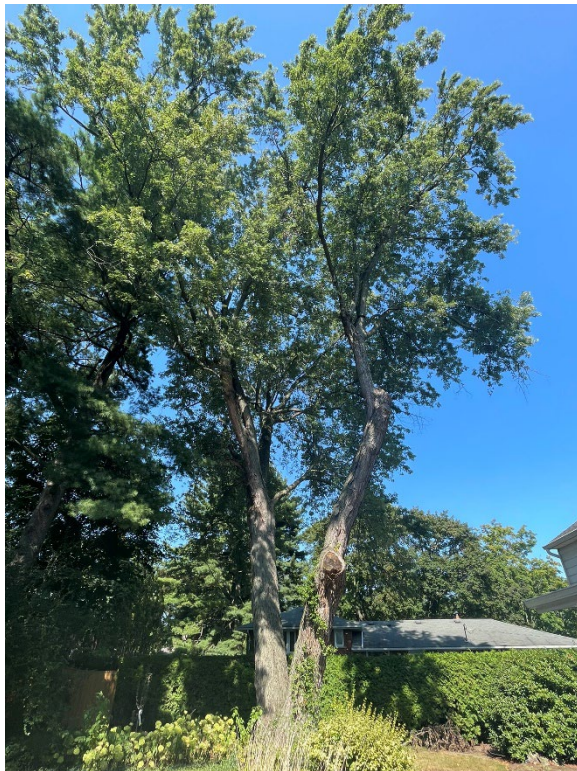
Tree 18 is a mature silver maple (*Acer saccharinum*) with a codominant structure originating from a V-shaped union at the ground. The tree has had a dynamic cable installed in the past, and large diameter limbs have been removed, the wounds of which have not sealed and decay is evident at wound locations. The proposed excavation would occur within three (3) or four (4) m of the trunk, or a distance of between 2 and 2.7 x the calculated trunk diameter. The combination of anticipated root injury and poor tree structure lead me to recommend removal.

**Image 12.** Tree 18.

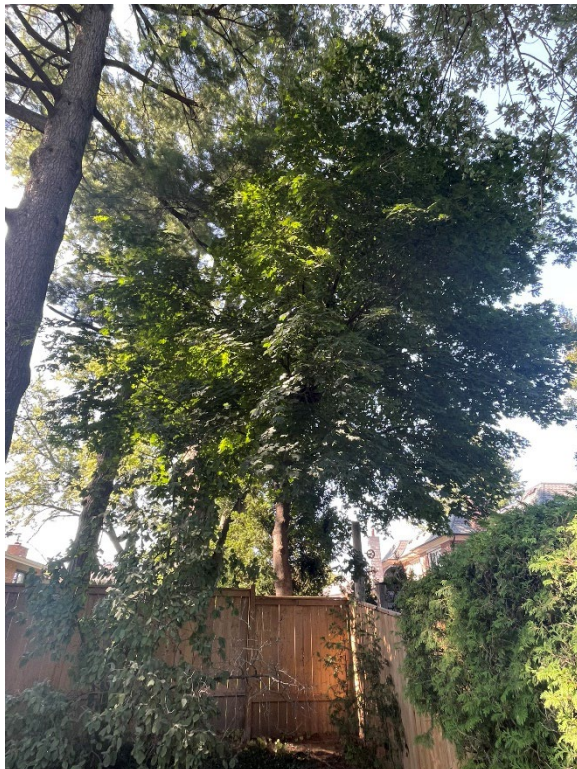
D	Norway Maple	<i>Acer platanoides</i>	~30	4	3	G	G	Neighbour (173 Dunwoody Dr)	Sweep (L), Pruning wounds (L), T-bar stake very near trunk	Preserve

**Image 16.** Tree D (center of frame).
