337 Douglas Avenue Oakville, ON Arborist Consultation

Tree # 1: Red Oak

SUBJECT: Arborist Report and Tree Preservation Plan 337 Douglas Avenue, Oakville, Ontario L6J 3S7

ARBORIST REPORT AND

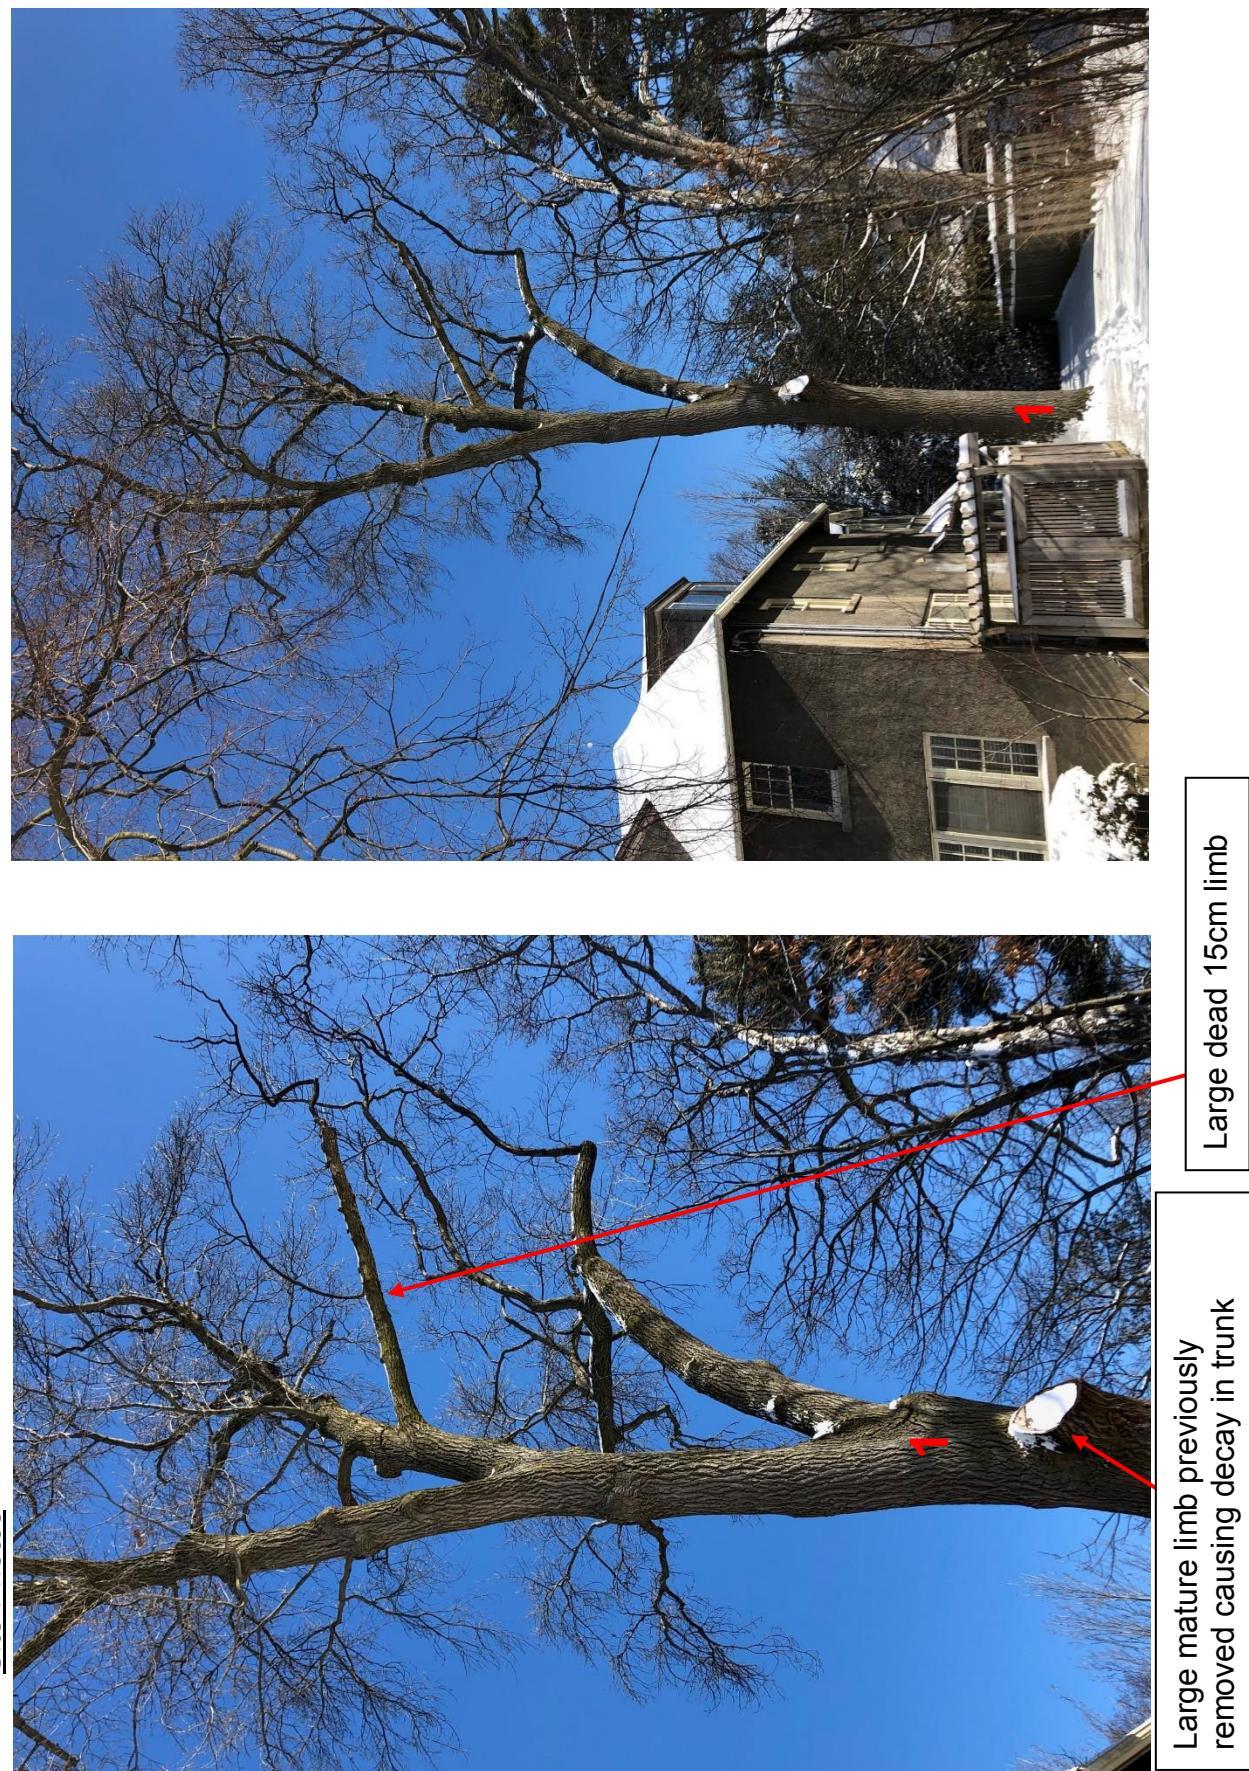
APPENDIX D

Notes		Large deadwood, Lowest	major limb previously	removed, Leaning South,	Crown decline, Trunk	decay. Tree protection	zone is 7.2 meters.	
Ownership		PRIVATE						
Preservation	Recommendation	REMOVE; Requires	removal to relocate	existing house to the	property to the north			
Structural	Condition	Fair						
Health		Fair						
Crown	Reserve (m)	29						
DBH	(cm)	112						
Species		Red Oak,	Quercus rubra					22
Tree	No	1
