TECHNICAL MEMORANDUM

Subject: Addendum to Cultural Heritage Landscape Strategy Implementation- Phase 2 Cultural Heritage Evaluation Report, 2031 North Service Road West, Oakville ON

July 21, 2020

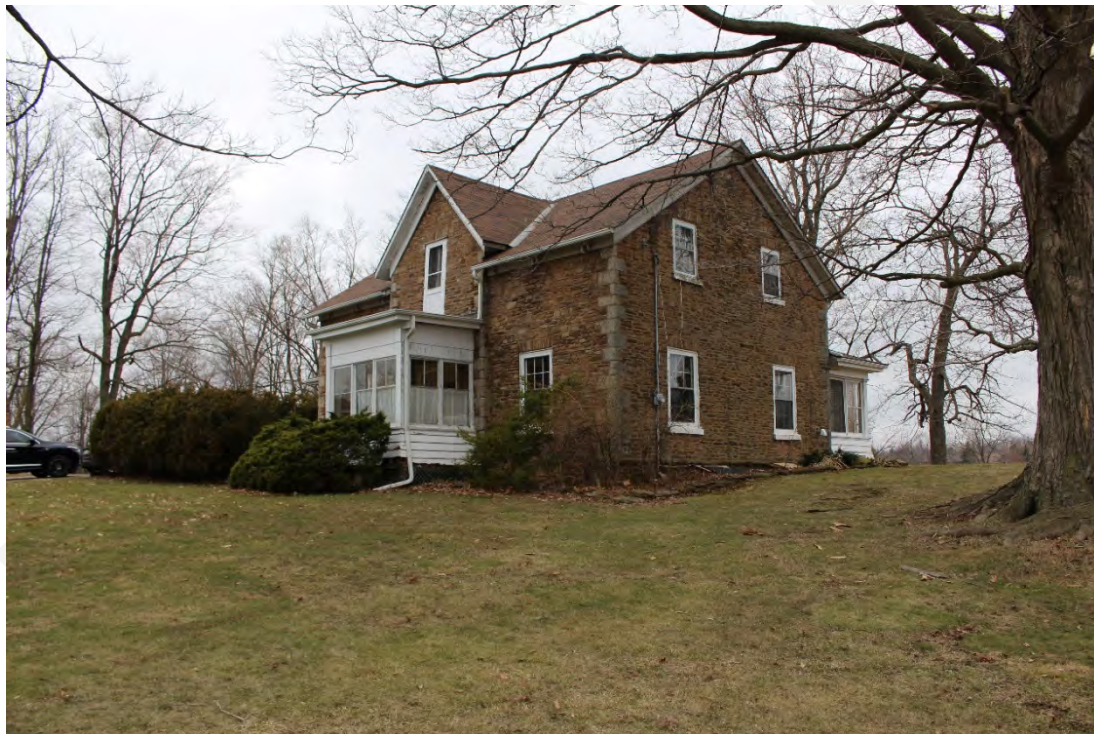
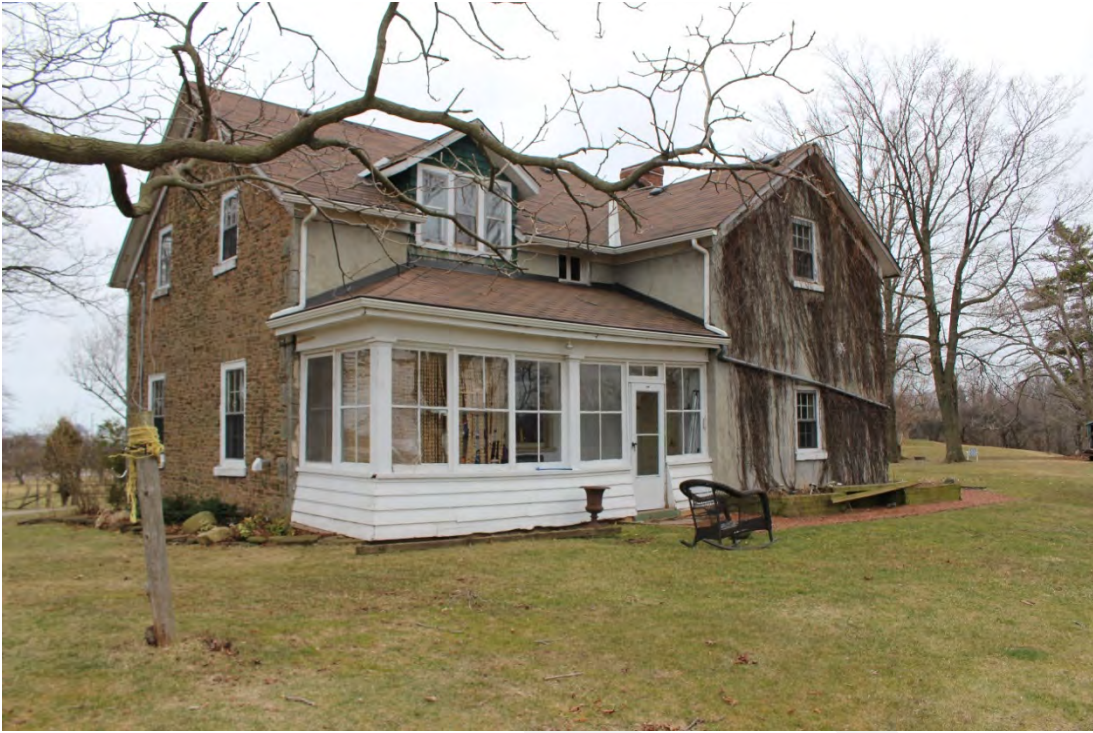
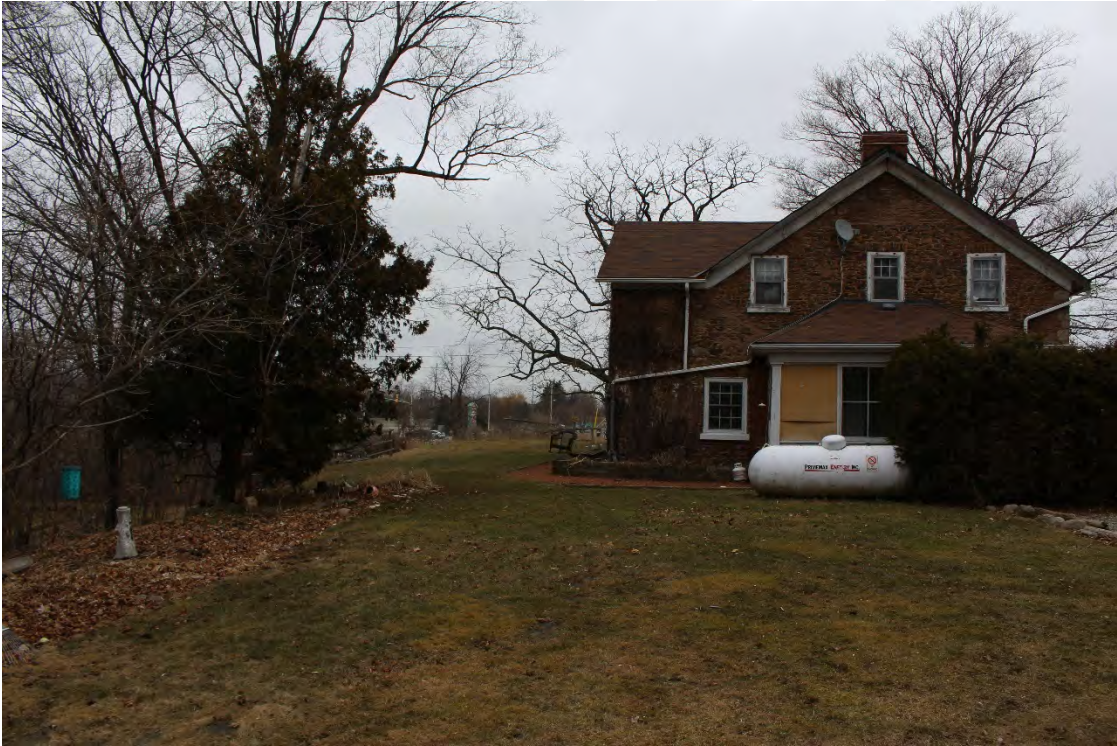
The most legible feature is the visually dominant one-and-a-half-storey stone 1858 residence, prominently located near the north-west corner of the property (see Figure 5 to Figure 7). A narrow, gravel drive leads from the North Service Road to the east side of the house, terminating in front of two 20th century sheds, observed to be in poor condition (Figure 3, Figure 4, Figure 8 and Figure 9). Including these two sheds, the property includes seven outbuildings.

Figure 5: Residence, east (front) facade (ML 2020).

Figure 6: Residence, north facade (ML 2020).

Figure 7: Residence, west facade (ML 2020).

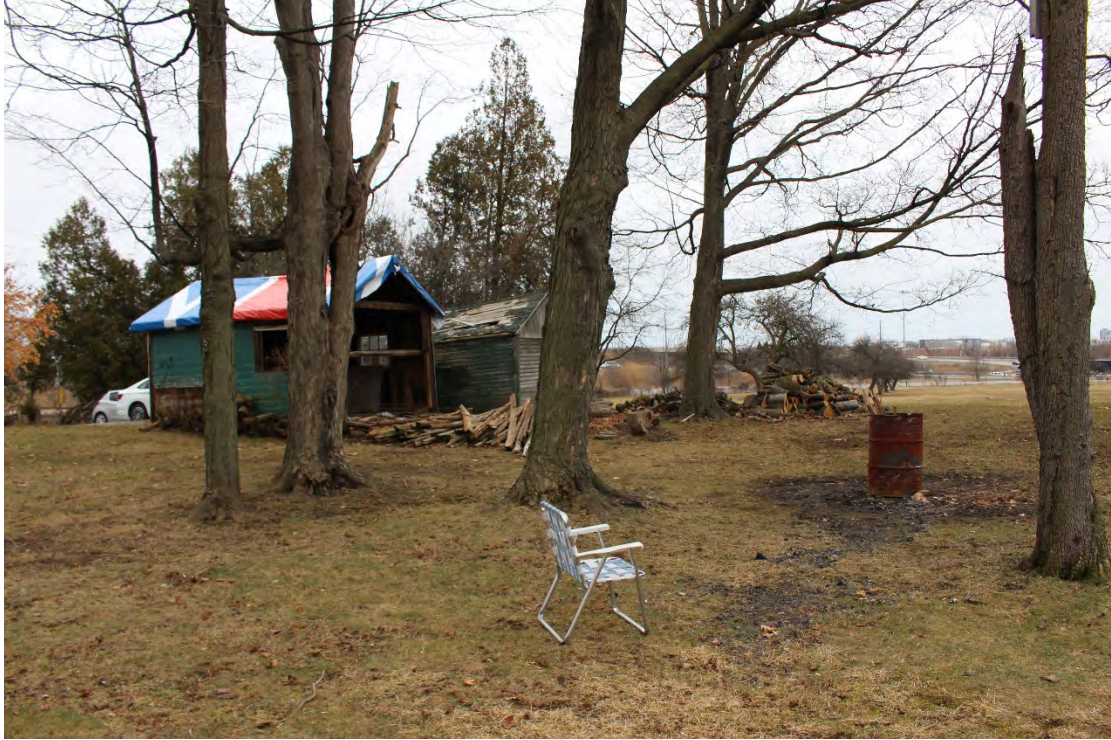
Figure 8: Sheds immediately west of the residence, at the end of the driveway (ML 2020).

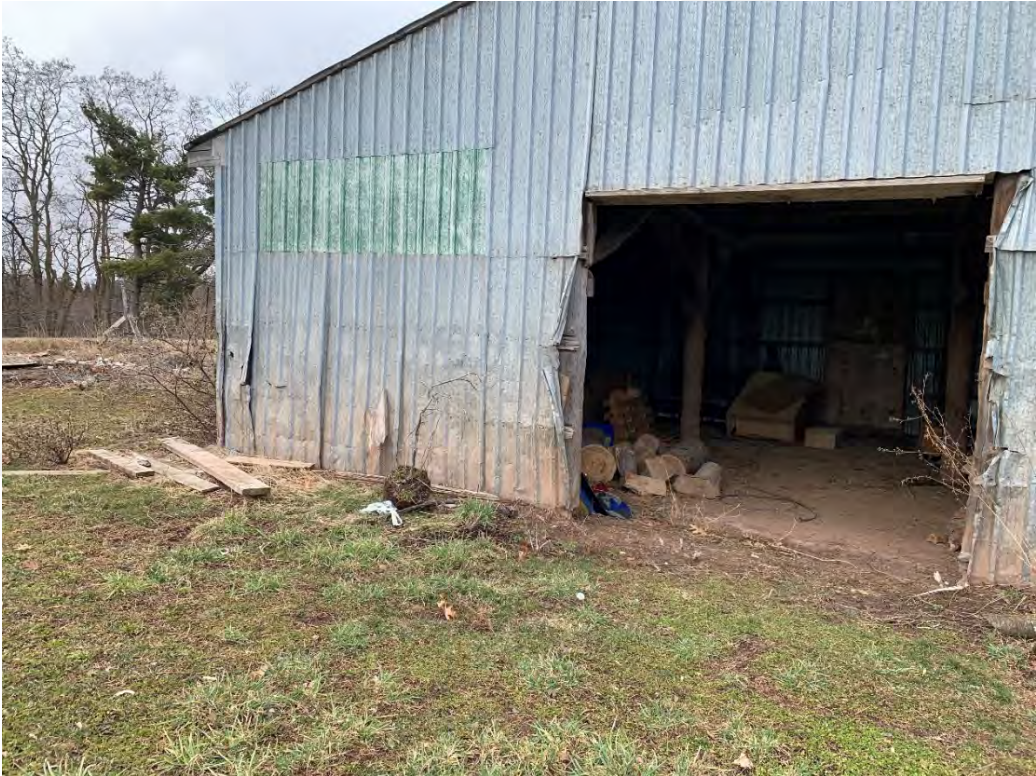
The outbuilding immediately north of the former orchard was constructed in the 1980s to support the harness racing track that existed at that time. This structure is wood frame with corrugated metal cladding (Figure 10 to Figure 12). The wide, open door is oriented towards the southeast, facing the Queen Elizabeth Way (QEW) and overlooking the former orchard; south of which the harness racing track was located in the last quarter of the 20th century (Figure 3).

Figure 11: 1980s outbuilding (CU 2020).

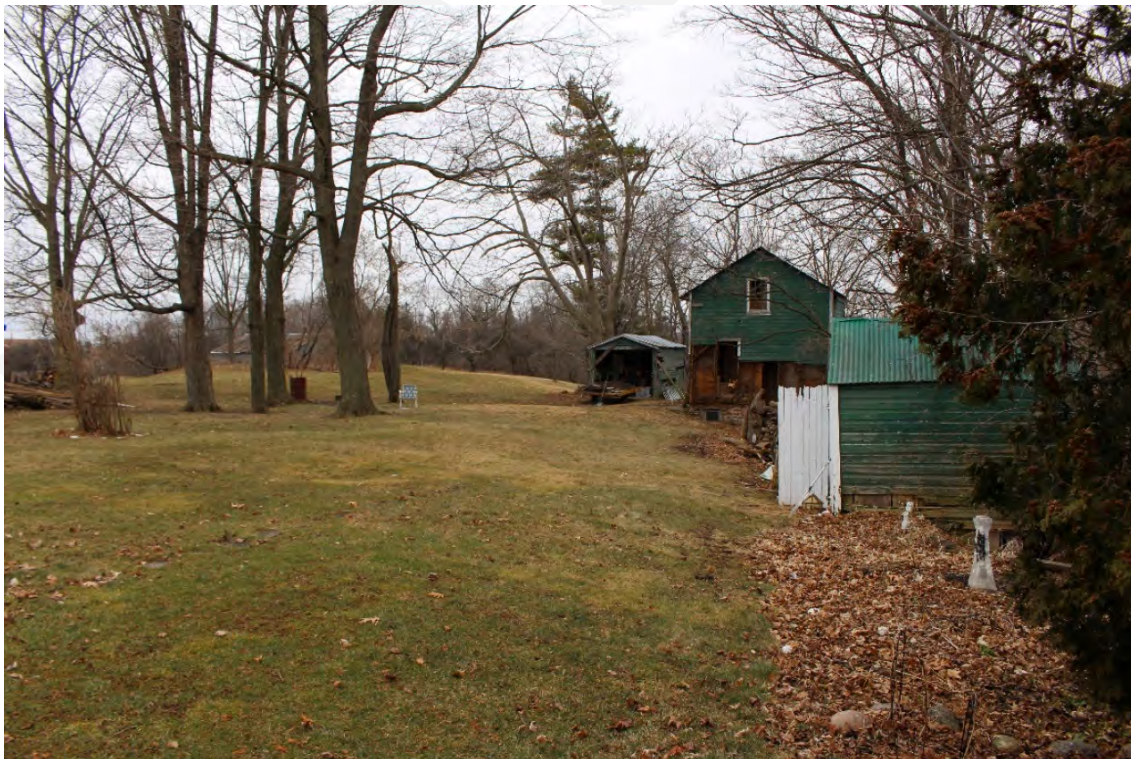
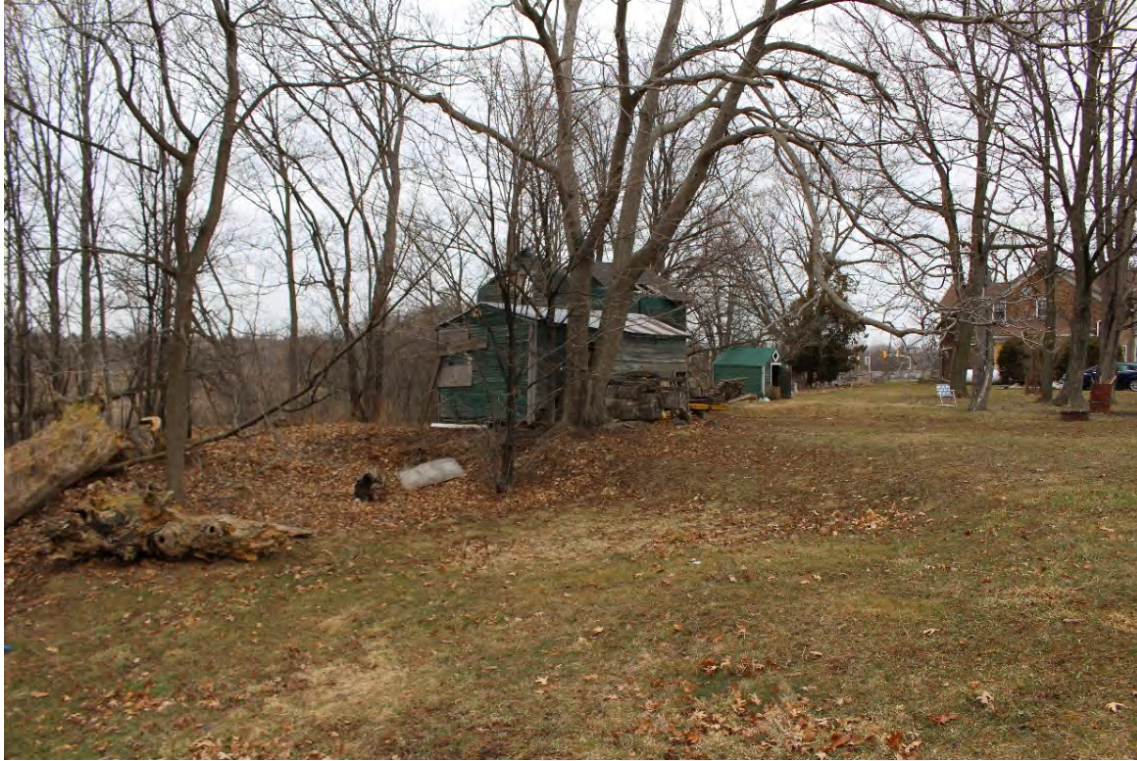
Two vernacular outbuildings (or portions thereof), west of the residence along the edge of the valley, appear to date to the mid- to late-19th century (Figure 13 and Figure 14). One of these, a shed, is a wood frame structure with wood cladding and a simple gable roof. Evidence of numerous foundation interventions/iterations are visible and the structure rests on a foundation that includes concrete with a stone wall along the east and north (Figure 15 to Figure 17). Although portions of the foundations appear to date to the mid- to late-19th century, the concrete portions of the foundation and superstructure are not representative of a specific type, style, method of construction, or materials.

A fourth shed is located south of this barn. It is a rectangular structure with a gable roof and it was observed to be in poor condition. The structure likely dates to the mid- to late-20th century and it is not representative of a particular type, style, method of construction, or use of materials. (see Figure 13, Figure 14, Figure 18, and Figure 19)

Figure 13: View of several outbuildings, looking west from residence (ML 2020).

Figure 14: View of outbuildings along top of valley looking east towards North Service Line and Third Line (ML 2020).

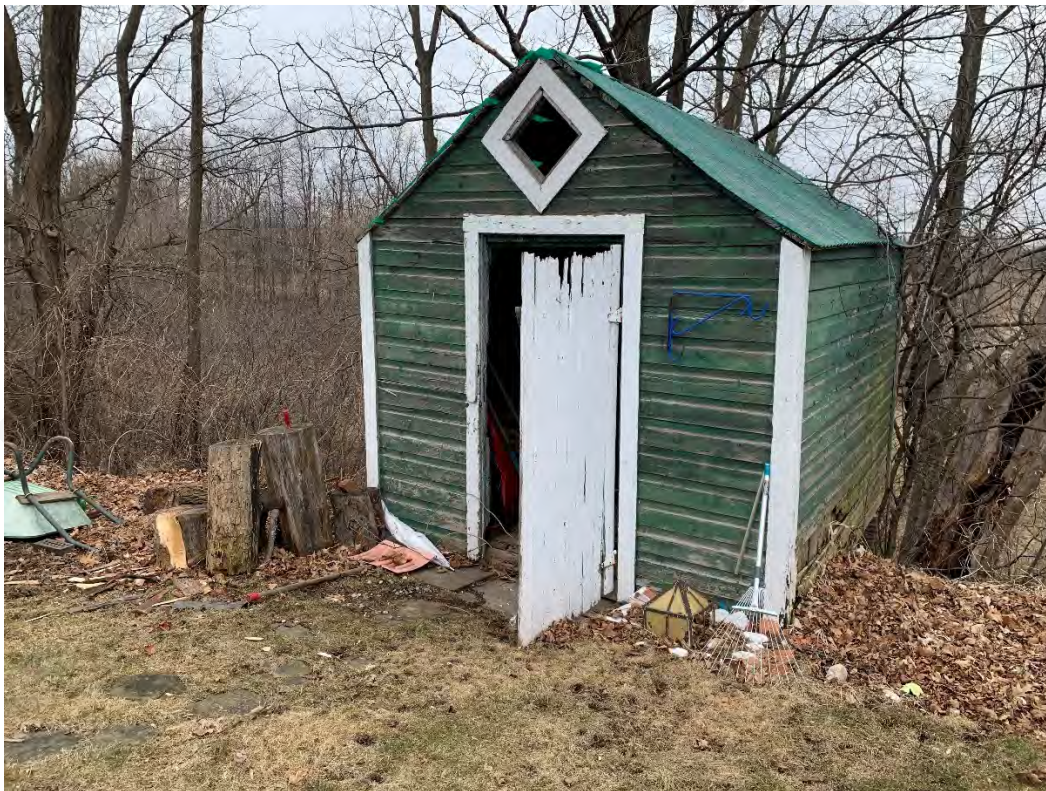
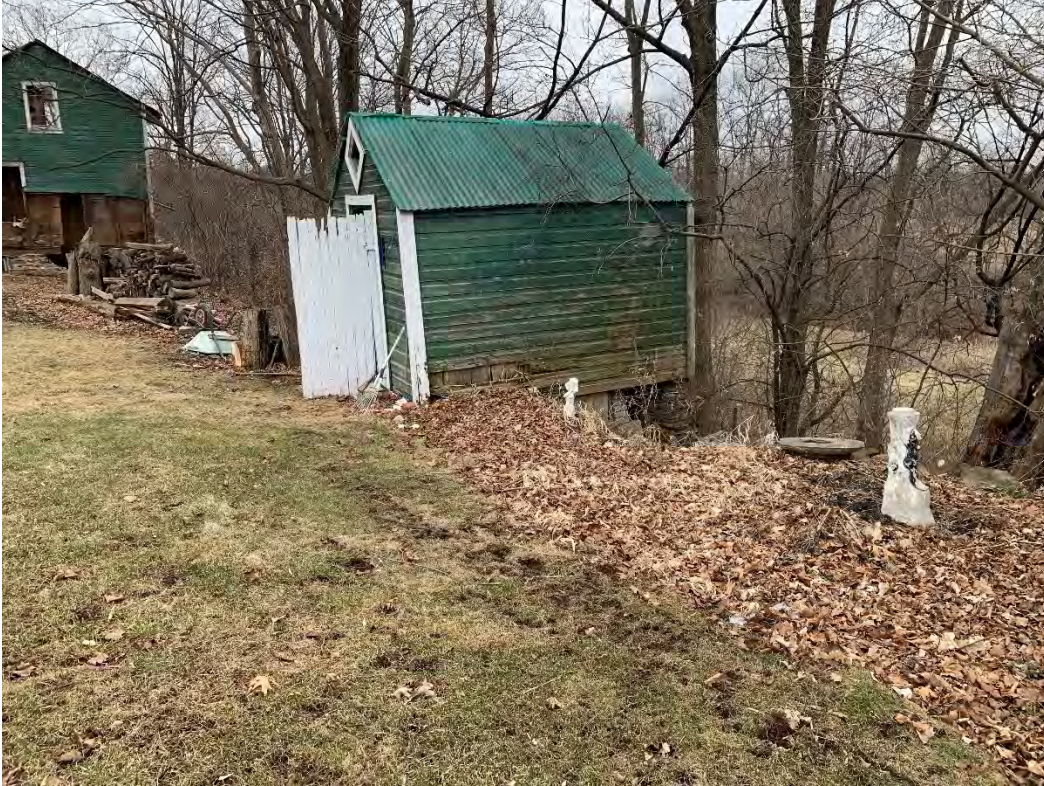
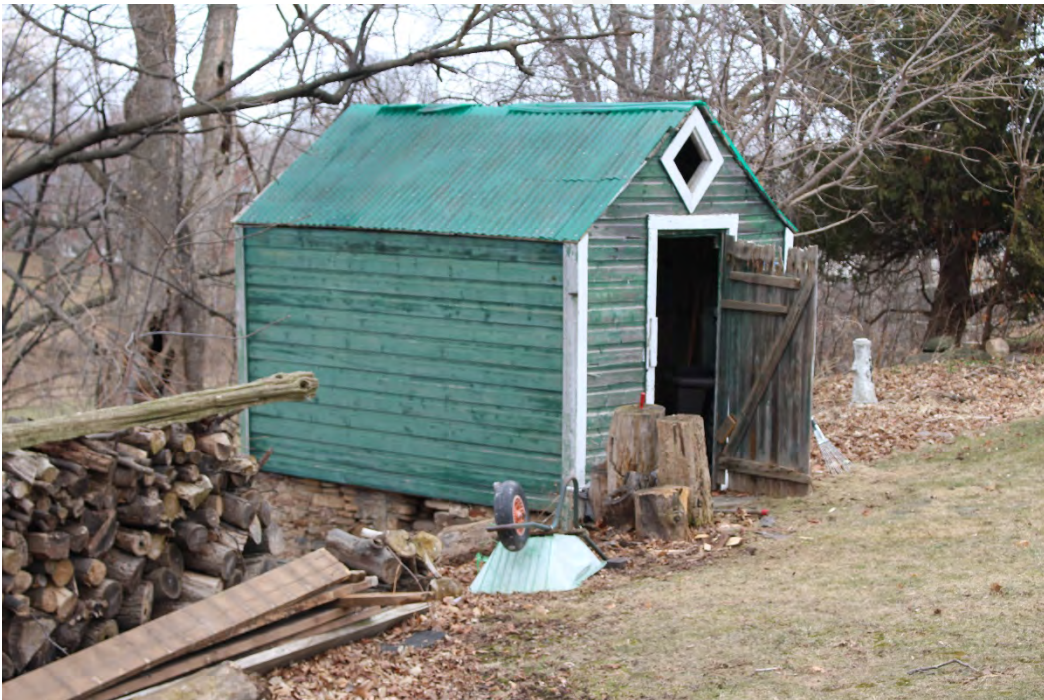
Figure 15: View of shed along valley (CU 2020).

Figure 16: View of shed along valley, looking west (CU 2020).

Figure 17: View of shed along valley, looking northeast (CU 2020).

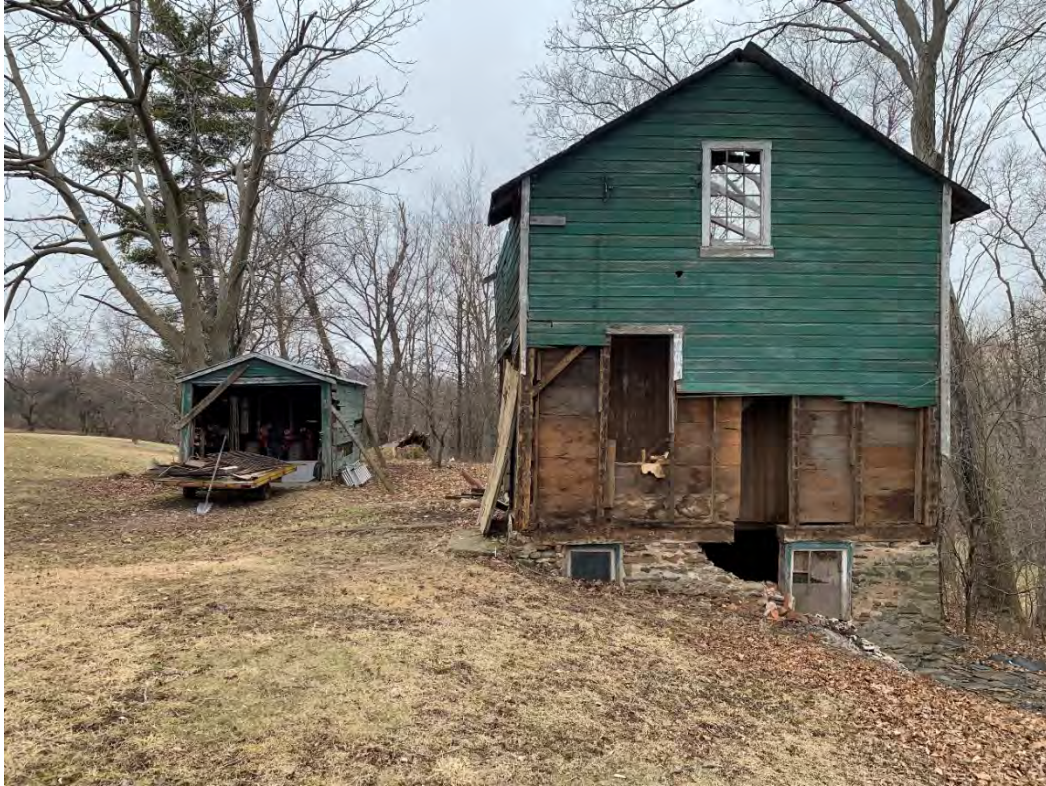
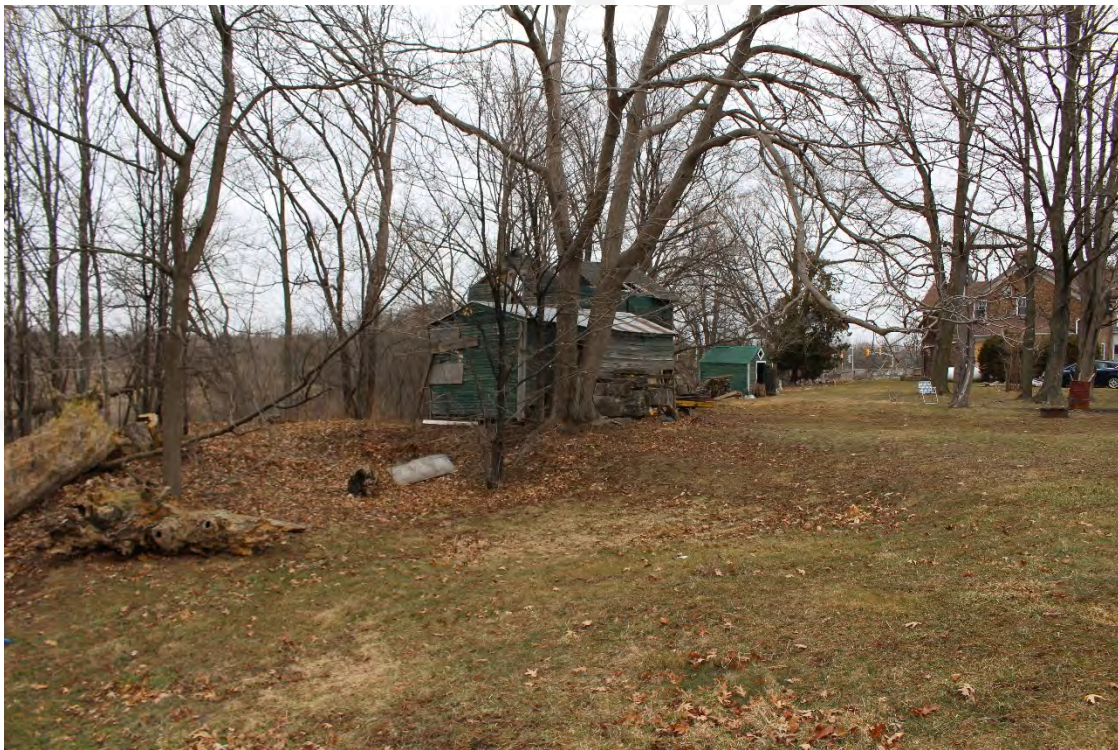
Figure 18: View of outbuildings along top of valley looking east towards North Service Line and Third Line (ML 2020).

Figure 19: View of outbuildings along valley looking east towards Third Line (CU 2020).

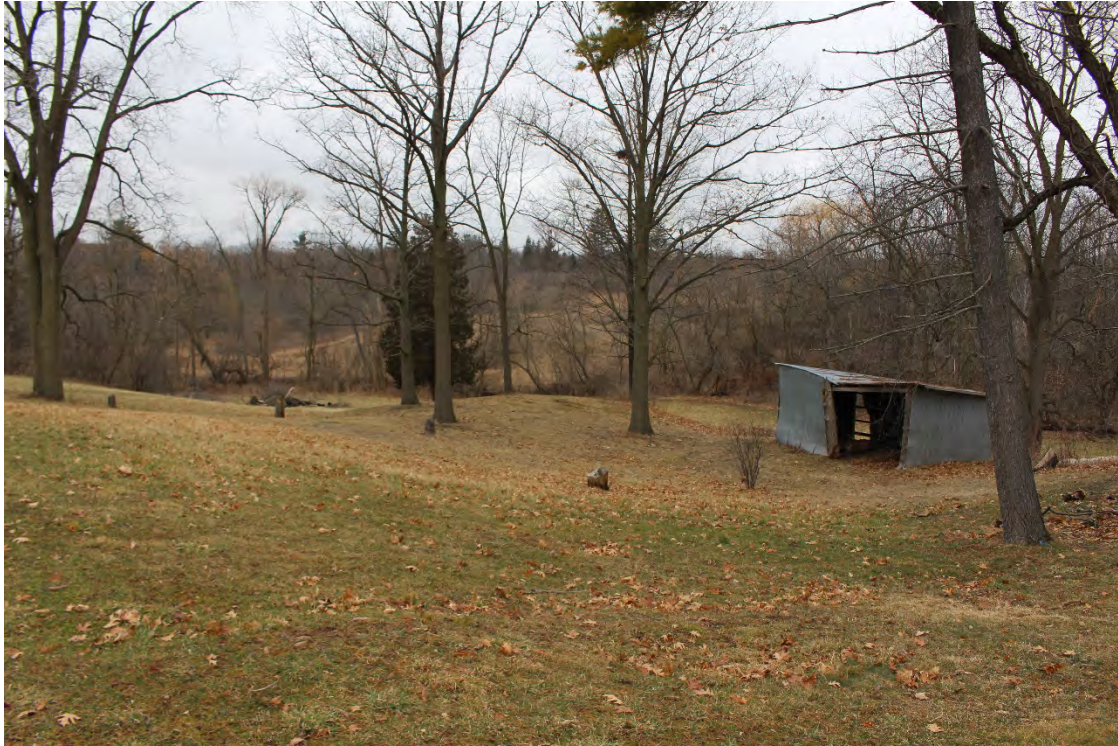
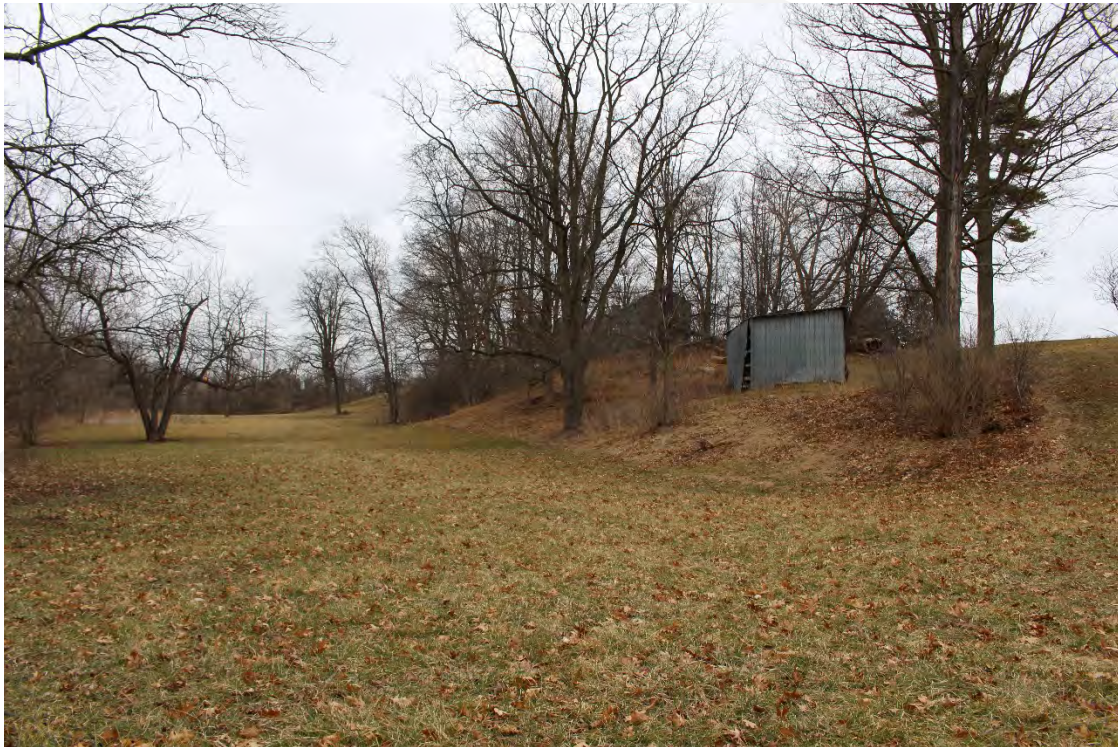
An expedient woodshed with wood frame and corrugated metal siding and a saltbox roof is located north of the outbuildings along the slope (Figure 20 and Figure 21). This structure was observed to be in poor condition and it is physically, visually, and functionally removed from the rest of the property.

Figure 20: View of woodshed looking north from top of valley (ML 2020).

Figure 21: View of woodshed looking east from base of valley (ML 2020).

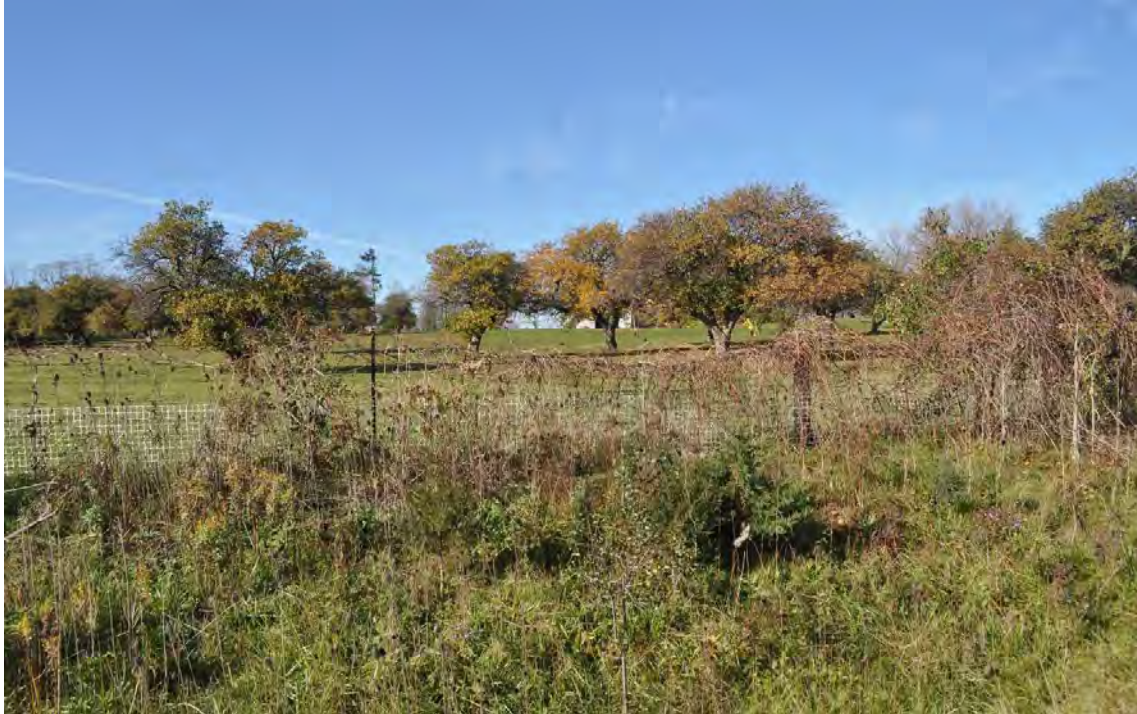
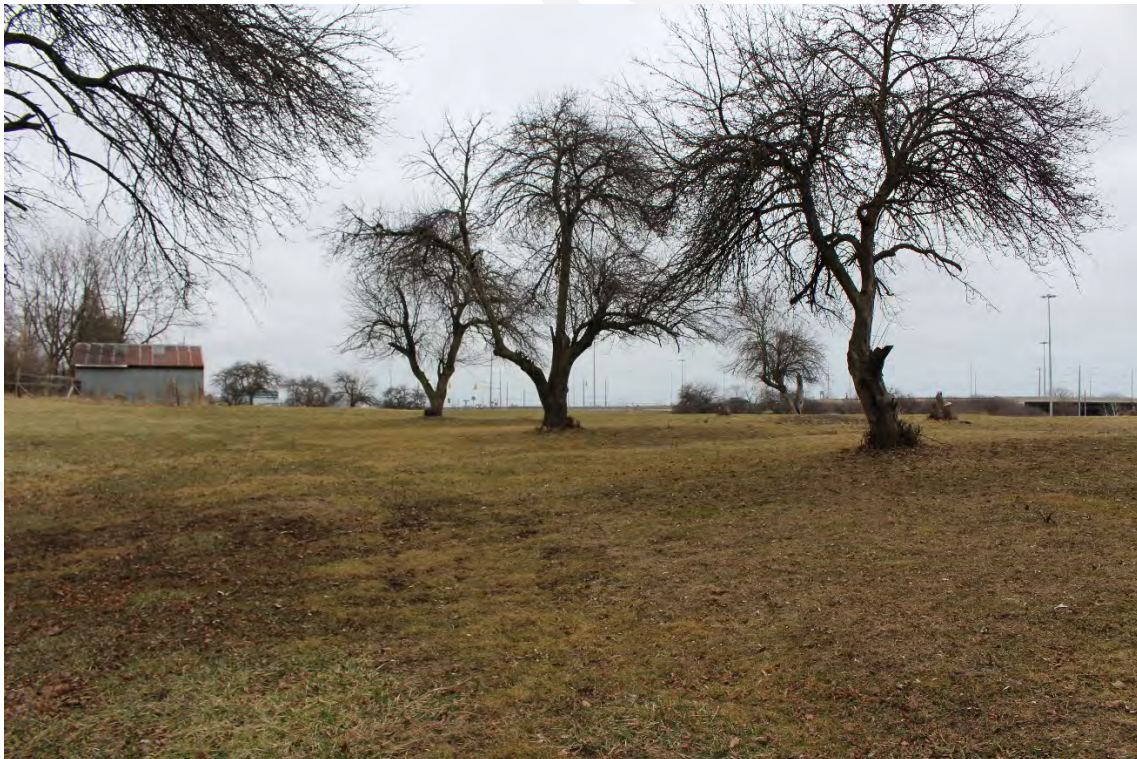
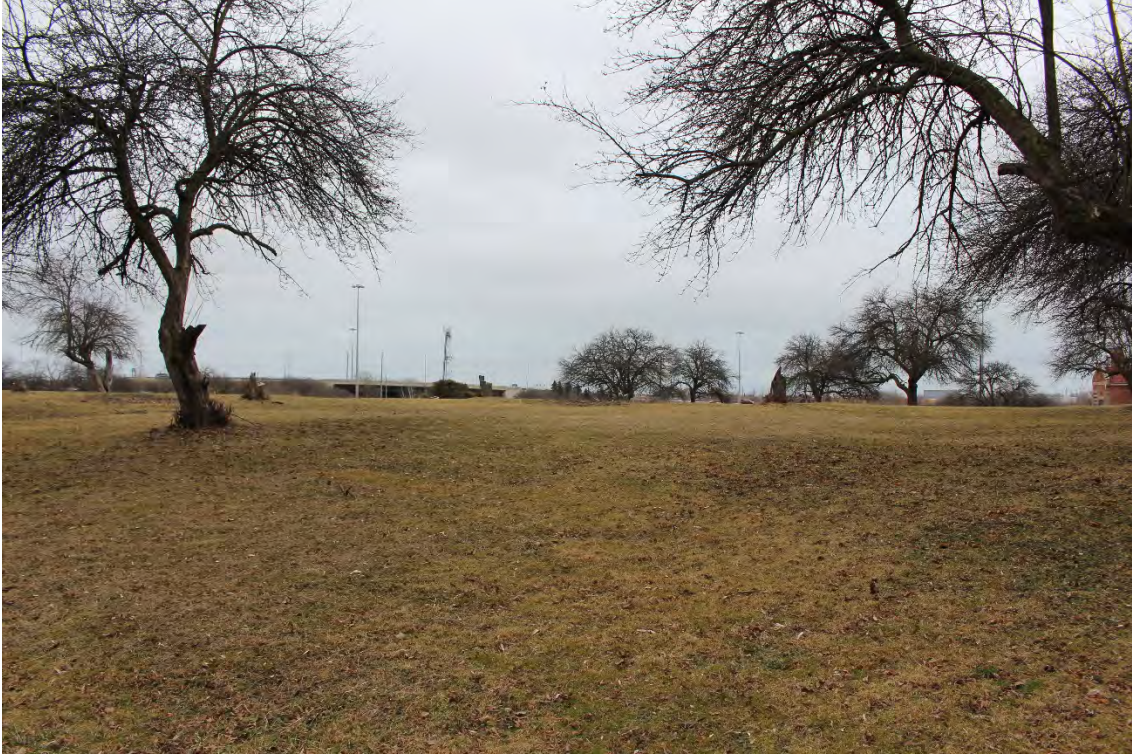
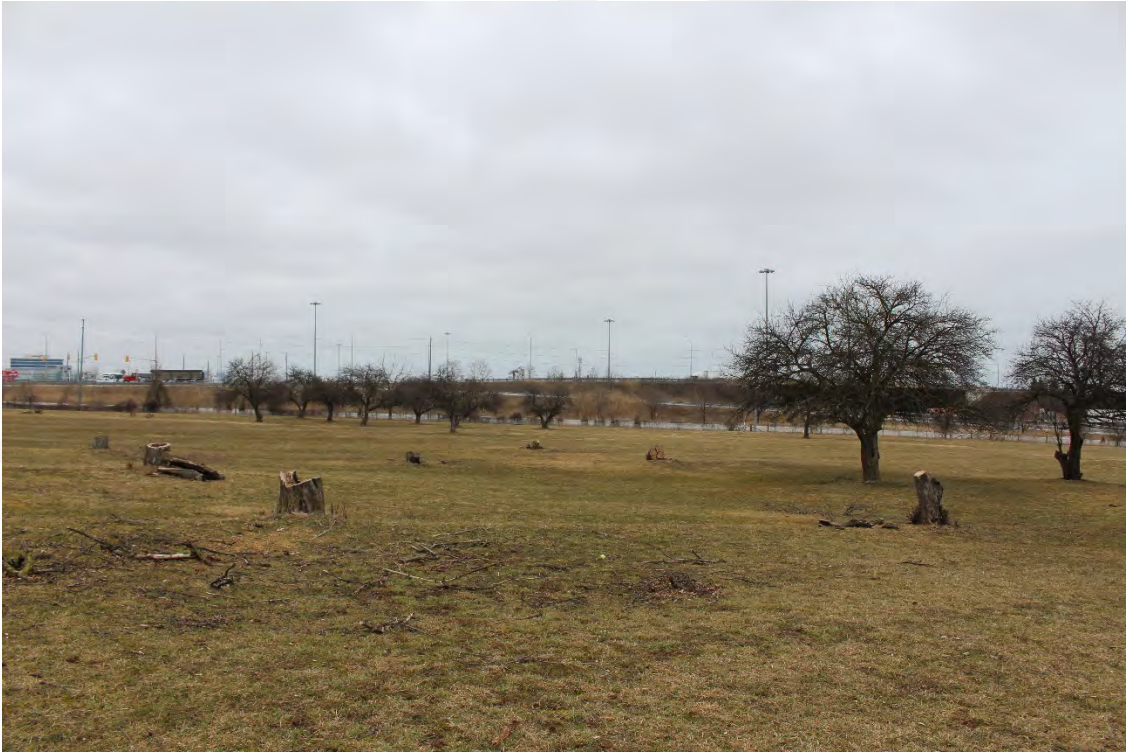
From the house, the horse barn, and driveway, the property slopes gently to the south toward the orchard. The remnant orchard comprises an approximately 4-acre portion of the property. During the 2020 site visit 28 apple trees were observed within the orchard area. As a result of the site visit, many of them determined to be in poor condition. The spatial relationship of the trees as an orchard has been greatly lost due to the large gaps within the grid (see Figure 24 through Figure 27). The decline of the orchard can be traced over time, through historical aerial photos. Aerial photos from 1954 and 1960 show an intact orchard with trees on a nine by nine grid. Over time, trees that were removed were not been replaced. Air photos from 1995, 2006, and 2015 show the steady loss of trees within the orchard. Additional trees have been removed since the 2016 site review. During the site visit, the former orchard viewed from a variety of vantage points and the orchard grid is no longer discernable.

Figure 24: Remnant rows of orchard trees as viewed from the public ROW in 2016 (CU 2016).

Figure 25: Remnant orchard trees and horse barn, looking east from rear of property (ML 2020).

Figure 26: View looking south across former orchard (ML 2020).

Figure 27: View looking southeast across former orchard (ML 2020).
