Inspec Homes
71 Richmond park Dr
Keswick, Ontario L4P 0A4

Inspection Report

4022 Fourth Line
Oakville , ONT L6M 4L4

Defective Summary

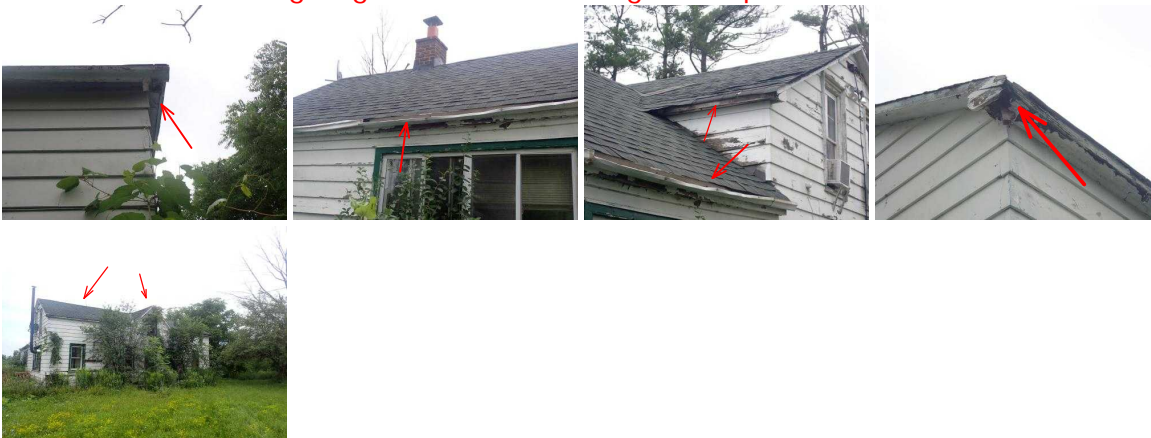
1. **Roof** Roof has damaged shingles with leaking and mold to the interior causing possible health issues. Also, damaged gutters and missing downspouts contribute to foundation problems.

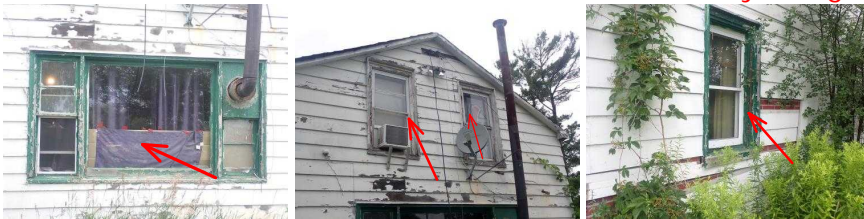
2. **Windows Wood** - Damaged leaking rotted windows, causing water intrusion and mold in the walls. This could be a health hazard for the family living inside.

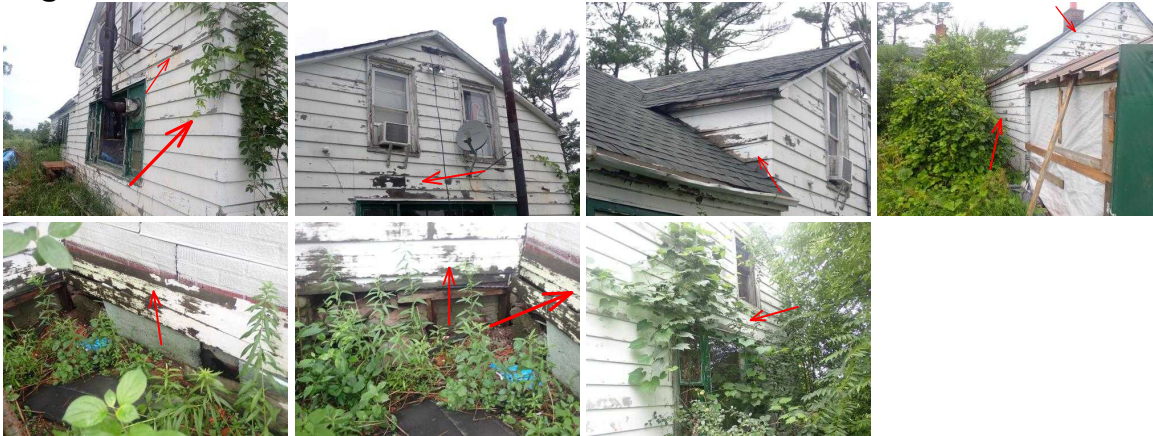
Siding (continued)

3. **Siding** Siding - Siding is falling apart allowing water to penetrate the in behind structure. This has caused the structure to rot and shift over the years, which has compromised the overall stability of the home. This results in an unsafe place to live.

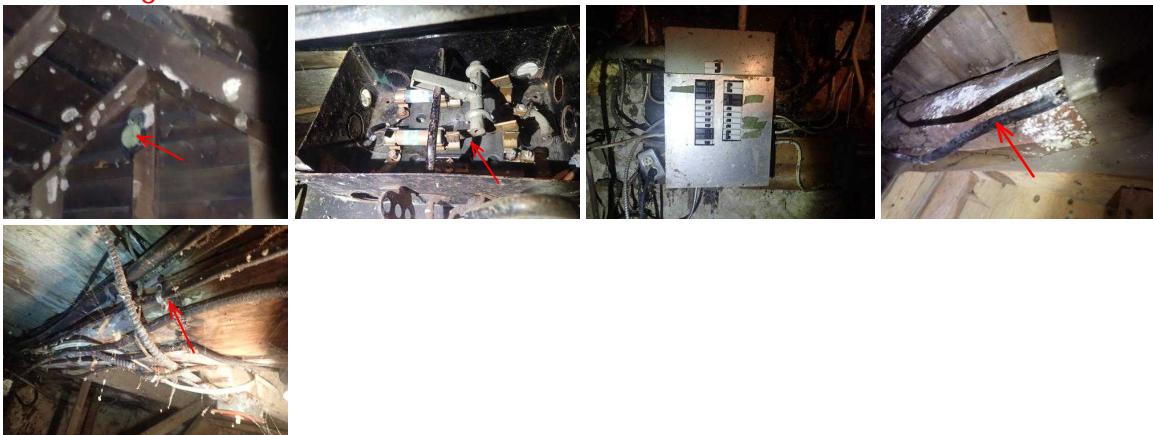
5. Electrical **Old panel is only a 60 Amp which is not enough for this dwelling. More importantly, the wiring in the home is knob and tube which is a severe fire hazard. Ensure safety.**

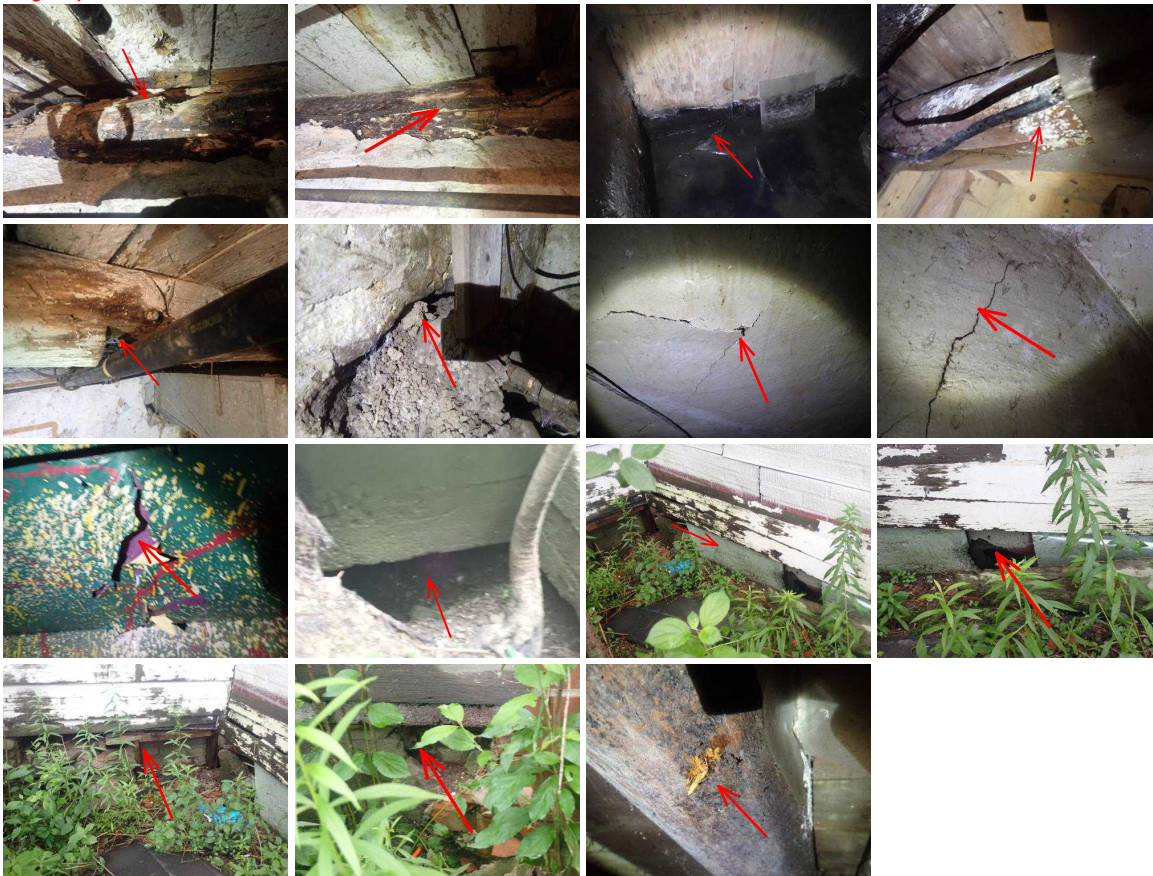
6. Structure Structure is compromised, with rotting of main wood joists, poorly supported beams, foundation wall crumbling from exterior to interior allowing water and animals into the inside. In my opinion, the house needs to be demolished before it falls down.

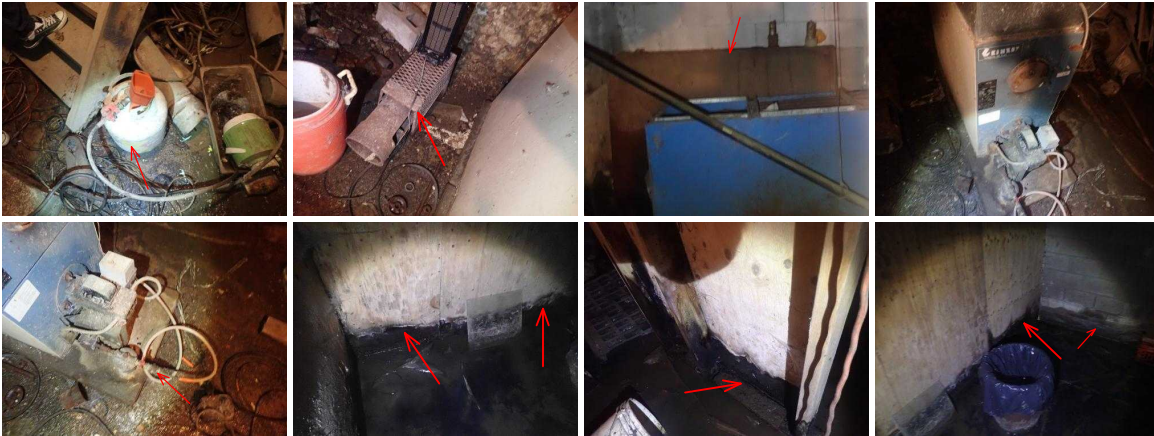
Basement (continued)

7. Basement Major water intrusion causing mold throughout the basement. Old oil tank noted and a propane cylinder with heater.

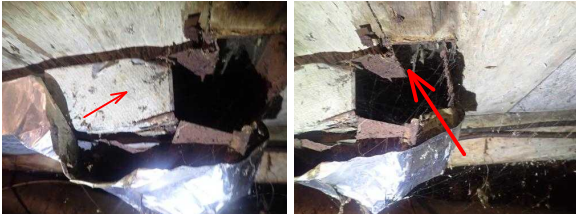
8. Asbestos Asbestos noted around venting, resulting in likely health hazards.

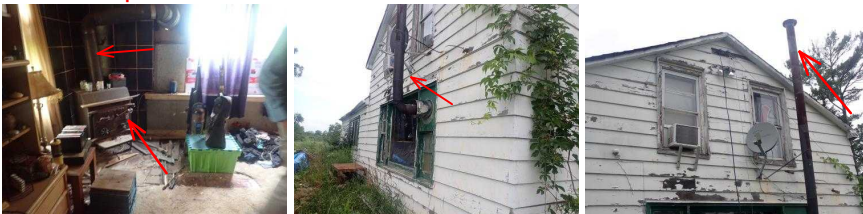
Living Space

9. Fireplace Fireplace was installed by the tenants. Unit is too close to the walls and has an improper hearth. The flue is not rated for today's standards as it is only single and not double. Also, all parts of the unit are too close to combustibles. This is a severe fire hazard.

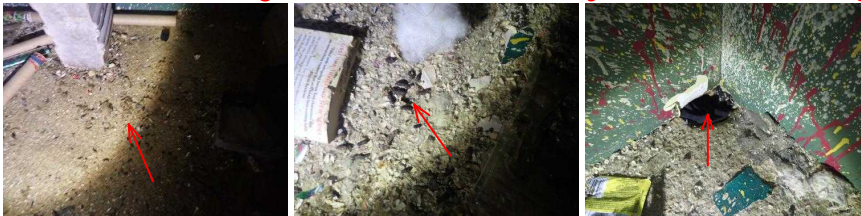
10. Bedroom An infestation of vermin and their waste was noted throughout the house in the bedrooms and living areas. This can likely lead to breathing issues and sickness.

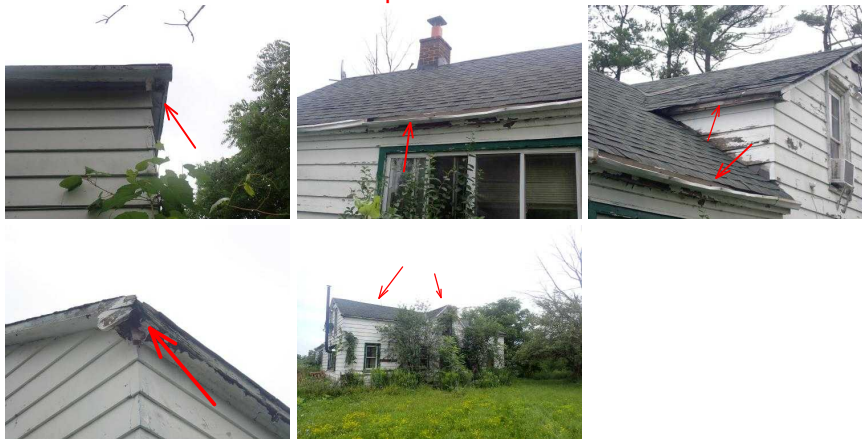
1. Defective

Roof Roof has damaged shingles with leaking and mold to the interior causing possible health issues. Also, damaged gutters and missing downspouts contribute to foundation problems.

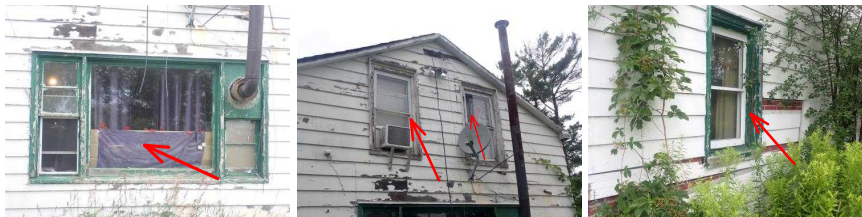
2. Defective

Windows Wood - Damaged leaking rotted windows, causing water intrusion and mold in the walls. This could be a health hazard for the family living inside.

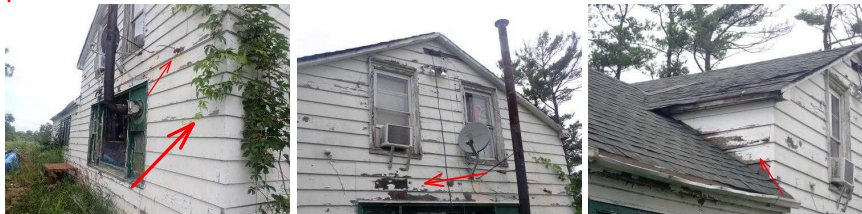
3. Defective

Siding Siding - Siding is falling apart allowing water to penetrate the in behind structure. This has caused the structure to rot and shift over the years, which has compromised the overall stability of the home. This results in an unsafe place to live.

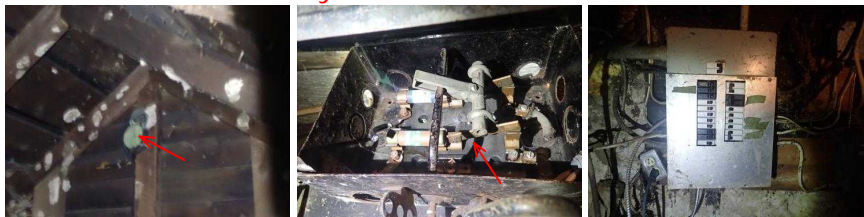
1. Defective

Electrical **Old panel is only a 60 Amp which is not enough for this dwelling. More importantly, the wiring in the home is knob and tube which is a severe fire hazard. Ensure safety.**

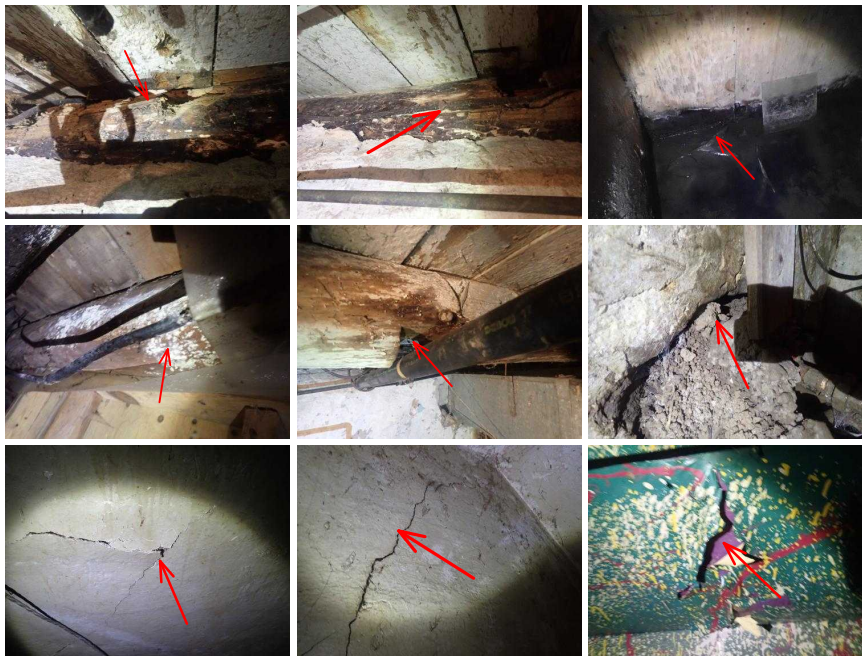
1. Defective

Structure Structure is compromised, with rotting of main wood joists, poorly supported beams, foundation wall crumbling from exterior to interior allowing water and animals into the inside. In my opinion, the house needs to be demolished before it falls down.

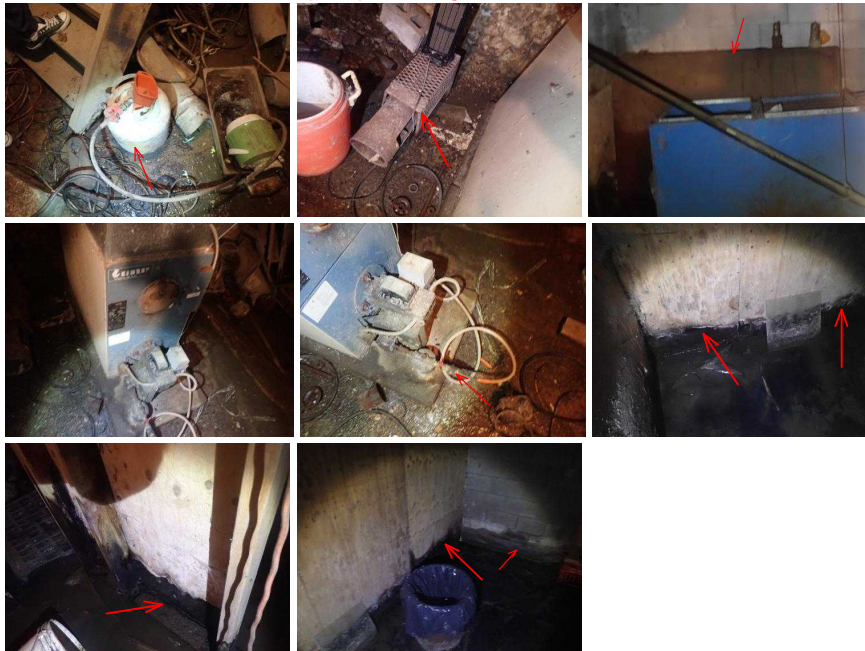
1. Defective

Basement Major water intrusion causing mold throughout the basement. Old oil tank noted and a propane cylinder with heater.

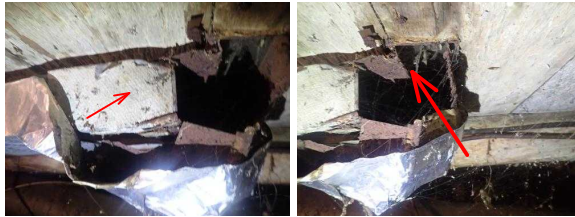
2. Defective

Asbestos Asbestos noted around venting, resulting in likely health hazards.

It is possible that asbestos and lead paint may have been used in this time period, recommend testing materials before any major renovations are anticipated.

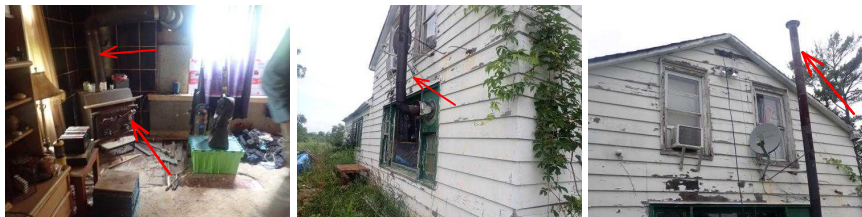
1. Defective

Fireplace Fireplace was installed by the tenants. Unit is too close to the walls and has an improper hearth. The flue is not rated for today's standards as it is only single and not double. Also, all parts of the unit are too close to combustibles. This is a severe fire hazard.

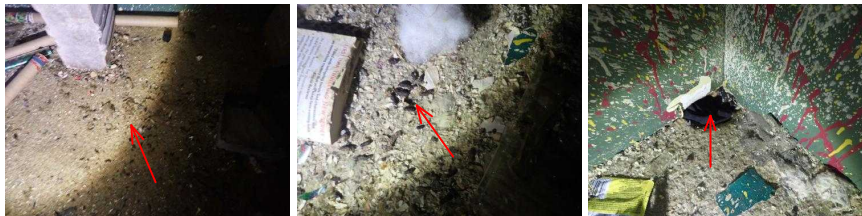
1. Defective

Bedroom An infestation of vermin and their waste was noted throughout the house in the bedrooms and living areas. This can likely lead to breathing issues and sickness.
