### **APPLICATION FOR MINOR VARIANCE**

**1230 Donlea Crescent, Oakvill, ON, L6J 1V7**

# ARBORIST REPORT AND TREE PROTECTION PLAN

1230 Donlea Crescent  
Oakville, ON

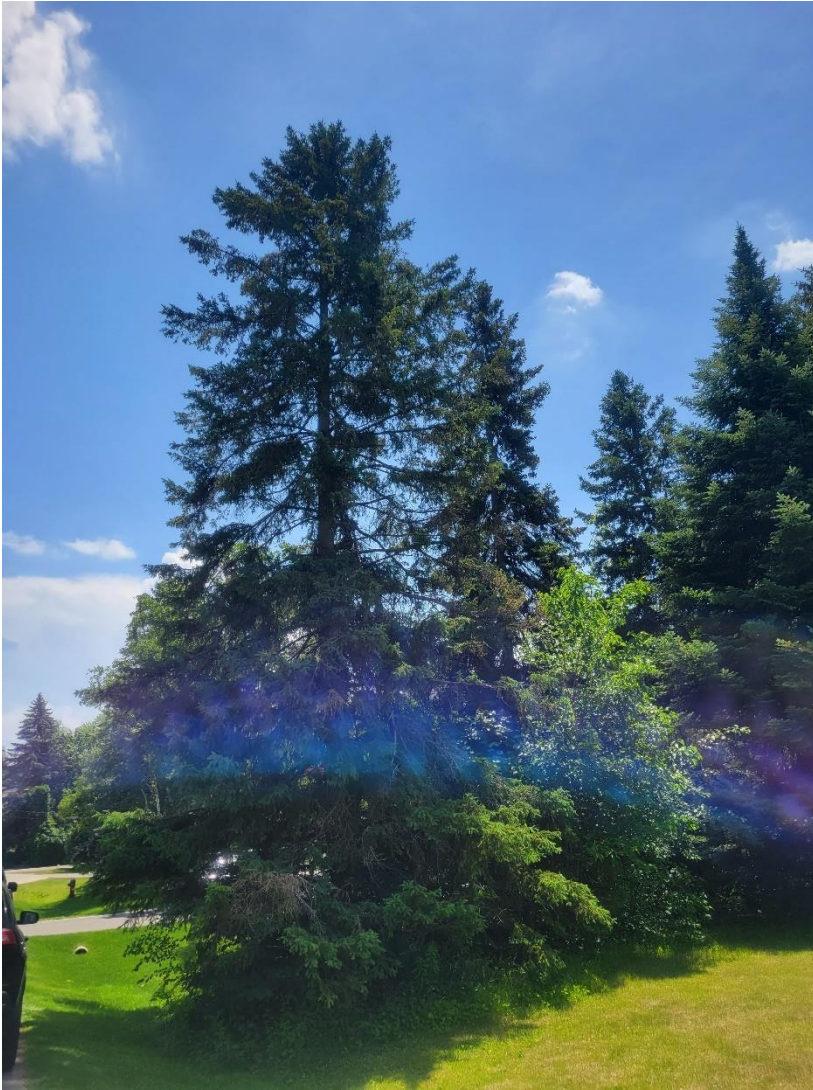
| Tree # | Common Name | Scientific Name | Diameter at Breast Height (DBH) | Trunk Integrity | Crown Structure | Crown Vigour | Crown Dieback | Tree Height | Dripline (radius) | Minimum Tree Protection Zone (mTPZ) (radius) | Actual TPZ (radius) | Comments | Action | Ownership |
|---|---|---|---|---|---|---|---|---|---|---|---|---|---|---|
| 1 | White Spruce | <i>Picea glauca</i> | 45 | FG | FG | F | 5 | 18 | 4.5 | 3 | 3m+ | Town Tree ID: 69731, minor chlorosis, minor broken branches, hanger | Preserve | Town |

**Photo 1. Tree 1 (centre, foreground), view looking south**

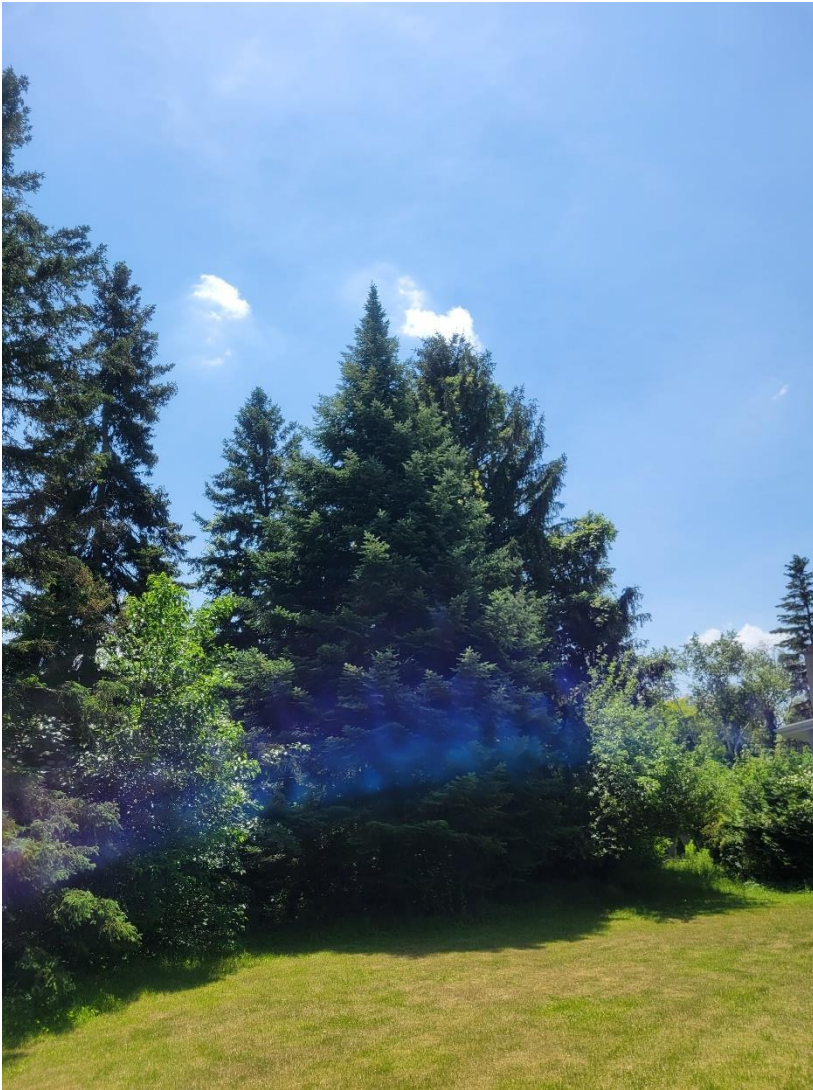
| Tree # | Common Name | Scientific Name | Diameter at Breast Height (DBH) | Trunk Integrity | Crown Structure | Crown Vigour | Crown Dieback | Tree Height | Dripline (radius) | Minimum Tree Protection Zone (mTPZ) (radius) | Actual TPZ (radius) | Comments | Action | Ownership |
|---|---|---|---|---|---|---|---|---|---|---|---|---|---|---|
| 3 | Balsam Fir | <i>Abies balsamea</i> | 36 | G | G | G | | 16 | 3 | 3 | - | | Remove | Private |

**Photo 3. Tree 3 (centre), view looking south**

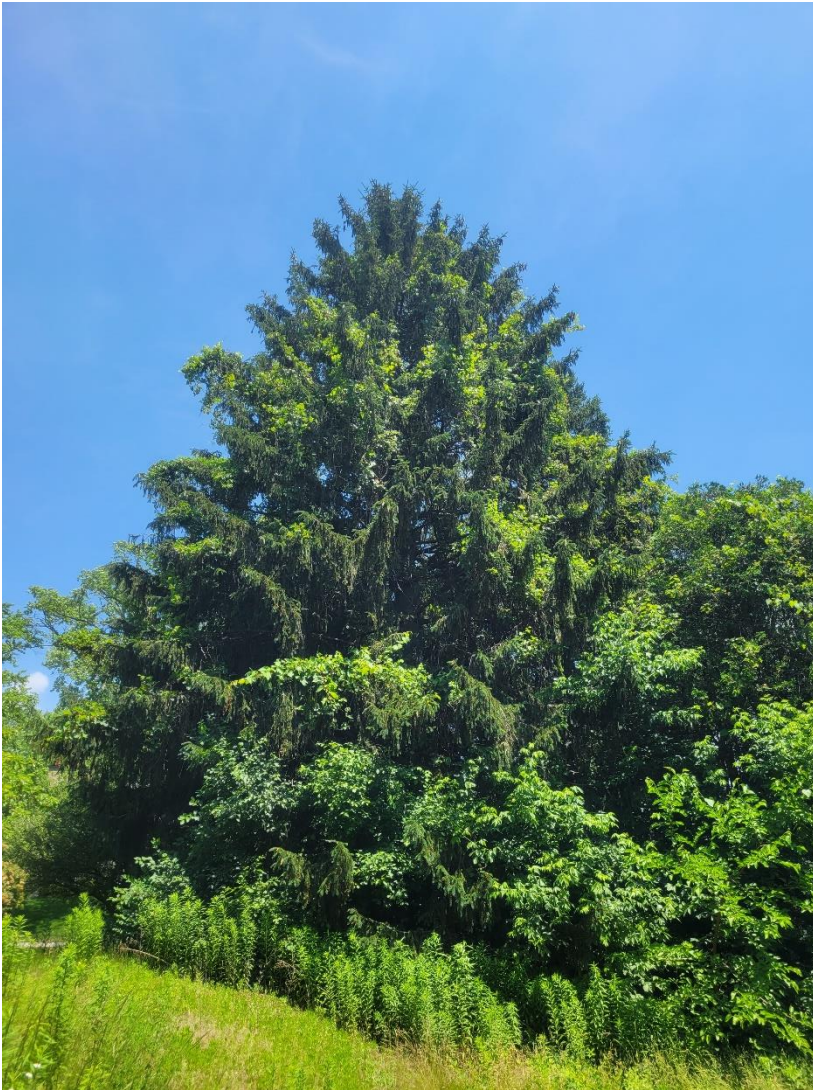
| Tree # | Common Name | Scientific Name | Diameter at Breast Height (DBH) | Trunk Integrity | Crown Structure | Crown Vigour | Crown Dieback | Tree Height | Dripline (radius) | Minimum Tree Protection Zone (mTPZ) (radius) | Actual TPZ (radius) | Comments | Action | Ownership |
|---|---|---|---|---|---|---|---|---|---|---|---|---|---|---|
| 5 | Norway Spruce | <i>Picea abies</i> | 45 | FG | FG | FG | | 18 | 6 | 3 | - | Moderate vine competition | Remove | Private |

**Photo 5. Tree 5, view looking northeast**

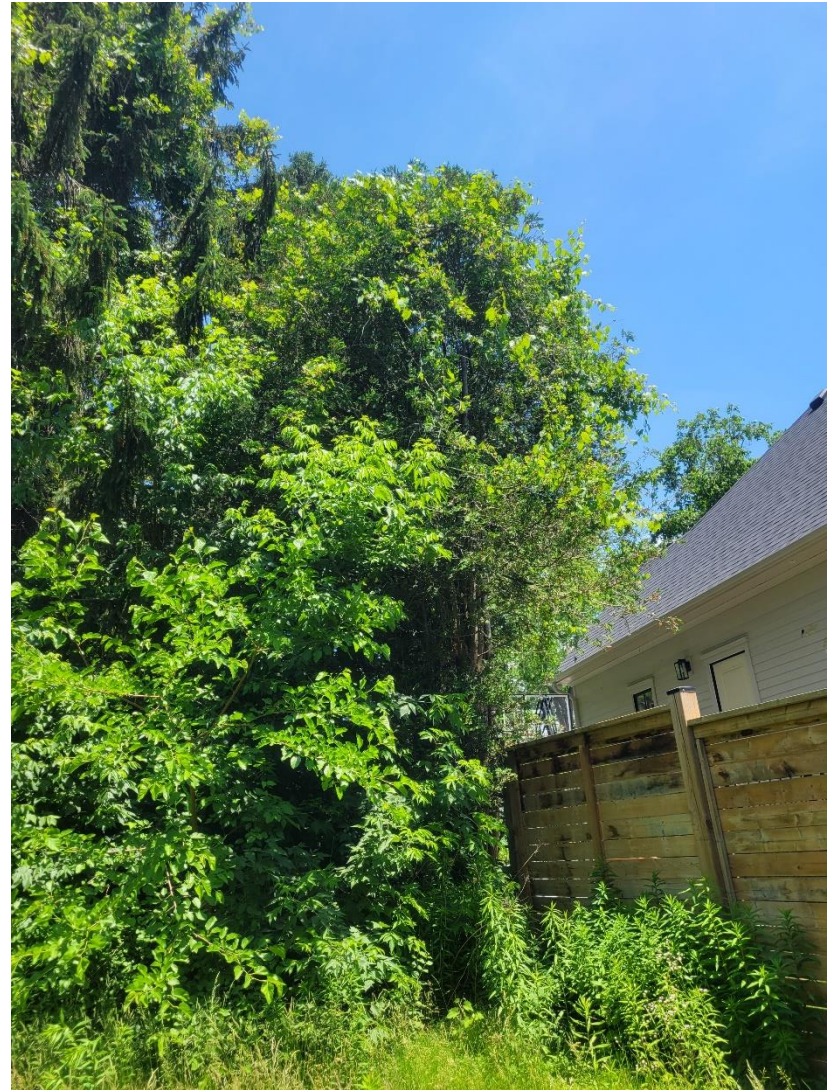
| Tree # | Common Name | Scientific Name | Diameter at Breast Height (DBH) | Trunk Integrity | Crown Structure | Crown Vigour | Crown Dieback | Tree Height | Dripline (radius) | Minimum Tree Protection Zone (mTPZ) (radius) | Actual TPZ (radius) | Comments | Action | Ownership |
|---|---|---|---|---|---|---|---|---|---|---|---|---|---|---|
| P6 | Eastern White Cedar | <i>Thuja occidentalis</i> | 10-22 | F | F | F | | 7 | 1 | 2.4 | 2.4m+ | 5 trees, multi-stem at 1m, raised crown, minor vine competition | Preserve | Neighbouring |

**Photo 6. Tree polygon P6, view looking northeast**

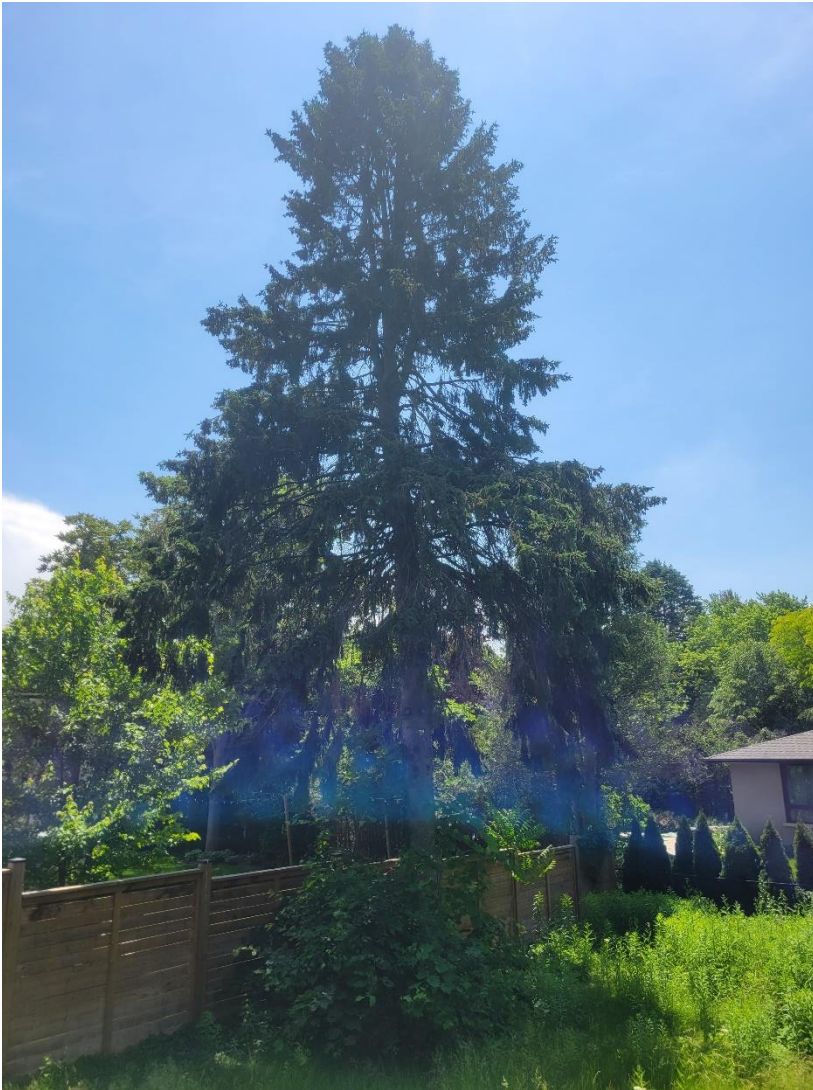
| Tree # | Common Name | Scientific Name | Diameter at Breast Height (DBH) | Trunk Integrity | Crown Structure | Crown Vigour | Crown Dieback | Tree Height | Dripline (radius) | Minimum Tree Protection Zone (mTPZ) (radius) | Actual TPZ (radius) | Comments | Action | Ownership |
|---|---|---|---|---|---|---|---|---|---|---|---|---|---|---|
| 7 | White Spruce | <i>Picea glauca</i> | 53 | FG | F | FG | | 18 | 5 | 3.6 | Dripline+ | Minor pruning wounds due to raised crown, multi-stem at 10m, minor broken branches | Preserve | Private |

**Photo 7. Tree 7, view looking south**

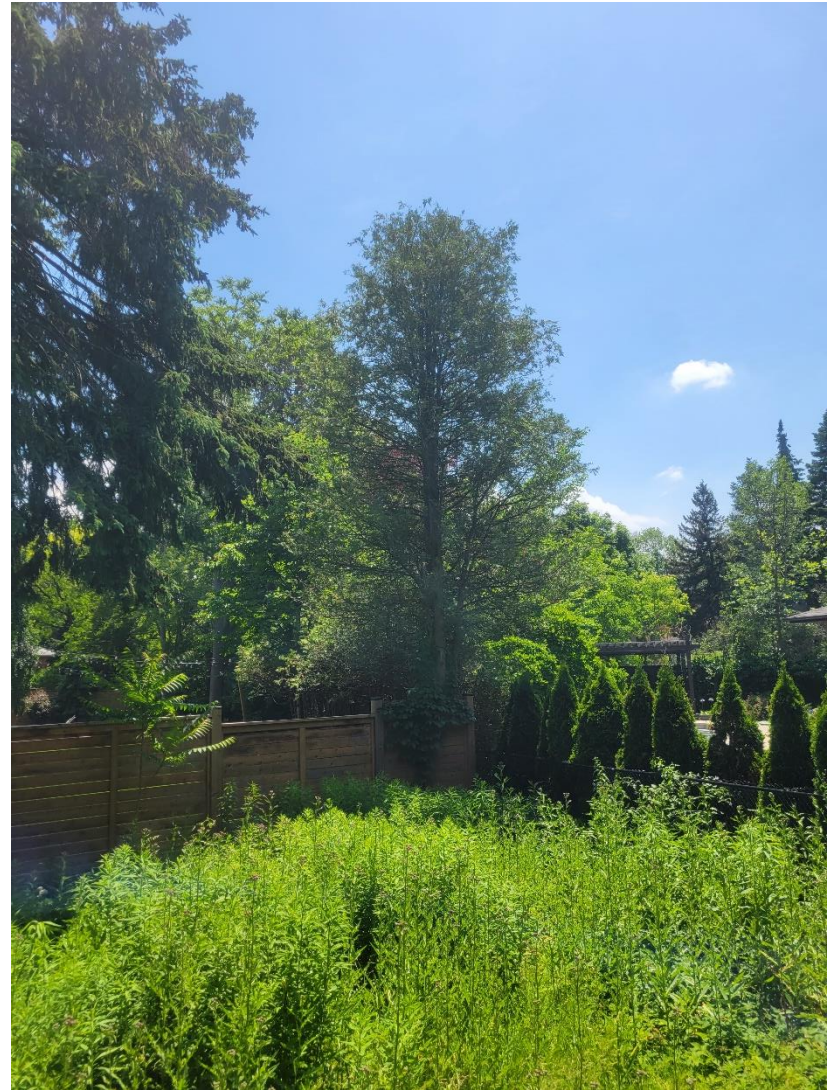
| Tree # | Common Name | Scientific Name | Diameter at Breast Height (DBH) | Trunk Integrity | Crown Structure | Crown Vigour | Crown Dieback | Tree Height | Dripline (radius) | Minimum Tree Protection Zone (mTPZ) (radius) | Actual TPZ (radius) | Comments | Action | Ownership |
|---|---|---|---|---|---|---|---|---|---|---|---|---|---|---|
| 8 | Eastern White Cedar | <i>Thuja occidentalis</i> | ~15 | FG | FG | FG | | 8 | 3 | 2.4 | Dripline+ | 3 stems | Preserve | Neighbouring |

**Photo 8. Tree 8, view looking south**

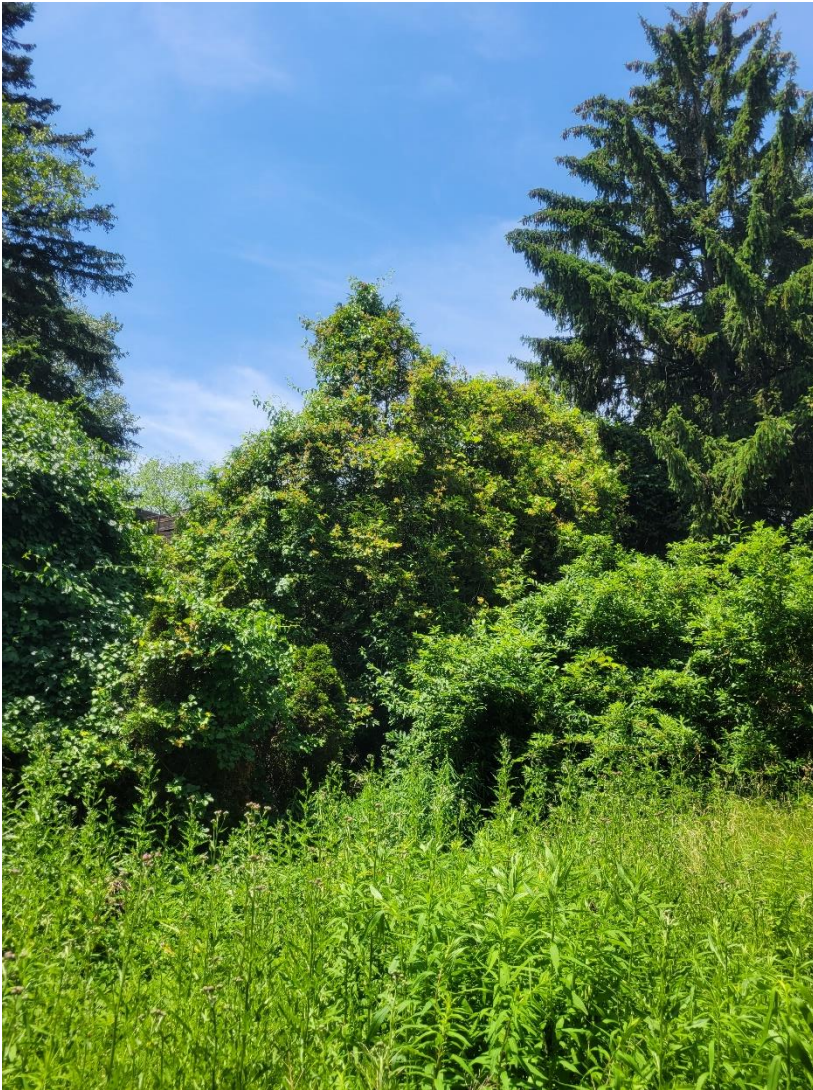
| Tree # | Common Name | Scientific Name | Diameter at Breast Height (DBH) | Trunk Integrity | Crown Structure | Crown Vigour | Crown Dieback | Tree Height | Dripline (radius) | Minimum Tree Protection Zone (mTPZ) (radius) | Actual TPZ (radius) | Comments | Action | Ownership |
|---|---|---|---|---|---|---|---|---|---|---|---|---|---|---|
| P9 | Eastern White Cedar | <i>Thuja occidentalis</i> | ~2-12 | F | F | F | | 3-6 | 1-2 | 1.8-2.4 | 2.4m+ | ~35 trees, minor lean to the southwest | Preserve | Boundary/Neighbouring |

**Photo 9. Tree polygon P9, view looking west**

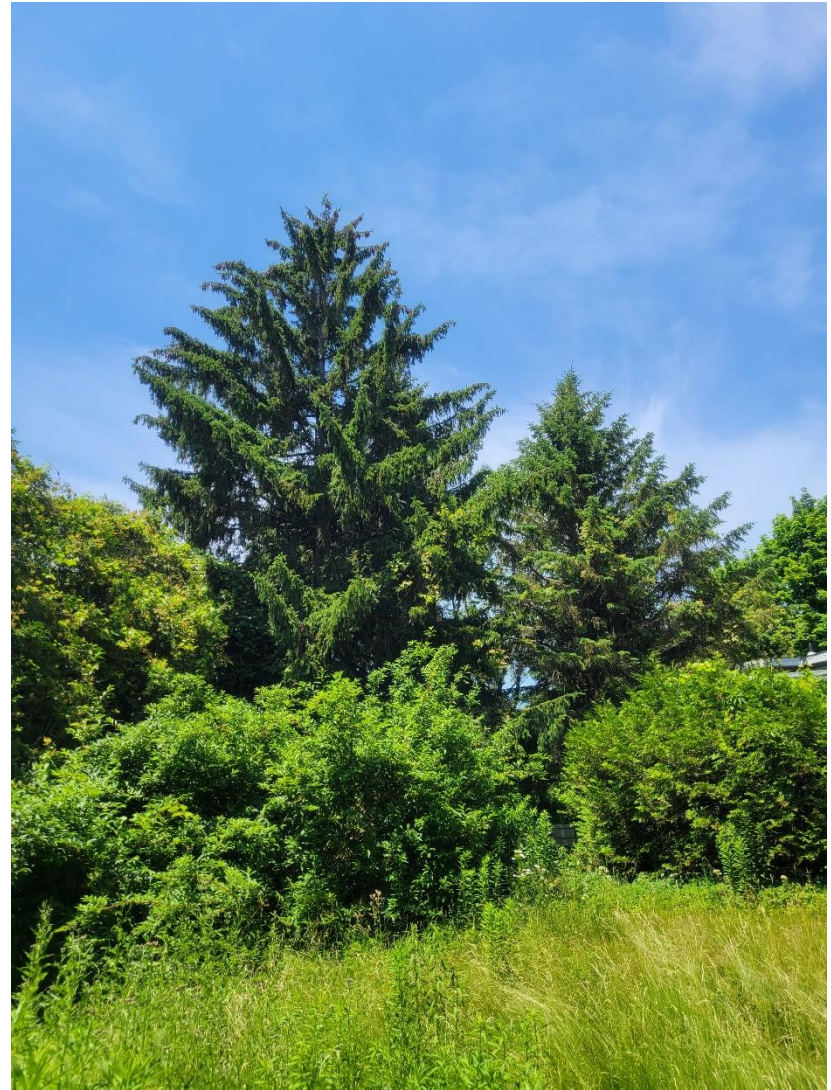
| Tree # | Common Name | Scientific Name | Diameter at Breast Height (DBH) | Trunk Integrity | Crown Structure | Crown Vigour | Crown Dieback | Tree Height | Dripline (radius) | Minimum Tree Protection Zone (mTPZ) (radius) | Actual TPZ (radius) | Comments | Action | Ownership |
|---|---|---|---|---|---|---|---|---|---|---|---|---|---|---|
| 10 | Norway Spruce | <i>Picea abies</i> | 58 | FG | FG | FG | | 18 | 5 | 3.6 | 3.6m+ | Minor pruning wounds, minor broken branches | Preserve | Private |
| 11 | Blue Spruce | <i>Picea pungens</i> | 37.5 | F | F | F | | 16 | 5 | 3 | - | Sparse, minor vine competition, multi-stem at 10m, minor pruning wounds due to raised crown, curved stem | Remove | Private |

**Photo 10. Trees 10 and 11 (left to right), view looking northwest**

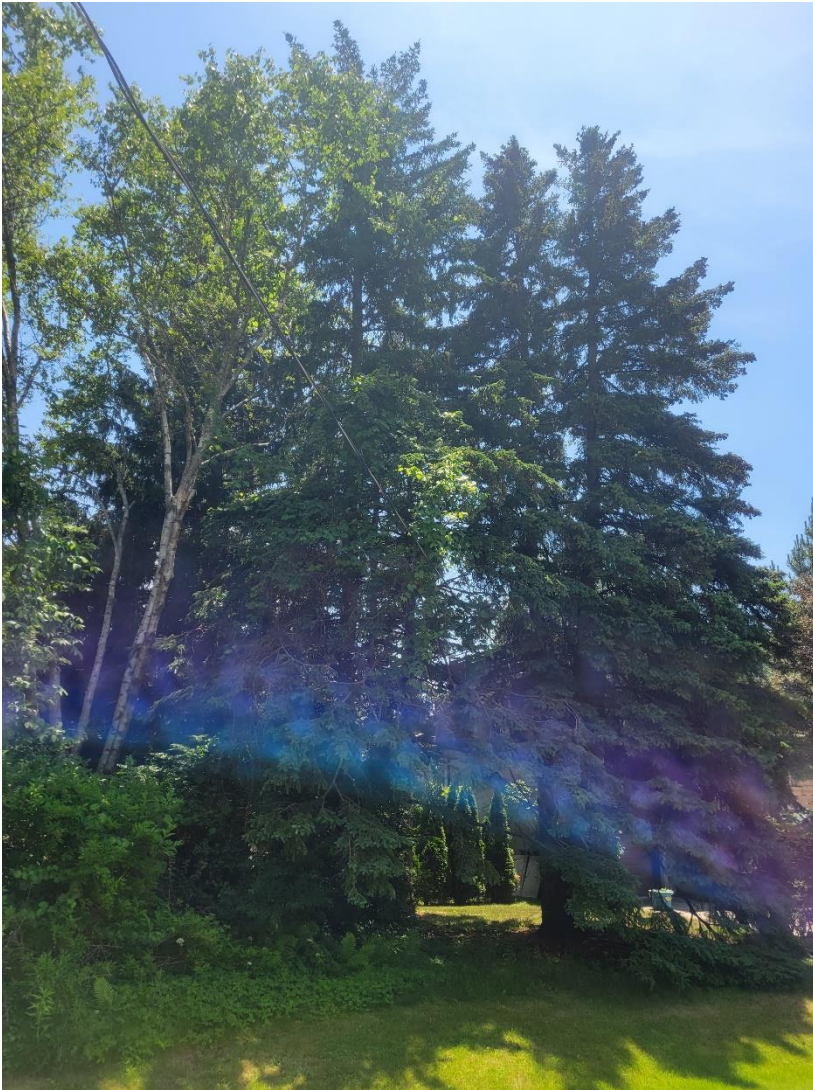
| Tree # | Common Name | Scientific Name | Diameter at Breast Height (DBH) | Trunk Integrity | Crown Structure | Crown Vigour | Crown Dieback | Tree Height | Dripline (radius) | Minimum Tree Protection Zone (mTPZ) (radius) | Actual TPZ (radius) | Comments | Action | Ownership |
|---|---|---|---|---|---|---|---|---|---|---|---|---|---|---|
| 12 | Norway Spruce | <i>Picea abies</i> | 45.5 | FG | FG | FG | | 18 | 4 | 3 | 3m+ | | Preserve | Private |
| 13 | White Spruce | <i>Picea glauca</i> | ~30 | FG | FG | F | | 14 | 3 | 2.4 | Dripline+ | Minor deadwood, minor broken branches, minor pruning wounds due to raised crown | Preserve | Neighbouring |
| 14 | White Spruce | <i>Picea glauca</i> | ~28, ~32 [42.5] | FG | FG | FG | | 16 | 3 | 3 | Dripline+ | Union at 1m, moderate asymmetrical crown due to competition | Preserve | Neighbouring |
| 15 | White Spruce | <i>Picea glauca</i> | 34, 18 [38.5] | F | FG | FG | | 16 | 4 | 3 | Dripline+ | Fused at base, minor sweep, minor vine competition, moderate asymmetrical crown | Preserve | Private |

**Photo 11. Trees 12 to 15, view looking southeast**

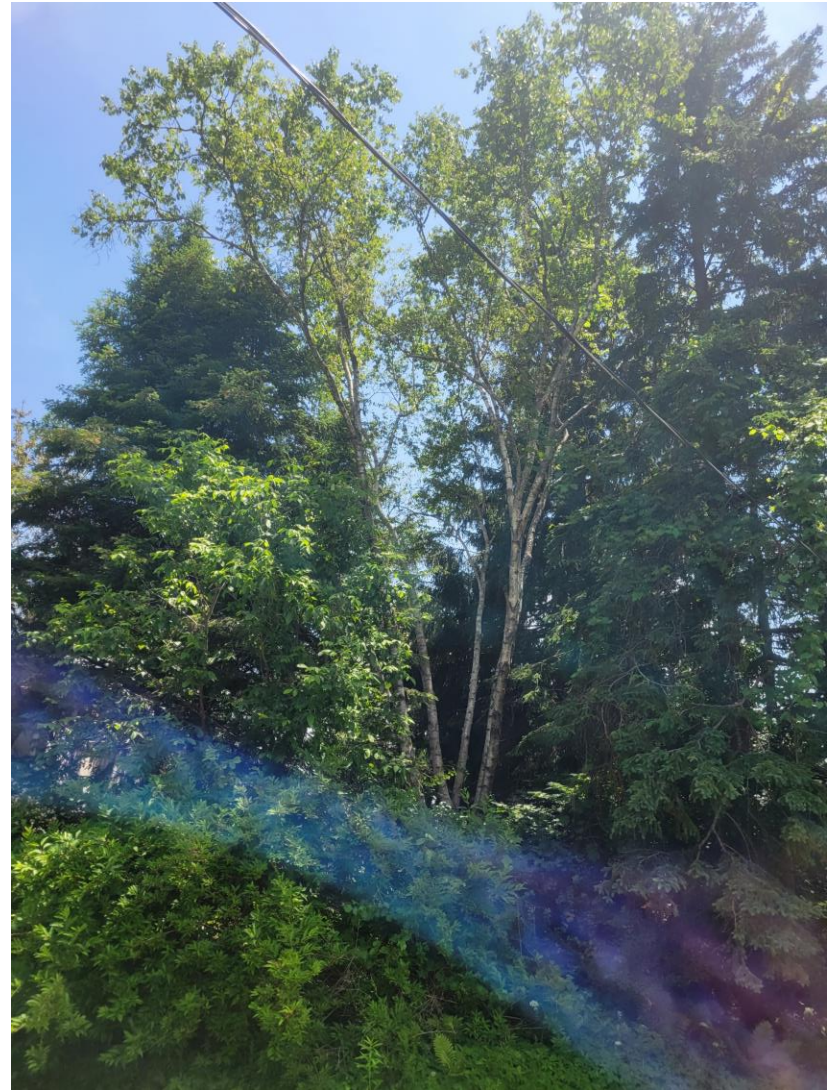
| Tree # | Common Name | Scientific Name | Diameter at Breast Height (DBH) | Trunk Integrity | Crown Structure | Crown Vigour | Crown Dieback | Tree Height | Dripline (radius) | Minimum Tree Protection Zone (mTPZ) (radius) | Actual TPZ (radius) | Comments | Action | Ownership |
|---|---|---|---|---|---|---|---|---|---|---|---|---|---|---|
| 16 | White Birch | <i>Betula papyrifera</i> | 26, 26, 27 [46] | F | F | F | | 16 | 6 | 3 | 3m+ | Conflict with shed, minor stem wound, union at base, minor pruning wounds, major defoliation, minor deadwood, minor broken branches, minor lean outwards, moderate vine competition | Preserve | Private |

**Photo 12. Tree 16 (centre), view looking southeast**

**ARBORIST NOTE:** Minor encroachment into the mTPZ of Tree 16 will be required to remove the existing shed. The shed should be removed gently by hand and the tree protection barriers installed immediately following demolition. Minor encroachment into the mTPZ of Tree 21 will be required to remove the existing wood curb and asphalt driveway. The wood curb and asphalt driveway within the mTPZ of this tree should be removed gently by hand. The area should then be restored using healthy topsoil and stabilized (seeded or sodded). The crown of Tree 19 may required minor pruning to accommodate the proposed dwelling. Any crown pruning should be conducted by a Certified Arborist following good arboricultural practices.

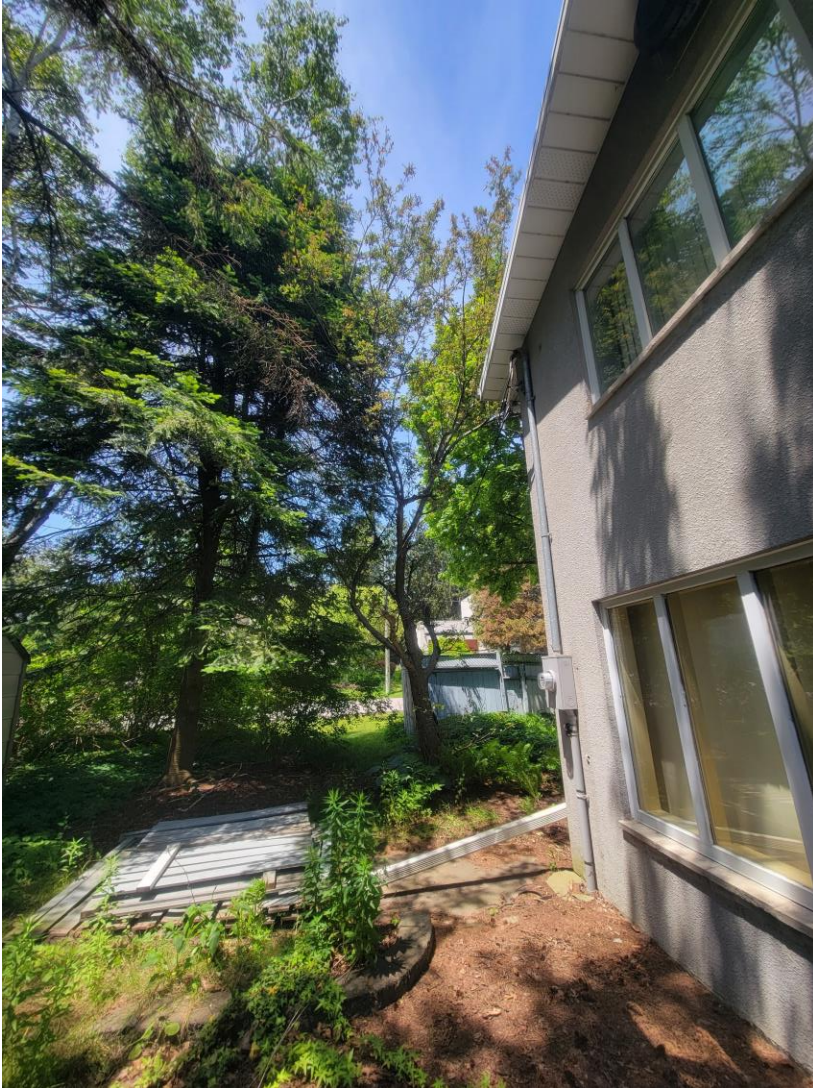
| Tree # | Common Name | Scientific Name | Diameter at Breast Height (DBH) | Trunk Integrity | Crown Structure | Crown Vigour | Crown Dieback | Tree Height | Dripline (radius) | Minimum Tree Protection Zone (mTPZ) (radius) | Actual TPZ (radius) | Comments | Action | Ownership |
|---|---|---|---|---|---|---|---|---|---|---|---|---|---|---|
| 17 | Balsam Fir | <i>Abies balsamea</i> | 35 | FG | F | FG | | 16 | 3 | 3 | - | Union at 6m, minor pruning wounds due to raised crown | Remove | Private |
| 18 | Apple species | <i>Malus</i> sp. | 26 | FP | FP | FP | | 8 | 3 | 2.4 | - | Moderate pruning wounds with decay and cavity, major epicormic branching, moderate asymmetrical crown, crook | Remove | Private |

**Photo 13. Trees 17 and 18 (left to right), view looking northwest**

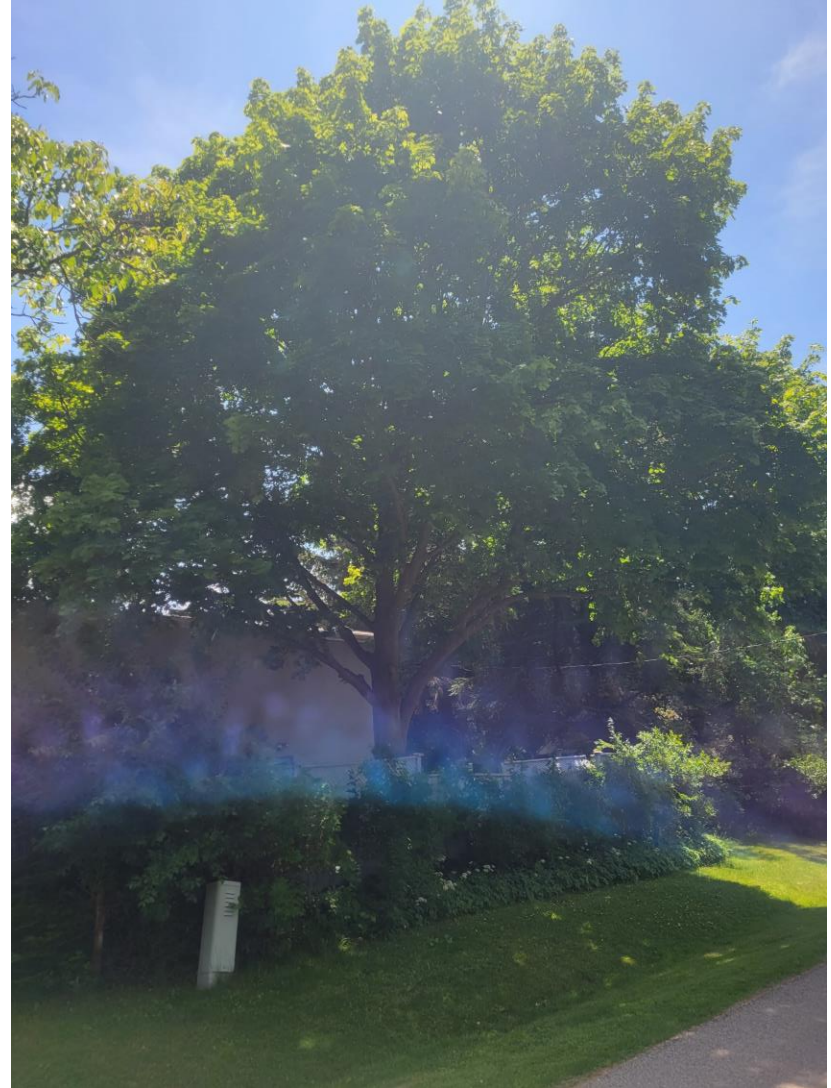
| Tree # | Common Name | Scientific Name | Diameter at Breast Height (DBH) | Trunk Integrity | Crown Structure | Crown Vigour | Crown Dieback | Tree Height | Dripline (radius) | Minimum Tree Protection Zone (mTPZ) (radius) | Actual TPZ (radius) | Comments | Action | Ownership |
|---|---|---|---|---|---|---|---|---|---|---|---|---|---|---|
| 19 | Norway Maple | <i>Acer platanoides</i> | 51 | F | FG | F | | 18 | 8 | 3.6 | 3.6m+ | Union at 2m with moderate included bark, minor growth deficit, moderate pruning wounds, moderate epicormic branching | Preserve | Private |

**Photo 14. Tree 19, view looking south**

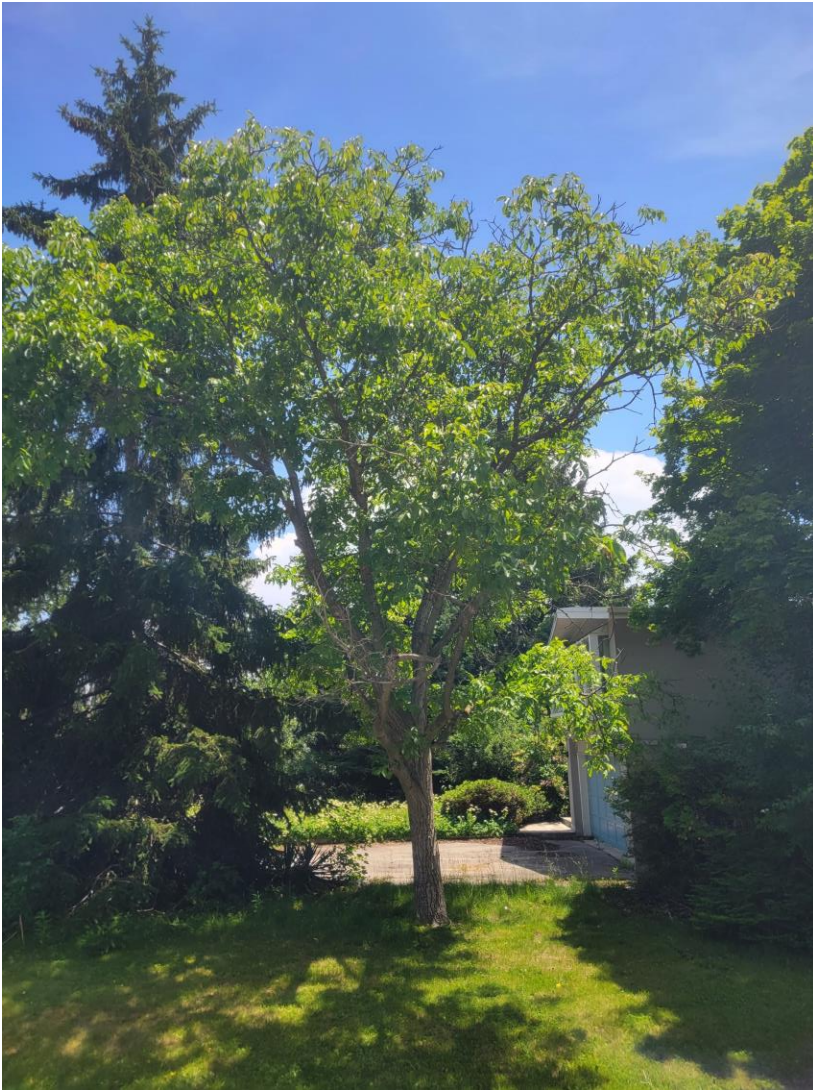
| Tree # | Common Name | Scientific Name | Diameter at Breast Height (DBH) | Trunk Integrity | Crown Structure | Crown Vigour | Crown Dieback | Tree Height | Dripline (radius) | Minimum Tree Protection Zone (mTPZ) (radius) | Actual TPZ (radius) | Comments | Action | Ownership |
|---|---|---|---|---|---|---|---|---|---|---|---|---|---|---|
| 20 | English Walnut | <i>Juglans regia</i> | 32 | F | F | F | | 5 | 8 | 5 | 3 | Town Tree ID: 10756, 2m seam/crack from base, small root flare, minor deadwood, minor epicormic branching, moderate pruning wounds with cavity | Preserve | Private |

**Photo 15. Tree 20 (centre), view looking southeast**

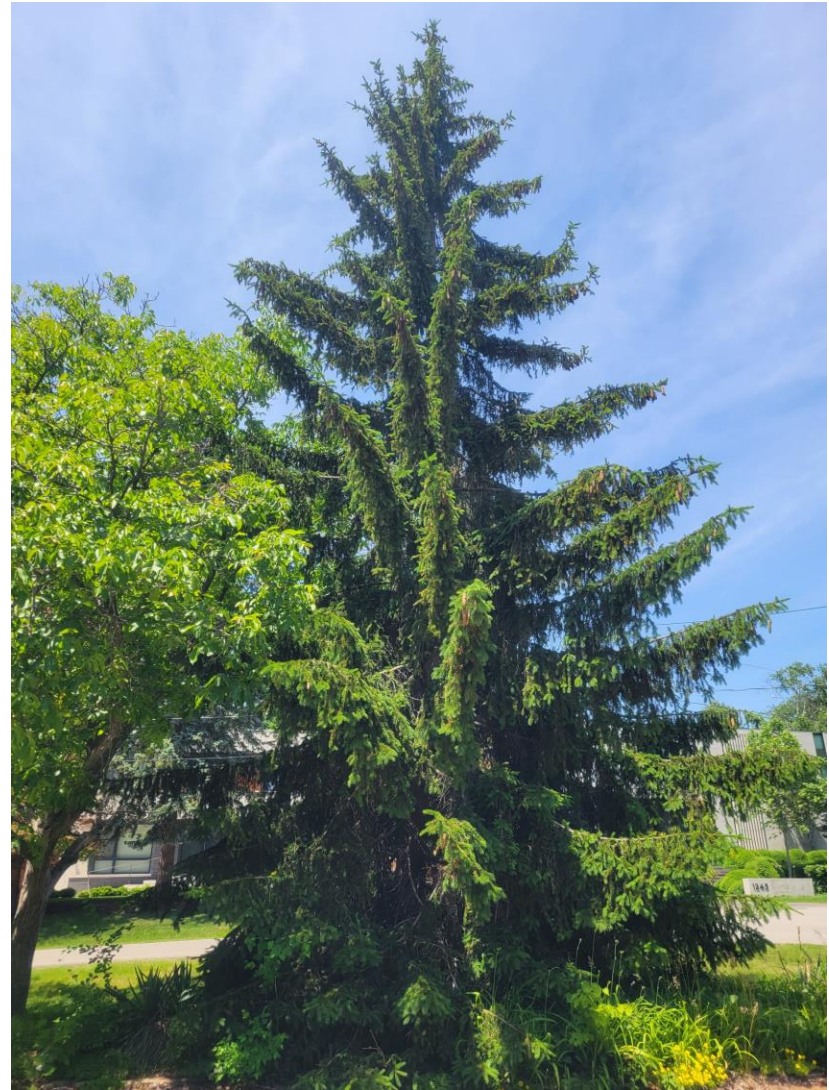
| Tree # | Common Name | Scientific Name | Diameter at Breast Height (DBH) | Trunk Integrity | Crown Structure | Crown Vigour | Crown Dieback | Tree Height | Dripline (radius) | Minimum Tree Protection Zone (mTPZ) (radius) | Actual TPZ (radius) | Comments | Action | Ownership |
|---|---|---|---|---|---|---|---|---|---|---|---|---|---|---|
| 21 | Norway Spruce | <i>Picea abies</i> | ~34 | G | G | G | | 18 | 3 | 3 | 2.4m+ | | Preserve | Private |

**Photo 16. Tree 21 (centre), view looking northwest**
