Cultural Heritage Evaluation Report
Cedar Lodge
149 Dunn Street, Oakville, Ontario

Town of Oakville
Heritage Planning
Authors: Kristen McLaughlin, Carolyn Van Sligtenhorst
December 2023

1. Executive Summary

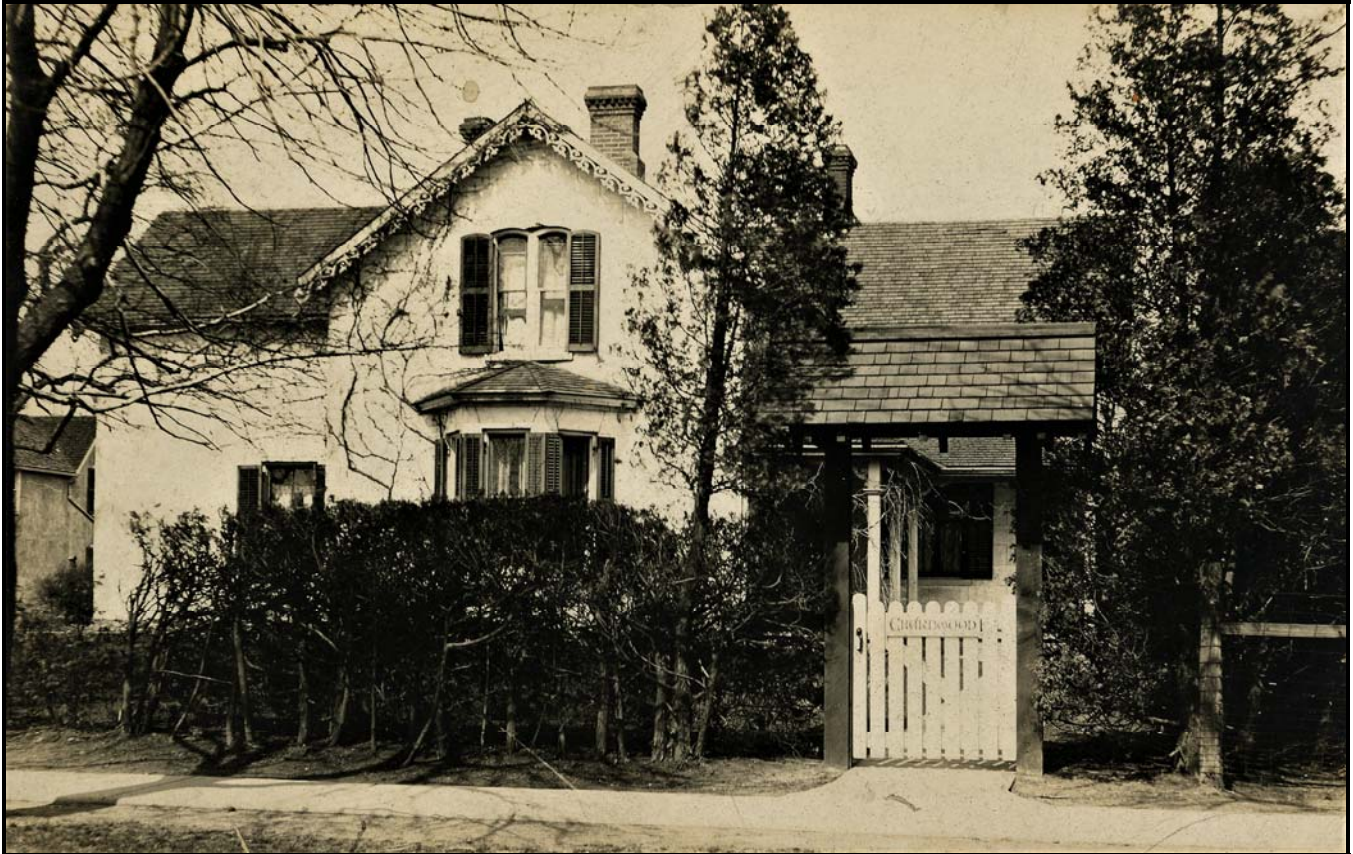
West elevation of 149 Dunn Street, pre-1976 but exact date unknown. *Source: Oakville Historical Society*

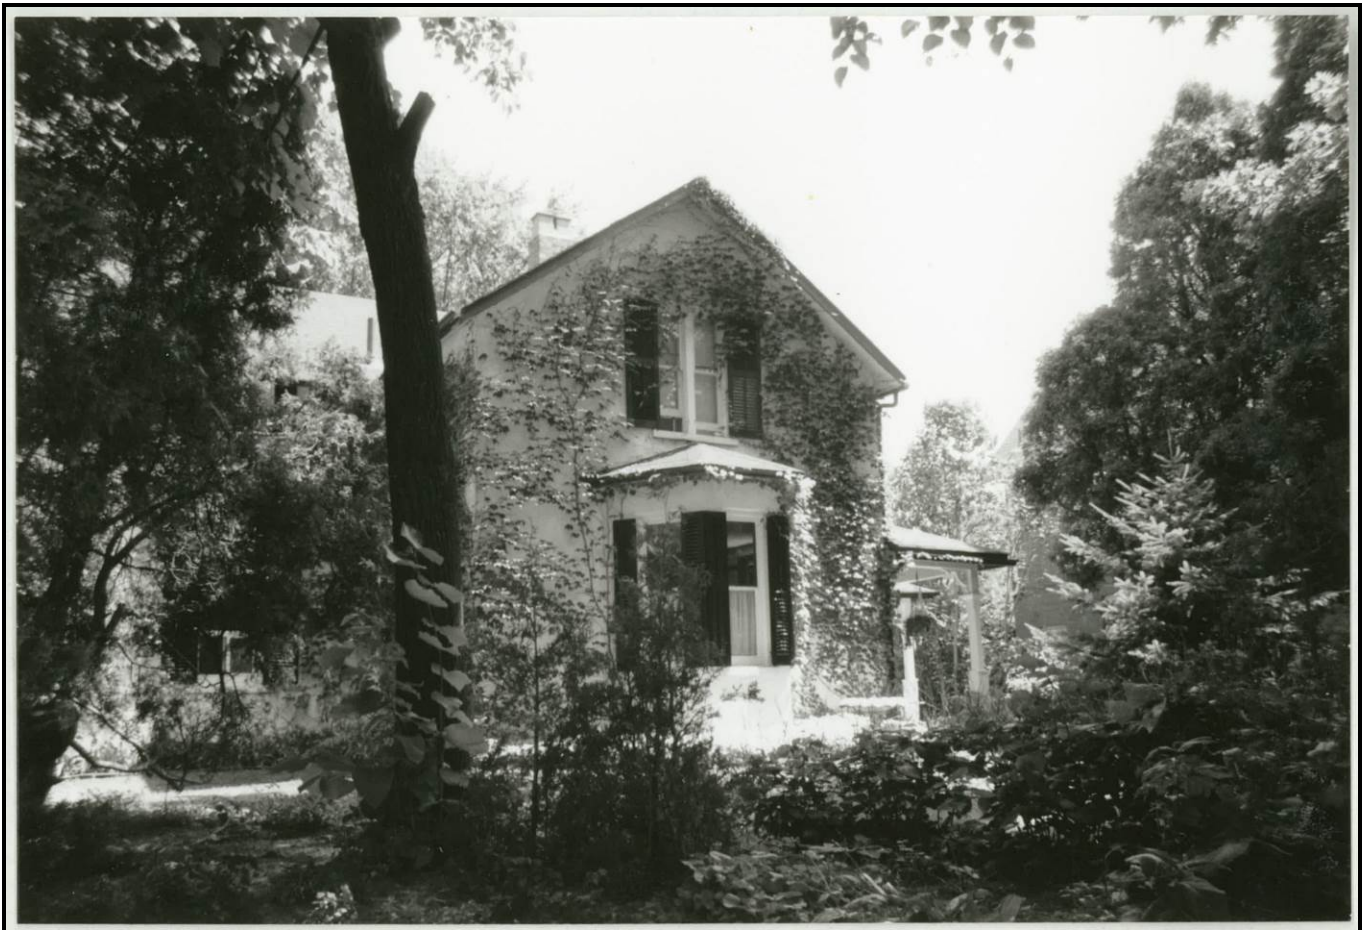
Historical photo of the south elevation of the subject property, circa 1980s. Source: *Town of Oakville Planning Services Staff*

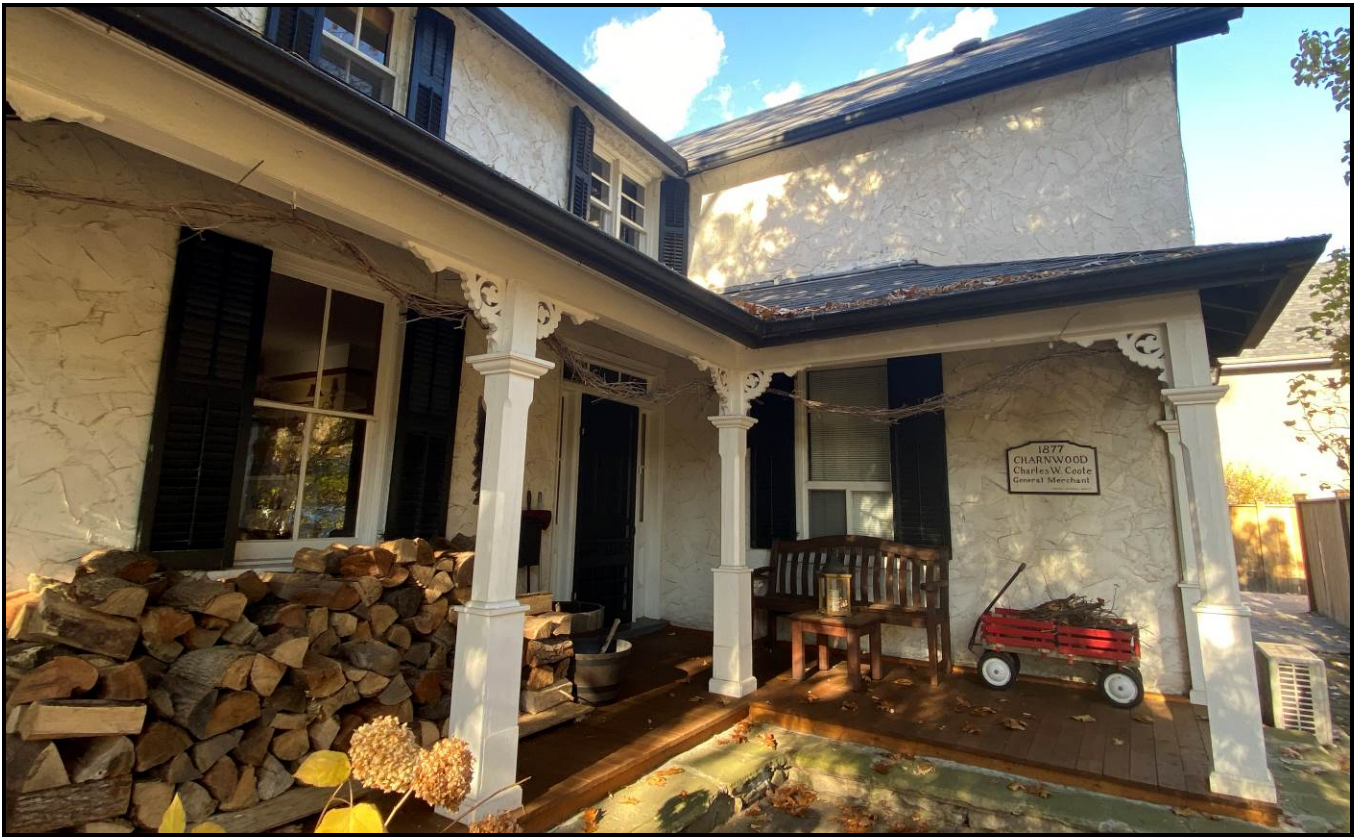
South elevation. Source: Town of Oakville Planning Services Staff

The original portion of the L-shaped home has the main door on the south elevation, with a bay window on the west elevation. The north wing was likely a later addition, with the roof extended onto the one-storey portion for further square footage. The one-storey portion is said to have originally been a garage and could have been added from a previously separate building, like a shed or carriage house, and it was then the roof was extended to a saltbox shape on that half of the house. However, it is not clear that this is the case, but the roof shape is quite unique and indicates a history of additions.⁵

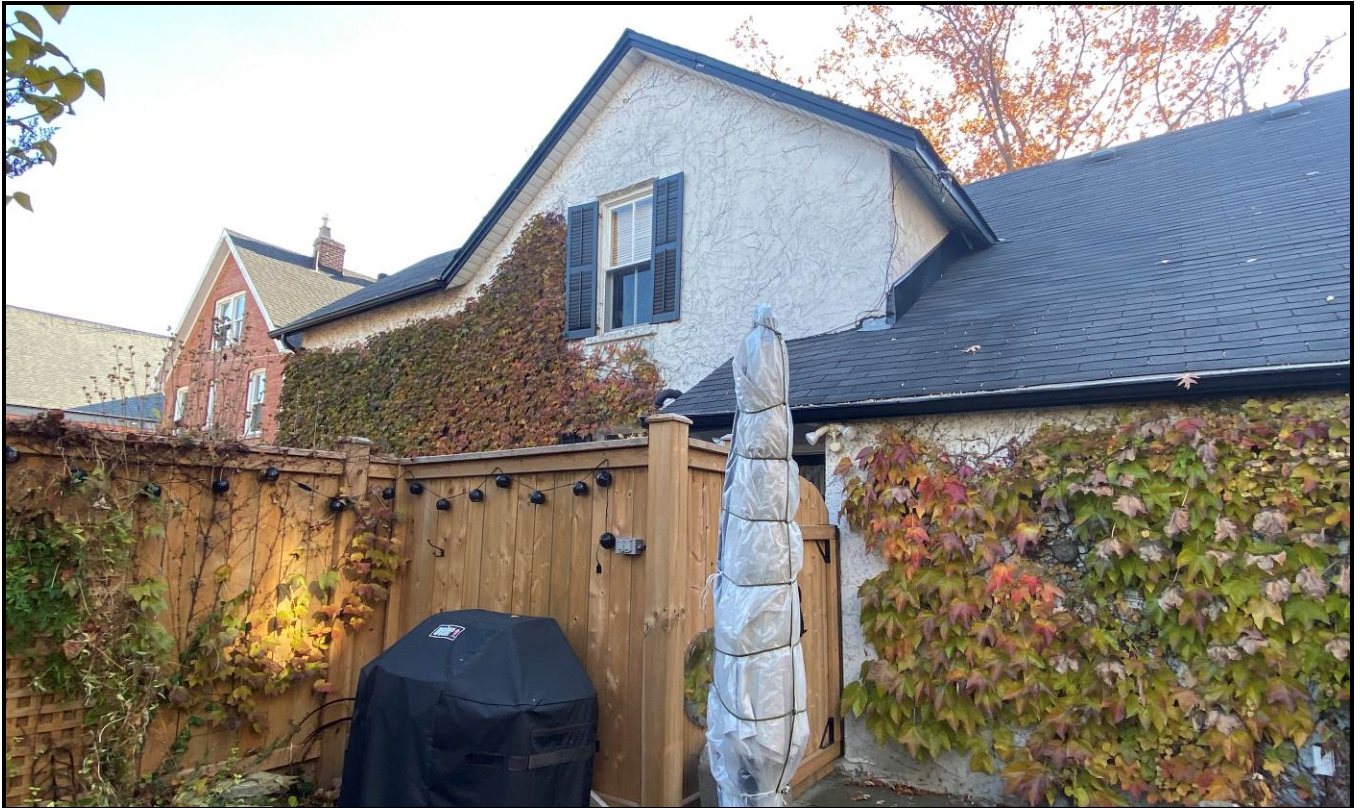
East elevation, showing one-storey addition and saltbox roof to the right. Source: Town of Oakville Planning Services Staff

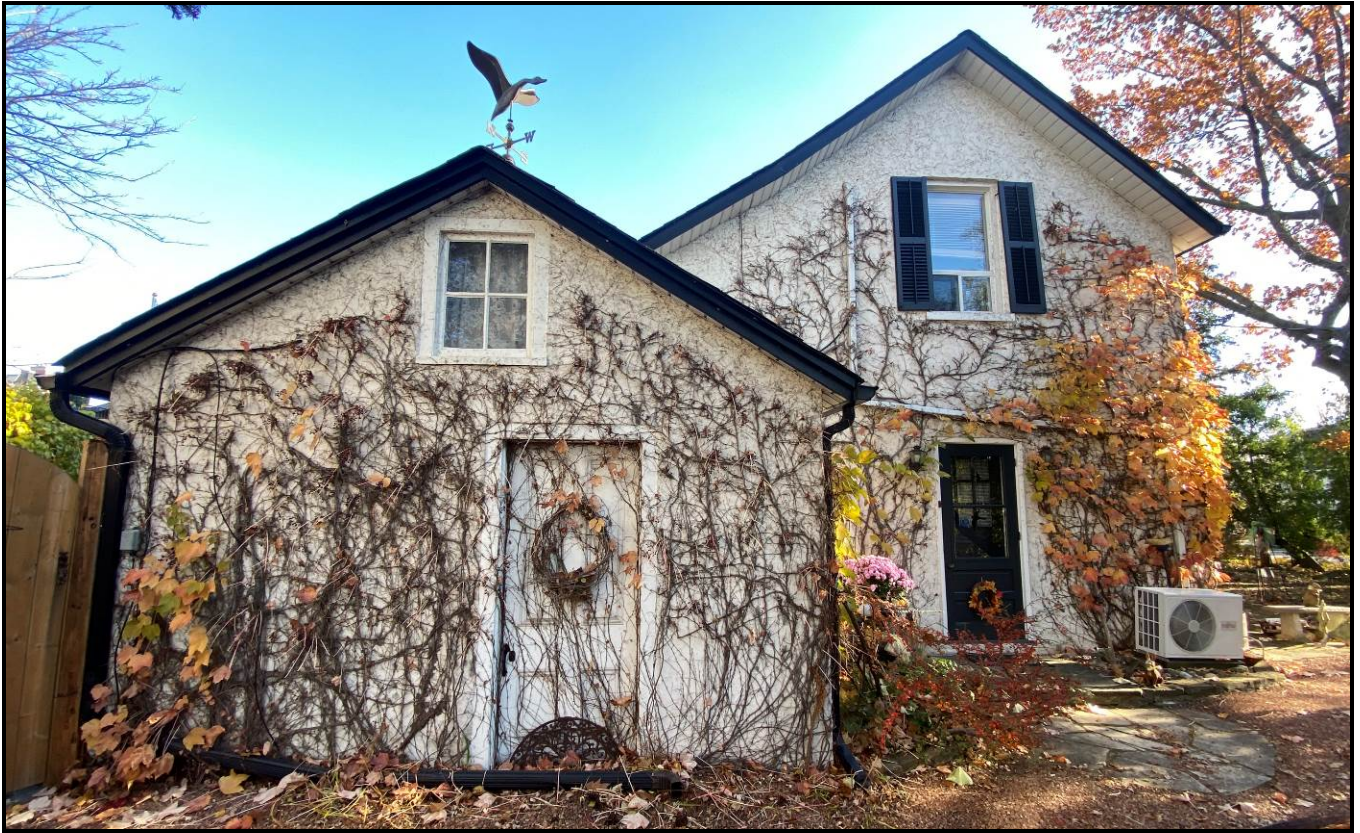
North elevation, showing the one-storey portion, the slope of the roof, and the north entrance. *Source: Town of Oakville Planning Services Staff*

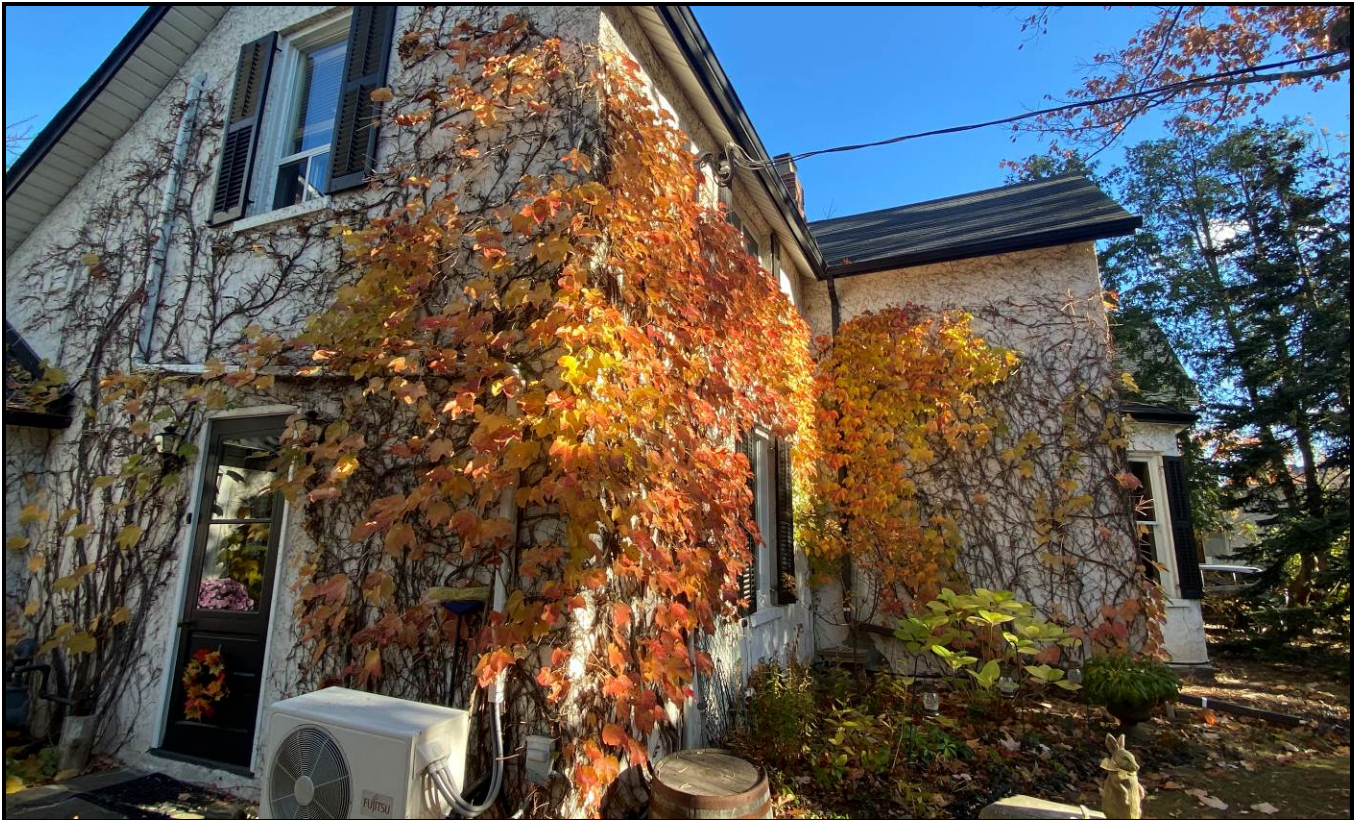
Showing the west façade from the north elevation. *Source: Town of Oakville Planning Services Staff*

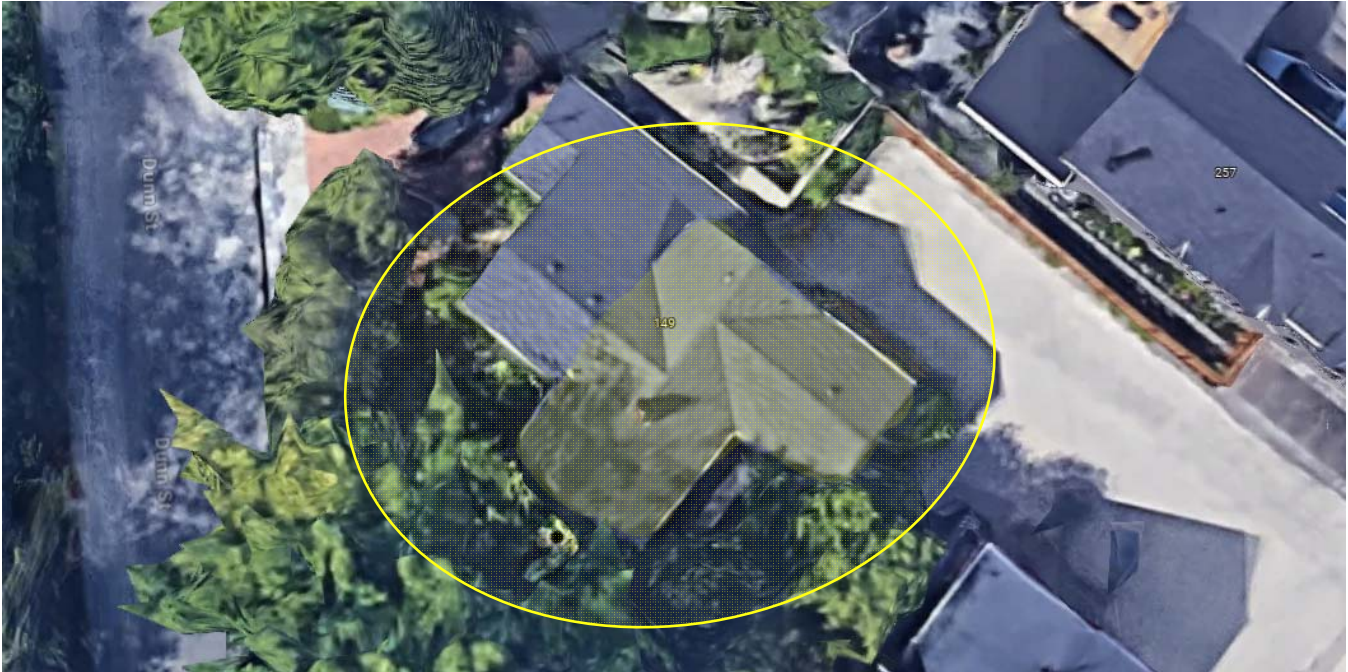
The aerial image below shows the original L-shaped storey highlighted in yellow to the south with the later two-storey and one-storey wings to the north.

Aerial view showing the shape of the house and its unique roof. The highlighted portion is the potential original layout. Source: Google Maps

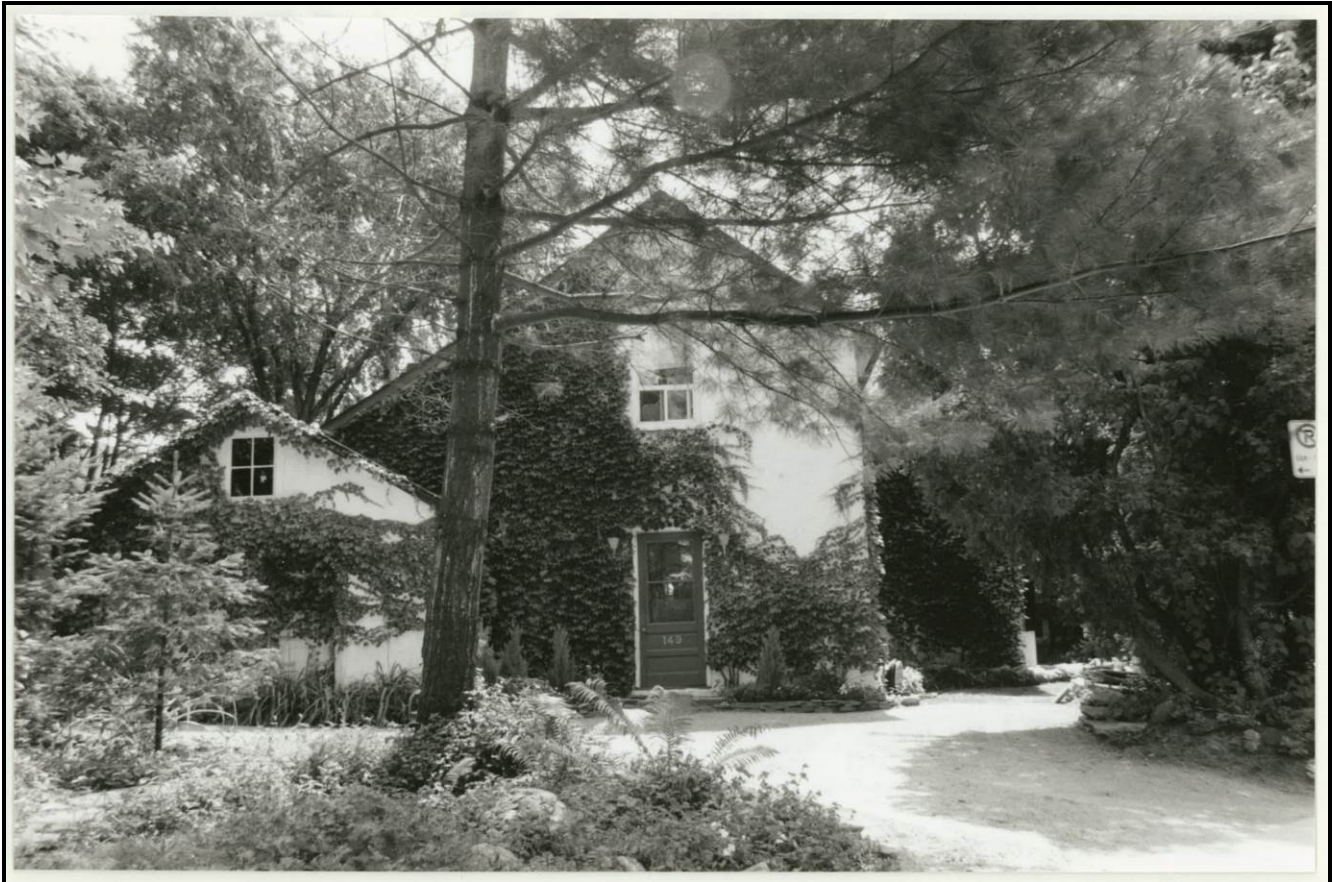
North elevation of the house, circa 1980s, showing the roof shape. There are no shutters on the upper window at this time. *Source: Town of Oakville Planning Files*

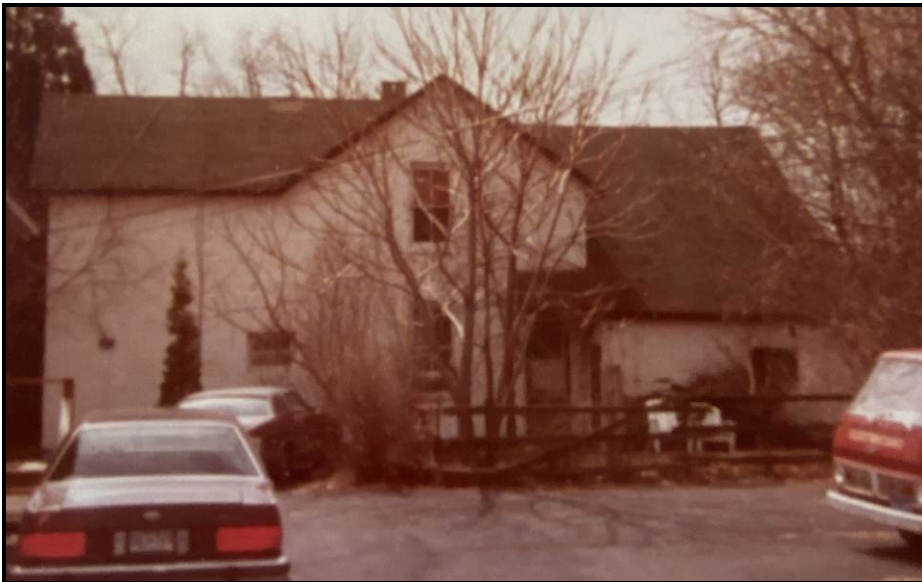
Photo from the 1980s of the east façade, showing the sloped roof to the one-storey portion, and the south gable wing connecting to the east-west portion of the house. *Source: George Chisholm, Town of Oakville Planning files*

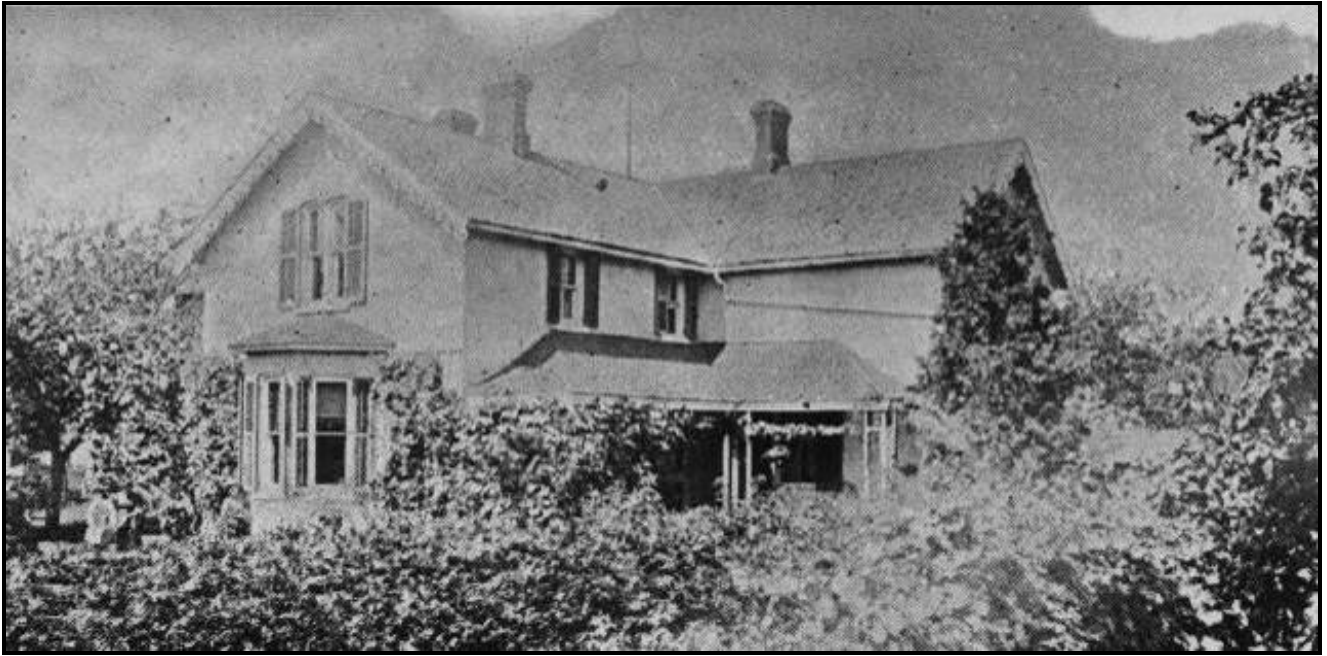
1897 photo, west façade, showing the south and west gables, as well as the verandah. The photo does not show the one-storey portion behind. *Source: Oakville Historical Society*

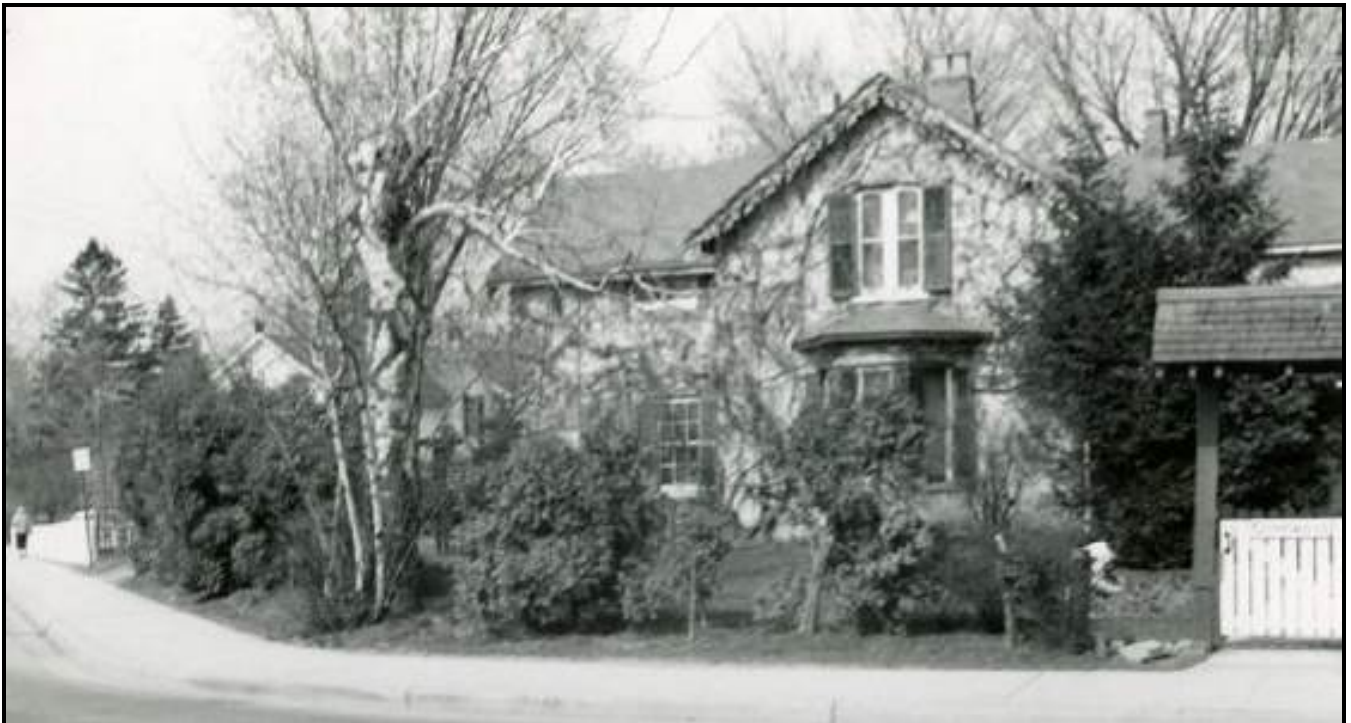
View of the west elevation circa 1957. The house had a lychgate as seen in the photo with the words 'Charnwood' on it. *Source: Oakville Historical Society*

A photo from the 1950s shows the gate with the name "Charnwood" on it. However, no other records could be found indicating when this name started to be used for the house, or by whom. The Oakville Historical Society plaque indicates it may have been used by the Cootes. Before this, it is noted as "Cedar Lodge" in the book *Beautiful Oakville* from 1897, when it was still owned by the Coote family.

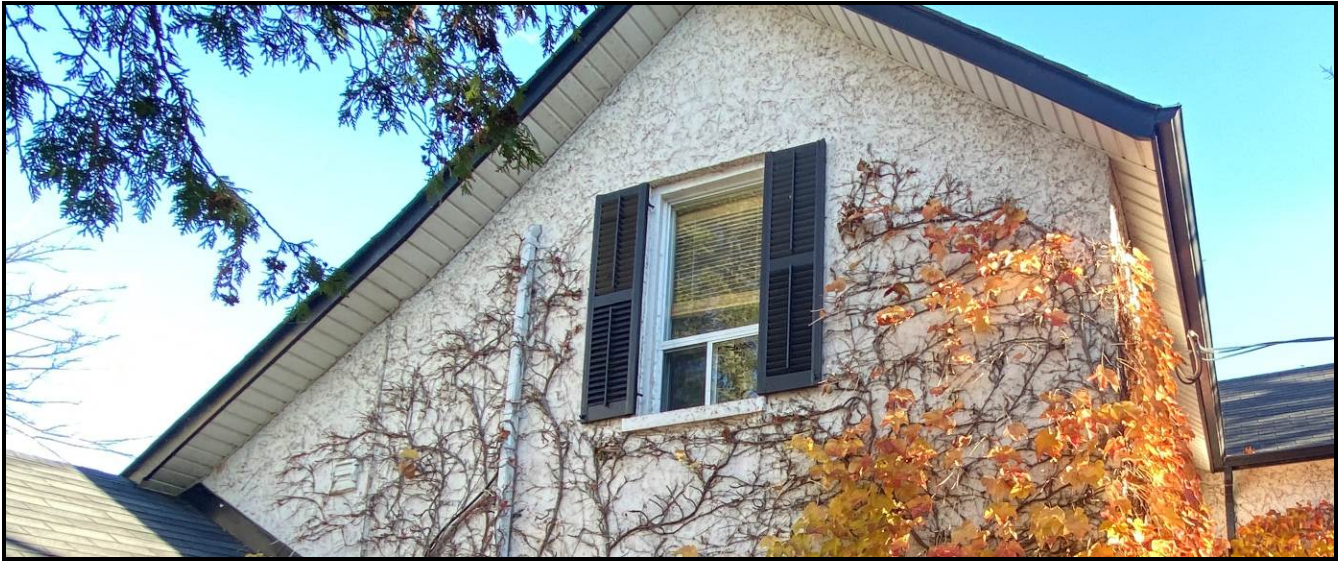
North elevation stucco, showing a pebbled appearance. It is similar to the stucco on the one-storey portion. *Source: Town of Oakville Planning Services Staff*

The house is clad in stucco, applied in two different ways on the south and north elevations. On the north, the stucco is a traditional heavily-textured material and on the south, a trowelled technique has been used, something that is more common from the mid to late 20th century. Stucco was not meant to be a long-term cladding, and it could have been resurfaced throughout its lifetime, explaining the differences in application. This difference may also be if the north gable and one-storey addition were later additions to the house and plastered by a different person.

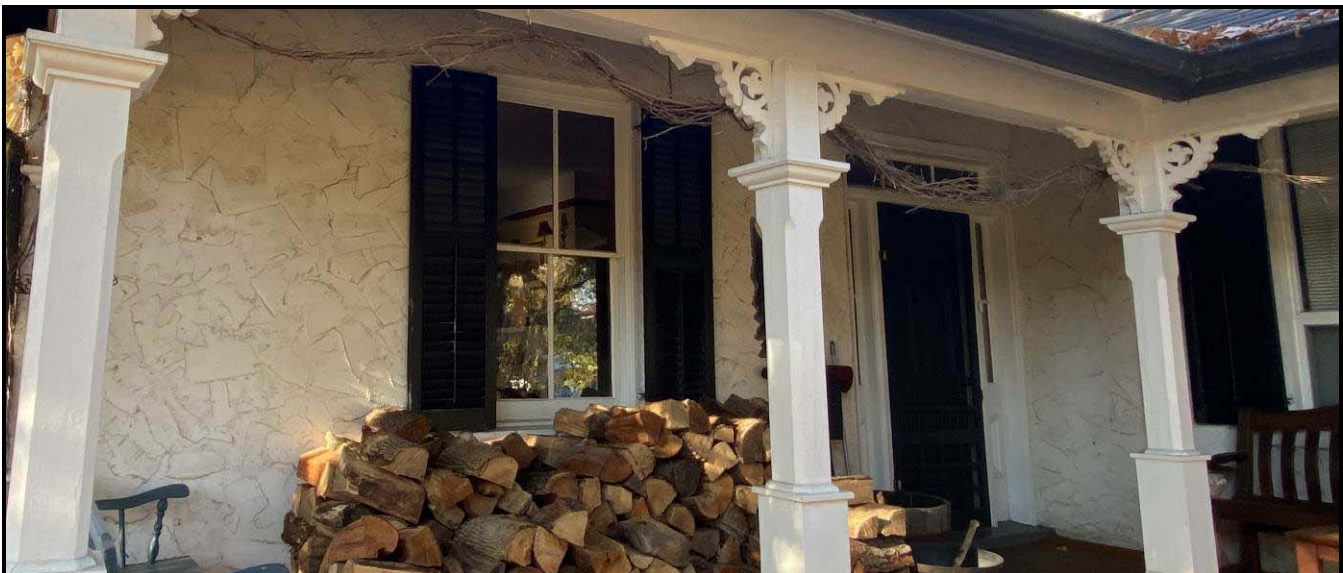
South elevation, showing a more trowelled texture for the stucco. *Source: Town of Oakville Planning Services Staff*

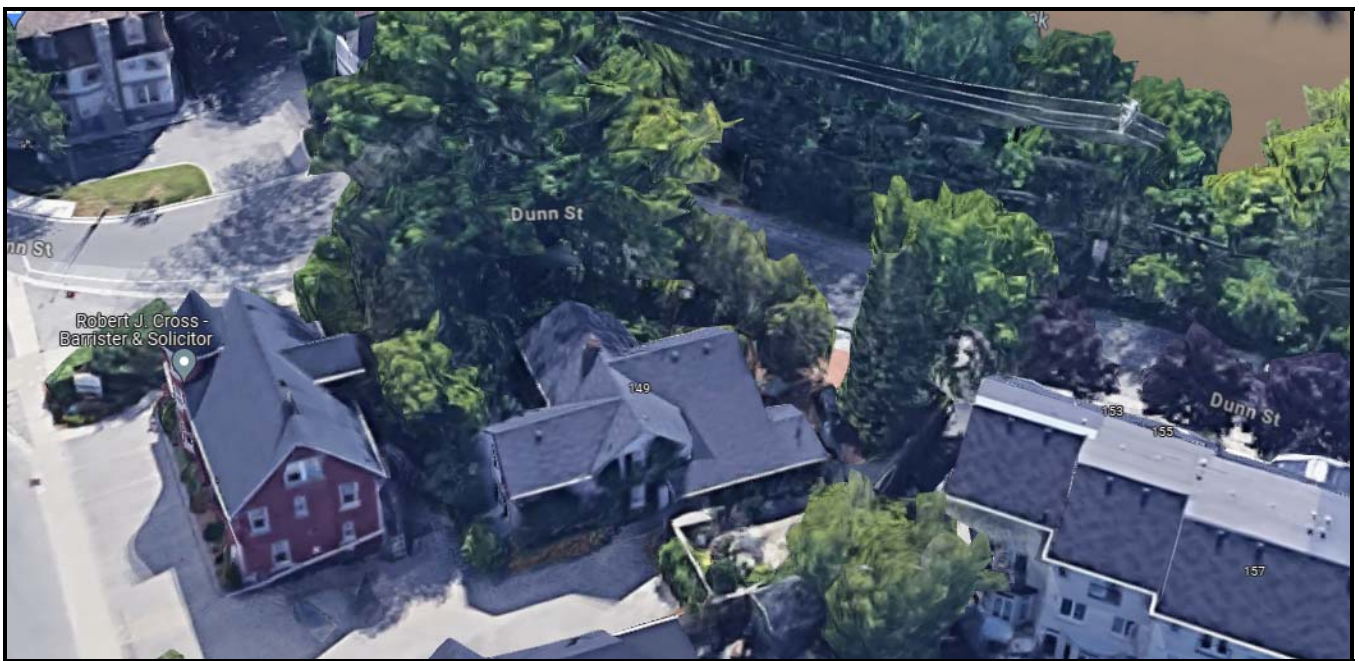
A 3D aerial view of the house, showing its shape, looking west. Notice the large amount of vegetation. *Source: Google Maps*

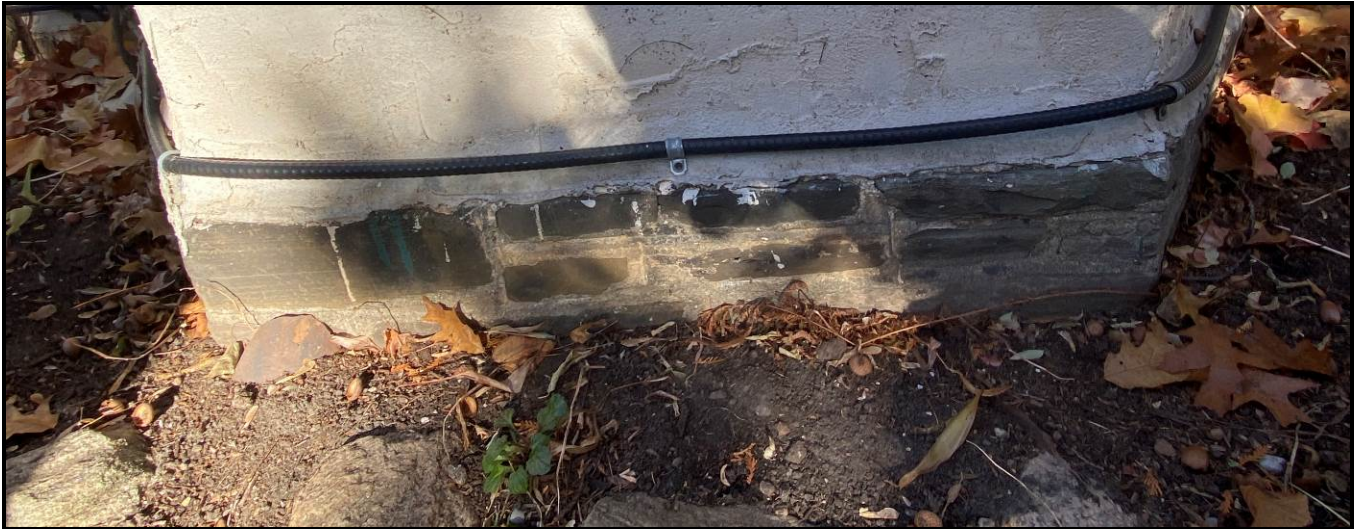
Close up of the foundation on the west elevation. *Source: Town of Oakville Planning Services Staff*

A lakestone foundation was common in historic houses and structures in Oakville in the early to mid-1800s and is present in the subject house as well.⁷ The height of the lakestone foundation is not the same on the north wing and the one-storey wing, further indicating they are likely additions.

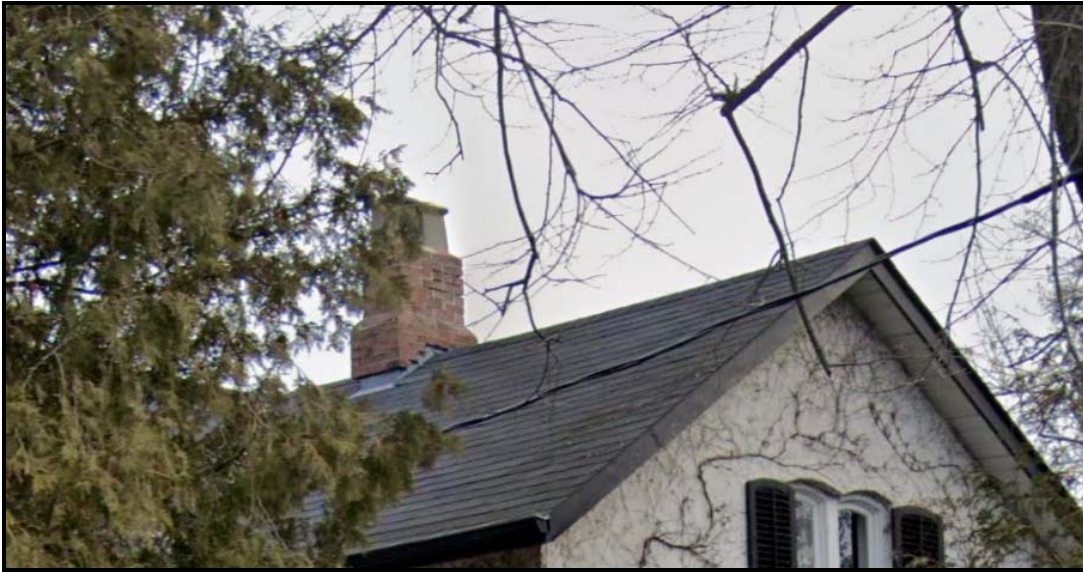
Current chimney. Source: Google Street View

Historically, there were three tall brick chimneys, as seen in the 1897 photograph below. Two have been removed and the last altered, as it is now shorter. This photo indicates, if the north wing was added, it was done by this time as that is likely where the third chimney sits in the photo. The photo also shows the decorative wooden bargeboard that is on longer present in the gabled eaves.

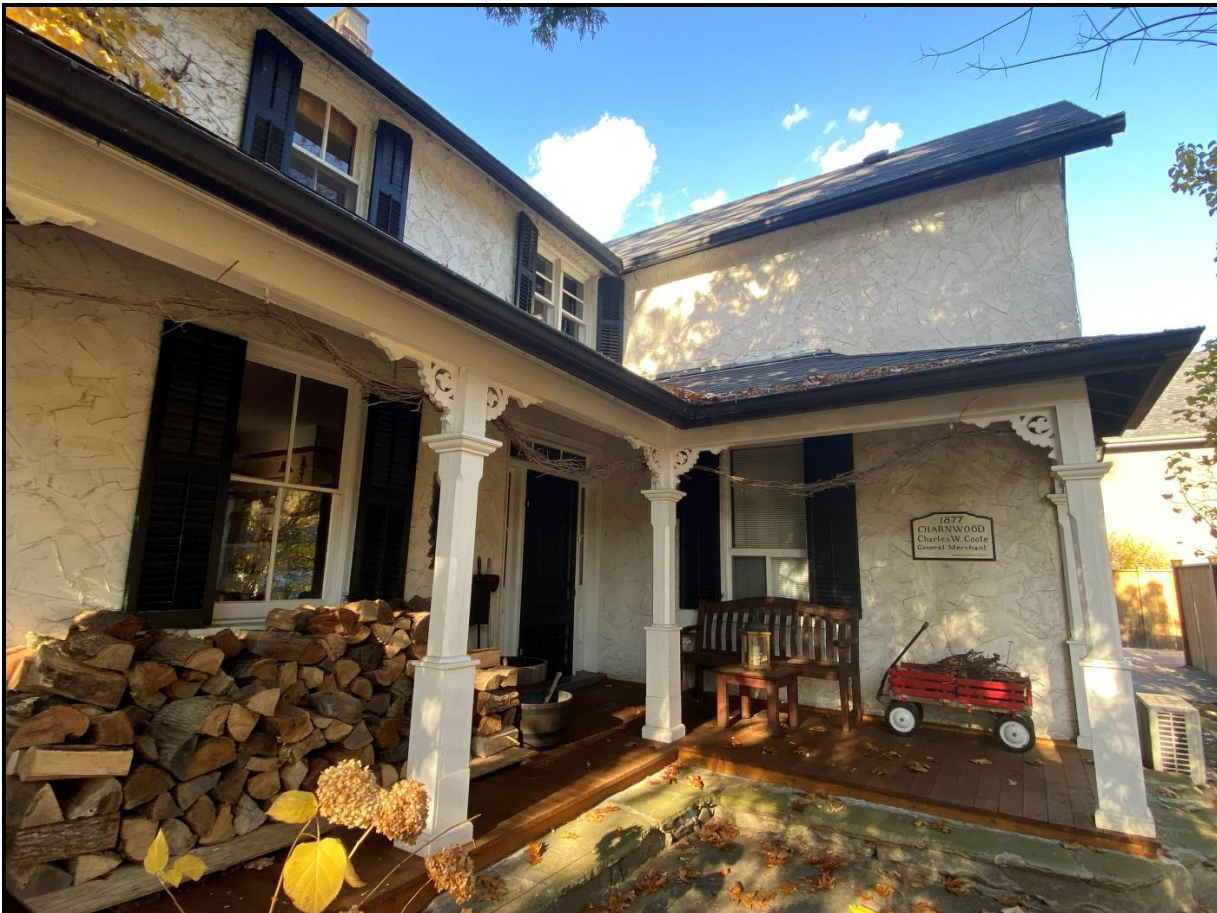
Verandah on south elevation, looking northeast. Source: Town of Oakville Planning Services Staff

Covered verandahs are a main element of Regency-style and Gothic Revival houses in Oakville.⁸ This house's main door is on its south elevation, under a covered verandah that extends across two elevations.

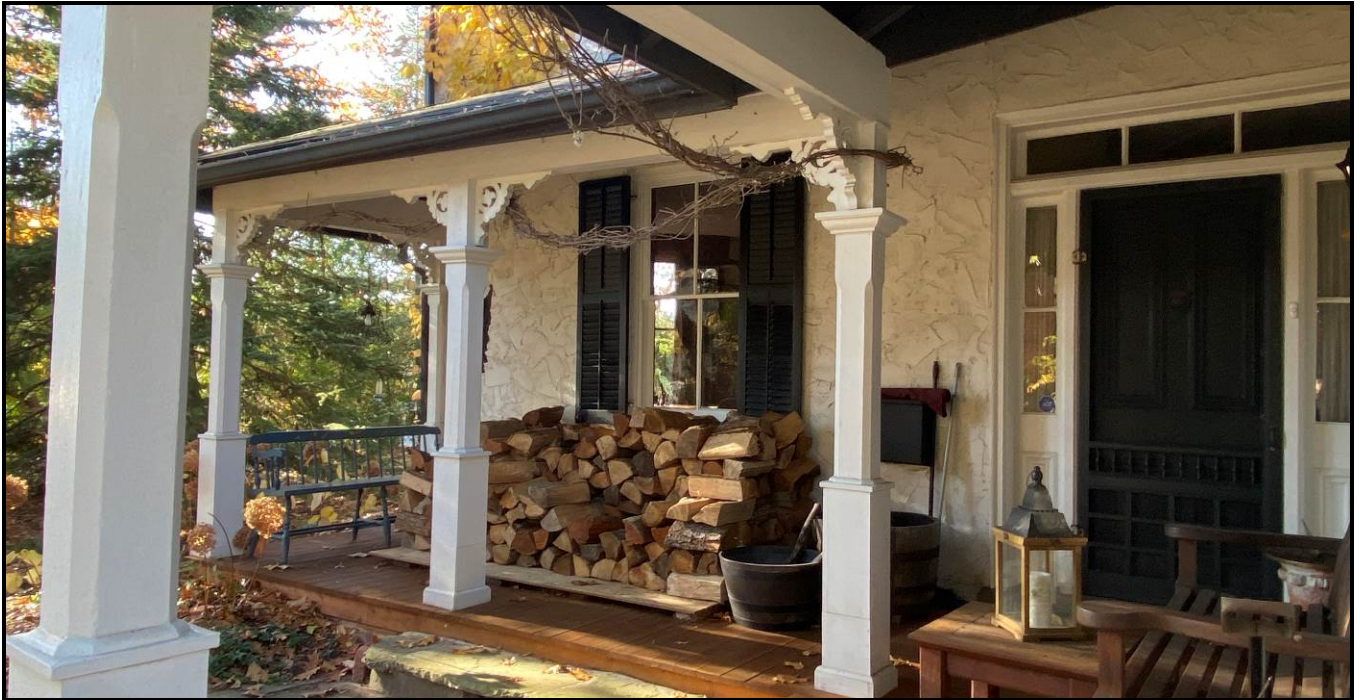
Verandah on the south elevation looking northwest. Historically, a path through the gate on the west elevation would have led here. Source: Town of Oakville Planning Services Staff

The verandah has wooden detailing, such as the pilasters on the wall edges and decorative wooden detailing along the roofline. The design is similar to Gothic Revival and Queen Anne houses that were built in the late 1800s. It appears these features are replacements from the early 20th century; if we look to the 1897 photo the porch columns appear different and more in the traditional Regency style, when verandah columns were more akin to treillage to allow vines to grow. This same style can be seen on other Regency houses in Oakville from around the 1850s.⁹ The Regency style was prevalent in Ontario from 1830 to 1880. The current columns can be seen in the 1950s photo but were likely installed in the early 1900s.

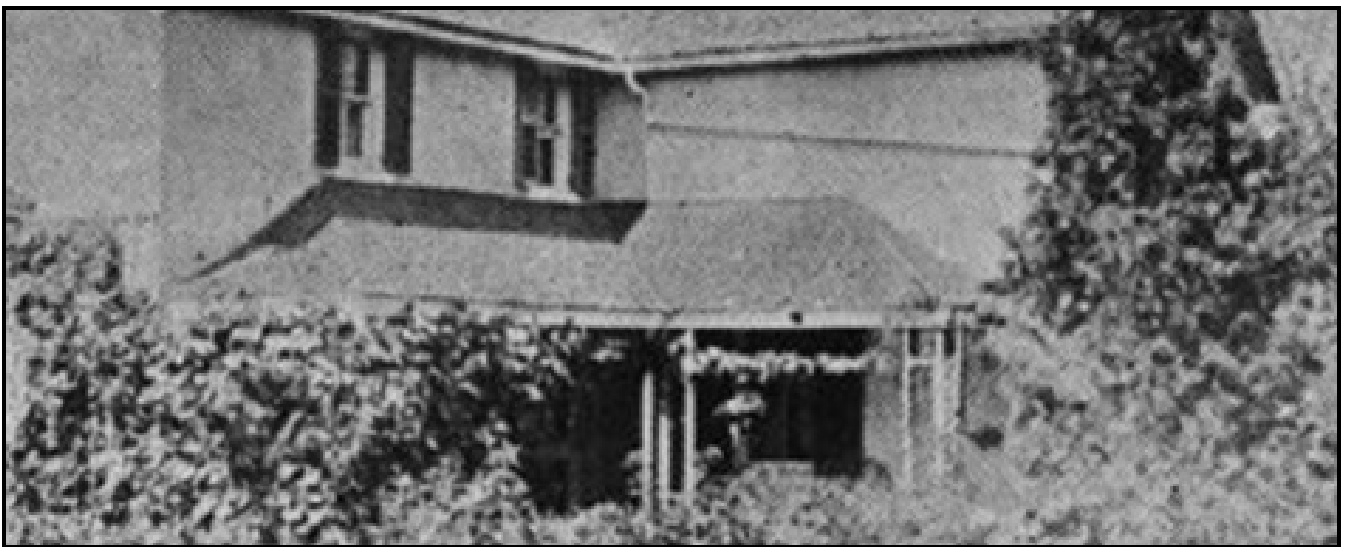
Close-up of the columns from 1897 showing a different column design. Source: Oakville Historical Society

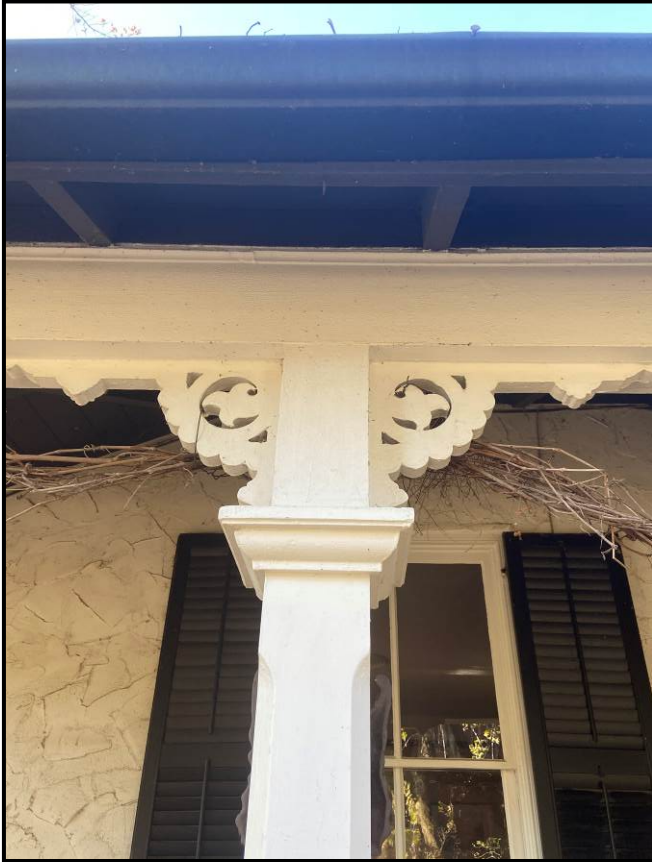
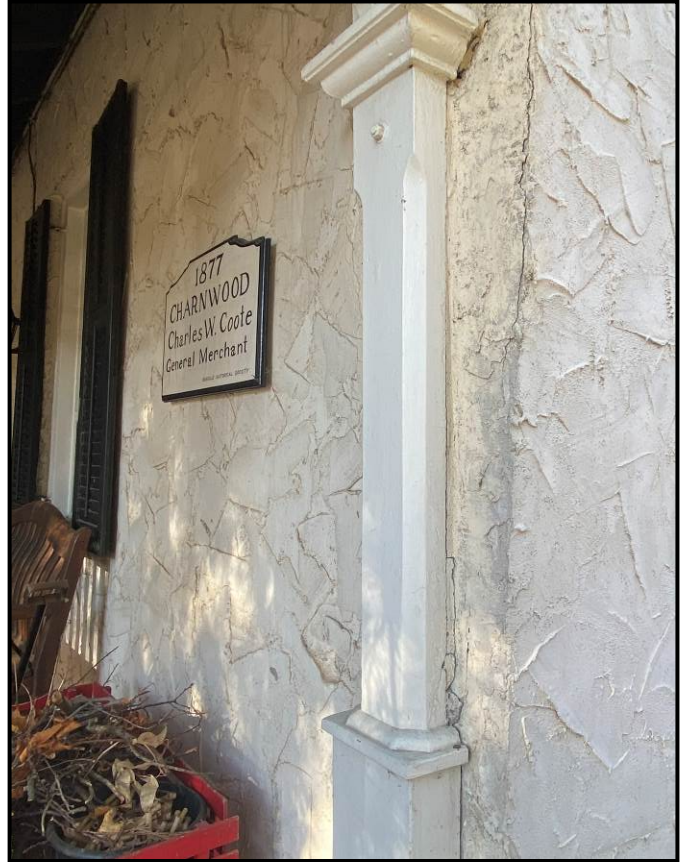
Examples of wooden detailing on the verandah. *Source: Town of Oakville Planning Services Staff*

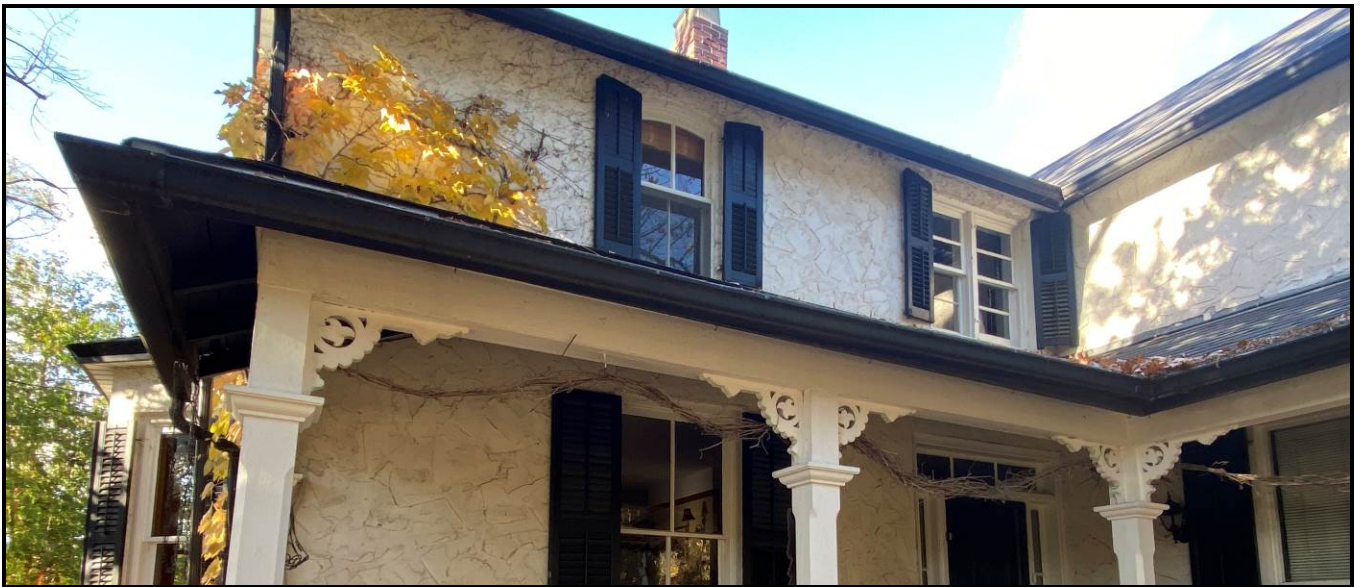
Projecting eaves above the porch. *Source: Town of Oakville Planning Services Staff*

The porch has projecting wooden eaves. The soffit in the rest of the house has been updated. Historically, the house had decorative wooden bargeboard on the gable edges, as seen in the historical photos.

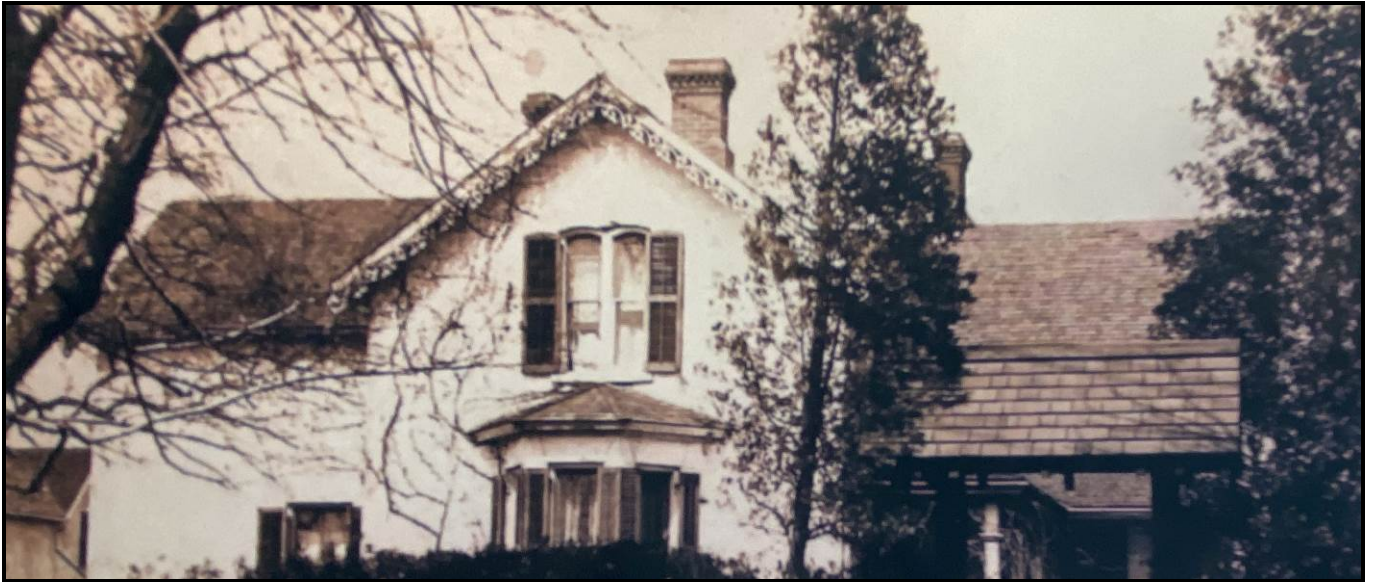
Bargeboard on the west elevation. The three chimneys are also visible. *Source: Town of Oakville Planning Services Staff*

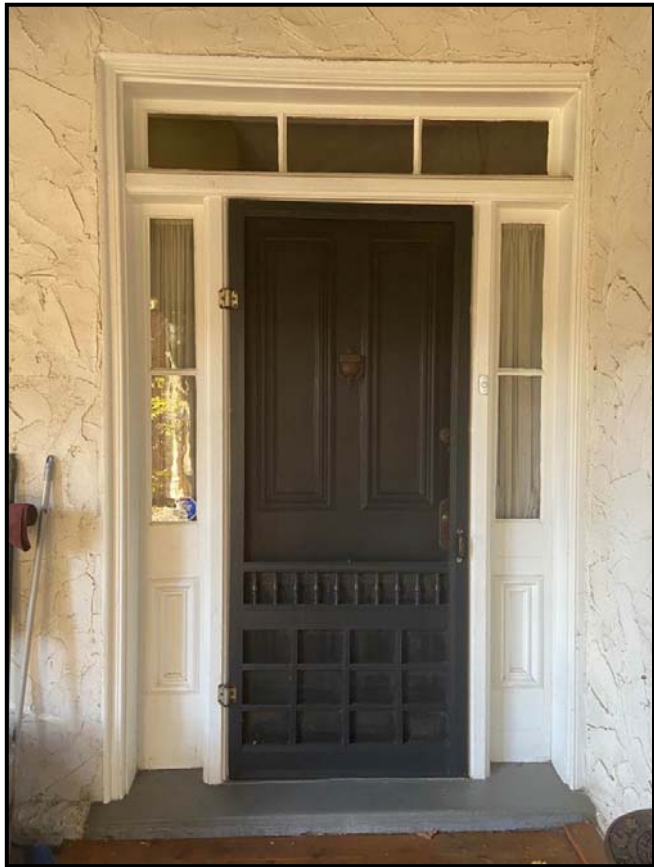
Front door showing the windows, the two-panel wooden door, and Victorian-style screen door. *Source: Town of Oakville Planning Services Staff*

The door under the south elevation porch is the original main entrance door. The gate from the west elevation (as seen on the cover photo) most likely led to a path that went to the verandah.¹⁰ The front entrance has sidelights and a transom window with three horizontal panes of glass. The sidelights have two panes each with wooden panels below. The wooden screen door and main panelled wooden door appear to be historic.
