Cultural Heritage Evaluation Report
Cedar Lodge
149 Dunn Street, Oakville, Ontario

Town of Oakville
Heritage Planning
Authors: Kristen McLaughlin, Carolyn Van Sligtenhorst
December 2023

1. Executive Summary

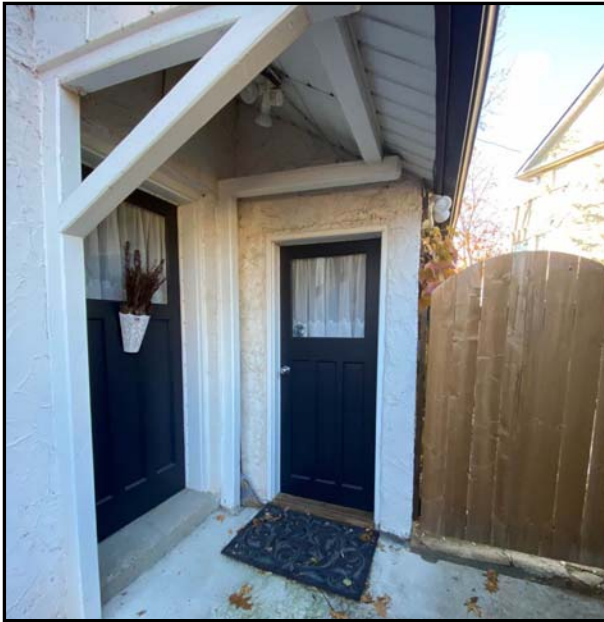
The two entrances on the east elevation that used to lead to the separate living spaces. *Source: Town of Oakville Planning Services Staff*

The east elevation of the house currently has two doors; one was added when the second storey of the house was used as an apartment from 1950 until at least 2000.¹¹ The interior has since been re-opened to the historical layout.¹²

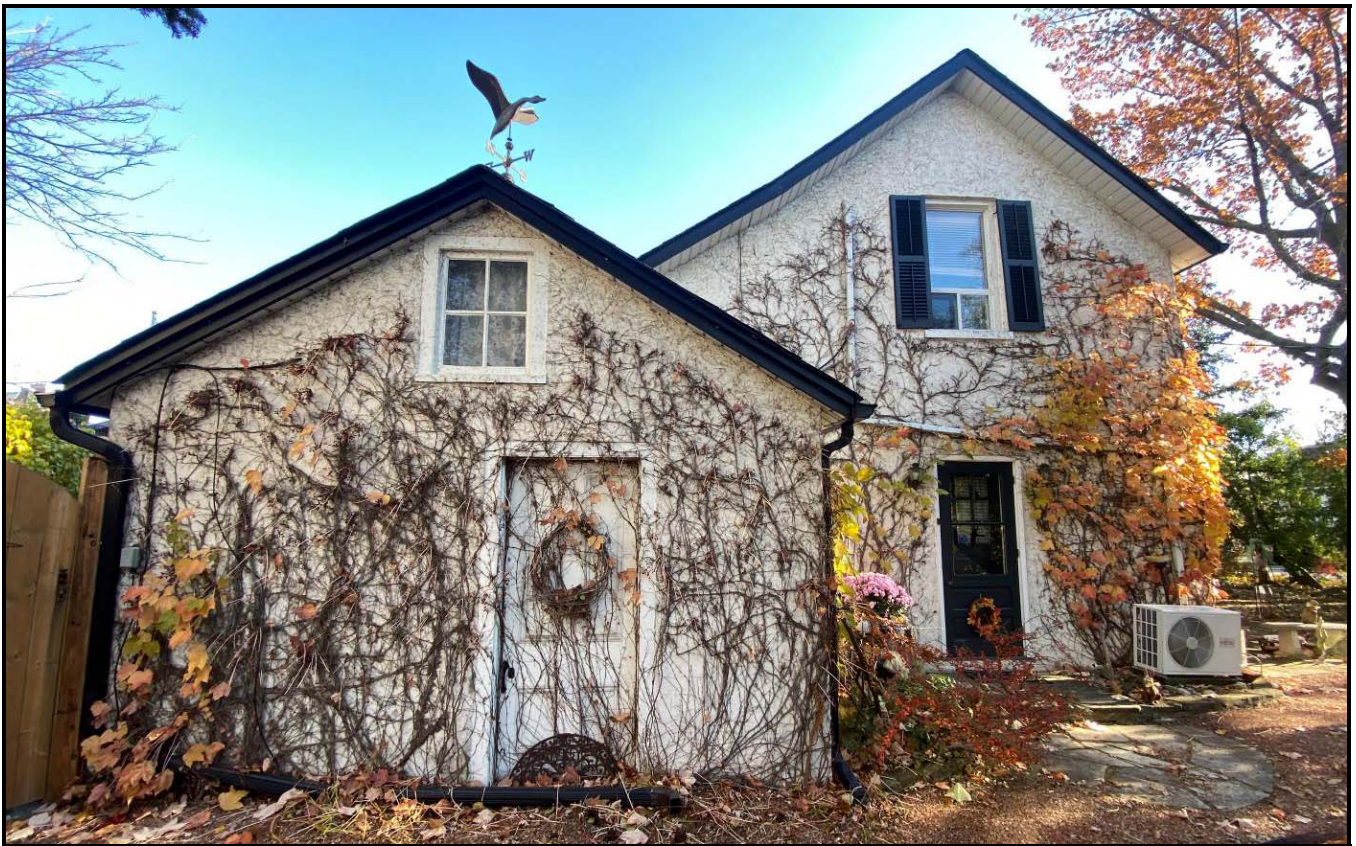
North elevation showing the two entrances. *Source: Town of Oakville Planning Services Staff*

The north elevation has another entrance, but with no sidelights or transom, typical of a more modest rear entrance. The one-storey portion also has a non-functioning door on this elevation, though it is likely that this door and the window above were salvaged from elsewhere as this portion was at one time used as a garage.

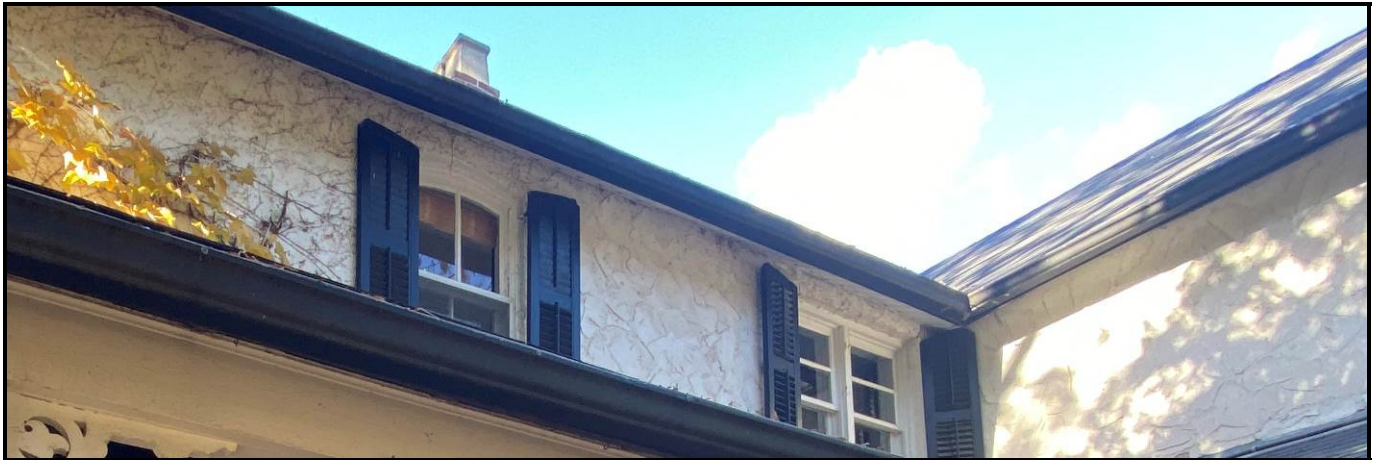
Windows above the verandah. The double window on the right replaced the original segmentally arched window that appears in earlier photographs. *Source: Town of Oakville Planning Services Staff*

There is a variety of heritage windows on this house. The majority of the windows are flat with no trim and plain sills, with the exception of the windows on the second storey of the original south portion of the house, which are segmentally arched. The historic wooden windows on the house are either 1/1 or 2/2 hung sash windows. Many of them have shutters, which may be historical, as they are hinged on the inside and could fit inside the windows frame.¹³ The exception may be the north and south gables, as there are photos of these without shutters. It is possible they were all replaced at one time, but they all utilize the historic-type hardware to actually swing into the inset windows and cover them.

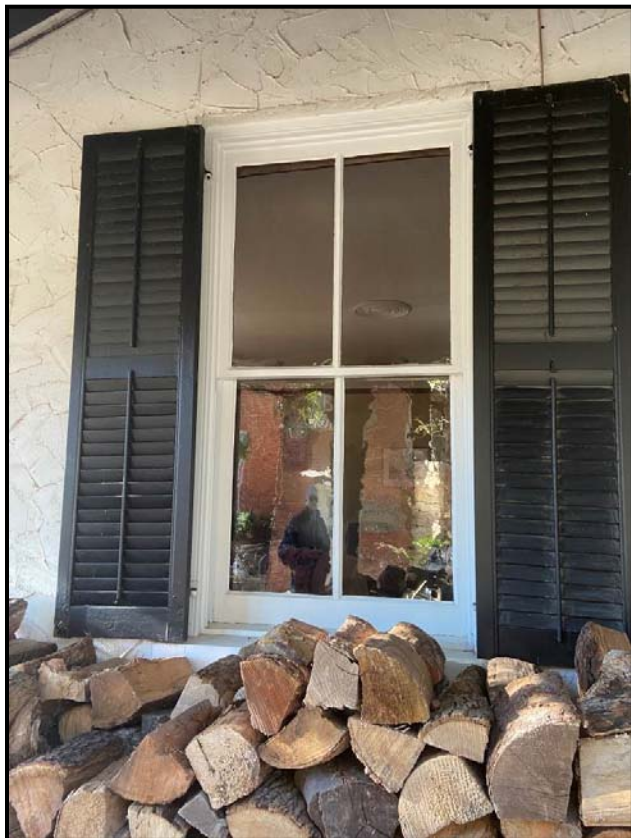
The window to the west of the entrance still has its wavy glass, an indication of an older house as this hand-blown method of making windows was used until the early 1900s.¹⁴

The front entrance window's wavy glass. *Source: Town of Oakville Planning Services Staff*
