## HERITAGE IMPACT STATEMENT

EFFECT OF DEVELOPMENT AT 530 CARSON LANE, OAKVILLE

PROPOSED DEMOLITION OF EXISTING BUILDING

JANUARY 5, 2024

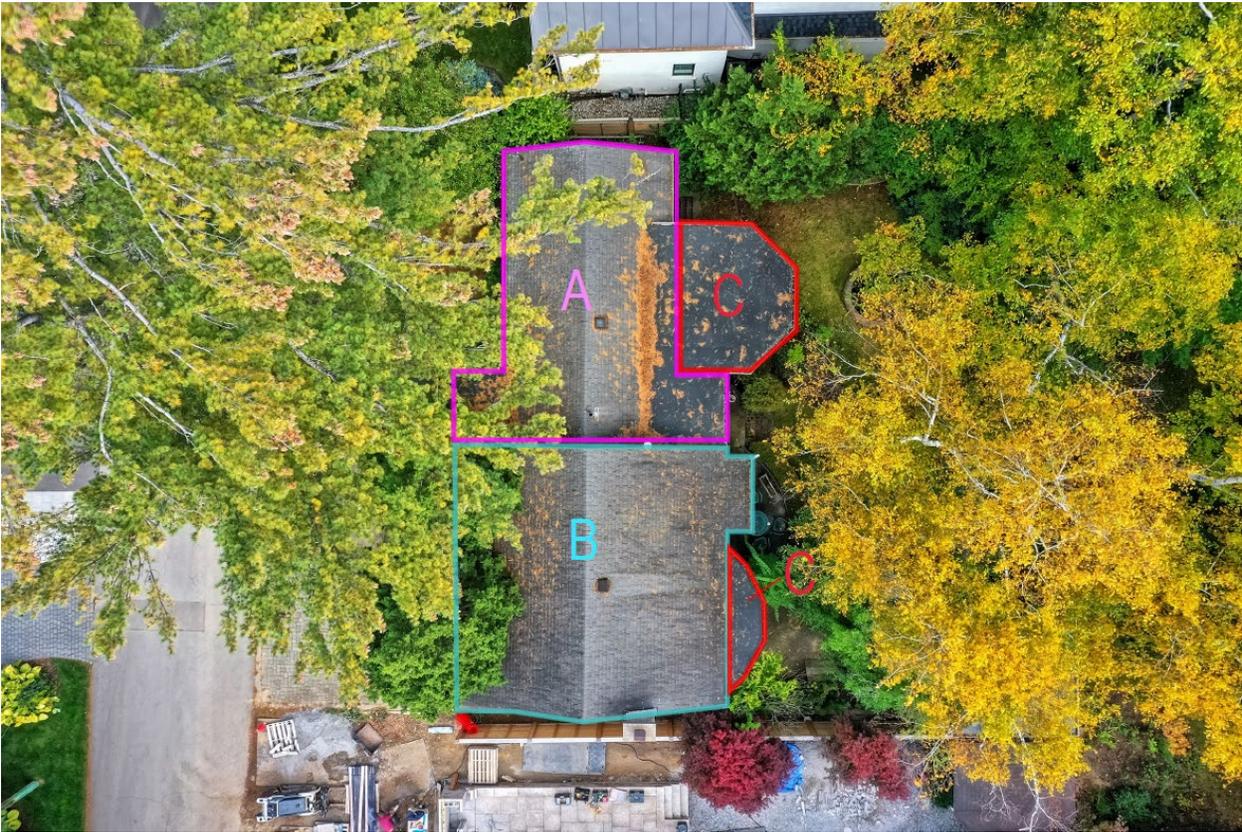
AIR PHOTO SHOWING DIVISION OF BUILDING INTO ELEMENTS

530 Carson Lane is a one-storey, single family home with stucco cladding, wood windows and trims and asphalt shingles. It presents itself in three discrete elements. Two of these are visible from the street and are labelled “A” and “B” in the air photo above. The third element “C” is visible from the rear.

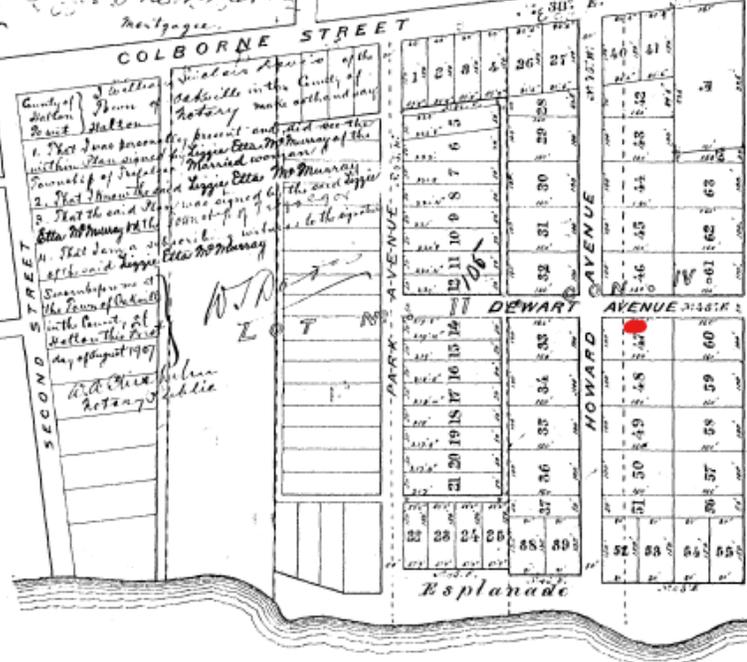
PLAN OF SUBDIVISION. SUBJECT SITE LOCATION IN RED

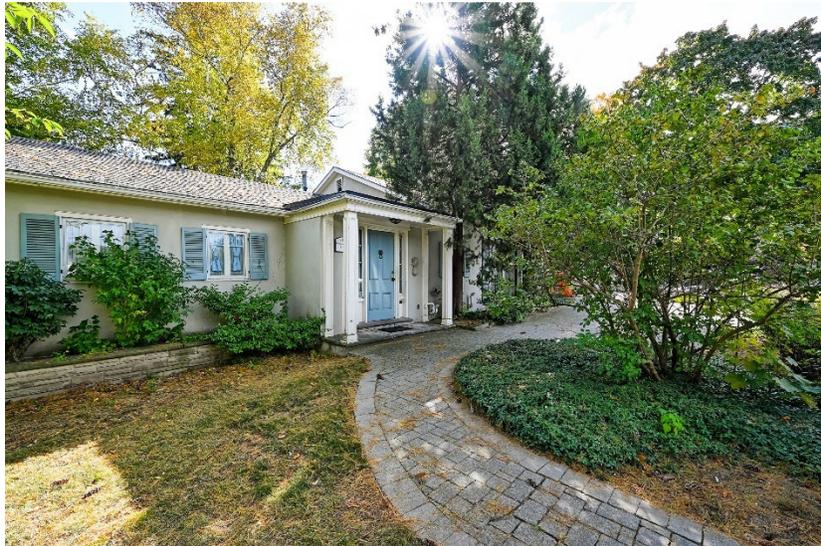
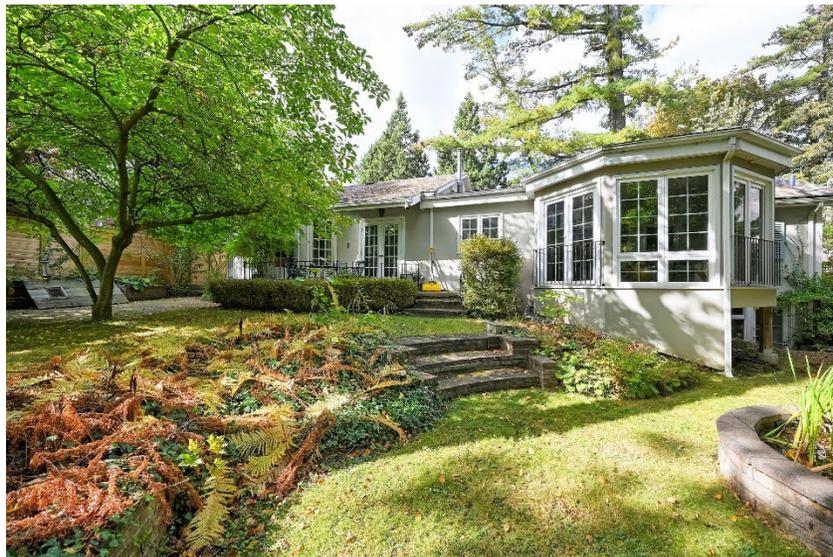
The building has recently been occupied. Observation of the building reveals that it is in generally good condition and with regular maintenance could be made to function indefinitely. No cracks or leaks were observed. The building is square, level and plumb and all floors felt solid underfoot. It has obviously had regular ongoing maintenance. Nothing about the Building's condition is atypical for a building of this age, indeed given its apparent age the condition is remarkably good.

**FRONT AND REAR ELEVATIONS SHOWING REGULAR MAINTENANCE, SERVICEABLE CONDITIONS**

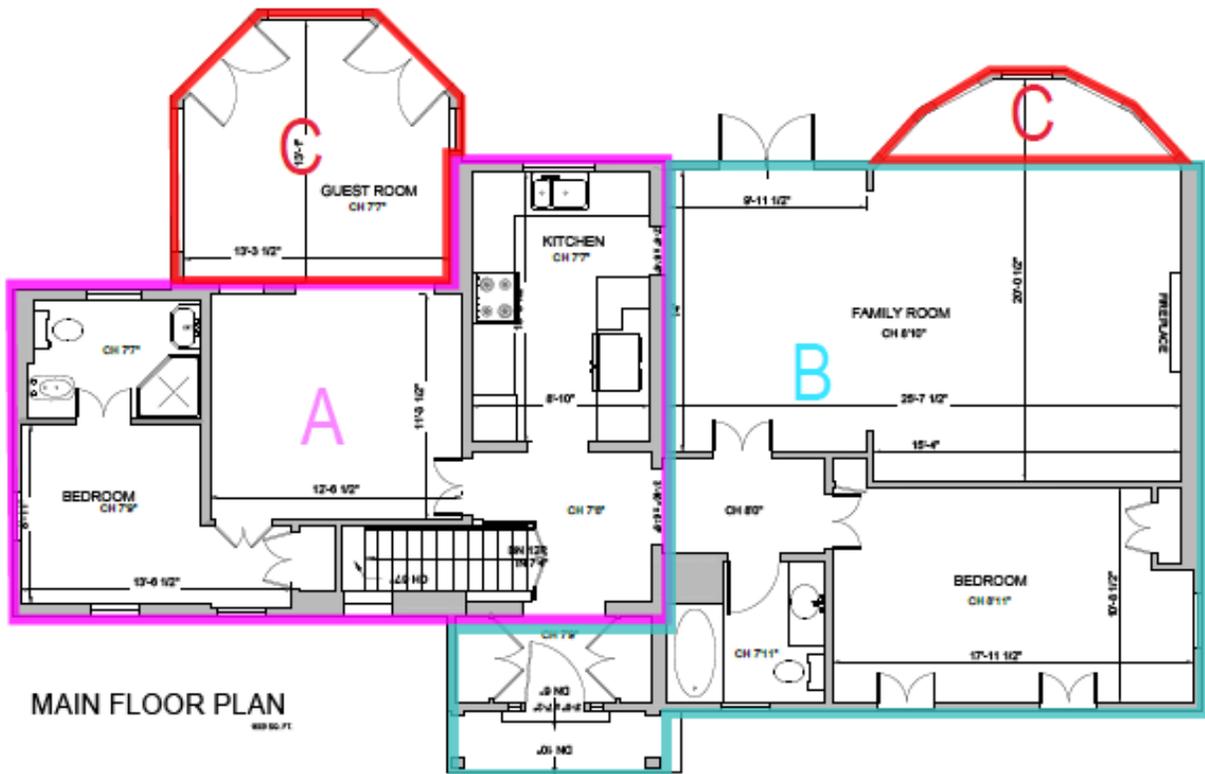
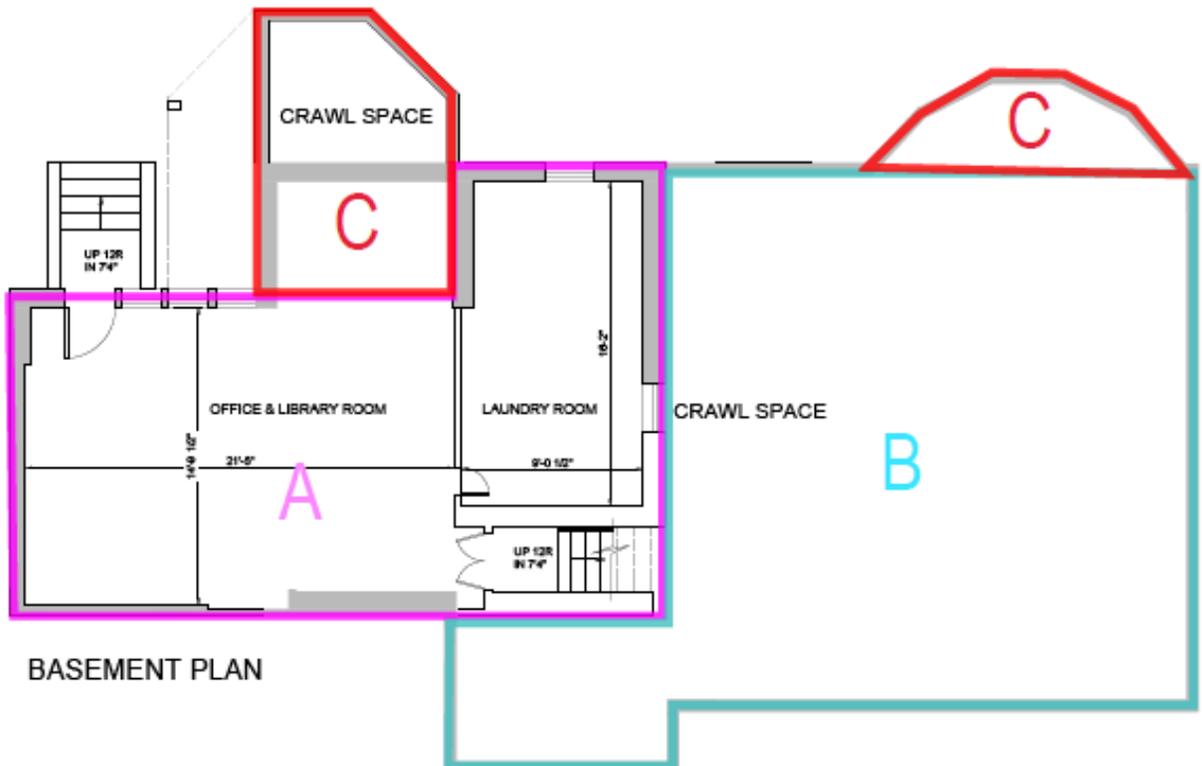
FLOORPLANS SHOWING SEQUENCE OF CONSTRUCTION

Element “A” is clearly the original part of the building. This is obvious from a number of factors including similarity in windows, flooring materials, wall thicknesses and the presence of a basement under only this part of the building. It was not possible to observe any original framing materials that would have given any more clarity of the construction date but generally the date of c. 1900 identified the front door plaque and confirmed by the historical research appears to be accurate.

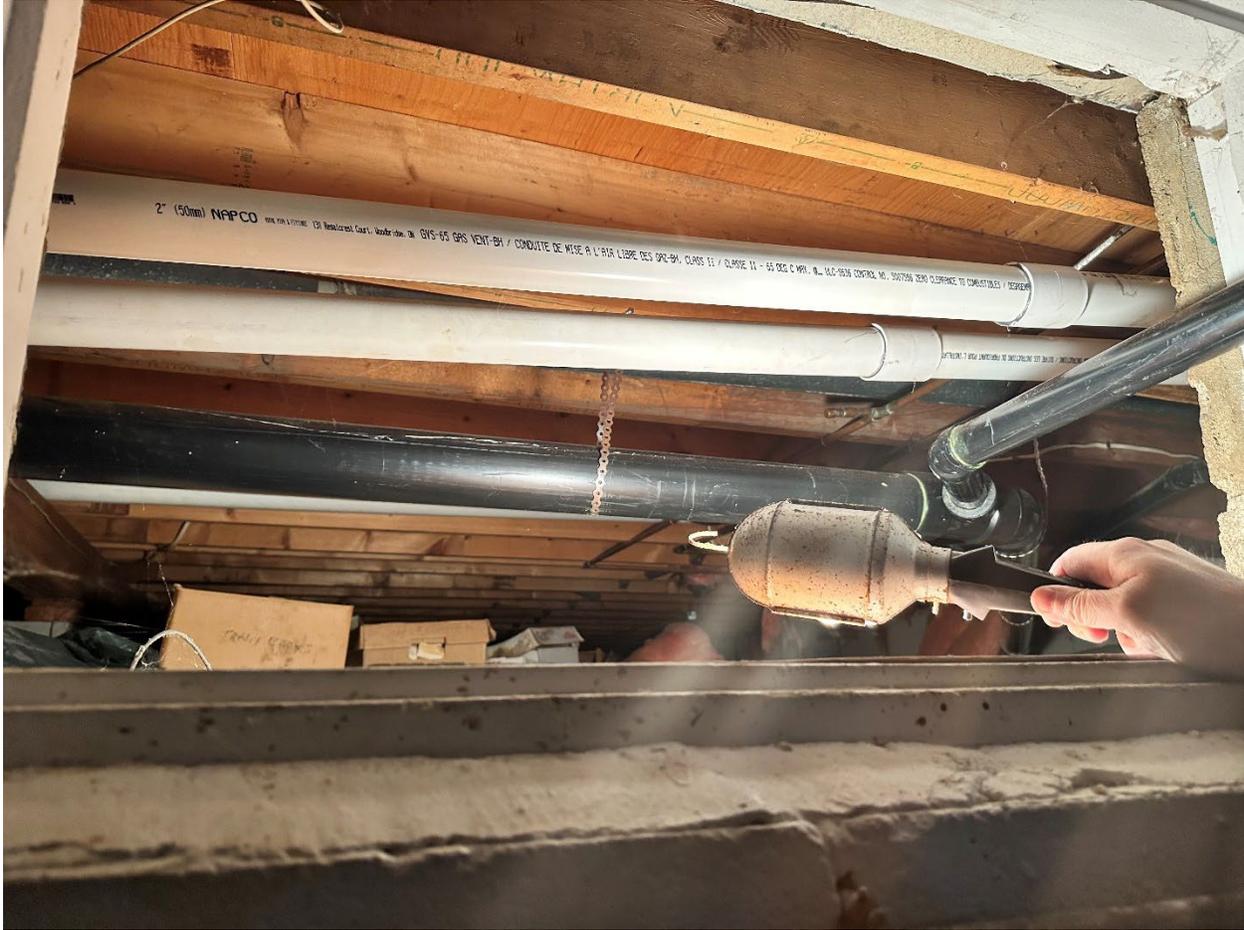
Element “B” was clearly built much later than “A” although the detailing and massing of these elements are similar. The date of construction of “B” cannot be determined conclusively but there are some clues that would indicate early to mid-20<sup>th</sup> century. The strongest indication of this comes from the framing materials which can clearly be seen in the crawlspace under “B”. These are modern, dressed joists that only became available in the mid 20<sup>th</sup> century. Early 20<sup>th</sup> century buildings were typically built with rough-cut joists. Another clue is the absence of any evidence of knob-and-tube wiring in the crawlspace. Even if this wiring had been removed, which often was done, it would leave a tell-tale pattern of paired holes in the joists and evidence of where the knobs had been fastened with wood screws to the joists. There is no evidence of this in the exposed framing in the crawlspace. This further substantiates a mid-20<sup>th</sup> century construction date for this building element.

**CRAWLSPACE UNDER "B" SHOWING MODERN FRAMING MATERIALS**

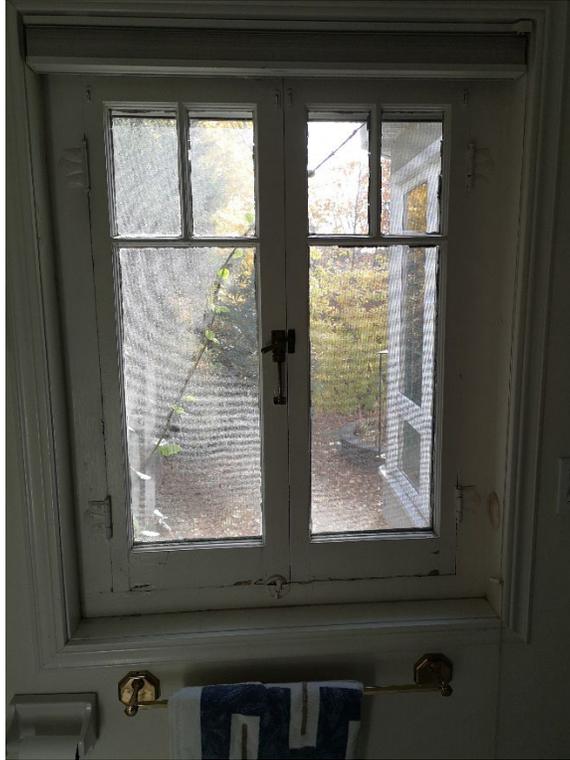
**ORIGINAL WINDOW ELEMENT "A"**

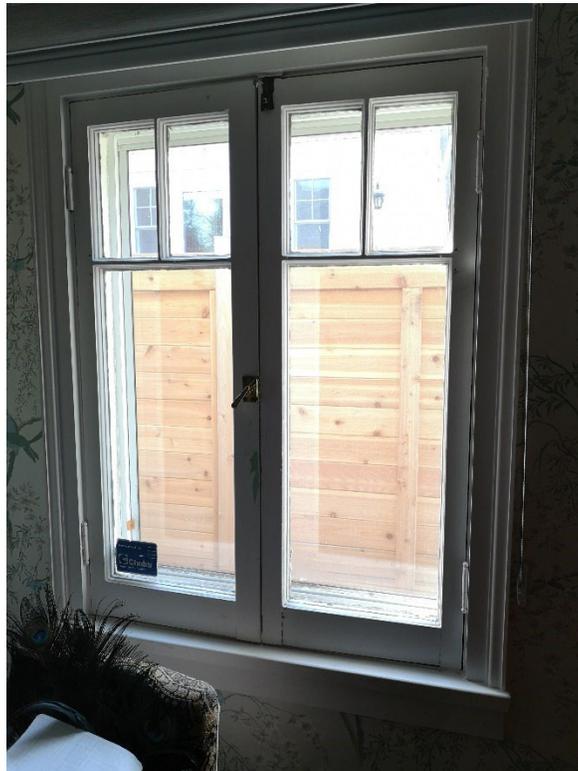
There are also significant differences between the windows and window hardware when comparing Elements “A” and “B”, with those in “B” similar to “A” but clearly newer.

**WINDOW ELEMENT "B". NOTE SIMILAR MUNTIN PATTERN BUT DIFFERENT HARDWARE FROM "A", FRAME WIDTH**

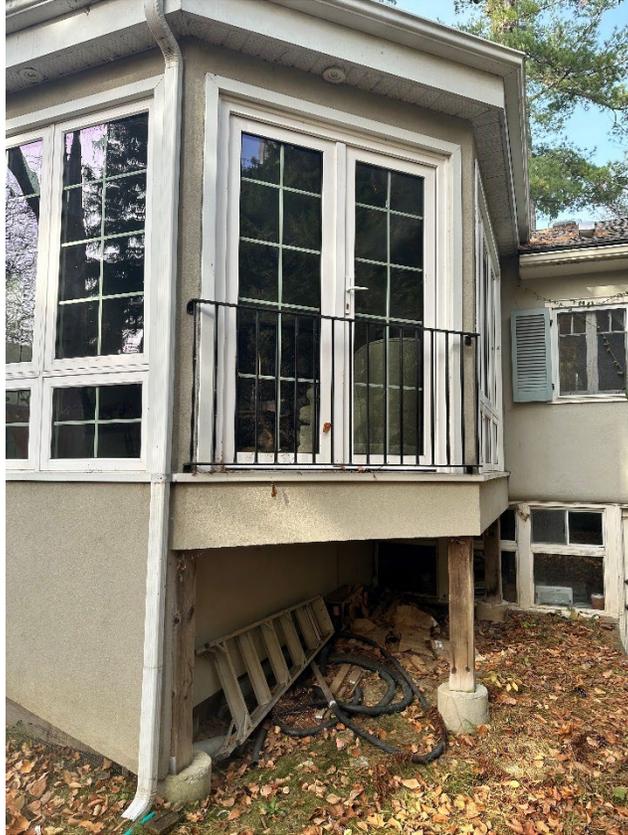
Element "C" is clearly a much more modern addition to the building. This is obvious from the window details, the exterior cladding and trim materials (aluminum trims), the octagonal shape which was a design feature of the late 20<sup>th</sup> century. All of these details let us determine with confidence that this addition was added likely in the 1980's or 1990's.

MODERN WINDOW ELEMENT "C"

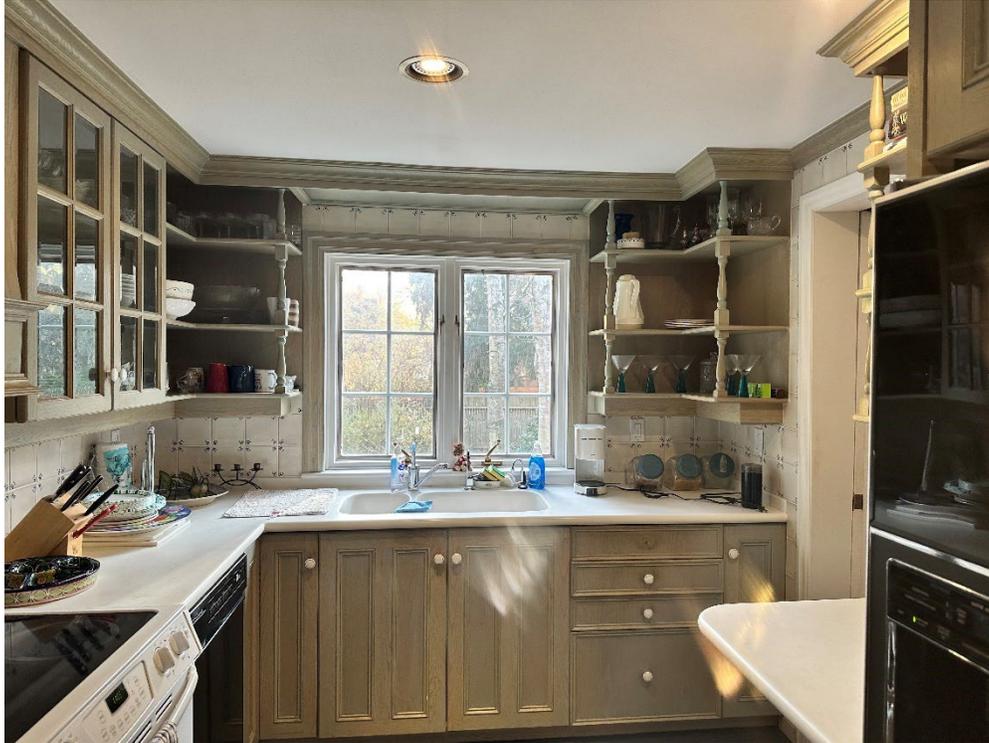
KITCHEN "A". NOTE INTERIOR FINISHES NOT ORIGINAL
