WESTDALE ROAD

THIS PLAN WAS PREPARED FOR DAVID SMALL DESIGNS

Proj. no.: 20-1870

The Al Masoudi Home

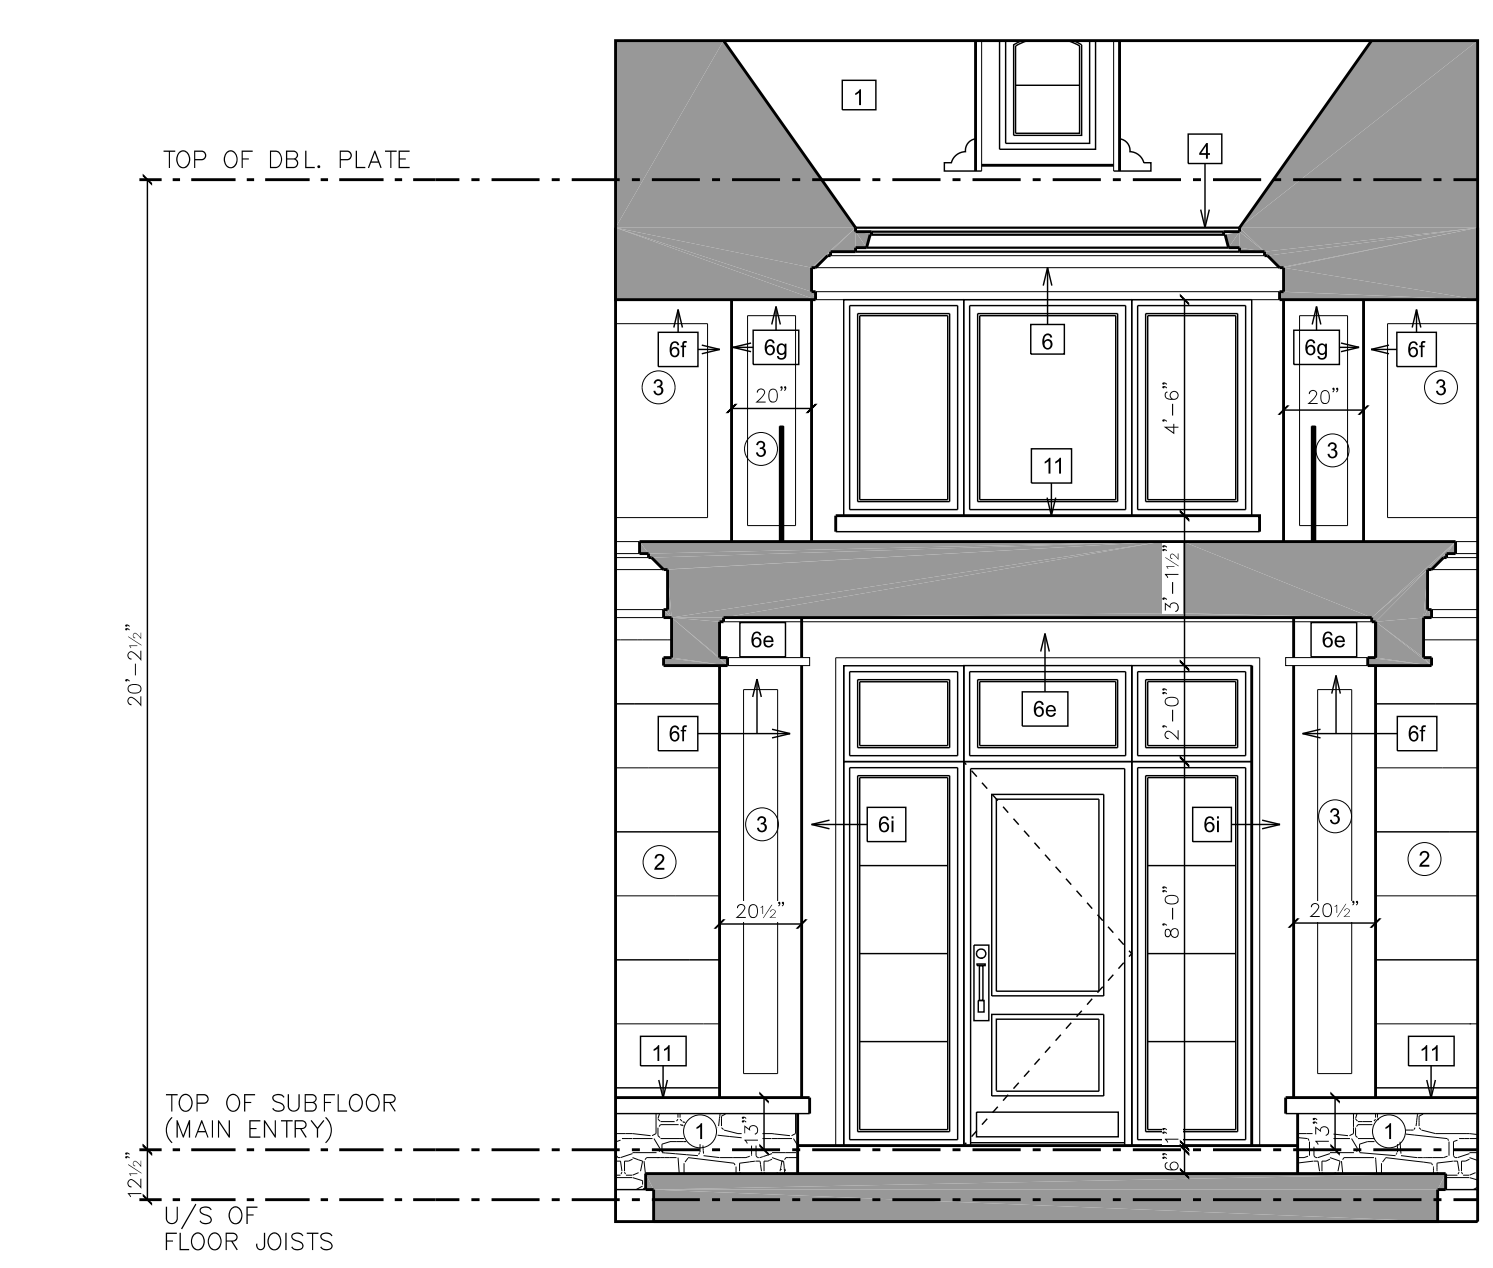
Hidden Elevation 'A'

Unprotected Openings Calculations - Right Side

Limiting Distance	4.21m
Wall Area	1086.8 sf (101.0 sm)
Opening Area Allowed	138.4 sf (12.7%)
Opening Area Proposed	90.9 sf (8.4%)

Please Note The Figure For % Openings Allowed Has Been Interpolated Based On O.B.C. Table 9.10.15.4 And Glazed Areas Were Used To Calculate Proposed Openings As Allowed By 9.10.15.4.

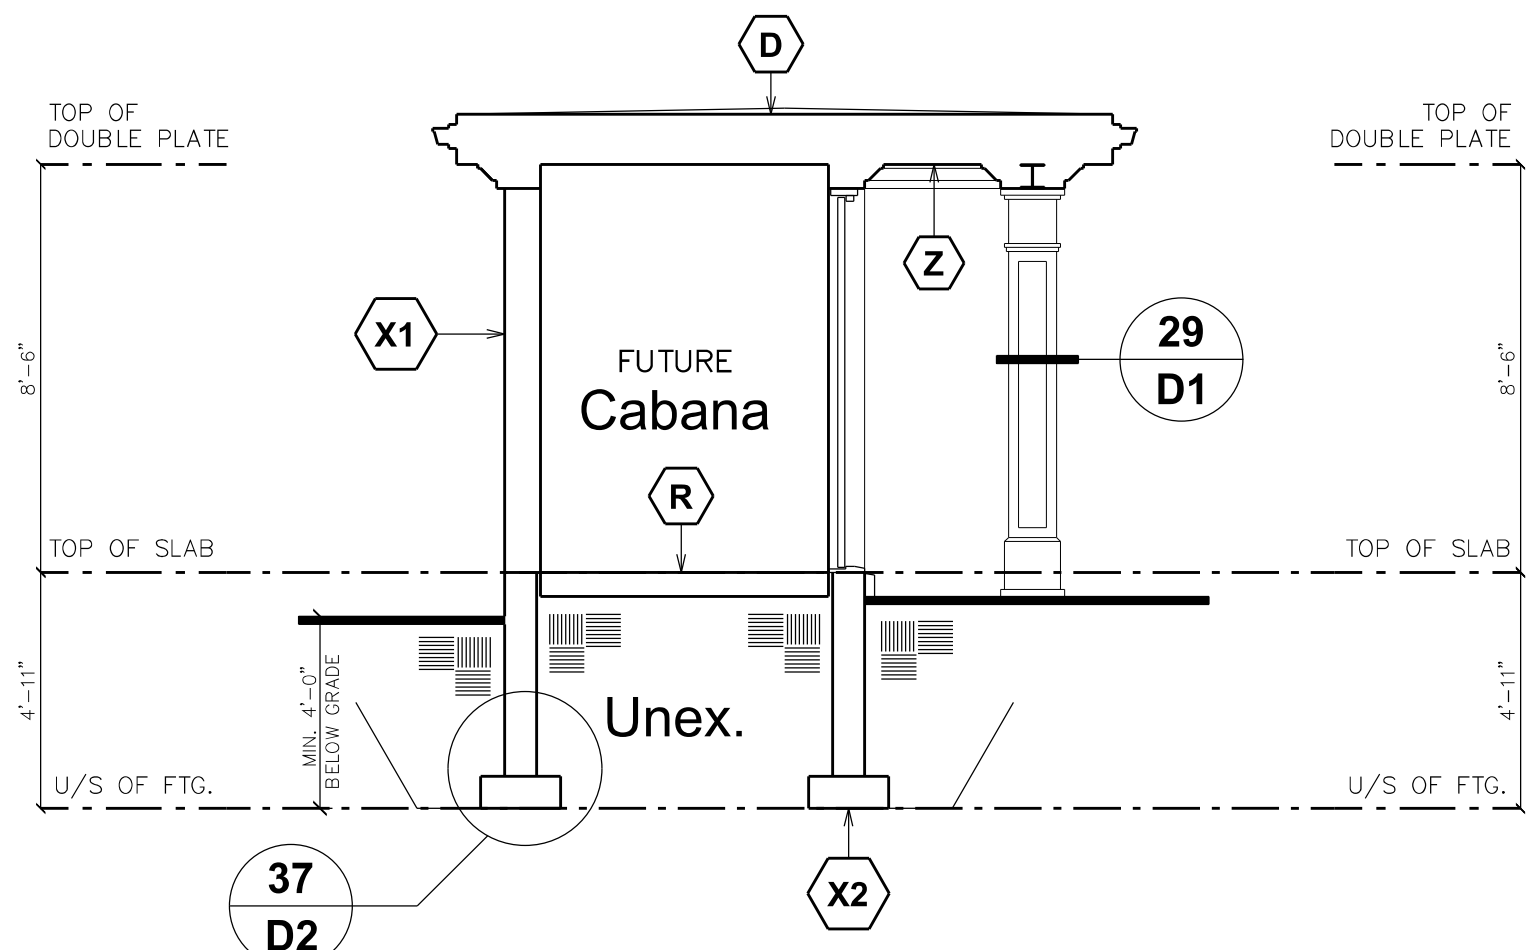
Section B-B

Section Notes

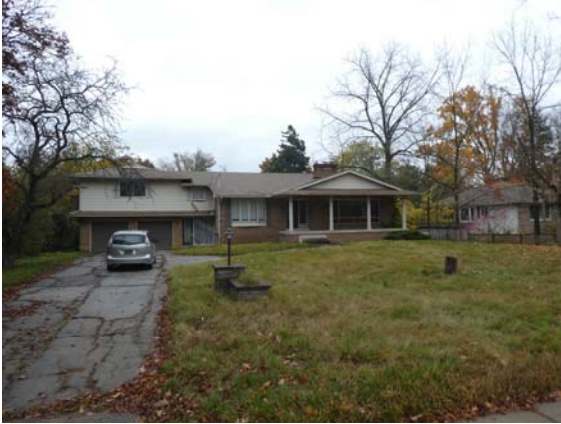
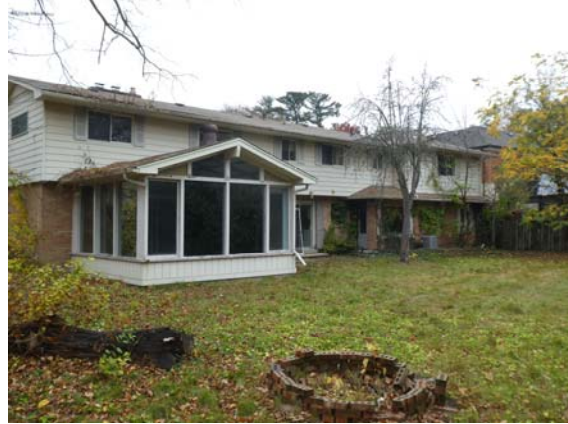
Photo #1

Figure #1: These 2 photos show the front and rear yard of the subject site at 1020 Lakeshore Road West as they appeared during the tree inventory conducted on October 30, 2023.

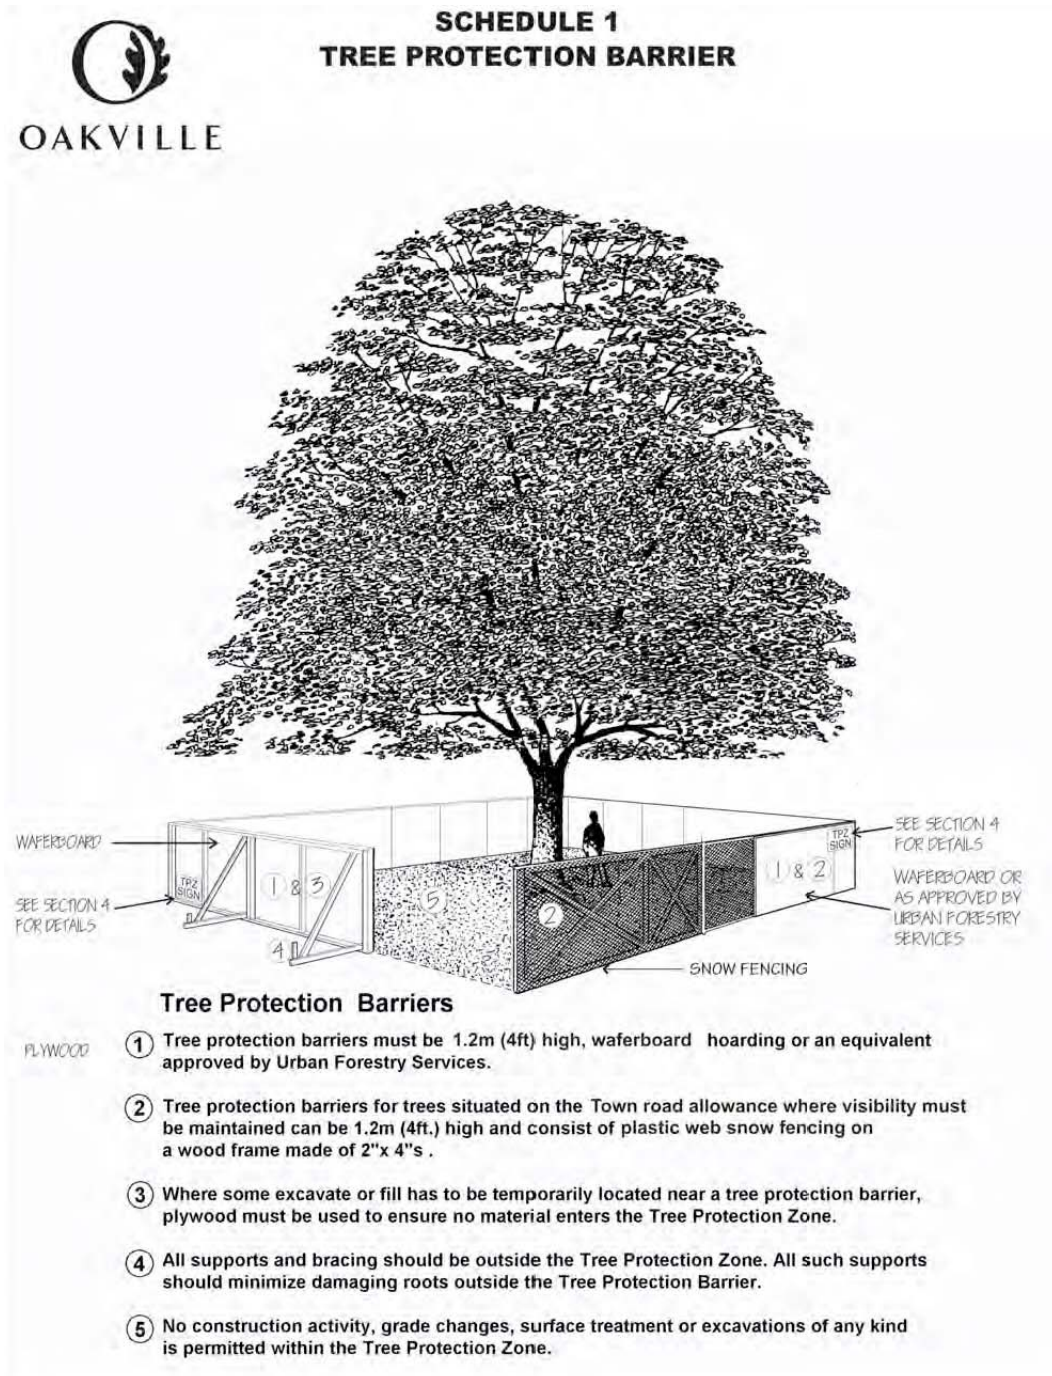
Town of Oakville TPZ Hoarding Specifications

The diagram below provides the Town of Oakville's standards for Tree Protection Zone (T.P.Z) hoarding.

A diagram of the proposed hoarding plan for this site can be found in Appendix A on Page 22 of this report. The recommended radial distances from the trunk for installation of TPZ hoarding are listed in Appendix B starting on Page 23 of this report, and the hoarding shall be installed using the following guidelines:

- 1) All TPZ hoarding shall be placed at the recommended radial distance from the base of all trees to be protected, or up to all existing and/or proposed hard surfaces to allow for construction.
- 2) Any large numbers of trees that can be grouped together in a closed box or continuous line system for protection shall have their TPZ hoarding placed at the recommended radial distance from the base of all of the largest peripheral trees of the system, or up to all existing and/or proposed hard surfaces to allow for construction.
- 3) Encroachment within a tree's TPZ will require a special permit from the Town of Oakville and/or on-site supervision by a Certified Consulting Arborist during any proposed excavation activities for root pruning and assessment.

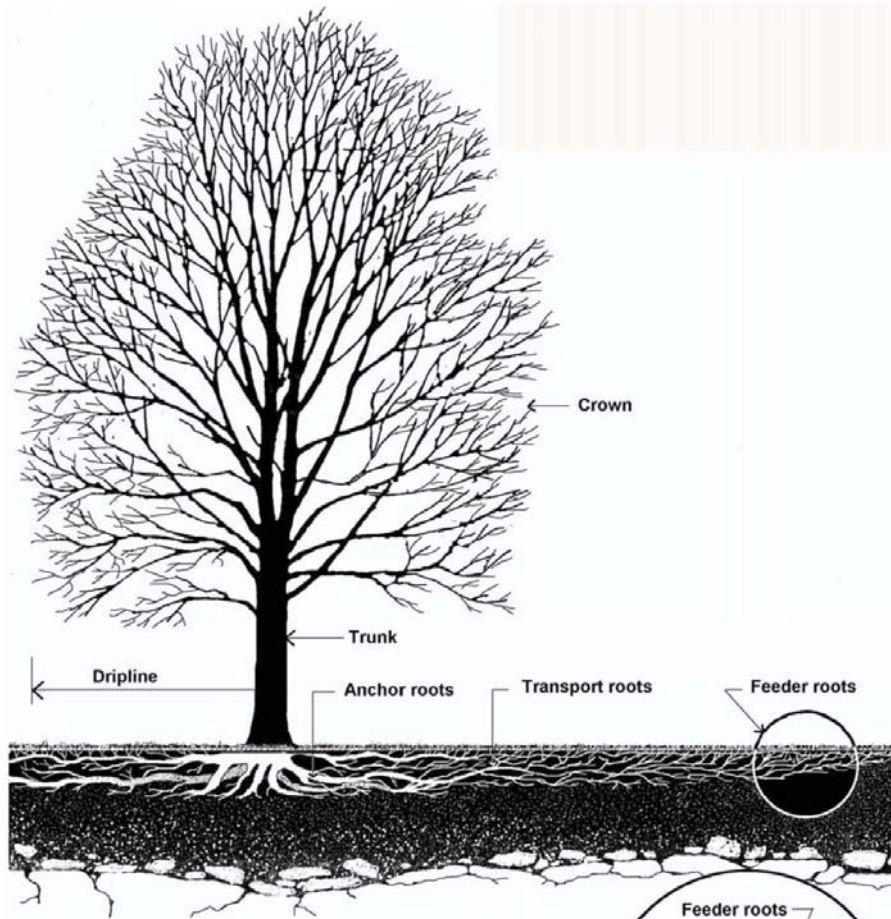
DETAIL TP-1

Optimal Tree Crown and Root Structure – Town of Oakville

A minimum of 1.5 M of well drained soil depth is required for the growth of a tree to maturity. A tree's root system grows mainly within the top 60 cm. of the surface and extends outward 2 to 3 times the dripline dimension. The root system of a tree has three main parts : The large "anchor roots" providing structural support ; a framework of "transport roots" ; and a complex network of "feeder roots" that grow outward and upward from the transport roots. These non-woody roots branch out to form fans of thousands of slender roots with fine root hairs. These tiny roots provide the major portion of the absorption surface of a tree's root system.

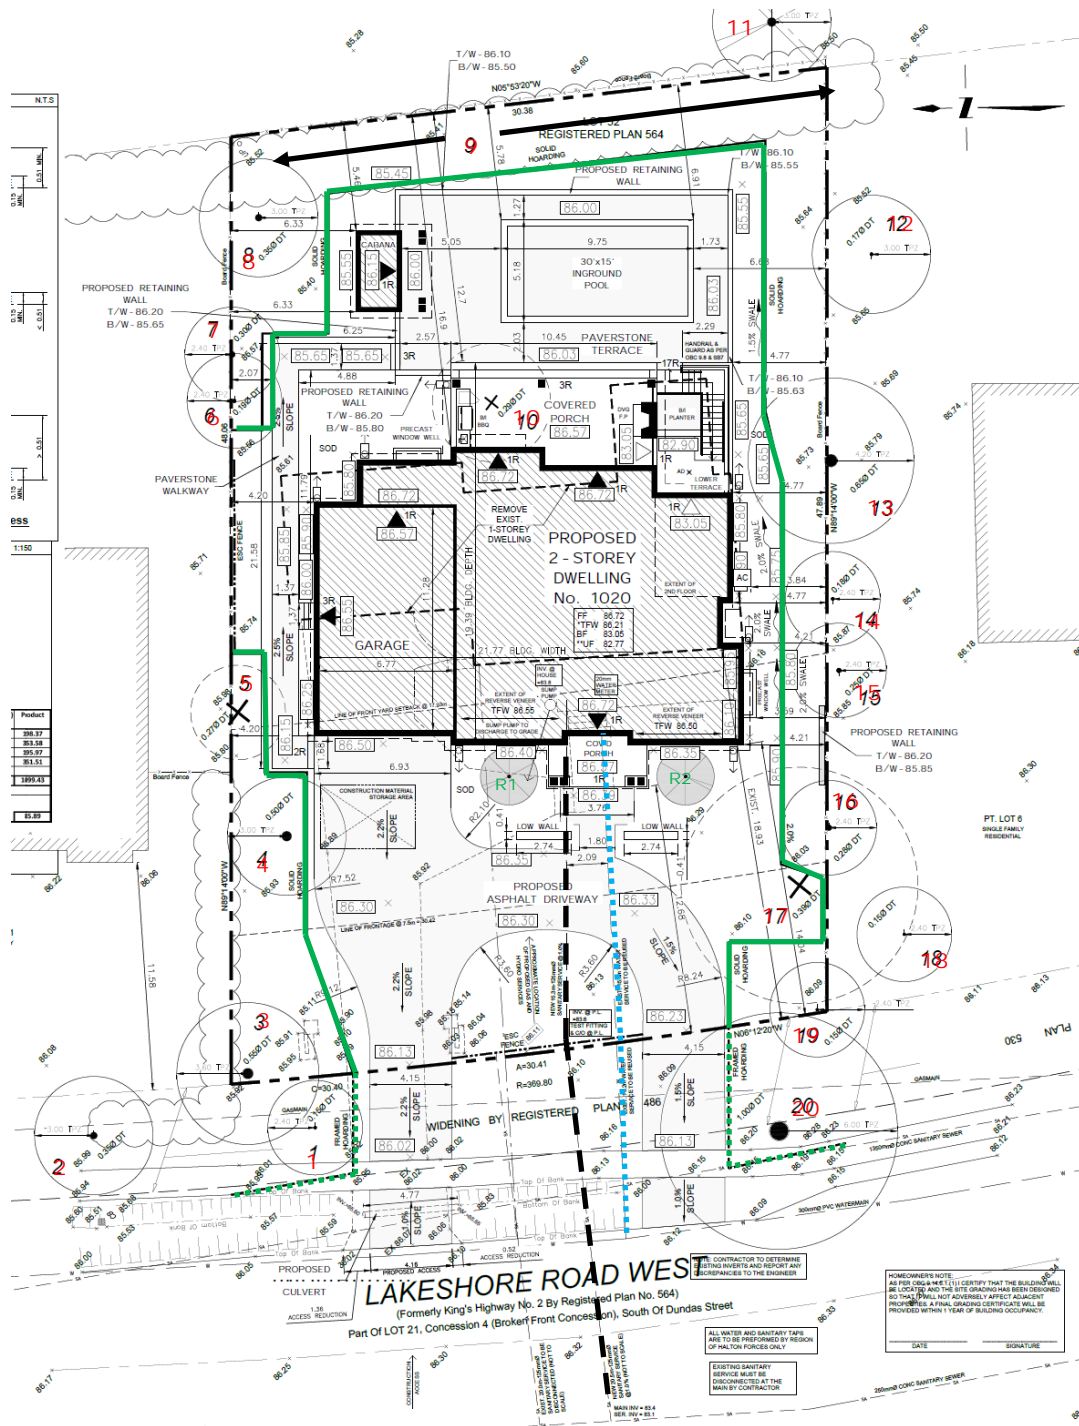
Appendix A: Proposed Site Plan – 1020 Lakeshore Rd. West, Oakville

Note: The location of Tree #12 is an approximation. The proposed Tree Protection Zone (TPZ) hoarding is drawn as green lines and has been drawn to scale on the site plan by the project architect. Rx denotes two (2) replacement trees and their approximate proposed locations.

Two (2) replacement trees and their approximate proposed locations are marked with the symbol **Rx** on the site plan in Appendix A on Page 22 of this report.

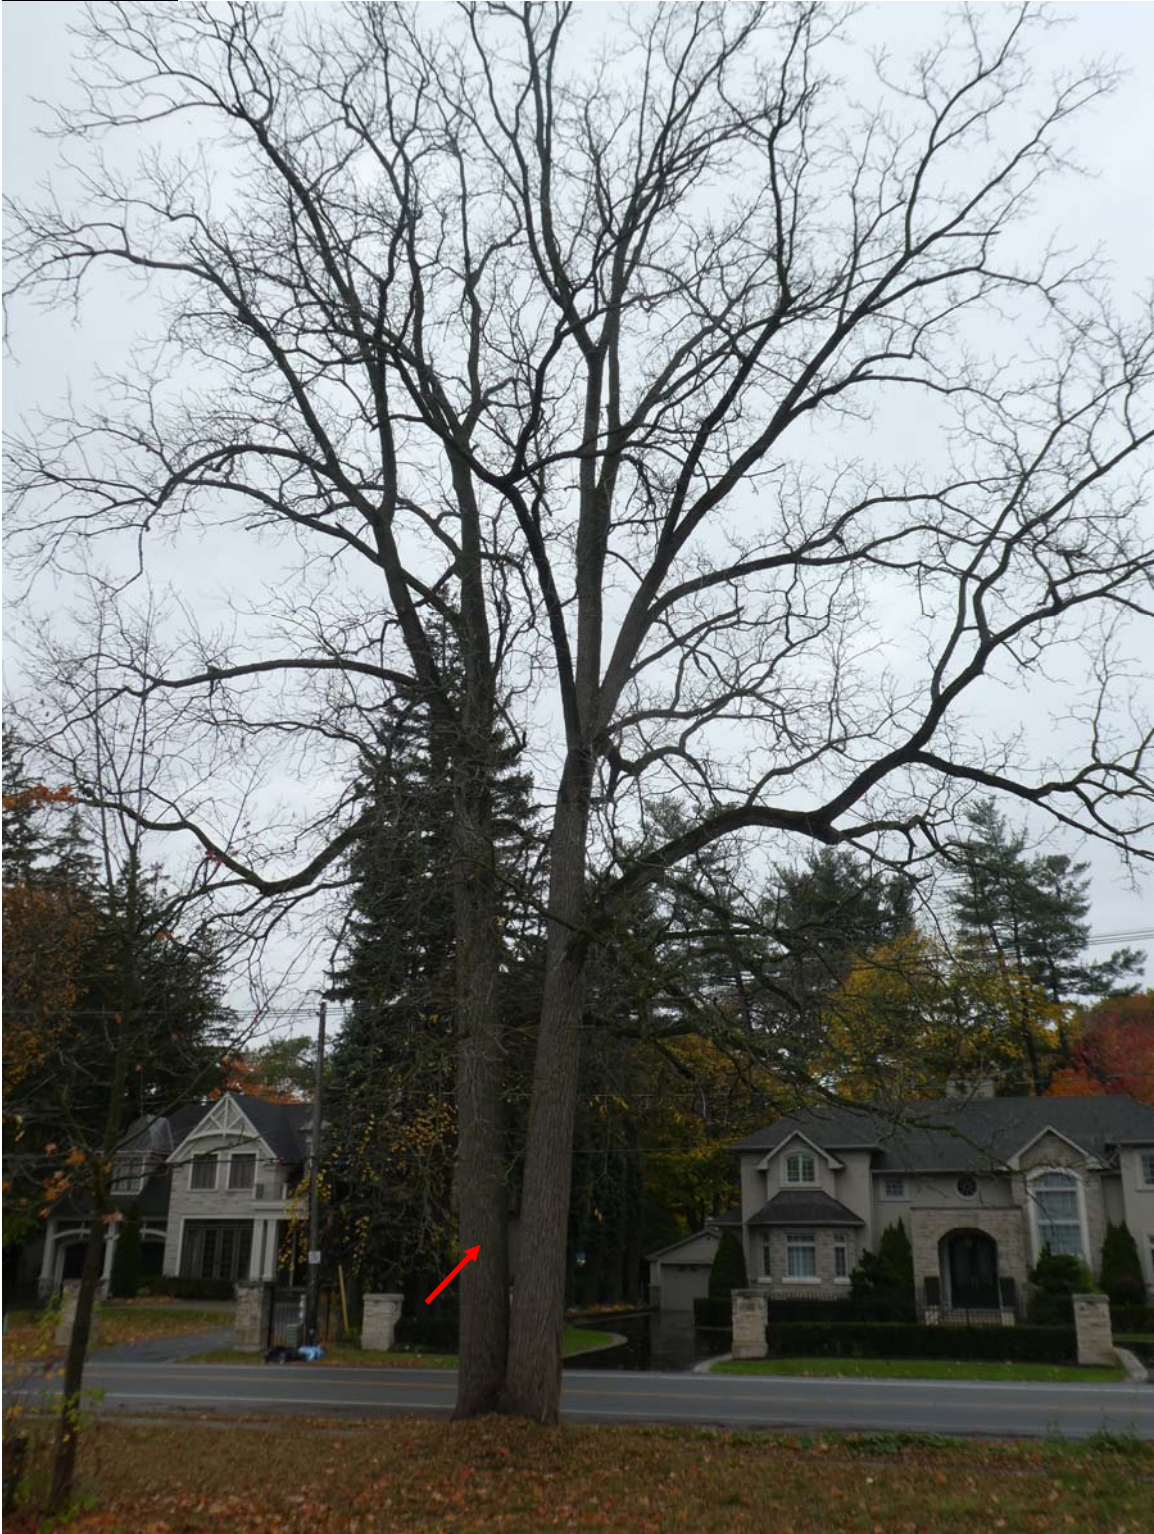
Photo #3 (Tree #20 – Black Walnut – Town tree – 100cm DBH – Minimum TPZ = 6.0m)

Please refer to Pages 7 and 13 of this report for further information.
