# FINAL REPORT:

Heritage Impact Assessment

324 Spruce Street, Town of Oakville, ON

Project #LHC0409

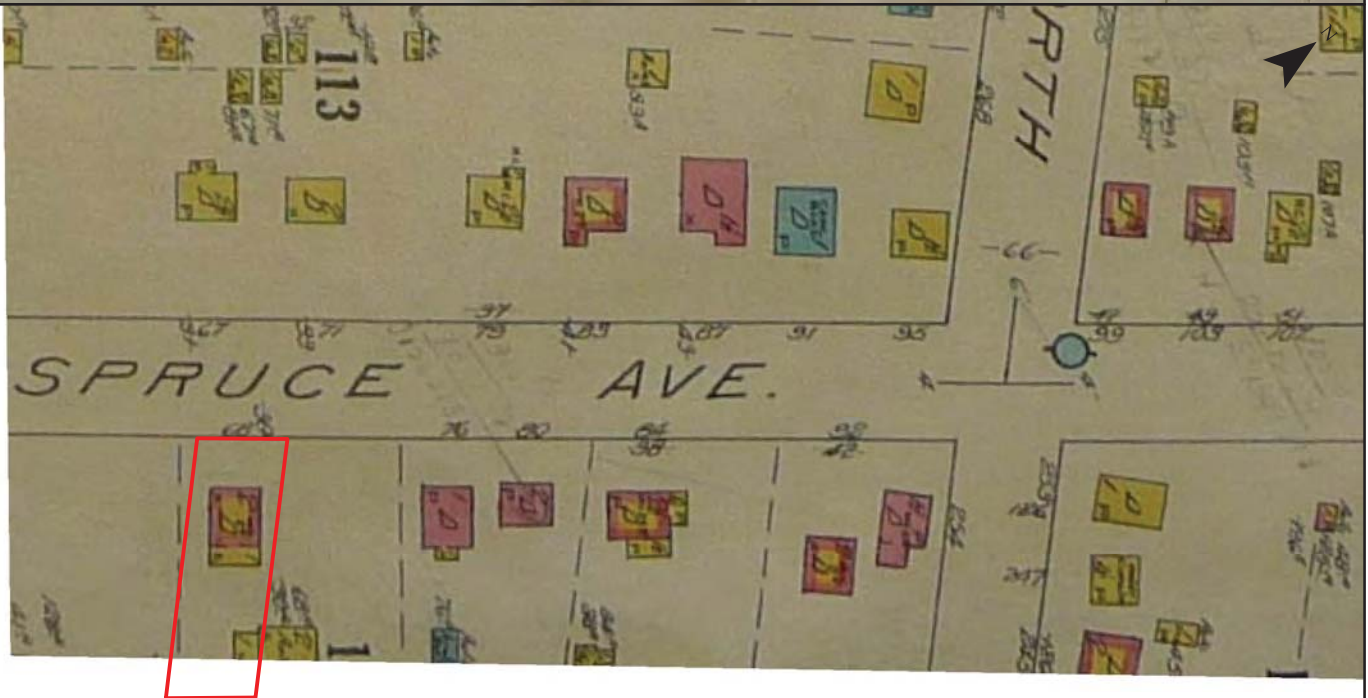
FIGURE # 7

Year	Data Medium (Figure)	Morphology
<b>1924</b>	FIP (Figure 7)	<p>One building is shown on the northwest side of Spruce Street (Plan 127 Lot 12).</p> <p>Three buildings are shown on the southeast side of Spruce Street and four buildings are shown on the northwest side of MacDonald Road. Present buildings are generally contained within a single property parcel as defined within Plan 121. The buildings differ slightly in size and shape but share a similar setback from Spruce Street.</p>
<b>1934</b>	Aerial (Figure 8)	<p>Six buildings are shown on the northwest side of Spruce Street. Aside from the building that fronts onto Reynolds Street (Plan 127 Lot 12), each building is similar size and shape and has a similar setback from Spruce Street. Each building's primary façade is parallel to Spruce Street.</p> <p>Three buildings are shown on the southeast side of Spruce Street. The buildings differ slightly in size and shape but share a similar setback from Spruce Street. The primary façade of each building is not parallel with Spruce Street; they are angled slightly to the north. This angle is in keeping with the lot shape defined in Plan 121.</p> <p>Five building are shown on the northwest side of MacDonald Road. The building closest to Reynolds Street (Plan 121 Block A) is larger than the others and has a deeper setback from MacDonald Road. The other four buildings are similar in size, shape, and setback distance. The primary façade of each building is not parallel with MacDonald Road; they are angled slightly to the south. This angle is in keeping with the lot shape defined in Plan 121.</p>

<b>1949</b>	FIP (Figure 7)	<p>Seven buildings are shown on the northwest side of Spruce Street (the building at Plan 127 Lot 12 is out of frame). Two additional buildings were constructed near Spruce Street's intersection with Allen Street. The newly developed buildings are similar in size and shape and have a similar setback to the others on the northwest side of the street.</p> <p>Six buildings are shown on the southeast side of Spruce Street. Buildings were constructed on 332 Spruce Street, 336 Spruce Street, and 386 Allen Street. The new buildings differ slightly in size and shape but share a similar setback from Spruce Street.</p>

15 September 1953.<sup>77</sup> No major discernable changes occurred on the Property by 1949 or 1954 (Figure 7 and Figure 8).

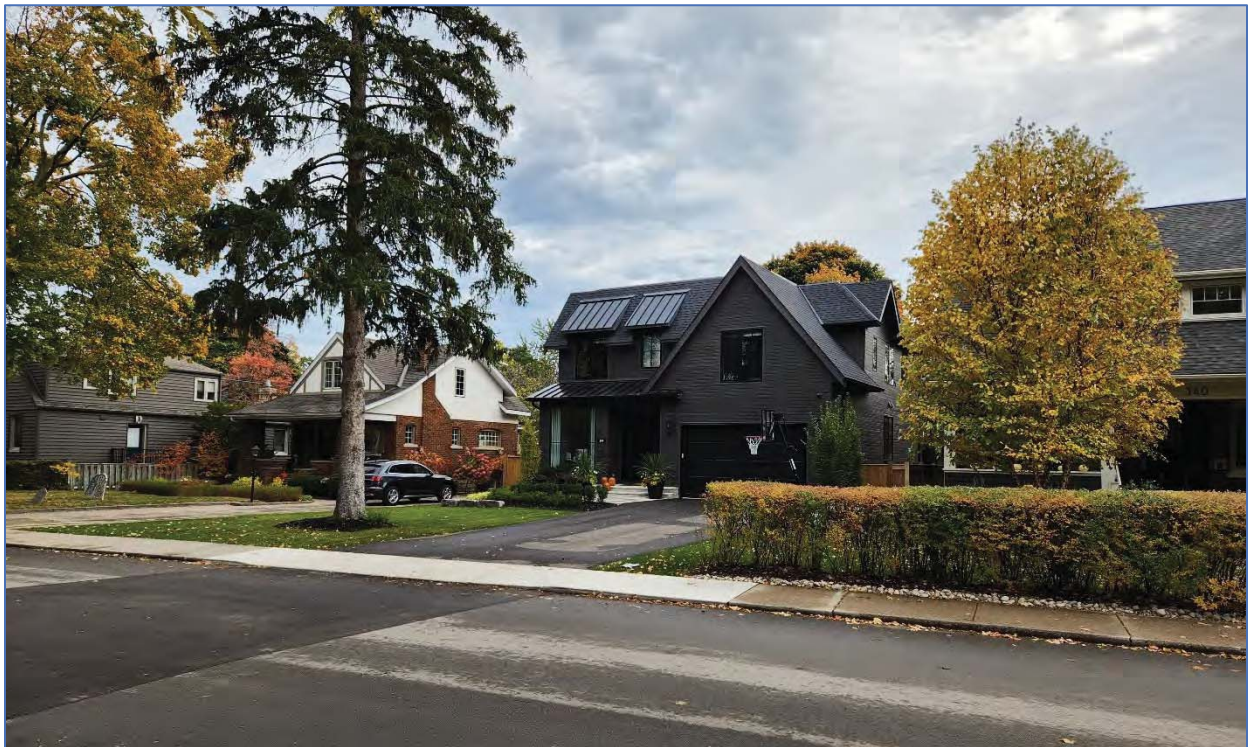
Photo 6: View of 340-348 Spruce Street

Buildings in the Property's immediate context generally have a moderate setback from the street, which is typically no less than 11.0 metres and no more than 17.5 metres, and have narrow side yards, which are typically no less than 1.0 metre and no more than 6.0 metres. This general composition was standard for properties in the 'Brantwood Annex' and 'Tuxedo Park' (Photo 6; see Appendix D).

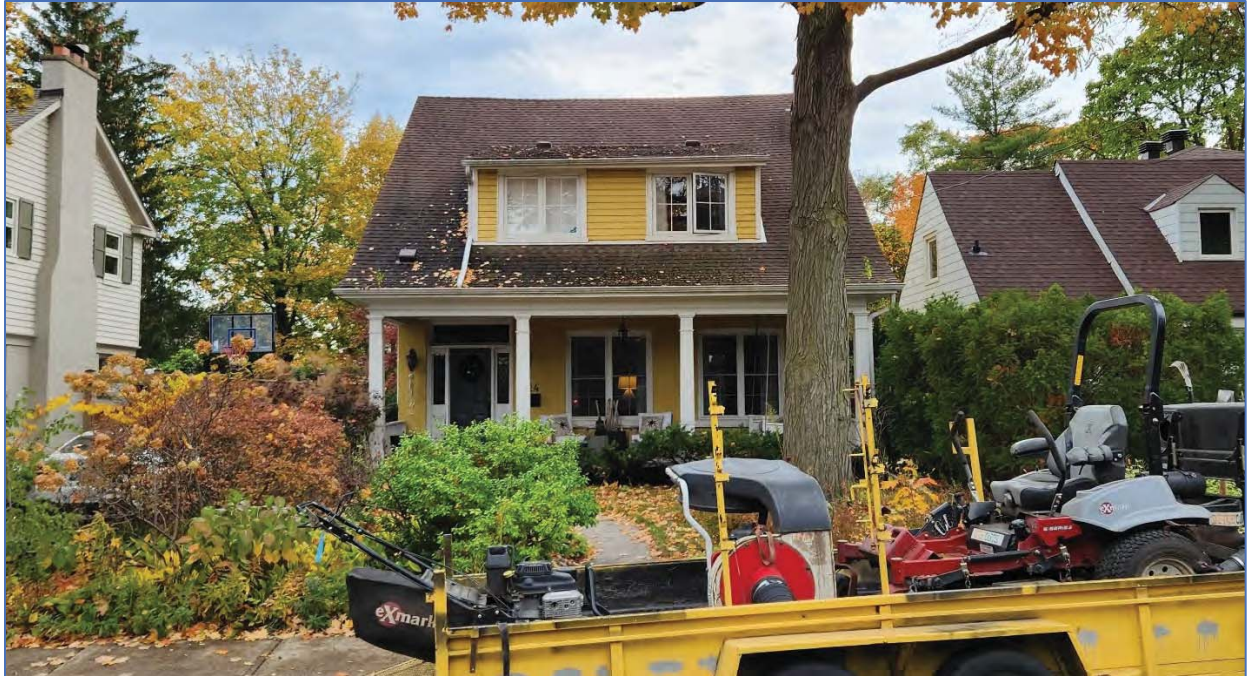
Photo 7: View southeast showing the primary, northwest elevation of the house

The Property is a rectangular lot with an approximate area of 675 square metres. It is on the southeast side of Spruce Street. The house is a two-and-a-half storey, brick, cedar shake, and clapboard siding clad house built between 1912-1924 with influences from the Craftsman Bungalow architectural style. The Property has a narrow asphalt driveway to the northeast of the house. It has a concrete walkway that curves from Spruce Street to the front porch and over to the driveway. The walkway divides the front yard into two distinct sides. The north side – between the driveway and walkway—is a garden with several shrubs and perennial flowers. The south side—between the walkway and southwest property line—has garden areas, some lawn, a mature Maple tree and a tall hedge along the southwest property line (Photo 7).

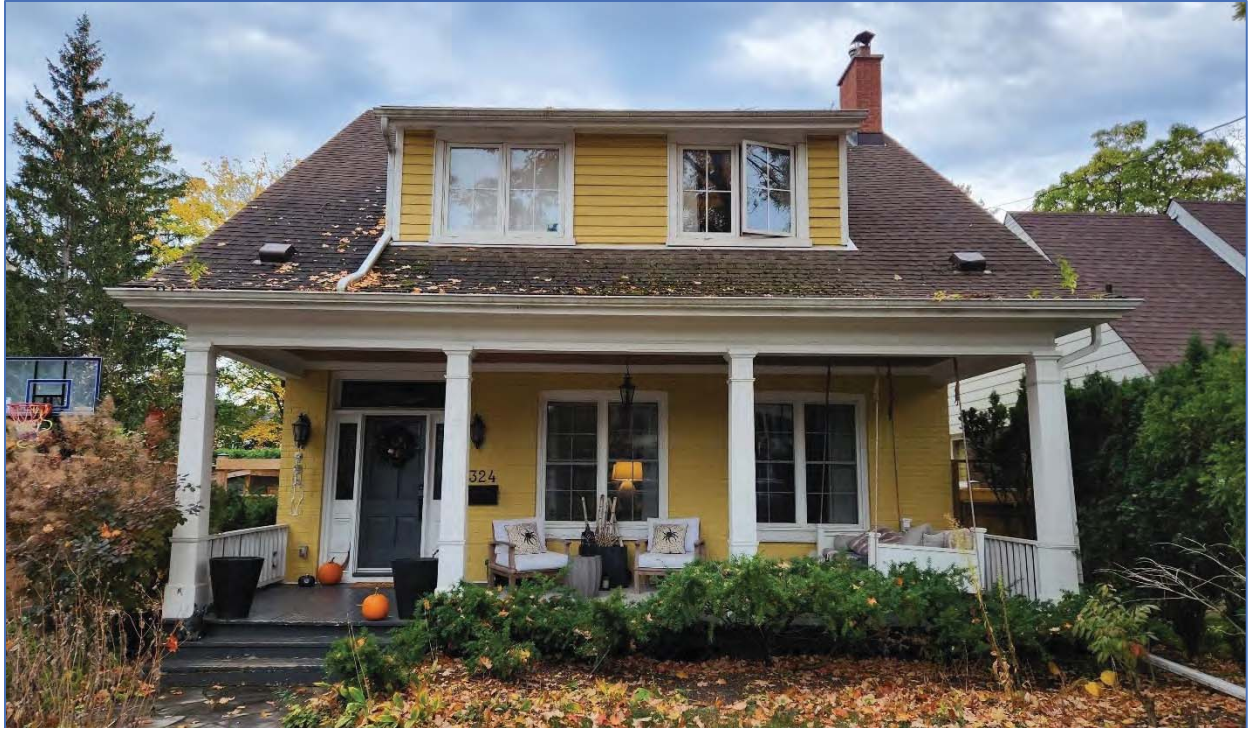
Photo 8: View southeast showing the primary, northwest elevation of the house

The house is a single-detached, rectangular building with two additions. The main house is approximately 8.5 metres wide and 9.4 metres deep. The first addition was constructed on the building's southeast elevation, adding an additional 2.5 (approximately) metres to the house's depth. A third, rear wing addition measuring approximately 4.9 metres by 3.7 metres is located on the southwest side of the house's southeast elevation. The house is two-and-half storeys, has a full below grade basement under its main section, and has a crawlspace under its additions. All foundation walls are concrete (see Section 5.3.2) (Photo 8). The façade has three bays. The main floor exterior wall is composed of brick set in a stretcher bond (Photo 9). The gable ends are clad in cedar shakes and the dormers and the additions are clad in clapboard siding (Photo 10 through Photo 12). Most exterior surfaces have been painted yellow. The house has a side gable roof with pent eave. It has asphalt shingles. The gable roof and pent eave moderately project from the house's northeast and southwest elevations. The roof extends over the house's front porch, creating a verandah (Photo 13). A single shed dormer is located on the upper half storey of the house's northwest and southeast elevations. The shed dormer roofs are clad in asphalt shingles and have shallow projecting eaves (Photo 11). A partially exterior, single stack chimney with two flues is located on the house's southwest elevation (Photo 14). The chimney is set in stretcher bond brick that has been painted yellow below the peak of the gable roof. Above the gable roof, the brick is unpainted and is dark red.

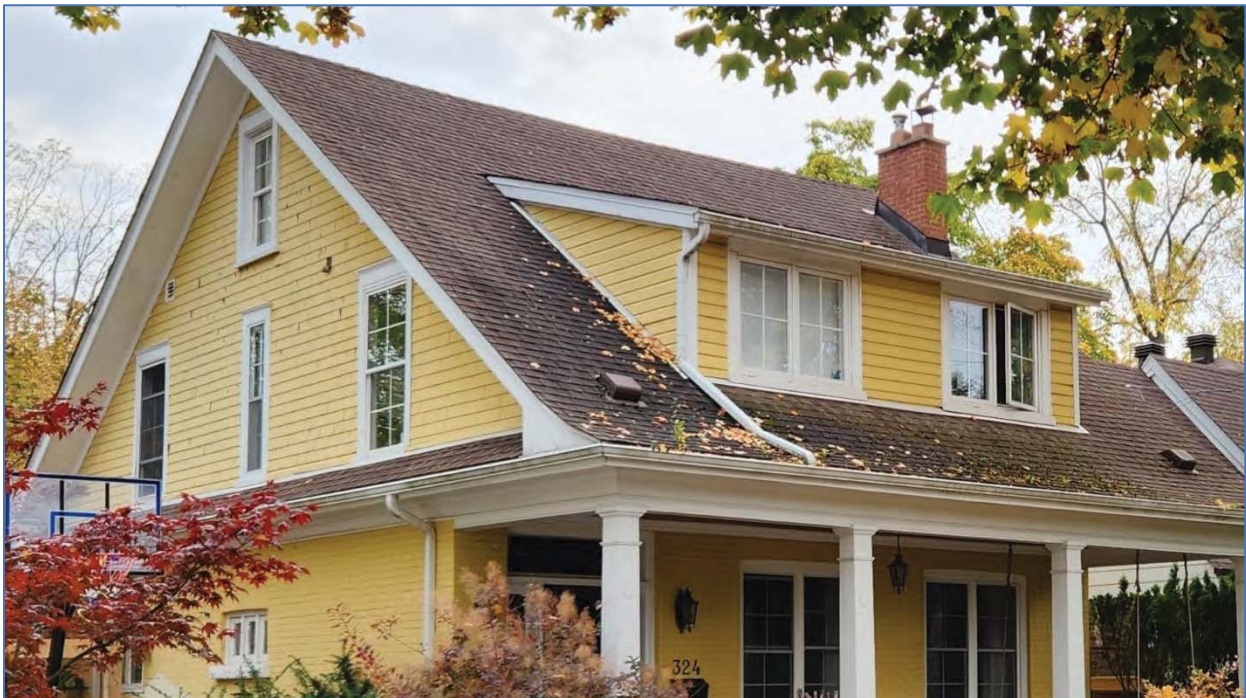
Photo 19: View south showing gable end and dormer windows

Windows set into the gable ends on the second storey and upper half storey have flatheaded openings and simple trim on all sides outside of the structural openings. Windows typically have one unit and a double-hung opening mechanism. Windows set into the dormers have flatheaded openings and simple trim on all sides outside of the structural openings. Windows are typically composed of two mullied units each with a double-hung opening mechanism (Photo 19).

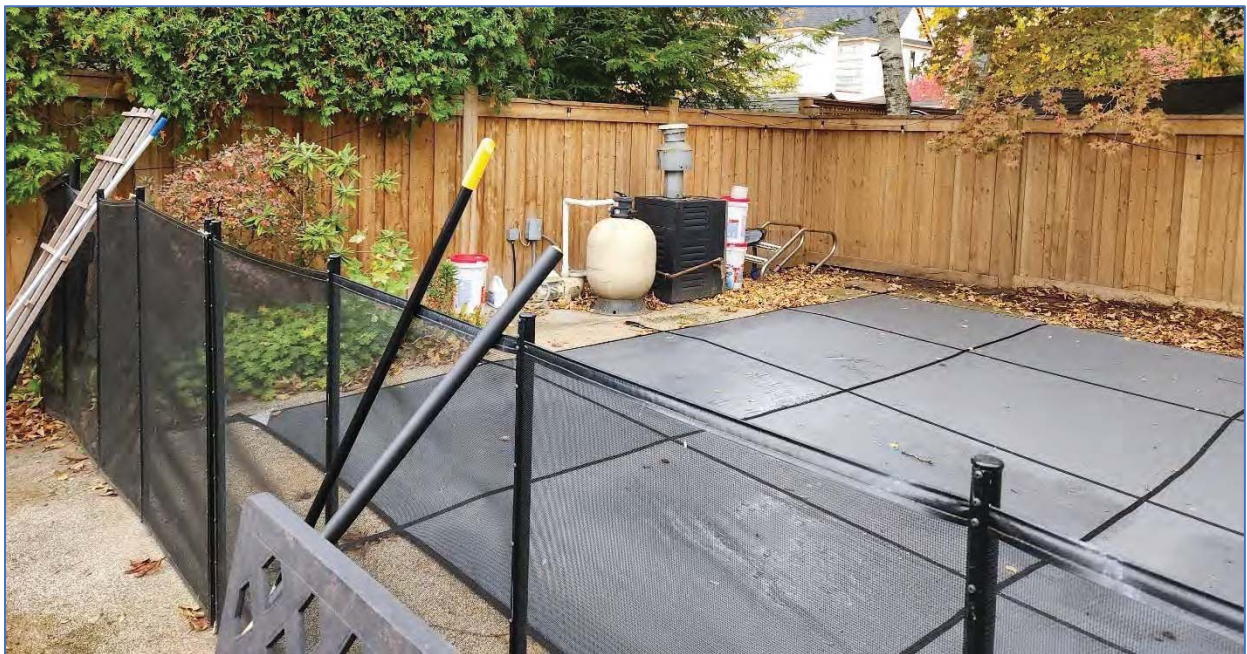
Photo 21: View east showing the backyard pool

A rectangular pool in the backyard has a concrete deck and is separated from the remainder of the backyard by a short mesh fence (Photo 21).

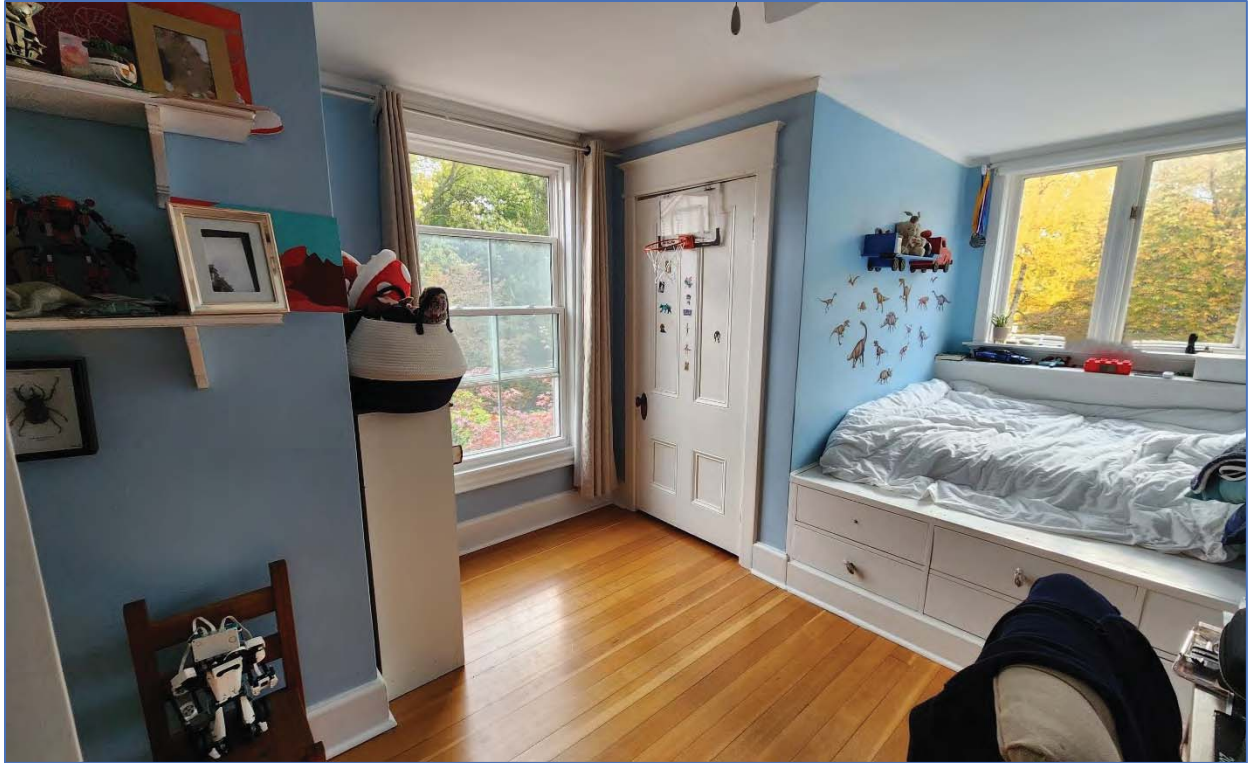
Photo 33: View southeast showing the southeast bedroom

The second storey hall has a light wood floor, white baseboards with rounded coping, smooth wallboard clad walls and ceiling, and crown moulding. It has four rooms, two on either side of the hall (Photo 31). The northeast, southeast, and northwest rooms are each bedrooms and generally share like materials. They each have a light wood floor, white baseboards with rounded coping, smooth wallboard clad walls and ceiling, and crown moulding (Photo 32 through Photo 34). The northwest bedroom and northeast bedrooms also have fireplaces. The fireplace in the northeast bedroom has a wooden mantle and the fireplace in the northwest bedroom has a cast iron firebox, wooden mantle, and tiled hearth (Photo 35 through Photo 37). The northwest bedroom has a four-piece ensuite bathroom accessed through its southeast wall. The ensuite bathroom has a light wood and tiled floor, white baseboards with rounded coping, smooth wallboard clad walls and ceiling, and crown moulding (Photo 38).

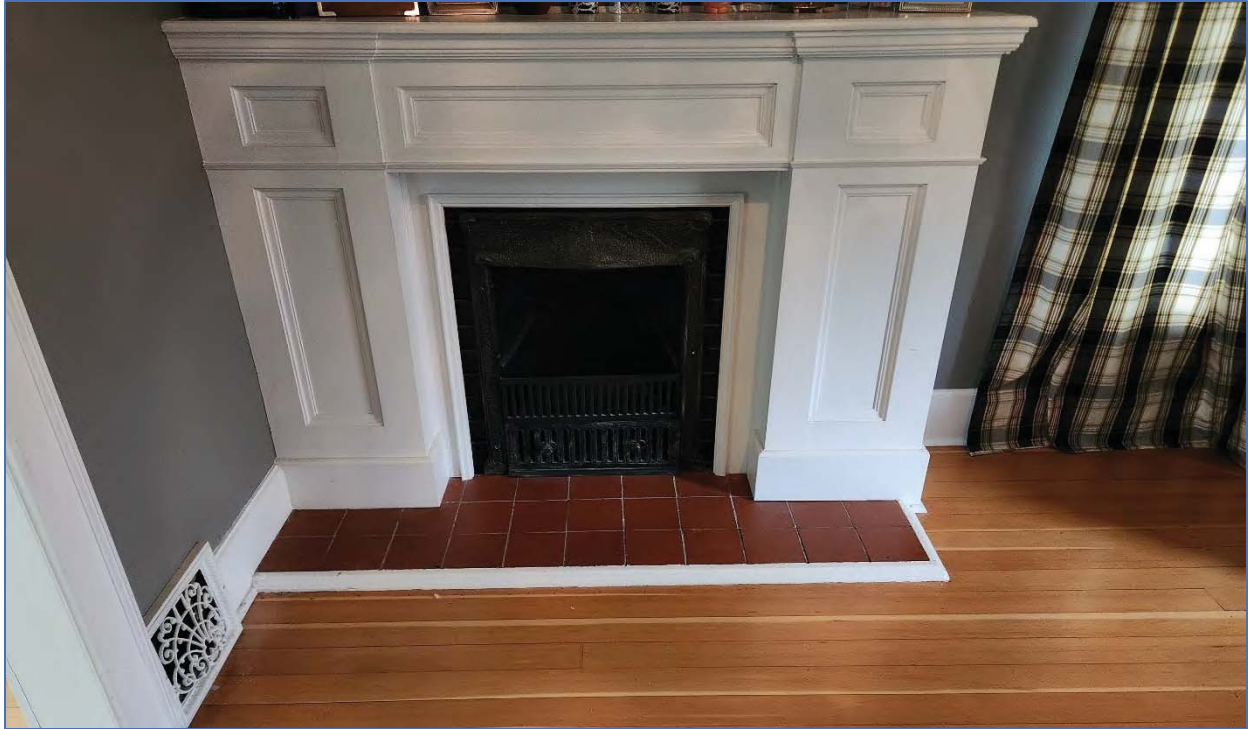
Photo 35: View southwest showing the fireplace in the northwest bedroom

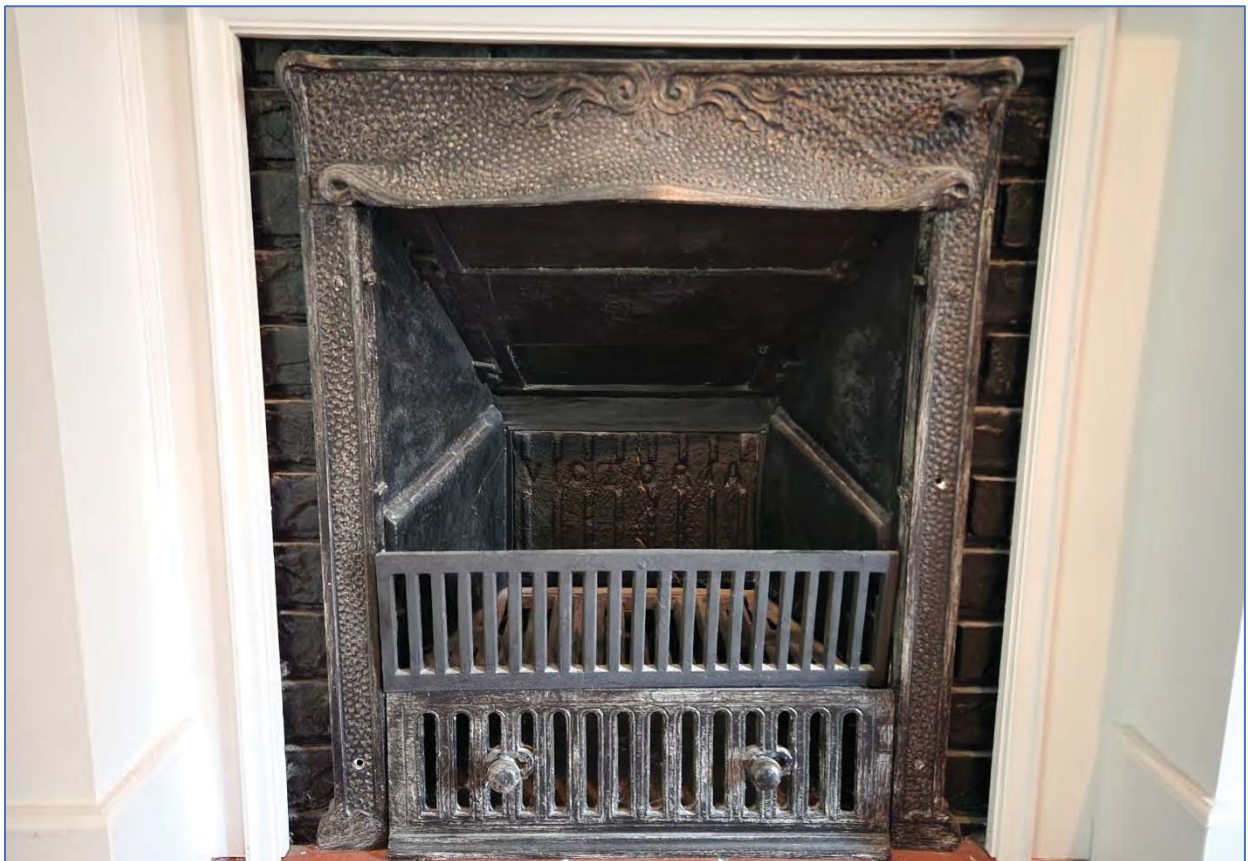
Photo 36: View southwest showing the fireplace in the northwest bedroom

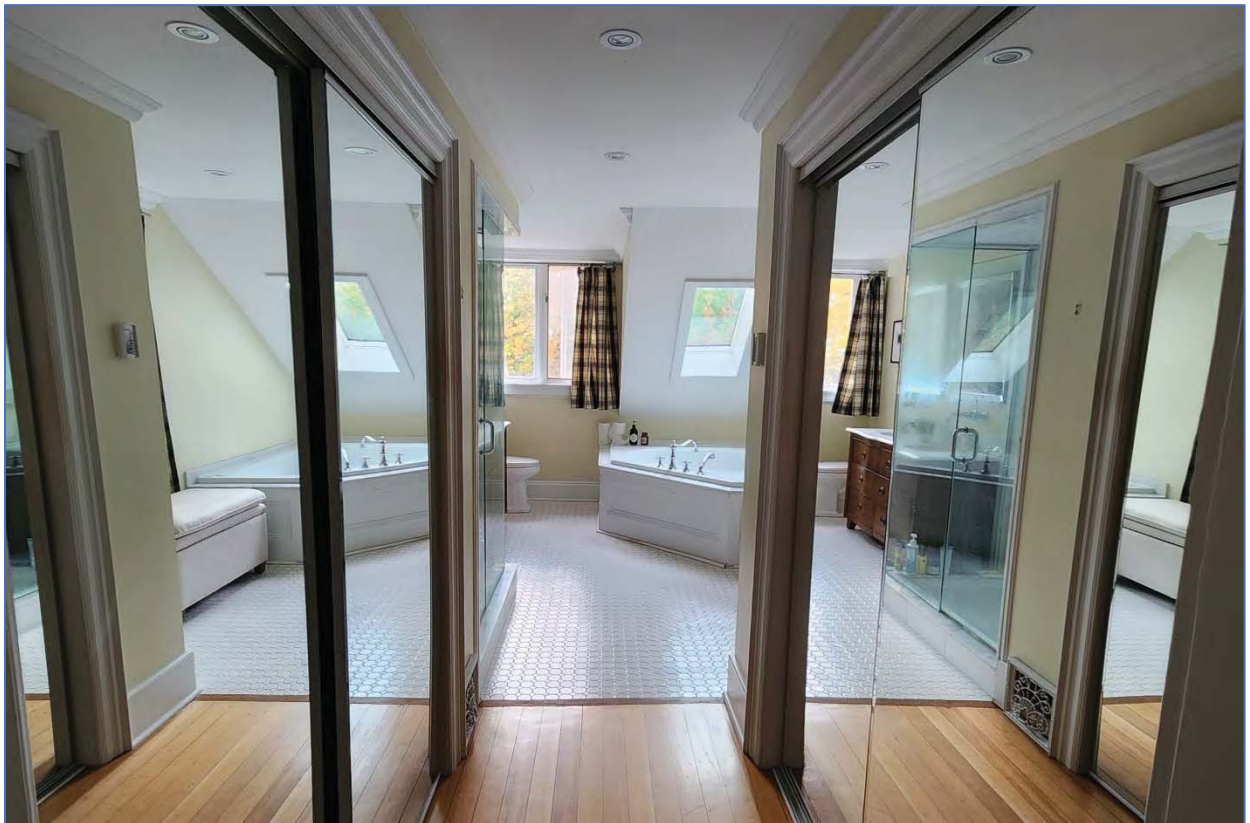
Photo 38: View southeast from the northwest bedroom showing the ensuite bathroom

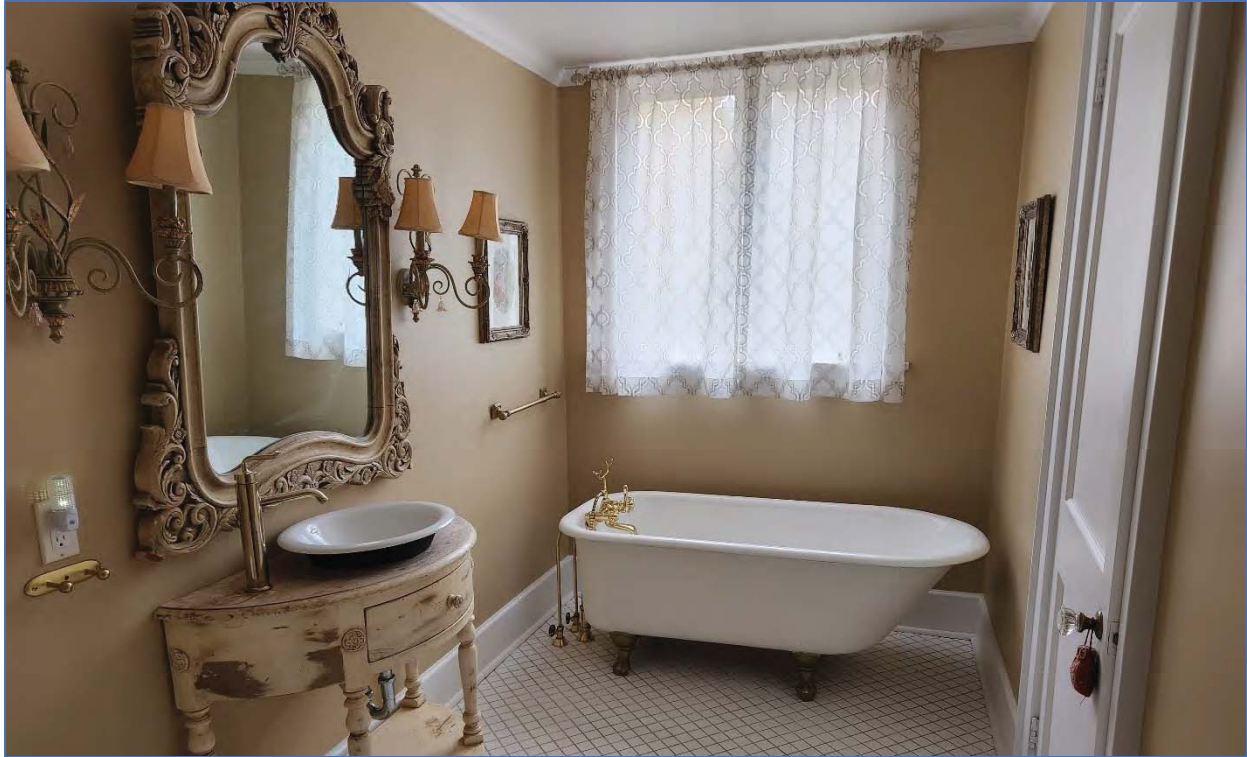
Photo 39: View southeast showing the second storey bathroom

The second floor also has a three-piece bathroom on its northeast side. The bathroom has a tiled floor, white baseboards with rounded coping, smooth wallboard clad walls and ceiling, and crown moulding (Photo 39).

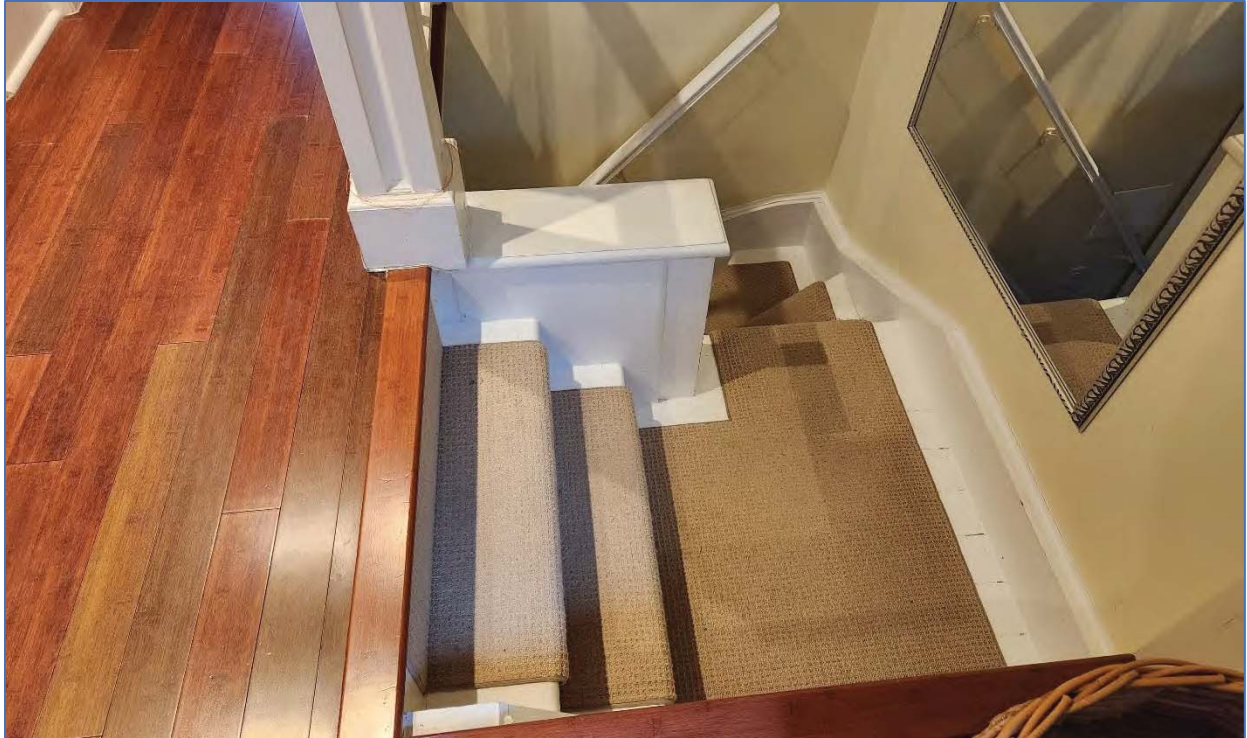
Photo 40: View northeast showing the “U” shaped stairway leading to the upper half storey

The house's upper half storey is accessed by a "U" shaped winder stairway accessible from the north side of the second storey's hall. The stairway is composed of wooden treads that are partially carpeted and a wooden handrail (Photo 40). The upper half storey has a bedroom, library, and washroom. The bedroom is located in the upper half storey's north section and the library is located in the upper half storey's south section. Both rooms use the same materials including a wooden floor, white baseboards with rounded coping, smooth wallboard clad walls and ceiling, and crown moulding (Photo 41). A three-piece bathroom is located between the bedroom and library on the northwest side of the upper half storey. The bathroom was not accessed in full during the site visit.

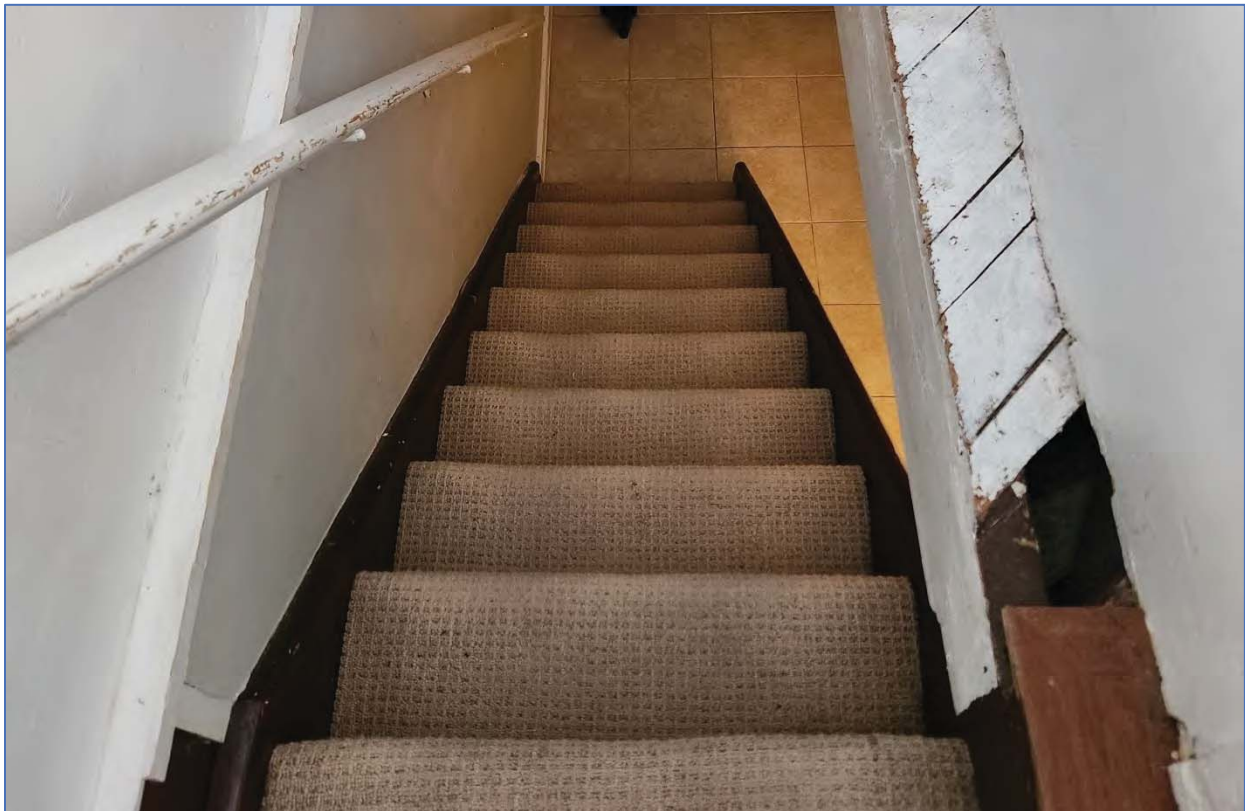
Photo 42: View southwest showing the basement stairway

The house's basement is accessed by an "L" shaped stairway accessible from the first storey's southeast quadrant near the kitchen (Photo 42). The stairway has carpeted treads and a wooden handrail. The basement is divided into three rooms including a multi-purpose room and two storage rooms. The multi-purpose room is the largest room in the basement and is divided into a laundry section and theatre section. Both sections have a tiled floor, painted wood panelled walls, and smooth wallboard clad ceiling (Photo 43 and Photo 44).

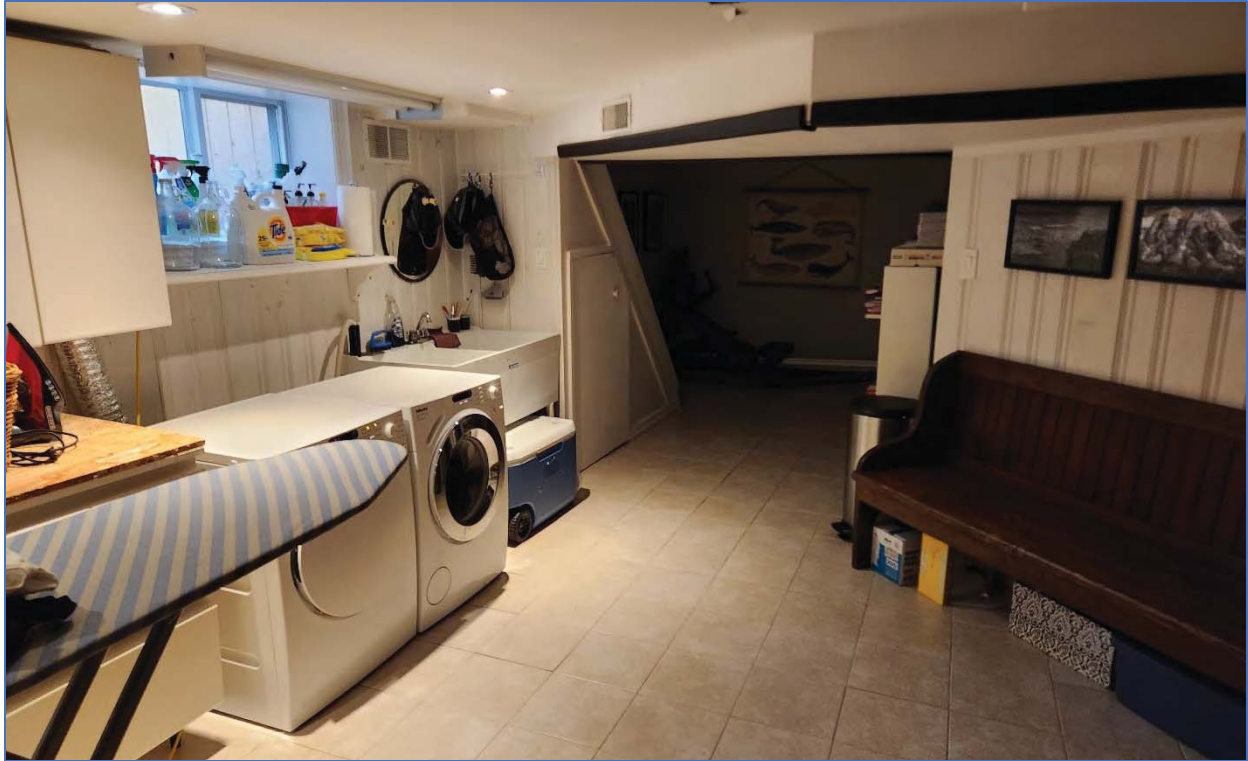
Photo 43: View southeast showing the laundry section of the basement

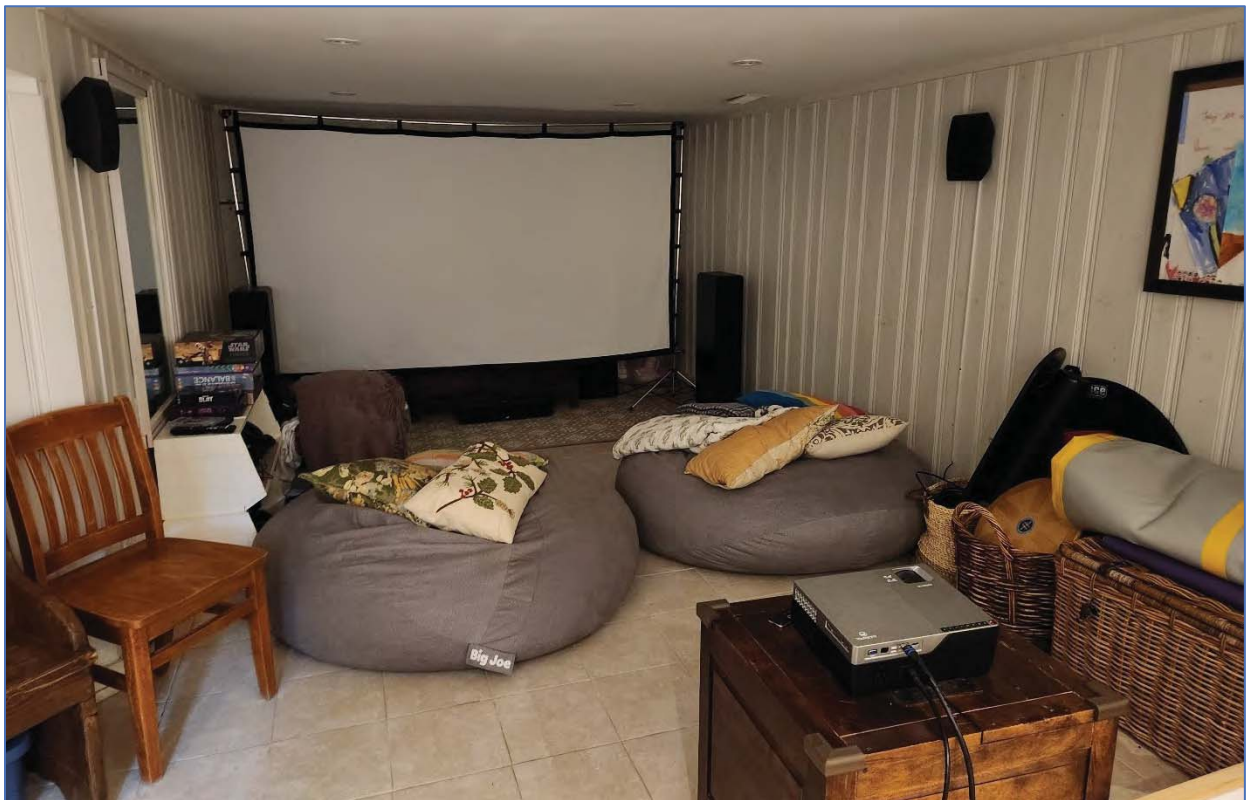
Photo 44: View southwest showing the theatre section of the basement

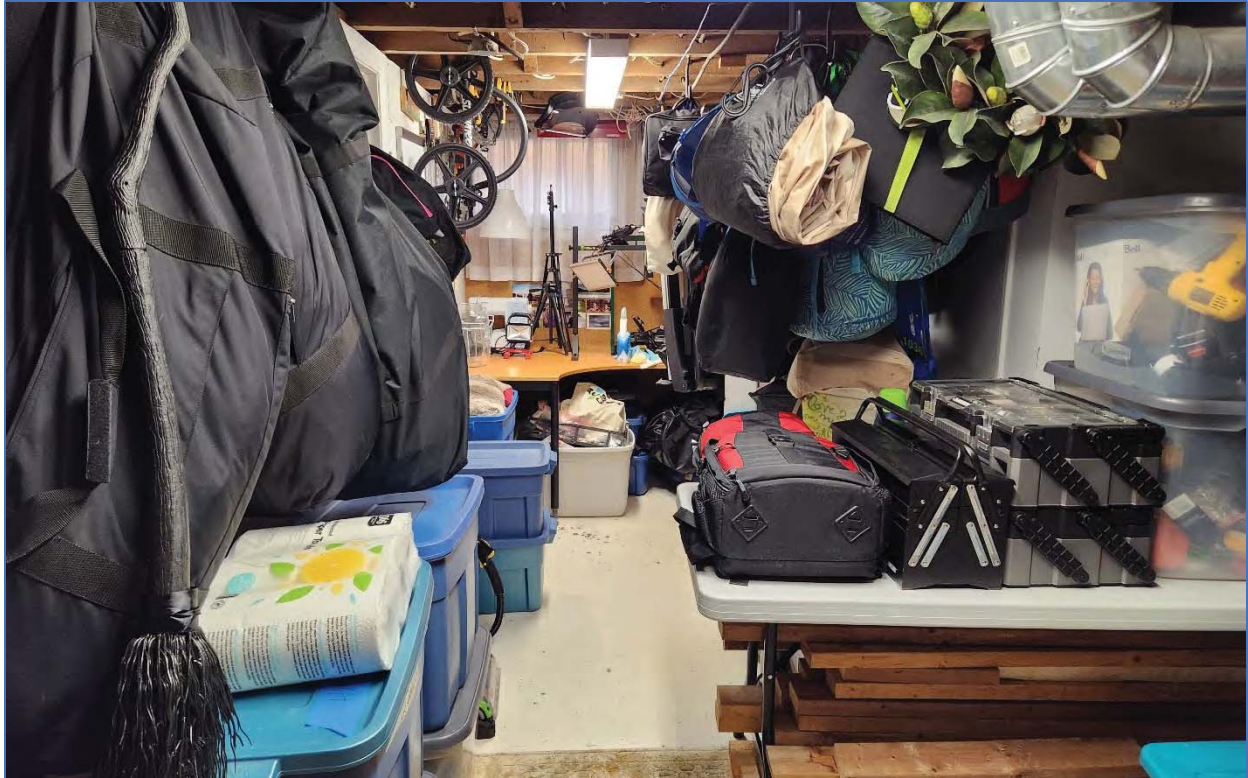
Photo 45: View southwest showing the eastmost storage room in the basement

The larger, eastmost storage room is accessed through a door near the bottom of the basement stairway. The storage room has a painted concrete floor; walls clad in a range of materials, including wood, cork, and wallboard; and an exposed ceiling (Photo 45). The smaller, westmost storage room is accessed through a door on the northwest basement wall near the laundry area. The smaller storage room has a painted concrete floor; walls clad in a range of materials, including wood, cork, and wallboard; and an exposed ceiling (Photo 46).

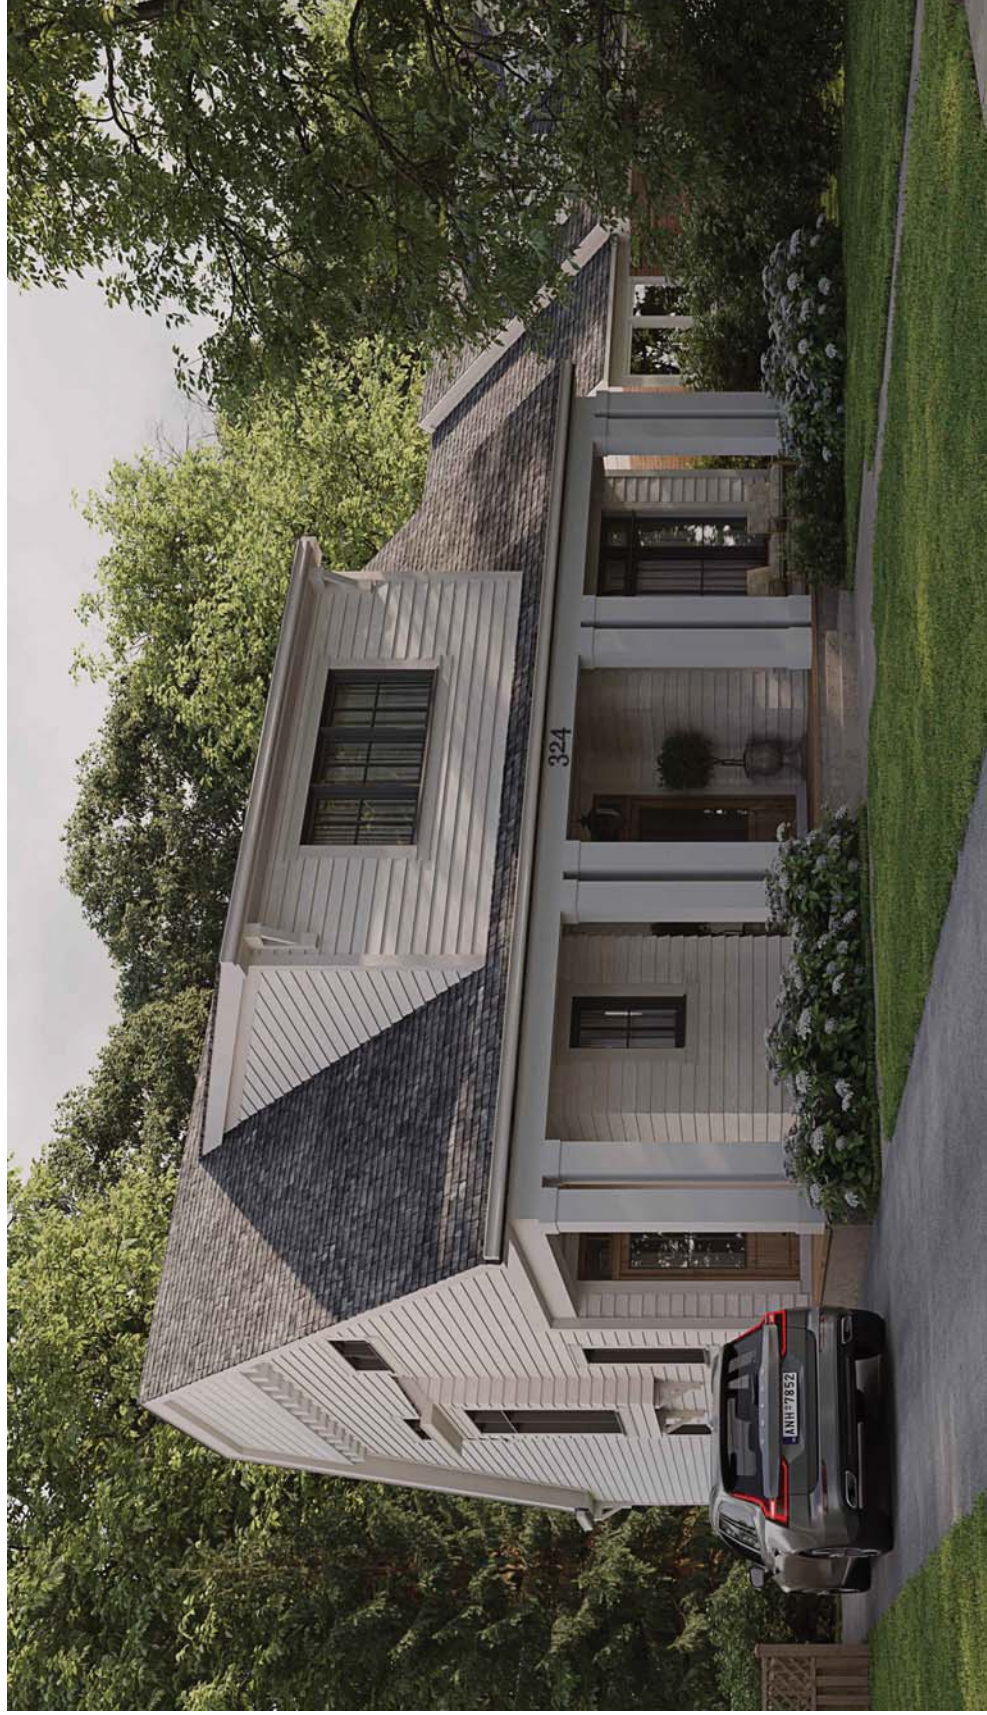
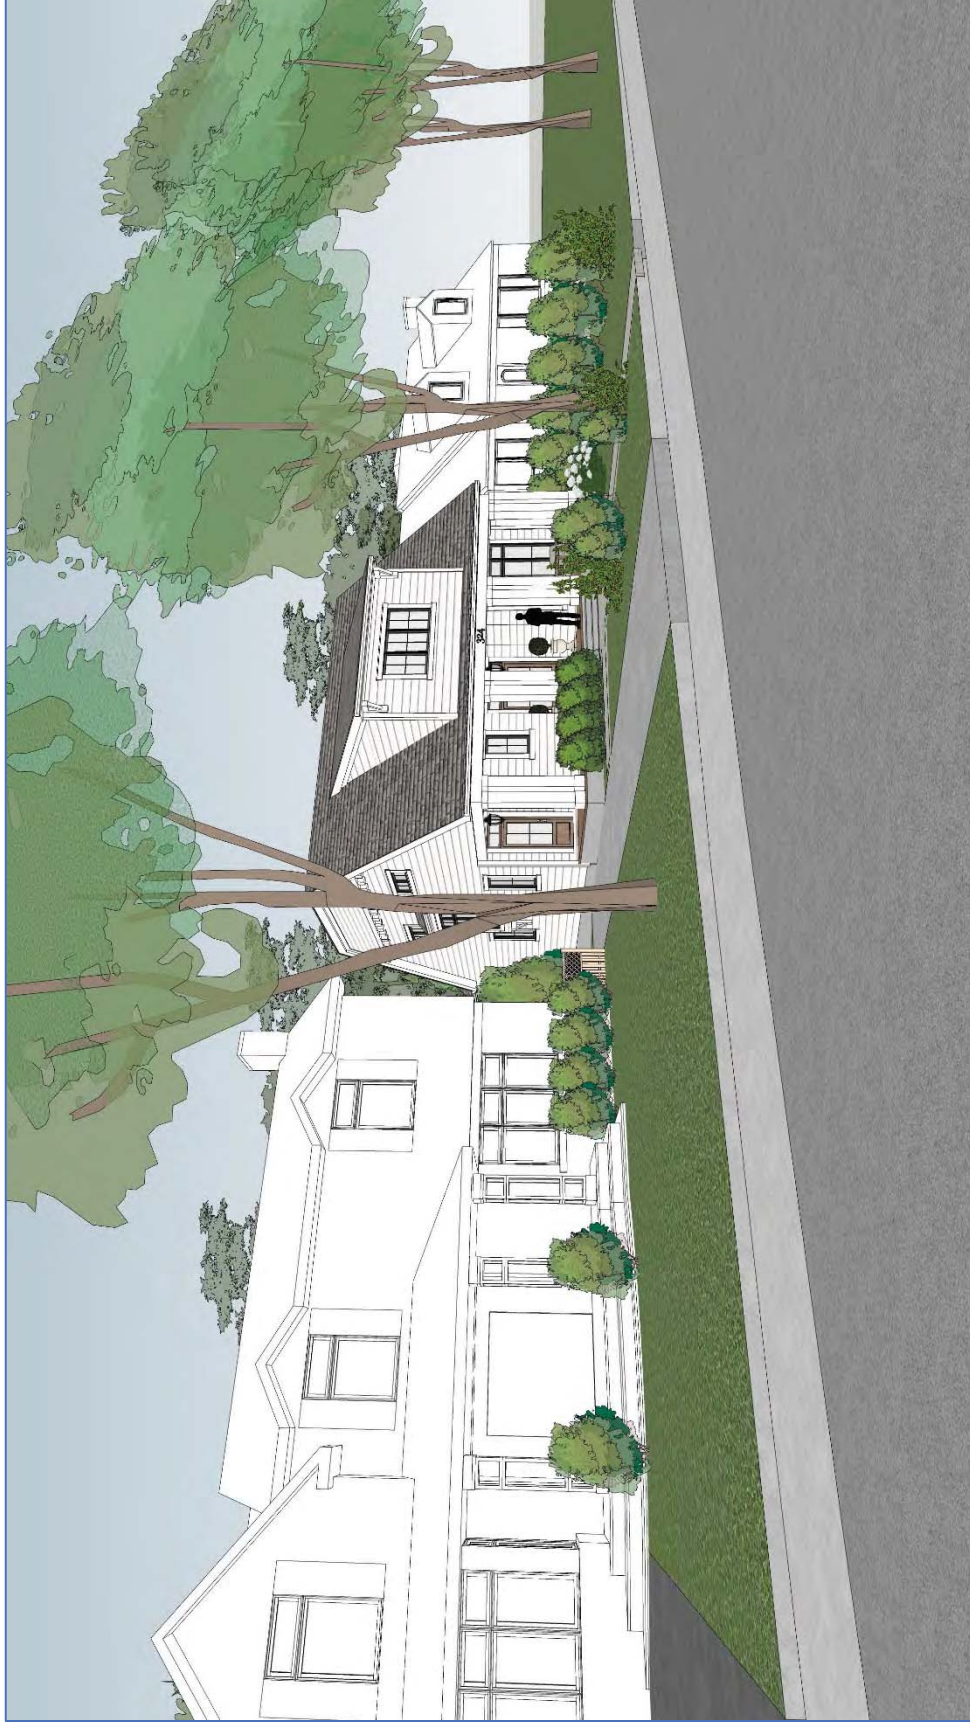
Figure 13: Colour rendering of proposed new residence

The Owner is proposing to demolish the existing two-and-a-half storey house on the Property and replace it with a new rectangular, two-storey house that appears as a one-and-a-half storeys from the Spruce Street right-of-way. The proposed house has a four-bay façade that faces northwest and is slightly angled to the north. It has a full below grade basement with concrete foundation walls. The first and second storeys are typically clad in engineered wood clapboard with cedar shake siding also present in select locations on the northeast, southeast, and southwest elevations. Wall details include cornerboards, modillions near the apex of gable ends, and brackets supporting dormer roofs. The house has a moderately pitched, truncated side gable roof. A central shed dormer is located on the building's northwest elevation. A shed dormer offset towards southwest, and a front gable offset towards the northeast are located on the building's southeast elevation. All roofs are clad in cedar shake shingles.
