Re: Minor Variance Application – 70 Brookfield Road

SURVEYOR'S REAL PROPERTY REPORT - PART 1

PLAN OF SURVEY AND TOPOGRAPHY OF
LOT 1
REGISTERED PLAN 437
TOWN OF OAKVILLE

Arborist Report - 70 Brookfield Road , Oakville, Ontario

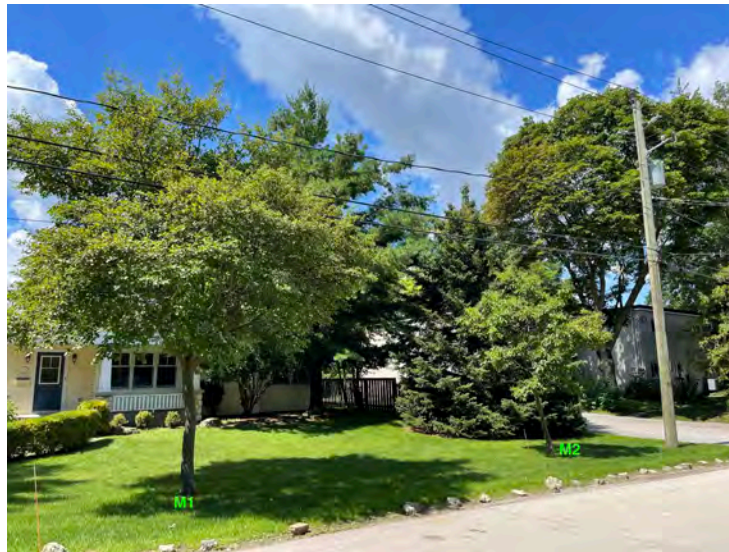
Tree number M1 is a 18cm dbh Dogwood that is growing near the street in front of the house. This tree is in fair condition and requires a tree protection zone of 2.4m.

Tree number M2 is a 11cm dbh Lilac Ivory Silk that is growing near the street in front of the house. This tree is in fair condition and requires a tree protection zone of 2.4m.
