To: Heritage Oakville Advisory Committee
From: Carolyn Van Sligtenhorst, Heritage Planner
Date: March 11, 2025
Subject: Heritage Easement Agreements for Tannery Walls

Cultural Heritage Evaluation Report
The Marlatt & Armstrong Company Limited
Remnant Historic Tannery Walls
39-53, 57-77 Forsythe Street, Oakville, Ontario

Town of Oakville
Heritage Planning
Authors: Elaine Eigl, Carolyn Van Sligtenhorst
February 2024

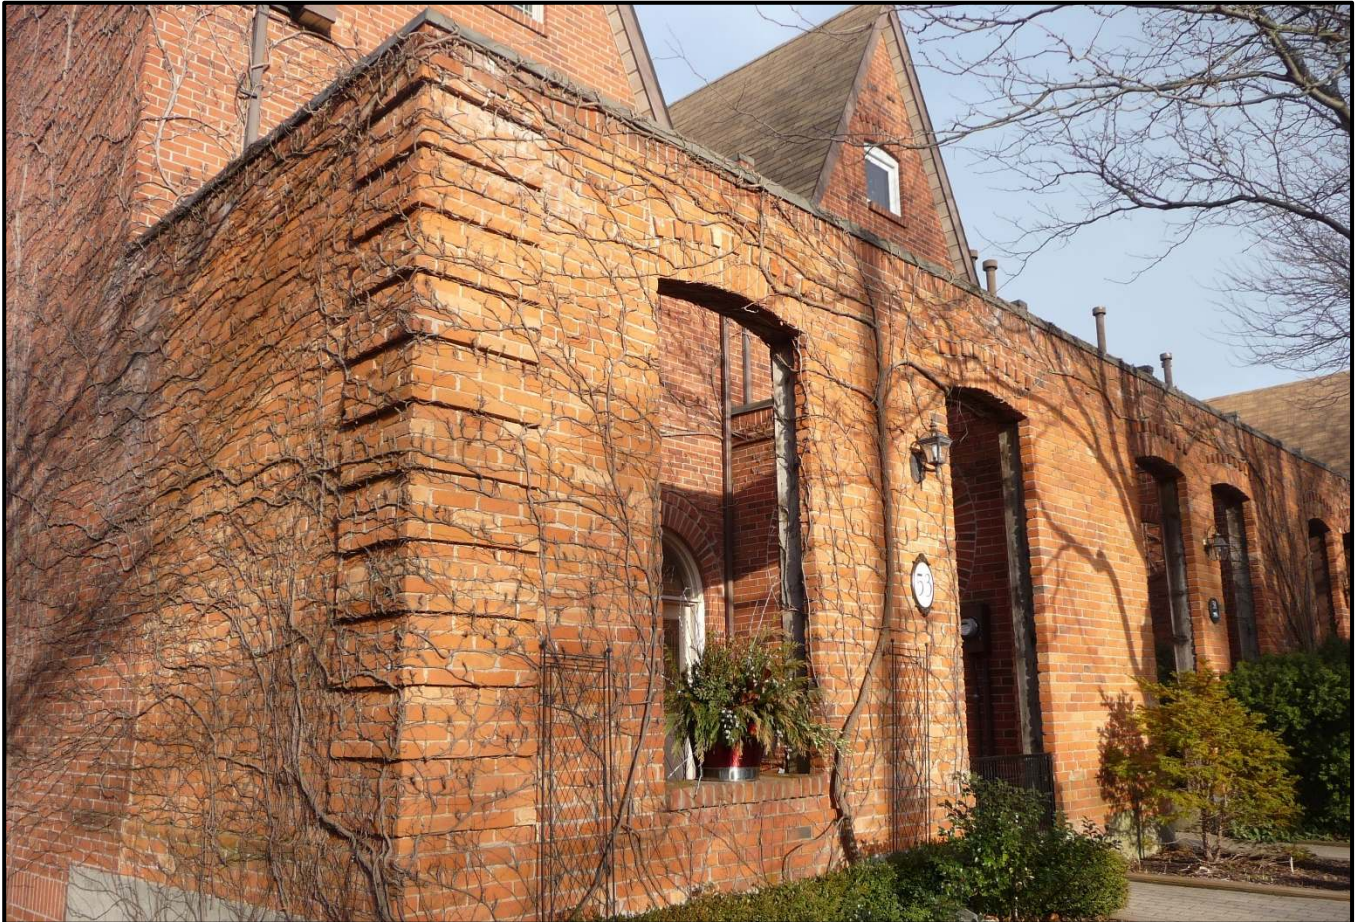
Remnant walls of the tannery buildings. Source: *Town of Oakville, Planning Services photo*

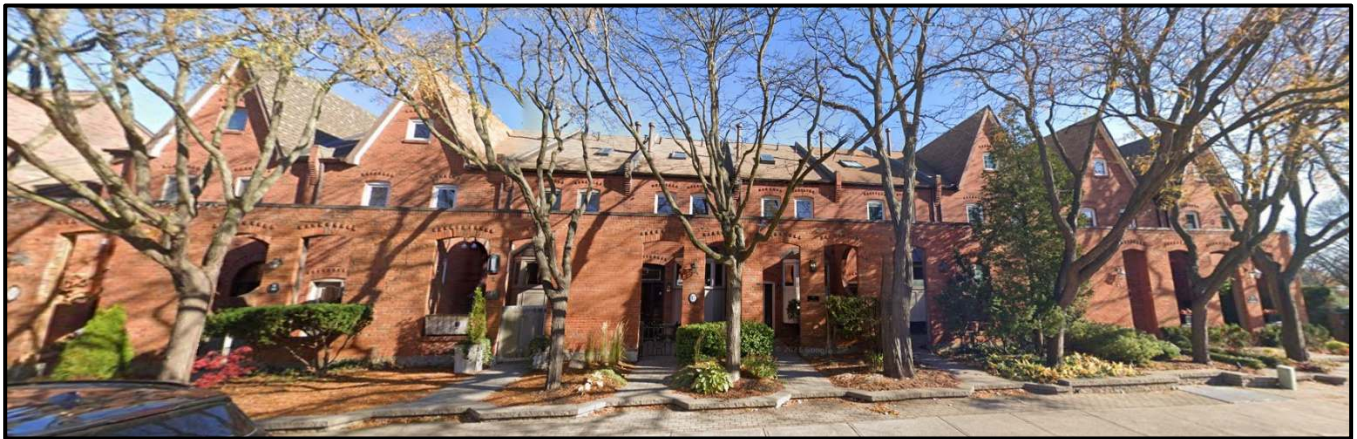
Looking east from Forsythe Street at the most southerly portion of the tannery walls, January 2021. *Source: Google Street View*

The circa 1880s building with a circa 1910-1913 addition, was a two-storey red brick building with a low-sloped gable roof. The brick was finished in a common bond pattern with rows of headers every eight rows. Radiating brick voussoirs were placed above windows and doors, with header bricks protruding from the brick surface to provide a dentil-like design element which also sheds water away from window and door openings. Concrete sills were placed below the windows, which were 2/2 wood sash windows segmentally arched at the top.

The circa 1880s portion was built on a lakestone foundation while the circa 1910-1913 addition had a concrete foundation. The bottom of the walls contained a brick plinth detailing, with bricks protruding from the face of the wall to define the base of the building. Basement windows were also finished with radiating brick voussoirs. The fenestration of the building would have been based on practical needs, with fewer windows on the main floor and more windows on the second floor.

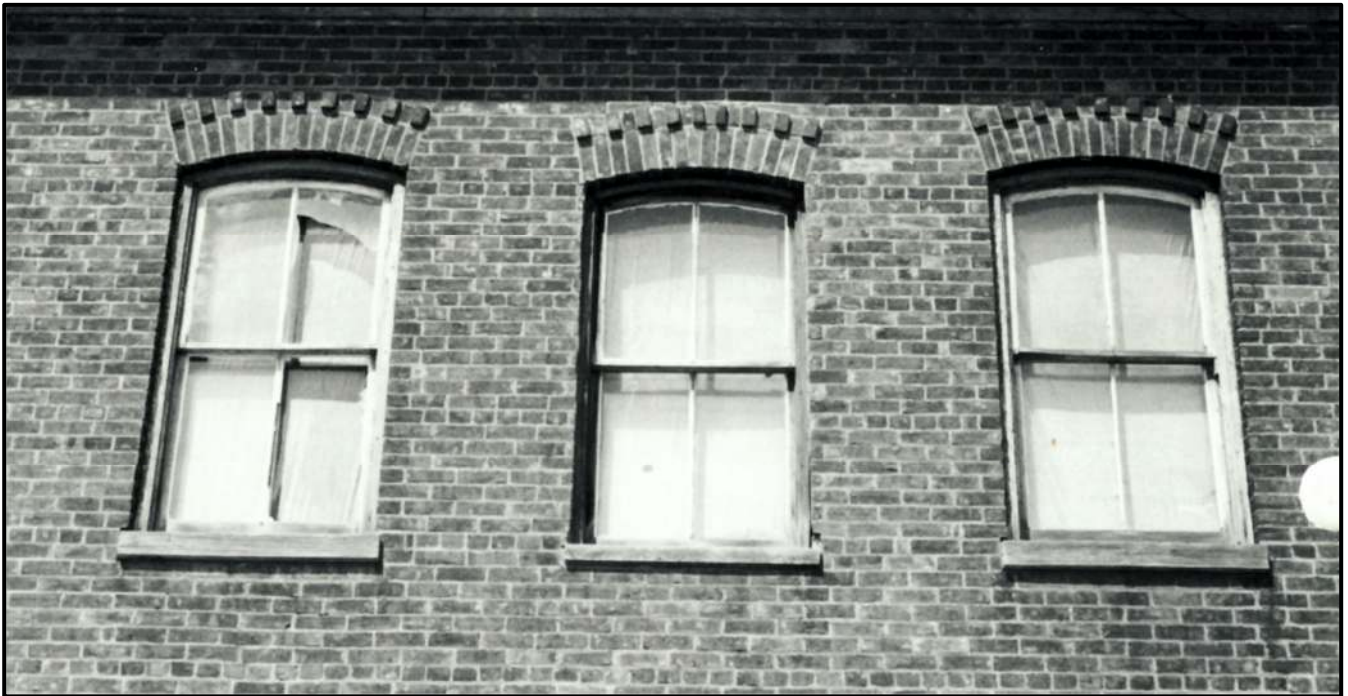
Close-up of windows on the second floor of the circa 1880s building. June 1978 Source: *Town of Oakville, Heritage Planning files*

The remnant walls that remain today are original and still in their historic location, but through the rehabilitation process, new window and door openings were created and some areas were re-bricked or repaired using salvaged bricks. The existing and additional window openings are longer than the originals and now have brick sills.

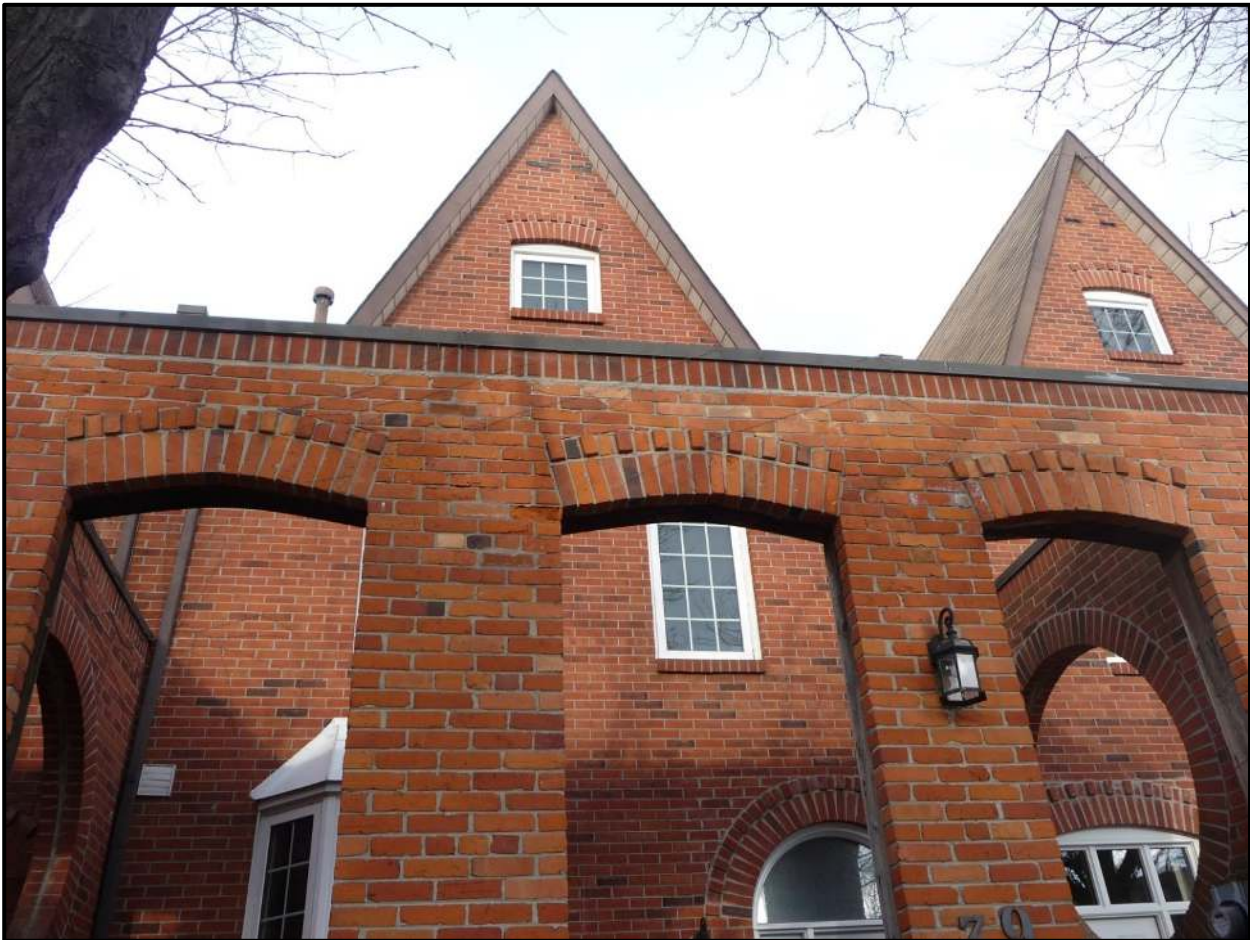
Remnant tannery walls in the forefront with new townhouses behind at 39 Forsythe Street. Source: *Town of Oakville, Planning Services photo*

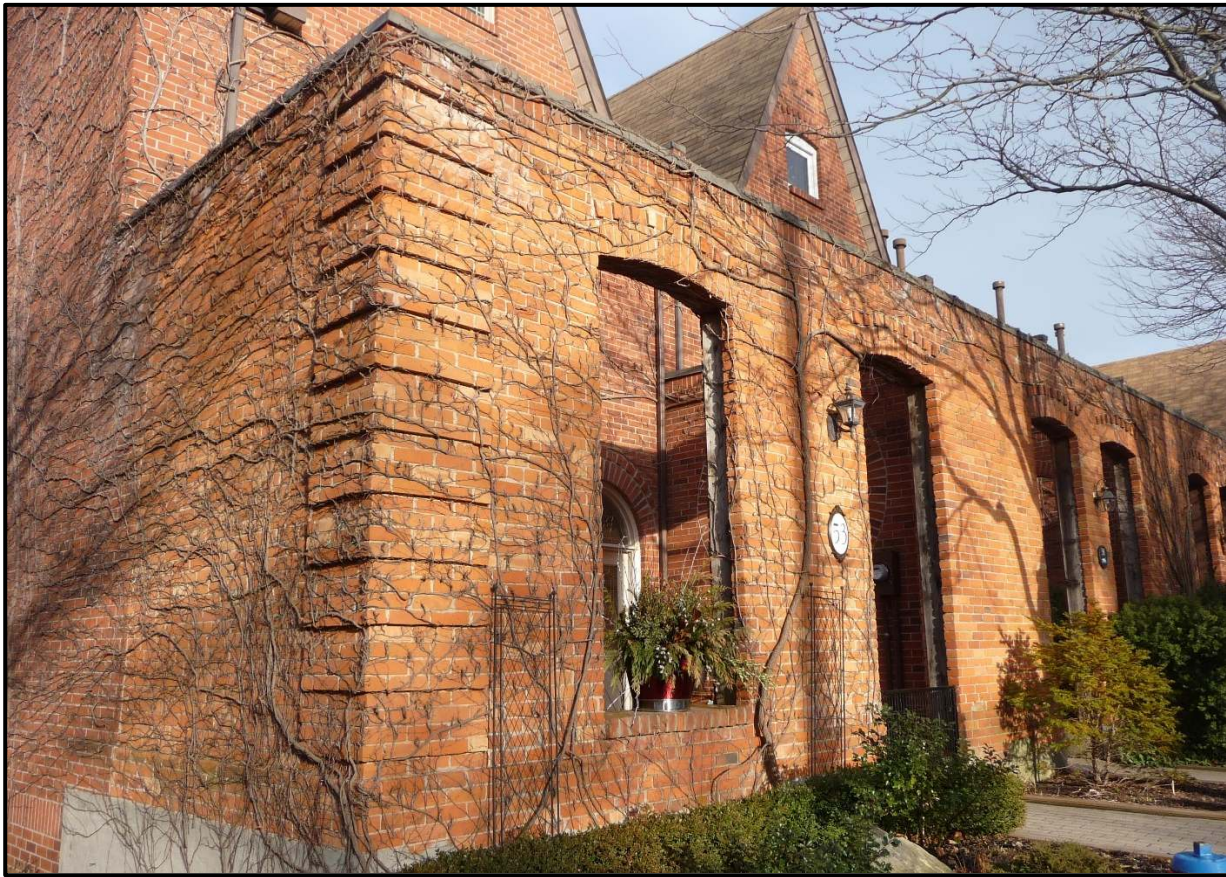
Remnant tannery walls with brick quoining remaining at 53 Forsythe Street. *Source: Town of Oakville, Planning Services photo*

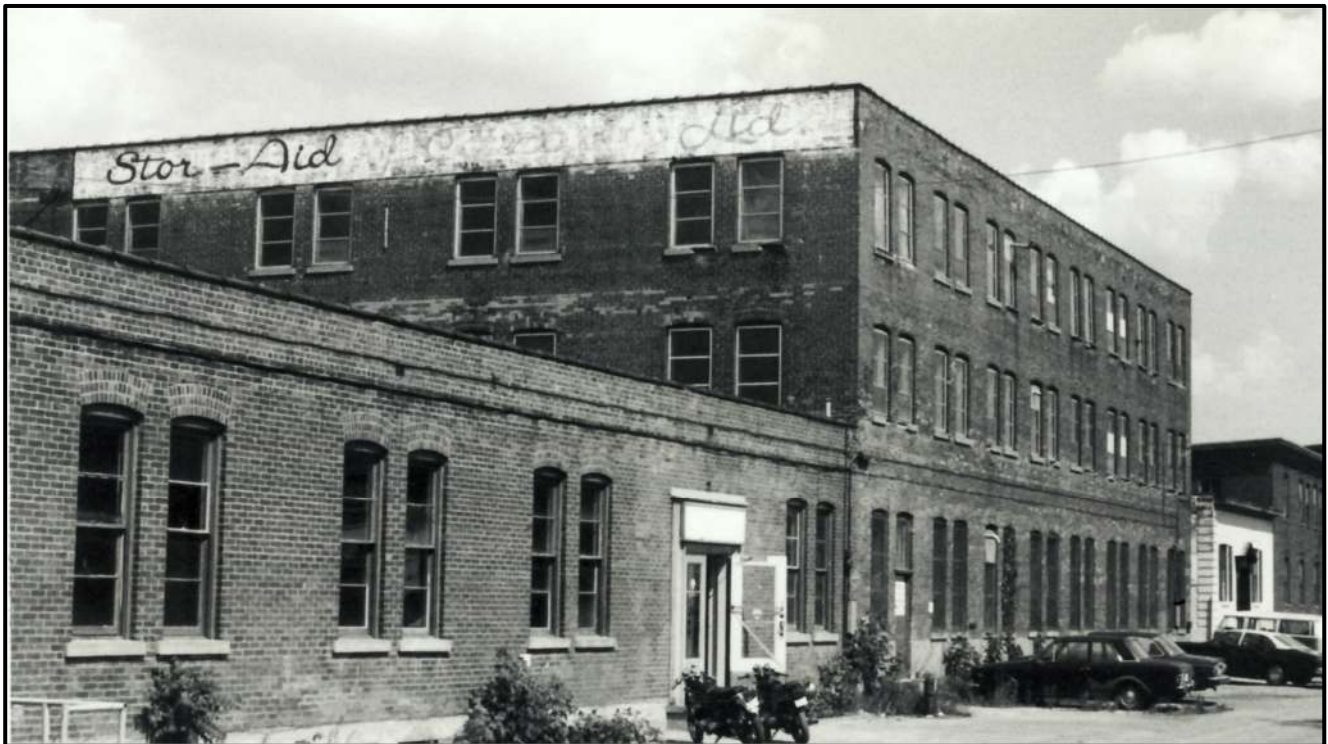
Tannery buildings with the three-storey building in the centre, June 1978. *Source: Town of Oakville, Heritage Planning files*

This flat-roofed structure was also constructed of red brick, this time in a common bond pattern with rows of header bricks every six rows. Window and door openings were segmentally arched with three rows of flat brick headers above each opening and concrete sills below. Window and door openings were paired up and provided plenty of natural light and air flow into the building.

The three-pane windows shown in the 1970s photos appear to have been replacements from the 1940s or 1950s as they are not arched and have horizontal proportions which reflect a mid-century industrial aesthetic.

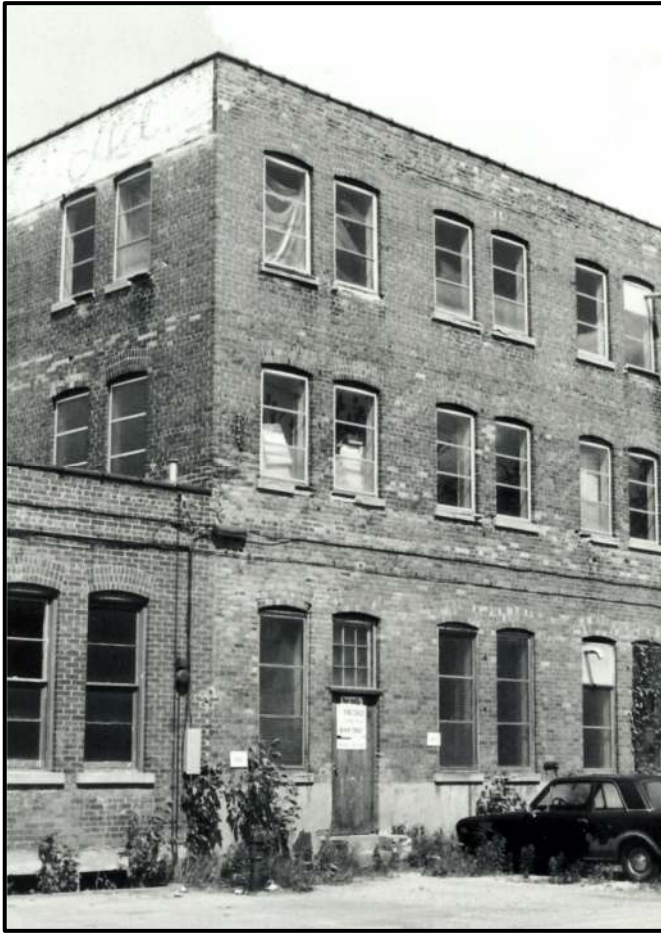
The three-storey building in June 1978 *Source: Town of Oakville, Heritage Planning files*

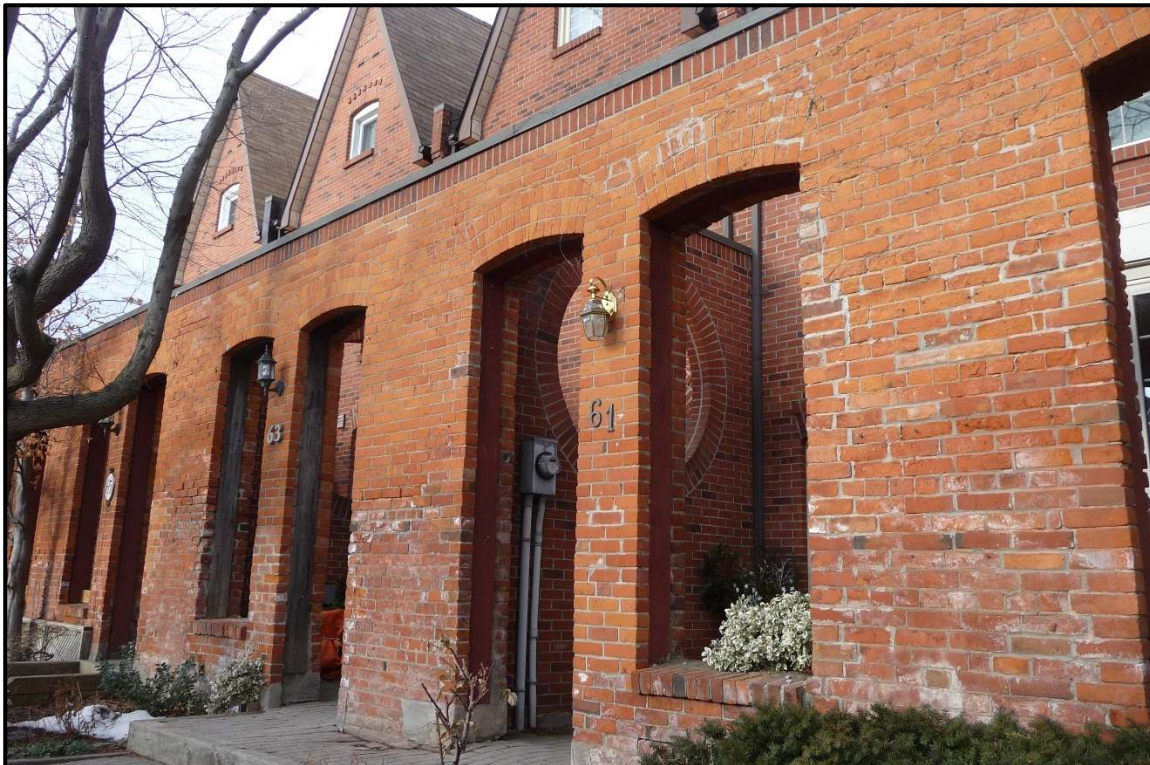
Remnant tannery walls at 61-65 Forsythe Street. *Source: Town of Oakville, Planning Services photo*

The brick pattern and rows of brick headers can still be seen in this section of the walls today. As seen in the south section of remnant walls, some window openings were extended to create doorways, and new brick sills were installed for the window openings. Perpendicular brick walls were also installed here to connect the remnant walls to the new townhouses and to provide a semi-private front courtyard.

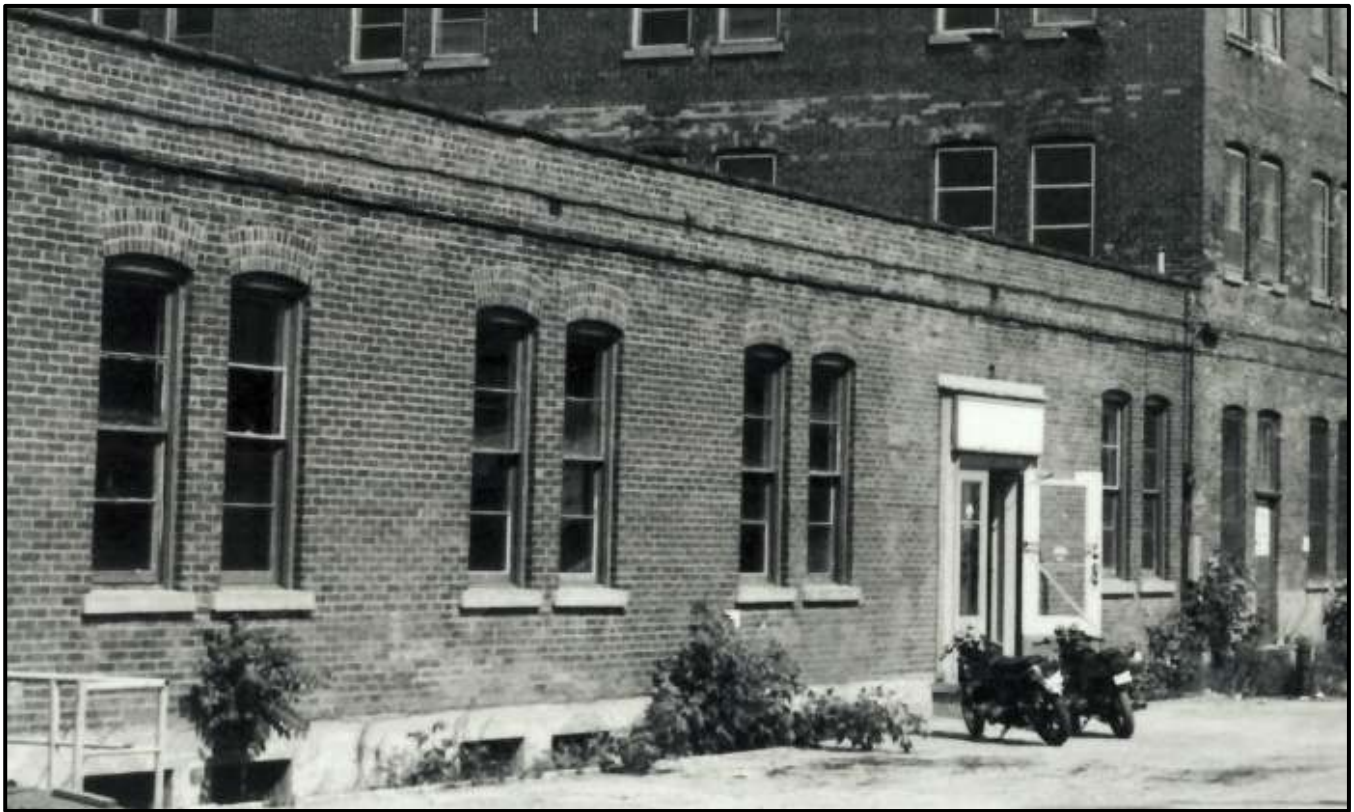
Constructed between 1932 and 1948, this building was the last structure to be constructed for the tannery along Forsythe Street. This building continued the aesthetic of the adjacent three-storey building by pairing up segmentally-arched windows and articulating openings with three rows of header bricks and concrete sills. The flat-roofed building was constructed with a concrete foundation and red brick walls in a running bond pattern, a brick pattern common to the early 20th century.

The one-storey building on the north end of the tannery site, 1978. *Source: Town of Oakville, Heritage Planning files*

While the original basement windows were filled in, the original walls remain intact. On the west elevation, all of the paired window openings were retained, and filled with either new 6/6 style windows or new entry doors with multipaned transom windows above. Concrete sills were replaced with new brick sills, matching the rest of the tannery remnant walls. The entrance shown in the 1970s photo above was replaced with two paired window/door openings to match the fenestration pattern on this wall.

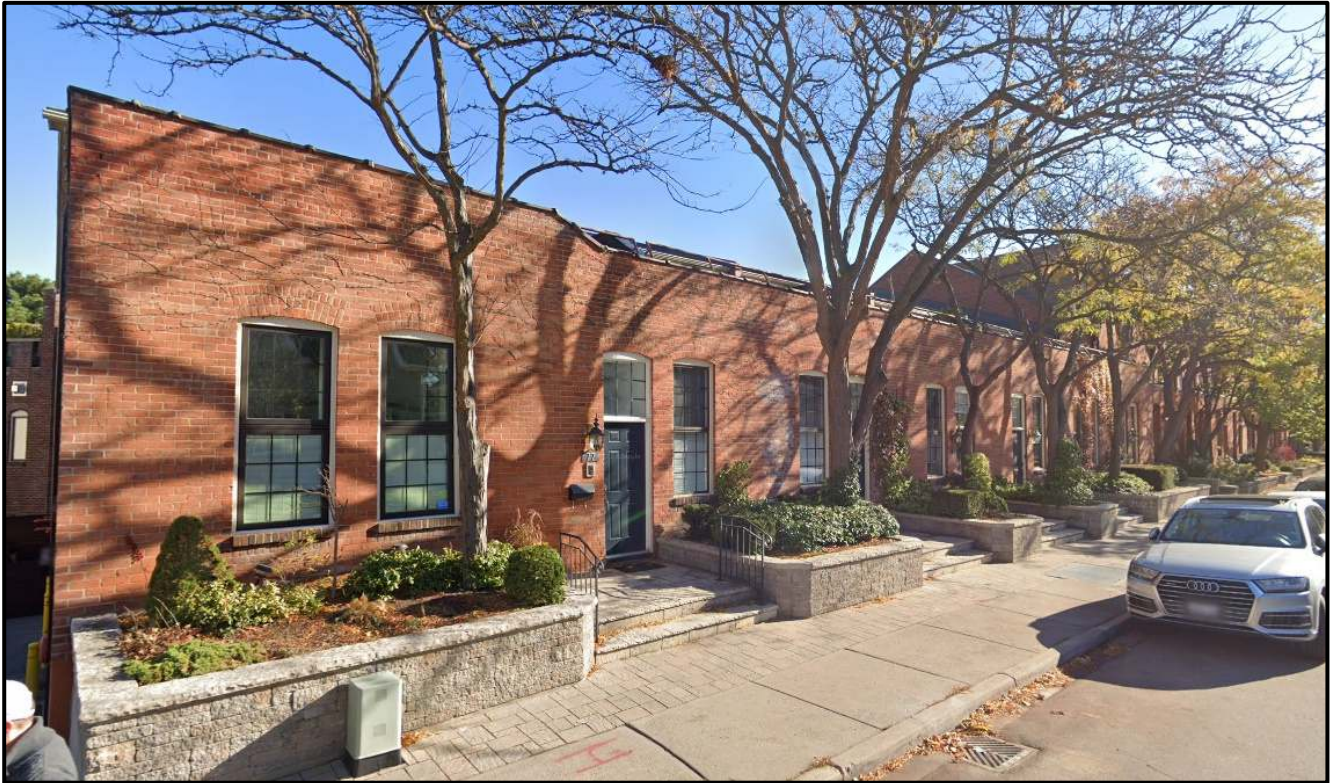
Looking southeast on Forsythe Street, at the northwest corner of the remnant historic tannery walls. January 2021.
Source: Google Street View

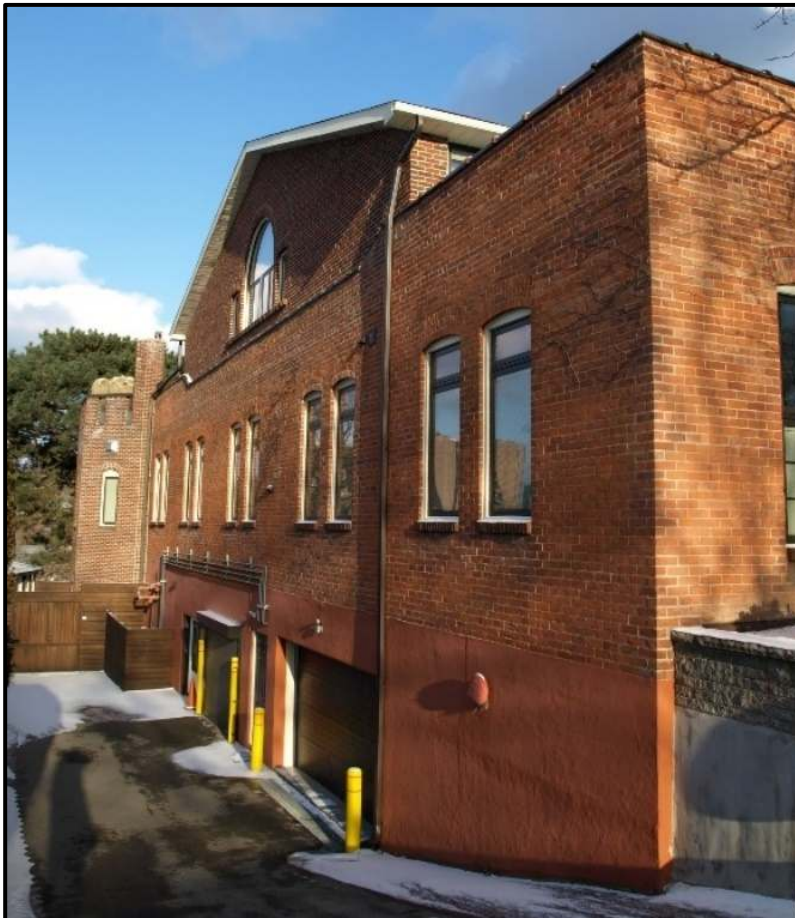
The north wall of the one-storey tannery building, January 2024. Source: Town of Oakville, Planning Services photo

On the north elevation, all of the one-storey brick wall was retained, along with the paired window openings, but with new windows and new brick sills. A new clerestory addition was built onto the roof of the one-storey building, and new additions were constructed to the rear. As is the case with all the townhouse units, there is underground parking below the units, with access to Forsythe Street on the north side of the north section and between the south and middle sections.

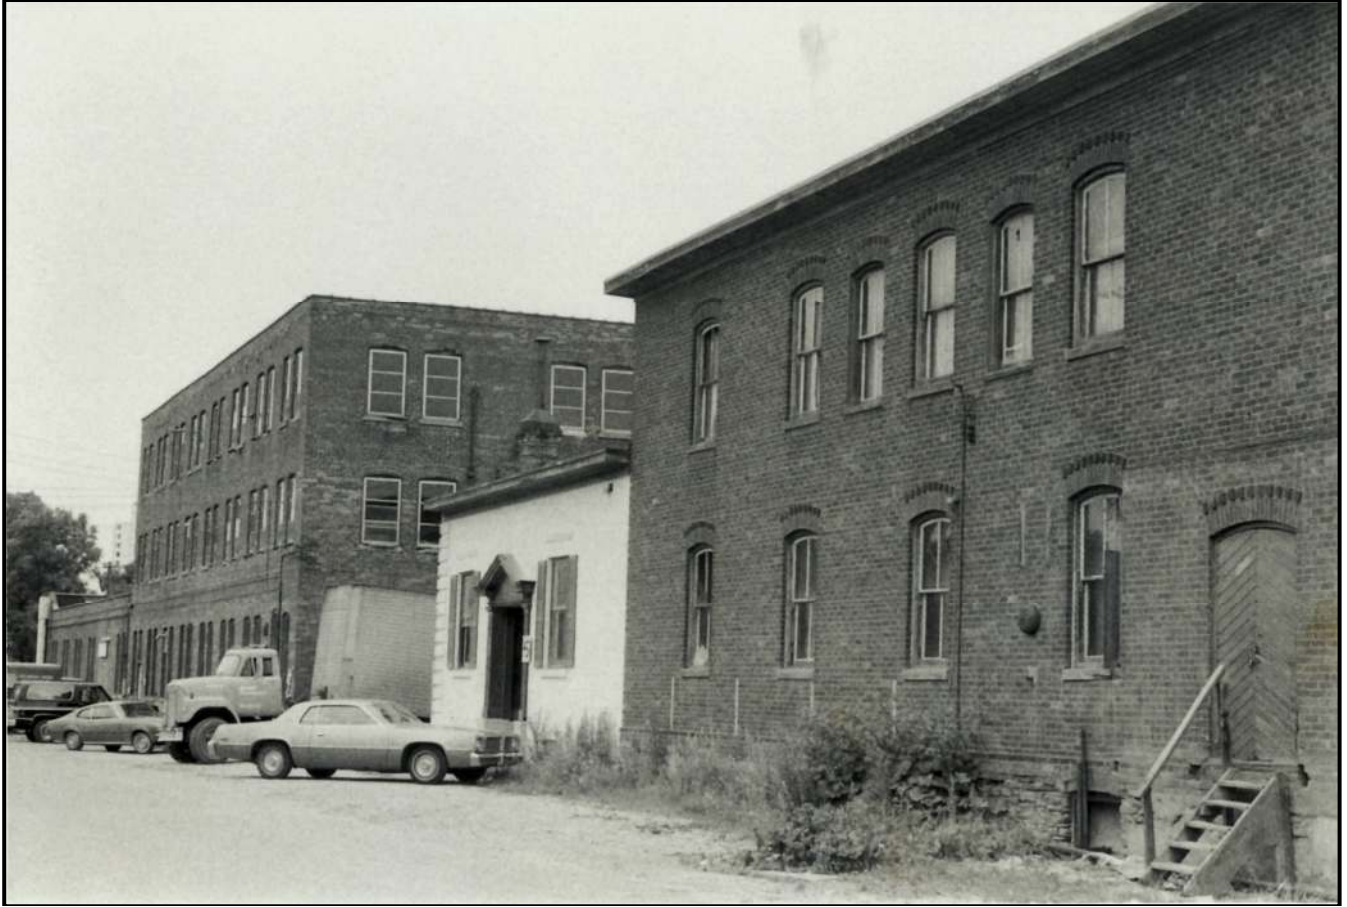
The circa 1880s structures include the two-storey building on the far right and the one-storey building painted in white in this 1978 photo.
Source: Town of Oakville, Heritage Planning files

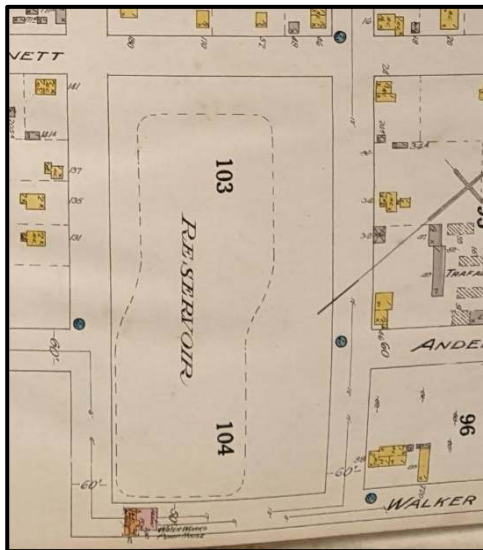
Left: The 1924 fire insurance plan shows the new, circa 1908, water reservoir located east of Kerr Street and west of Wilson Street. Source: Underwriters' Survey Bureau, *Insurance Plan of the Town of Oakville, 1924*.

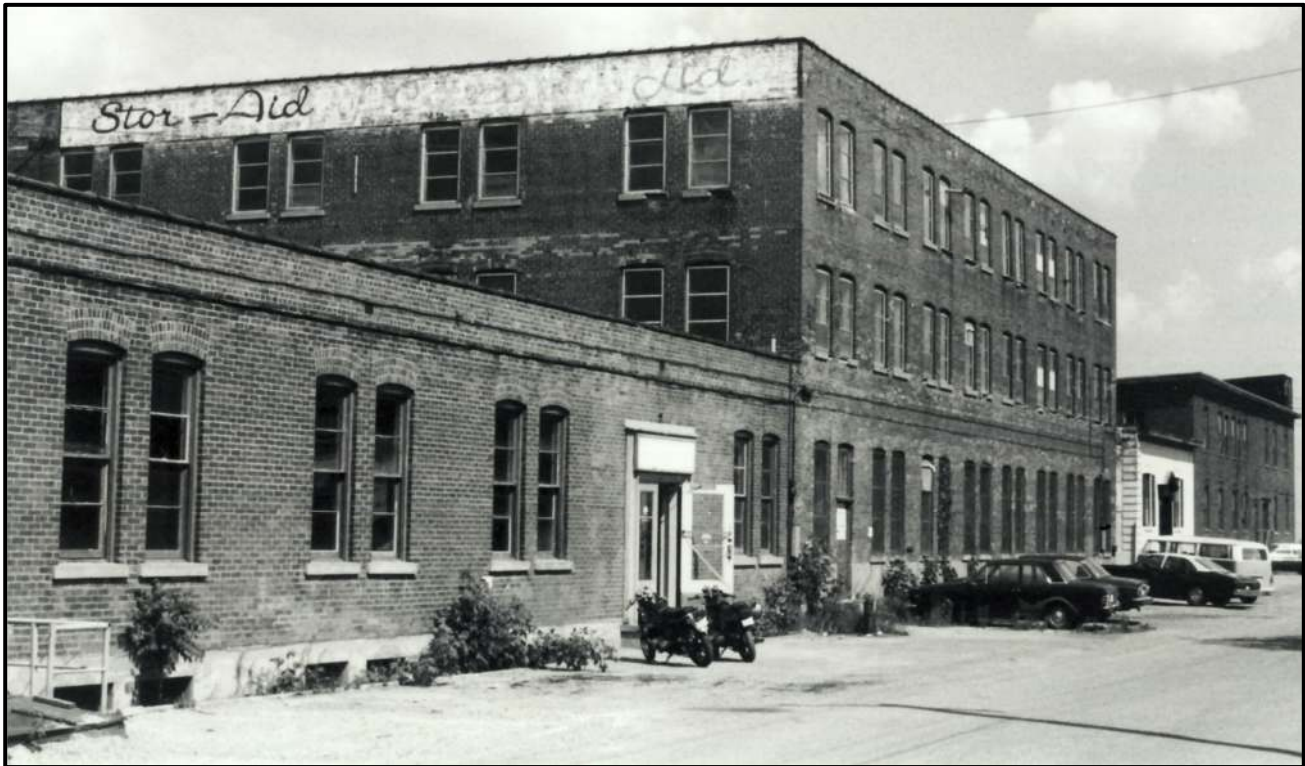
The circa 1930s one-storey building is on the left of this 1978 photo. Source: *Town of Oakville, Heritage Planning files*

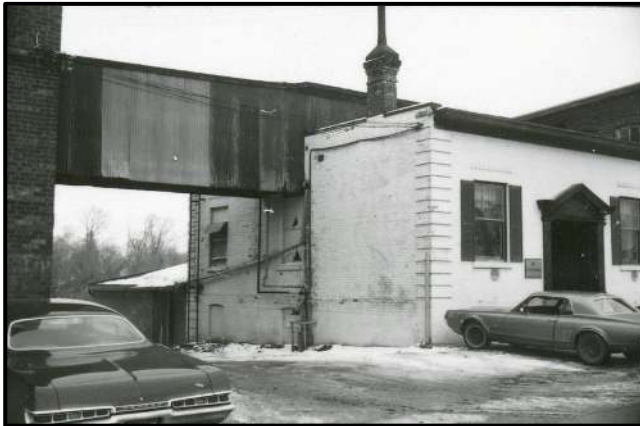
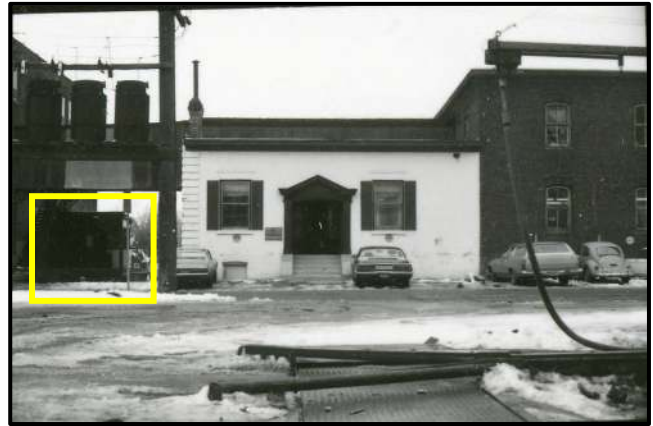
In the late 1970s the overhead passageway sat atop of 45 Forsythe Street and a small loading dock was attached to the three-storey brick building. It is visible in the photo on the right and is highlighted in yellow. *Source: Town of Oakville, Heritage Planning files*

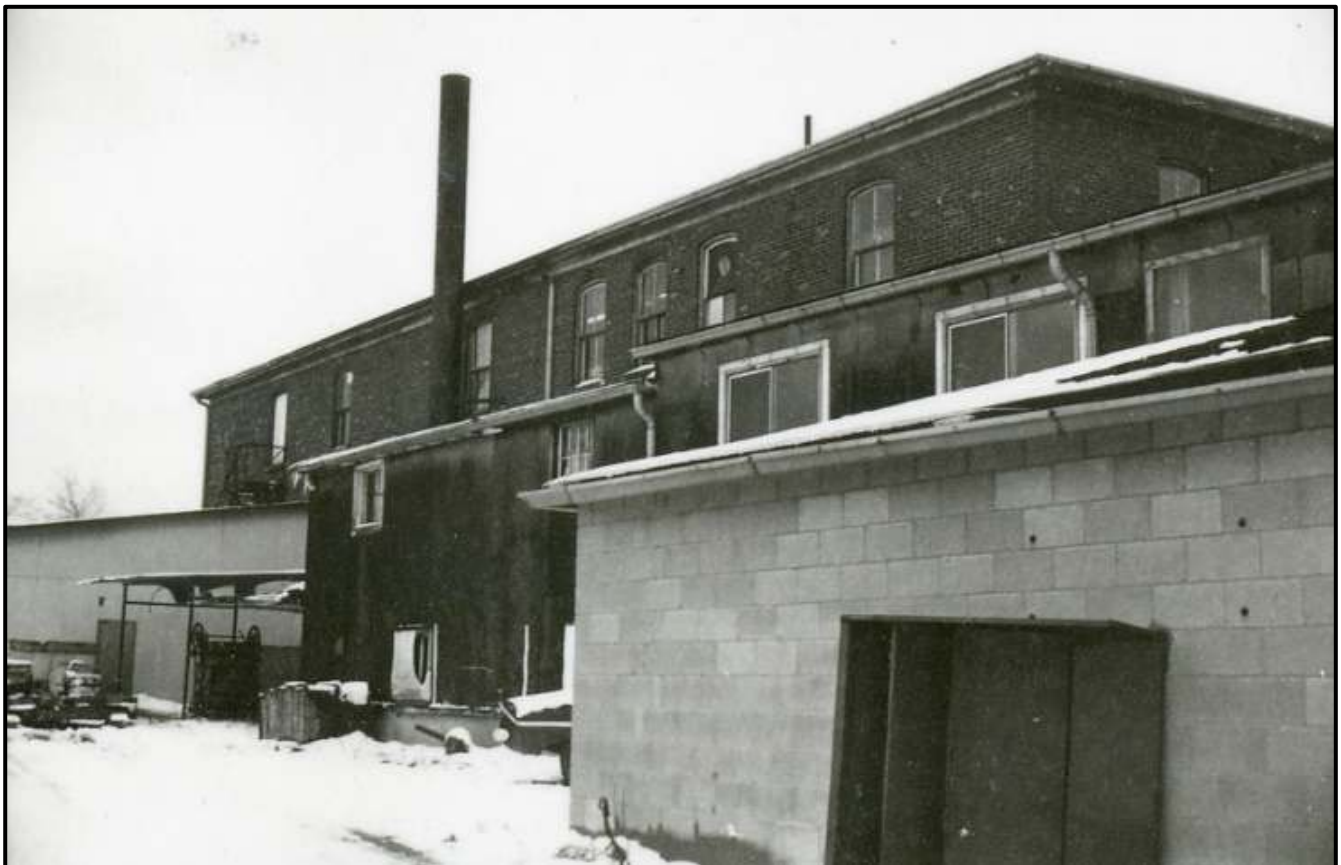
The image below shows the partial rear elevation of the structures including, from left to right, the smaller frame, brick, and concrete block additions or building sections.

Rear elevations of 51-53 Forsythe Street, when the buildings were part of Stor-Aid of Canada Ltd. Image taken as part of the Canadian Inventory of Historic Building project, 1971. *Source: Town of Oakville, Heritage Planning files*

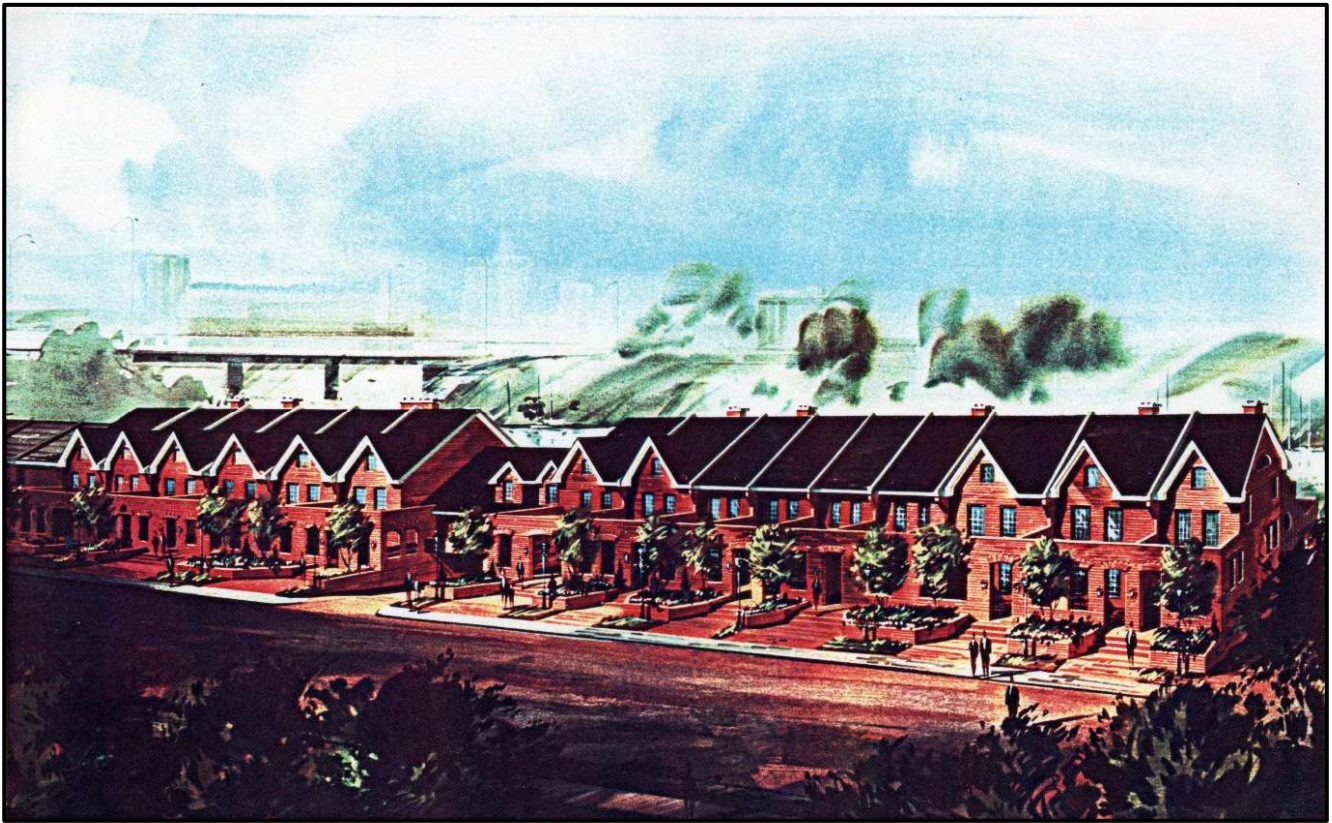
Dunlop Farrow Aitkens' Tannery Cove design concept. Undated.

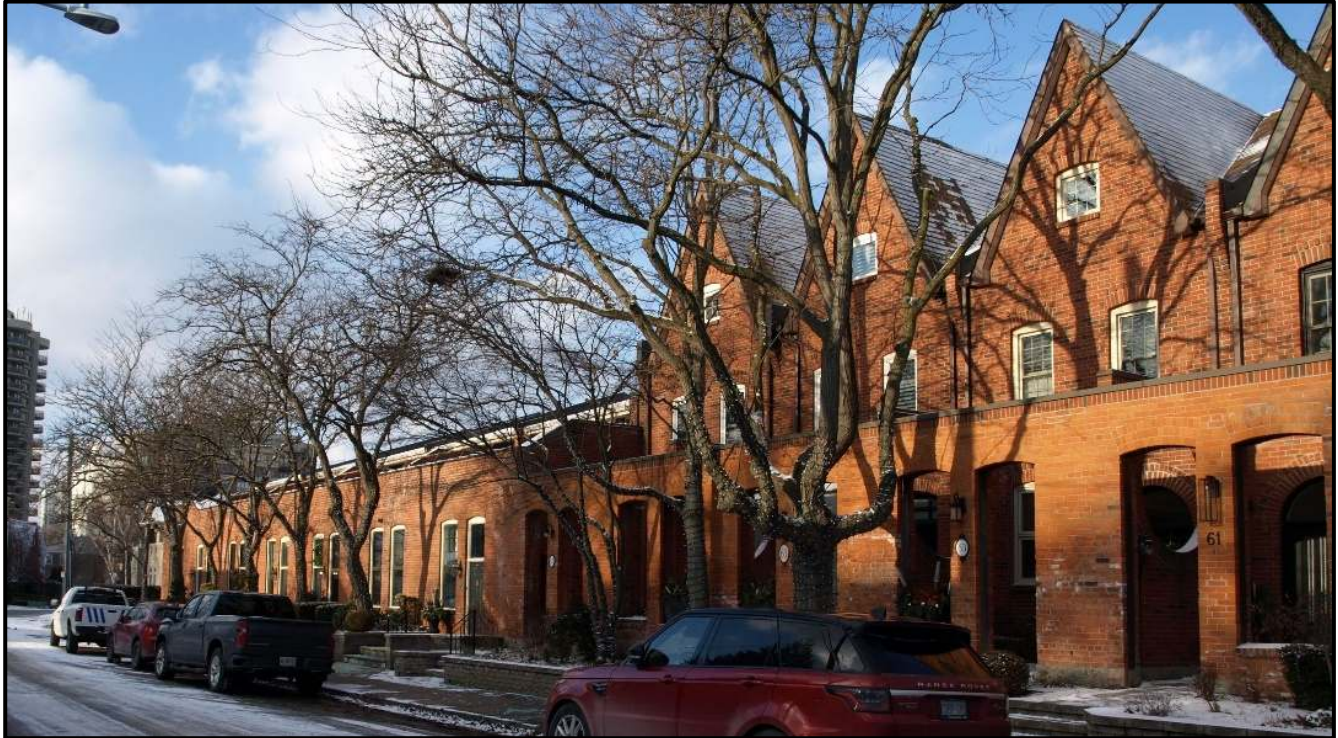
Tannery Cove on the right and Port Villa on the left. January 2024. *Source: Town of Oakville, Planning Services photo*

Not long after the Tannery Cove townhouses were completed, the Port Villa development was completed directly to the north, rehabilitating the circa 1930s one-storey building into additional townhouse units. This project retained the existing north and west walls and provided each unit with a terraced area on the flat roof of the first storey remnant historic tannery walls. Additional living space was constructed on the second floor and to the rear, facing the harbour. Access to underground parking is through a driveway where Burnet Street once ended.

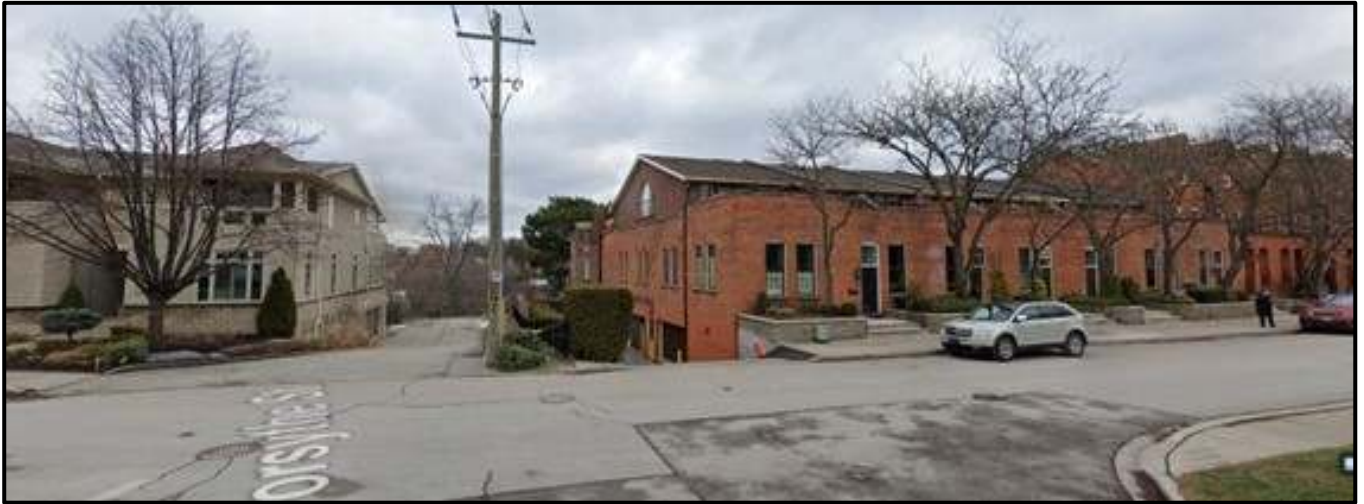
Looking east towards Sixteen Mile Creek at the north-most elevation of the remnant historic tannery walls of The Marlatt & Armstrong Co. Ltd., building at the intersection of Forsythe and Burnet Streets. January 2021. *Source: Google Street View*

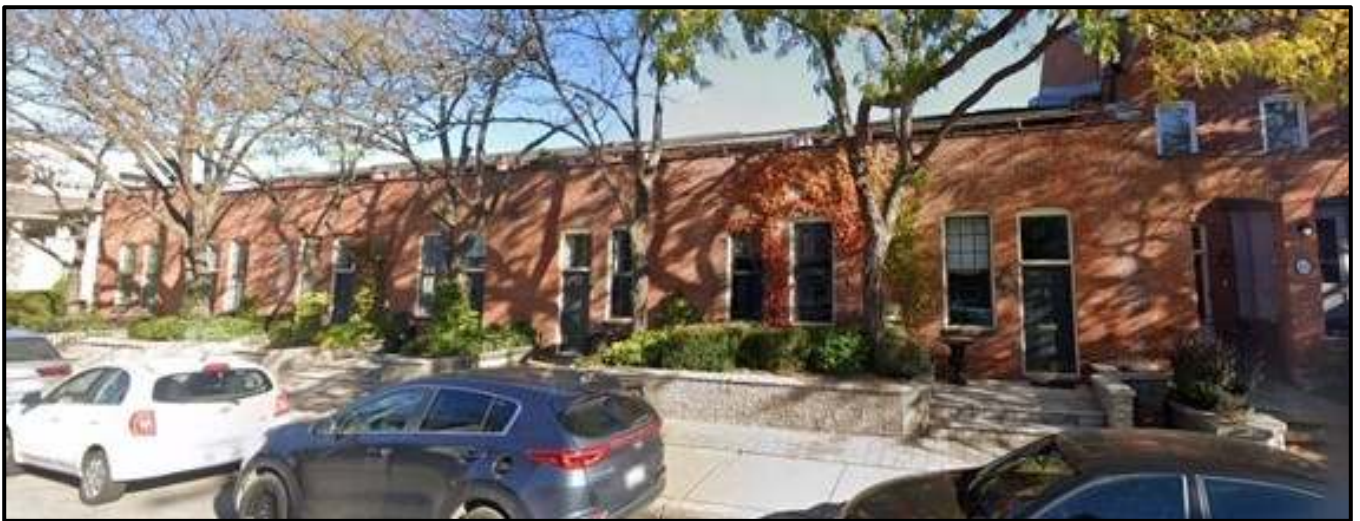
Looking northeast on Forsythe Street, at the west façade of the one-storey Marlatt & Armstrong remant historic tannery walls. November 2020. *Source: Google Street View*

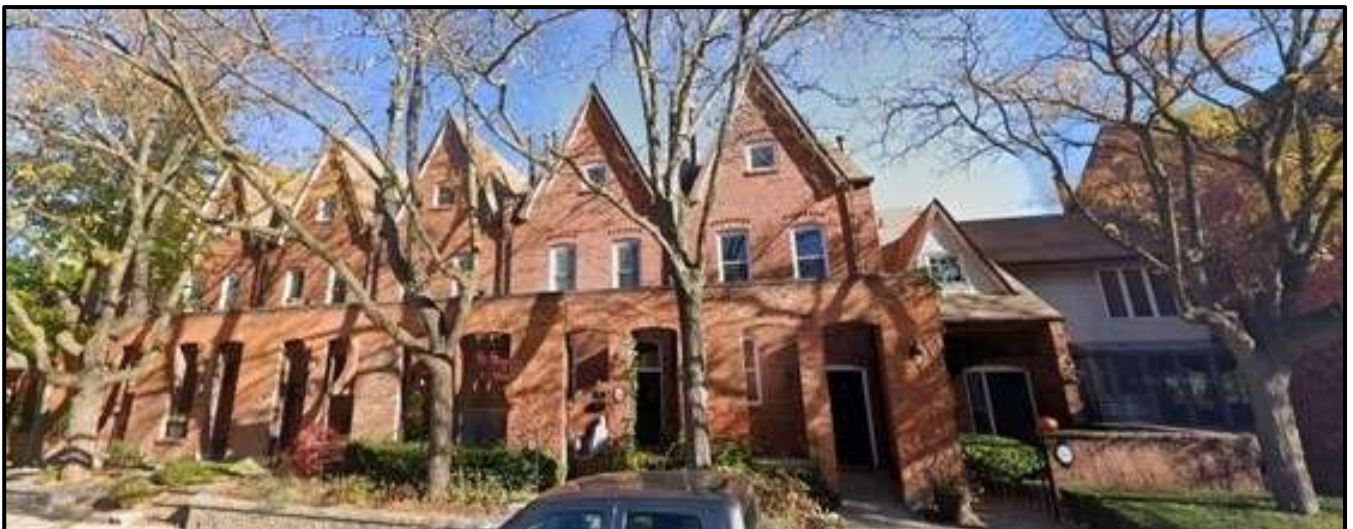
Looking northeast on Forsythe Street, at the west façade of the one-storey Marlatt & Armstrong remant historic tannery walls. November 2020. *Source: Google Street View*

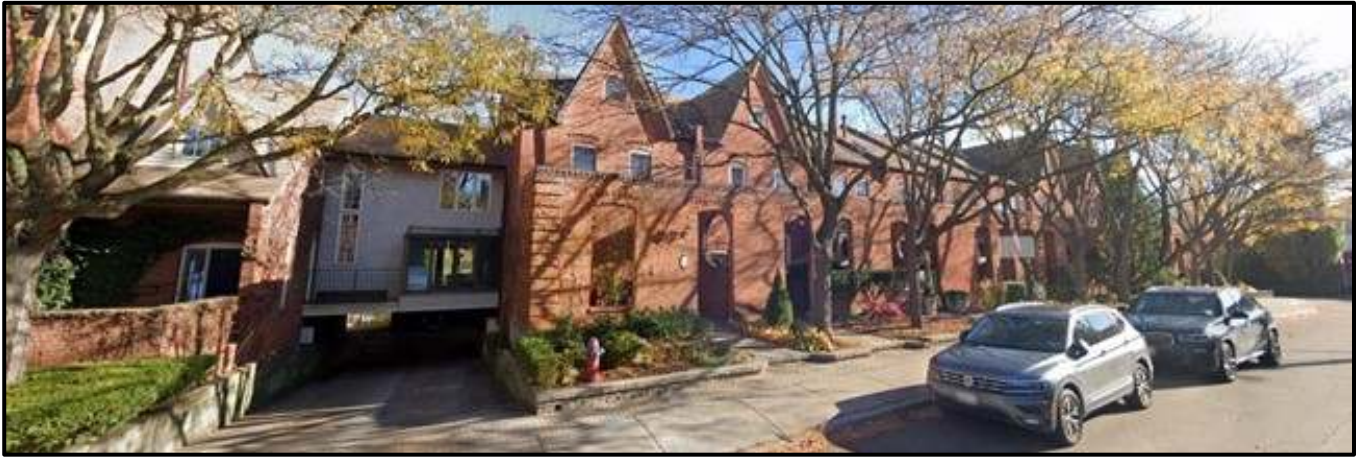
Looking southeast on Forsythe Street, at the west façade of the one-storey Marlatt & Armstrong remnant historic tannery walls. This was the location of the overhead passageway between the two buildings. November 2020. *Source: Google Street View*

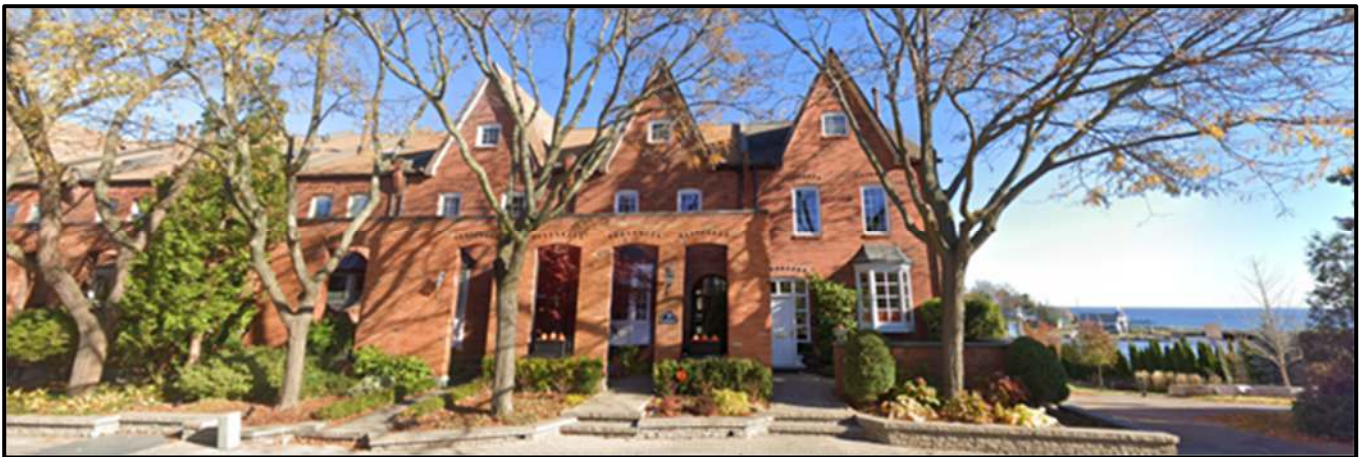
Looking at part of the west façade of the townhouse complex on Forsythe Street. The one-storey Marlatt & Armstrong remnant historic tannery walls begin in front of 39 Forsythe Street. November 2020. *Source: Google Street View*
