The Karas Home
1547 Bayview Road

Plan of Lot 22
Registered Plan 358
Town of Oakville,
Regional Municipality of Halton

Site Plan

SUBJECT: Arborist Report and Tree Preservation Plan 1547 Bayview Road, Oakville (amended Nov.19/24)

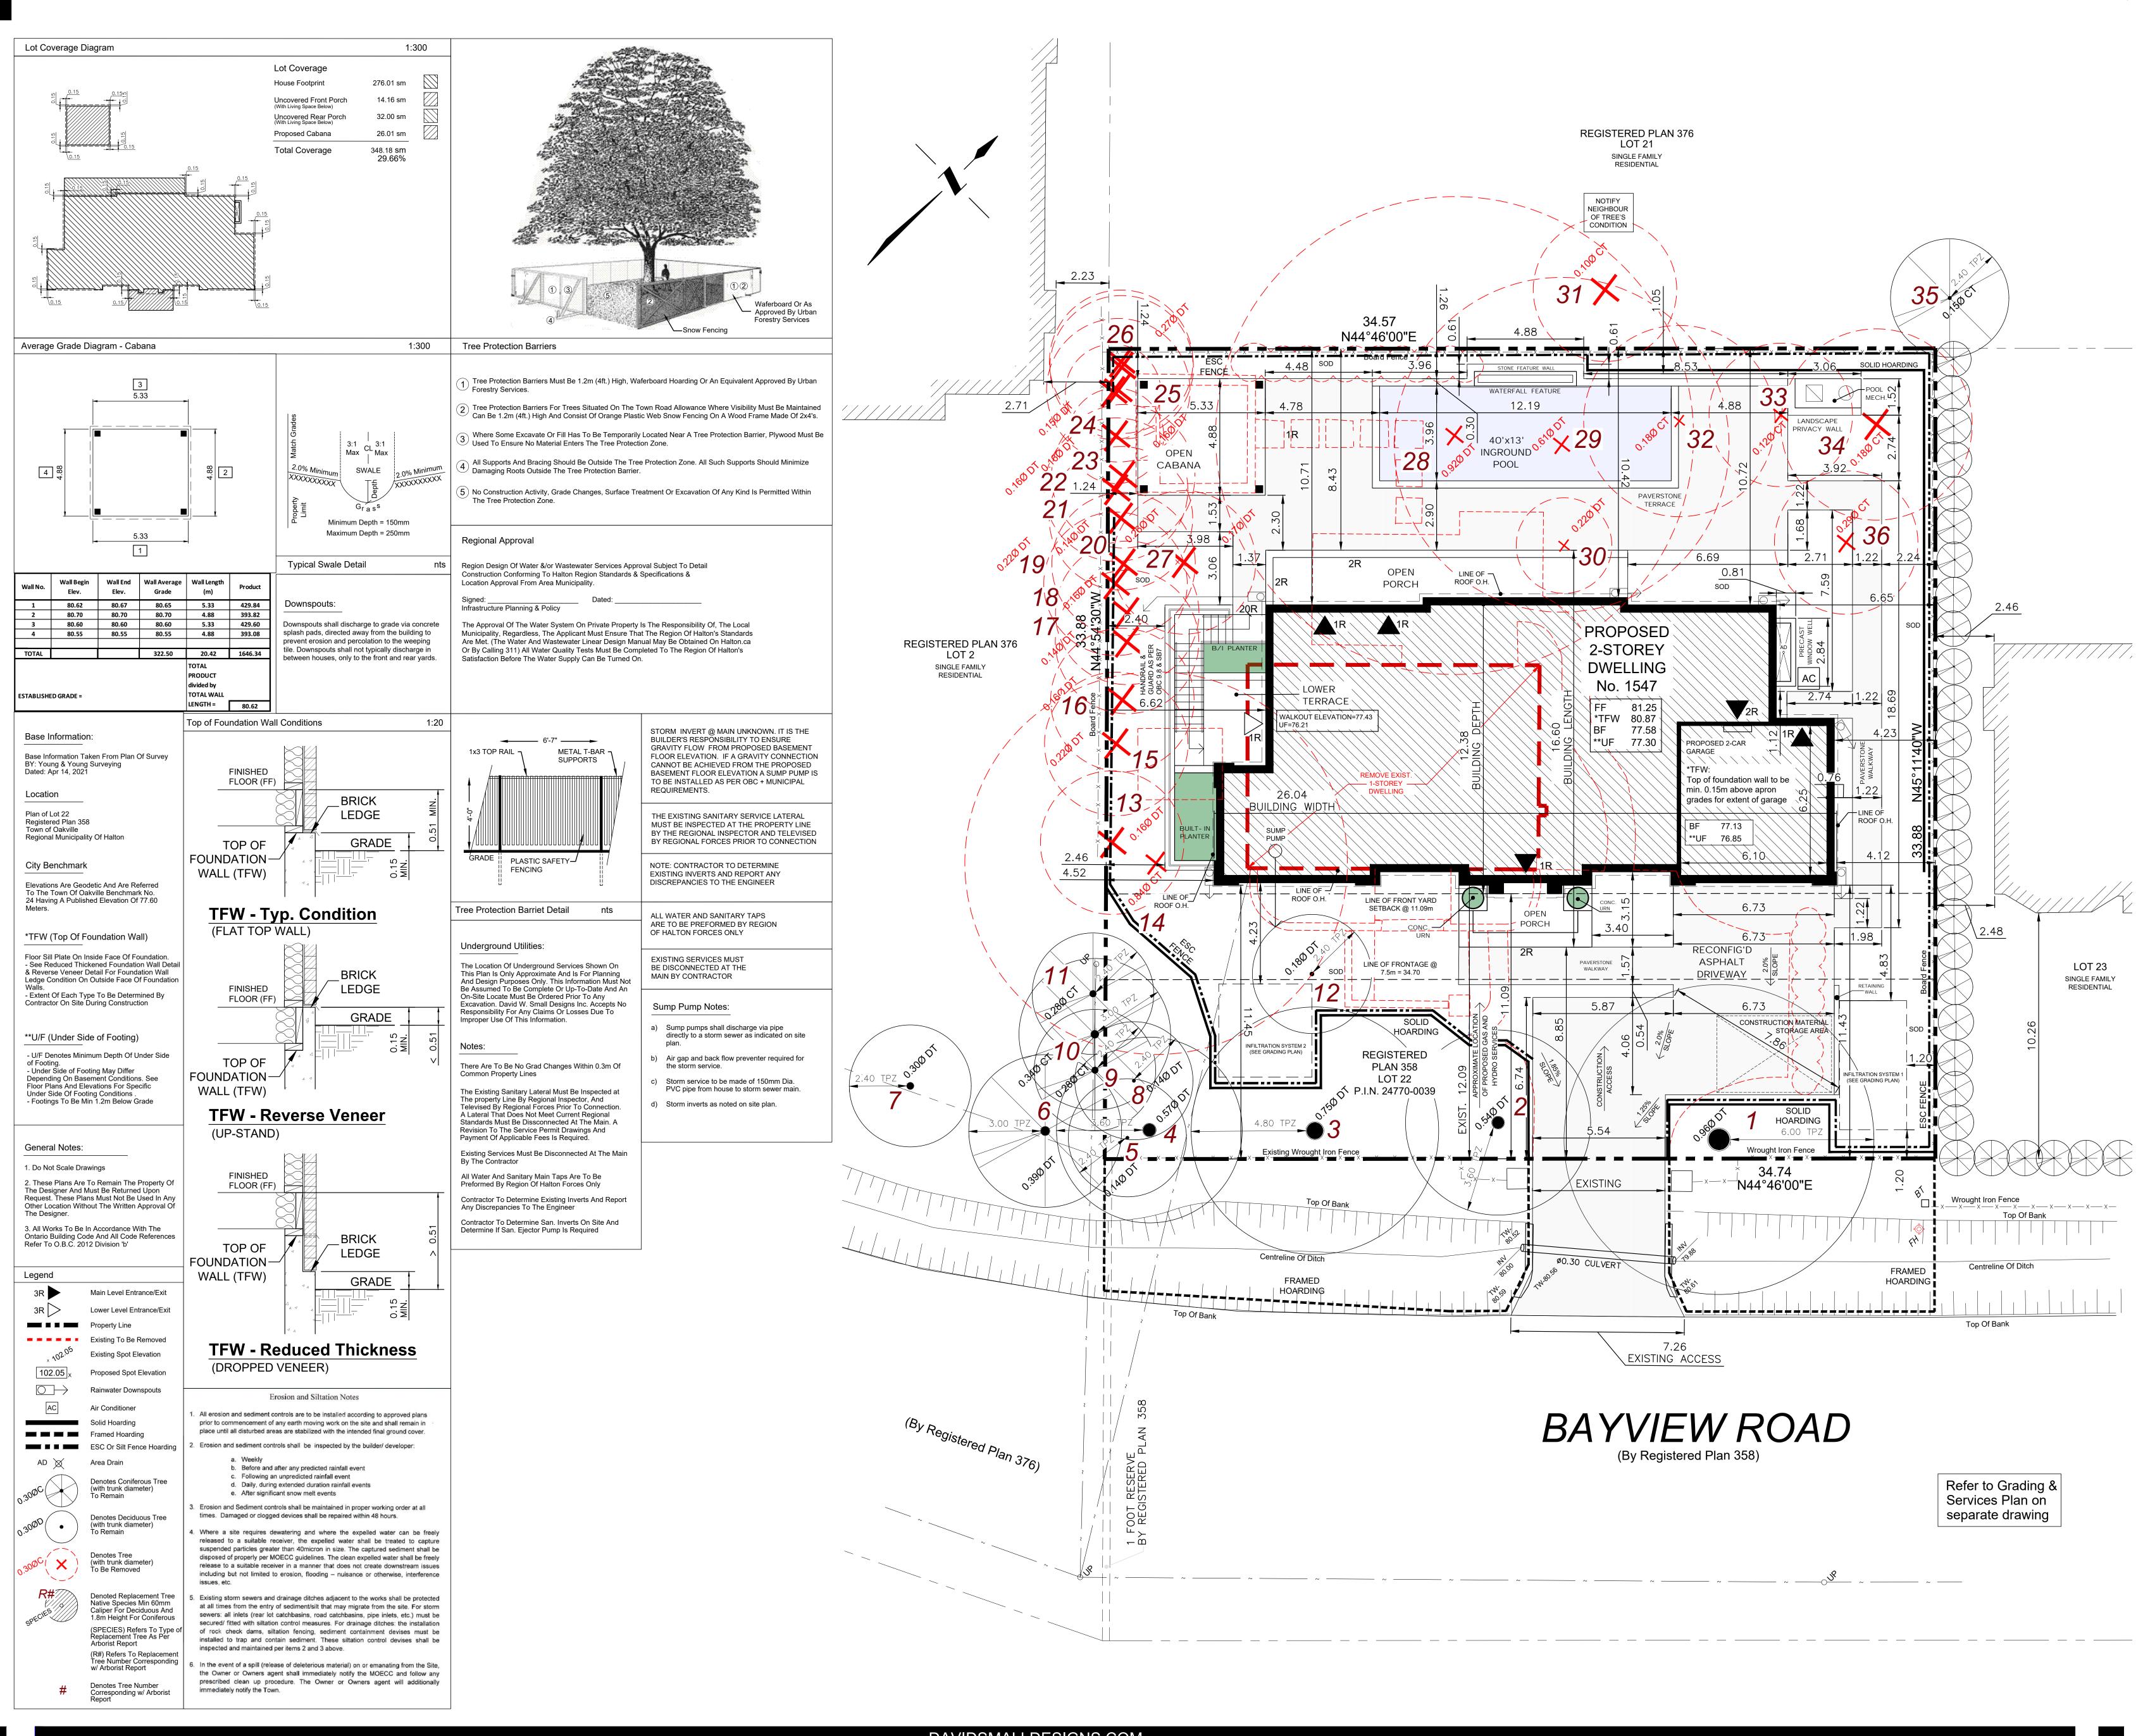
Lot Area Zoning Established Grade	1173.97 sm	(0.11 Ri 8
Floor Area		
Ground Floor (Includes 71.2 sf of Stairs)	232.68 sm	2504.
Second Floor (Excludes 86.5 sf of Stairs & 671.4sf Of Open T	203.85 sm to Below)	2194.
Total Area	436.53 sm	4698.
Garage (Measured to Interior Face of Garage Walls)	38.09 sm	410.
Finished Basement	222.10 sm	2390.

Measured to Inside Face of Finished Basement Walls)									
Lot Coverage									
Proposed Footprint (Including Garage)	23.51%	276.01 sm							
Proposed Uncovered Front Porch (With Living Space Below)	1.21%	14.16 sm							
Proposed Uncovered Rear Porch (With Living Space Below)	2.73%	32.00 sm							
Proposed Cabana	2.22%	26.01 sm							
Total Proposed Coverage	29.66%	348.18 sm							
Max Allowed Coverage	25.00%	293.49 sm

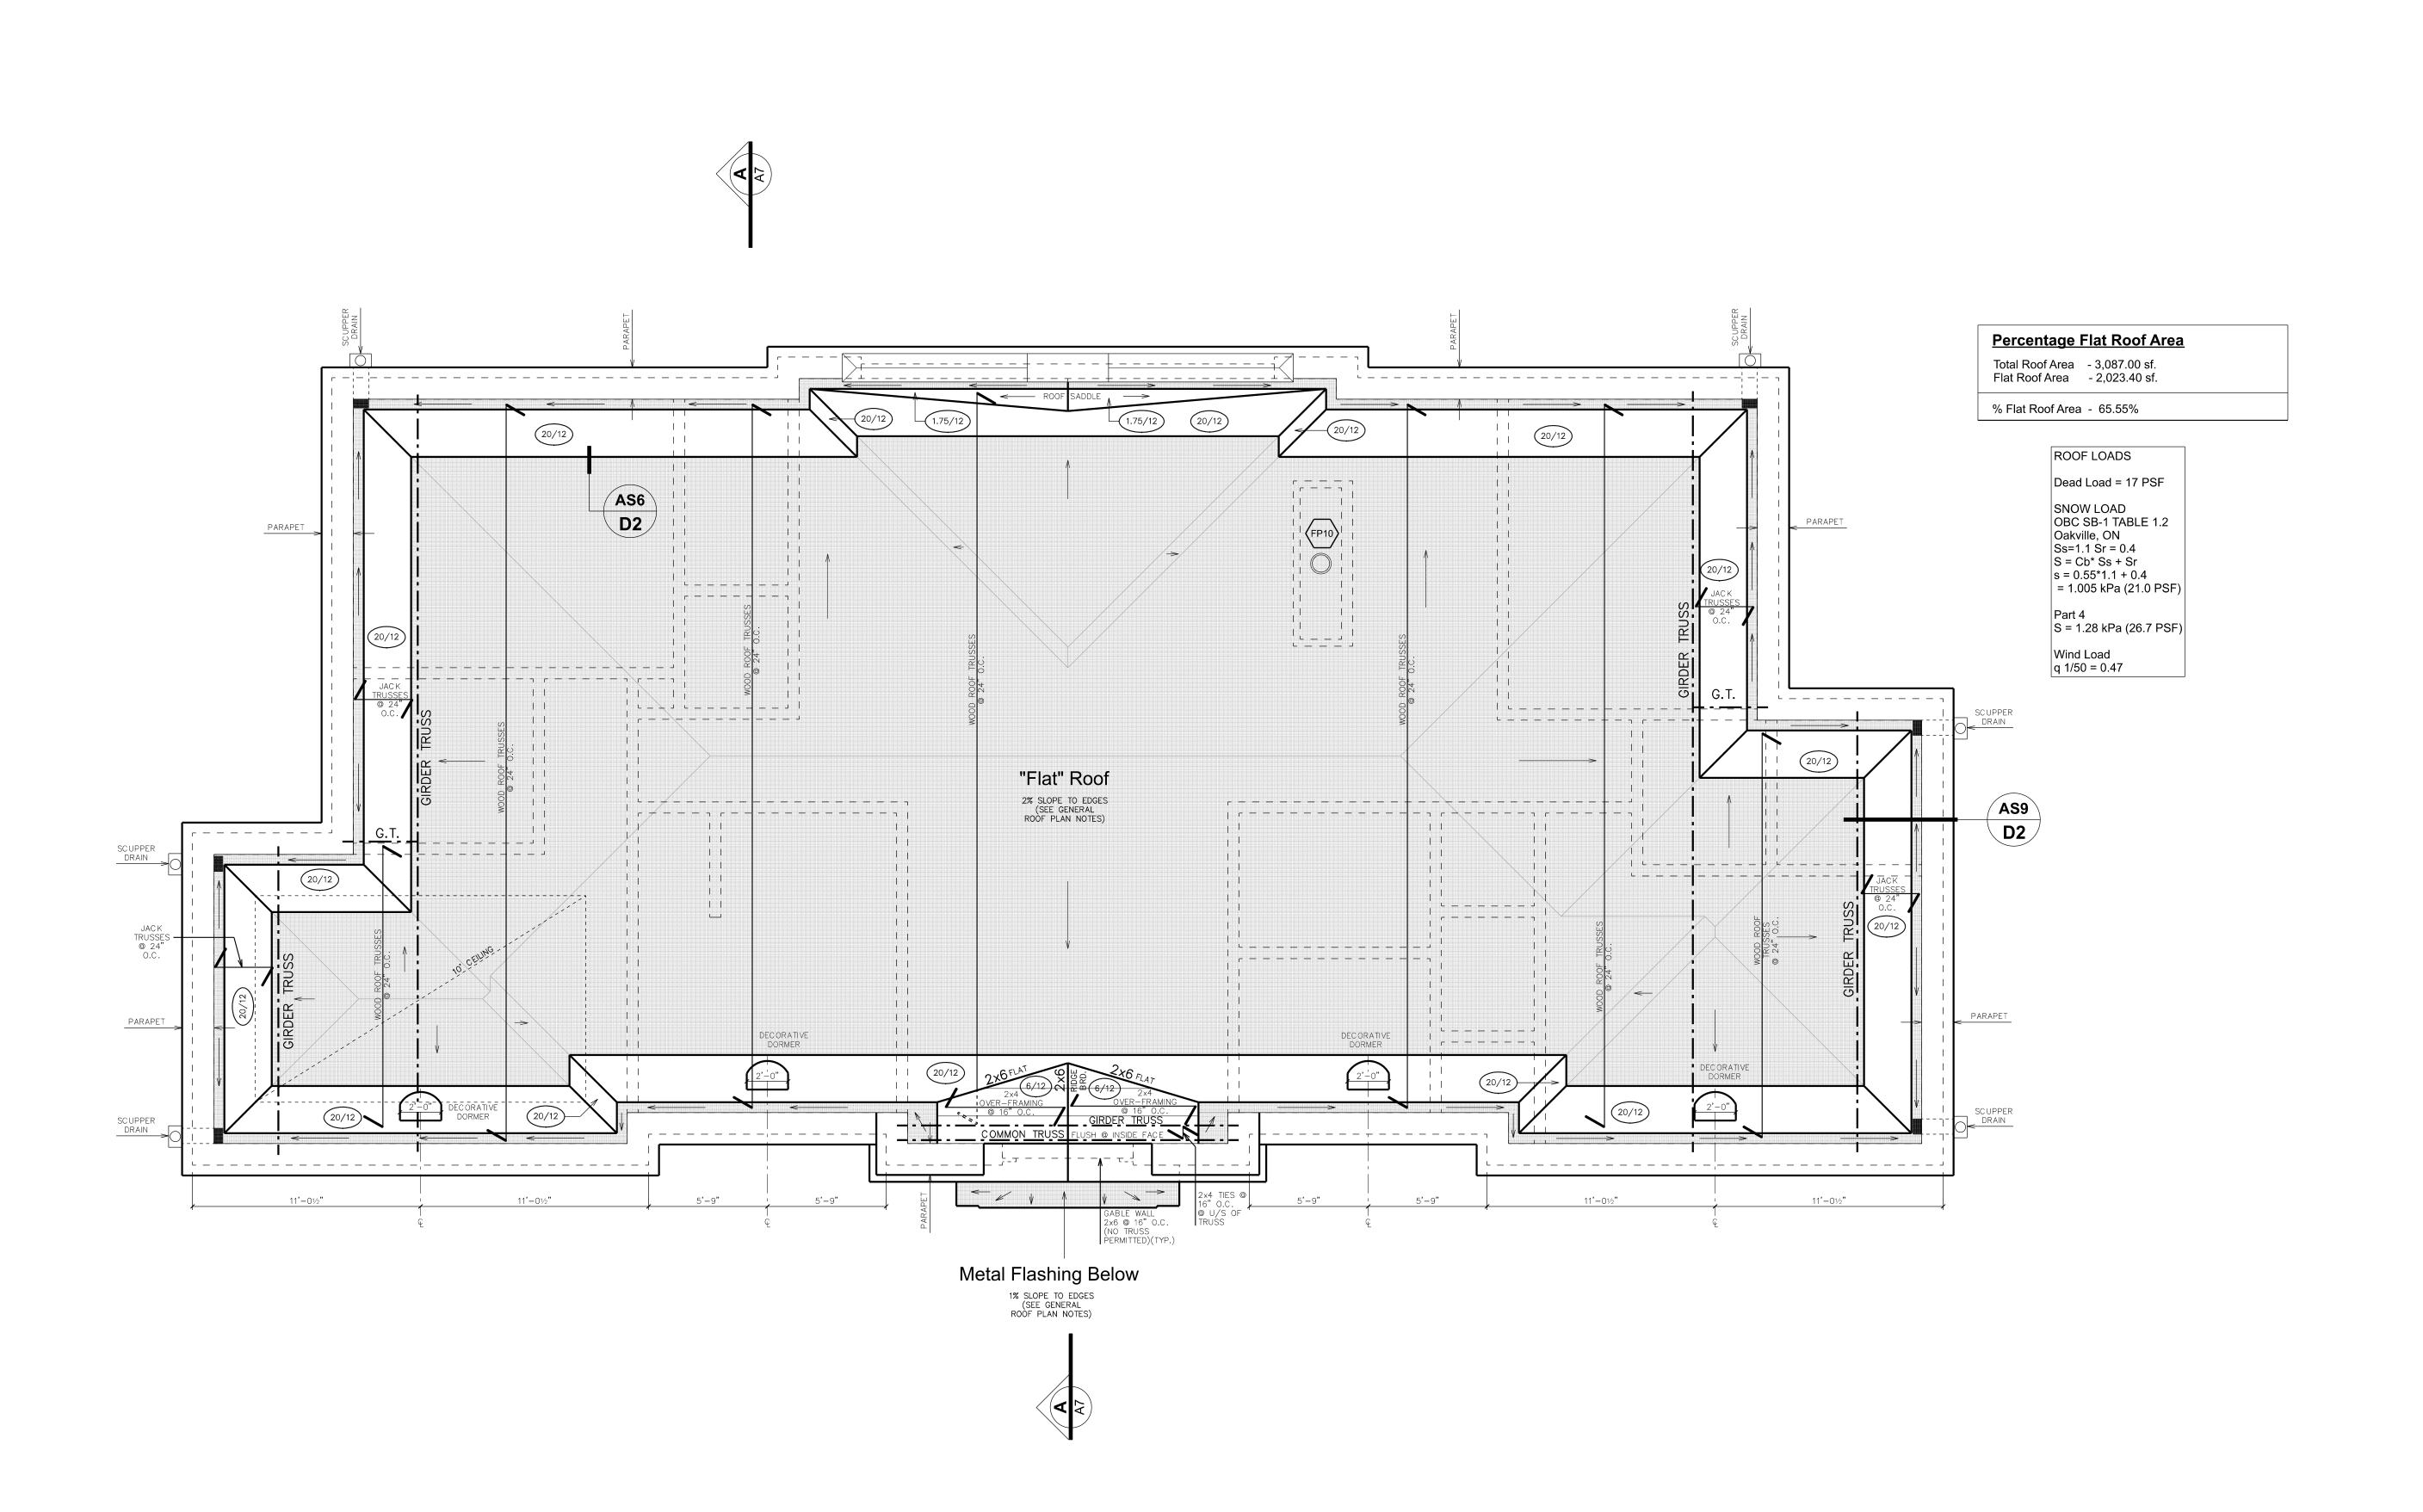
Roof Notes

All roof slopes to be 20/12 unless noted otherwise

= Flat Roof - 2% Slope to Edges (See General Roof Plan Notes)

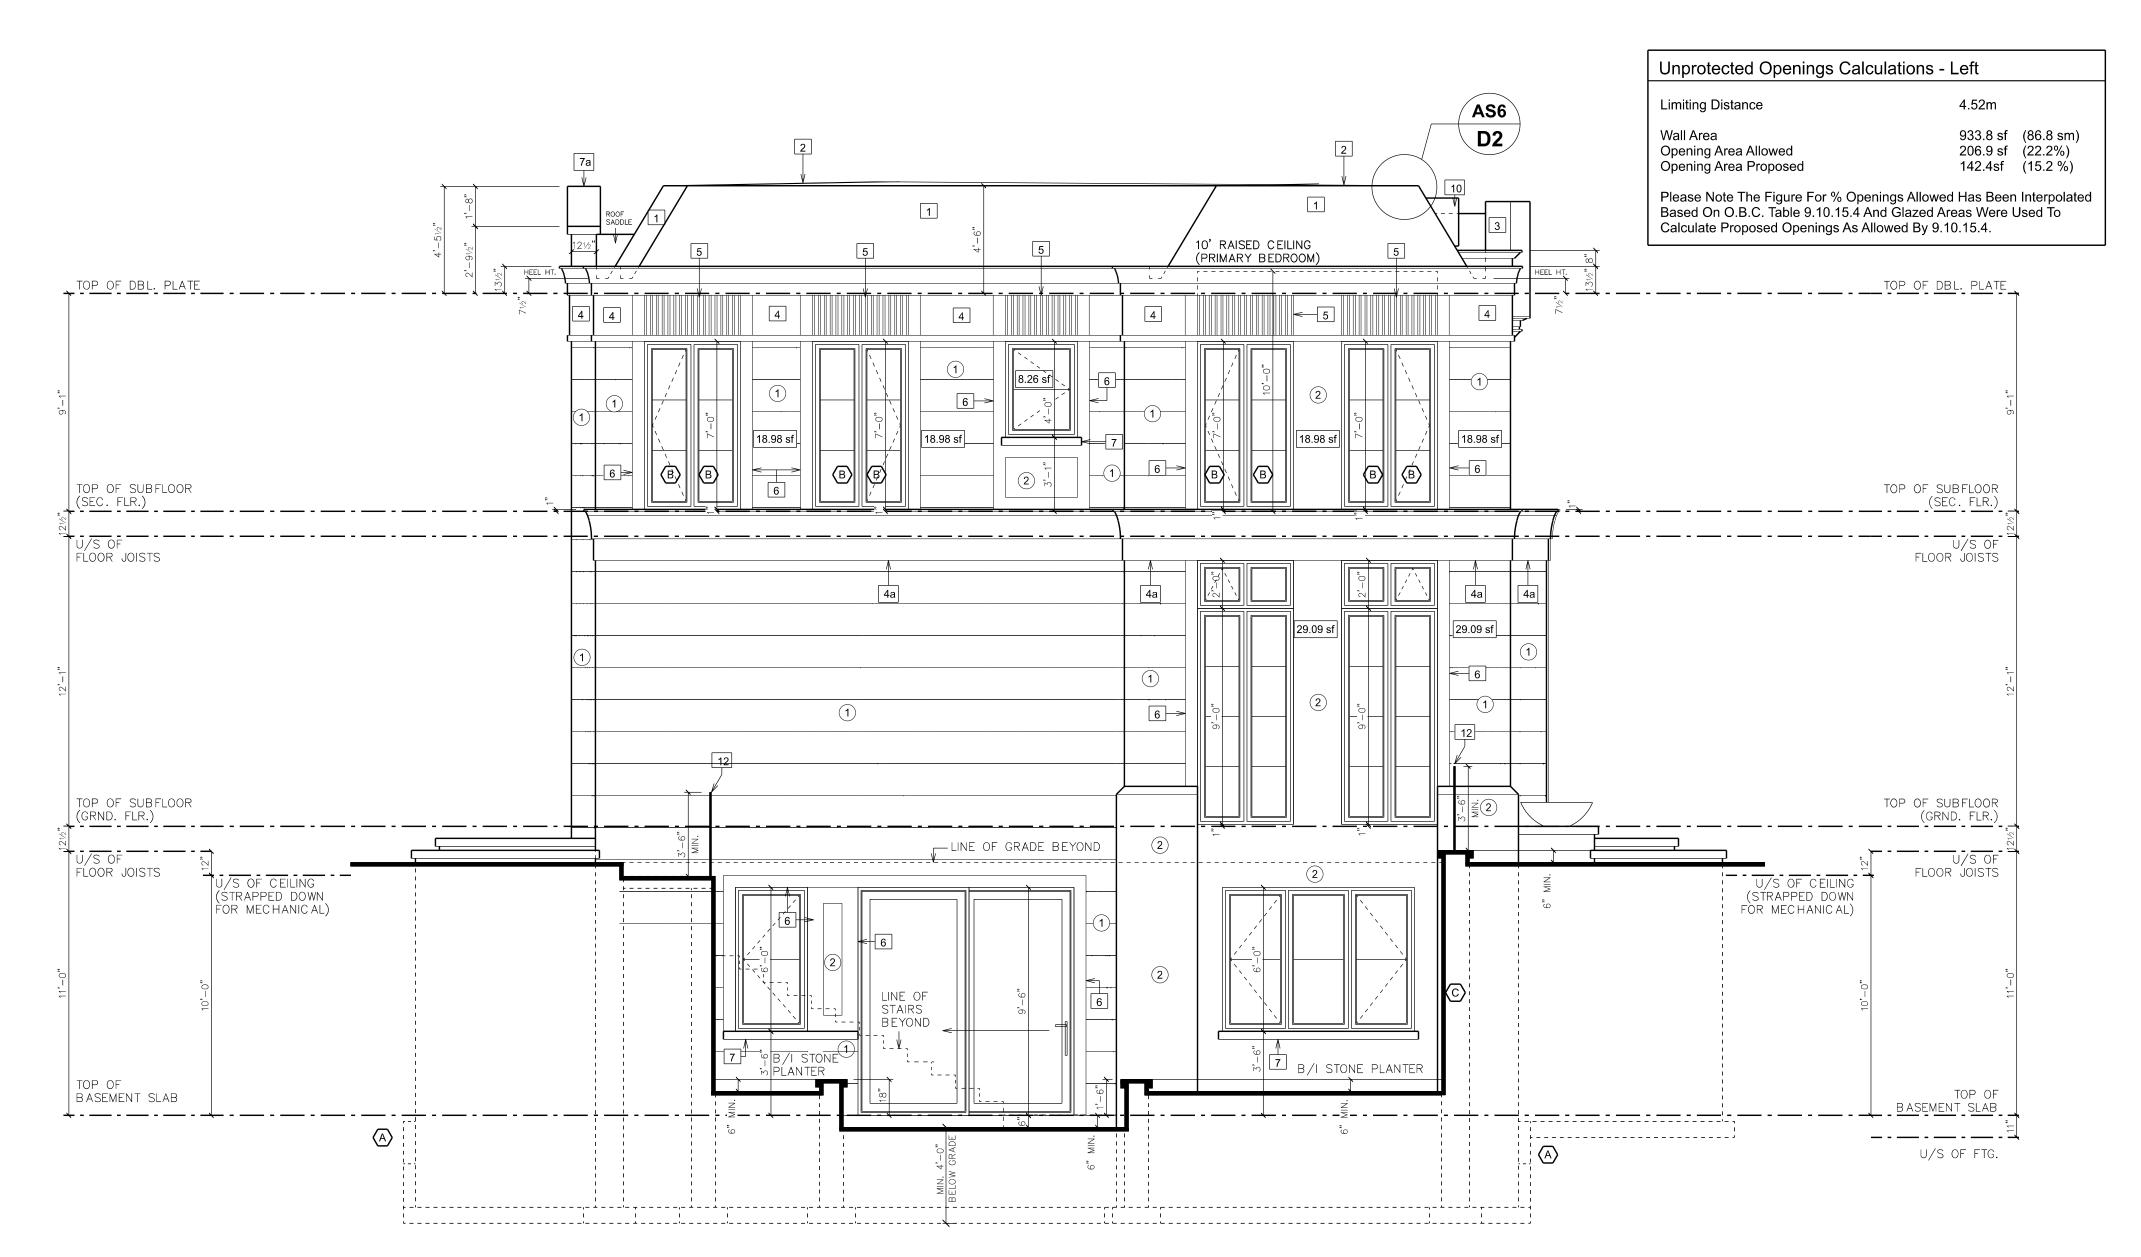
Left-Side (West) Elevation

1.0 Materials

- (1) Smooth Face Cut Stone
- 3 ACM Panel

2 Cut Stone Panel

- 1 Faux Slate Shingles
- 2-Ply Torched On Rubber Membrane Roof Sloped To 2% To Outside Edge On 1/2" Plywood Roof Sheathing On Roof
- Raised Seam Prefinished Metal Roofing

- 12" Wide Prefinished Aluminum Fascia c/w Starter Strip & Drip Edge 1"x12" Base Fascia Board 1"x6" Flat Stock 6" Prefinished Aluminum Gutter
- 14.5" Crown Mould Cut Stone Trim on 4 Flat w/ 2" High x +\- 1-1/4" Deep Bottom Trim (Total 3'-1/2" High)
- 4a 14.5" Crown Mould Cut Stone Trim on Flat (Total 2'-1/2" High)
- 4" Crown Mould Cut Stone Trim on Flat w/ 2" High x +\- 1-1/4" Deep Bottom Trim (Total 12" High)
- 4" Crown Mould Cut Stone Trim on Flat (Total 8" High)
- 4" Crown Mould Cut Stone Stepped Trim on Flat (Total 10" High)
- 4" Crown Mould Cut Stone Trim on Flat 4" Crown Mould (4e (Total 6" High)
- Cut Stone Fluted Headers (To Match Window Width)
- 6 6 Cut Stone Trim Recessed 1 1/2
- 7 4" Cut Stone Sill c/w 2" Projection 7a 4" Cut Stone Coping Cap w/ 2" Projection
- 8 2'-8" Diameter Cut Stone Medalion
- g 2'-0" Diameter Recessed Cut Stone
- 2'-0" Diameter Metal Decorative

- 11 12"x12" Cut Stone Clad Post As Shown
- Frameless Tempered Glass Panels Min. 42"
 Above Fin. Decking Contractor To Provide Shop Drawing To Inspector Prior To Installation To Ensure They Meet All Aspect Of OBC. 9.8. & SB-13 Of The Supplement

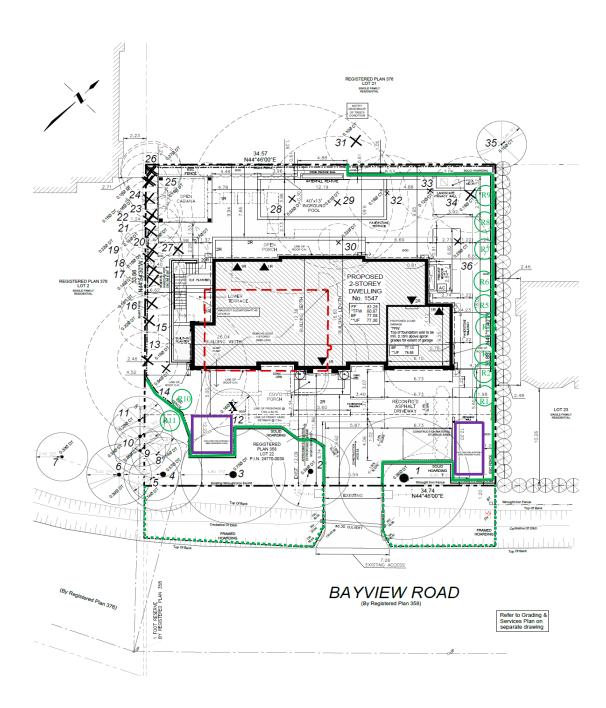
Appendix A: Proposed Site Plan – 1547 Bayview Road, Oakville

Note: The locations of Trees #5, 6, 8, 16-20 and 27 are approximations. The proposed Tree Protection Zone (TPZ) hoarding is drawn as green lines and has been drawn to scale on the site plan by the project architect. Rx denotes eleven (11) replacement trees and their approximate proposed locations.

Legend:		
Solid Hoarding	Framed Hoarding	
Infiltration systems (proposed)

<u>Eleven (11) replacement trees</u> and their approximate proposed locations are marked with the symbol Rx on the site plan in Appendix A on Page 21 of this report.

A diagram of the proposed hoarding plan for this site can be found in <u>Appendix A on Page 21</u> of this report. The recommended radial distances from the trunk for installation of TPZ hoarding are listed in <u>Appendix B starting on Page 22</u> of this report, and the hoarding shall be installed using the following guidelines:
