Property: 1349 Clearview Dr.

Please find here within an application for consent, comprised of a proposed severance of the above noted property.

A minor variance is also being sought to permit reduced frontages for each lot.

SEVERANCE SKETCH OF  
PART OF LOT 7  
REGISTERED PLAN 432  
IN THE  
CITY OF OAKVILLE

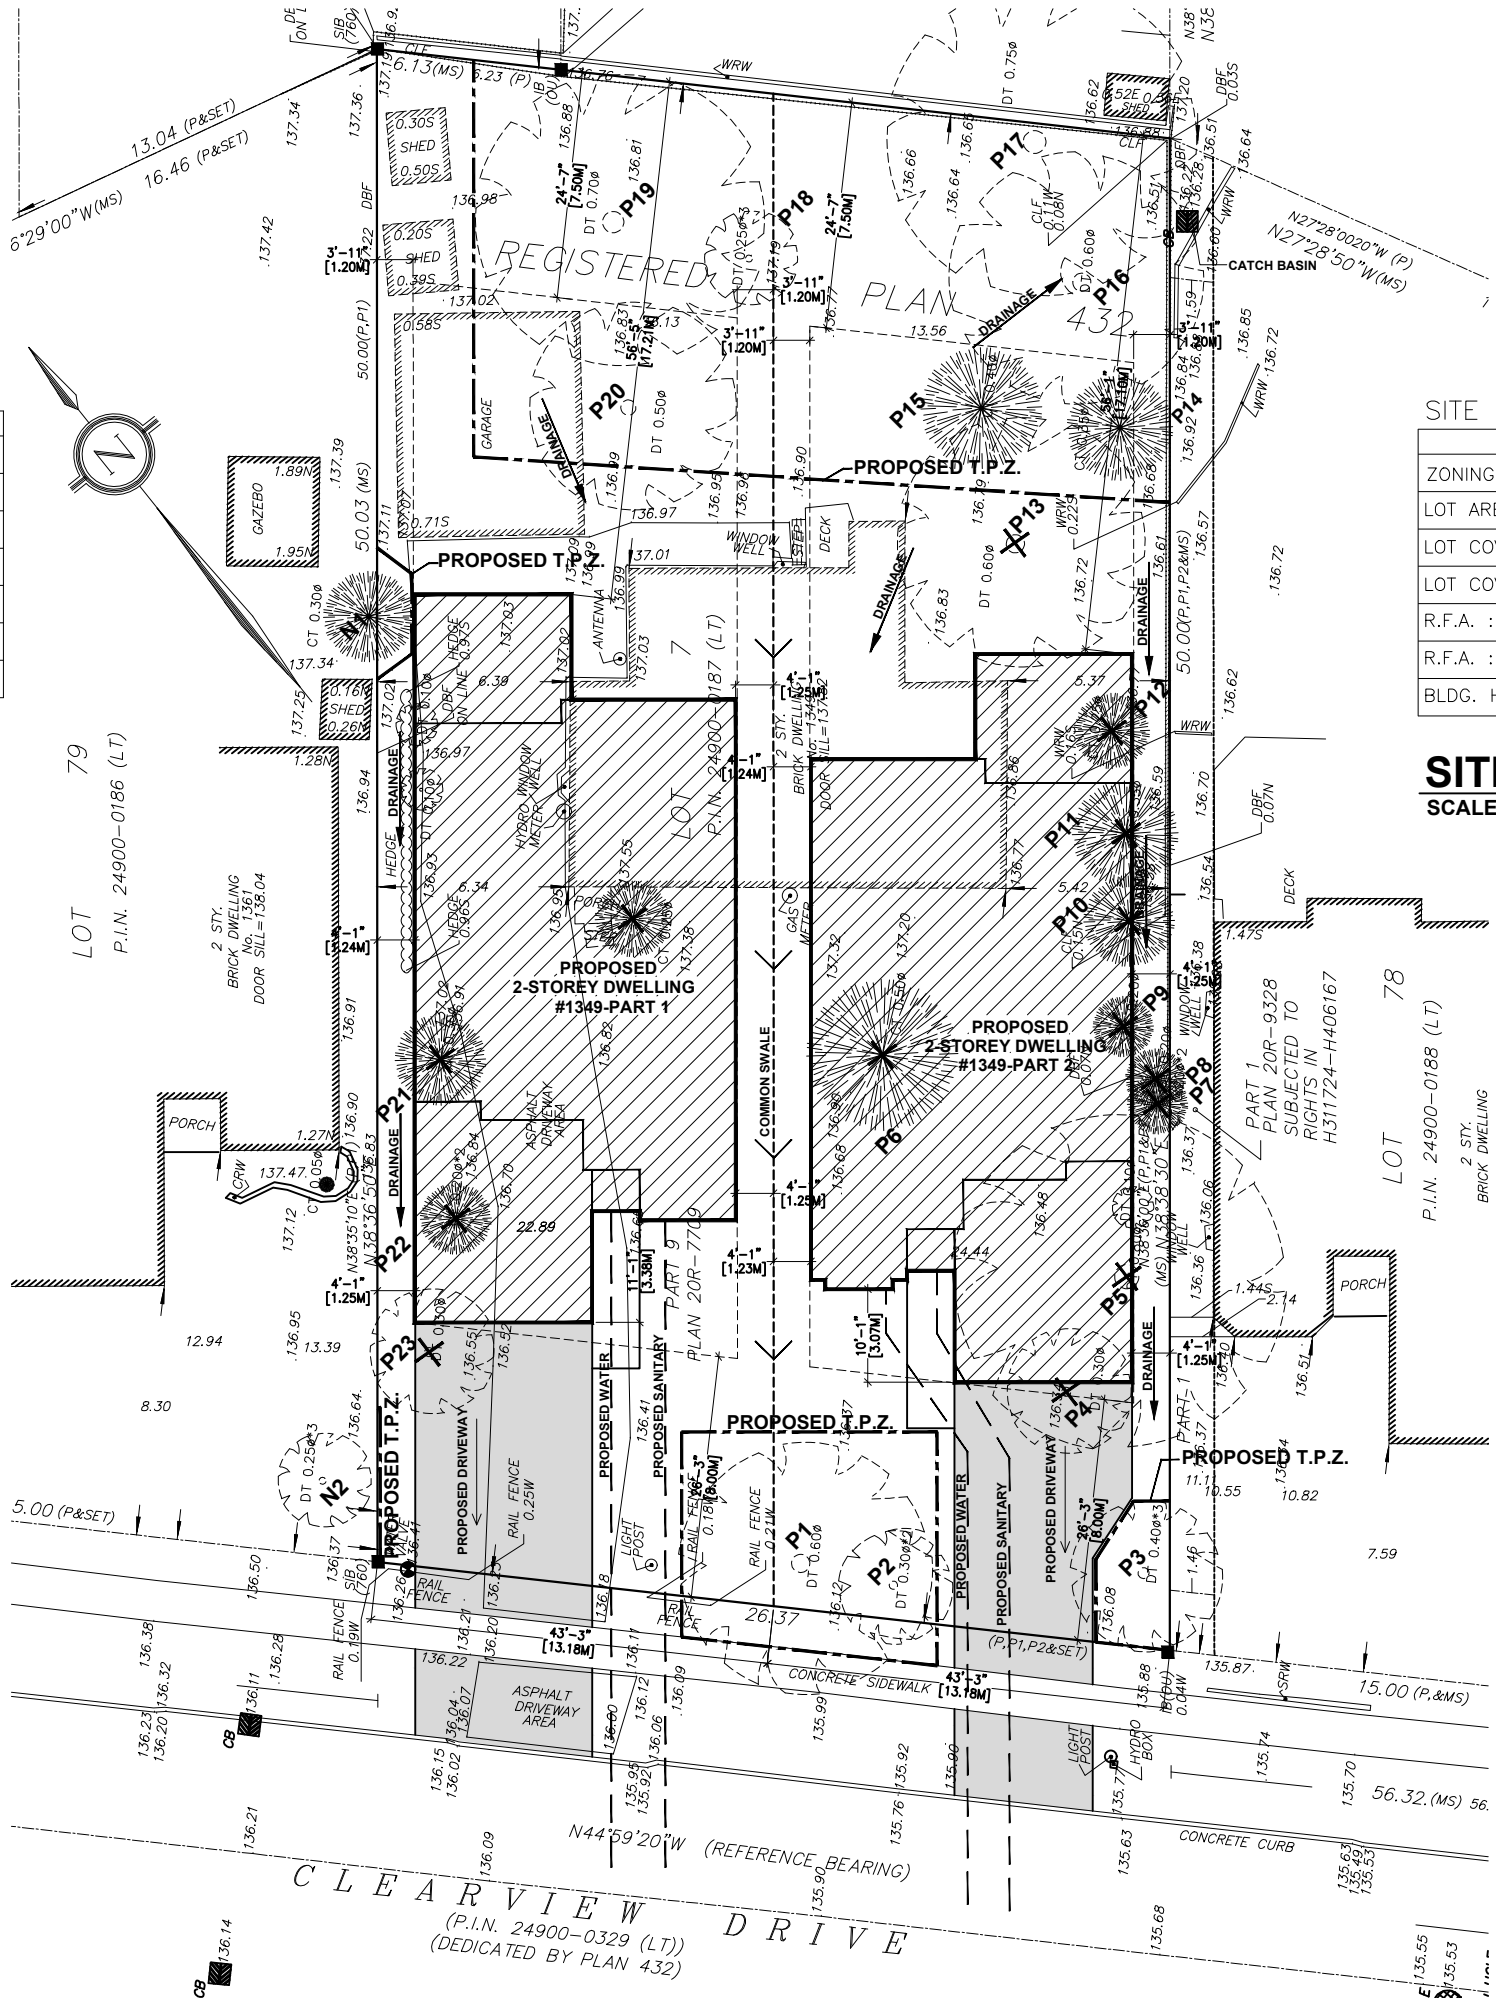
SITE PLAN

SITE STATISTICS: 1349 CLEARVIEW DRIVE–PART 1

EXISTING	PROPOSED	TOTAL	ALLOWED
ZONING:	RL3			
LOT AREA:	655.38M2			
LOT COVERAGE:	--- M2	220.21M2		229.38M2 2,469 SQ. FT.
LOT COVERAGE:	---	%	33.6%	35 %
R.F.A. :	--- M2	318.43 M2	--- M2	N/A M2
R.F.A. :	---	%	48.59%	N/A %
BLDG. HEIGHT (PEAK)	--- M	8.43M	--- M	12 M

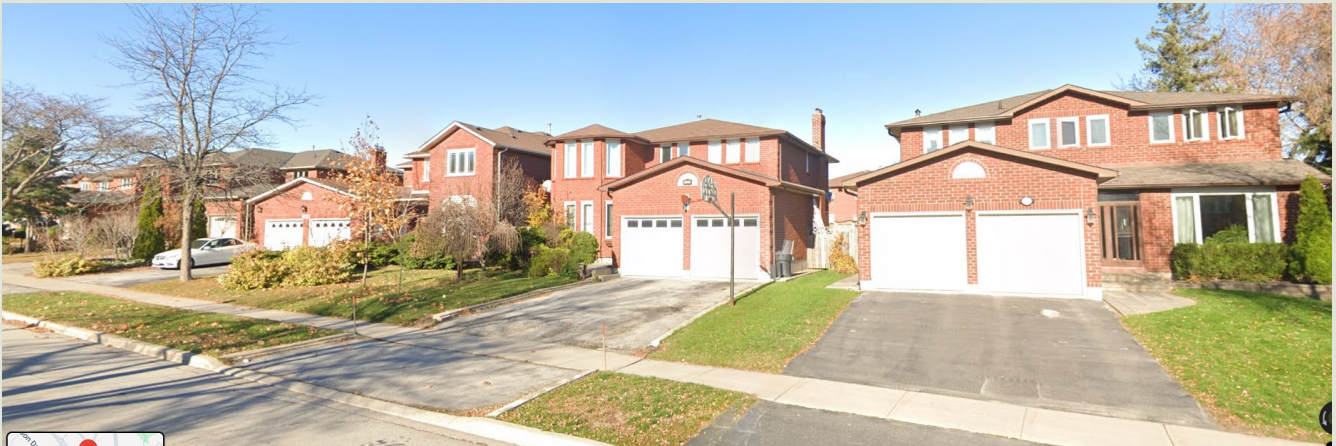
Image 1  
Streetscape looking North from the subject property.

13. The existing area is comprised of “subdivision” style homes built in the late 1980’s to early 1990’s. The two most notable and common architectural features of the existing housing stock are brick veneer and projecting garages. The proposed dwellings also feature projecting garages for this reason and the exterior front facades are also comprised mostly of brick.
