Cover Letter

Property: 1349 Clearview Dr. April 16 2025

This and application for consent and minor variance and is comprised of a proposed severance of the existing property resulting in two parcels to accommodate two single family-dwellings.

Tree Protection Plan

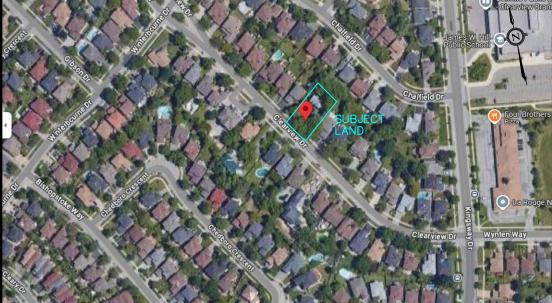
SEVERANCE SKETCH OF PART OF LOT 7 REGISTERED PLAN 432 IN THE CITY OF OAKVILLE

SCALE & NOTES

Scale 1:300

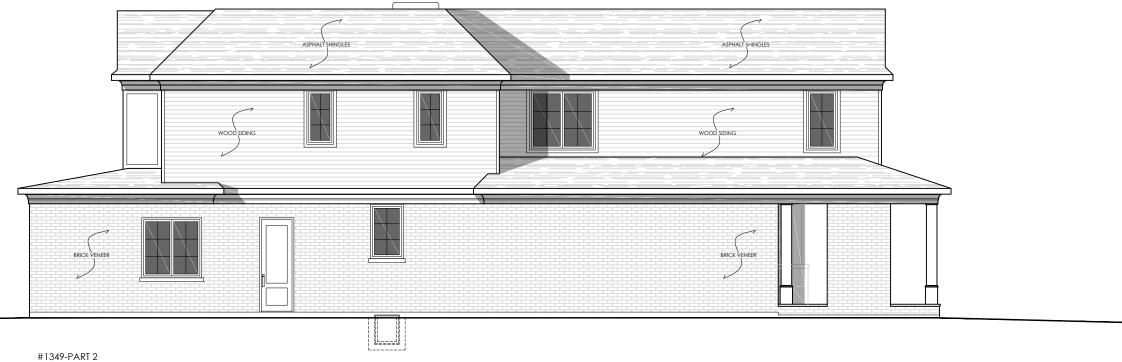
EAST SIDE ELEVATION
SCALE: 1:100

- 6. The East side elevation of the proposed dwelling on Part 2 has been designed in such as way to provide massing relief, because this façade projects behind the existing dwelling at 1345 Clearview. This is achieved by stepping back a large portion of the 2nd floor wall facing the East side which introduces a roof element at the mid point of the wall, severving as a visual separation of this wall.
- 7. For the proposed dwelling on Part 1, only a small portion of it projects beyond the adjacent dwelling located at 1361 Clearview Dr. Only the rear covered porch is meaningfully projecting beyond the rear face of 1361 and this element is open on three sides and only one-storey in height. A portion of the 2nd floor will also be visible but this has also been stepped back with a mid level roof to assist in breaking up the wall massing.

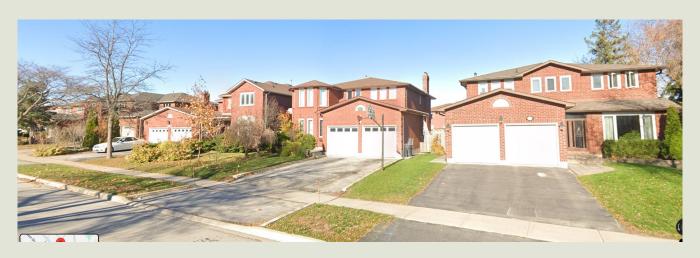
Image 1
Streetscape looking North from the subject property.

13. The existing area is comprised of "subdivision" style homes built in the late 1980's to early 1990's. The two most notable and common architectural features of the existing housing stock are brick veneer and projecting garages.

The proposed dwellings also feature projecting garages for this reason and the exterior front facades are also comprised mostly of brick.
