Town of Oakville

Evaluation of Traffic Operations on Bronte Road between Lakeshore Road
West and Marine Drive

FINAL REPORT

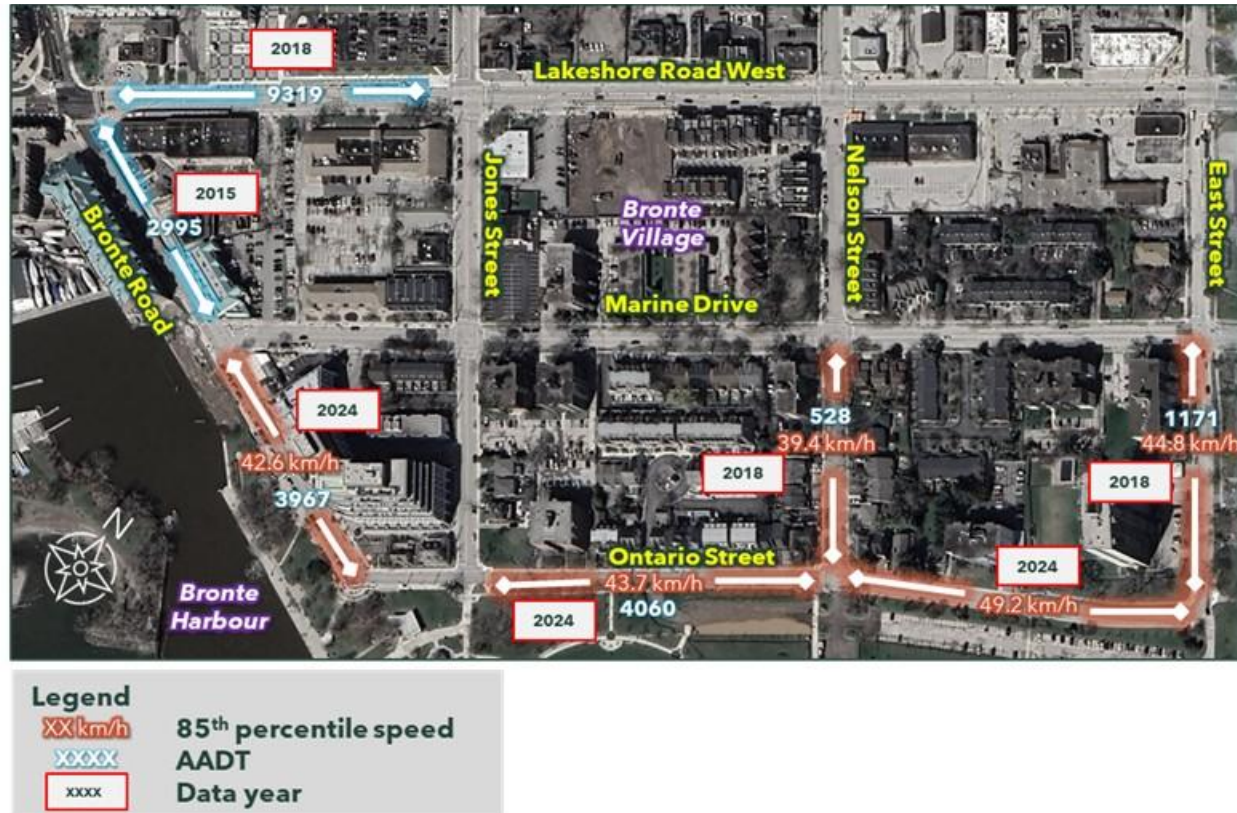
Figure 14: Speed and Volume Summary

Speed information was obtained from TES for the road segments within the study area. Data available ranged between 2018 and 2024. Overall, low operating speeds are present along Bronte Road, Nelson Street and East Street. One segment on Ontario Street between Nelson Street and East Street presented moderate speeding with an excess speed of 9 km/h over the posted speed limit.

Similarly, volume information was obtained from TES for the road segments within the study area. As shown in **Figure 14**, Lakeshore Road West carries the highest volumes within the study area with approximately 9,319 annual average daily traffic.

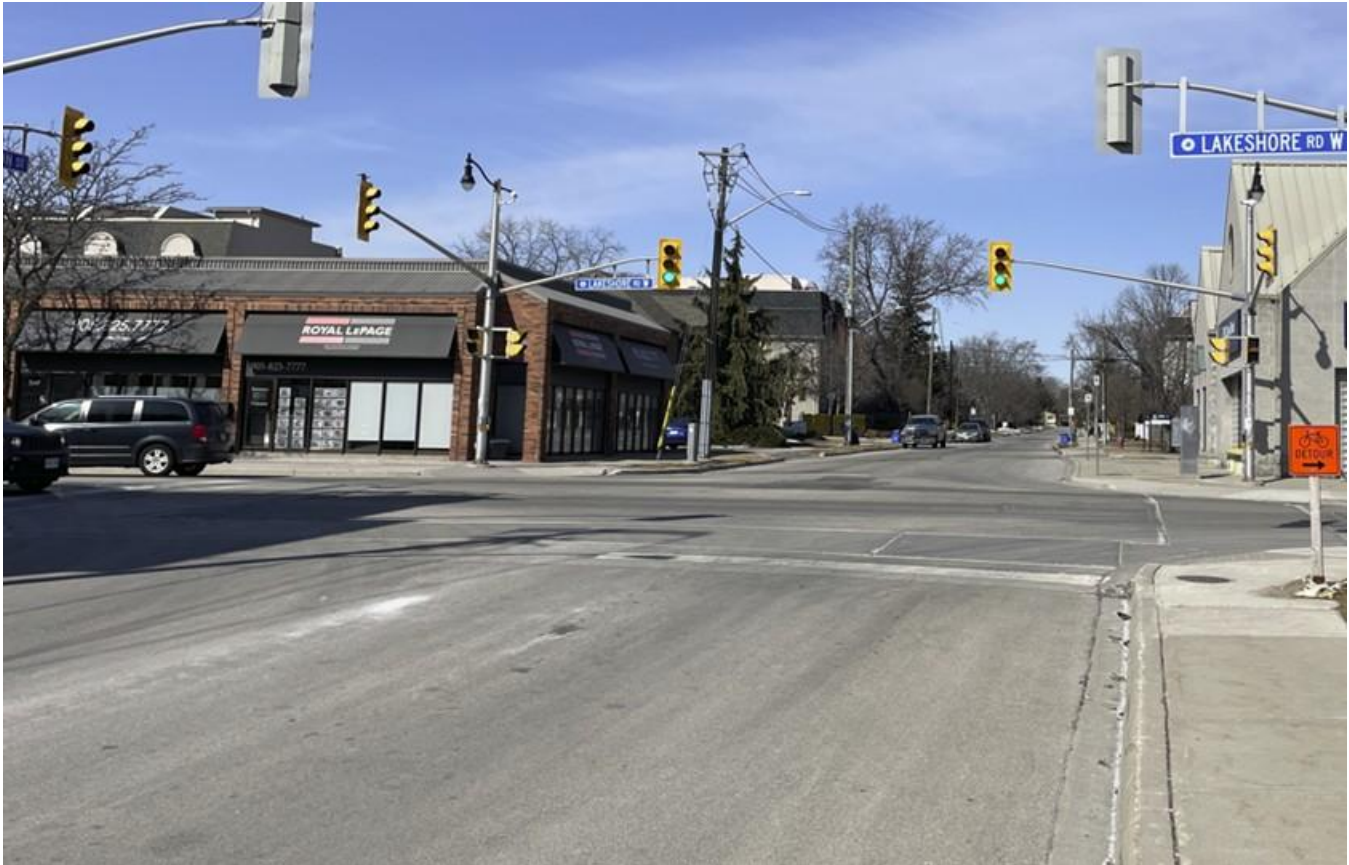
Faded pavement markings were observed at the following intersections:

- Lakeshore Road West and East Street:
 - South, west and east legs (undergoing construction)
- Lakeshore Road West and Nelson Street:
 - South and East legs (undergoing construction)
- Bronte Road and Marine Drive:
 - North and south legs (near construction area)

Figure 22: Faded Pavement Markings at Lakeshore Road West and Nelson Street

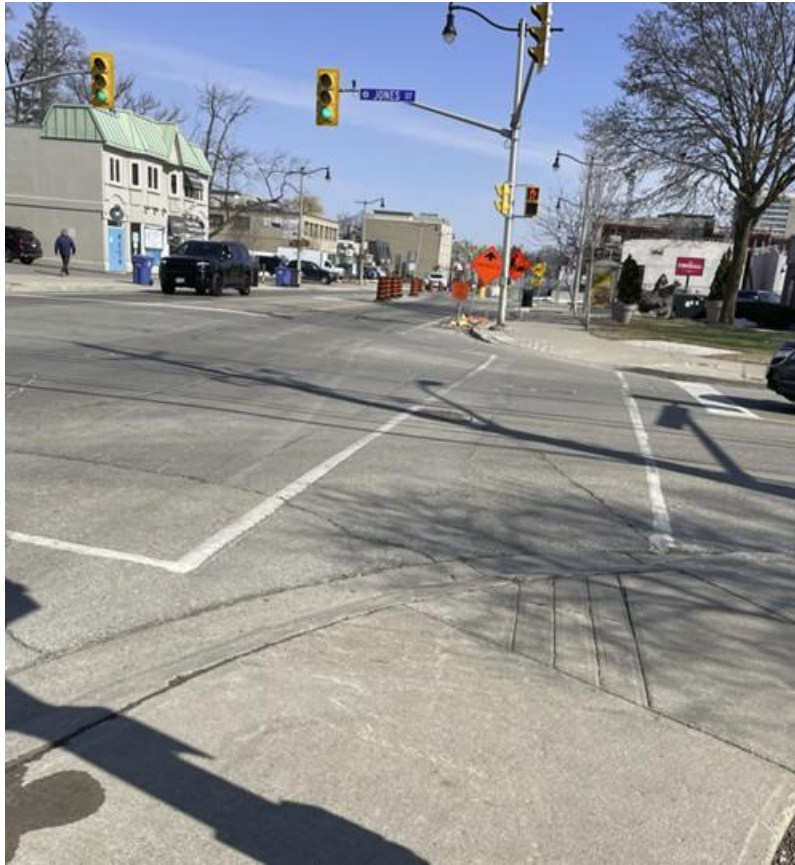
The signalized intersections along Lakeshore Road West have single line crosswalks at all approaches, with the exception of Lakeshore Road West and Bronte Road, which has ladder crosswalks for all approaches, including the channelized southbound right-turn movement. Similarly, the unsignalized intersections within the study area also have single line crosswalks on all approaches, with the exception of Bronte Road and Marine Drive.

Figure 23: Single Line Crosswalks at Lakeshore Road West and Jones Street

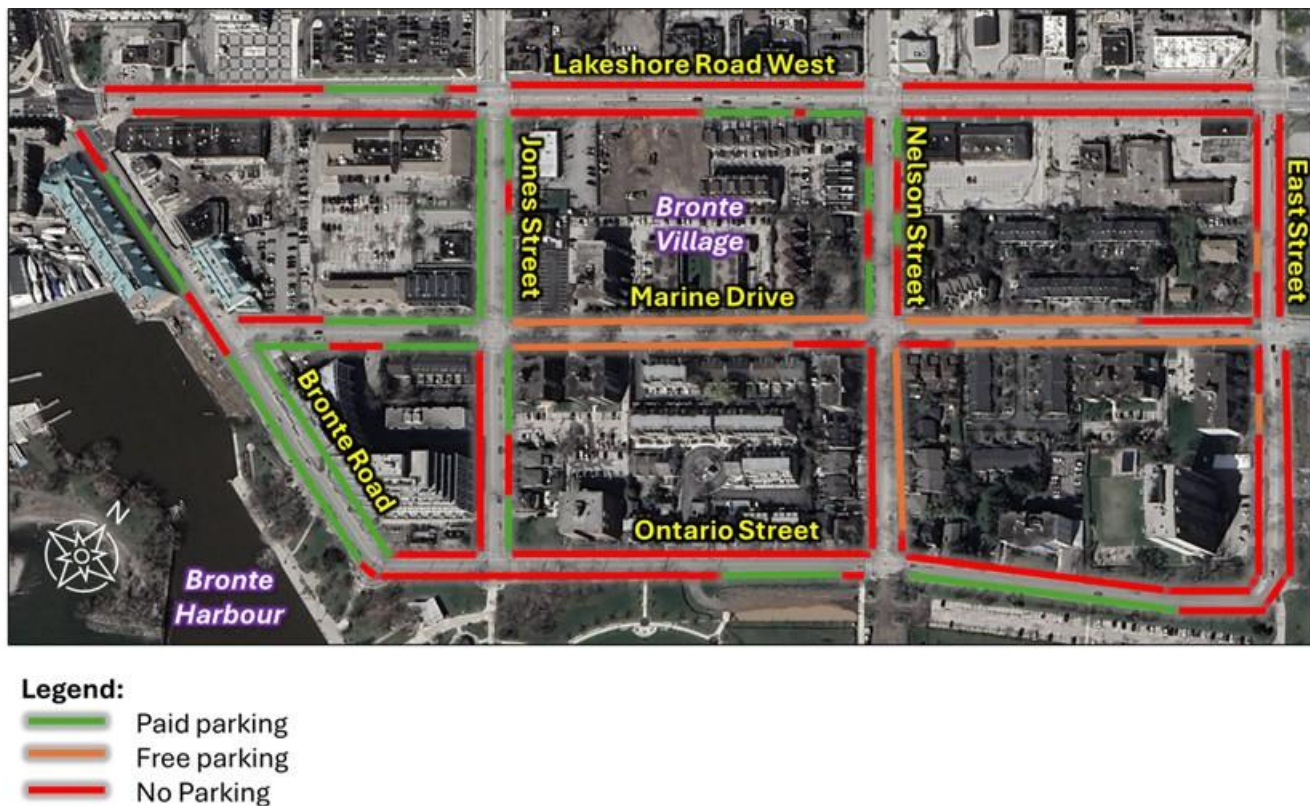
Figure 24: On-Street Parking Map

On-street parking is permitted along multiple roads within the study area. A higher utilization of on-street parking was observed during the weekend site visit along Bronte Road between Lakeshore Road and Ontario Street. **Figure 24** shows the locations where on-street parking is allowed. As it can be seen, some streets allow on-street parking along the entire road. This may create visibility issues for vehicles approaching an intersection as the STOP sign may not be visible or the parked vehicles may restrict the sight line of other incoming vehicles.

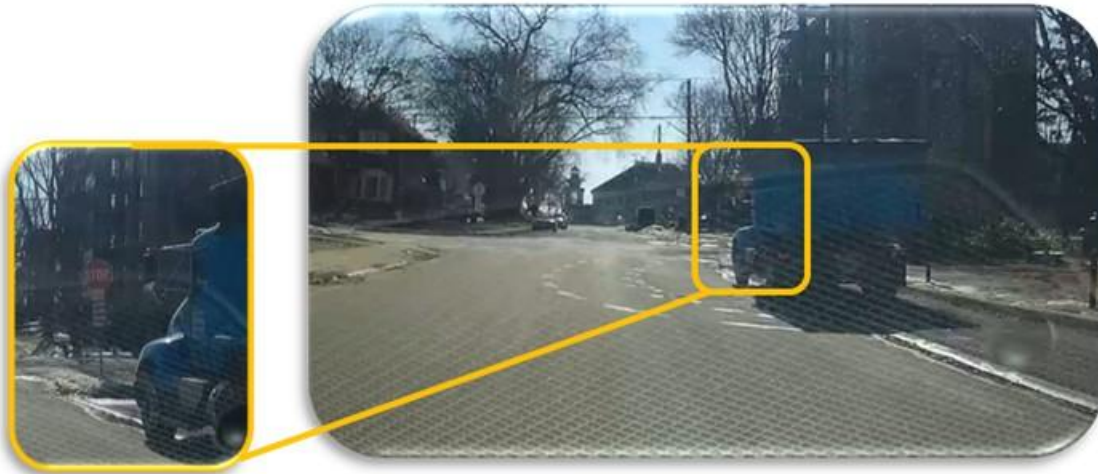
During the site visit it was also observed that when a large vehicle was parked on the permitted area on the west side of the north leg of the intersection of Nelson Street and Marine Drive, the STOP sign would be obstructed by the parked vehicle, as shown in **Figure 25**. While not observed elsewhere, there is a likelihood that legally parked vehicles could be blocking visibility of STOP signs at other locations in Bronte Village.

Figure 25: STOP sign obstructed by parked vehicle

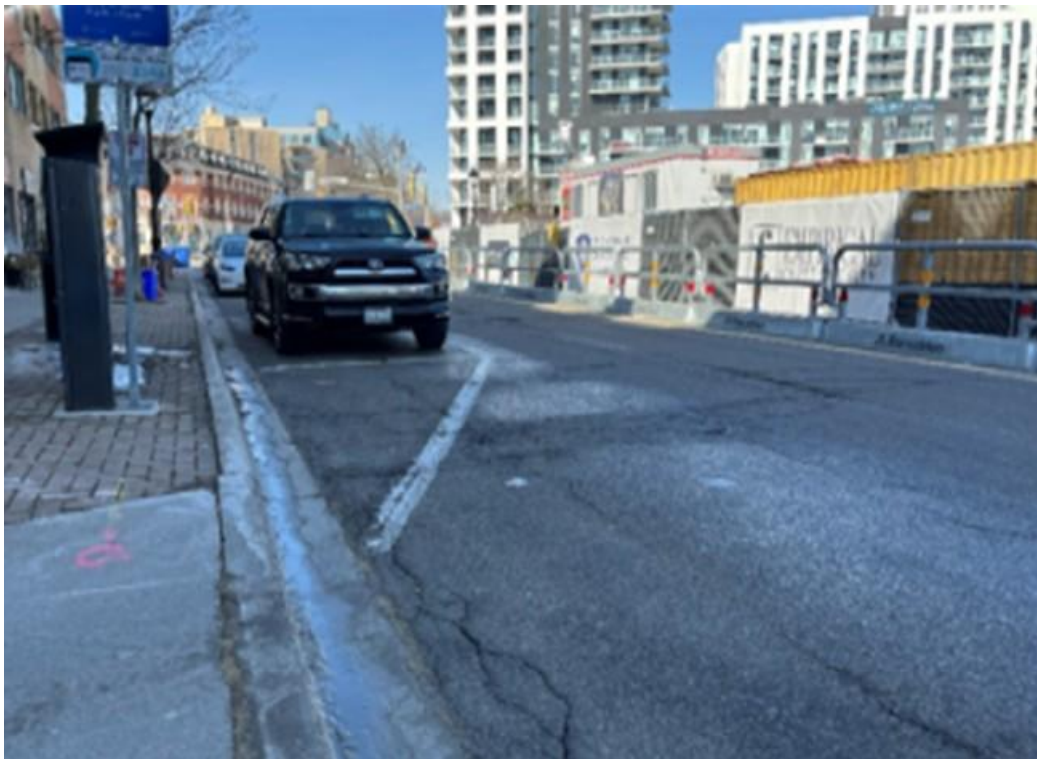
Parking facilities are present on the west side of Bronte Road between Lakeshore Road West and Marine Drive. During the site visit, it was observed that parked vehicles limit the visibility of approaching vehicles travelling southbound on Bronte Road to drivers exiting the parking facilities (**Figure 26**).

Figure 26: Looking left from 100 Bronte Road parking lot exit

For this road segment, it was noted that there is limited visibility of incoming vehicles for drivers exiting the parking facilities on Bronte Road. The obstruction was observed to be caused by the vehicles parked on the street.

Along Bronte Road between Lakeshore Road and Marine Drive, consider the removal of 1 – 2 parking spaces near the parking garage entrances to improve visibility of approaching vehicles.

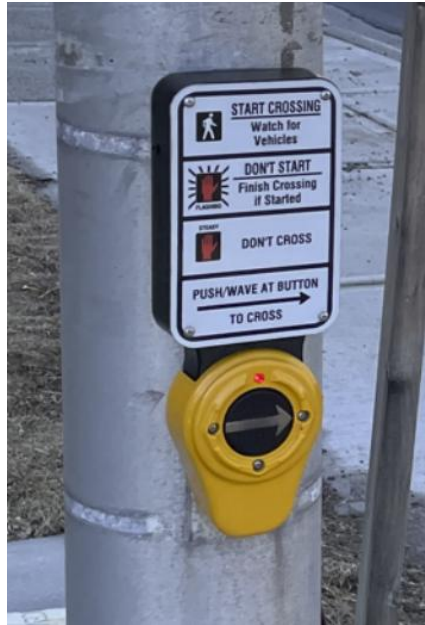
Figure 28: AODA compliant pushbutton

Elements within the study area were reviewed for compliance with the Accessibility for Ontarians with Disabilities Act (AODA)². It was noted that the majority of pushbuttons at signalized intersections were equipped with Accessible Pedestrian Signals (APS) and an arrow pointing in the direction of travel (**Figure 28**). However, some of the pushbuttons at the intersection of Lakeshore Road West and East Street did not have a directional tactile arrow (**Figure 29**).

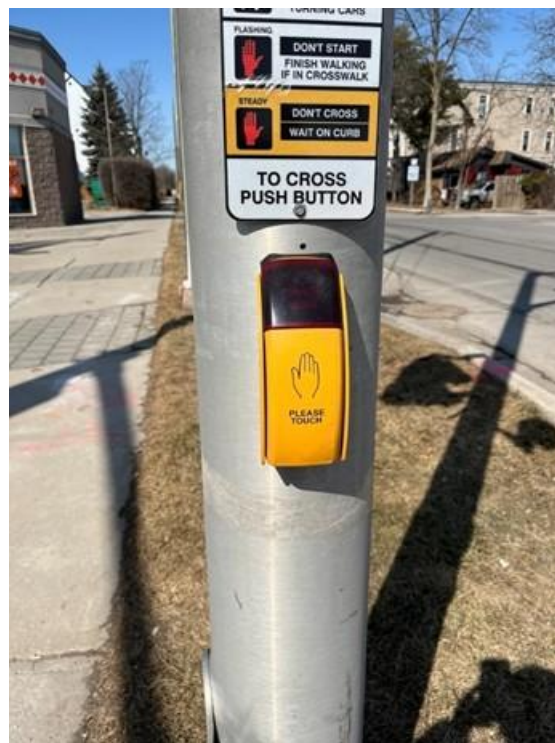
Figure 29: Pushbutton Missing Tactile Directional Arrow

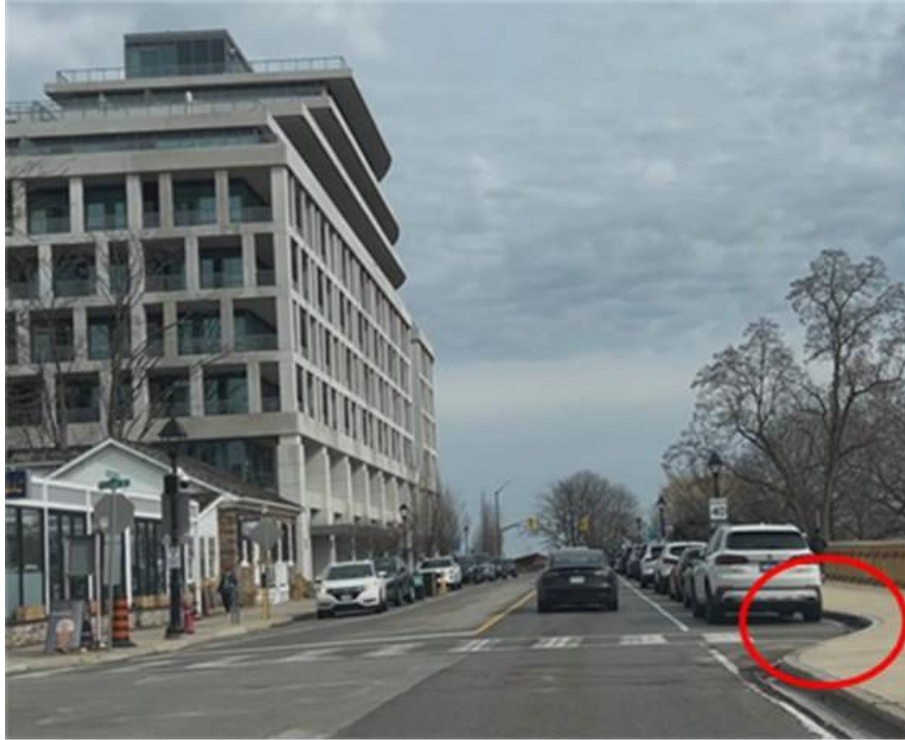
It was also observed that the crosswalk on the south leg of Bronte Road and Marine Drive does not have a curb ramp on the west side of Bronte Road, as shown in **Figure 30**.

Figure 30: Crosswalk with curb ramp missing

- Construction of curb cut on the west side of south leg crosswalk with tactile surface indicators following OPSD 310.033³

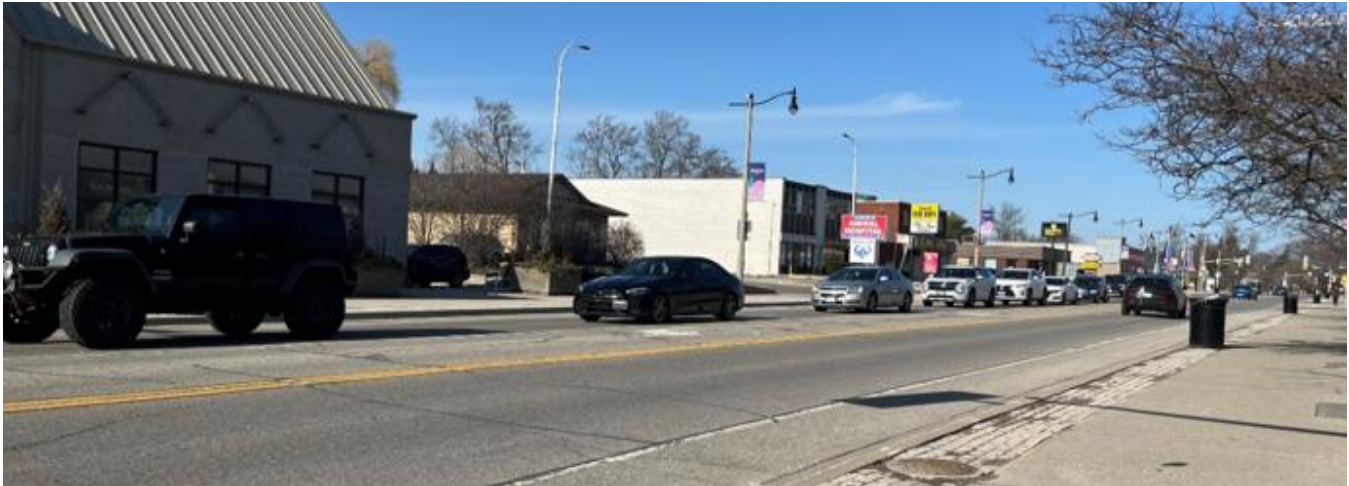
Higher volumes were observed during the PM peak hour, especially along Lakeshore Road West. Queue build-up was observed in the westbound direction along Lakeshore Road West on approach to Nelson Street (**Figure 31**). However, the queues were observed to be cleared every cycle.

Figure 31: PM Peak queues westbound at Lakeshore Road West and Nelson Street

- Queues spilling back to adjacent intersections were observed for the westbound direction on Lakeshore Road during PM peak
- Wide southbound right-turn channel
