Heritage Research Report

148 Balsam Drive

February 2015

HERITAGE RESEARCH REPORT STATUS SHEET

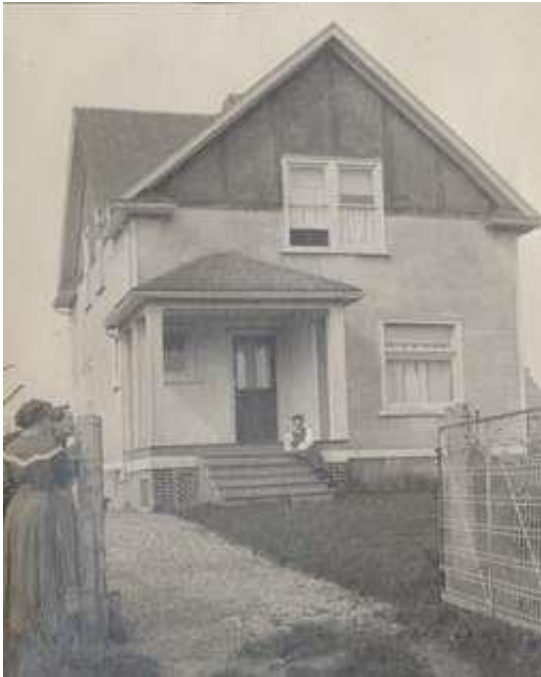
Figure 1: 148 Balsam Drive, main elevation showing the original half timbering in the gable, stucco finish and hipped roof front porch. [Source; OHS, 1912]

Records indicate that the residence at 148 Balsam Drive was constructed c.1912. The house is a 1-1/2-storey frame building with a cross gable roof and walls clad in stucco. Original design features include Tudor Revival details such as the pebble-dash stucco, faux half-timber in the gables, and two small diamond pane windows on the ground floor at the north-east corner. The original entrance was recessed under an open porch with a hipped roof. There was a small barn located behind the house.

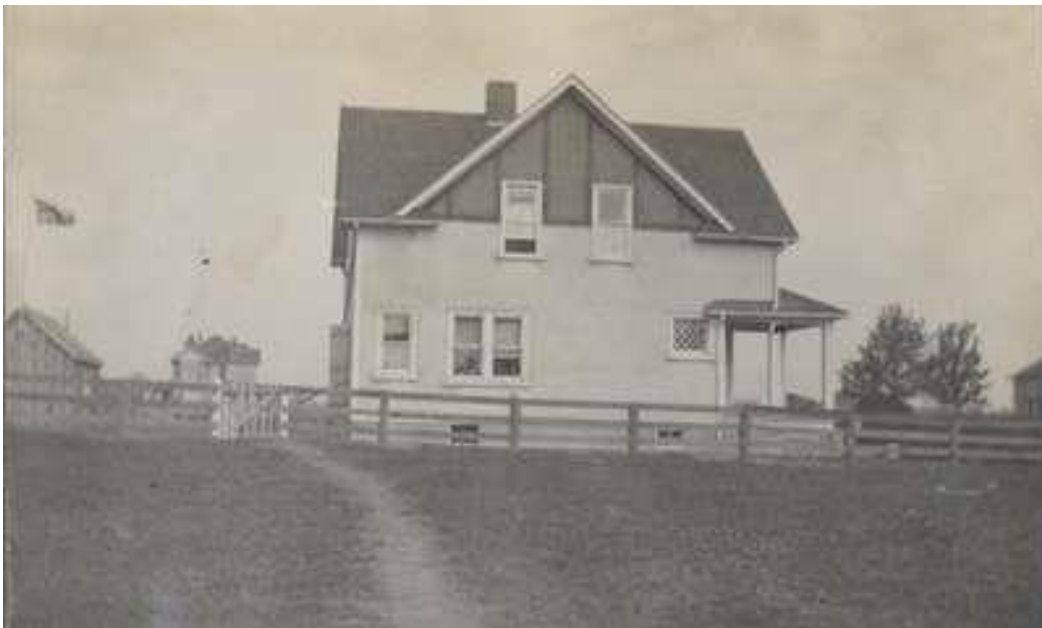
Figure 2: 148 Balsam Drive, south elevation showing the original front porch and inset front entrance. [Source: OHS, 1912]

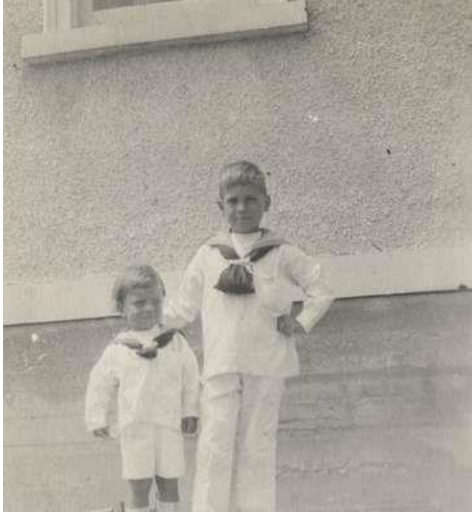
Figure 3: 148 Balsam Drive, south elevation showing the original pebble-dash stucco. [Source: OHS, 1919]

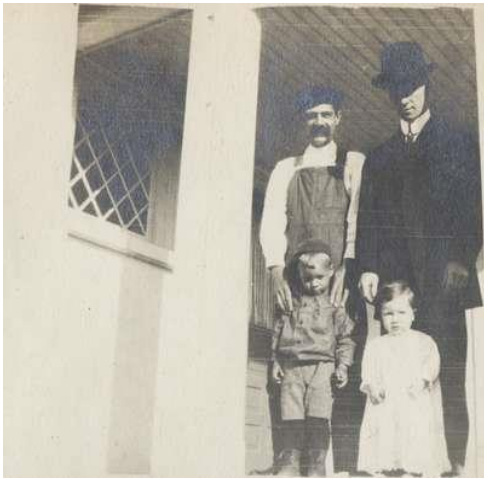
Figure 4: 148 Balsam Drive, main elevation showing original diamond-pane window and front porch. [Source; OHS, 1912]

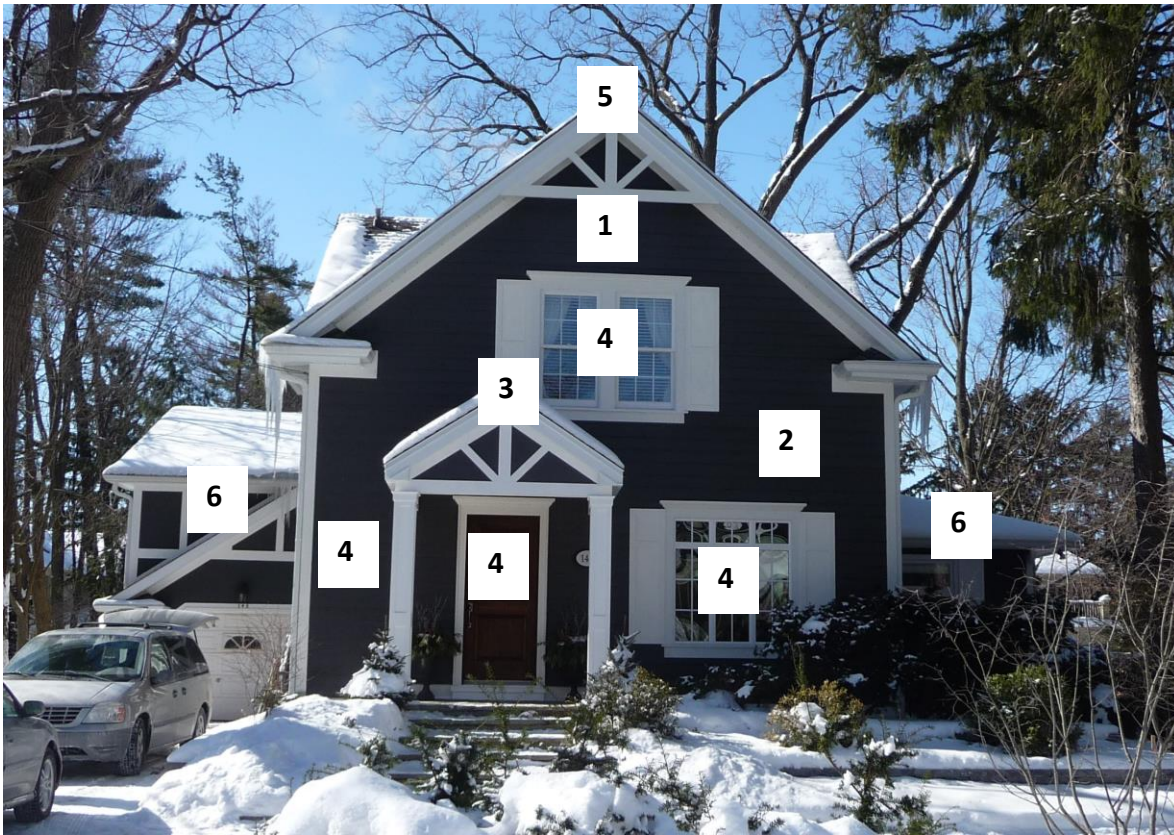
The property has been substantially modified over the years. The original cross gable roof has not changed but many of the original features have been removed or significantly altered. The barn building and the wood rail fence have disappeared. The original hipped-roof porch on the front has been removed and replaced by a smaller porch with a gable. The recessed entry has been built out and the two diamond-paned windows on the south-east corner have been removed. The exterior has been re-clad with wood cladding. All the original doors and windows have been recently replaced with modern windows. New decorative features have been added to the exterior including wood window shutters, wood trim around the windows, and wood barge boards in the gables. Substantial additions have been added at the rear and on both side elevations. The interior has been completely altered and no original finishes remain.

Due to the considerable alterations and the removal of character-defining features, this property has limited design and physical heritage value.

Figure 5: 148 Balsam Drive, main elevation showing alterations and removal of character-defining features: 1. Removal of half timbering in the gables. 2. Re-cladding with wood siding. 3. Removal and replacement of the hipped roof porch. 4. Removal and replacement of all original windows and doors. 5. Introduction of new barge boards. 6. Extensive side and rear additions. [Source; M. Hobson, 2014]

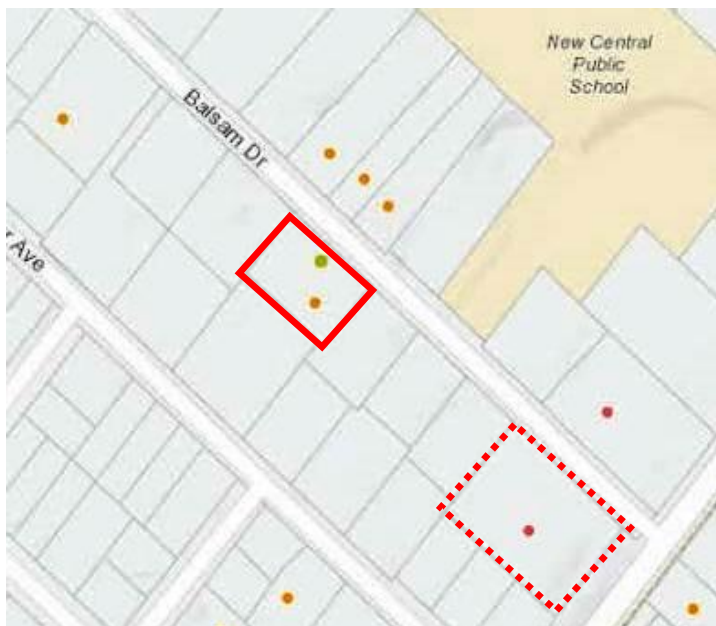
Figure 11: 148 Balsam Drive (left) is now visually and physically separated from Balsam Lawn (right) by three suburban lots. [source: 2015 GIS map]
