# HERITAGE IMPACT ASSESSMENT

2467 & 2477 Old Bronte Road

17-083-01

This Heritage Impact Assessment (HIA) revises the HIA dated July 12, 2017 in response to comments from Heritage Planning Staff in the Town of Oakville and has been prepared on behalf of 1 Oak Developments for the property municipally known as 2467 & 2477 Old Bronte Road (the “Development Site”) to assess the impact of a proposed new development on recognized on-site and adjacent heritage properties.

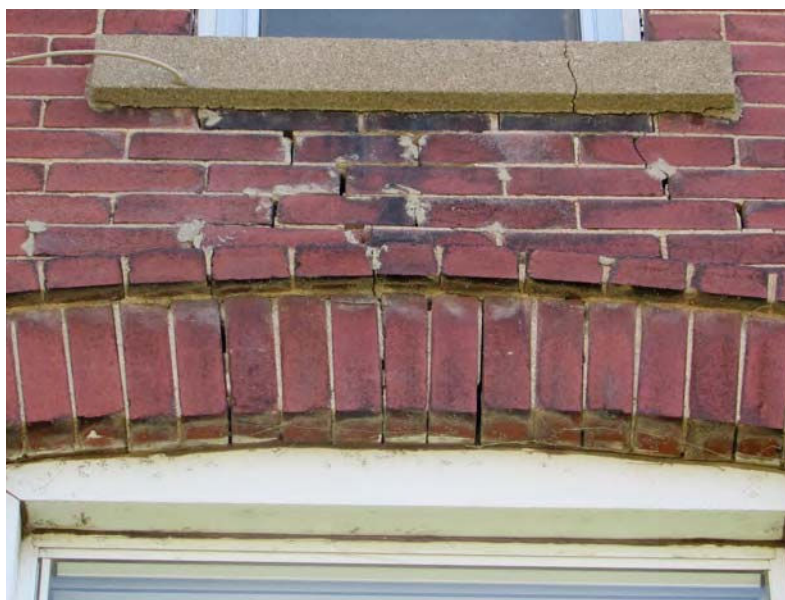
34. Stepped cracks between arch and sill, and deteriorated mortar joints

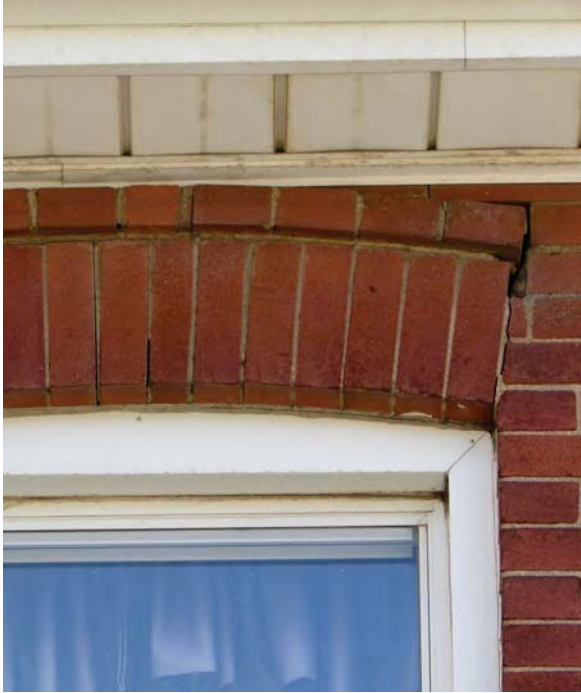
35. Deteriorated and open mortar joints (West Elevation)

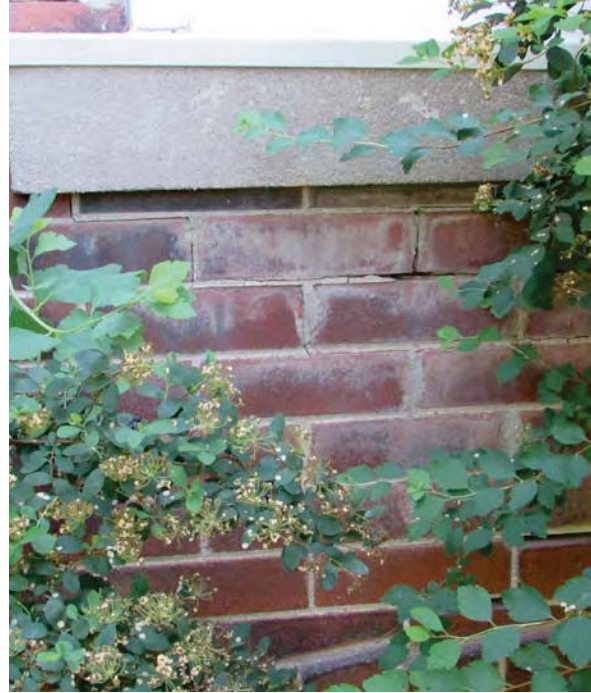
36. Stained bricks, and efflorescence under sill (West elevation)

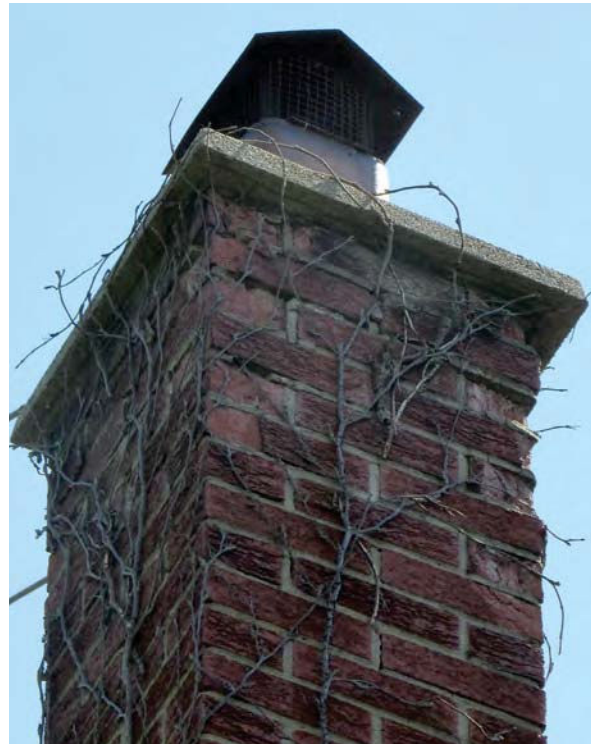
The chimney to the original building is in a poor condition. Vegetation is growing around it, obscuring much of the brick. The bricks at the top are spalled, and there are open mortar joints.

38. Spalled bricks and deteriorated mortar joints on chimney

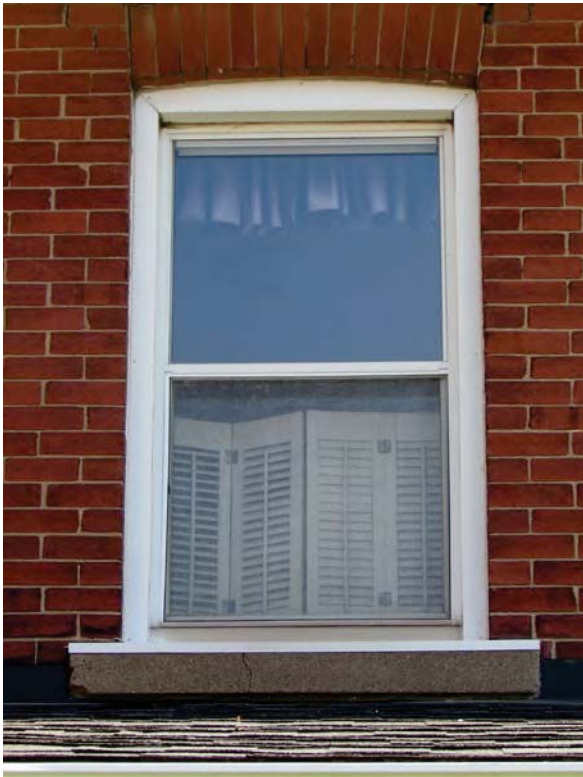
The metal framed windows appear to be in a fair condition. The timber framed windows are in a poor condition, with paint missing from sections of them. The concrete sills are in a fair condition with most them cracked. There are two original stone sills located in the enclosed porch, these are in a good condition.

41. Example of condition of metal framed window (West elevation)

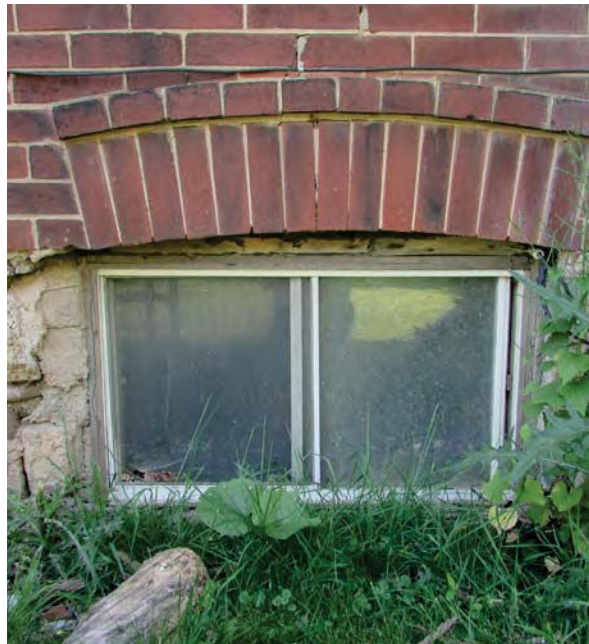
42. Poor condition of timber framed window (North elevation)

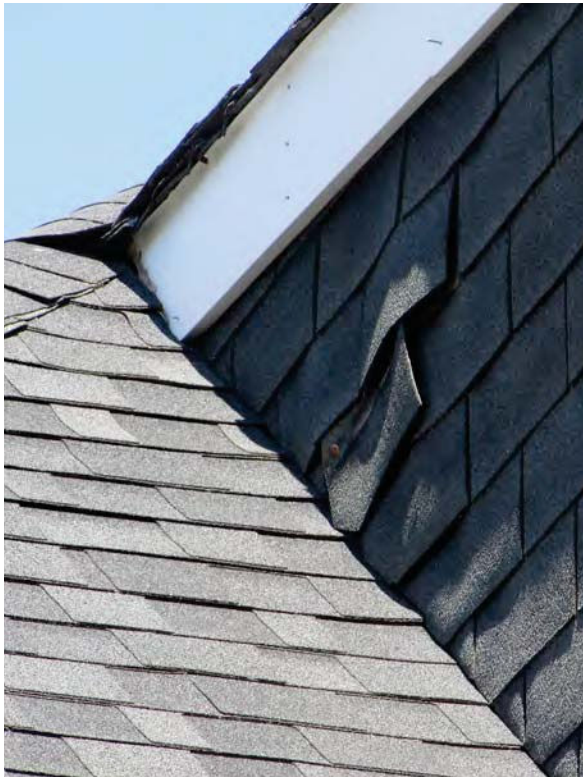
The roof is in a good condition, with a small number of shingles lifting. The soffit and fascia are in a good condition, with some minor staining from where vegetation has been removed. The rainwater system appears to be in a good condition (note it was not raining, and no water was poured down to confirm if rainwater system functions adequately).

45. Lifting shingles on dormer extension.

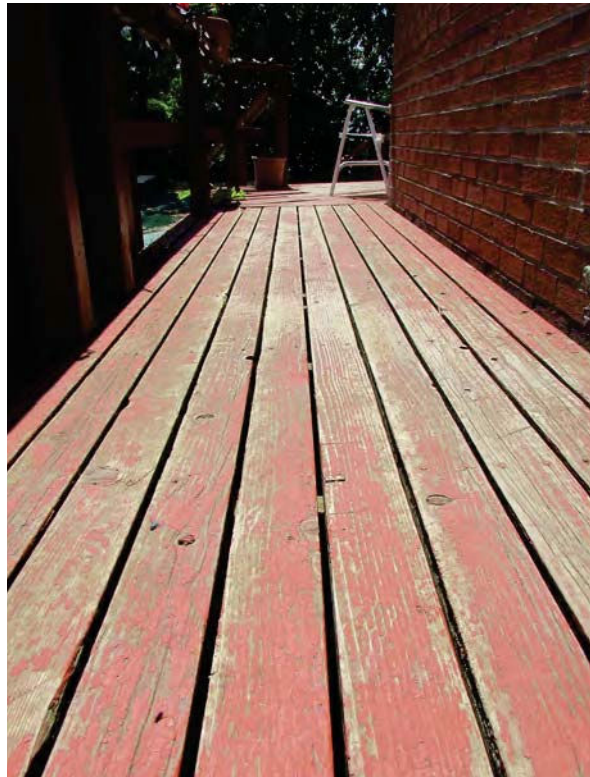
The deck at the rear of the building is in a poor condition, weathered, with paint peeling.

46. Poor condition of timber deck.

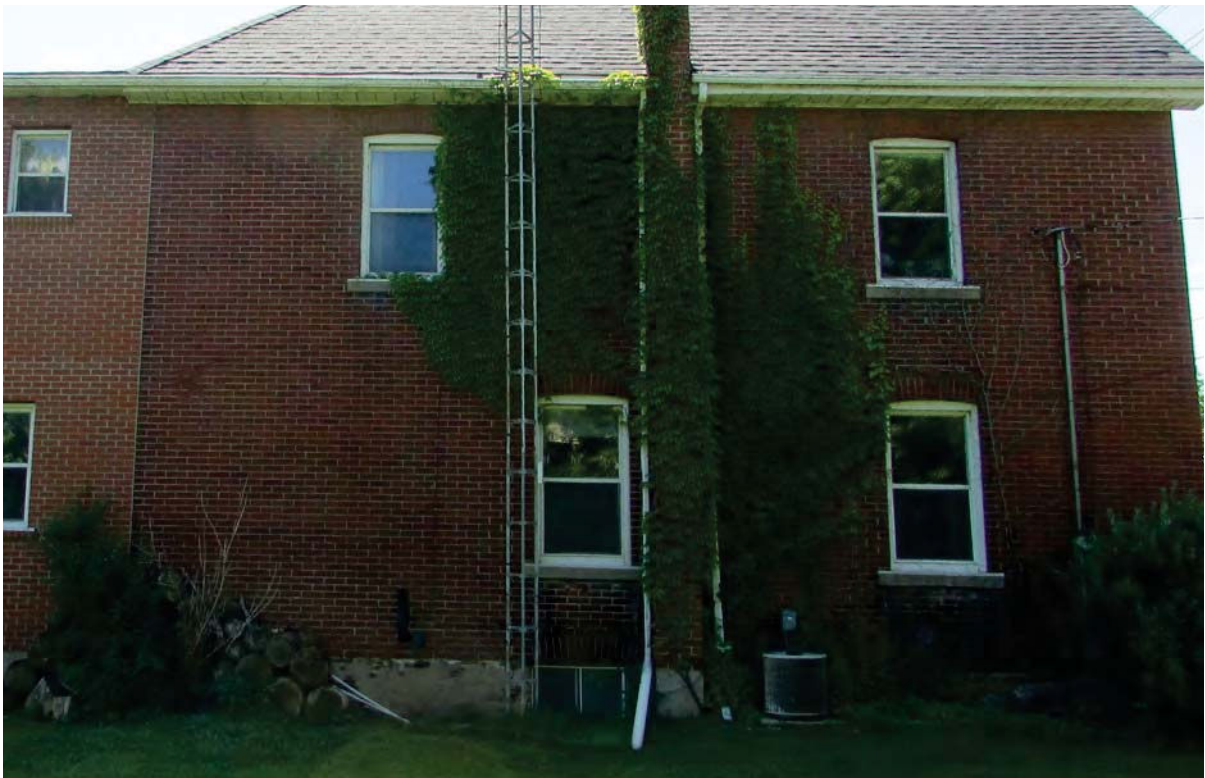
48. Vegetation on brick (North elevation)

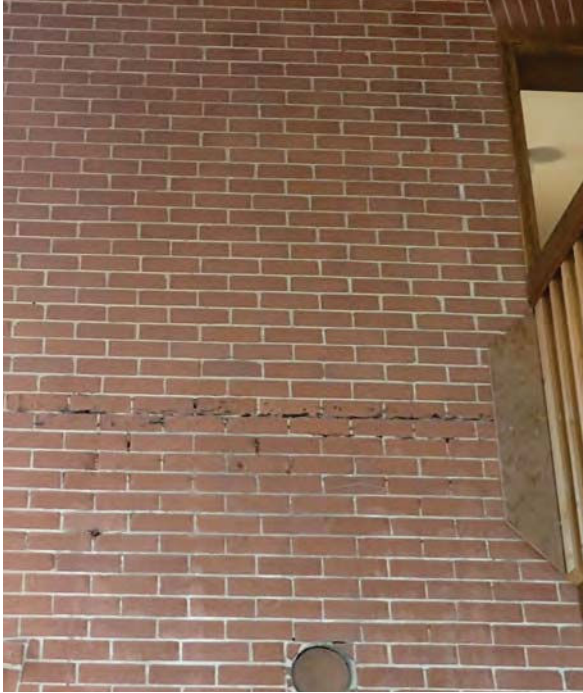
The 1980s addition at the rear of the 1911 house is in a good condition. The original external bricks at the rear of the 1911 house have been left as an exposed wall within the interior of the 1980s addition. These bricks have been cleaned with an abrasive type of material which has removed the face of the brick, and given the bricks a different texture, and shade of colour to the rest of the original bricks. These bricks are chipped in places, and a number of the joints are missing mortar.

59. Missing mortar from joints at rear of 1911 section of house.

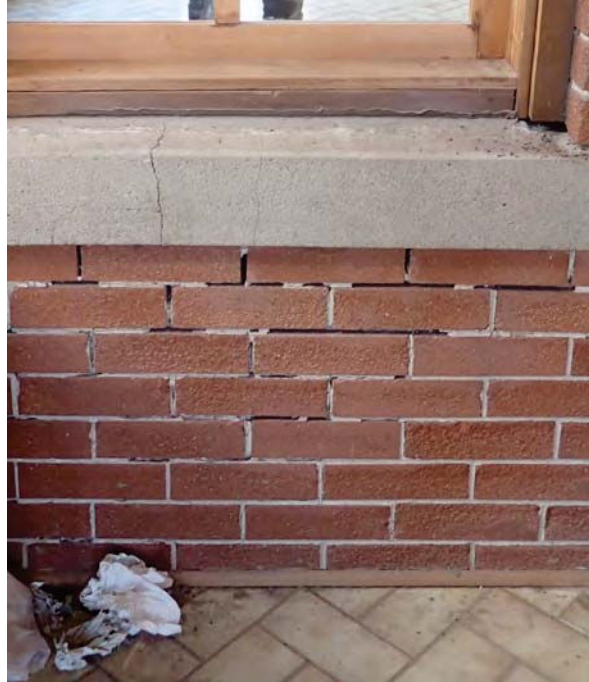
60. Missing mortar from joints, and rough texture of surface of original bricks due to abrasive cleaner.

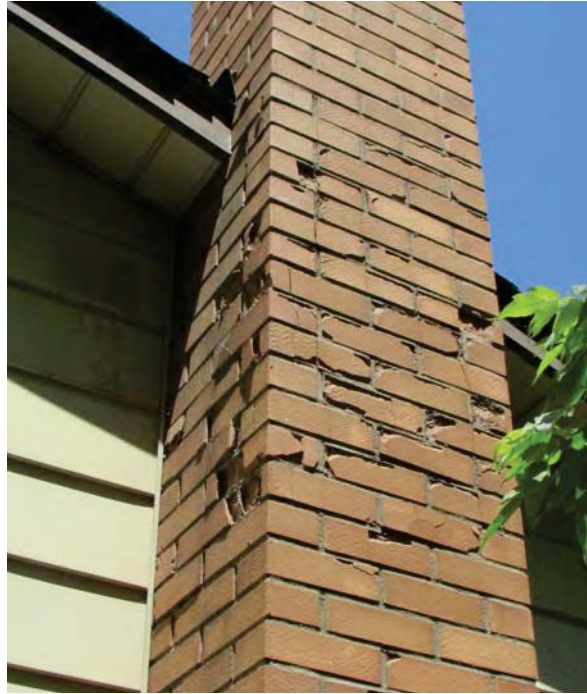
The two chimneys are in a poor condition. One chimney appears to have previously been reduced in height to roof level, and has bracing around to support it. The vertical mortar joints in this chimney increase in width with each course, indicating that there has possibly been previous movement in this chimney, and it has had to be repointed. This and the other chimney both have spalled bricks.

66. Spalled bricks at chimney

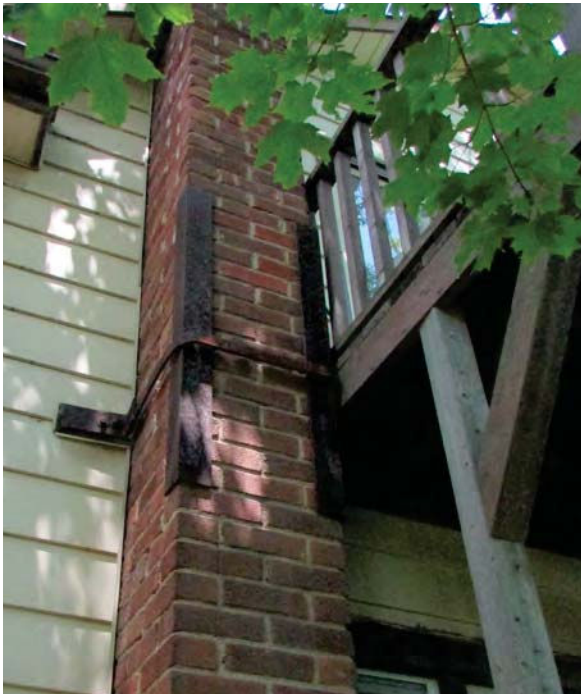
67. Bracing support for chimney

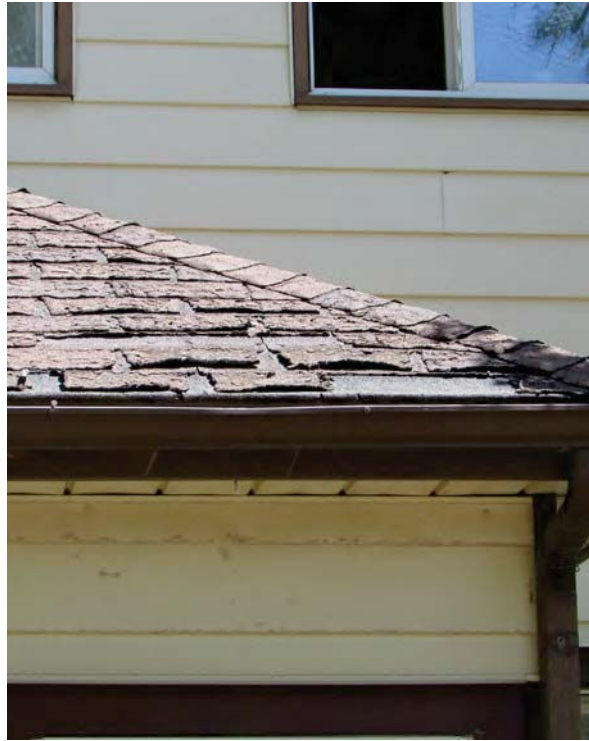
72. Deteriorated shingles on roof.

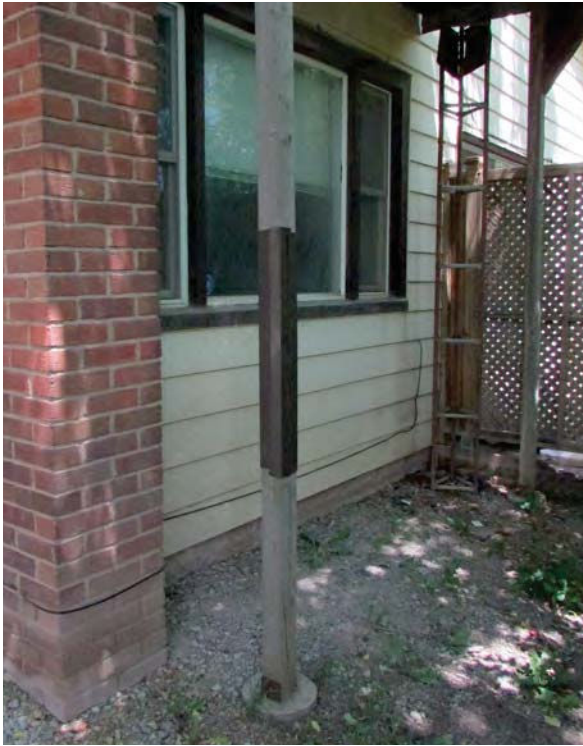
The timber deck at the rear of the building is in a good condition. The timber deck on the second floor was partially viewed from grade. This deck is in a poor condition, with one of the structural supports wrapped in a metal sleeve. The reason for the repair is not know, but it is likely that the timber had started to split.

73. Metal support for timber post to deck above

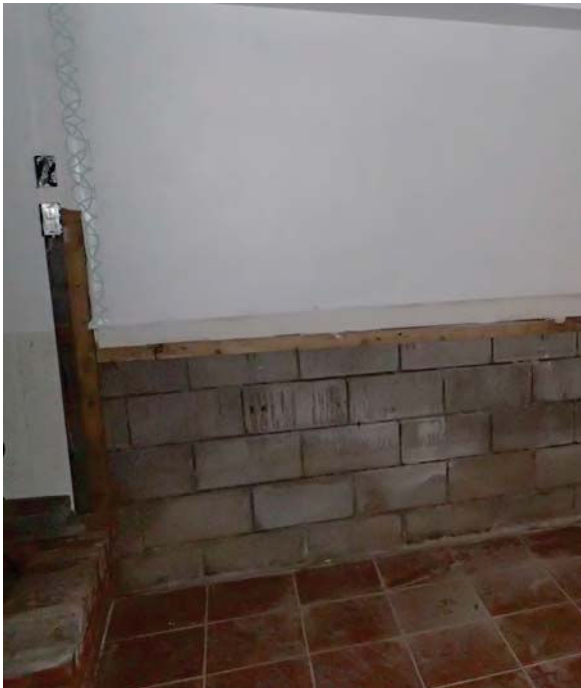
The 1980s basement at the rear is in a fair condition. Drywall boards have been removed, exposing the concrete blockwork behind. The stairs to the basement have wood panelling that pre-dates the construction of the basement. This panelling has probably been taken from elsewhere in the house.

86. Removed drywall revealing concrete blockwork in 1980s basement.

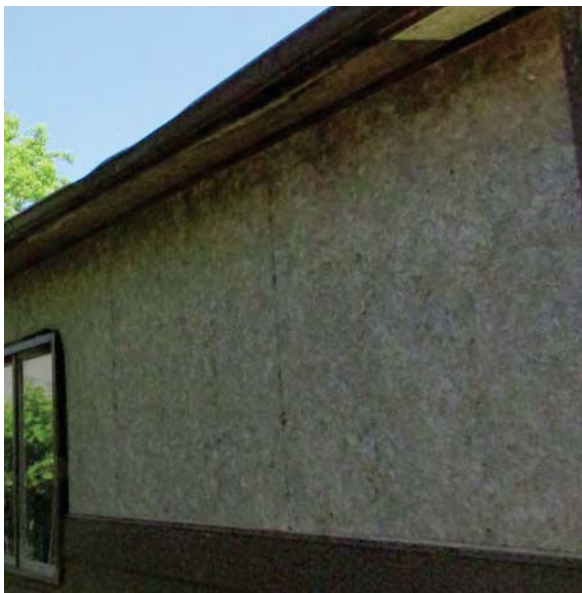
The condition of the exterior of the building is mostly in a poor condition, with some building elements that are in fair condition. The dark coloured metal cladding is in a good condition. This cladding has been partially removed on the North elevation, revealing particle board behind. This particle board is in a poor condition, with staining indicating water damage. The walls on the rear elevation are covered with two different materials; metal cladding, and shingles. The shingles are in a poor condition, falling off the wall, revealing particle board behind.

97. Missing metal cladding. Note dark stains at top of board indicating water damage (North elevation)

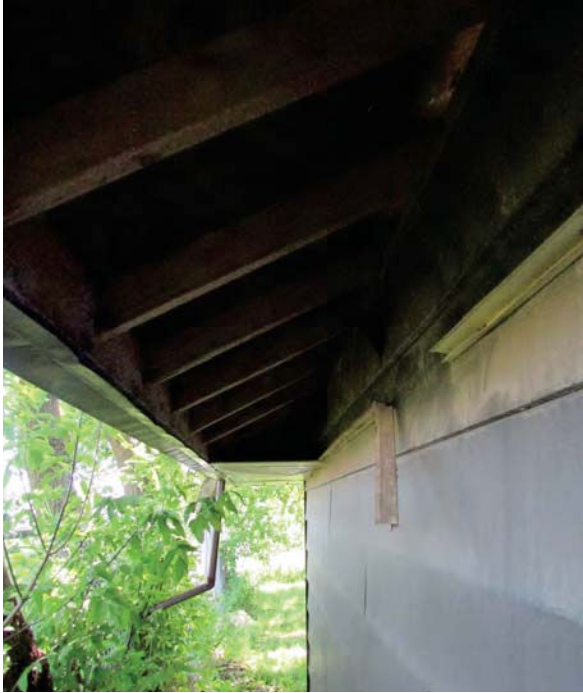
The fascia boards and soffits are metal. Where they exist they are in a fair to poor condition. On the North elevation the soffit has been removed, revealing water damaged particle board behind. The soffit has been removed, or fallen away on part of the rear elevation, and is beginning to fall down on the South elevation.

105. Missing soffit (Rear elevation)

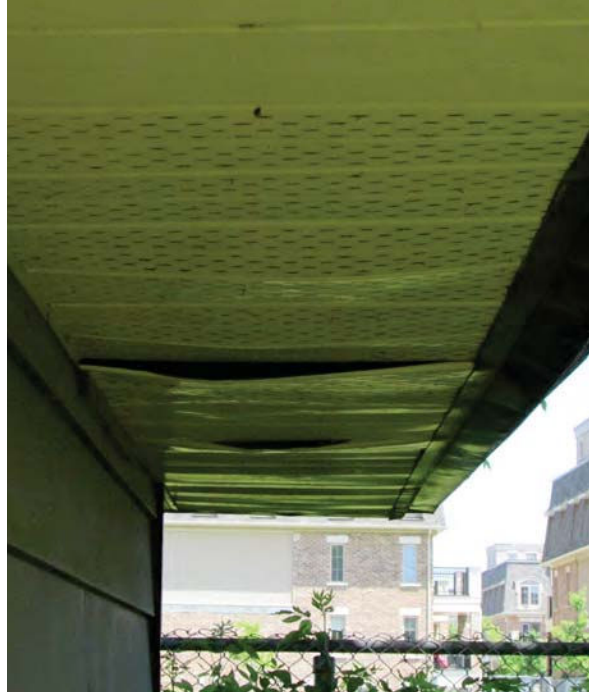
106. Damaged soffit (South elevation)

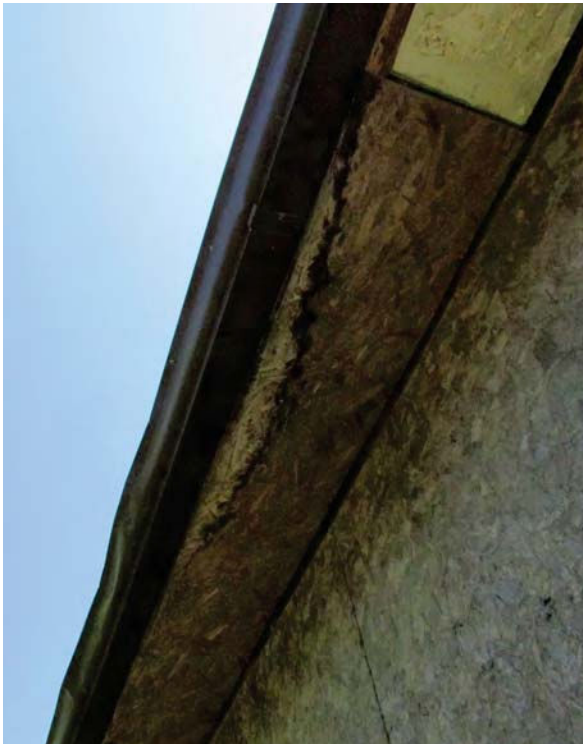
107. Missing soffit. Note water damage to particle board (North elevation)

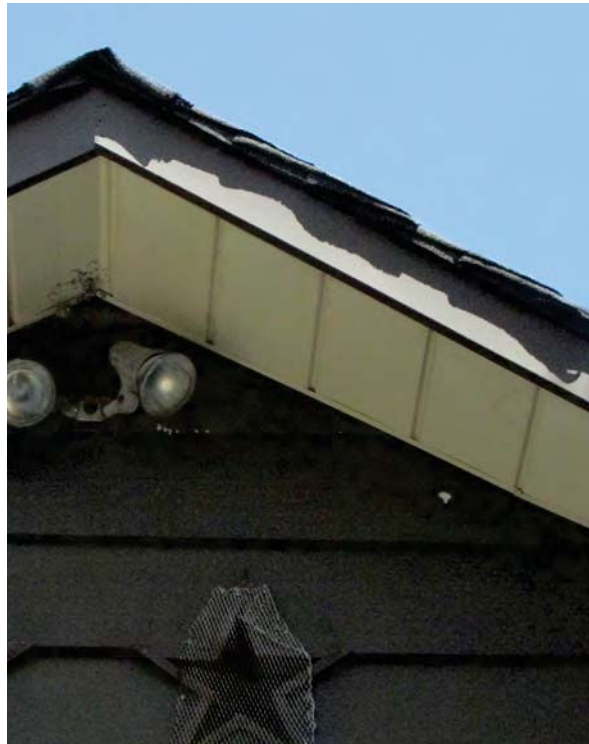
108. General condition of fascia and soffit (West elevation)

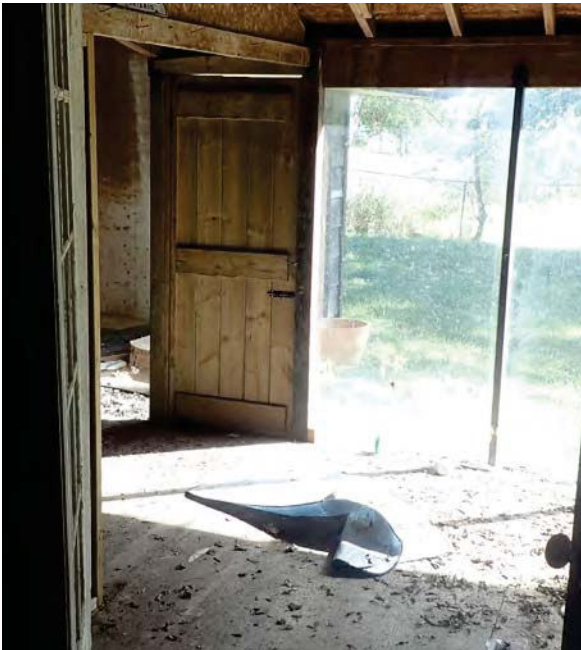
The South extension was only partially viewed due to rubbish bags in this location, and a mice infestation. The South extension has full height glazing along the external walls. This addition is in fair to poor condition.

113. Poor condition of Southern extension.

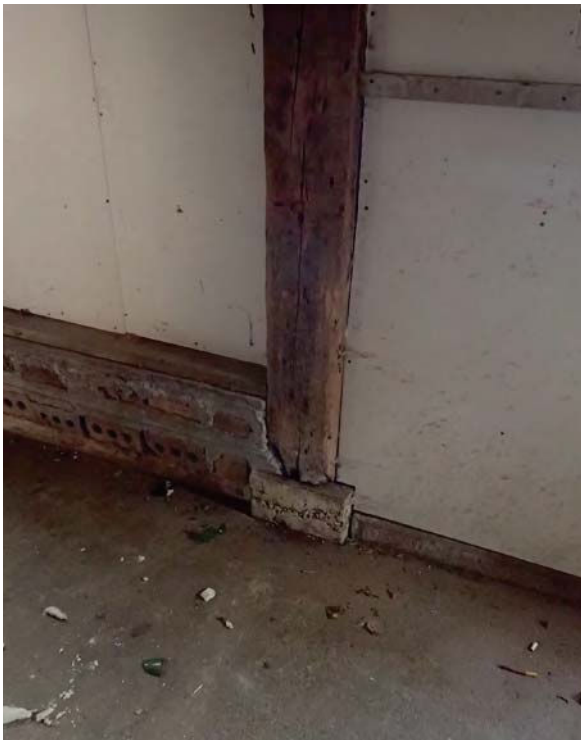
The original barn is in fair to poor condition. A limited number of the timbers can be seen, and it has not been possible to tell if this is a complete frame or if they have been re-purposed. One timber post on the ground floor is exposed and a small concrete pad has been cast at its base to raise the post off the ground. The concrete floor on the first floor appears to be in a good condition. The walls in the room on the first floor, which was used as an office, have a mixture of finishes. Large original wood panels that have been white washed have been installed horizontally against the frame. In places in this room a more modern wood panelling has been installed, presumably over the top of these larger planks.

117. Base of timber post with concrete foundation.

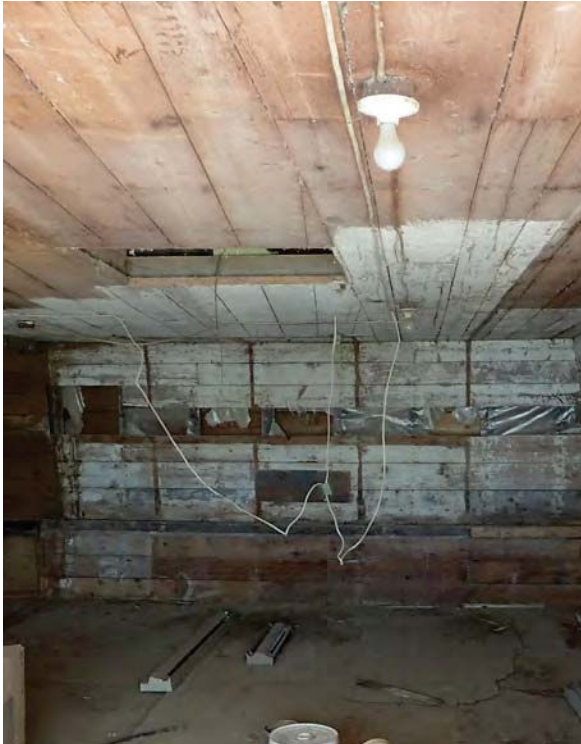
125. General condition of second floor, with missing planks of wood on wall.

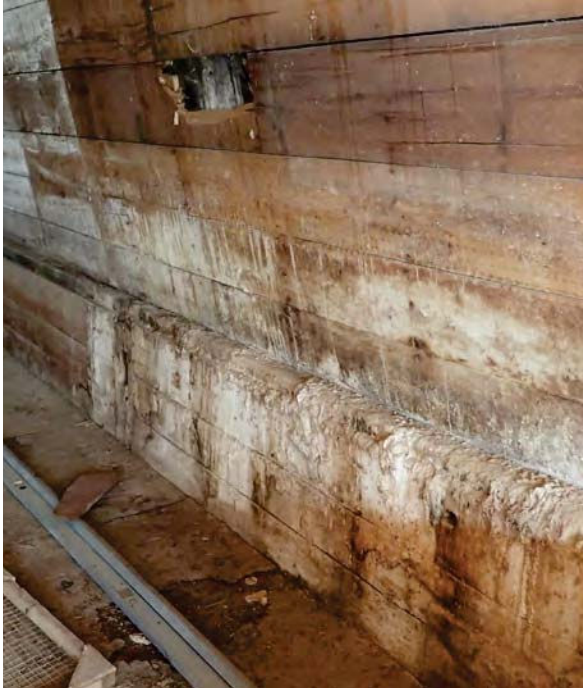
there are large white stains, which are presumed to be the residue of excrement. The loft hatch was open, and a photograph was taken which shows part of the timbers that form the roof. This space was not viewed and accessed due to concerns over raccoon infestation, as raccoon excrement was noticed on the second floor.

127. Excrement staining to wood wall planks, and hole in planks.

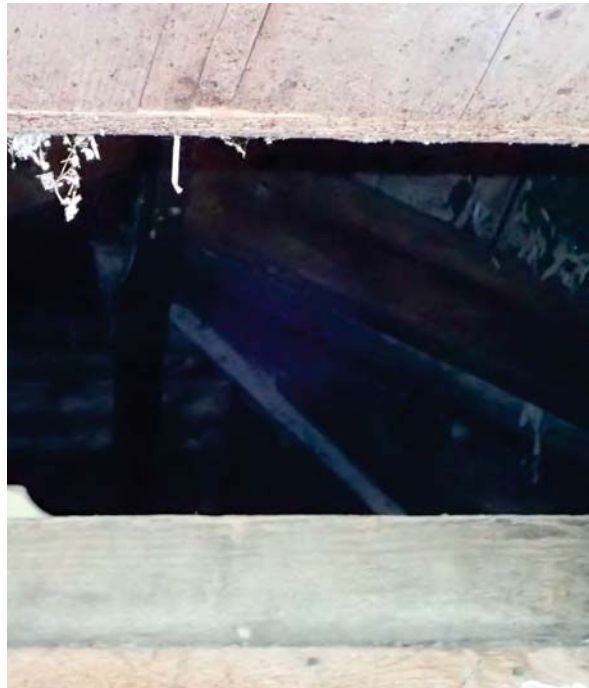
130. Partial view of roof space through open loft hatch.
