Re: Delisting of 1196 Linbrook Road, Oakville, under the Ontario Heritage Act.

Further to your request respecting the above please find the following information, opinion and recommendation respecting the subject property and its removal from the Town of Oakville's municipal register. On page 15 of this letter report I conclude as follows:

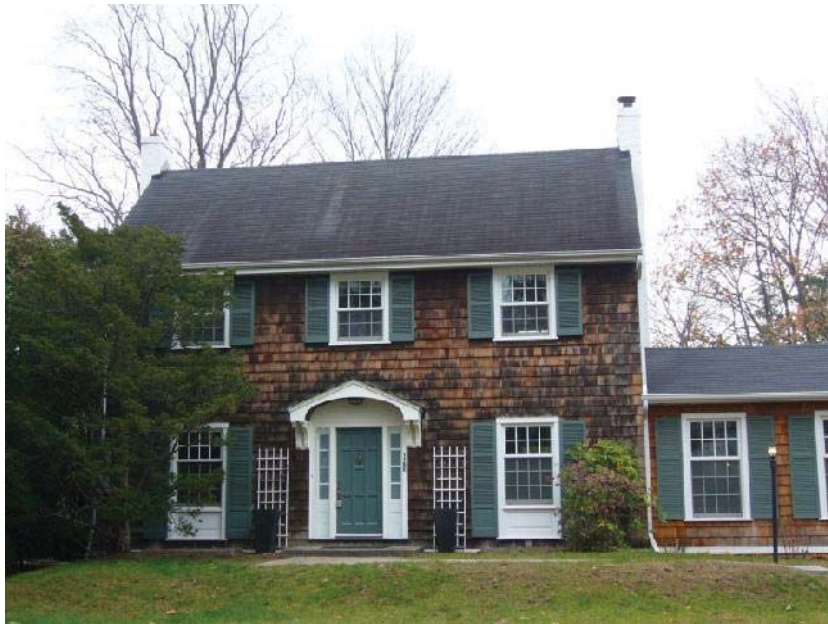
View from Linbrook Road looking south showing main house and symmetrical arrangement of façade

The front façade of the residence is symmetrical in design comprising three (3) bays with a centrally placed entranceway on the ground floor flanked on each side by a rectangular sash window (8 over 12) with inoperable or faux shutters. On the upper storey the symmetrical composition is repeated with a central window over the entranceway and all consisting of rectangular, almost square, sash windows (8 over 8) flanked by inoperable or faux shutters.

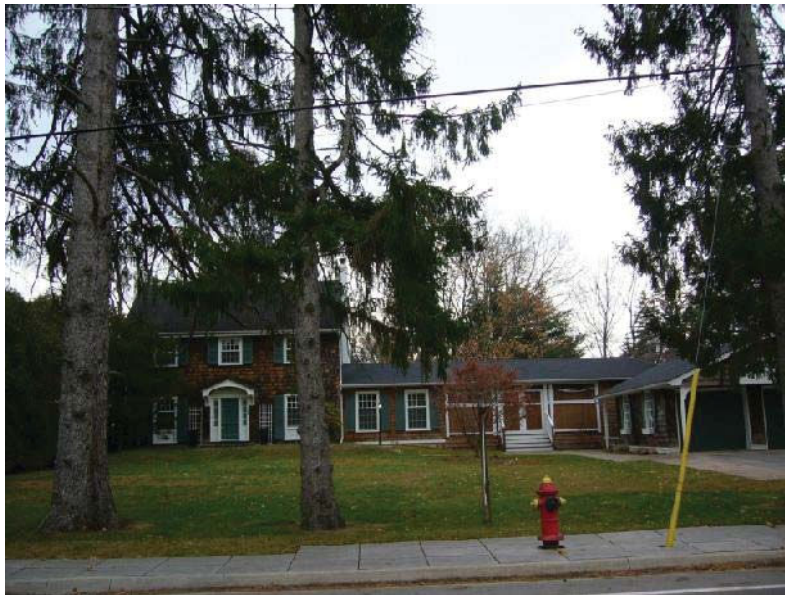
The subject property is listed in the municipal register on the basis of any potential cultural heritage value being vested in the residence and no other part of the property. The house is located in close proximity to the east property lot line and has had a number of attached additions built on the west façade, as well as a detached double garage that projects forward of the original building, all of which are clad in wood shingle (See photograph below and at the end of this report).

View from Linbrook Road looking south showing main house, additions and garage

As noted previously there are several, one-storey additions and a garage constructed on the west side of the building façade which are not original to the house. All are sheathed in wood shingle and while presenting a generally uniform finish to the overall building mass this elongated, linear arrangement disrupts the expected symmetry associated with classical, and in this case Colonial Revival, design and construction forms.

Overall the integrity of the original building is compromised by the construction of later additions to the rear and on the west side which fundamentally disrupts the balance and symmetry expected in the classically influenced Colonial Revival style. The building plan and form is now essentially linear in nature along an east-west axis across the lot. Alterations and loss of original windows also diminish integrity.

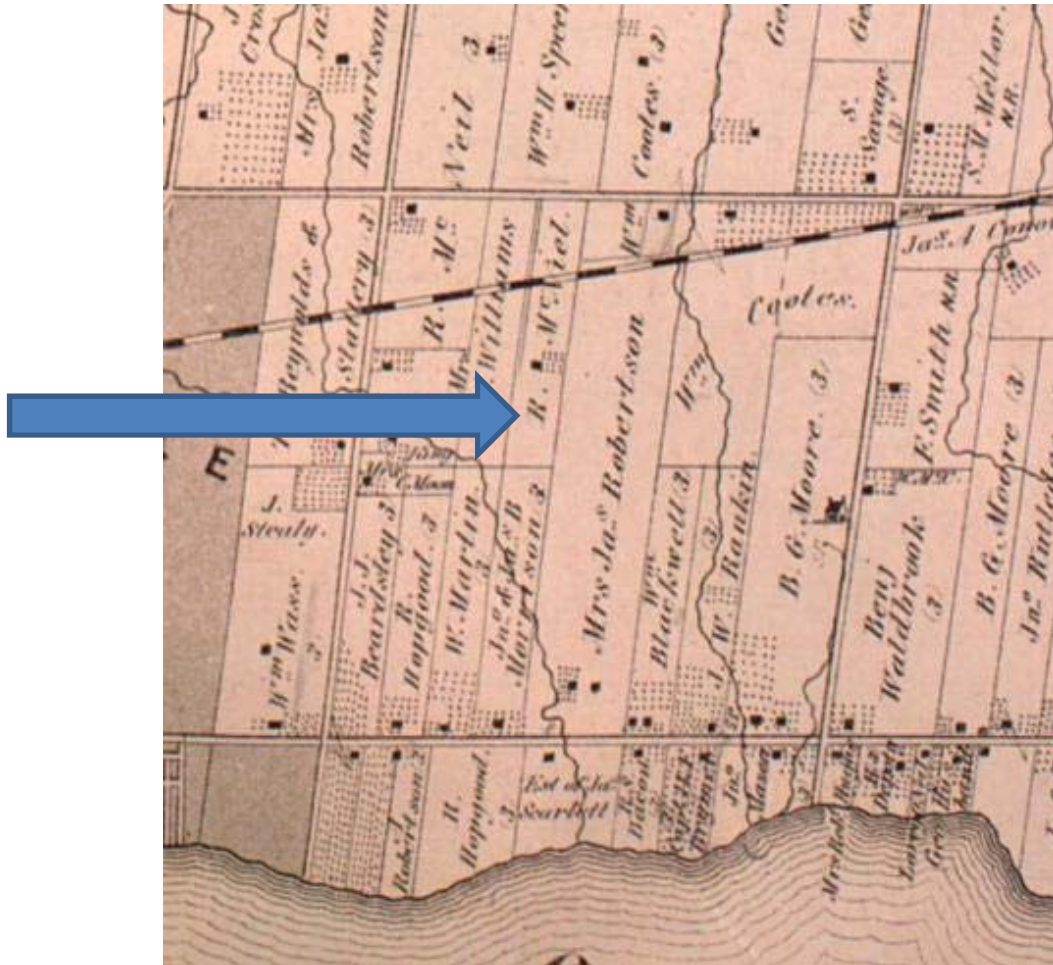
(Extract from Illustrated Historical Atlas of the County of Halton, 1877)

In reviewing the chain of title that was prepared at my request as background to this report it is evident that in 1875 the subject property comprised part of the NE1/4 of Lot 9, Concession 3 South of Dundas Street, then owned by Emma McNeil. Emma McNeil is likely the spouse of Roderick McNeil, a "small fruits grower" originally from Scotland, and shown as the owner in 1877 (Extract from Illustrated Historical Atlas of the County of Halton, see following). The lot line dividing lots 9 and 8 is now Morrison Road.

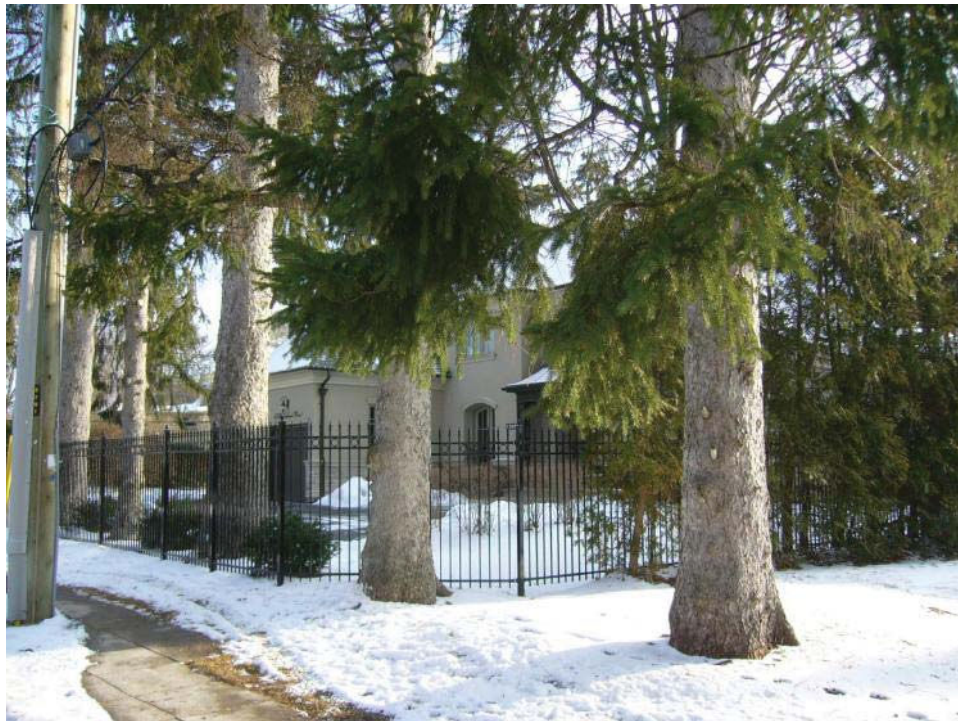
Immediately to the east of the subject property is 1208 Linbrook Road which is a two storey residential structure clad in an Exterior Insulation and Finish System (EIFS) See below.

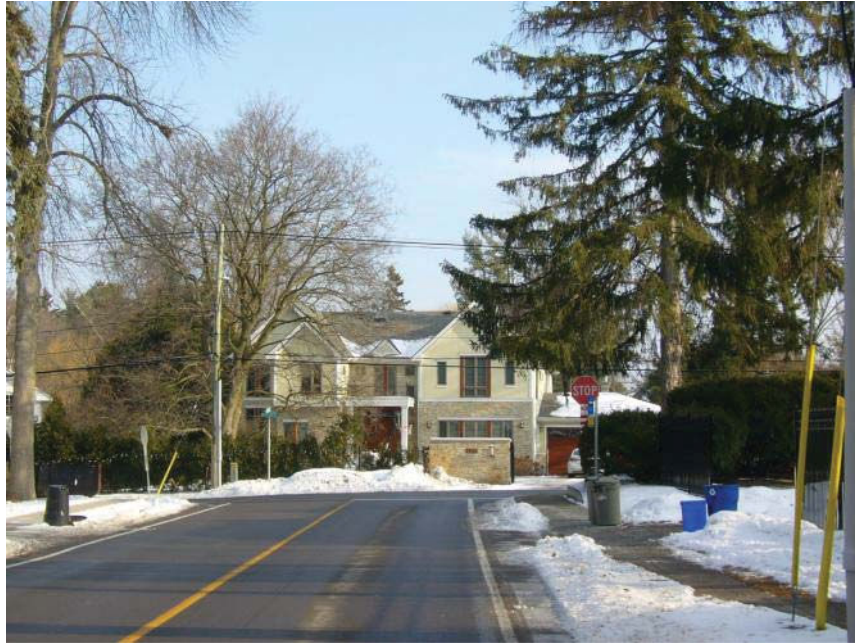
423 Morrison Road is a two storey house with cross gable roof terminating the view eastwards along Linbrook Road. It is clad in stone on the ground floor with vertical cladding on the upper floor (Below).

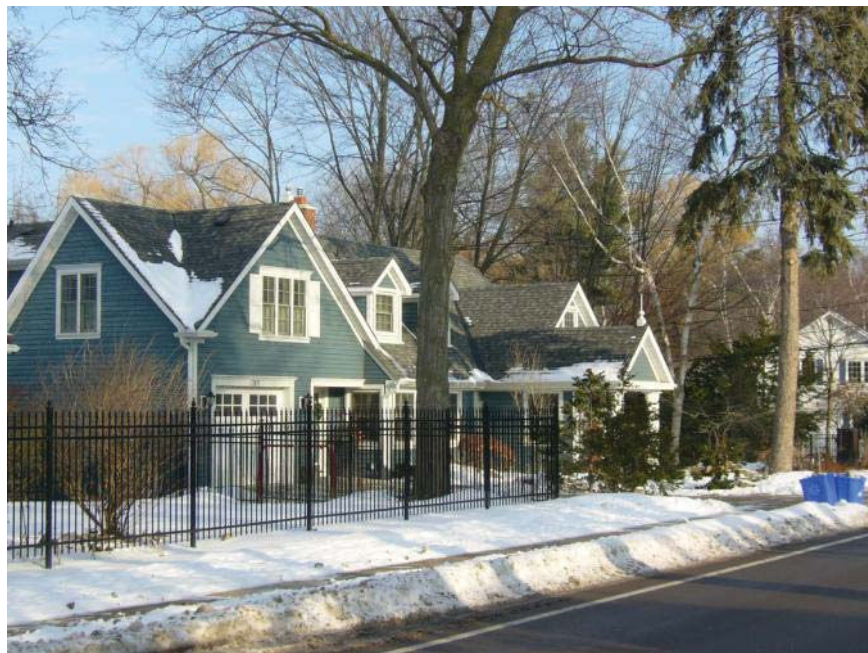
1207 Linbrook Road is located on the north side of the road and comprises a one-and-a-half storey residence with an irregularly shaped hipped roof and dormers (Below).

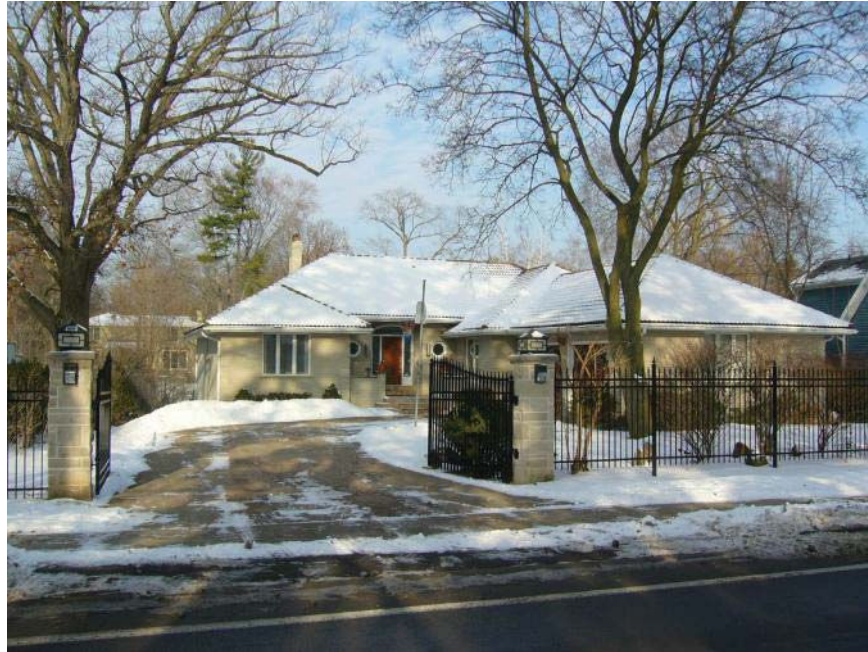
1199 Linbrook Road, located on the north side of the road, is a single storey, brick house with a hip roof (Below).

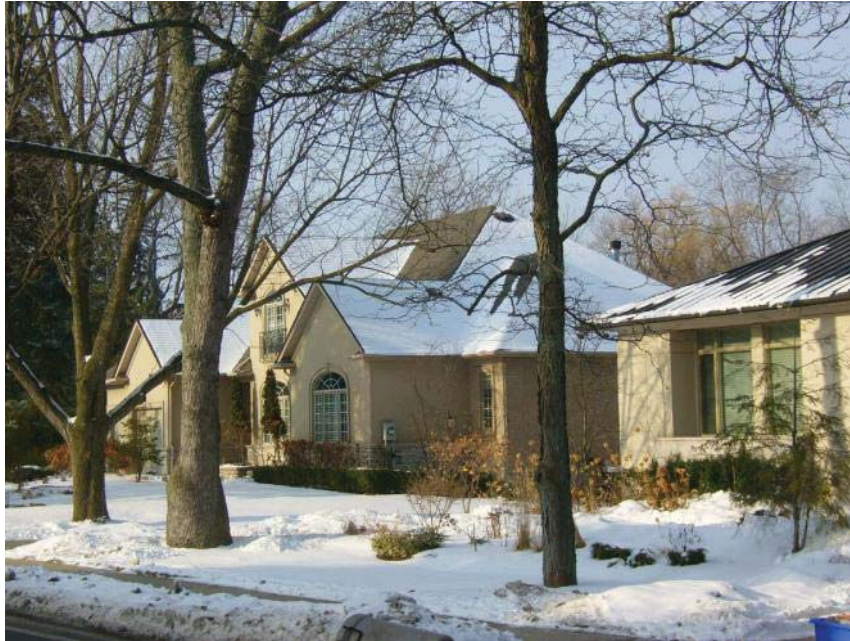
1185 Linbrook Road, located on the north side of the road, is a one-and-a-half storey, EIFS clad front façade residence with brick on the side façade (See below).

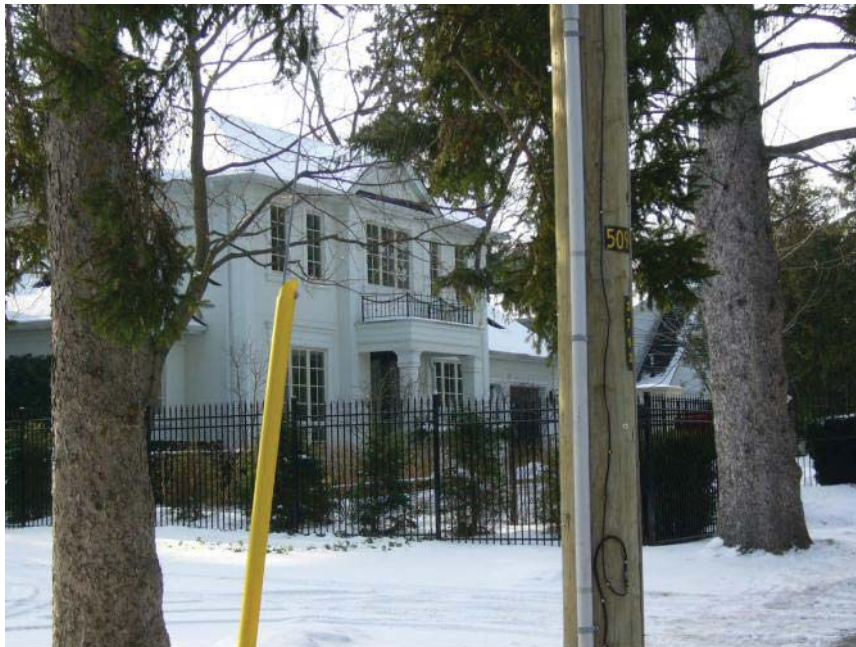
1190 Linbrook Road is located on the south side of the road immediately adjacent to the west of the subject property, and comprises a two storey structure clad in EIFS (See below)

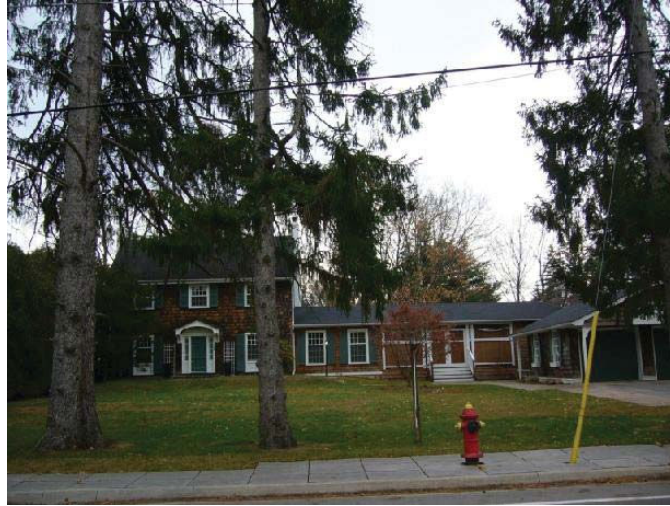
View from Linbrook Road looking south showing main house, additions and garage

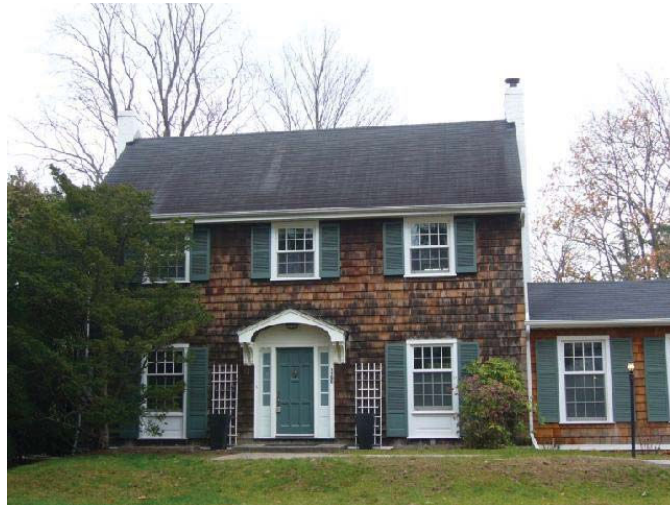
View from Linbrook Road looking south showing main house and symmetrical arrangement of façade

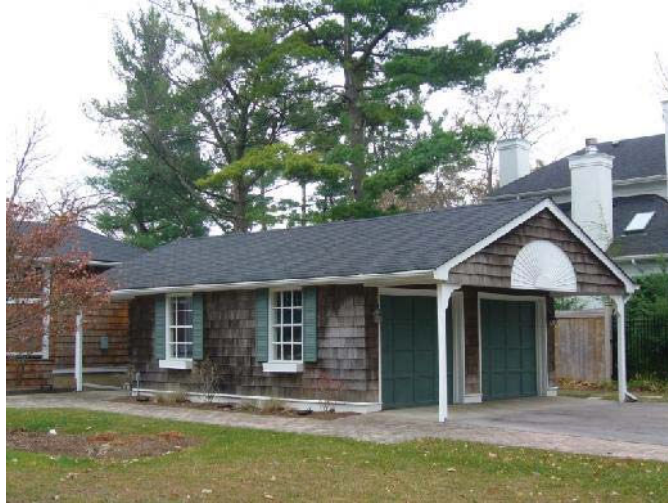
View from Linbrook Road looking southwest showing garage

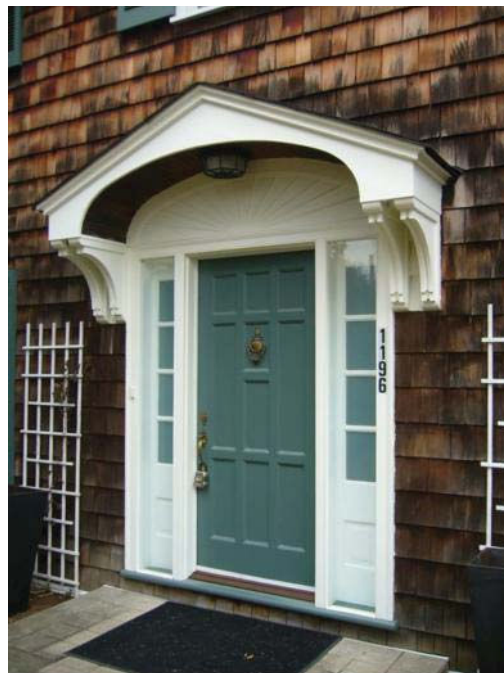
While the sash windows (of synthetic or metal construction) are likely replacements the central entranceway appears to be original to the building with sidelights on each side of the panelled door, a blind fanlight above, all of which is surmounted by a projecting front gable portico with a curved underside. Columns are absent and the portico is supported by paired brackets on either side of the

View of central entranceway, portico, sidelights and blind fanlight

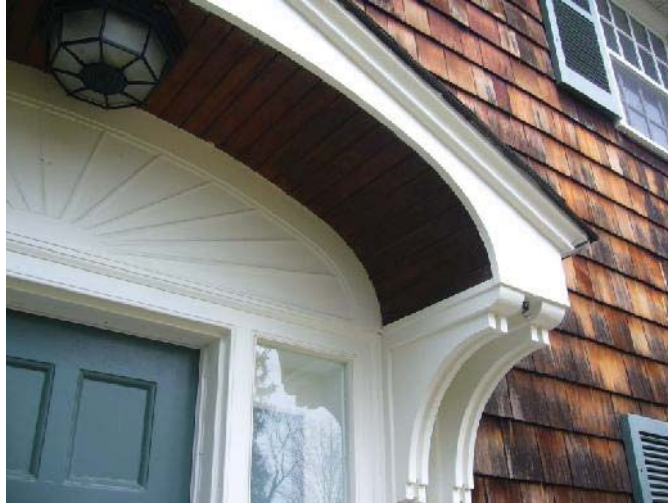
View of detail of central entranceway, portico, sidelights, blind fanlight, paired brackets and curved underside

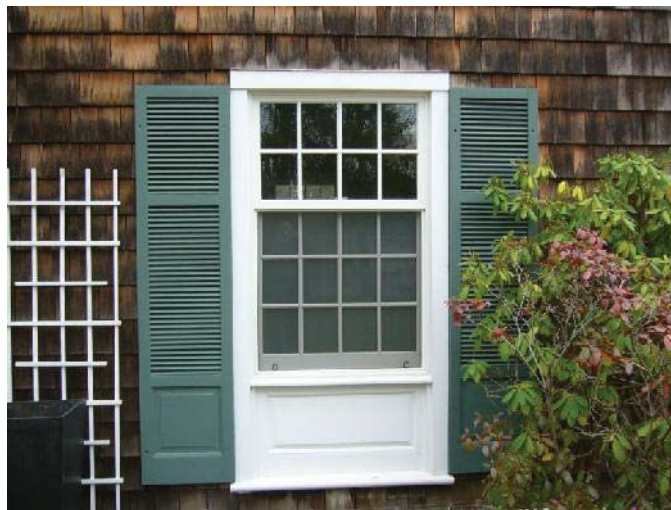
View of sash window with eight (8) over twelve (12) lights or panes flanked by faux shutters with exterior wall of wood shingles

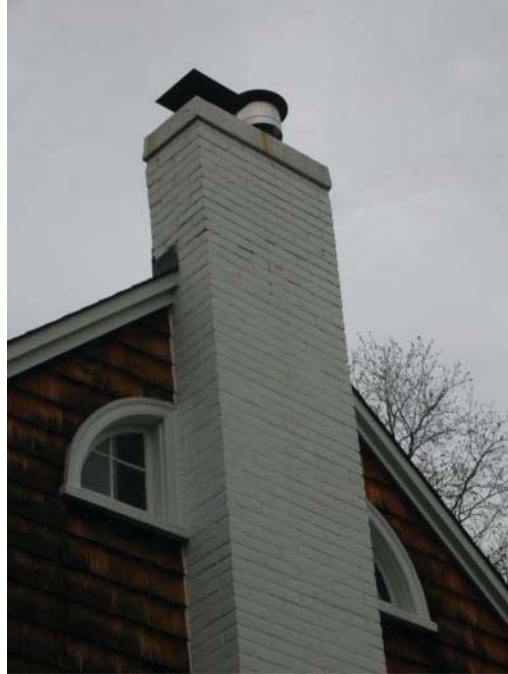
Each gable end of the residence is distinguished by an end chimney symmetrically placed that breaks the ridge line and projects above the roof. The chimney is of brick construction, painted white and flanked on either side by quarter-round windows.

View of west gable end with white painted brick chimney and flanking quarter round windows

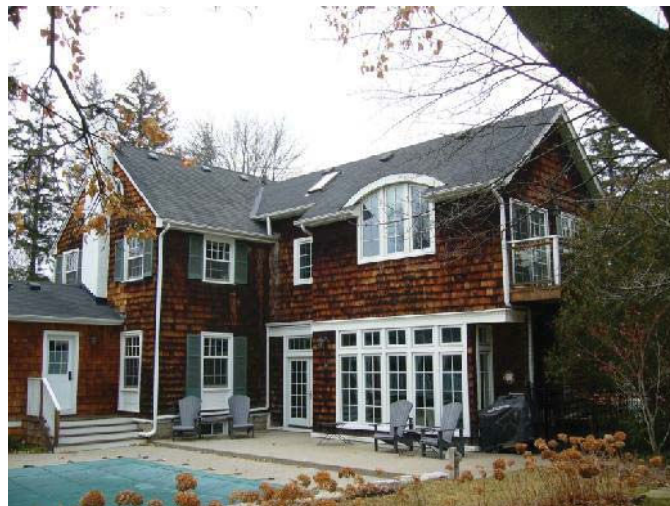
At the south façade a rearward, two-storey linear building mass accommodates additional living space with the ground floor characterized by a bank of windows that faces onto a concrete patio and a pool area. On the upper level a balcony projects southwards from the building face. As with the front façade all exterior wall surfaces are clad in wood shingle.

View of rear façade looking northeast.

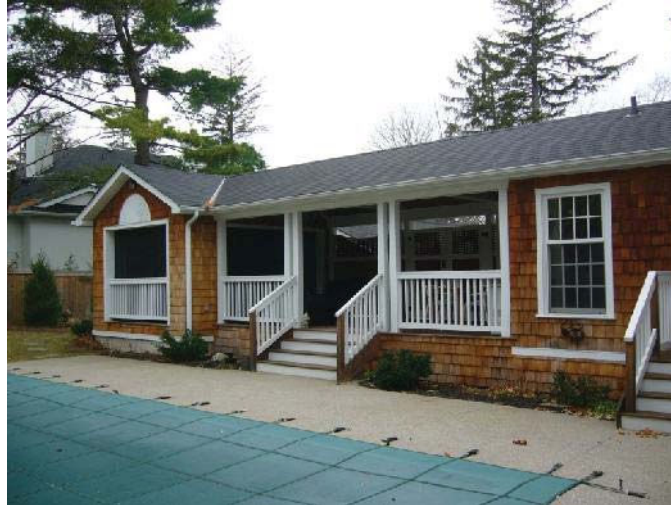
View of rear façade looking northwest showing one-storey additions.
