Heritage Research Report

**129 Douglas Avenue
Oakville, ON**

May 2016

HERITAGE RESEARCH REPORT STATUS SHEET

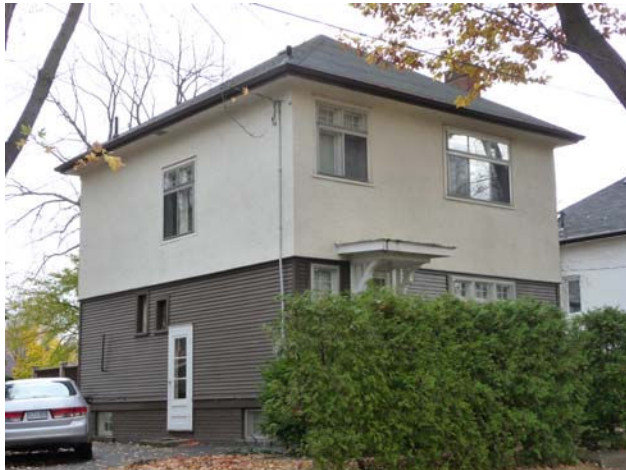
Figure 2 – Northwest corner view

- Removal of the one storey rear addition in the late 1950s (which still existed on the 1949 Fire Insurance Plans).
- Windows have been replaced on the second storey of the south and east elevations (see figure 2). All storm windows have been replaced with aluminum storms.

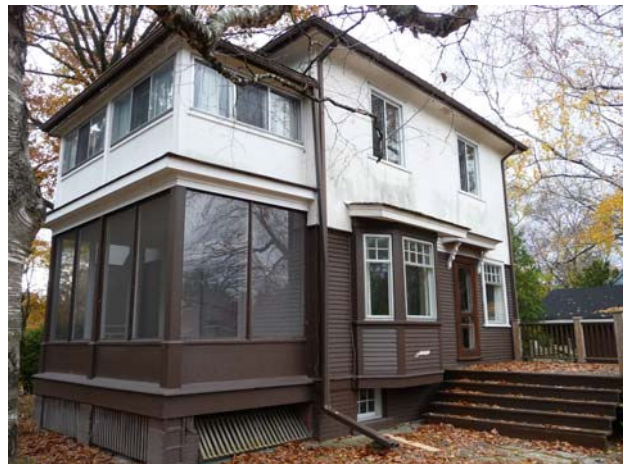
Figure 3 – Southeast corner view

- The two storey sunroom on the south elevation of the residence was likely added between 1930 and 1949 (seen in Figure 3). The addition required the removal of several original windows and the floors of the sunroom do not line up with the interior of the house. The sunroom windows have been altered since the early 1960s.

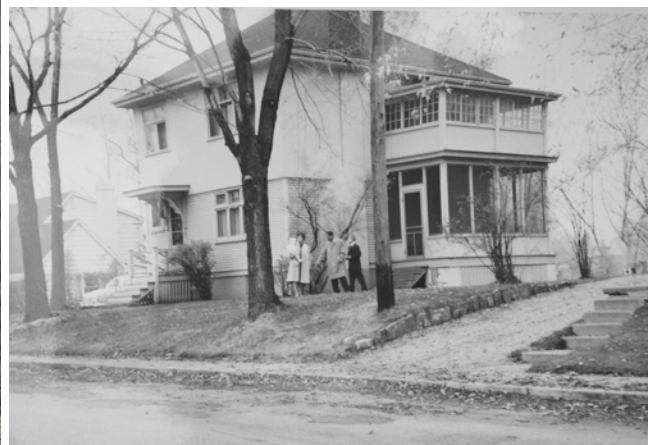
Figure 5 – Photo circa 1961 (courtesy of owner)

- The stucco cladding on the second storey was added circa 1956 and slightly overhangs the horizontal wood siding on the first storey.
- The front stoop (and possibly the portico overhang) were replaced circa 1956. The stoop has been replaced again several times since then.

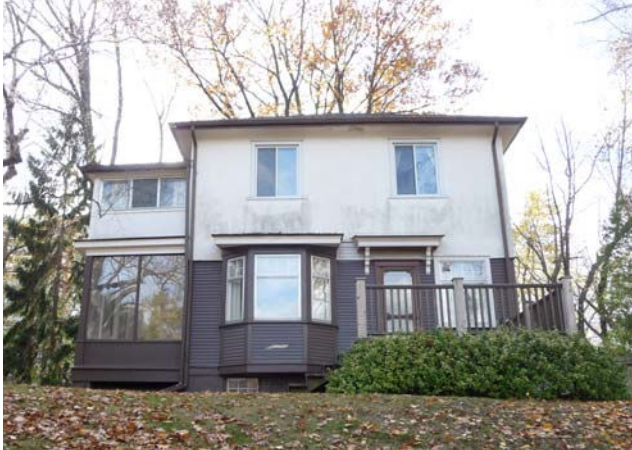
Figure 6 – West/rear elevation view

- Original sash windows on the west and north elevations and the ground floor of the east elevation, covered with aluminum storms.
- The horizontal wood cladding on the first storey is likely original, although it may be a replacement of earlier wood cladding.

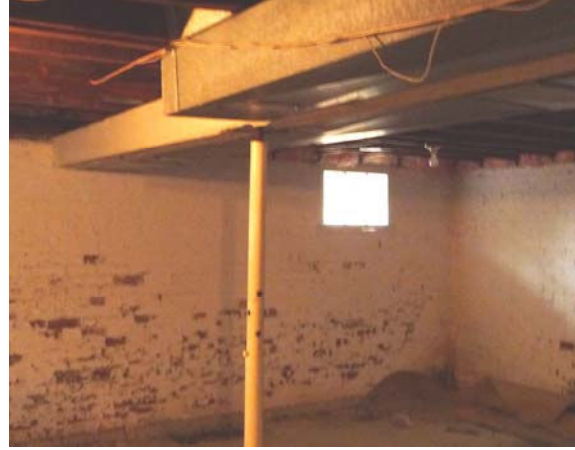
Figure 7 –Interior, brick foundation

The brick foundation of the house is slightly atypical, but not uncommon. While concrete blocks or poured concrete were more commonly used for residences of this period, brick may have been used due to its availability or cost effectiveness.

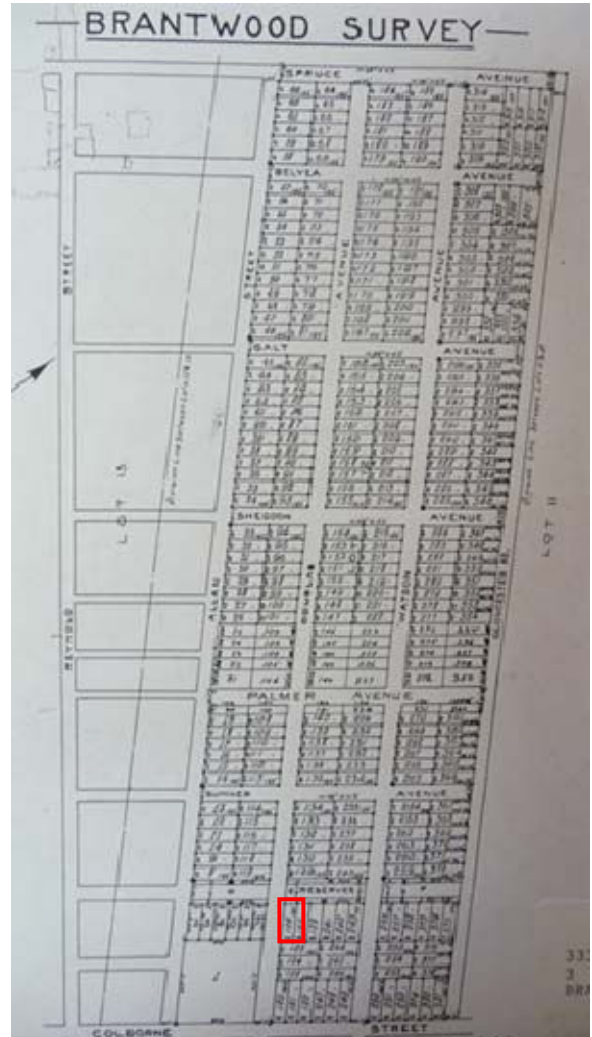
Figure 8 – Brantwood Survey, 1907

The subject property is the largest residential lot on its block, with the house located in the midpoint of the western frontage along Douglas Avenue. The current lot configuration has changed from the original Brantwood Survey, which originally had lot 126 fronting onto Randall Street. The change in the lot orientation has disrupted the original Brantwood survey as the property is now parts of the original lots 126, 127 and 128.
