# 104 BURNET STREET, OAKVILLE

## HERITAGE ASSESSMENT REPORT

# 104 BURNET STREET - HERITAGE ASSESSMENT REPORT

**Regarding:** Structural Assessment Report – Existing Structure  
104 Burnet Street, Oakville, Ontario

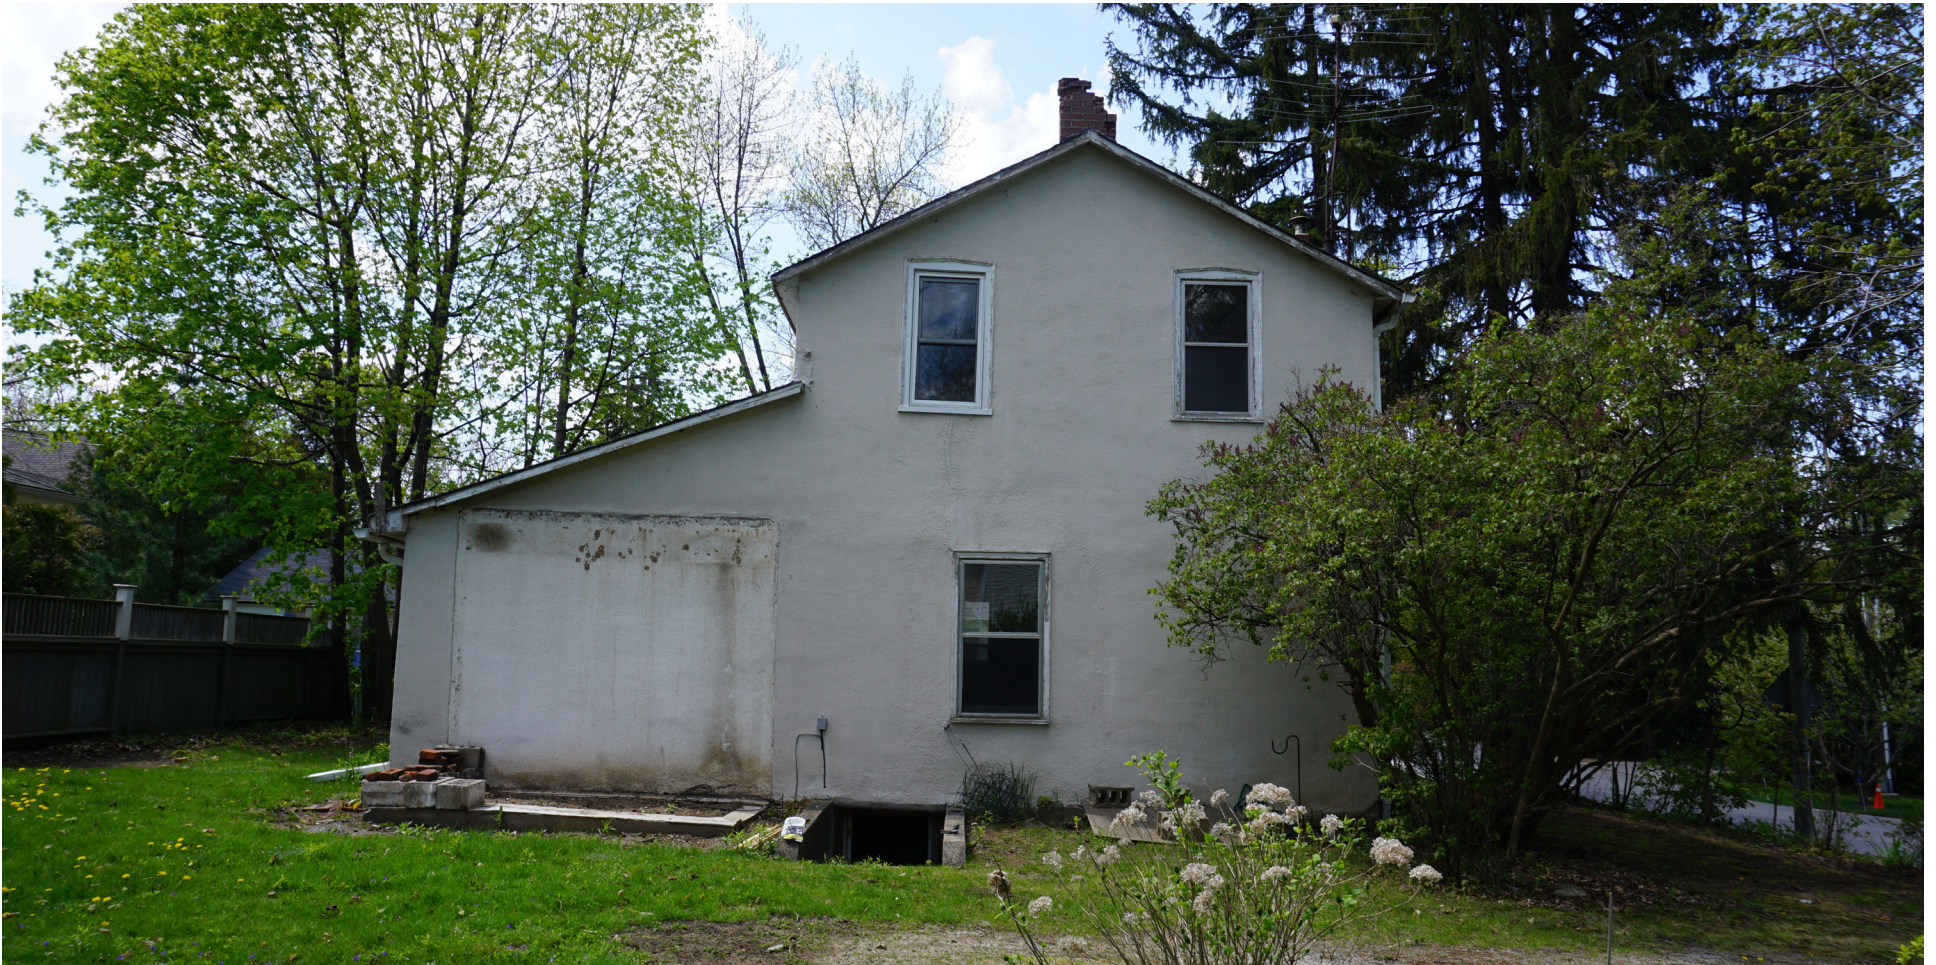
Rear view from South East - Access way to the basement, the foundation of a former addition and the additions outline on the rear can all be seen in the above photo

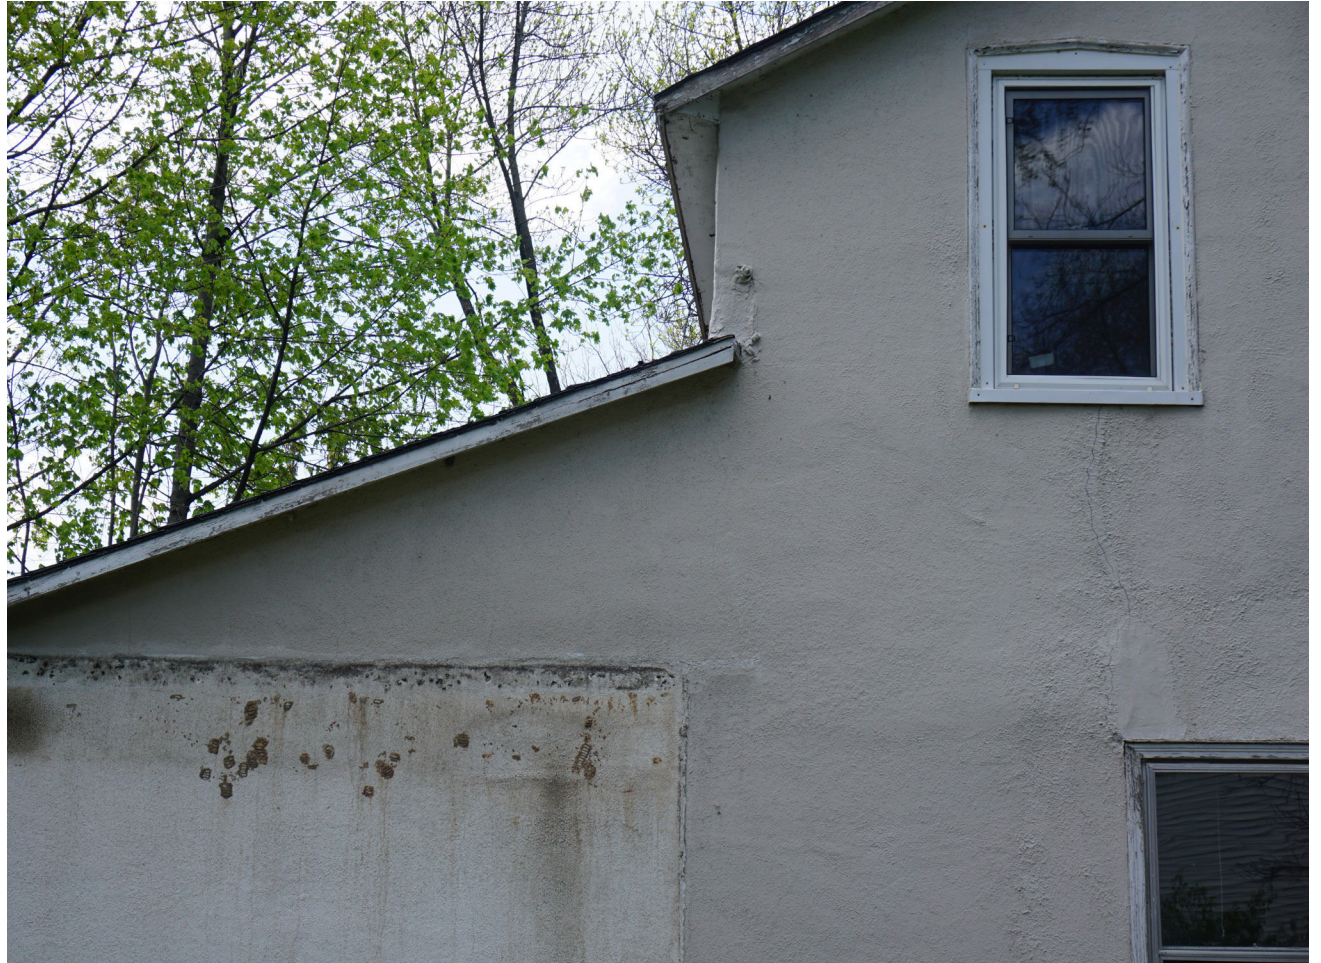
The house has pleasing proportions, with its asymmetrical façade design and original windows. The exterior is well weathered, with cracks in the stucco and a structurally unsound chimney that is missing bricks. The trim is weathered, with rotten wood at the soffits and fascia. The house lacks eaves troughs and/or down spouts as well. At the back of the house, a cellar is accessible from the exterior of the house. A one storey shed addition was added to the original building on the west side.

Cracks, deterioration, and outline of a former addition visible on the Exterior wall

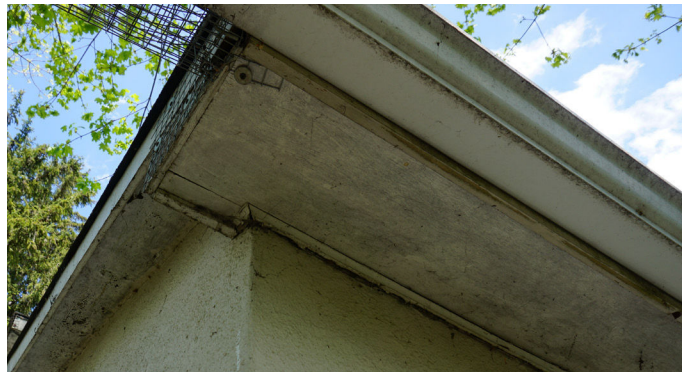
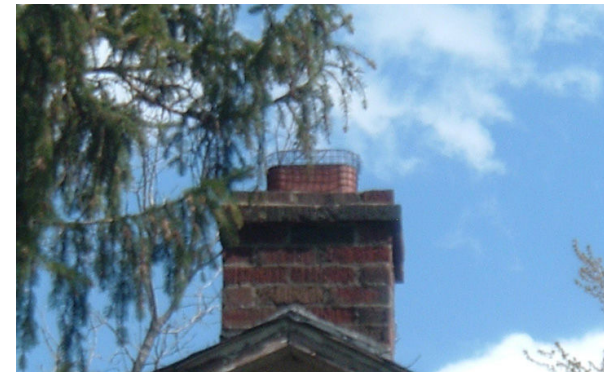
Views of the Chimneys

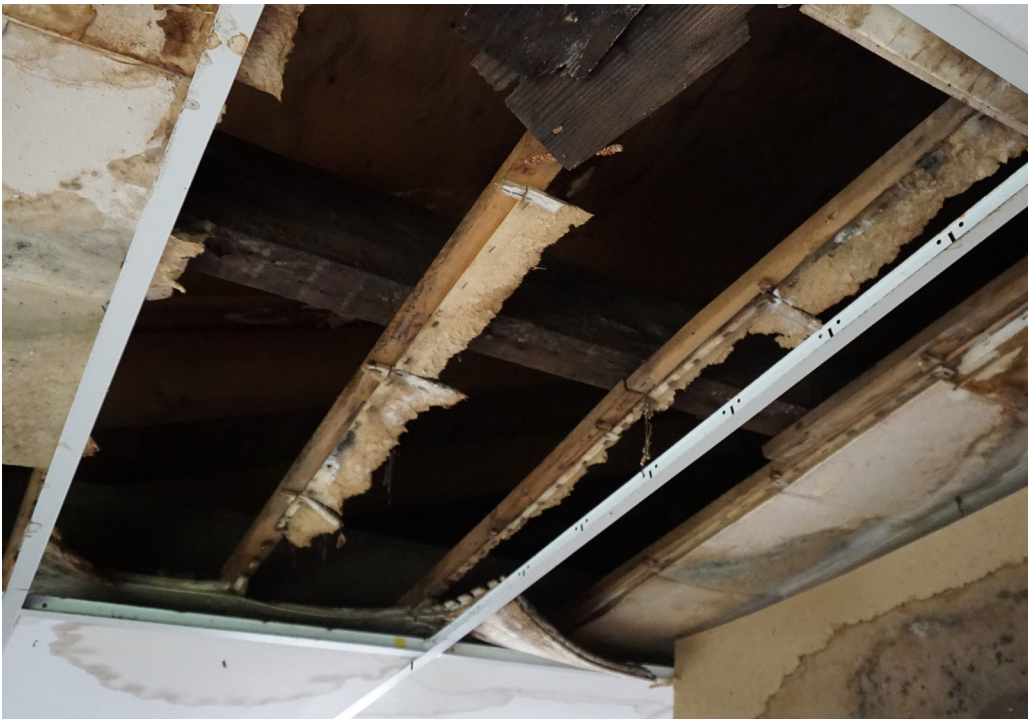
Although the interior seems to have held much of the character of the house, it has been severely neglected and is currently in a very poor state of repair. It is understood that raccoons inhabited the home for a period of time, while the shed kitchen area and ground floor show evidence of a fire. The plaster ceiling was damaged and instead of repairing the original, a drop ceiling was added. The floors of both the first and second level are soft and sloping inward, and although some finished flooring remains, much of it has been damaged or removed. In addition, the bathroom does not appear to have any original fixtures.

View of the Kitchen ceiling deterioration

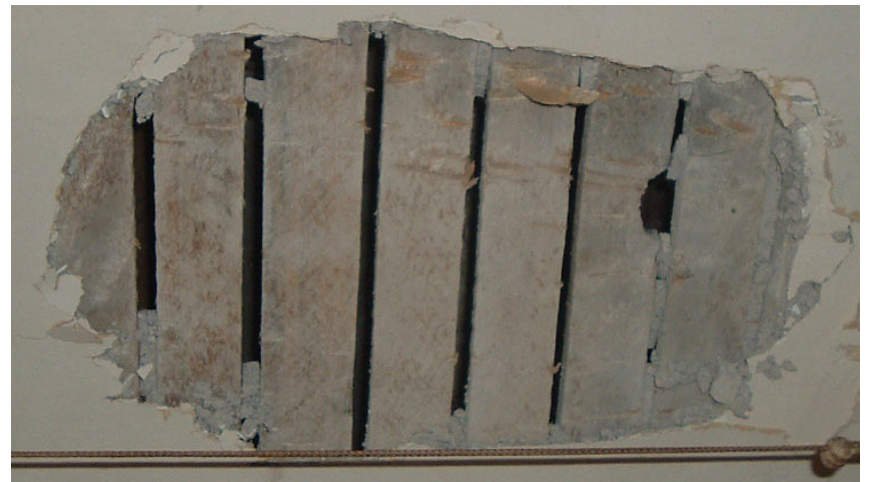
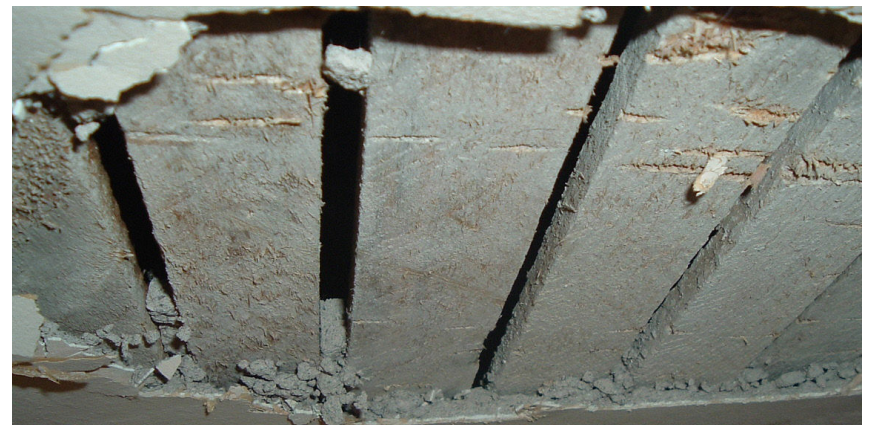
Views of the interior wall construction/wood lath and plaster

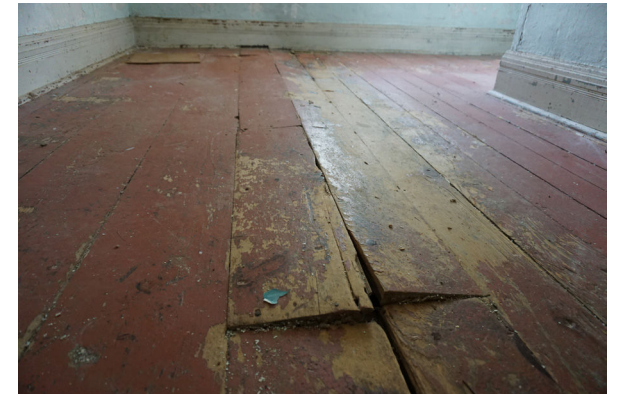
Softening and lifting of flooring on the second level

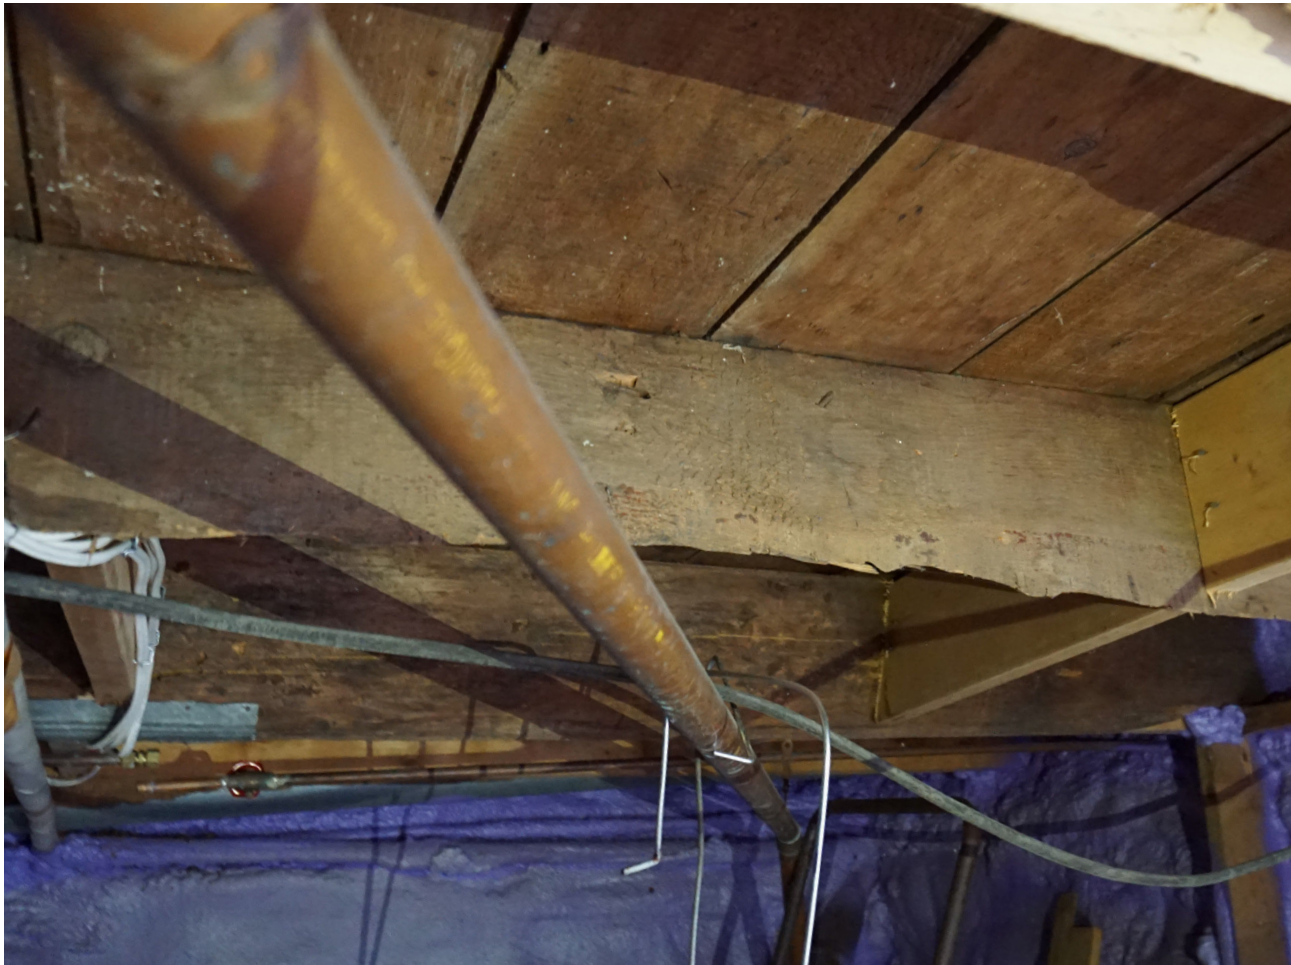
The basement, accessed only from the exterior, has low ceilings, and the visible joists are widely spaced. With the basement prone to flooding, the moisture has also rotted the beams. Although make shift beams and posts have been added, there are sections that are still missing portions of the 2x12's which have become soft, easily penetrable, and have begun twisting under the load. Under the addition the small space is largely unexcavated, with an earthen floor and posts that have been added to help support the additional floor. The foundation is made of lake stone, but is collapsing and in need of repointing. Against the exterior walls, spray foam was used to plug holes and add insulation.

View of rotting joists in the basement

Based on the information above, it is our opinion that the existing main floor support structure (beams, columns and pad footings) be removed and replaced with new structure that conforms to the requirements of the 2012 Ontario Building Code.

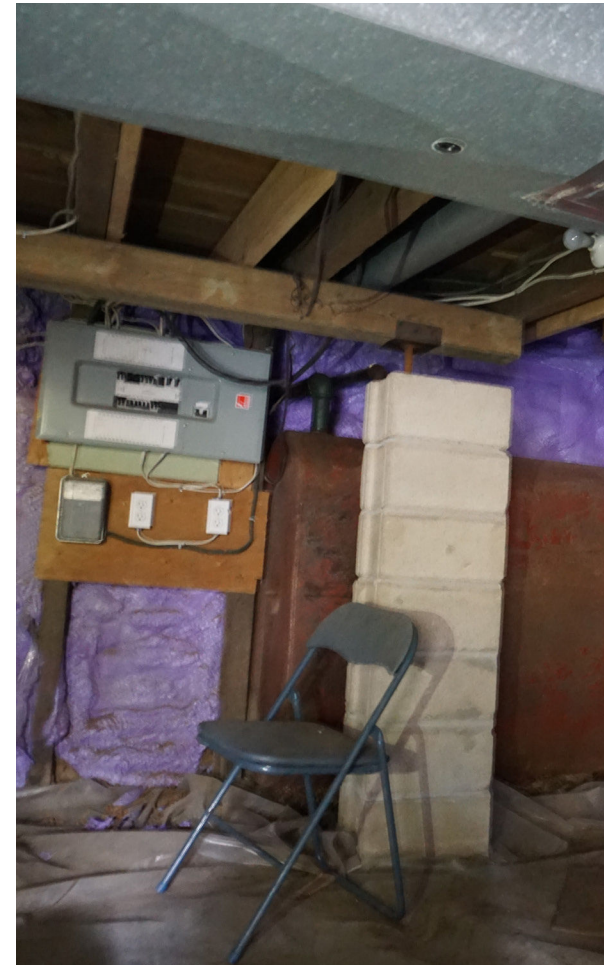
View of a column and post added to support the floor

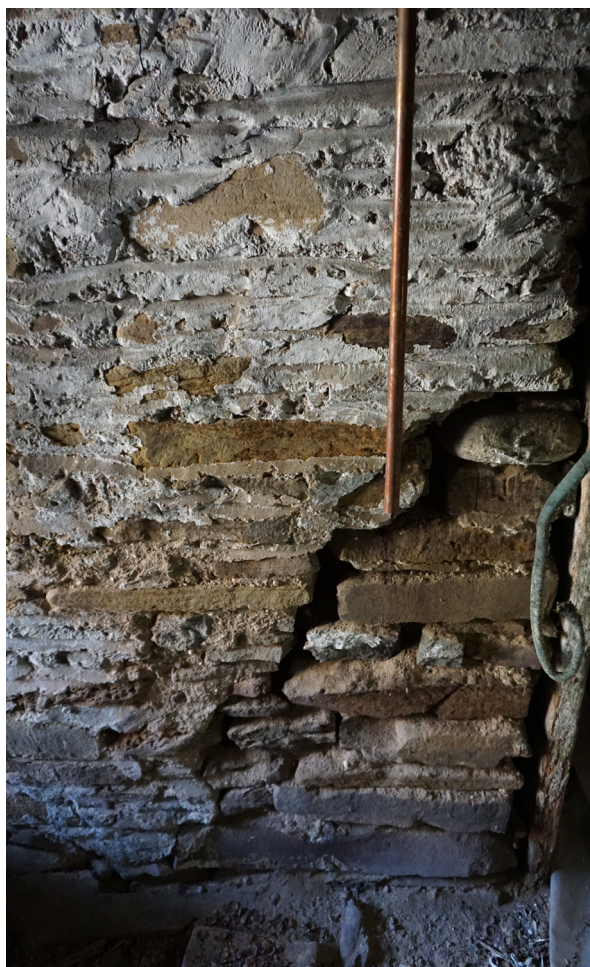
Lake Stone Foundation degradation

It is also our recommendation that the existing foundation structure be temporarily shored until project specific documentation for remedial works can be prepared by a professional engineer.

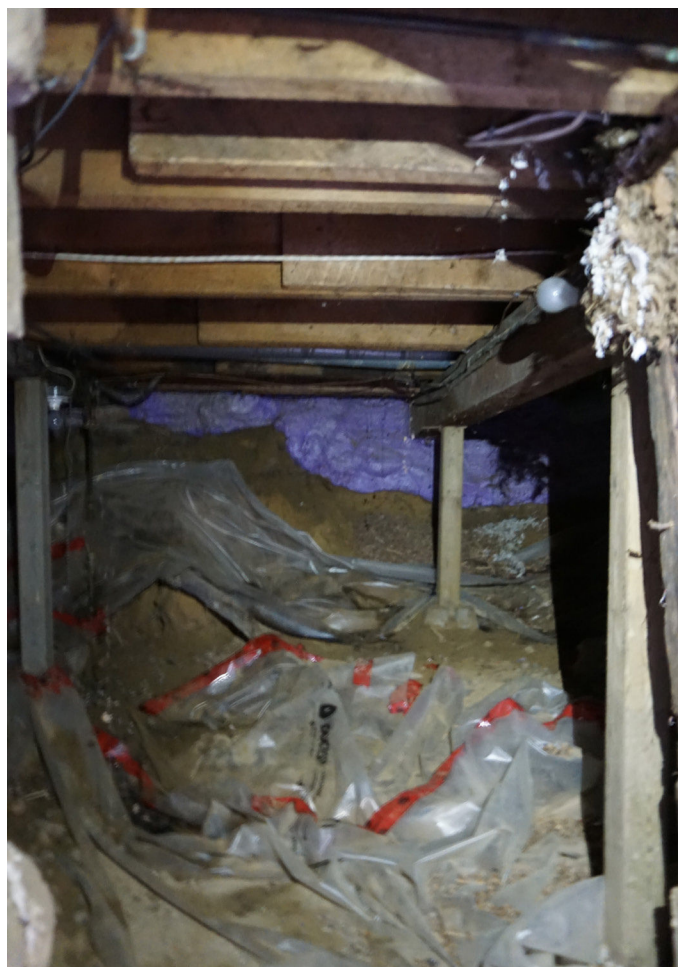
View of the partially excavated area under the addition

It was also noted on site that extensive foundation works (excavation of native soils around the perimeter of the foundation) have taken place without proper permitted documentation and direction. This is evident in the discovery of several sections of laterally unsupported foundation walls and lack of proper foundation bearing structure. These sections of foundation wall should be shored until proper foundation structures can be installed under the guidance of a professional engineer.

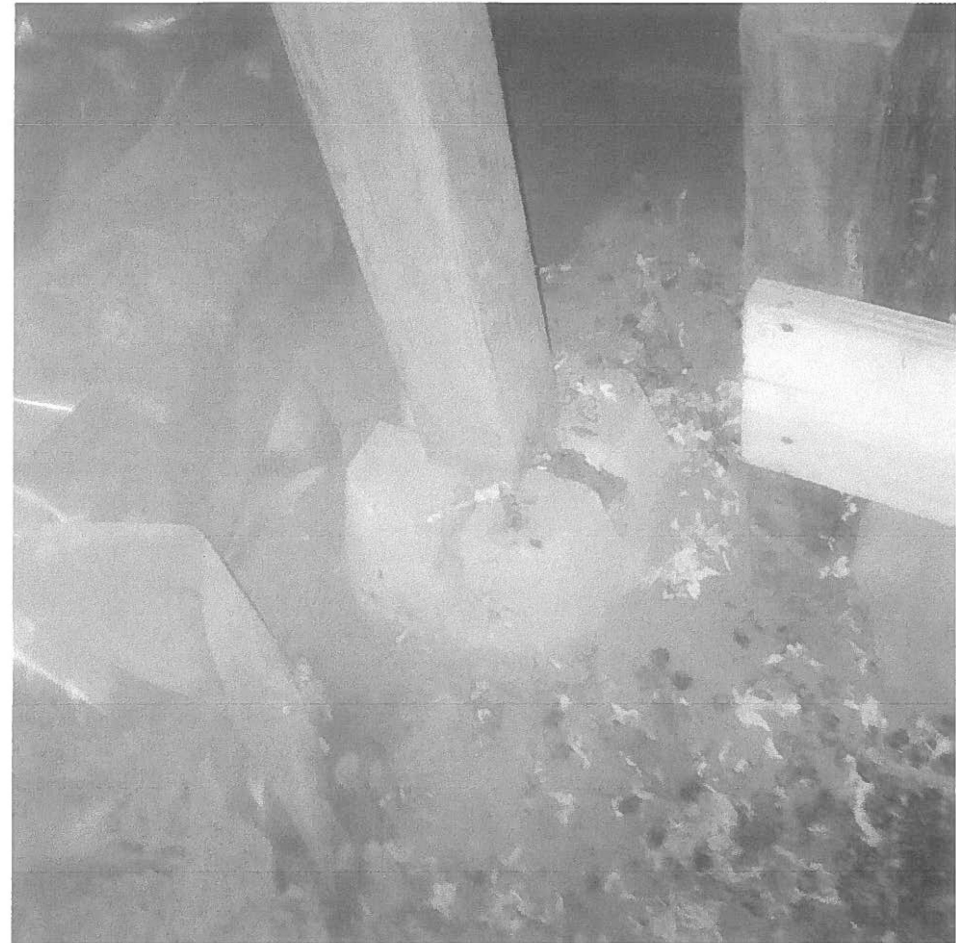
**Figure 1.0 Photo of Main Floor Support Structure (Remedial Works) – Inadequate Support Post/Foundation**

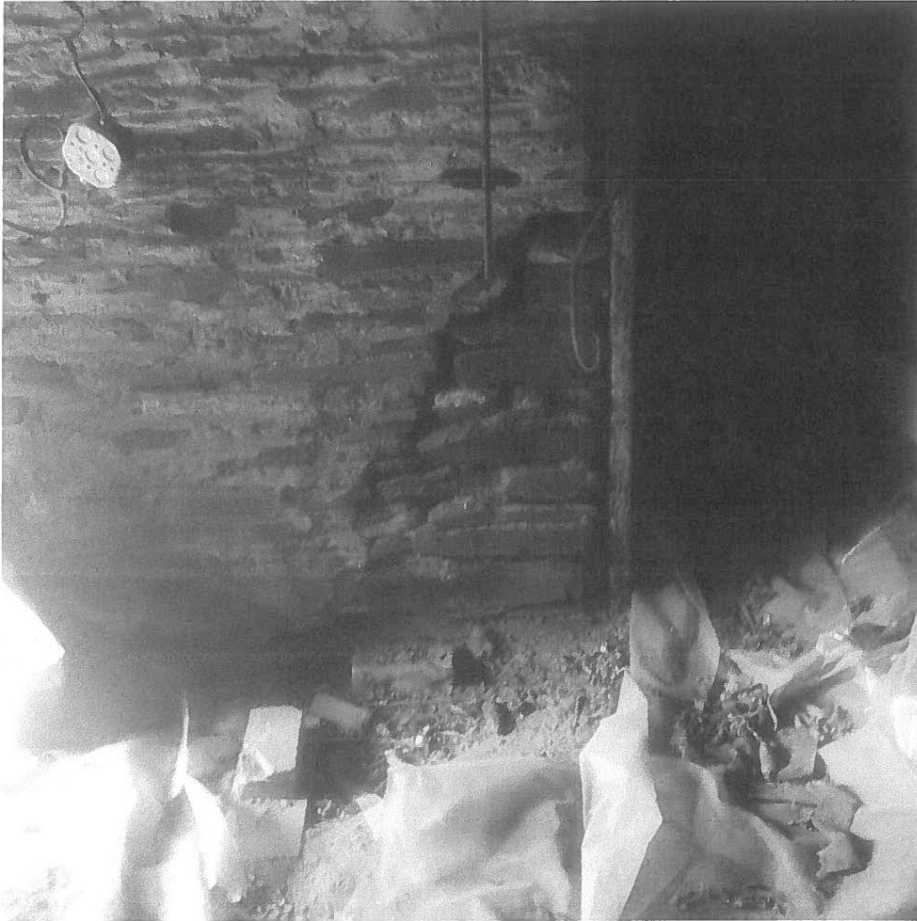
It was noted on site, that sections of the existing rubble stone foundation walls are significantly deteriorated, see Figure 1.1., and extensive remedial works and perhaps complete replacement is required (*destructive investigation required to confirm*).

Figure 1.1 Photo of Foundation Wall Deterioration
