***Conservation Plan for the Cultural Heritage  
Landscape of the Erchless Estate***

*8 Navy Street, 110 – 114 King Street, Oakville Ontario*

Town of Oakville  
Heritage Planning  
September 2019

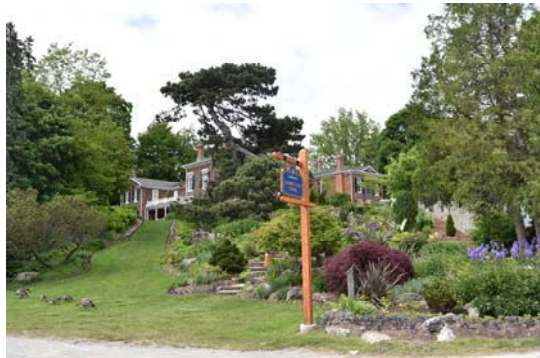
Attribute	Description	Photograph	Rating
<b>Key attributes of the significant cultural heritage landscape, including:</b>			
Its defined geographical area	The elevated natural embankment overlooking Lake Ontario, Sixteen Mile Creek and the entrance to Oakville Harbour.

Good

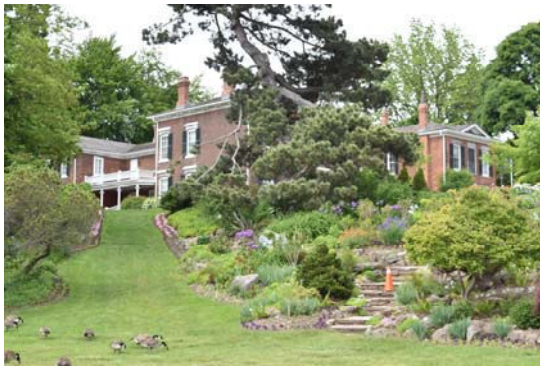
Attribute	Description	Photograph	Rating
<b>Key attributes of the significant cultural heritage landscape, including:</b>			
Its unique spatial organization	The whole designed cultural heritage landscape articulates the interrelationships between the property's topography, natural elements, hardscaping features, and its historic buildings.

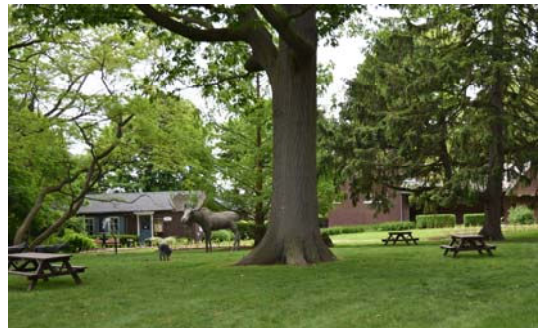
Good
Its physical and functional layout and circulation route patterns	The whole designed cultural heritage landscape's placement and variety of mature trees, shrubs, and gardens.

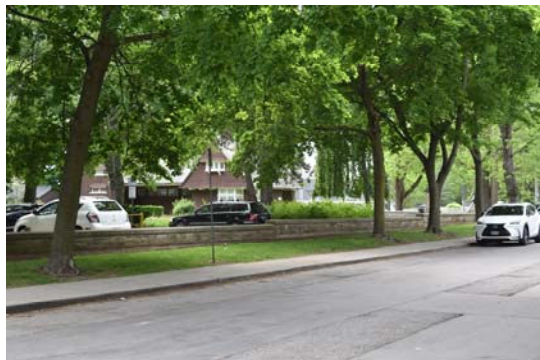
Good
Its physical, functional, visual, and historical links to the surrounding neighbourhood	The whole designed cultural heritage landscape's residential and open space setting adjacent to Lakeside Park and the surrounding residential neighbourhood known as Old Oakville Heritage Conservation District.

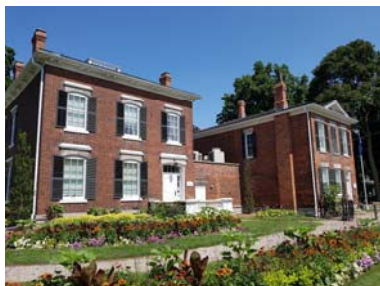
Good
Its three historic buildings	The whole designed cultural heritage landscape's historic buildings, specifically, <i>Erchless</i> , the amalgamated, former residential and commercial structure; the

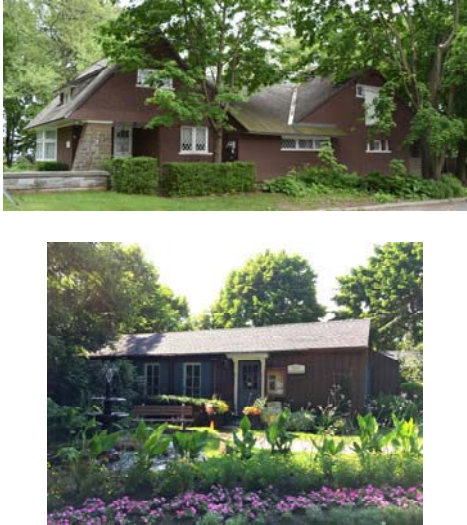
Attribute	Description	Photograph	Rating
<b>Key attributes of the significant cultural heritage landscape, including:</b>			
	<i>Coach House and Gardener's Cottage</i> , the former stable/coach house; and the <i>Cottage</i> , the former residential structure.

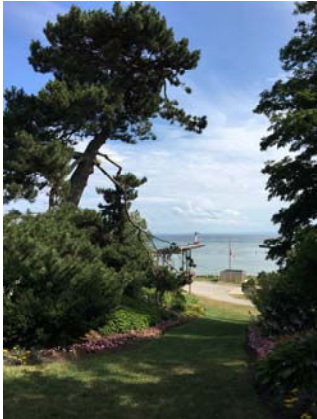
Its views and vistas	The whole designed cultural heritage landscape's views and vistas to, from, and between Lake Ontario; Sixteen Mile Creek; the entrance to Oakville Harbour; <i>Erchless</i> ; the <i>Coach House and Gardener's Cottage</i> ; and the <i>Cottage</i> .

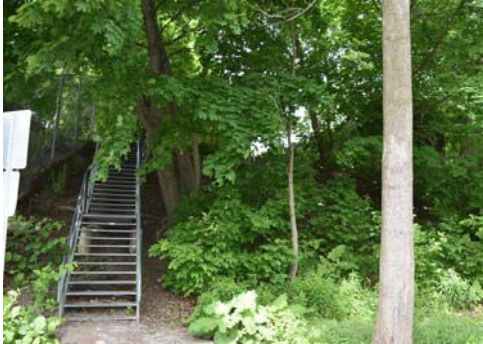
Good
Its waterfront access	Via stairways and the street south of <i>Erchless</i> , which runs south past the former <i>Custom House</i> towards the harbour.

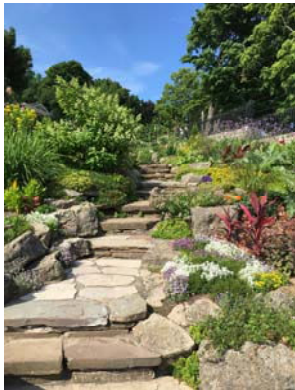
2	Good
Its 1920s Dunington-Grubb and Stensson Landscape Architects designed rock garden	Architectural features associated with the Dunington-Grubb and Stensson design including flagstone steps and path leading down to the water.

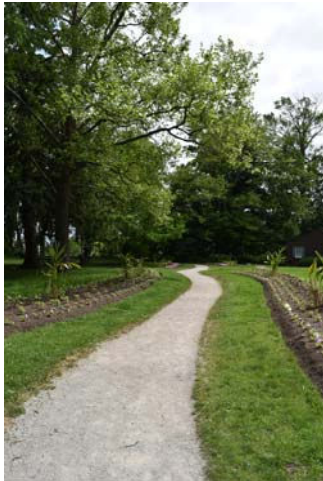
Good
Its park-like grounds and pathways	Architectural features associated with the late 19 <sup>th</sup> century Dick and Wickson design including the former, curvilinear carriageway which now serves as a footpath.

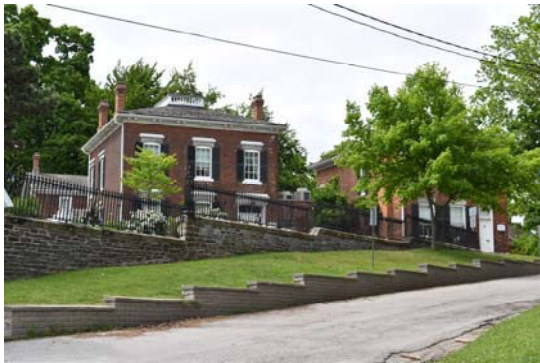
Attribute	Description	Photograph	Rating
<b>Key attributes of the significant cultural heritage landscape, including:</b>			
Its various wall features	The c.1858 stone and metal fence and gates south of <i>Erchless</i> , which runs south from the former Custom House gate towards the harbour.

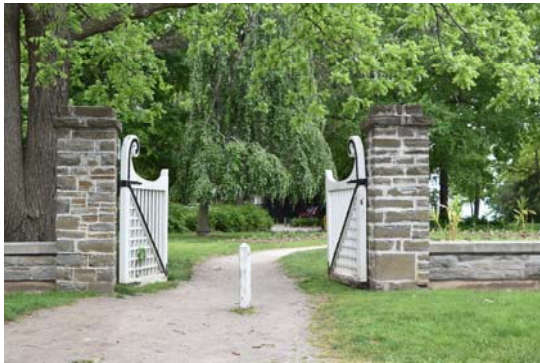
Good
Its various wall features	Its late 19 <sup>th</sup> century Dick and Wickson designed stone gateposts and wooden gates on King Street.

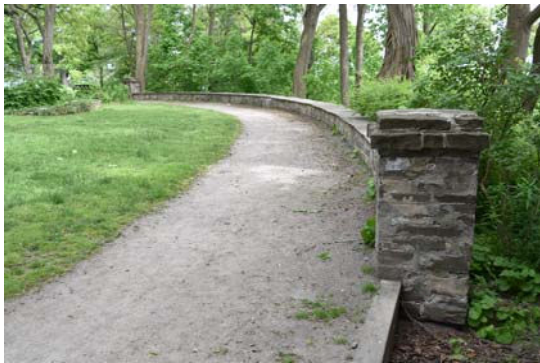
Attribute	Description	Photograph	Rating
<b>Key attributes of the significant cultural heritage landscape, including:</b>			
Its various wall features	The curved stone wall, running along the top of the bank overlooking Sixteen Mile Creek, which is a remnant of the Dick and Wickson designed late 19 <sup>th</sup> century carriageway.

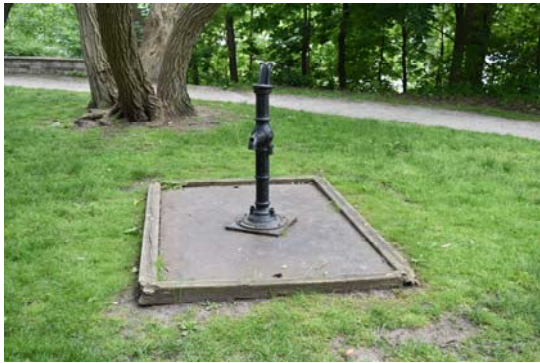
Fair
Its remnant features from Captain William Wilson's home, located close to the curved stone wall	The lake stone foundation walls, which have been used as the foundation for the water tower, the location of a garden pool/fish pond; and, are now the location of a garden.	 	Good
Its remnant features from Captain William Wilson's home, located close to the curved stone wall	Captain Wilson's hand pump.

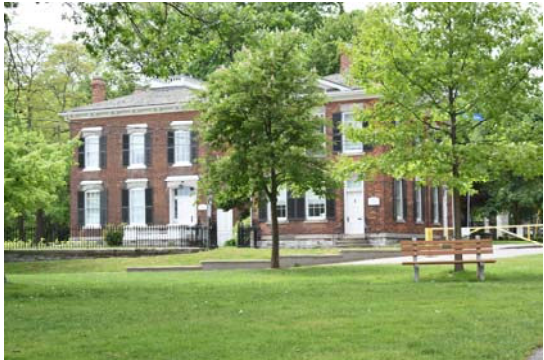
Attribute	Description	Photograph	Rating
<b>Erchless' key exterior attributes, including:</b>			
Its 19 <sup>th</sup> century shape and form	The amalgamated residential and commercial structure, constructed in the Italianate and Classical Revival styles.

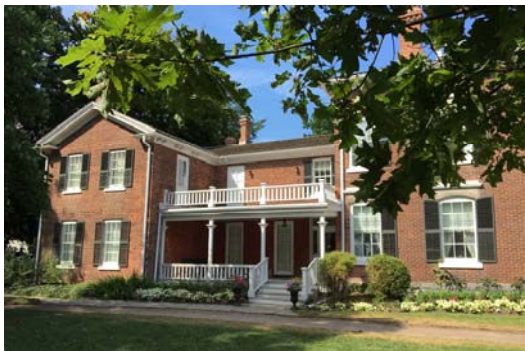
Good
Its combined 1-½ and 2-storey massing	The structure's massing is an architectural feature that articulates the evolution of the structure over the course of its history.

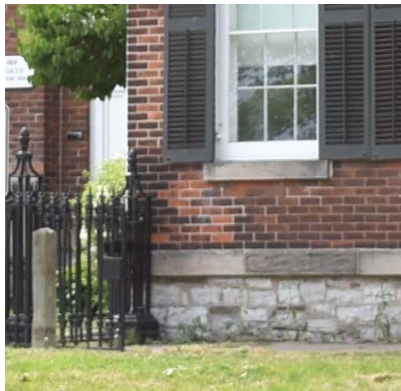
Good
Its lake stone foundation, exposed above grade and topped by a stone course	The lake stone foundation is an architectural feature that is representative of 19 <sup>th</sup> century construction materials and methods.

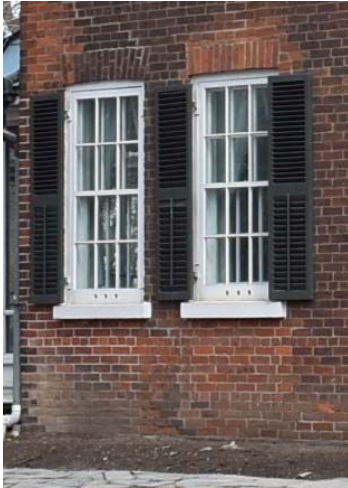
Attribute	Description	Photograph	Rating
<b>Erchless' key exterior attributes, including:</b>			
Its brick cladding, including brick headers above windows and doors	The structure's cladding is representative of early 19 <sup>th</sup> century construction materials and methods.

1. Open/deteriorated mortar joints should be repointed with an appropriate lime-based mortar. (Category 'B' Alterations – Town review and consent is required);

2. Spalling masonry should be inspected to determine its cause. If it is the result of poor repointing, hard mortar should be carefully removed and replace with softer, period-based mortar that matches the original in composition, colour, texture and profile. (Category 'B' Alterations – Town review and consent is required);

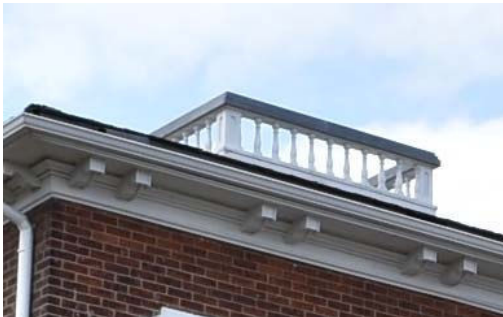
Fair
Its wood shingle clad, combined gabled and hipped roofs	The c.1858 residential addition's functional railed deck, a.k.a. widow's walk, with its wood handrail and decorative wood pickets is an architectural feature that represents mid-19 <sup>th</sup> century construction materials, methods and style.

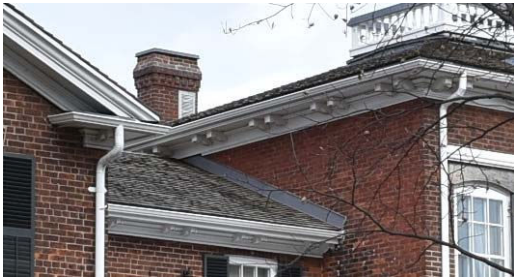
Good
Its wood shingle clad, combined gabled and hipped roofs	Architectural features that are representative of 19 <sup>th</sup> century construction materials and methods, include its wood cornice, cornice returns, soffits and brackets.

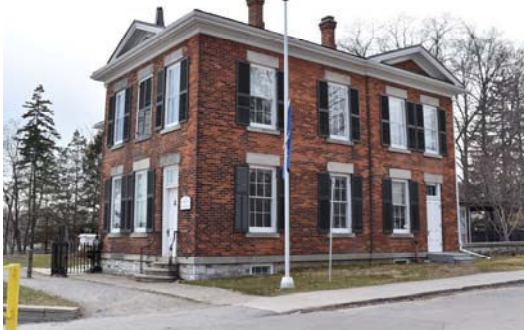
Attribute	Description	Photograph	Rating
<b>Erchless' key exterior attributes, including:</b>			
Its wood shingle clad, combined gabled and hipped roofs	The Custom House's centrally located pediment on the south façade, and an offset pediment on the east façade are architectural features that represents mid-19 <sup>th</sup> century construction materials and methods.

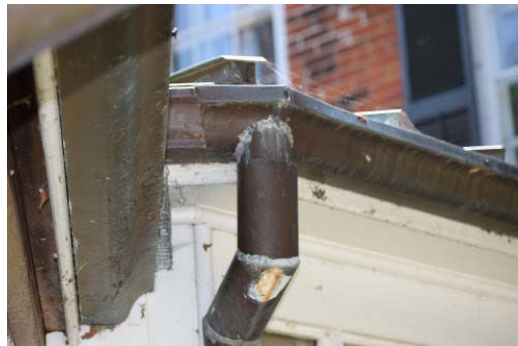
Good
Its copper eaves troughs and downspouts	Much of the structure's period/period appropriate copper eaves troughs and downspouts remain.

4. Damaged downspouts should be replaced and extended where needed to ensure water is being directed away from building foundations. Ensure all gutters and downspouts are clear of debris. (Category 'A' Actions – Exempt Works – no Planning Services staff review required).

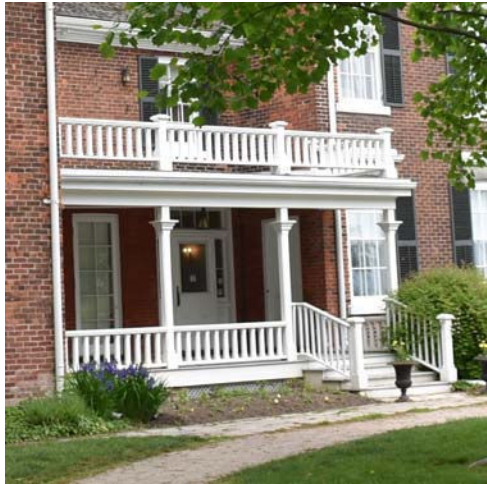
Good
Its 2-storey wooden balcony and porch	Located on the west elevation, the balcony and porch is an early 21 <sup>st</sup> century architectural feature which is a replica of the late 19 <sup>th</sup> century version.

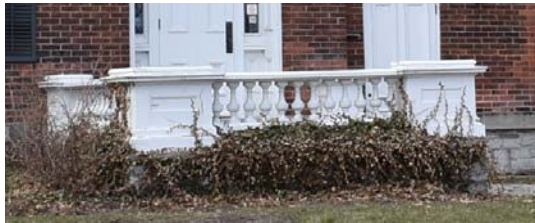
Good
Its formal 19 <sup>th</sup> century front entryway on the south elevation	Its classical stone terrace with its wood handrail and decorative wood pickets which is an architectural feature that represents mid-19 <sup>th</sup>

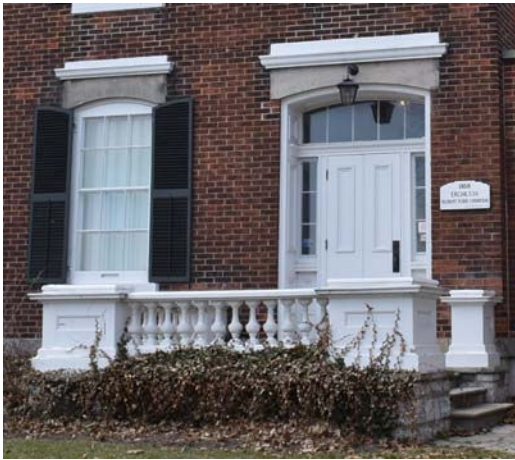
Attribute	Description	Photograph	Rating
<b>Erchless' key exterior attributes, including:</b>			
	century construction materials and methods.		
Its formal 19 <sup>th</sup> century front entryway on the south elevation	The wood door including the wood paneled and glass sidelights, curved wood transom window, associated wood trim, stone header and wood hood mould are architectural features that represents mid-19 <sup>th</sup> century construction materials and methods.

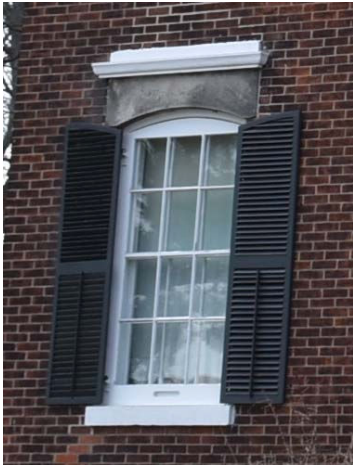
Good
Its 19 <sup>th</sup> century wood doors and windows	The associated wood trim, stone sills and headers, and wood hood moulds are architectural features that represents mid-19 <sup>th</sup> century construction materials and methods.

3. Loose paint should be carefully scraped from wood surfaces. The wooden elements should be repaired and repainted as necessary. (Category 'A' Actions – Exempt Works – no Planning Services staff review required);

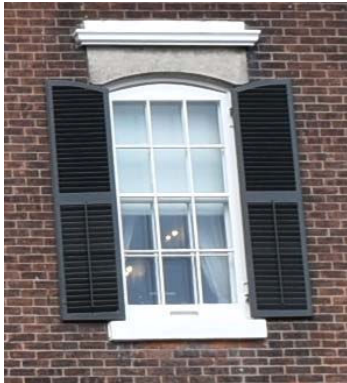
Good
Its wood louvered shutters	The shutters are architectural features that are representative of mid-19 <sup>th</sup> century construction materials and methods.

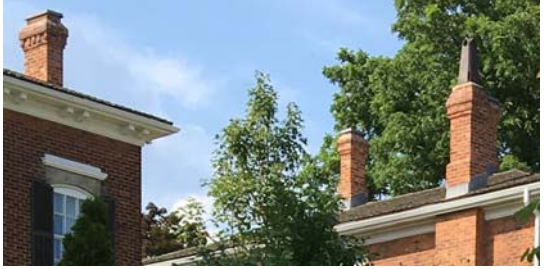
Attribute	Description	Photograph	Rating
<b>Erchless' key exterior attributes, including:</b>			
Its red brick chimneys	Located on both the former residence and Custom House buildings, the chimneys are architectural features that are representative of 19 <sup>th</sup> century construction materials and methods.

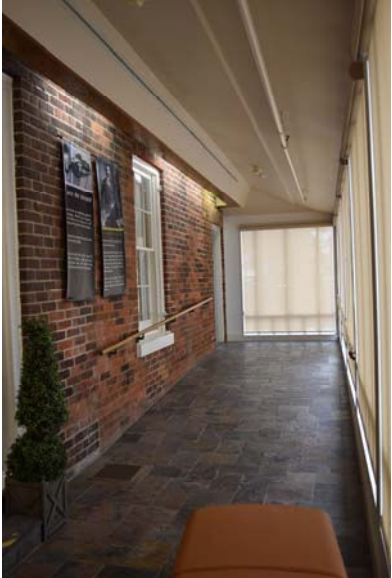
Attribute	Description	Photograph	Rating
<b>Erchless' key interior attributes, including:</b>			
Its layout, materials and finishes, up to and including all changes made by Emelda (Beeler) Chisholm, who resided on the property until 1952	Its red brick walls, which were originally exterior walls.

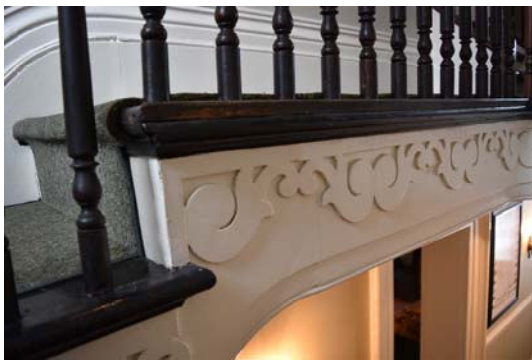
Attribute	Description	Photograph	Rating
<b>Erchless' key interior attributes, including:</b>			
Its layout, materials and finishes, up to and including all changes made by Emelda (Beeler) Chisholm, who resided on the property until 1952	Its wood stairs, paneling, mouldings, floors, and baseboards are architectural features that are representative of 19 <sup>th</sup> century construction materials and methods.

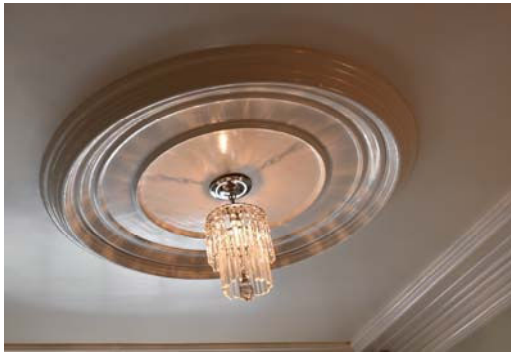
Good
Its layout, materials and finishes, up to and including all changes made by Emelda (Beeler) Chisholm, who resided on the property until 1952	Its plaster walls and ceiling medallions are representative of 19 <sup>th</sup> century construction materials and methods.

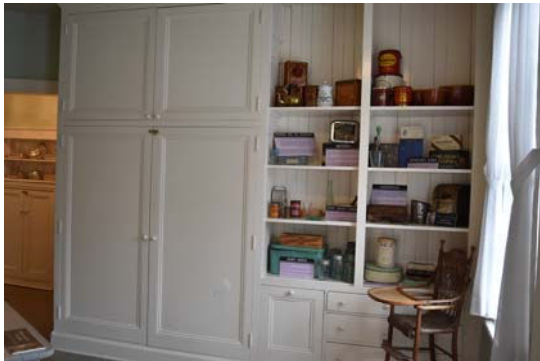
Attribute	Description	Photograph	Rating
<b>Erchless' key interior attributes, including:</b>			
Its layout, materials and finishes, up to and including all changes made by Emelda (Beeler) Chisholm, who resided on the property until 1952	It's built in cabinetry in the c.1839 residential addition are representative of 19 <sup>th</sup> century construction materials and methods.

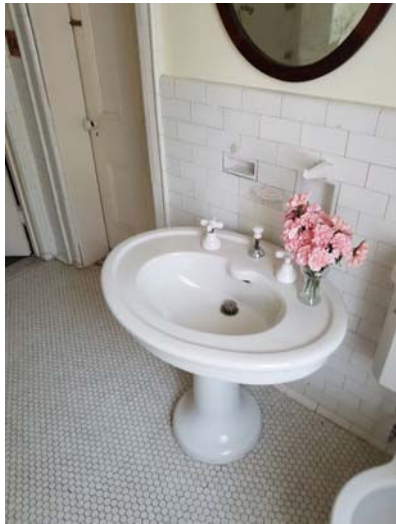
Good
Its layout, materials and finishes, up to and including all changes made by Emelda (Beeler) Chisholm, who resided on the property until 1952	The early 20 <sup>th</sup> century bathroom fixtures in Emelda's 2 <sup>nd</sup> floor bathroom including the sink with the faucet built right into the basin, the floor and wall tiles, the bathtub, and the shower with its unusual 12-shower head configuration, are representative of early 20 <sup>th</sup> century construction materials and methods.

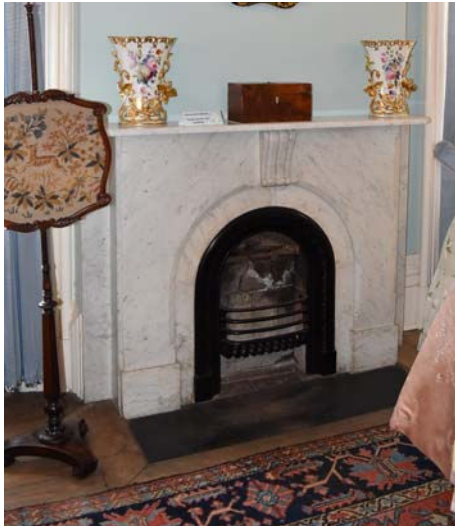
Good
Its layout, materials and finishes, up to and including all changes made by Emelda (Beeler) Chisholm, who resided on the property until 1952	Its original, Neo-Classical marble and stone fireplaces, including their metal inserts are representative of 19 <sup>th</sup> century construction materials and methods.

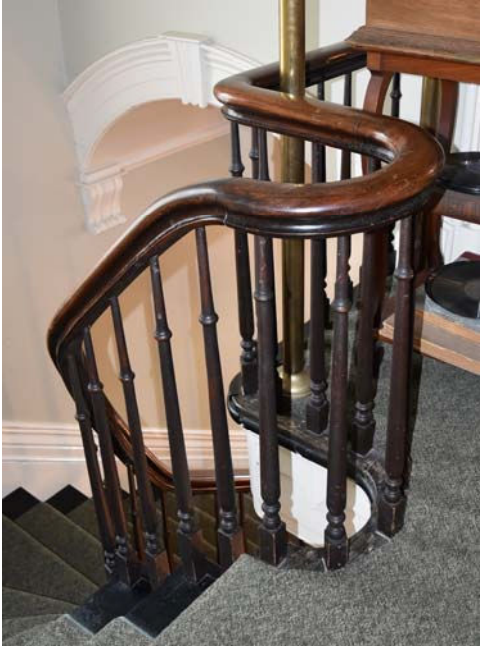
Attribute	Description	Photograph	Rating
<b>Erchless' key interior attributes, including:</b>			
Its layout, materials and finishes, up to and including all changes made by Emelda (Beeler) Chisholm, who resided on the property until 1952	Its curved wood handrail in the former Custom House section are representative of 19 <sup>th</sup> century construction materials and methods.

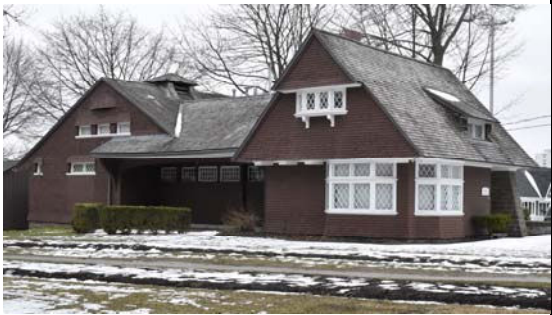
Attribute	Description	Photograph	Rating
<b>The <i>Coach House and Gardener's Cottage</i>'s key exterior attributes, including:</b>			
Its late 19 <sup>th</sup> century shape and form	The Dick and Wickson designed structure constructed in the Shingle style.

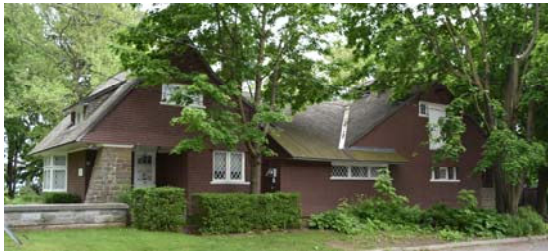
Attribute	Description	Photograph	Rating
<b>The <i>Coach House and Gardener's Cottage's</i> key exterior attributes, including:</b>			
Its 1-½ storey massing.	The structure's massing is representative of Shingle style architecture.

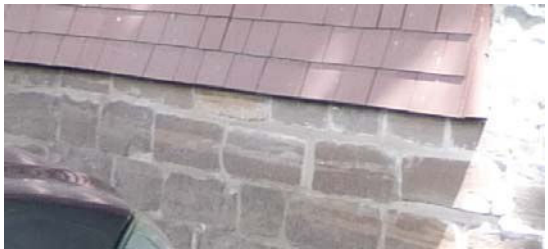
Good
Its lake stone foundation, exposed above grade	The lake stone foundation is an architectural feature that is representative of 19 <sup>th</sup> century construction materials and methods.

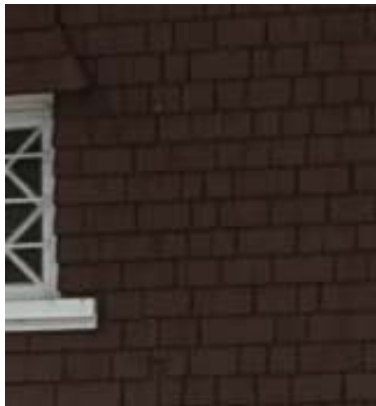
Good
Its wood shingle cladding	The structure's cladding is representative of Shingle style architecture.

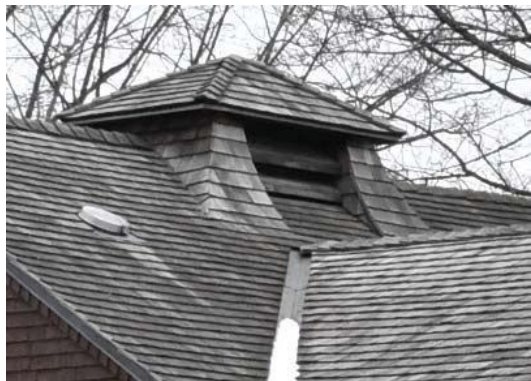
Good
Its steeply pitched, cross gable roof, clad in wood shingles	The roof's pitch, its materials, and its wood-shingled cupola are architectural features that are representative of late 19 <sup>th</sup> century construction materials and methods.

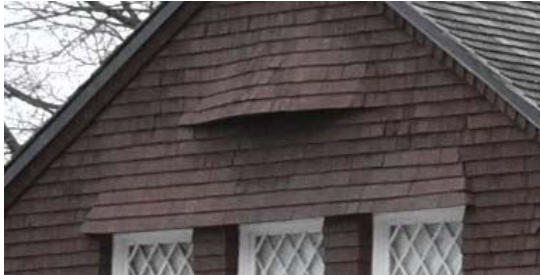
Attribute	Description	Photograph	Rating
<b>The <i>Coach House and Gardener's Cottage</i>'s key exterior attributes, including:</b>			
Its steeply pitched, cross gable roof, clad in wood shingles	The eyebrow vent opening is a unique architectural feature that is representative of late 19 <sup>th</sup> century construction materials and methods.

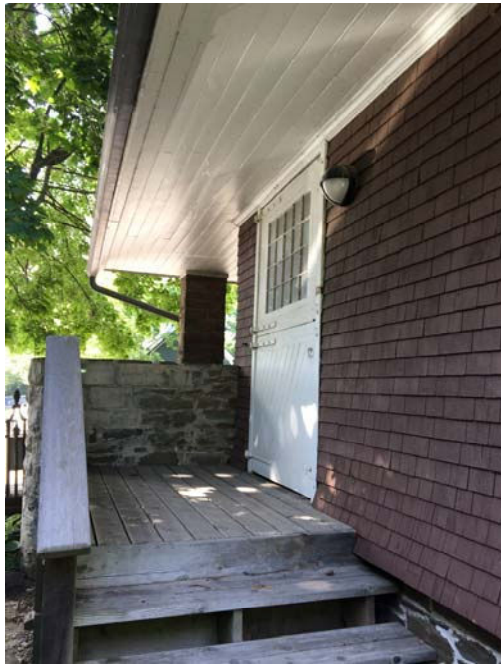
Good
Its wood tongue and groove soffits, porch ceilings and exposed rafter tails;	The soffits, ceilings and exposed rafter tails are representative of Shingle style architecture.

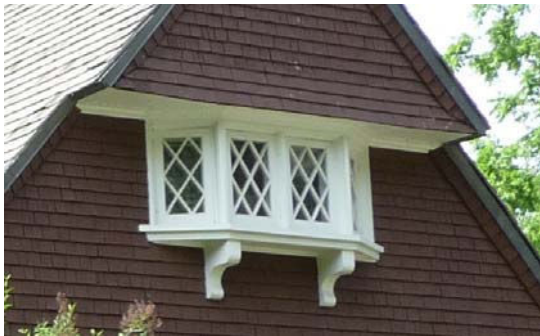
Good
Its wood doors and windows	The wood doors and windows, including all associated trim, sills, flared wood shingle headers, and wood brackets are architectural features that are representative of Shingle style architecture.

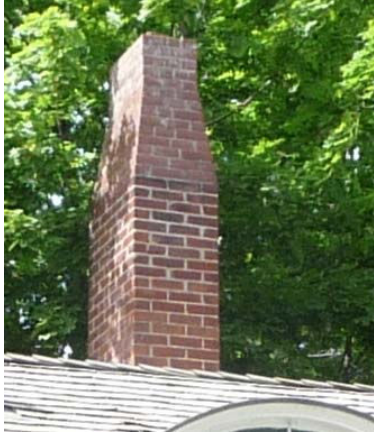
Attribute	Description	Photograph	Rating
<b>The <i>Coach House and Gardener's Cottage</i>'s key exterior attributes, including:</b>			
Its red brick chimney	The brick chimney is an architectural feature of Shingle style architecture.

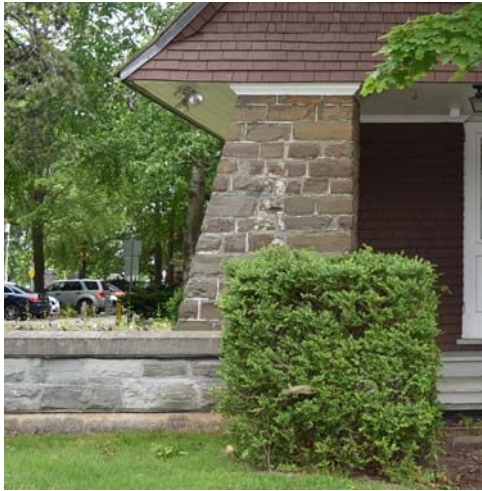
Good
Its asymmetrically tapered stone column at the north-east corner of the building	The structure's stone column is an early example of an architectural feature more commonly associated with Craftsman architecture, the style that followed Shingle style architecture.

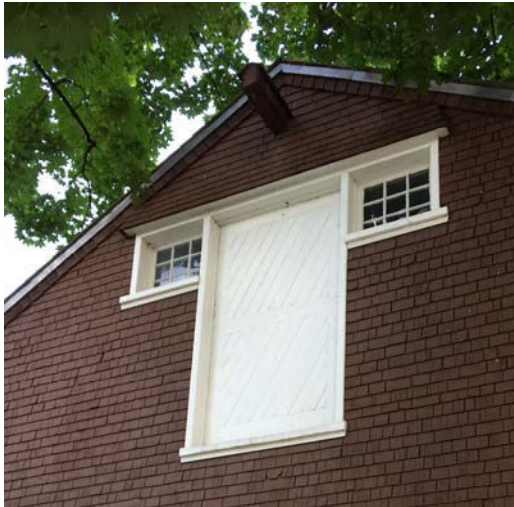
Good
Its ridge beam hoist, or "catshead"	The ridge beam is an architectural feature that is representative of late 19 <sup>th</sup> century construction materials and methods, and is a remnant feature of the building's original use.

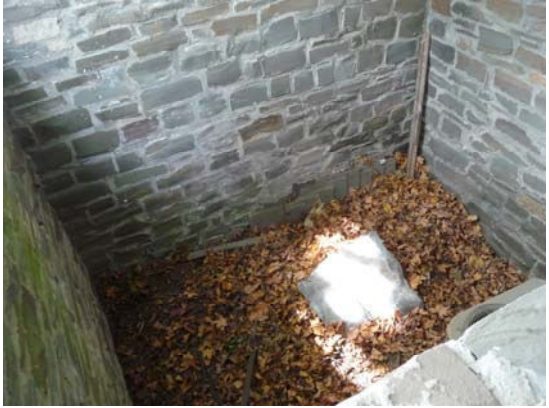
Attribute	Description	Photograph	Rating
<b>The <i>Coach House and Gardener's Cottage's</i> key exterior attributes, including:</b>			
Its stone manure pit walls	The manure pit is an architectural feature that is representative of late 19 <sup>th</sup> century construction materials and methods, and is a remnant feature of the building's original use.

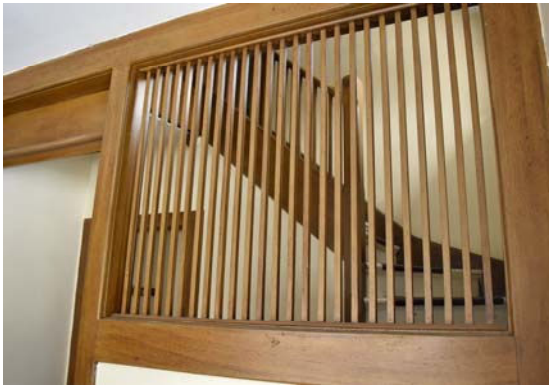
Attribute	Description	Photograph	Rating
<b>The <i>Coach House and Gardener's Cottage's</i> key interior attributes, including:</b>			
Its layout, materials and finishes	Its wood floors, stairs, baseboards, chair railings, mouldings, and wood screen wall with vertical slats are architectural features that are representative of late 19 <sup>th</sup> century construction materials and methods.

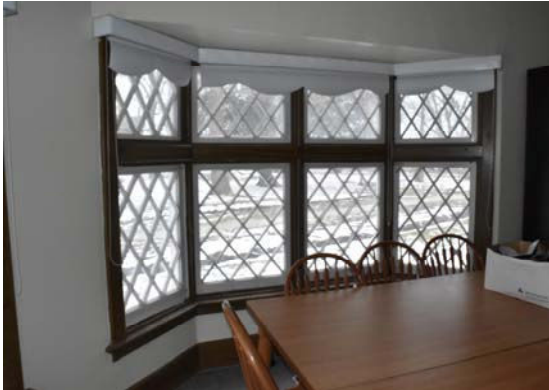
Good
Its layout, materials and finishes	Its wood windows and doors and associated trim are architectural features that are representative of late 19 <sup>th</sup> century construction materials and methods.

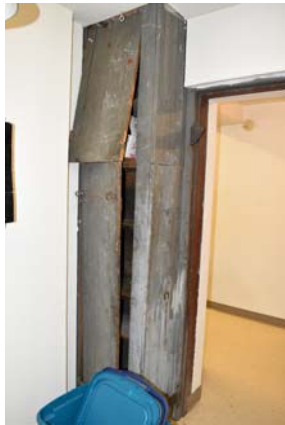
Good
Its layout, materials and finishes	The wooden cupboards in the stable area are features which are representative of late 19 <sup>th</sup> century construction materials and methods, and are remnants of the building's original use.

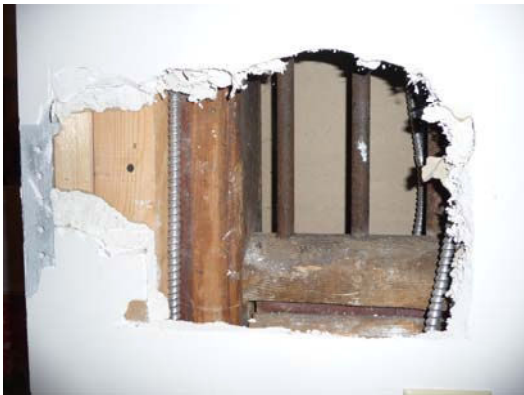
Good
Its layout, materials and finishes	The remnant stable partitions, made of wood and metal bars, are architectural features that are representative of late 19 <sup>th</sup> century construction materials and methods, and is a remnant feature of the building's original use.

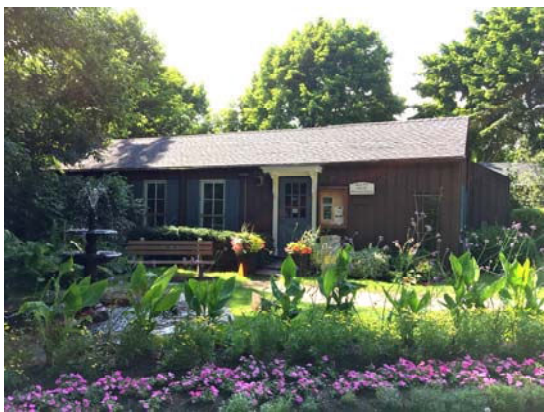
Attribute	Description	Photograph	Rating
<b>The <i>Cottage's</i> key exterior attributes, including:</b>			
Its mid-20 <sup>th</sup> century shape and form	The structure is an amalgamation of two separate residential buildings that were constructed in the vernacular style.

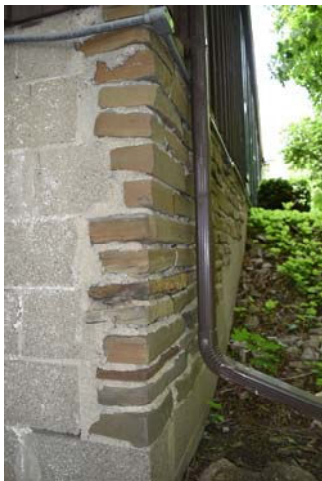
Good
Its remnant lake stone foundation	The remnant of the lake stone foundation is an architectural feature that is representative of 19 <sup>th</sup> century construction materials and methods.

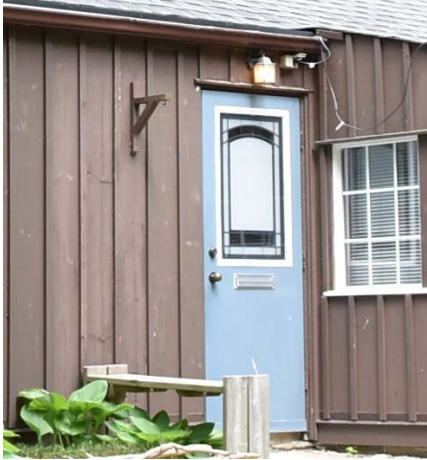
Attribute	Description	Photograph	Rating
<b>The <i>Cottage's</i> key exterior attributes, including:</b>			
Its wood board and batten cladding	The structure's cladding is representative of its vernacular style of construction.

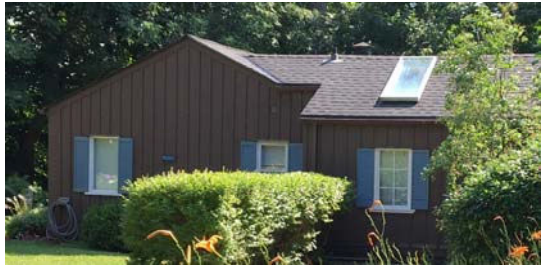
Good
Its low pitched, cross, open gable roof; and,	The roof's pitch, its materials, and its lack of ornamentation is representative of its vernacular style of construction.

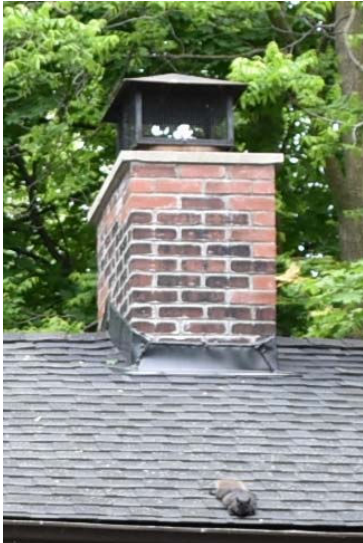
Good
Its brick chimney.	The brick chimney's simple design is representative of its vernacular style of construction.

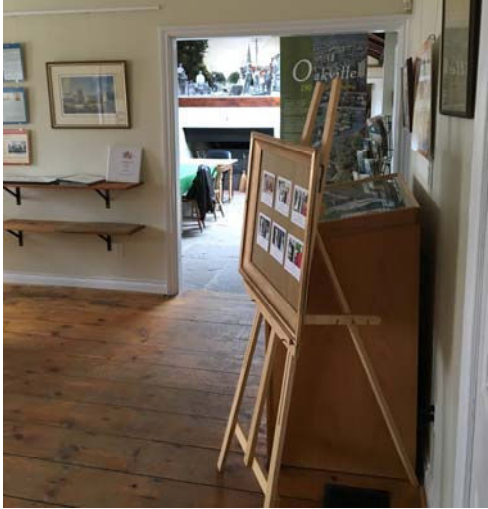
Attribute	Description	Photograph	Rating
<b>The <i>Cottage's</i> key interior attributes, found in the section built for Dr. Juliet (Chisholm) Turney, including:</b>			
Its entry room's (aka lobby area) wood plank floors	The entry room's floors are representative of its vernacular style of construction.

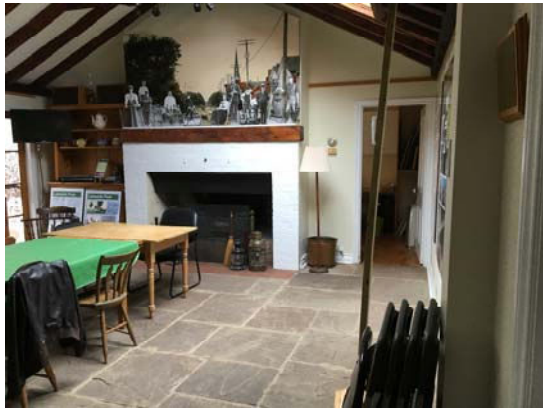
Good
Its main room's flagstone floors, painted brick fireplace with wood mantelshelf, and wood beamed ceilings	The main room's floors are representative of its vernacular style of construction.
