# Recreational Trail Accessibility Audit and Strategy

Prepared by: Paradigm Transportation Solutions Limited Parks and Open Space Department, Town of Oakville April 8, 2019

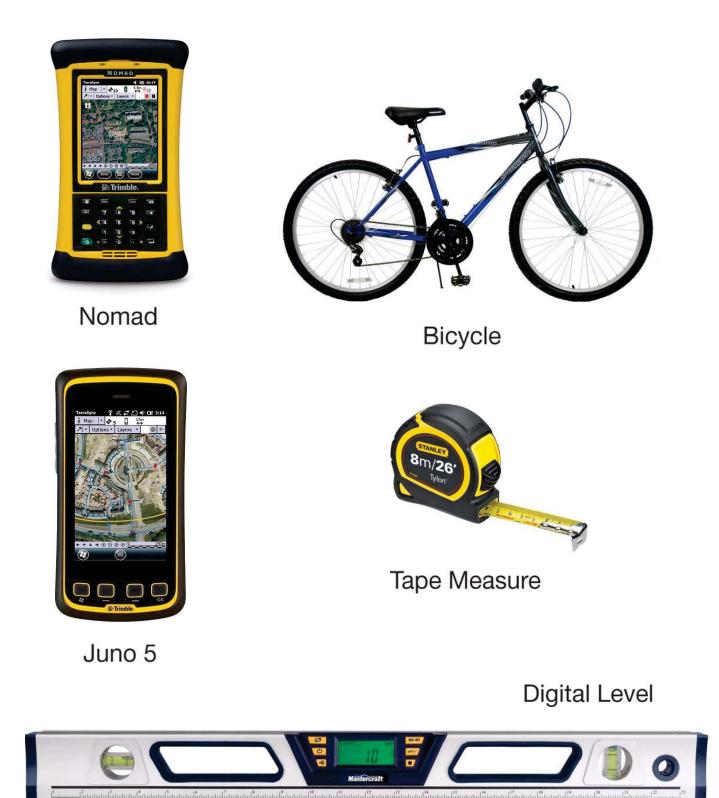
Figure 3.2

Survey staff were provided a comprehensive training program explaining the data collection process, condition assessment and rating procedure (to ensure consistency) and health and safety policies. All staff were provided a data collection handbook for reference in the field, with instructions and guidance on various matters such as how to assess trail condition and measure trail width, running slope and cross slope.

**Data Collection Equipment**

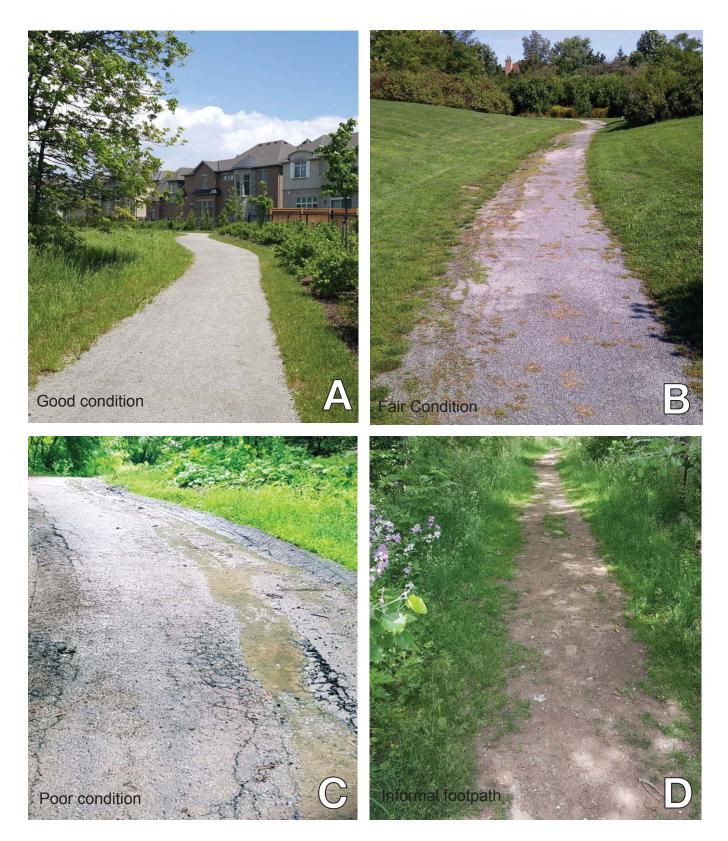
Figure 3.3

- Surface Type attribute based on visual observation;
- Stable Surface attribute based on a visual assessment of the overall stability of the segment;
- Condition attribute based on a visual assessment of the physical condition of the segment using the following rating system, which is illustrated in Figure 3.3;

- A Good condition, continue with regular maintenance (i.e. trail grooming and edge mowing)
  - B Fair condition, minor rehabilitation or maintenance required over a localized segment of trail (i.e. pathway clearing or trail resurfacing)

- C Poor condition, notable surface, drainage or grading deficiencies occurring predominantly along a segment of trail, recommended for capital rehabilitation

# Recreational Trail Overall Condition Illustrations

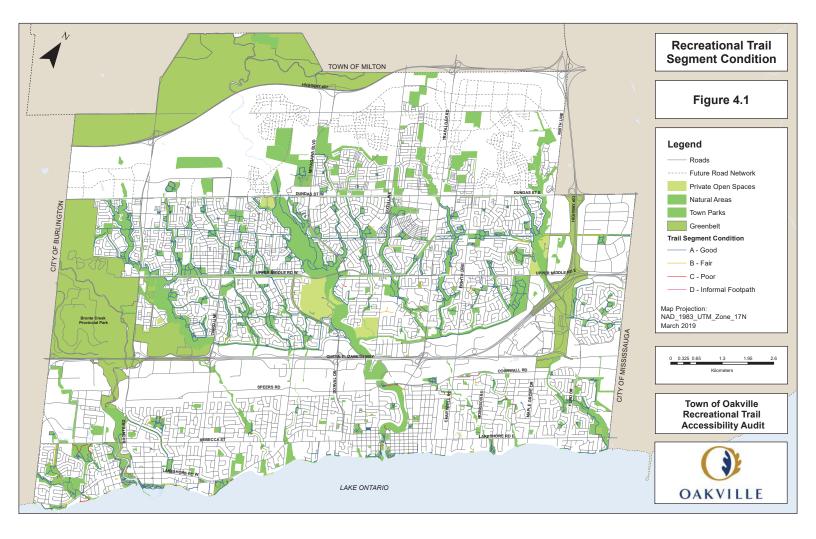
**Table 4.5** summarizes the overall condition of the network and indicates only two percent (2%) of the network requires capital improvements or rehabilitation. Most of the network is in good condition and can continue with regular maintenance or minor repairs.

**Figure 4.1** illustrates the overall condition of the trail network alongside parks and other major pedestrian generators and destinations in the town.

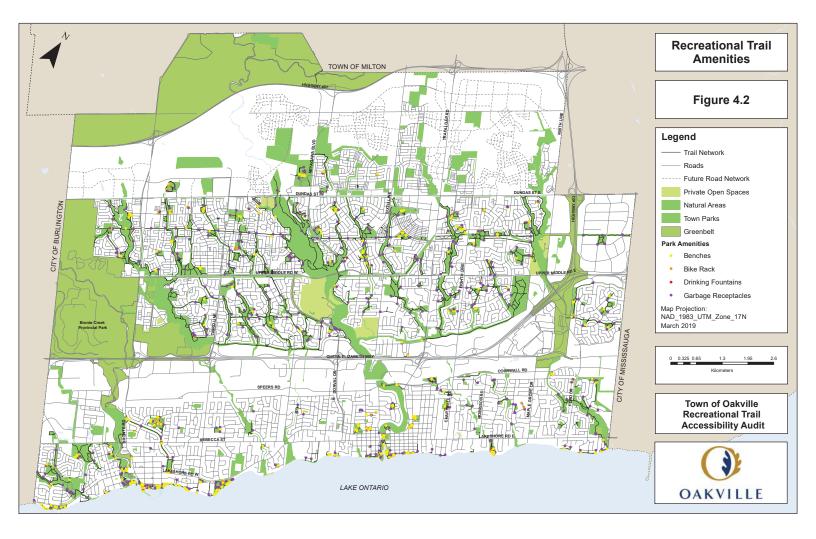
The park and trail feature categories included: benches, bike racks, drinking fountains/water bottle filler, garbage receptacles. **Figure 4.2** shows the location of these amenities. **Table 4.6** provides a summary of the four different park and trail features, with the average rate observed per kilometre of trail.

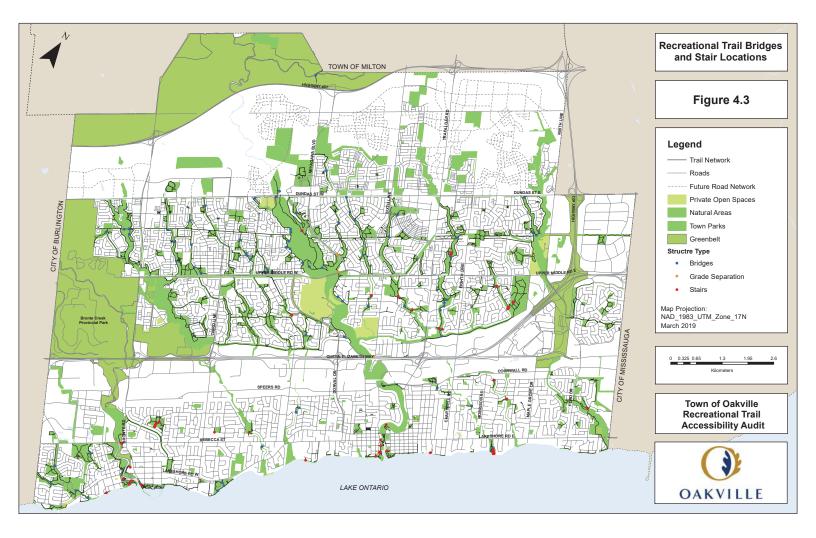
**Figure 4.3** illustrates the location of all bridges (81) and stairs (63) along with the total number recorded. **Figure 4.4** denotes the location of all P-Gates (219) and bollards (173). Most P-gates and bollards were rated to be in "fine" condition (235) or just needing paint (125). A small number require attention.

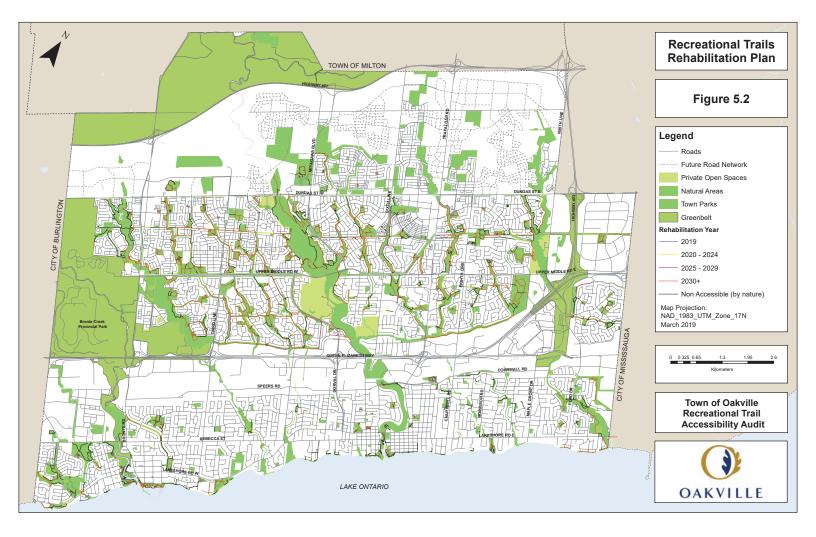
**Figure 5.2** illustrates the location of the proposed trail improvements over a tenyear program. **Appendix C** provides more detailed maps illustrating the recommended immediate (2019), short-term (2020-2024), long-term (2025-2028) and beyond the ten-year horizon implementation plans.

- Endorse and implement the ten-year Rehabilitation Improvement Plan to remove physical barriers and improve safety and security by addressing those items identified in this report;
- Undertake a public awareness campaign to promote the town's recreational trails system and accessibility standards;
- Update their master plans, design standards and guidelines and by-laws to reflect current accessibility requirements; and
- Adopt and apply the proposed Accessibility Checklist in Appendix D when planning or designing new or redeveloping existing trails to ensure compliance with the Integrated Accessibility Standards of the AODA.

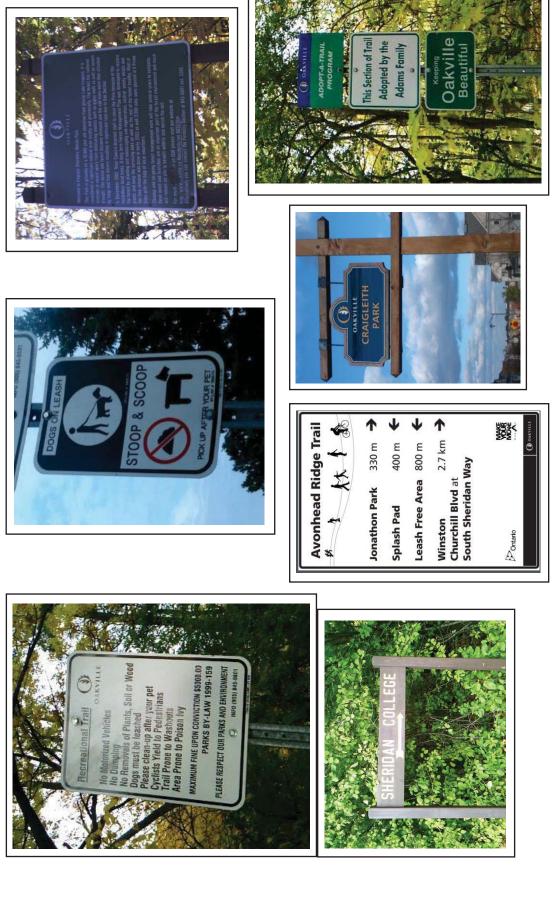
Figure 6.1

# **Existing Oakville Trail Signage**

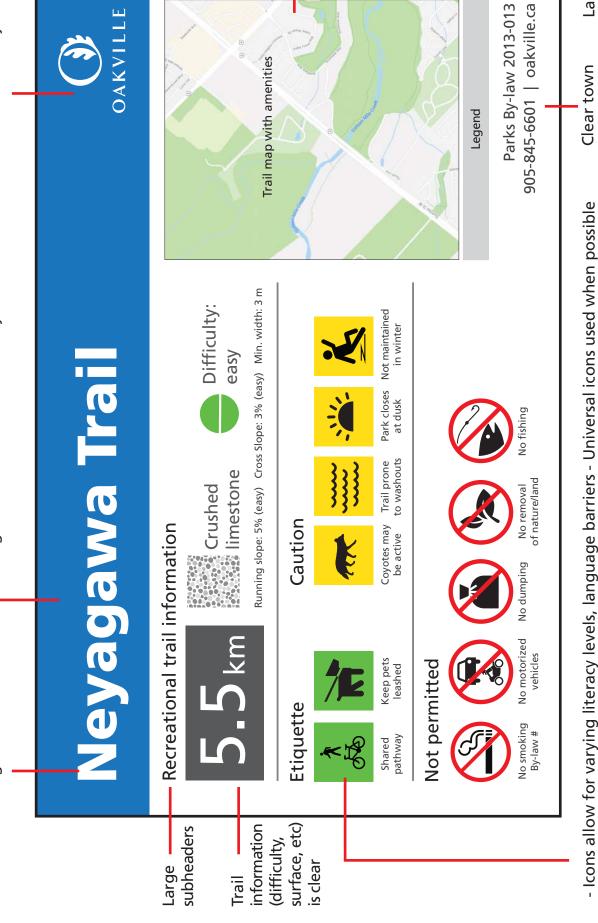
Figure 6.3

Major trailhead sign (recommended)

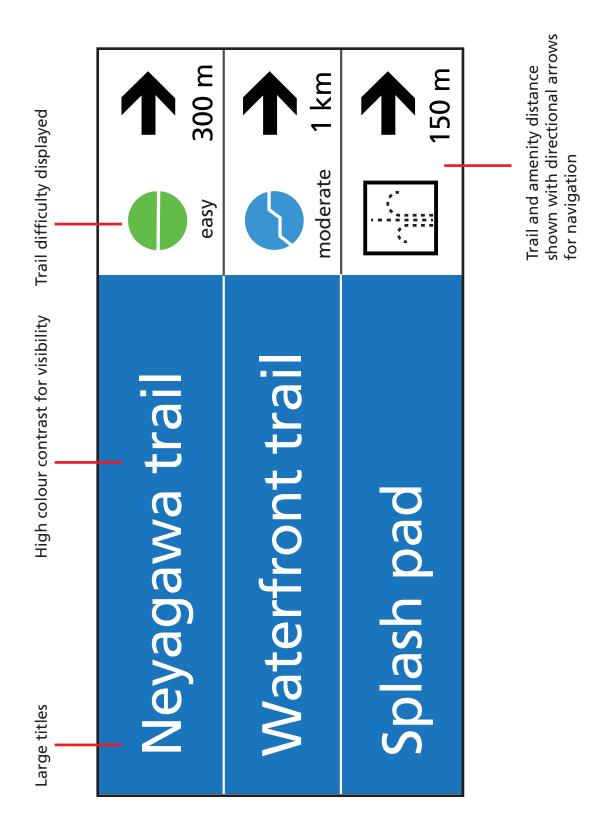
# Figure 6.5

# Minor trail access sign (recommended)

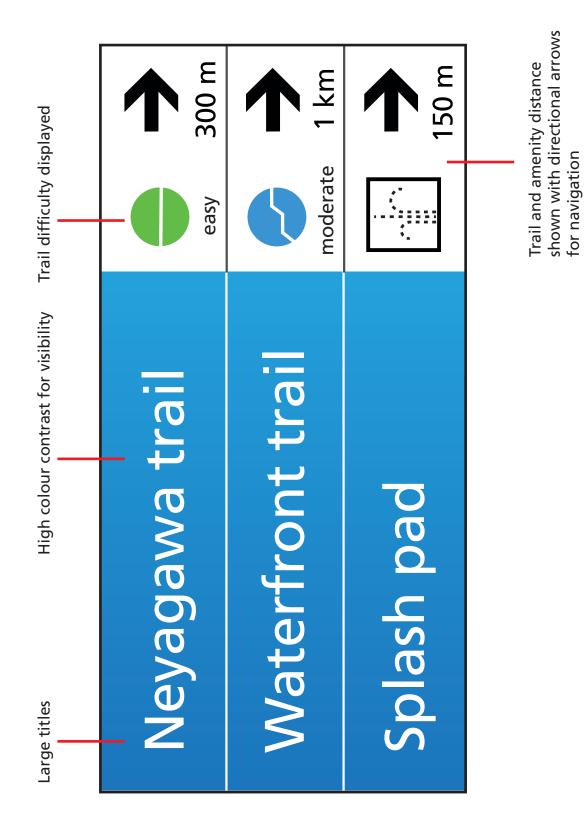
Minor trail access sign (option 2) Figure 6.8
