The Abdullah Home

1360 Lakeshore Rd. West, Oakville ON

**SUBJECT: Arborist Report and Tree Preservation Plan
1360 Lakeshore Road West, Oakville**

Arborist Report and Tree Preservation Plan

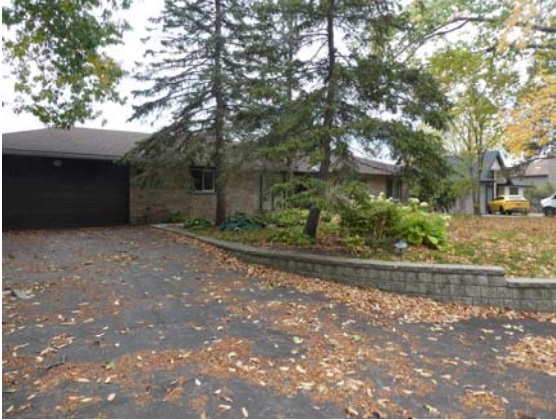
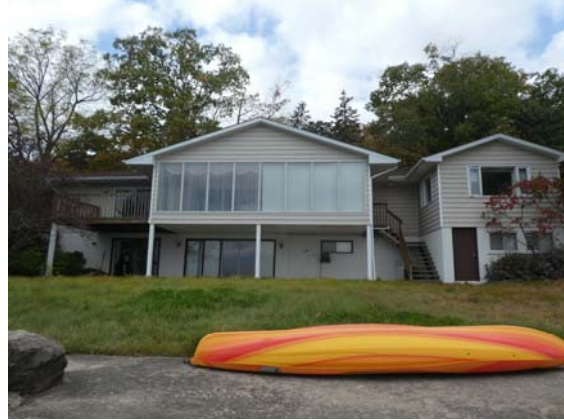
Photo #1

Figure #1: These 2 photos show the front and rear yard of the subject site at 1360 Lakeshore Road West as they appeared during the tree inventory conducted on October 18, 2023.

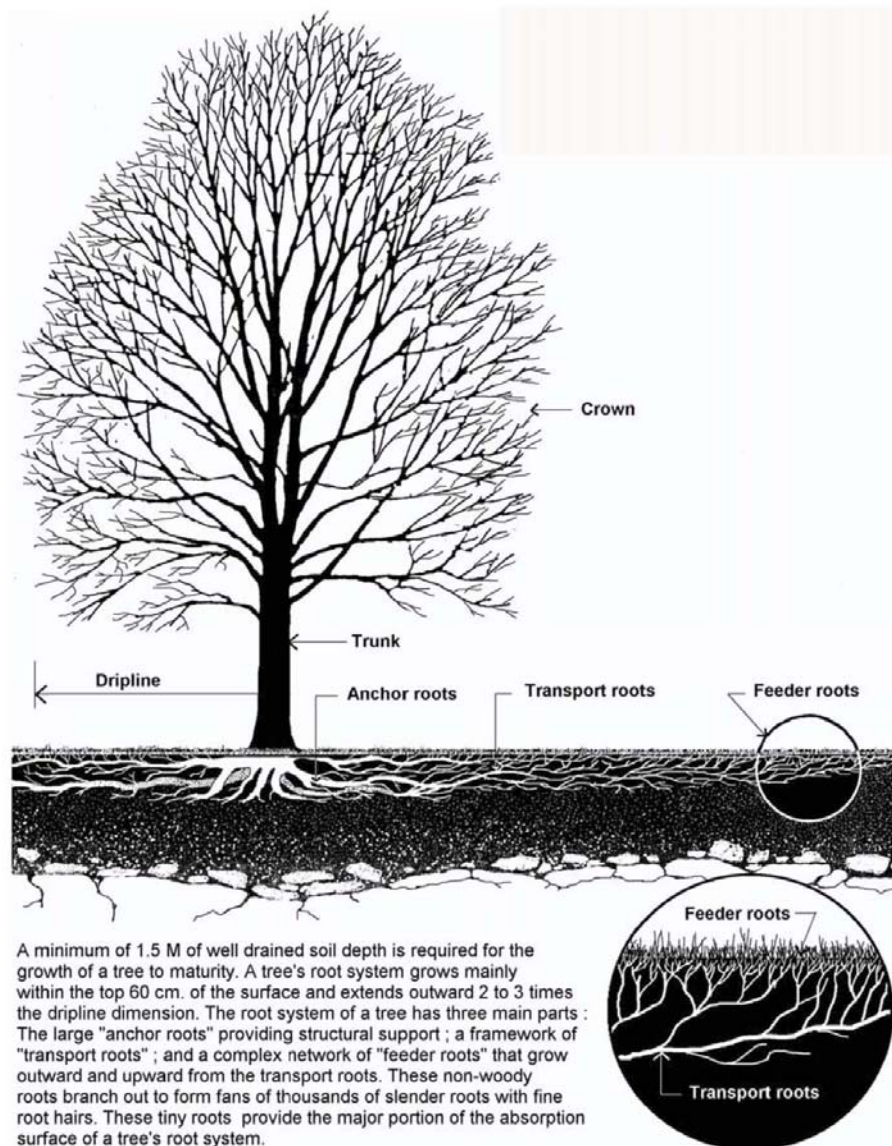
DETAIL TP-1

Optimal Tree Crown and Root Structure – Town of Oakville

The Crown and Root Structure of a Tree in an Optimum Growing Environment

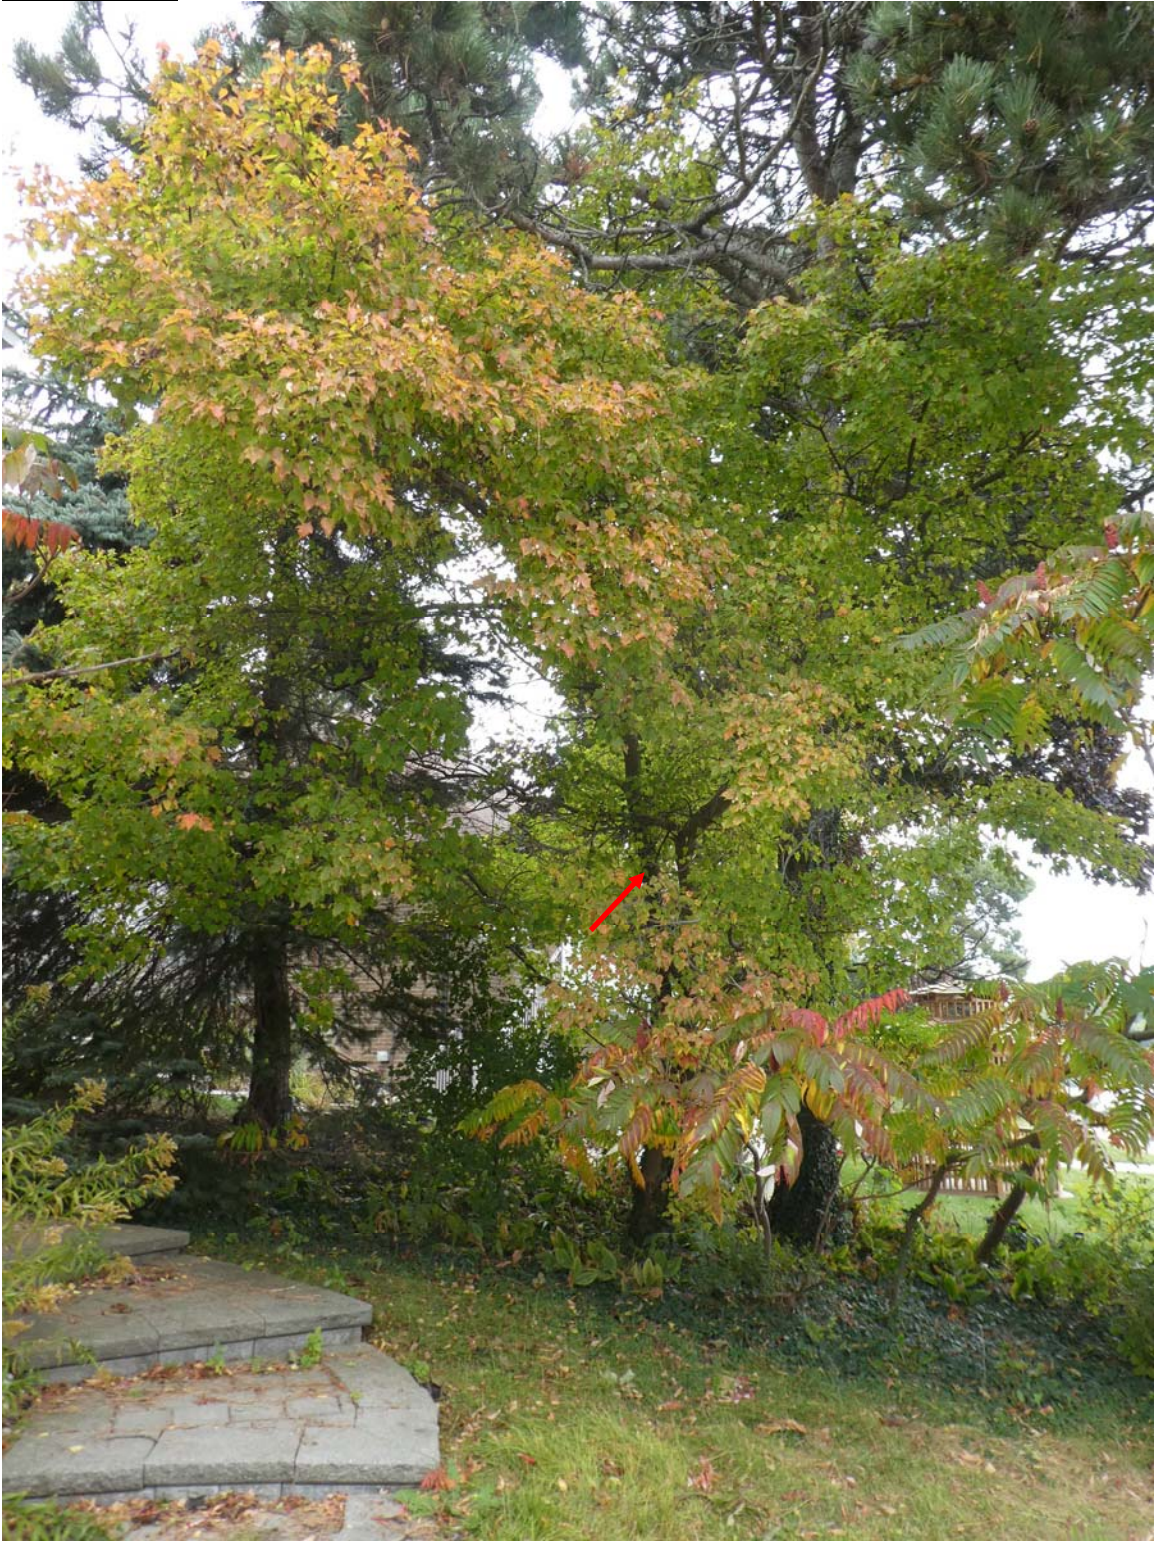
Photo #3 (Tree #4 – 25cm DBH – proposed for removal)

- 1.) Replacement tree numbers were derived as follows:
 - a. Tree #4 – 25cm DBH 2 replacement trees
 - b. Tree #10 – 29cm DBH 3 replacement trees
 - c. Tree #16 – 24cm DBH 2 replacement trees
 - d. Tree #17 – 30cm DBH 3 replacement trees
10 replacement trees
- 2.) Ten (10) replacement trees and their approximate proposed locations are marked with the symbol **Rx** on the site plan in Appendix A on Page 22 of this report.

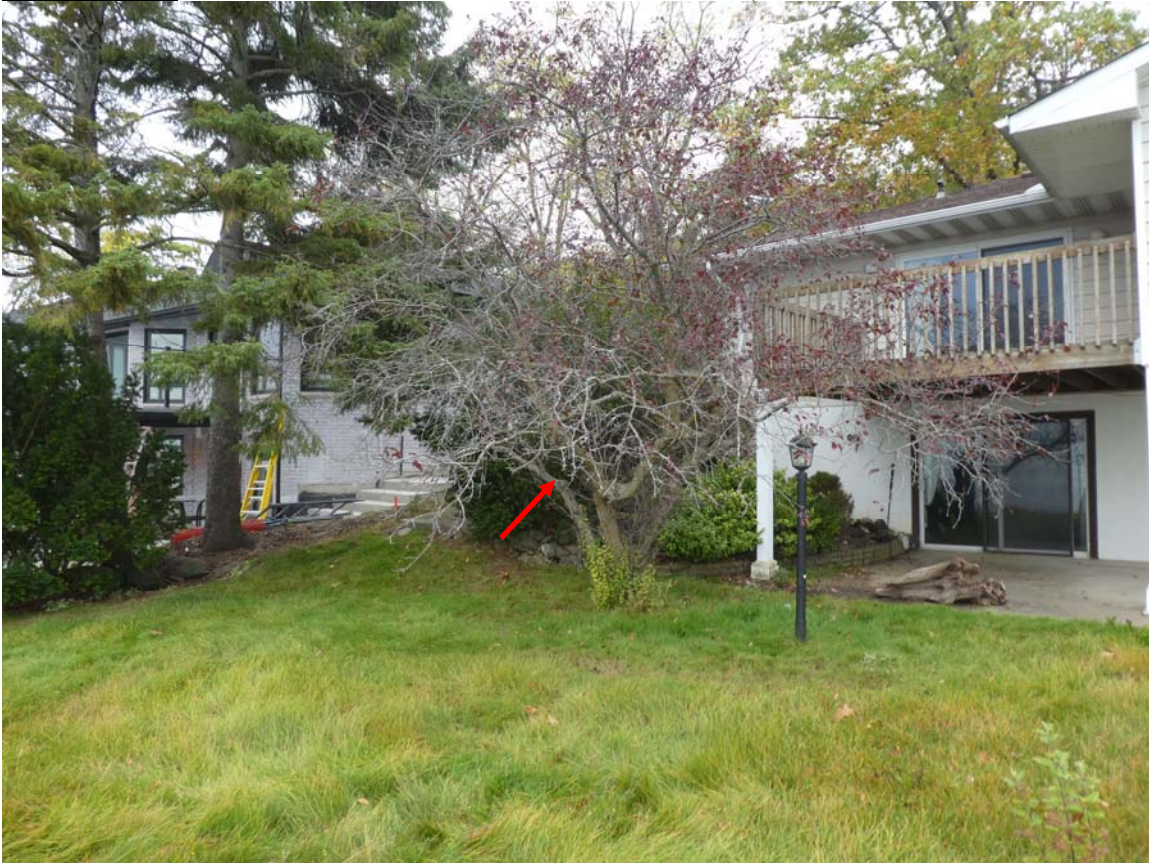
Photo #4 (Tree #10 – 29cm DBH – proposed for removal)

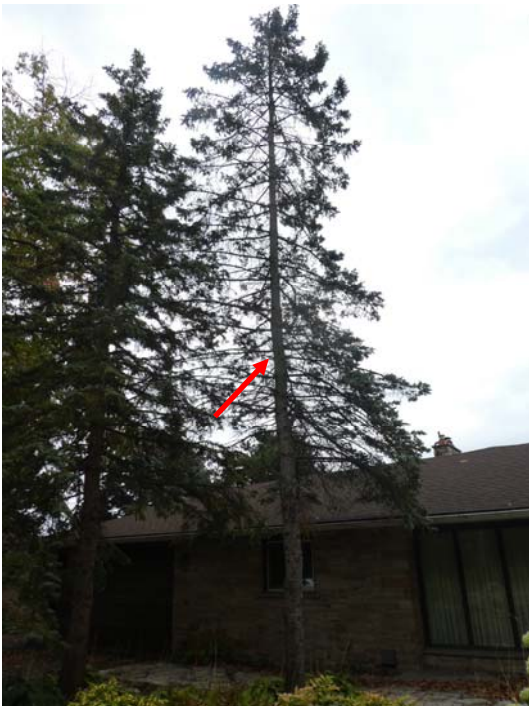
Photo #5 (Tree #16 – 24cm DBH – proposed for removal)

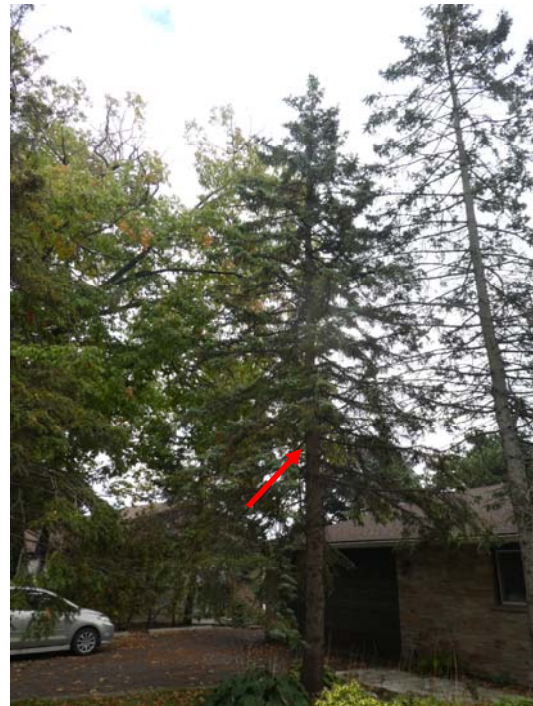
Photo #6 (Tree #17 – 30cm DBH – proposed for removal)
