# 43: 2165 Dundas St. West, Smith-Carrique Barn and Shed

# 1. Description of Property

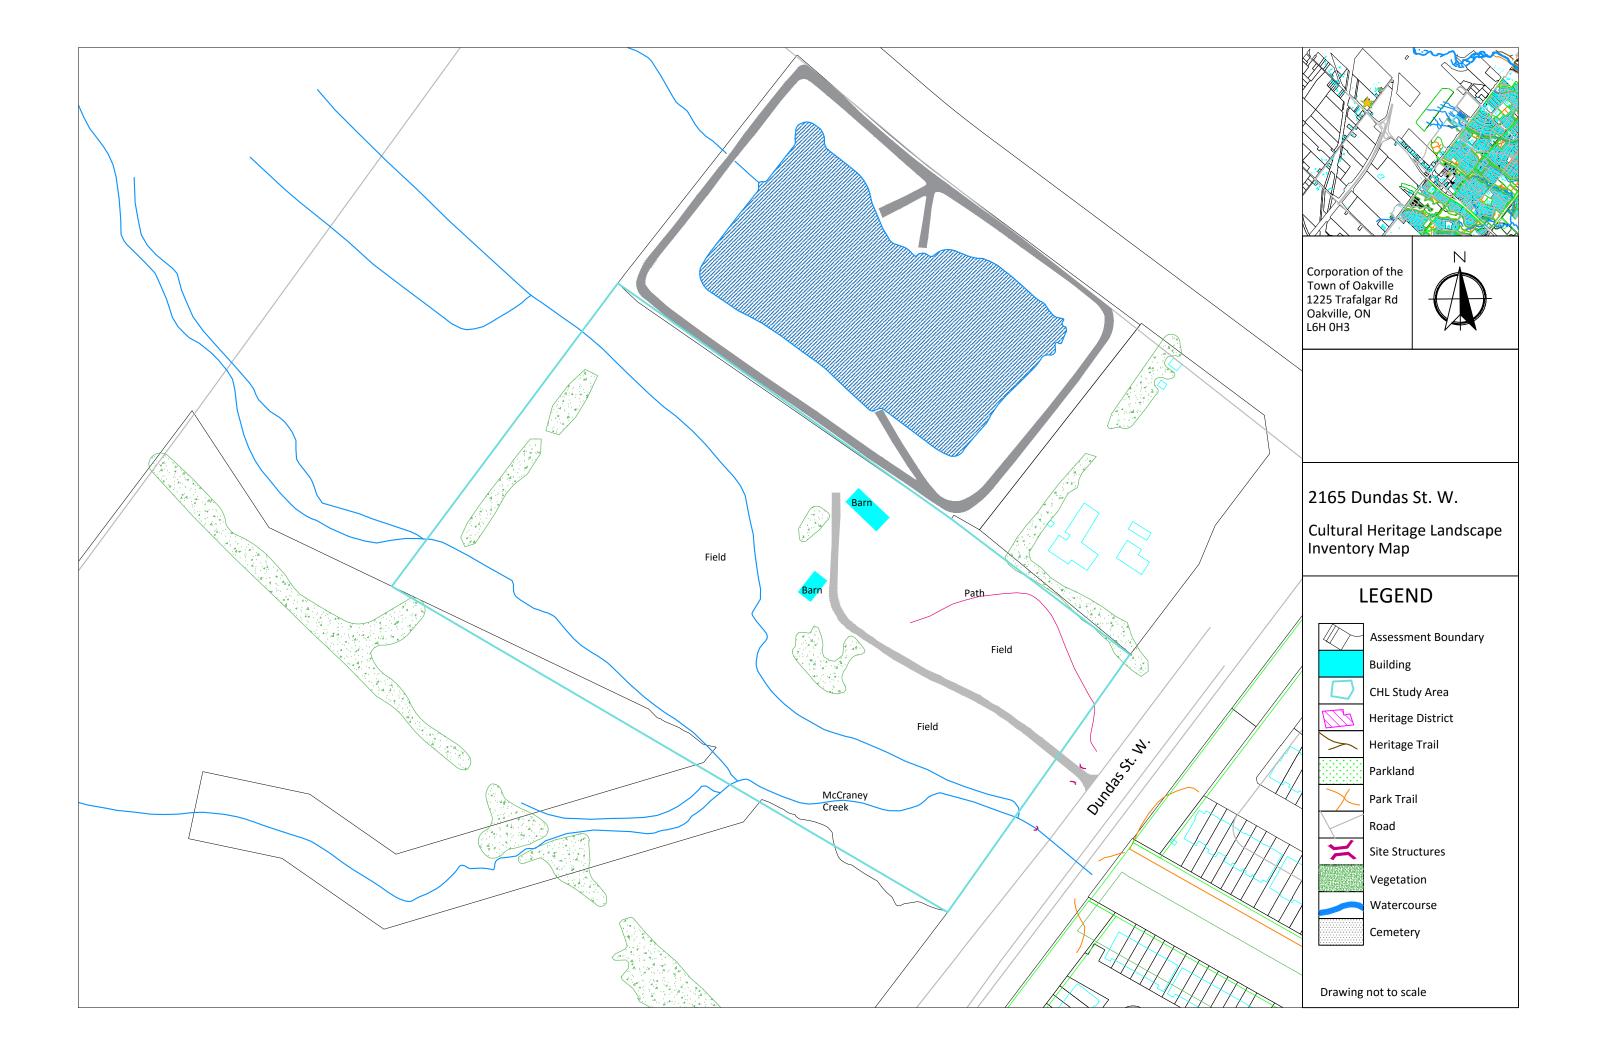
Figure 1: 2615 Dundas St. West. (AB, 2015)

- Barn- gambrel style metal roof, it appears to be built with cinderblock, with a vertical plank wood second storey. Windows are missing, but openings remain. Modifications to openings on southern exterior second storey.
- Shed-gable style metal roof made with flush board exterior. Windows are missing, but square openings remain.
- Large rectangular storm water management pond located directly east.
- Gravel path surrounding storm water management pond.
- Gravel laneway runs north from Dundas St. West to the outbuildings.

Today the outbuildings are located in a large, open area – formerly a field, it has now become naturalized and the buildings are in a diminished state. The house is no longer present. Much of the Village of Palermo has also disappeared.

The property may be associated with the agricultural history of Trafalgar Township. However, with the loss of the farmhouse, the naturalization of the fields, and the reduced condition of the remaining sheds, it has lost much of its integrity as a cultural heritage landscape and no longer retains its heritage value.

- Consider initiating a rural properties study to evaluate and consider protection and planning for farmsteads as a group; and
- Cultural heritage resources have been lost. The property is no longer associated with a farmstead complex. Consider removal as a Listed property on the Register of Properties of Cultural Heritage Value of Interest (NOT Designated).

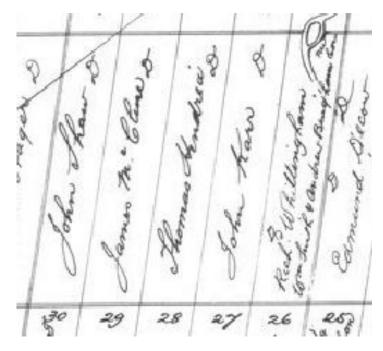
Figure 3: 1806 Wilmot Survey showing Lot 26-30, Con I (NDS) (Wilmot Survey, 1806)

The earliest portion of Trafalgar Township to be surveyed was Dundas Street in 1795. Dundas Street through Trafalgar had been partially cleared by 1800, but in order to ensure the timely clearing of "The Dundas Road" allowance, the first lots to be granted to settlers were along this route. In 1806, Deputy Provincial Surveyor Samuel S. Wilmot surveyed the County of Halton, including Trafalgar Township 1806. The 1806 Wilmot Survey shows Lots 26 to 30 patented to at least five different owners (Figure 3).

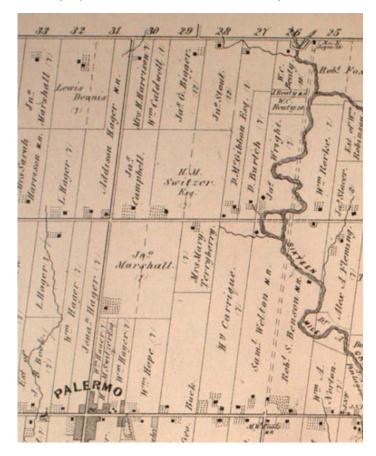
Figure 4: 1877 Map showing Carriaque on lot 27, to whom the property is associated (Illustrated Historical Atlas of the County of Halton, Ont, 1877)

The 1877 Map of Trafalgar (Figure 4) shows M. Carrique on Lot 27 and two buildings adjacent to Dundas Street. Each building is surrounded by an orchard and there is a third orchard in the southwest corner of the lot. The village of Palermo is located directly west; with a population of more than 300, it was one of the largest villages in the area. <sup>2</sup>
