**320 Maple Avenue, Oakville**

**BUILDING ASSESSMENT REPORT:**

**February 7, 2018**

**Prepared by: T. Murison**

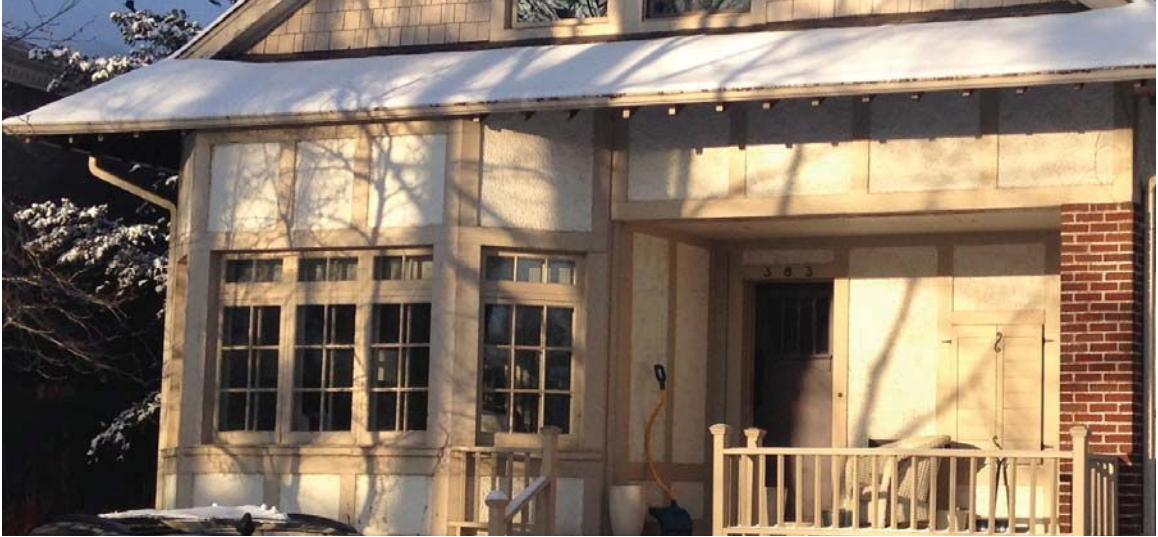
**2.14** Arts & Crafts Cottage with stucco panels circa 1905. Texture of the stucco is pebbly with small stones brought to the surface. 383 Douglas Ave. The vertical “timbers” above are aligned with similar “timbers” below the windows. This is a feature of decorative half timbering which suggests that the trim is both real structure and load bearing, essential characteristics which provide the “honesty” of form espoused by Ruskin and others before the Arts & Crafts Movement. The narrow transom lights and bell-cast roof, wall proportions etc. are also reminiscent of Japanese influenced Arts & Crafts design that were the inspiration for a carefully planned façade. This house was likely designed by an architect with knowledge of contemporary Arts & Crafts design themes.

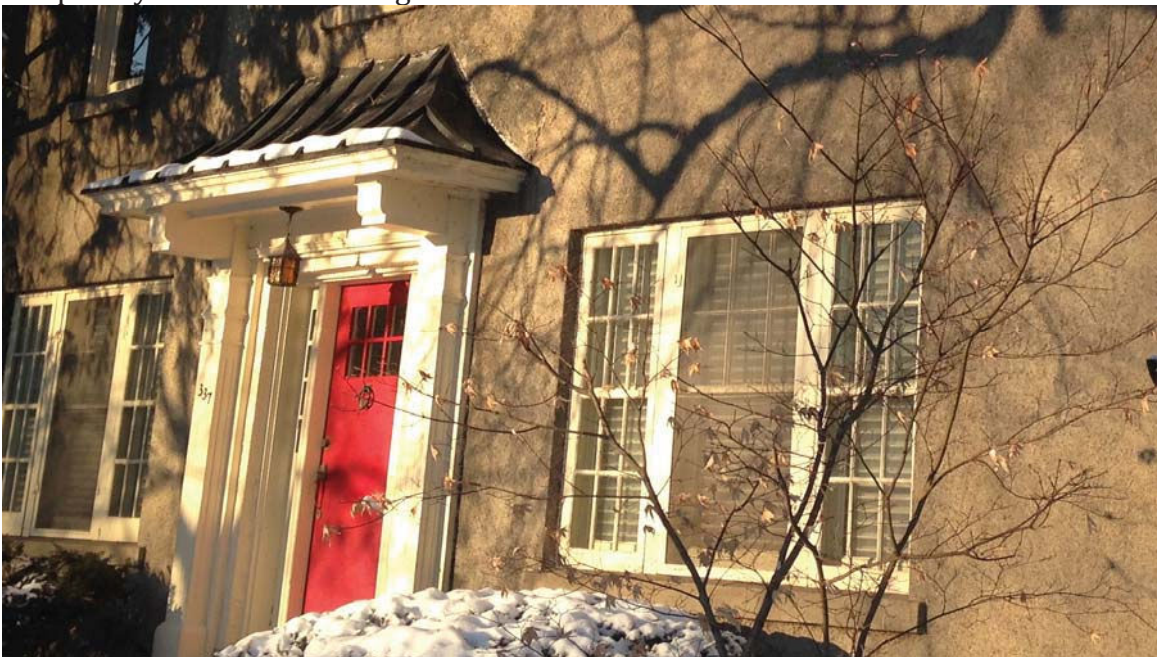
**2.15** #337 Douglas Ave., Oakville, a two storey house with fine aggregate stucco. This subdued and uniform texture is more typical of houses circa 1925. The natural grey stucco colour weathered gradually. The character of the stucco was appreciated as an “honest” material, another hallmark of Arts & Crafts.

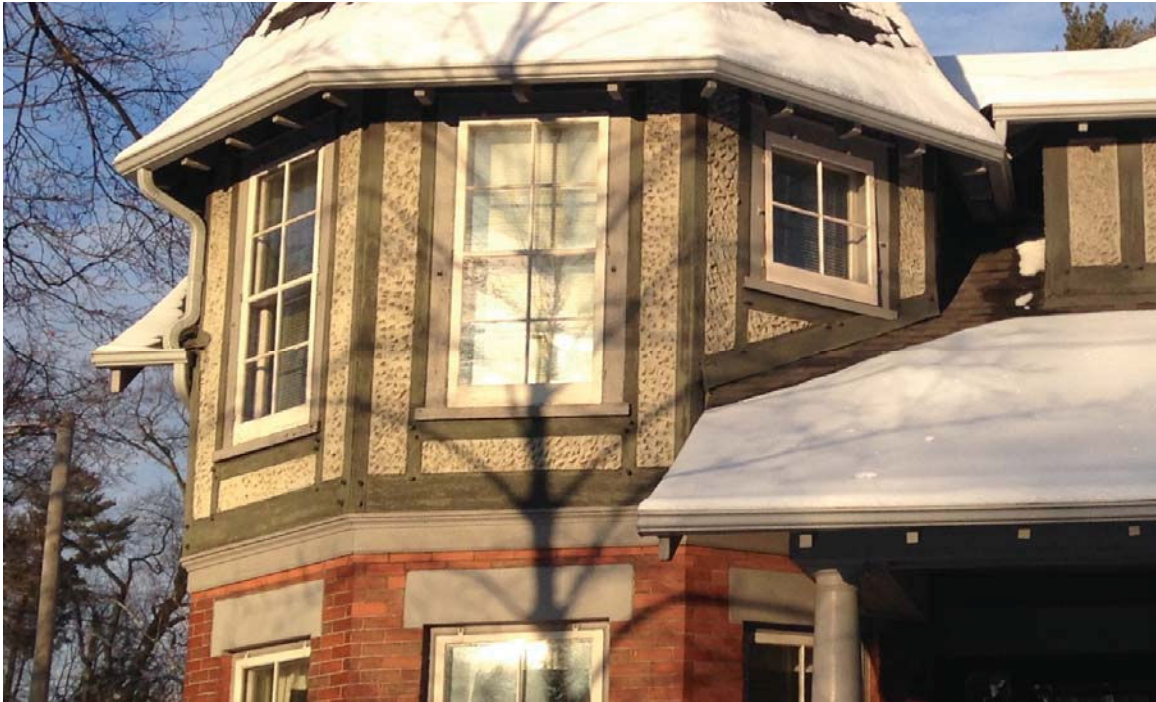
**2.16** #359 Douglas Ave., Oakville. Another example of Tudor Revival with stucco in panels. In this beautiful example the “half timbers” are actually pegged in place with protruding oak trenails. The stucco has light texture with small triangular indentations made with the trowel, circa 1910. Stucco was not painted but left exposed to weather along with the stone lintels, sills & freize board painted a colour similar to that of the limestone lintels. The eavestroughs are modern and cover the rafters.

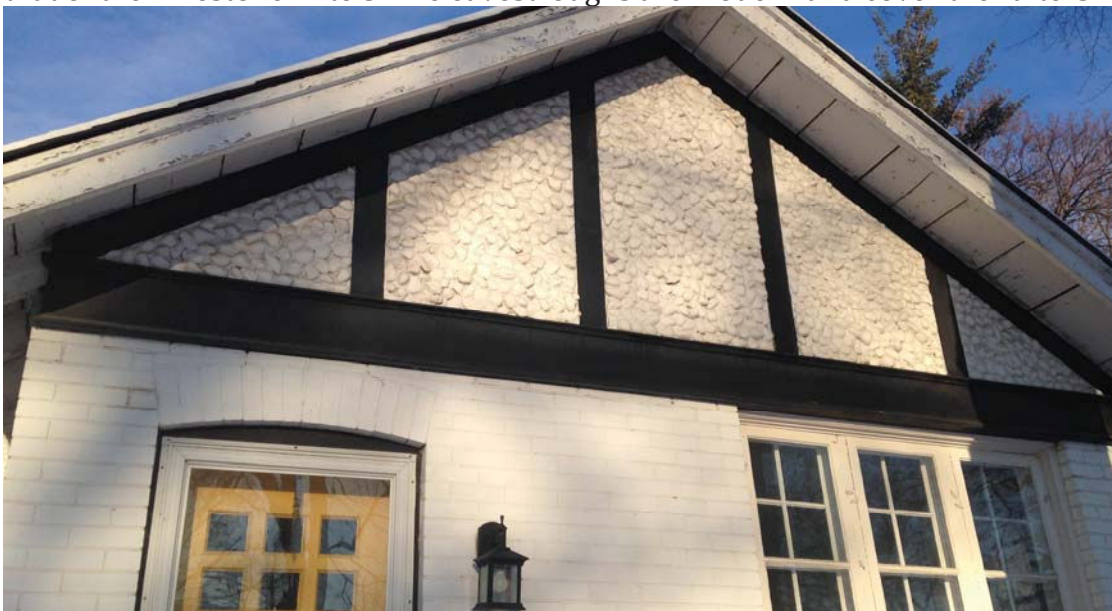
**2.17** # 379 Douglas . A timid sort of “half timber” with small boards at wide spacing. The panels are not stucco but painted cobble infill, convex in form. concave. The moderate (4”) size cobbles create the most dramatic texture found in similar age houses. The poor quality of the soffit is quite different from the previous example. This example of another ill conceived builder’s special, had brick walls and arches.

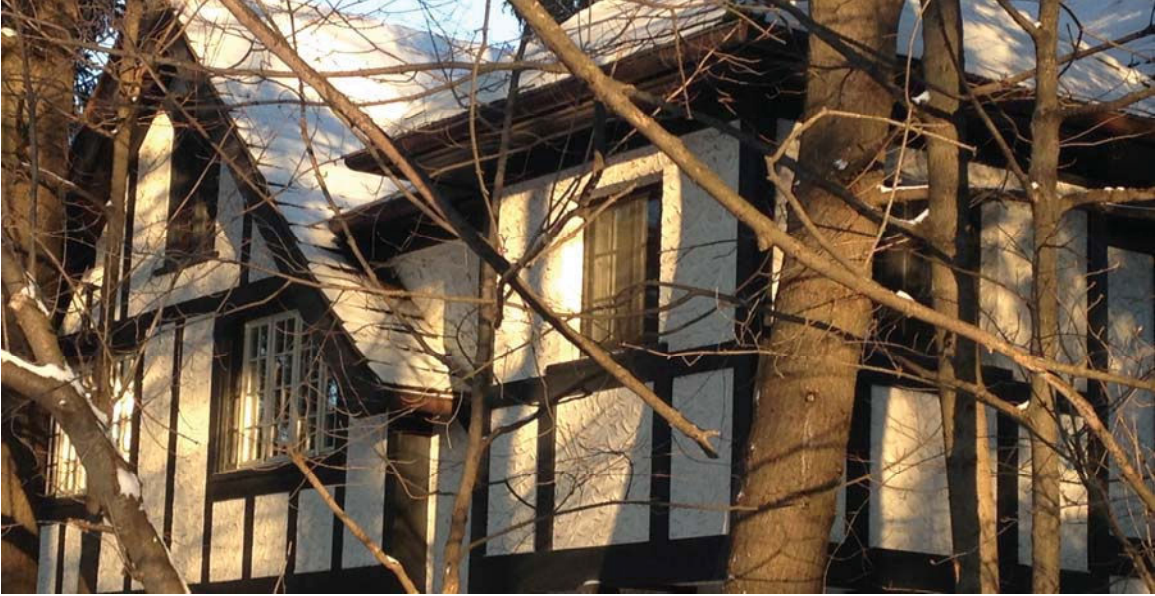
**2.18** # 38 Second Street. The heavy texture and downward stroke used by the plasterer is similar to that at 320 Maple, but this former barn was heavily modified in the 1970's or later. The stucco finish has been installed on top of the cedar shakes on the steep roof. They are not more than 40 years old. While dramatic, this is a good example of a modern style of stucco that was not used in early 20<sup>th</sup> century in Oakville.

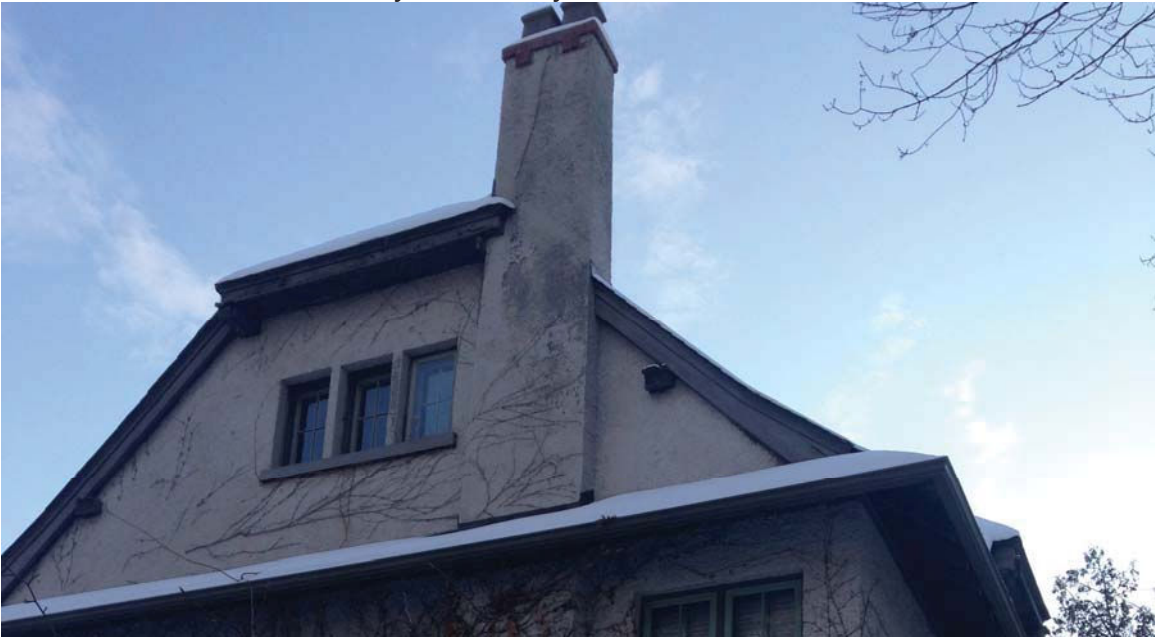
**2.19** Another example of smooth Arts & Crafts stucco circa 1910, 335 Watson Ave. The small brackets are integrated with fascias & mouldings projecting eaves with exposed rafter tails multiple "ganged" windows, and emphasized chimneys with ornamental caps & flues. The effect is subtle & carefully planned. No "half timbering" was used but brick details were added to punctuate the stucco at sills and corners. This sophisticated example with hipped gables is more German or Baltic than British though the window arrangements are similar to those of C.F.A. Voysey, an exemplary Arts and Crafts Architect.

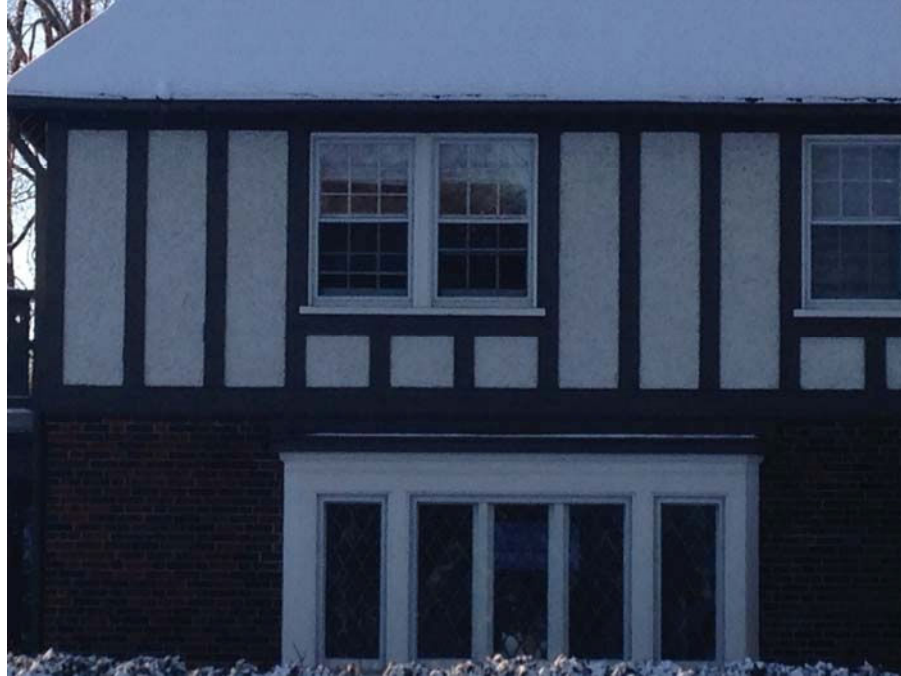
**2.20** # 429 MacDonald Ave. This is another example of an early 20<sup>th</sup>. C. “Tudor Revival” house, with a subtle mix of brick textures at the ground floor and center gable, “half timber and stucco” at the second floor flanking the center gable, and a heavy timber portico at the entry. The timbers are raised away from the pebbly stucco and protect it from weather. The proportions of timber to stucco are similar to that of medieval wattle and daub infill. The absence of diagonal braces makes this design slightly monotonous and formulaic.

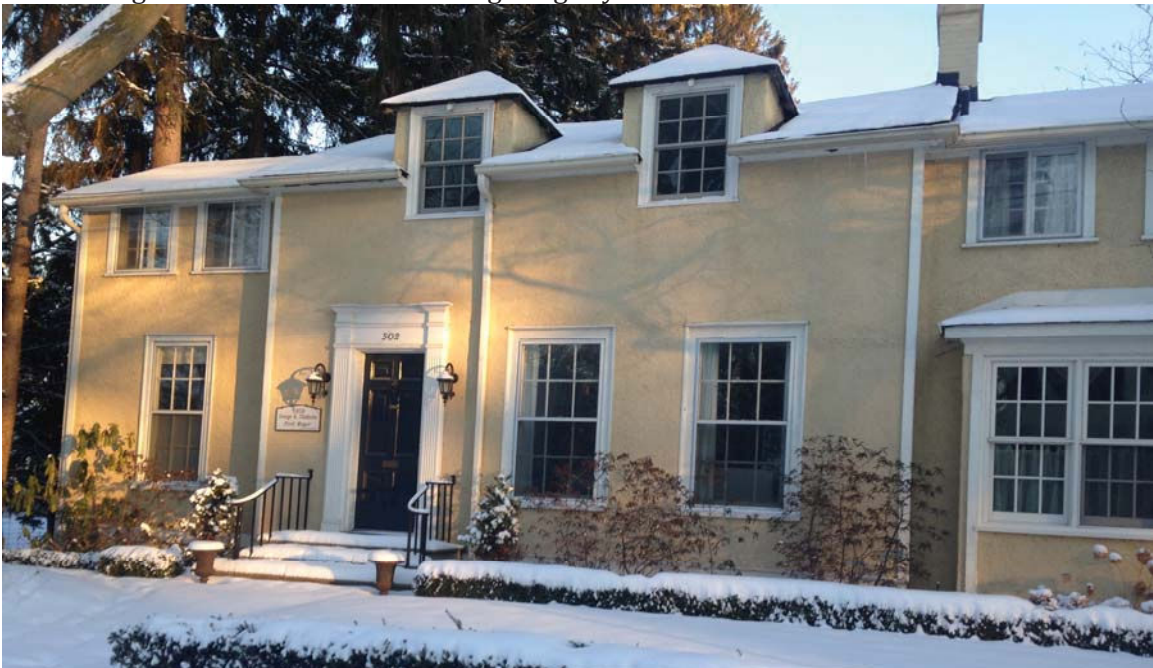
**2.21** #320 George Street. Much modified house circa 1859, with additions in early 20<sup>th</sup>. C. The stucco is slightly rough but without rusticated embellishment and sweeps. Many houses in the center of town have a consistent texture & workmanship, often painted as here to conceal several stages of repair and addition. This is vernacular rather than Arts and Crafts.

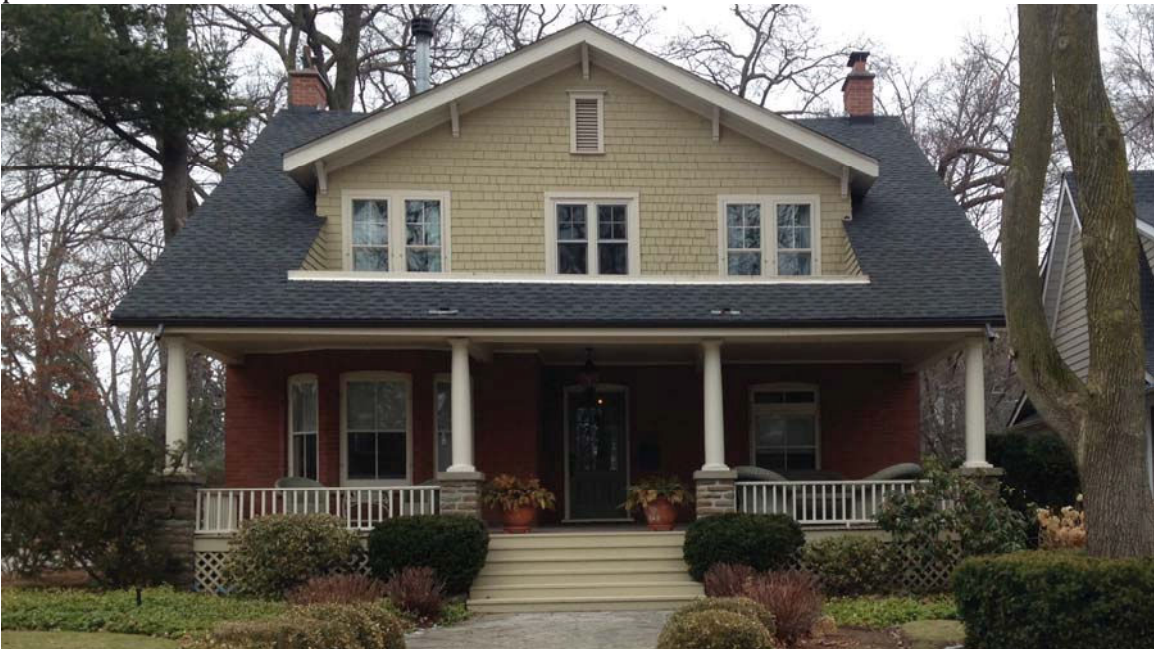
**3.08** Contemporary Arts and Crafts house, Watson Avenue, Oakville. Note the (5) carefully spaced brackets with fretsawn solid struts and jointed blocks in the upper gable. The verandah  $\frac{3}{4}$  columns on masonry plinths are also carefully spaced and fitted to the deck so the center two columns align with the middle brackets above. The house offers a symmetrical façade except where the interior plan places the door to the hallway off center. This house was probably designed by an architect and incorporates neat details like the ventilation louver for the attic space.
