Building Condition Assessment
and Recommendations for Moving a Dwelling at
1158 Burnhamthorpe Road, Oakville

1.1 Executive Summary

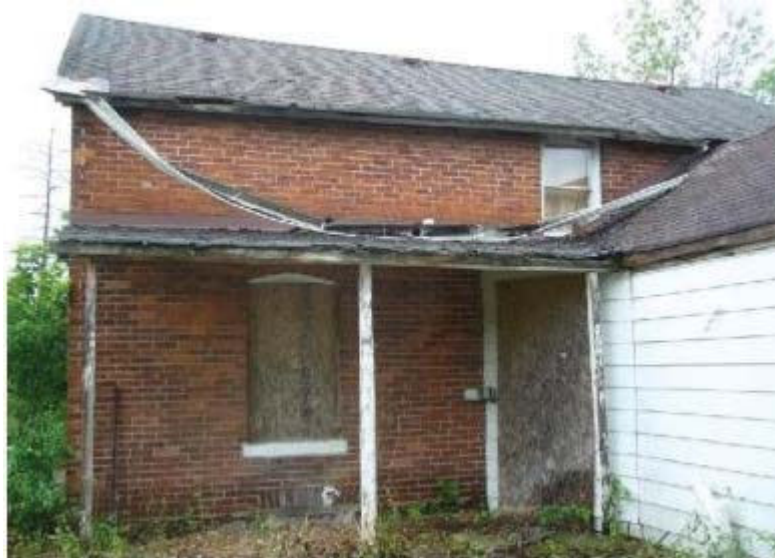
West elevation, 2017 (David Cuming)

The Albertson-Dryland roof pitch is steeper than neoclassical norms, yet not quite to the pitch of typical gothic revival houses. It has the symmetrical form of an early house but the fenestration is distinctly odd. Very unusually, it has a single window asymmetrically placed in each of the front and rear walls of the upper floor when none is typical.

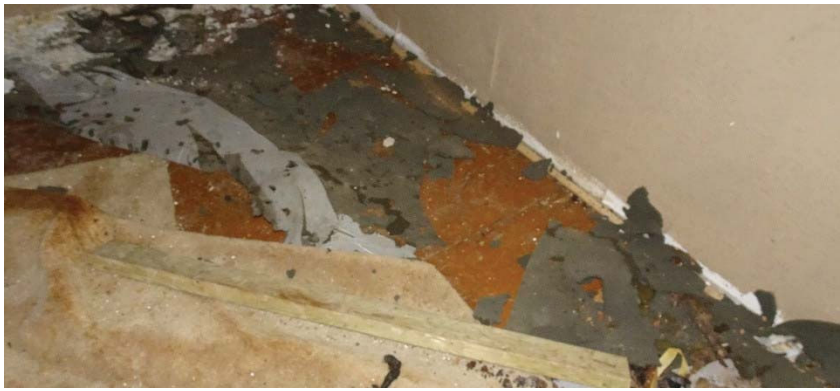
This is unheard of as original material in an 1858 farmhouse in Canada West; the circular saw had been invented but was only beginning to be introduced into the country. Even a decade later circular sawn wood was a rarity and hardwood flooring was not yet in fashion in refined homes, never mind farmhouses. Confirmation of these assumptions is seen on the second floor of the house where the typical 1" thick, random width 8" and wider pine flooring (thinner and wider than the original ground floor) typical of the 1850s still exists.

Wide pine flooring on 2nd floor

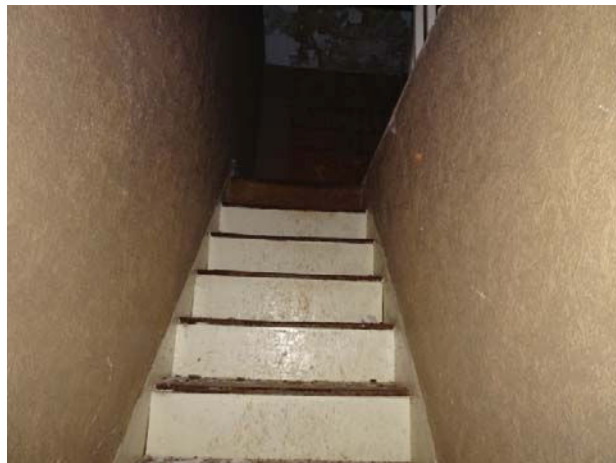
The narrow pine stairs leading to the second floor appear original, as does the damaged plain pine balustrade, the previously noted flooring, and the plain beaded casing upstairs.

Original narrow pine stairs

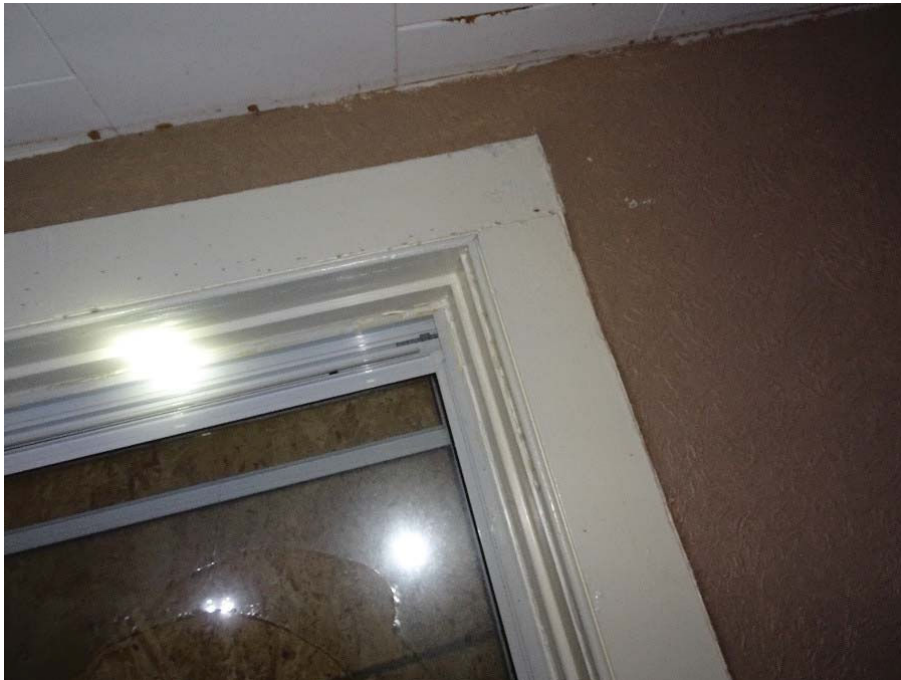
Older style beaded casing on 2nd floor

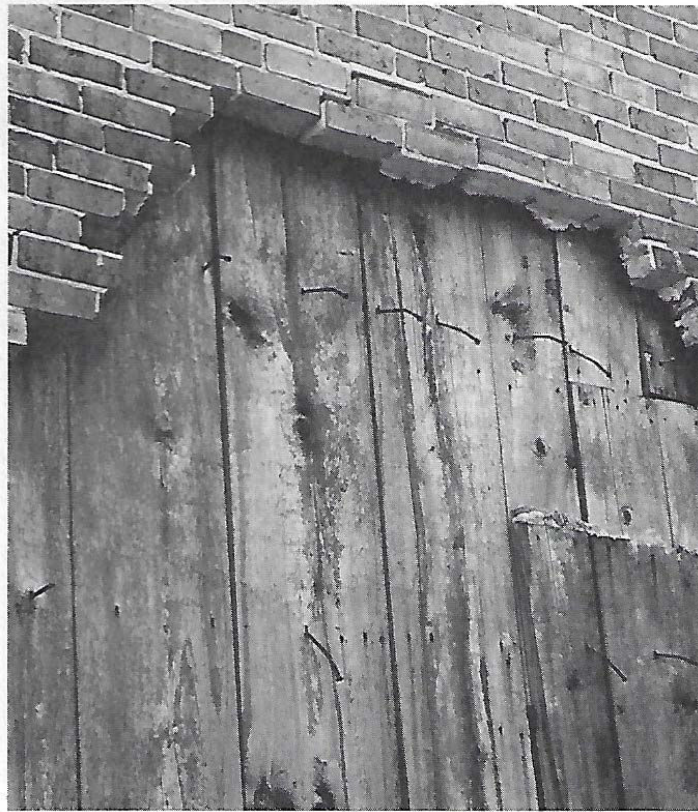
Brick veneer over original wood siding,
Nigel Hutchins, Restoring Houses of Brick & Stone, Van Nostrand Reinhold, 1982
