**HERITAGE ASSESSMENT REPORT:
CULTURAL HERITAGE, LISTED STRUCTURES REPORT**

September 25, 2020

**Doug R. Barker, P. Eng.
110 Chisholm Street,
Oakville, Ontario
L6K - 3H9**

**T. Murison Restoration Consultant
288 Woodale Avenue,
Oakville, Ontario
L6K - 2N6**

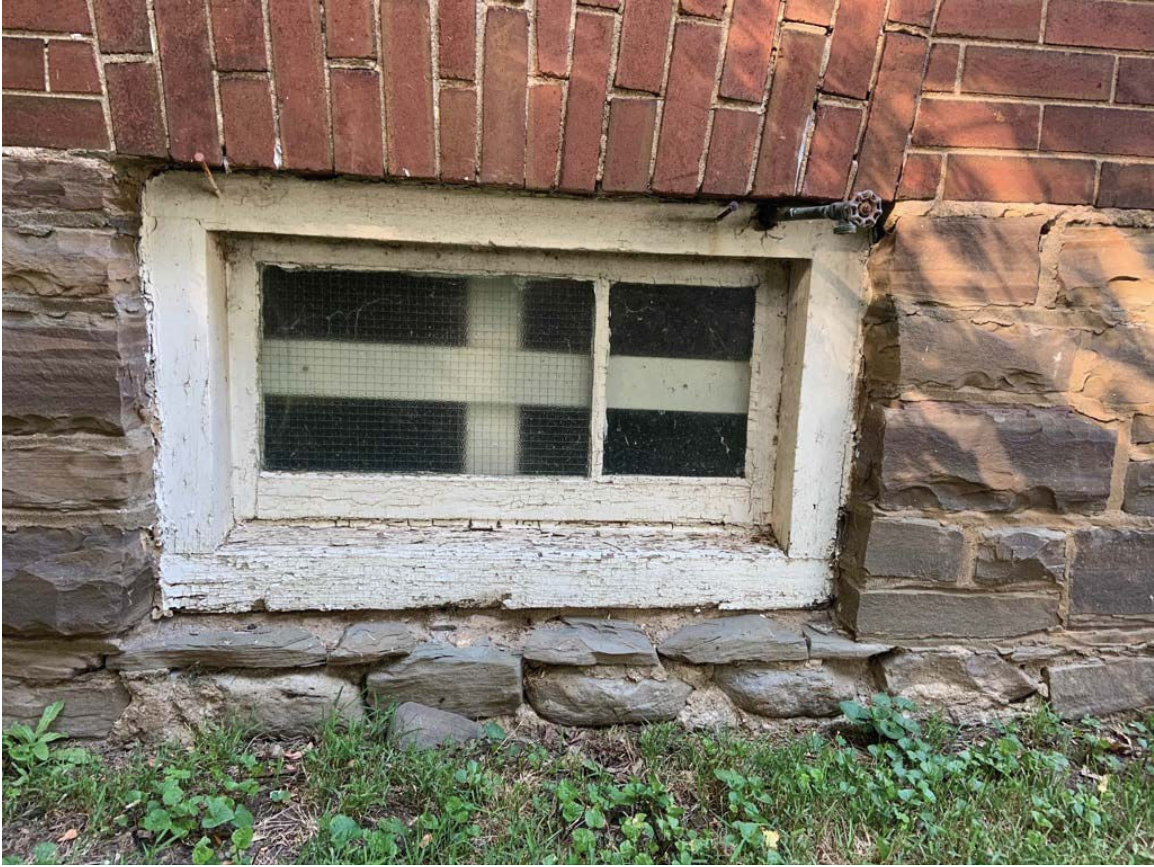
3.0.3 The grey mortar between the stones is hard and durable. It may contain Portland cement as well as lime and the coarse (sharp) sand. The joints were struck with a slightly parabolic pointing tool to create a symmetrical concave joint.

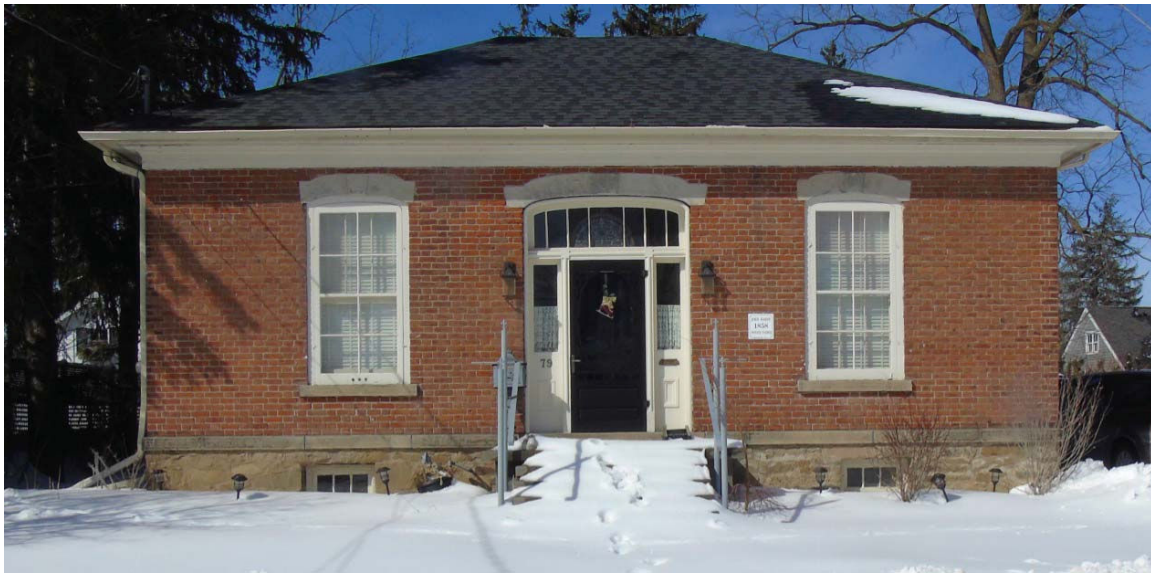
3.0.20 A mid-19th. century house at # 79 Victoria Street in Milton, center hall "bungalow" (single story). Note that the limestone water table separating the rubble limestone foundation from the brick above, is highly visible and clearly defines the floor level. In this case the water table projects 1" beyond both masonry surfaces, and is "dressed" with a "pecked" face and "drafted margins", a border approximately 1-1/4" wide made with a toothed chisel so that lines are left perpendicular to the edges of the piece. While characteristic of all but the cheapest mid-19th century construction, it is virtually absent by WW1. It is also worth noting that the front wall of this house consists of several "wythes" or layers of brick, which are loadbearing and not a veneer over frame walls. This was expressed by using a mixture of "stretchers" (long brick - sides) and "headers" (short brick -ends) in a pattern known as English bond on the important façade wall.

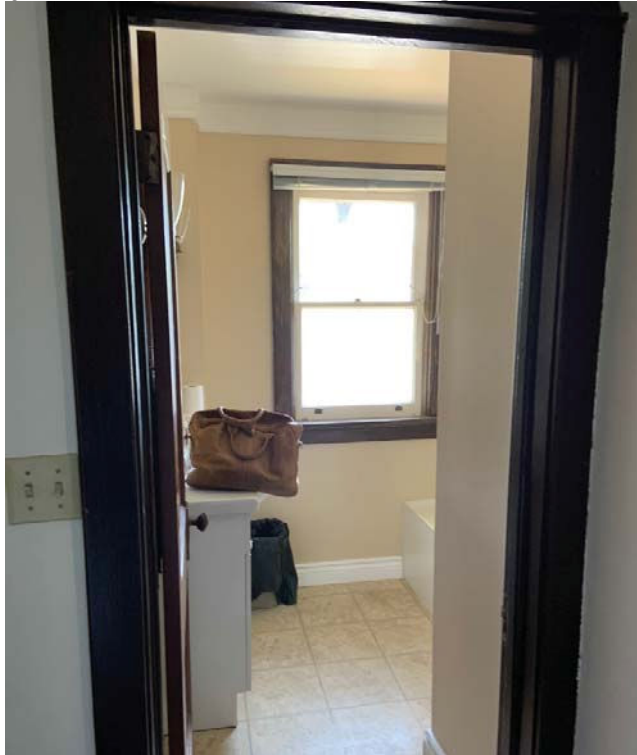
3.0.67 Bathroom refurbished with new tile floor, drywall and presumed insulation and vapour barrier in exterior walls.

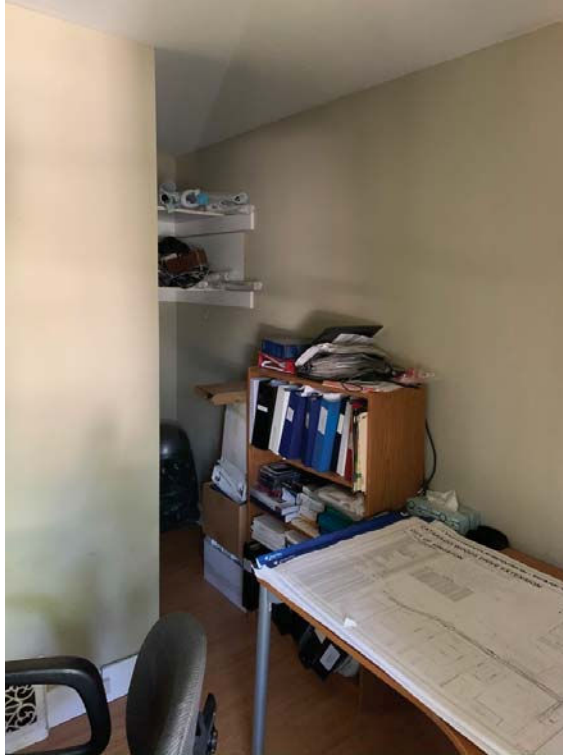
3.0.70 "Cold" closet over first floor kitchen verandah. This space was probably the full width of the back bedroom before the bathroom was enlarged and modernized.

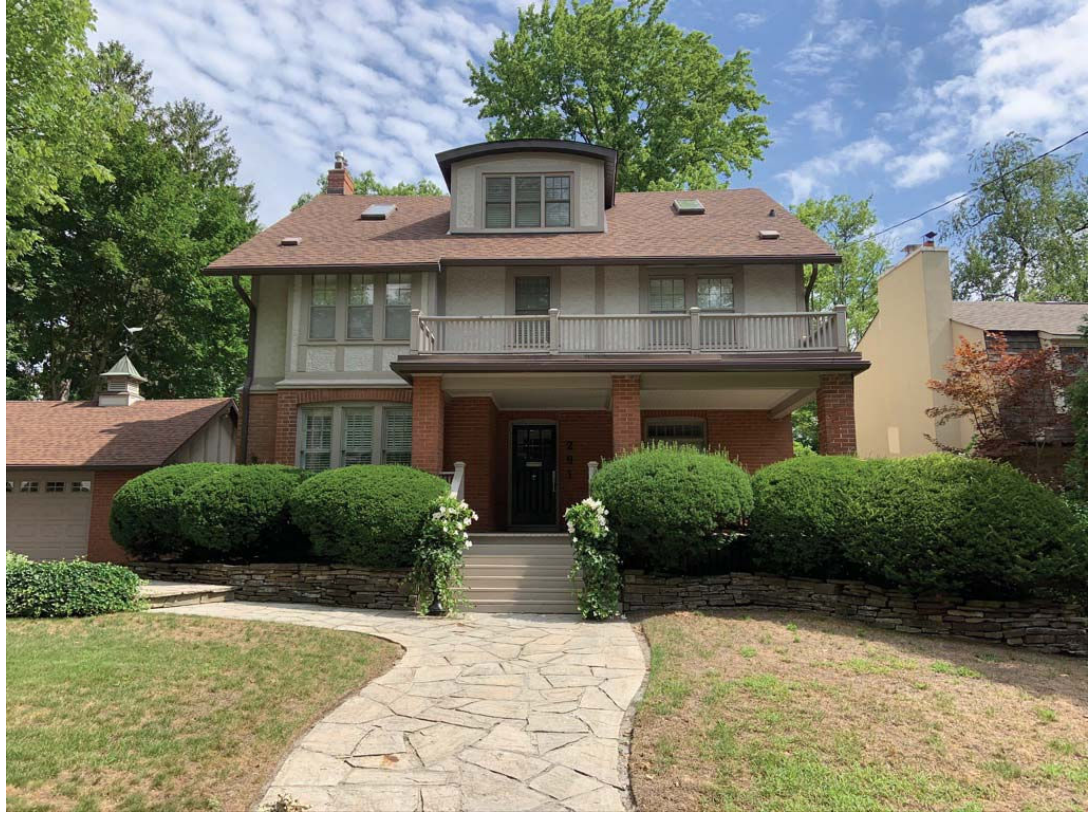
6.1.14 #291 Watson Avenue, Oakville. A larger and more formal house with faux half timber and stucco at second floor. Note brick porch and large dormer are more recent additions. Garage to the left is also a later construction.

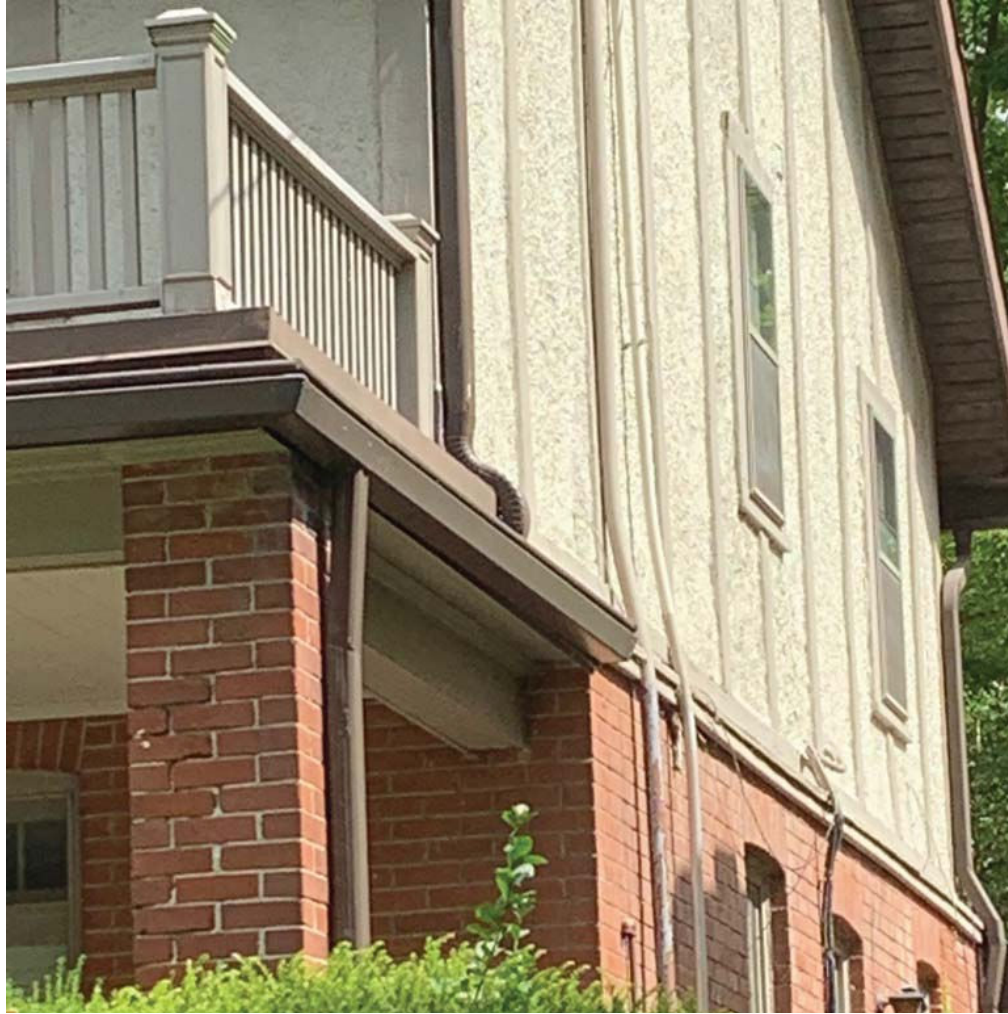
6.1.15 Photo detail of stucco wall above first storey brickwork. Note that the stucco and false “half timber” has been applied to the sheathing without strapping so that the stucco is behind the plane of the brick below. This requires a flashing to divert rainwater from the stucco to a drip edge beyond the brick. The soffit boards in this case run perpendicular to the gable wall. A fascia was used here to finish the roof.

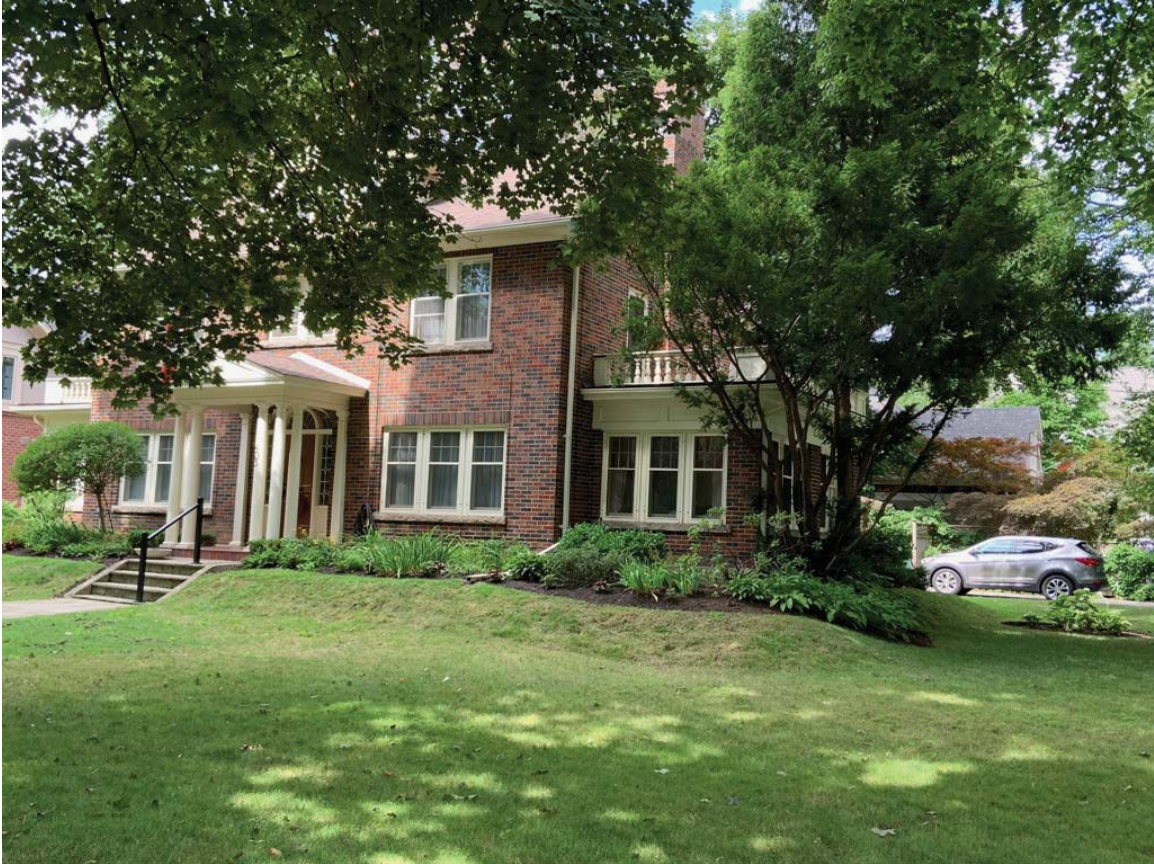
6.1.16 #403 Galt Avenue, Oakville. A well built two story house post-WW1 less than a decade newer than #110. The brick veneer (running bond) was used for the entire height of the wall. The rustic quality of the Shingle Style is gone, as the designer has opted for solidity and calmness preferred in the 1920s. The broad verandah has been reduced to a small formal entrance canopy. The owners were no longer planning to sit outside and chat with their passing neighbours in the evening and were perhaps more aware of their social position as the established “middle class”. An enclosed “sunroom” or study on the gable end of the house represents the “privatization” of space for family use, or awareness that the owners. One must wonder whether the social trauma of the Great War also resulted in families turning inwards. The classical portico is impressive and elegantly detailed, but the house seems to be more bland and withdrawn to those of only a decade before. The thin band of indeterminate shrubs and featureless lawn surrounding the house also emphasizes the disinterest in what is happening outside the home. This house shows, perhaps, the difference between the general sociability of the lower middle class at 110 Chisholm and the upper middle class in east Oakville.

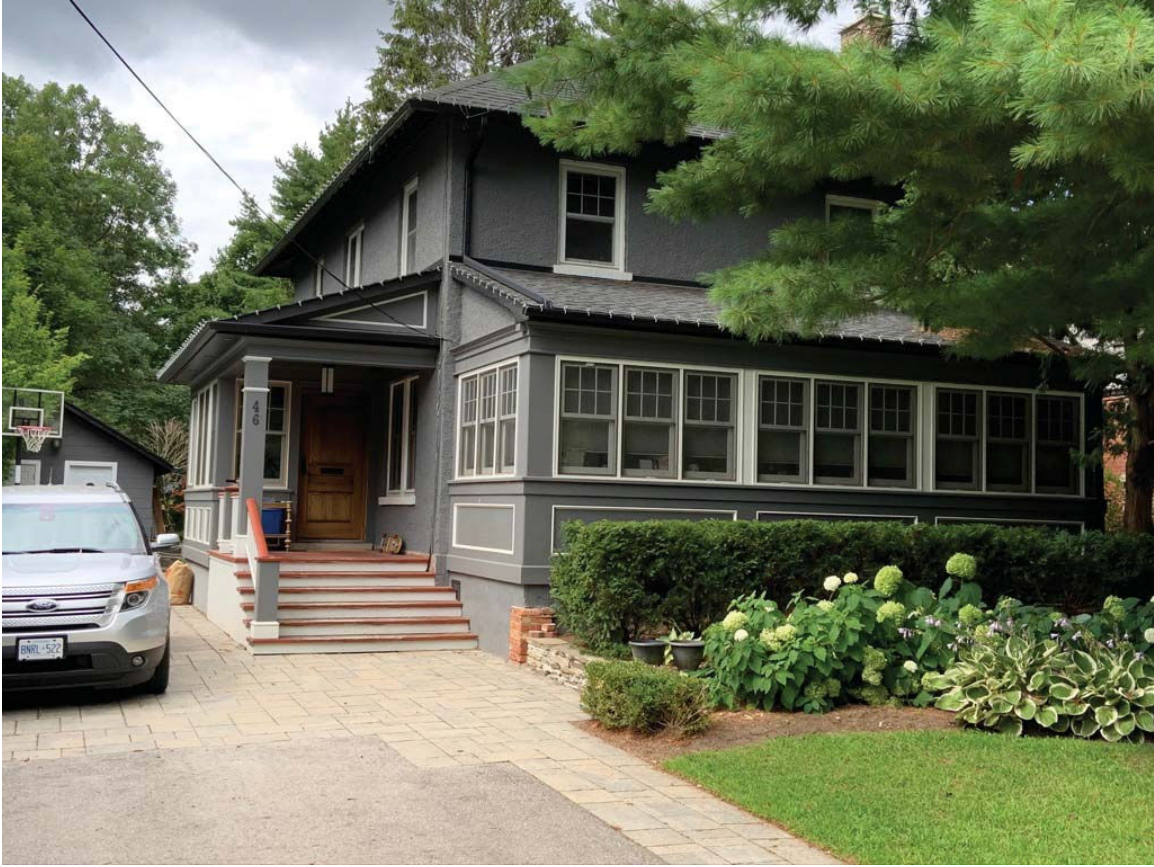
6.1.17 # 46 Park Avenue, Oakville. This frame house has a verandah across the entire street elevation of the house. The entry porch has been placed on the south side of house, with hall and stairs to the second floor. Masonry (with the exception of the exterior chimney), ended at the first floor with the framing clad in stucco from the water table to the soffits. This may also be post-WW1 as is suggested by the transition to an entry on the side of the house, which became common around 1925.

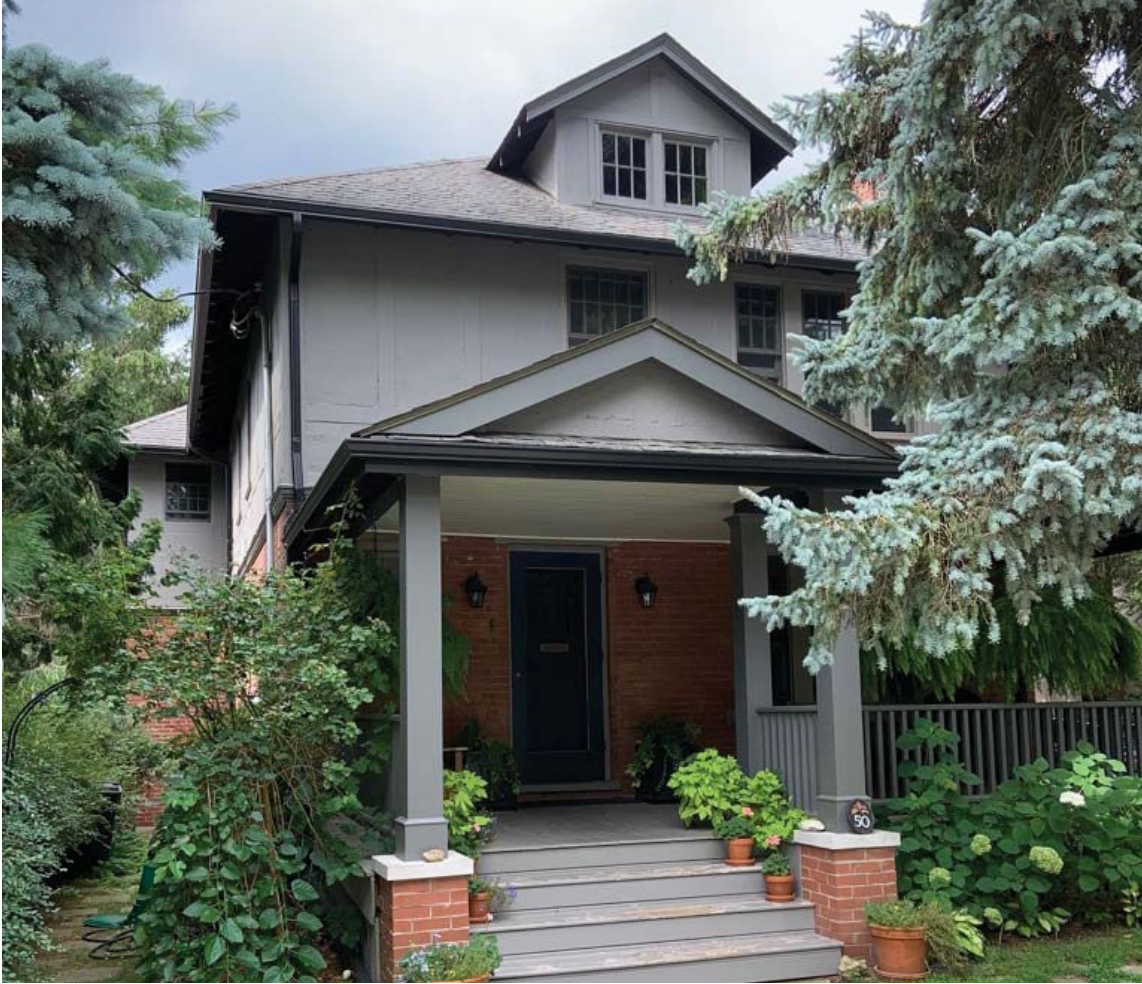
6.1.18 # 50 Park Avenue. This two storey house has the typical verandah and side hall entry. Notice that the brickwork is terminated like # 110 at the second floor, with a heavy moulding (string course) covering the brick and bedding the stucco and faux half timber above. The stucco infill between the boards is finished flush to the face. The stucco is unfortunately too smooth to show a visible distinction with the woodwork since it has been repainted in the last several years. Where more texture is present or cobbles were inserted as “dashwork”, the half timber is better defined and has interest. The rafter tails were probably exposed originally, but covered by a fascia to allow eavestrough to be used. This house (#50 Park Avenue, Oakville) was also constructed around 1910 so is another contemporary example of a “builder’s special” to the subject house. The attic dormer features an ornamental pair of small six-pane sash windows centered in the gable dormer on the hipped front roof.

The front porch also features a gable to emphasize the doorway, though the piers and columns have been rebuilt with different proportions relative to the deck. The second floor “half timber” was far more visible, and defined several years ago when painted in contrast to the stucco.

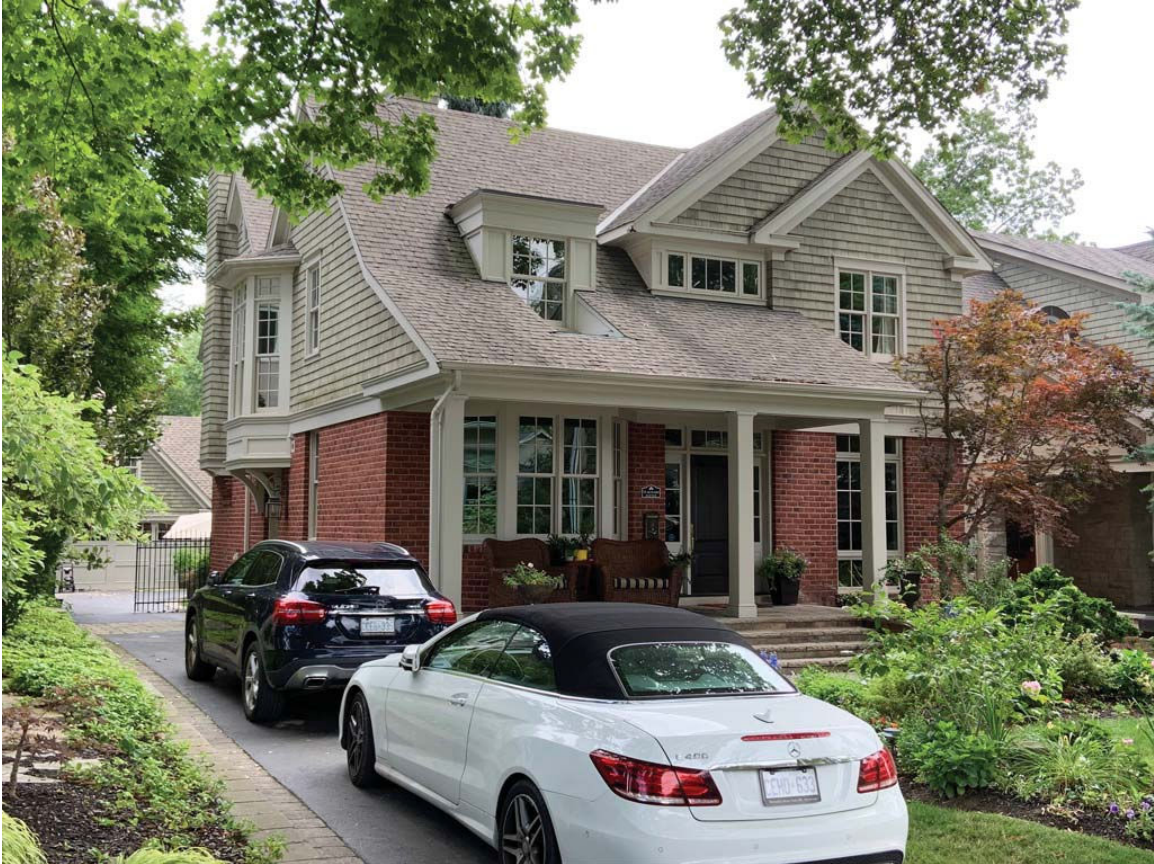
6.1.19 The popularity of the shingle/brick cottage is seen in a more convincing way in this completely modern house which demonstrates that a convincing Arts and Crafts House can still be made to replace older structures. The brick is probably a modular metric size. The shingle clad second story at the side and front gables is carefully detailed but terminates at narrow trim under the soffits. Shingle moulds and string courses are used convincingly at the roof verge, on roof returns and along the top of the brickwork. While these details are all quite historically accurate several things give the house away as being modern. The chimney was clad entirely in shingles. It is obviously a stainless steel “B-vent” flue. The random window types and unusual proportions of the pane sizes in the sash indicate that all the windows are new, and that the window openings were designed subservient to interior spaces rather than suited to symmetry on the exterior. The blunt shed dormer with sill recessed into the verandah roof and “layered” second gable at the second floor hall light are typical 21st. century affectations. When we look to the nicely detailed Oriel window on big brackets over the side door, we also notice that the ridge of the roof occurs as two parallel ridges with an intervening valley. An oriel was never used in this configuration except in the most peculiar circumstance of an addition to some house in Wales or Cornwall. Although we could not view the gap between these two parallel ridges, it is quite likely that there is a low slope roof between them that drains rainwater towards the top of the oriel.

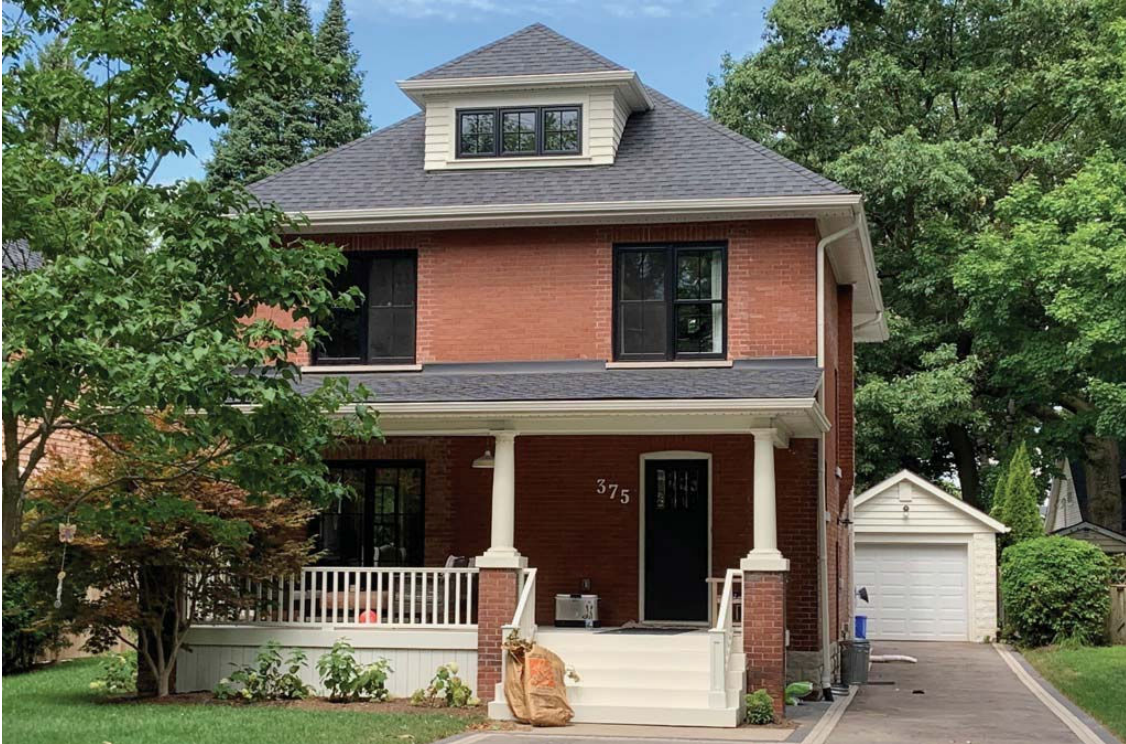
6.1.20 #375 Spruce Street built after #379. Wall openings have recently been altered to allow paired sash instead of single narrow sash as seen next door at 379. Note alignment of the new window jambs with the dormer above. Chimney removed on east (kitchen) side. Porch original with repairs.

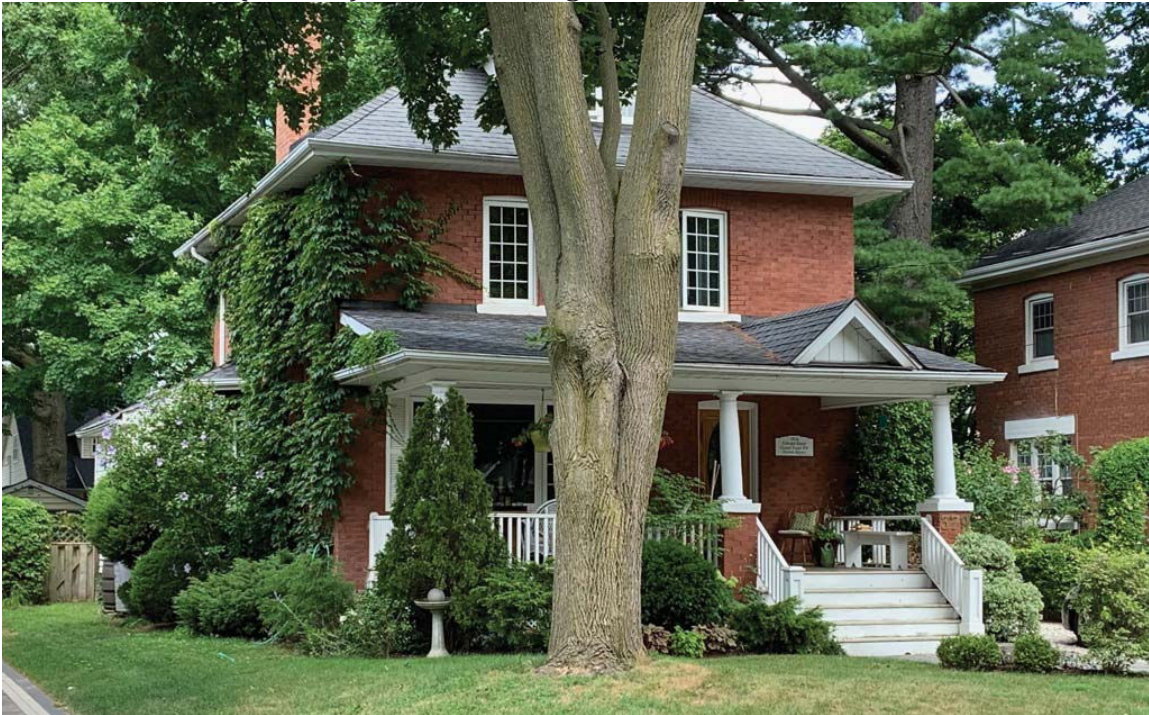
6.1.21 #379 Spruce Street, built 1914. Columns in porch out of plumb due to sandy soil below. Original pediment over entry. Dormer on hipped front of roof original.

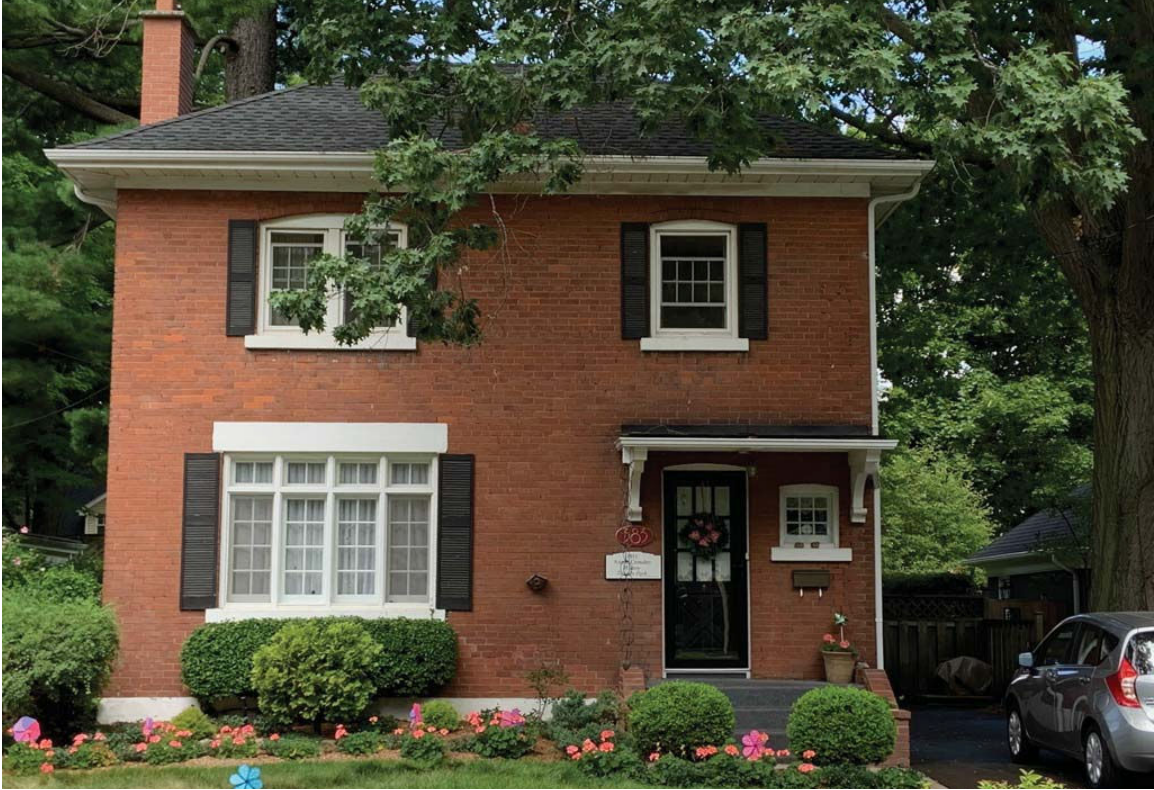
6.1.22 #383 Spruce Street, built 1911 for Annie Crossley, Widow. Similar running bond brick with substantial stone lintels & sills on main windows. Canopy & hall window unaltered. Quadruple gang casement windows & transoms. This well built house represents a preferred, higher quality construction than #110.

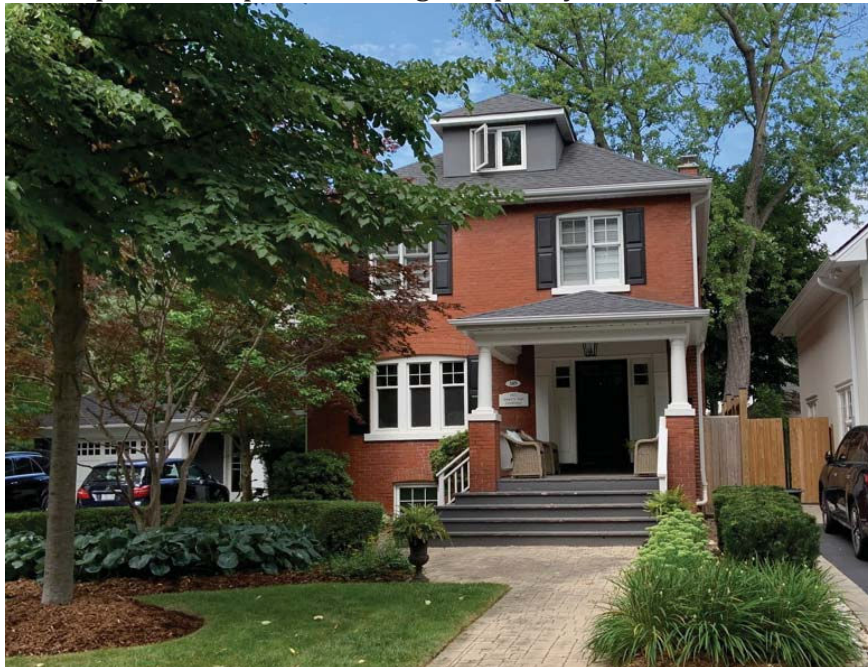
6.1.23 # 371 Spruce Street. Another interpretation of the side hall "four square".

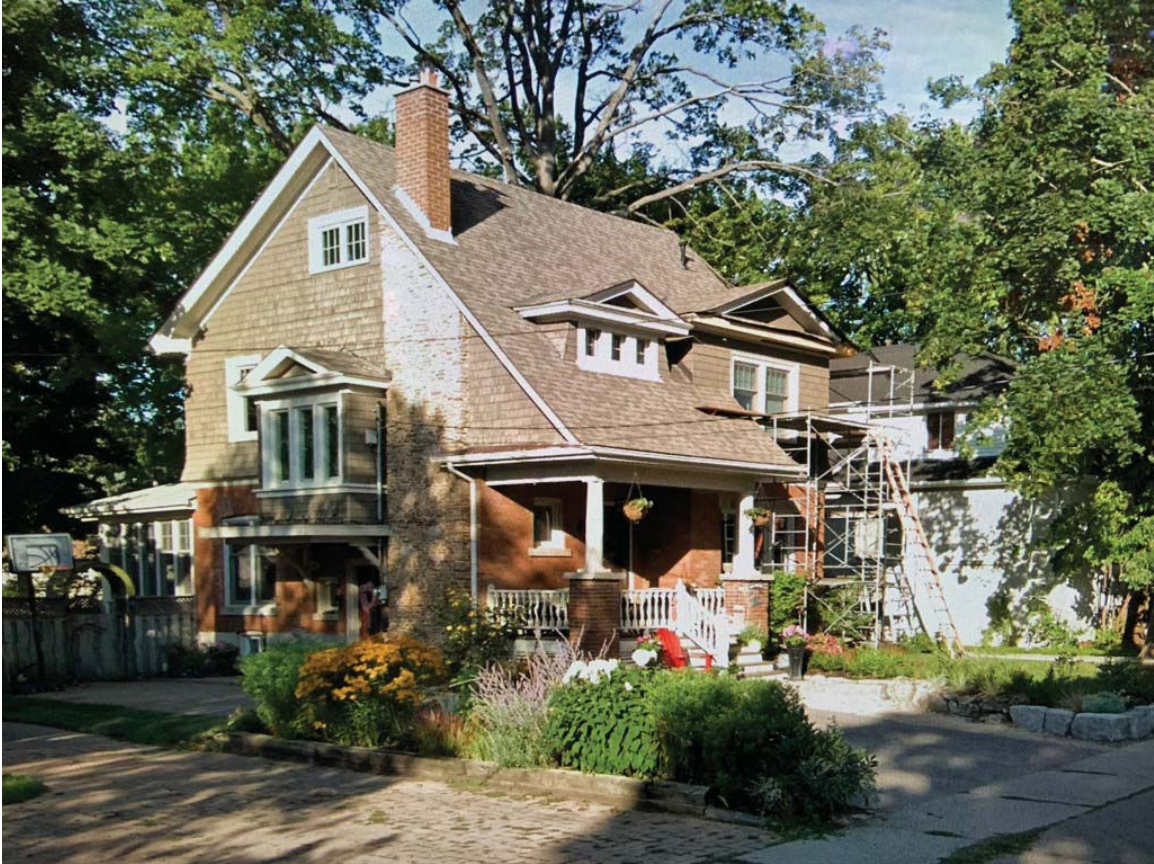
6.1.24 #389 Spruce Street, built 1921 for James Earl. Heavy stone sills with brick arches in the veneer. Spacious entry canopy with half columns. Grand entry unit door & sidelights. The cobble chimney with brick top is very unusual. The Cape Cod second floor, rear, indicates a recent alteration to increase floor area at the 2nd. floor.

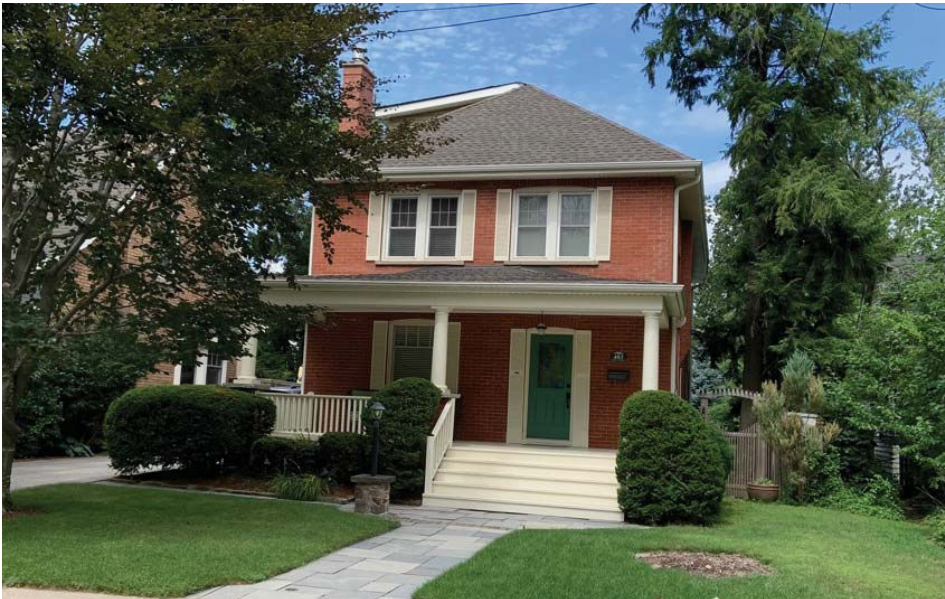
6.1.25 #403 Spruce Street. This house has ganged windows, simpler door, similar wood verandah and no dormer. It was probably built in the late 1920s.

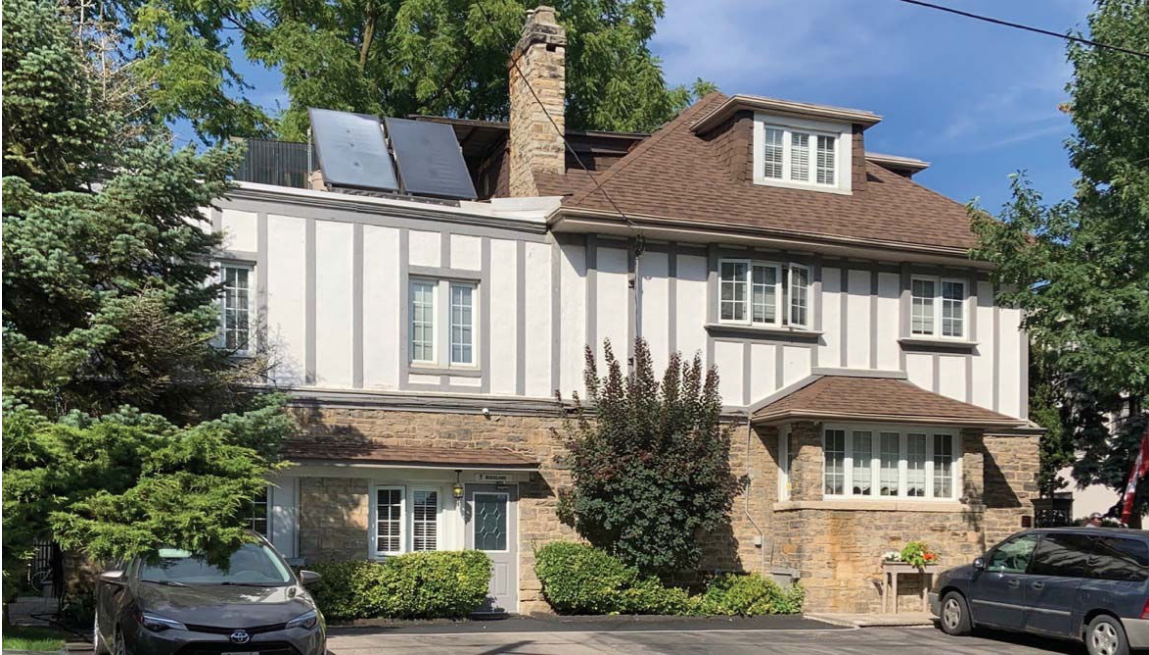
6.1.26 #3, #5 & #7 Woodlawn Avenue, Port Credit. This curious building was constructed in 1910 as a house with two attached apartments. Queenston limestone was used for the thick, (22") ground floor walls all round the perimeter of the complex floor plan. The walls above were framed almost flush with the masonry. The faux half timber and stucco second floor has an unusual low slope roof over the two northerly apartments, which suggest that their addition to the structure was an afterthought. One might expect that if they had been included in the initial plans, that the hipped roof of the southerly unit would have been designed to extend across the entire façade, providing a projecting roof to protect the walls entirely. It is possible that the change was made during construction or after the budgets had been established, so that the owner could create additional revenue from his building.

6.1.27 Other parcels of land from this lot were sold off along Lakeshore Road, just meters away, during what was a very active time for real estate development before WW1. This subdivision of original surveys is similar to that of Lots 2 & 5 Block 63 where #110 was built after a new lot was assembled. In this case, the uniformity of masonry and references to late medieval or Tudor construction, reflect a very common theme in the Edwardian period between the death of Queen Victoria in 1901, and the beginning of WW1 in 1914. Many windows on the building are ganged casements of various sizes. It is unusual to see that the ground floor is so close to grade. A basement is not discernable from the street, and entry to the two apartments is directly from grade. This gives the impression that the masonry is a plinth, supporting the living spaces above. This sense of solidity and connection to ground, while possibly unintended, reaffirms the fortress-like imagery of the house. This is both charming and bizarre, with few contemporaries.

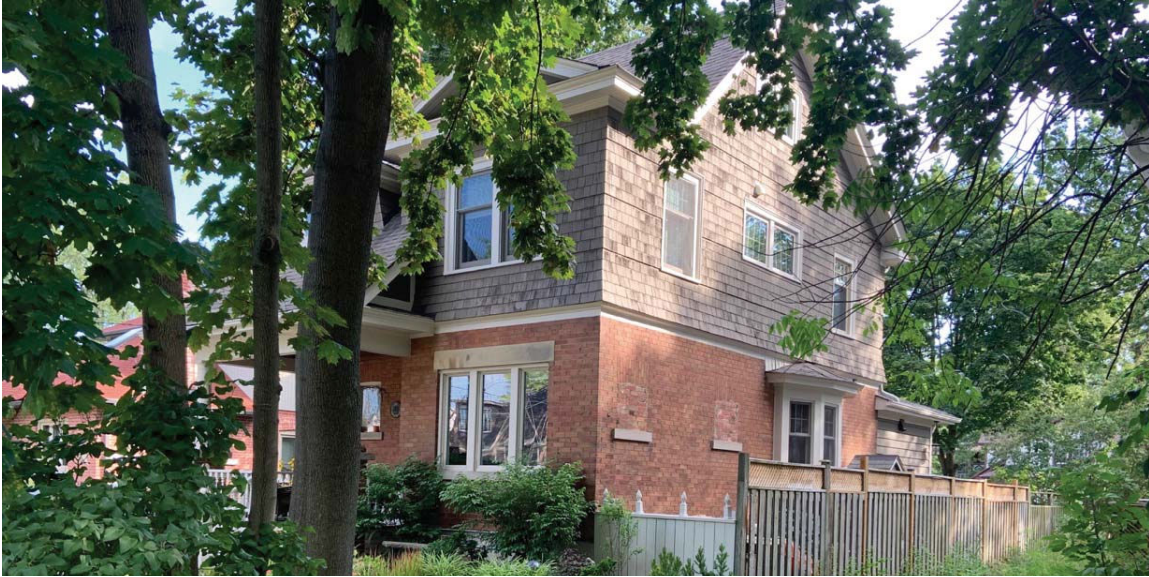
6.1.28 # 28 Briarwood, Port Credit, appears to have been built around 1928 in Port Credit. It is a similar width as #110 Chisholm. The brick veneer was applied over the two story framing in the same way as the subject house, but the ridge of the roof runs parallel to the street elevation. Since there was no main gable on the street, there was less opportunity to embellish the façade with a decorative window, brackets and other details. The entry is wider and more spacious with a hall closet on the side wall, and corridor to the rear of the house bypassing the stairs which rise along the exterior wall. A wide verandah has been omitted in favour of an entry porch which does not shade the triple casement living room window, embellished with it's own stone lintel and sill. Side lights on the living room indicate that additional decorative windows were included to brighten this room. Features such as the projecting bay window on what was the dining room and more elaborate turned columns of the porch, along with the regular double-lapped shingles every 5th. course, suggest that this house was built to a higher standard of finish.

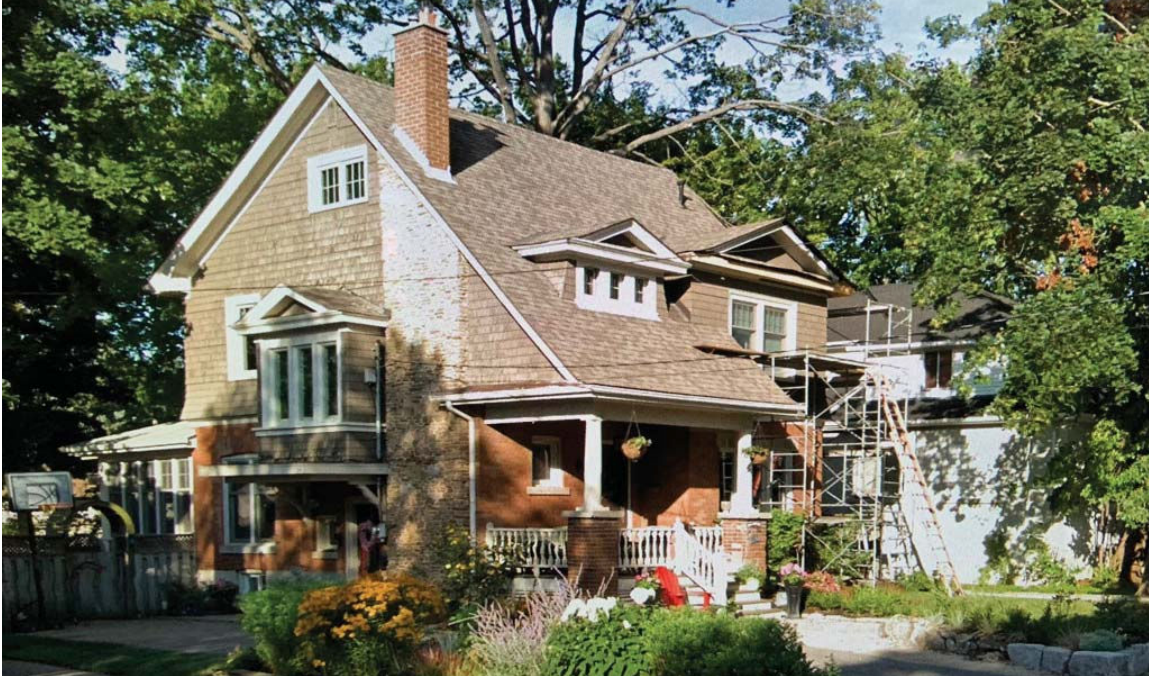
6.1.29 # 28 Briarwood Avenue, Port Credit. This house has been altered and is now deceptive in its form. The Asymmetrical façade with large and small gables above the front porch, are matched by another projecting bay over the side door. Three windows are ganged together in the bay which is apparently a half height window seat on the stairs, but the structure supporting the bay projects even further as a deep canopy over the driveway. This is a modern alteration. The roof rises higher on the back half of the house forming a full height second floor wall for the rear bedrooms. There are no other examples of this “salt box” style roof, suggesting that it is a modern addition to increase headroom in the rear half of the house without altering considerably the front elevation. If the original roof ridge were just above the chimney the roof would match many other examples of this house. This means that the attic window and larger window behind the stair bay, are also modern. The brick chimney above the roof is higher than in other examples and the new cap suggests that it was raised to meet the requirements for efficient venting above the new ridge. Below the roof the chimney was built with small rounded cobbles, apparently collected from the beach or from a recycled masonry wall. While the stone texture is interesting, it is the only example of a “rusticated” chimney being applied against original brick veneer. We might conclude that this invention, was made to embellish the house as it was being constructed, though it is possible that it was added later but before the current roof and chimney modifications. We also see that the porch railings have been raised to at least 7” above the deck, probably to improve the height of the handrail and bring it closer to compliance with the building code. The house has undergone a series of pleasant and practical changes without altering its façade much. The additions have been extensive and suggest that considerable expense has been required to perpetuate its use as a family home.

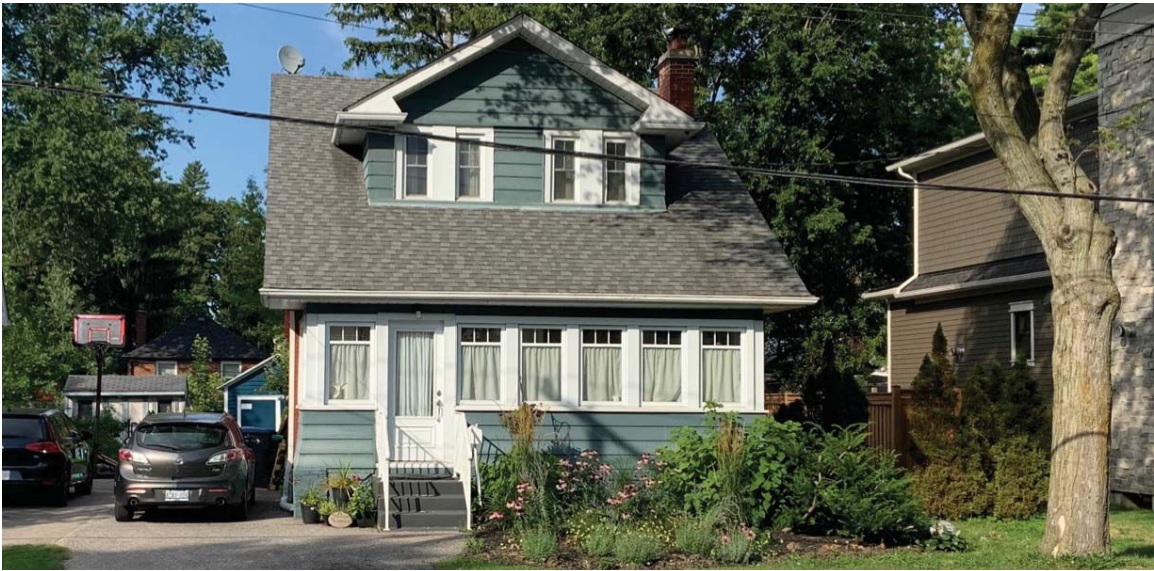
6.1.30 This Mississauga house has brick gable walls (not visible from the front elevation) up to the second floor. The full width verandah and dormer have been re-clad with broad siding. While different in overall impression, this represents a more unified design that suggests a modest cottage near the lake rather than a more grand Stick Style house. The small transom panes above each of the fixed windows in the verandah, reference Arts and Crafts buildings and are similar to #110.

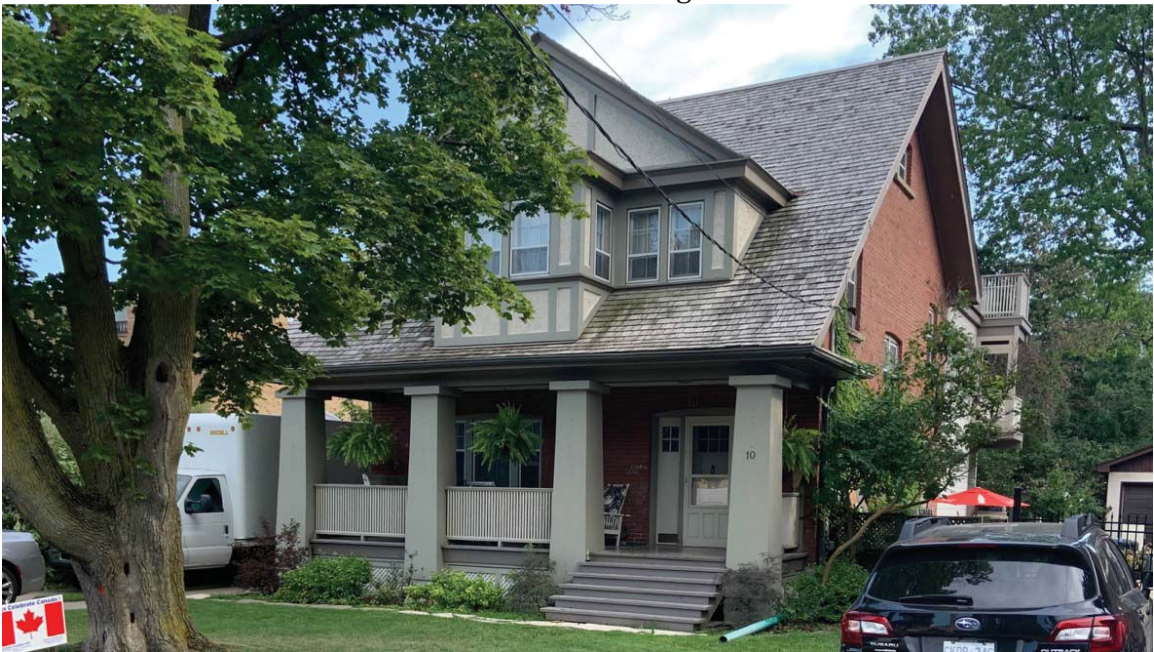
6.1.31 # 10 Briarwood Ave.. Port Credit Another unified verandah-cottage roof, but with a very unusual compound bay at the second floor. The space above the verandah ceiling was framed as a floor with the narrow front section built right over the girder at the front, and the two flanking areas set back approximately 3' from this plane. This rather fussy design gave return windows on the front projection, while keeping a triangular, blank, half gable on the next parts. The design treated the

roof of the small front bay as a shed dormer against a much more prominent gable wall above in the same plane as the side bays. This charming space would be ideally suited for placing a dressing table or writing desk within an illuminated bay flanked with windows on three sides. The stucco & half timber wall treatment outside unified the pattern by carefully “outlining” each window and element of the complex bay. The gables on either side of the house were not finished with shingles or faux half-timber, but brick up to the underside of the soffit. While it could be argued that the house is really a two storey brick house with an elaborate half timber front bay, it is a familial contemporary or cousin to the subject house.

6.1.31.2 The floor plan of # 10 Briarwood is assymetrical with an apparently generous side hall and entry door on the right side of the verandah. The verandah and dormer above obscure this by unifying the elements closest to the street with symmetry. The interior plan is de-emphasized.

6.1.31.3 The stucco covered porch piers do not appear to be original to the house. The proportions and ill-considered uniformity indicate that the original piers or piers and columns have probably been replaced recently with stucco covered, plywood boxes. We can see painted stone blocks below the stucco boxes and level of the deck which probably supported the original wooden columns. The railings between the piers appear to be original. These overblown piers reduce daylight and appreciable space within the verandah which is contrary to the intended airiness of the bays above, a very unfortunate contrast. Given the kinship and similar date of construction, this is a better example of a carefully planned and well detailed house.

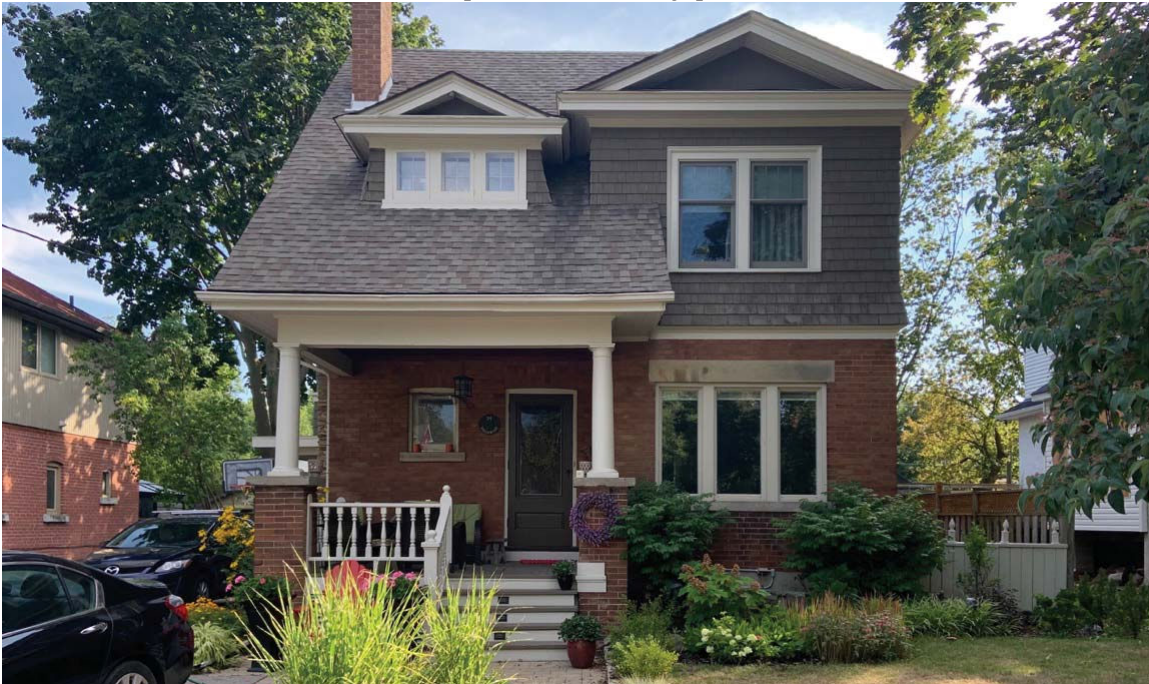
6.1.32 This late Arts and Crafts house takes the assymetrical design to a logical conclusion. The exterior verandah, dormer, gable and each variation in window type are unique elements on the elevation with emphasis on the division between the

great downward sweep of the main roof against the plane of the two story frontage and gable. The result is a charming if not quite perfect arrangement of features. Most jarring is the contrast between a triple gang casement window with heavy stone lintel in brick veneer at the ground floor with the larger paired single hung sash in shingles in the bedroom above. The builder clearly recognized that he did not have enough room to use a triple gang window at the second floor because of the encroaching overhang of the porch roof, so opted to use a double window instead. If he had done the same at the ground floor with a double window of the same width under the stone lintel, the result would not be so strange. Curiously, the large and small gables were given similar treatment with trim across the window heads and up the gables. Both roof pitches match, but the smaller gable has too much trim in with a smaller soffit. It would have been more logical to treat the two gables differently and assymmetrically as virtually everything else on the elevation is handled. This combination of features is probably quite unique. One would not expect to find everyone of these features in this arrangement even once in a very large number of houses. #110 is symmetrical and more conventional than this type.
