**HERITAGE ASSESSMENT REPORT:
CULTURAL HERITAGE, LISTED STRUCTURES REPORT**

September 25, 2020

**Doug R. Barker, P. Eng.
110 Chisholm Street,
Oakville, Ontario
L6K - 3H9**

**T. Murison Restoration Consultant
288 Woodale Avenue,
Oakville, Ontario
L6K - 2N6**

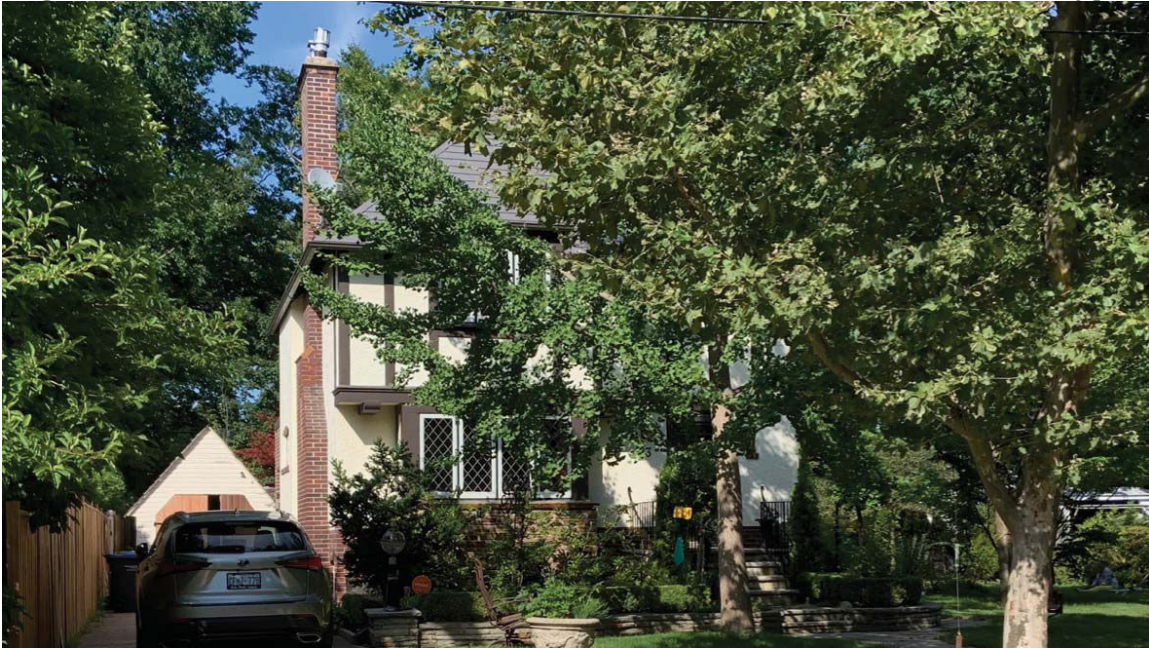
6.1.33 This house has eliminated the first floor masonry above the sill of the bay window. Half-timber and stucco was used convincingly because of the broad ornamental brackets that suggest the bay is real “Jetty” construction as seen in medieval buildings. It is worth noting that this clever design feature originated with primitive timber buildings on narrow urban streets. The “jetty” projections at the upper floors allowed more floor space over the narrow laneways in dense medieval towns. This charming element can be seen here from a distance seldom available in the original condition. The way that the ganged bay window stops beneath this overhang is elegant and logical, as the windows above are also aligned to the same centers as they would likely be with heavy timber framing. Here, there is less masonry but more cohesive style in a house that is very close in size to # 110. The subdued but clever hipped dormers on the second floor windows also improve the

character of the façade. The design owes much of its sophistication to English houses of the early 20th. century, not the rusticated Arts and Crafts of New England and Canada. While contemporary, and probably built with many of the same components, it is far more elegant and likely to be preserved as an outstanding example of its type. Note also the very crude garage behind the house, which would be completely in keeping with #110 (if they had built a garage there to house the new 1910 McLaughlin-Buick or 1912 McKay Roadster).

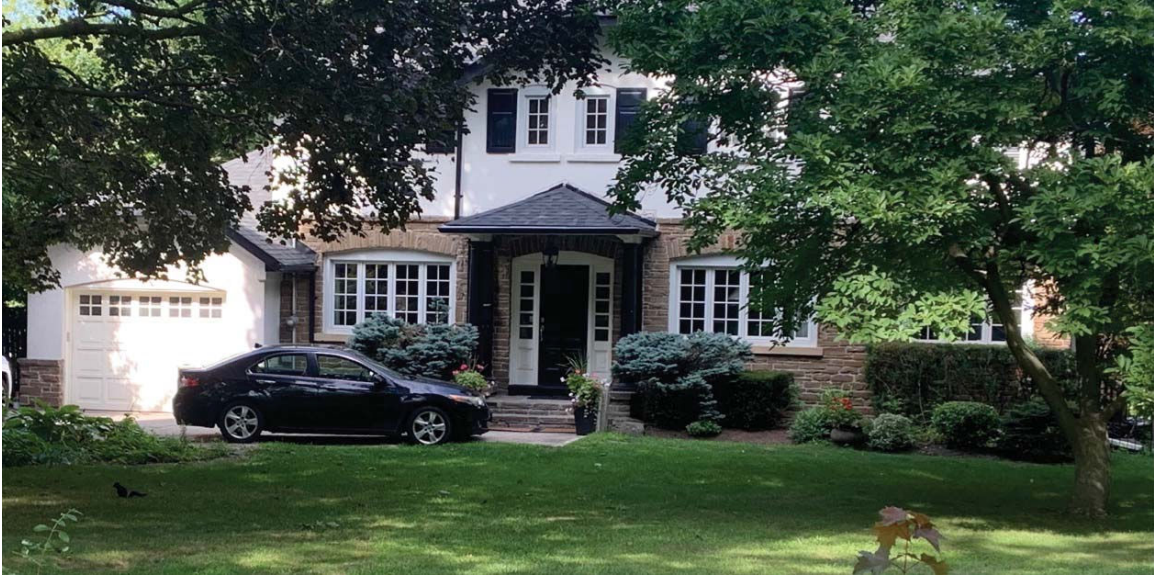
6.1.34 # 1375 Stavebank Road, Port Credit. A similar house with symmetrical center hall plan, modest entry roof on brackets and ganged windows with masonry arches in the veneer wall. The stone veneer is composed of small pieces of squared, but rock faced, random rubble. The weathered appearance of the stone suggests great age and permanence of the house, even when new. The sawn limestone sills under the windows, are only 4" high, and beautifully dressed. The masonry arch and understated door with sidelights speaks the language of true form following function, the mantra of a luminary such as Frank Lloyd Wright, who said, "Form Follows Function – that has been misunderstood. Form and function should be one, joined in a spiritual union. Put another way, houses that are designed by an architect will aspire to these higher ideals, where those built by the untrained, will have incomplete perfection. Amateur design and application has some historic value whether for uniqueness, method of construction or the significance of the inhabitants. Exemplary types must be compared carefully with other examples to calibrate their ranges.

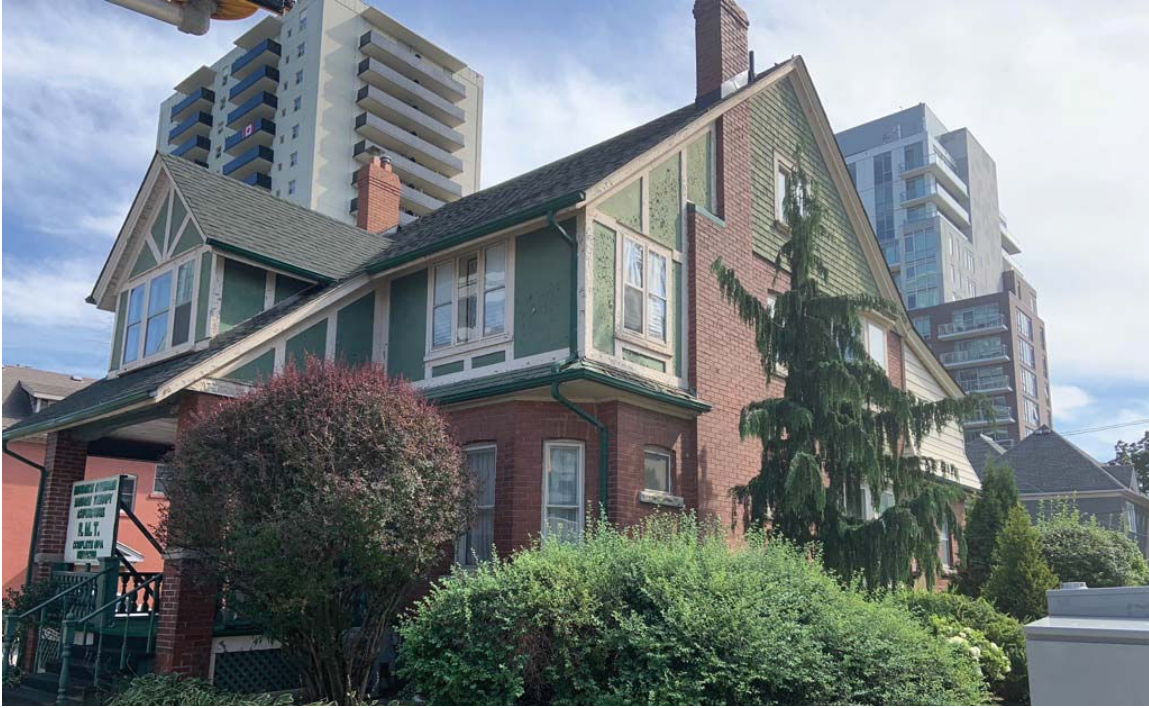
6.1.35 #20 Hurontario Road, Mississauga. This large house uses many Arts and Crafts features in strange ways. The brick walls at the first floor are extended up into the second floor as broad chimney backs, and remnant wall panels at corners for no apparent reason. The stucco and half timber wall cladding on the front façade might be expected to extend beyond the chimney and around the second floor.

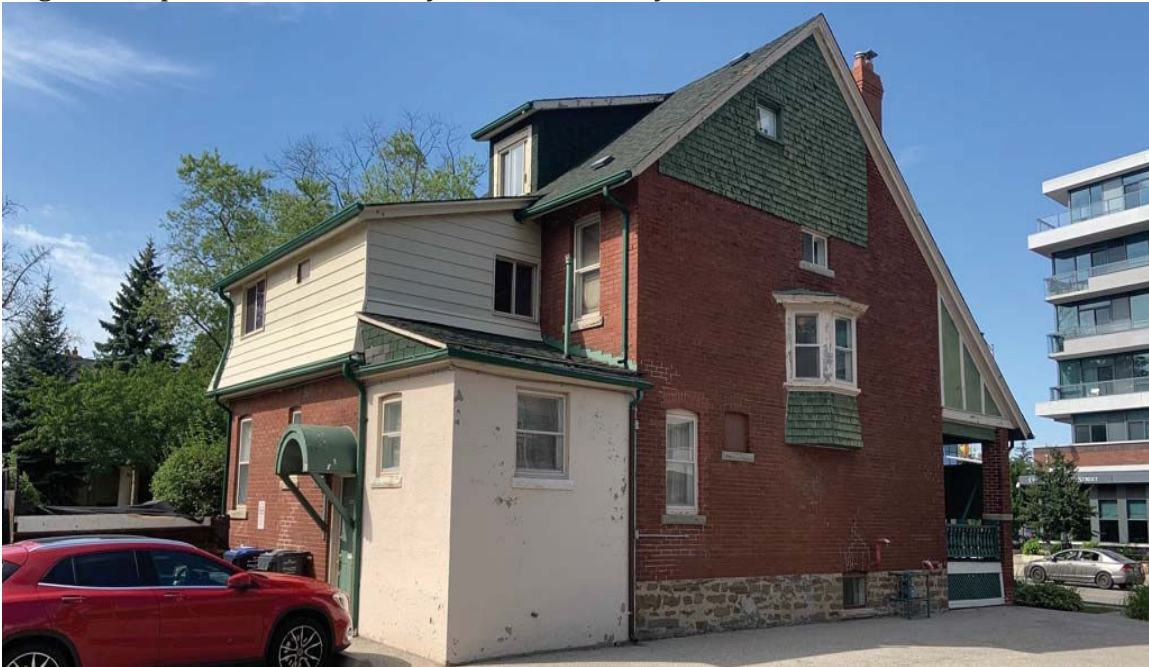
6.1.36 Side elevation facing Lake Ontario shows a small half gable of stucco over the verandah, and a residual portion of the attic gable in shingle. It appears to be a two storey brick house with embellishments marred by later additions and an attic shed dormer. While the oriel window is clad in shingle, two peculiar small windows

above it suggest that there is a stairwell and possible bathroom going up to the attic floor. The builder assembled different design elements in a pastiche. The faux half timber and shingle was applied without a sense of unity to the overall design.

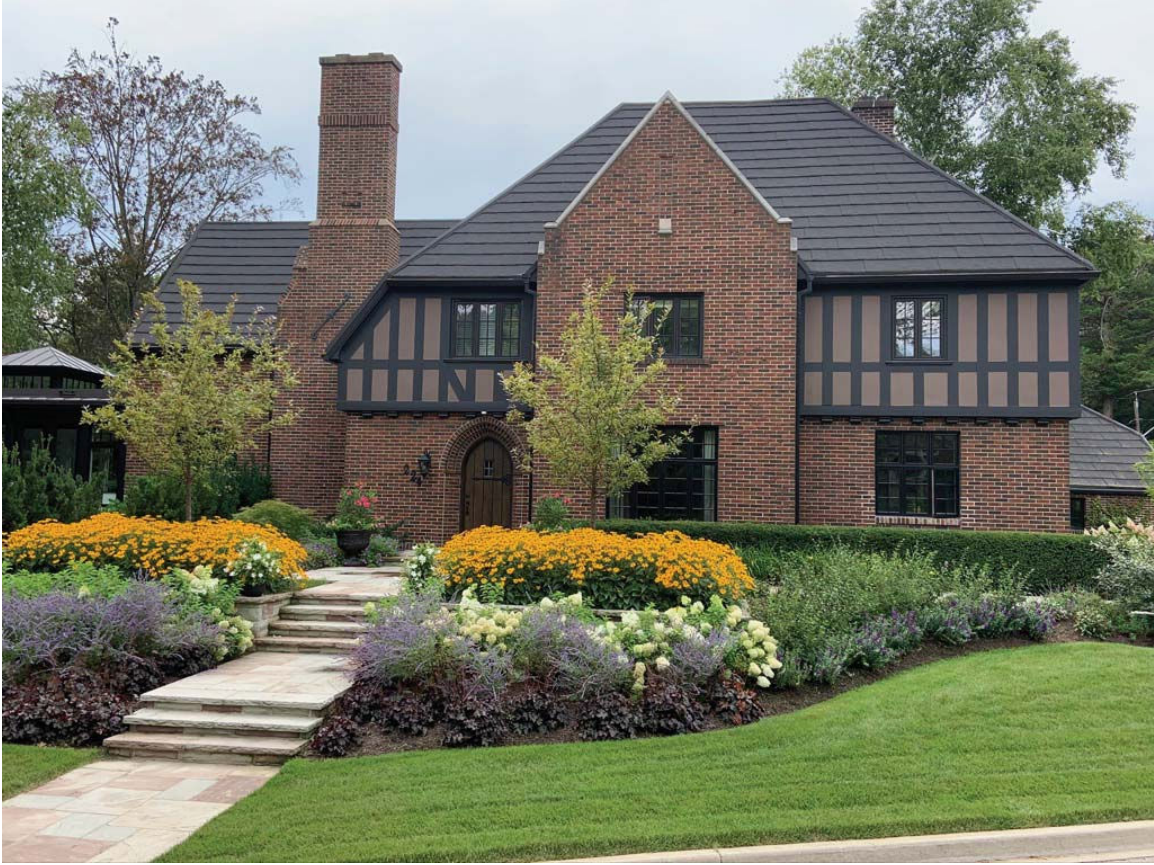
6.1.38 # 224 Rossmore Boulevard, Burlington. This is a supremely confident and flawless example of the “stratified” Arts and Crafts design. Every detail and proportion is perfect. The design has a logical balance with contrasting details that represent both the interior room functions and harmonious exterior design. The small multi-pane ganged windows are logical and understated. The parapet gable with stone coping returned on horizontal “shoulders” at the eaves, is what one would expect in a late medieval manor house, as this fine example represents so well. The painted stucco and half timber are subdued with an appropriate colour scheme. The only feature that detracts from this house is the roof finish. The dark tiles are too regular to replicate the irregular textures of traditional crafts of “tiler” or “slater”. This is a minor deficiency in an otherwise outstanding example of the type. This house must have been designed by a top notch architectural firm in the early 1920s. The quality of construction and design of # 110 Chisholm does not come close to this house.

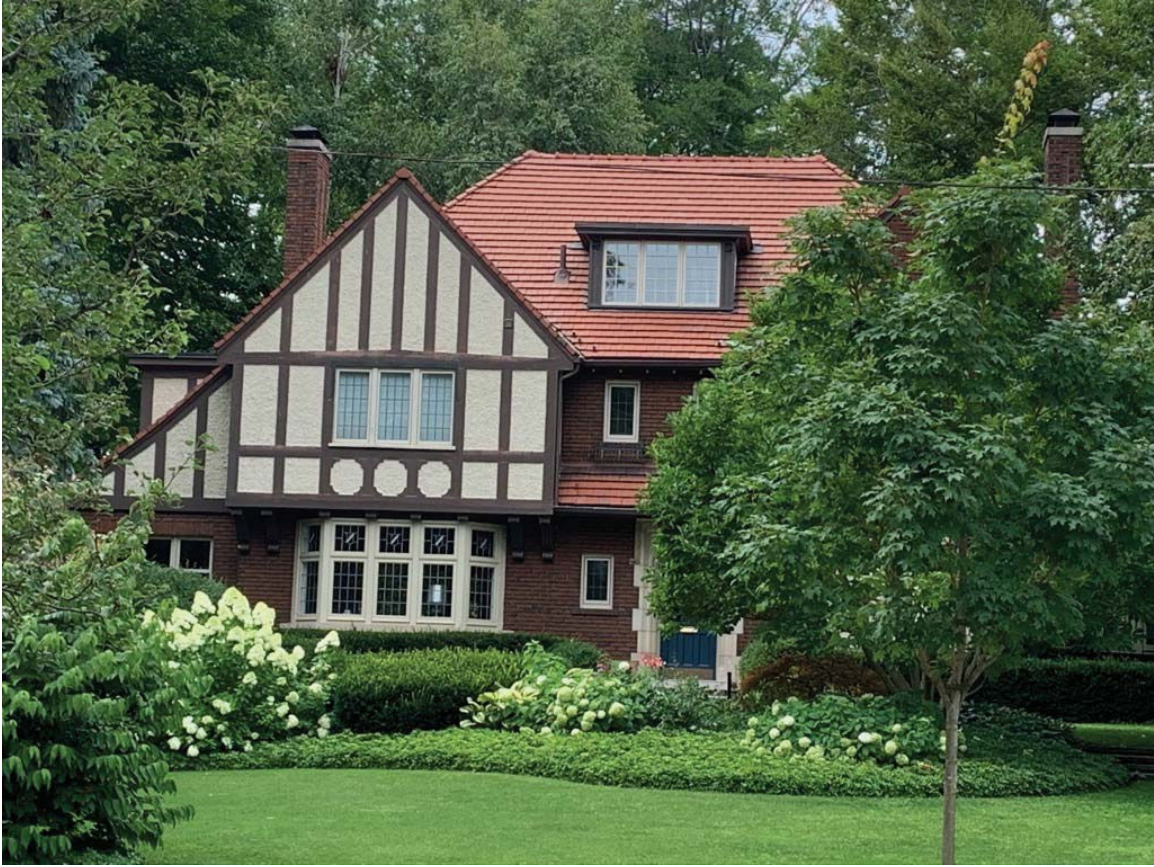
6.1.39 South Drive & Hart Avenue, Burlington. Here is another outstanding example of a faux-Tudor, Arts and Crafts house. The first floor brick veneer is rougher in texture and darker in colour to emphasize the windows and entry. The entry door surround is cut limestone with quoins keyed into the brickwork. The masonry pattern is Late Perpendicular Gothic as per # 233 Rossmore Avenue, with a fine door having nine wood panels instead of glass. The tile roof across the entry was probably shingle when built, but is a very appropriate substitute material. Windows in the sidelight and large bay have leaded panes in the casements and transoms. Windows at the second floor were also leaded casements. The large projecting gable bay at the second floor was finished with faux half-timber and stucco in a somewhat irregular if symmetrical fashion. The use of the three fussy “bracketed” panels under the windows draws too much attention to this piece of wall and the proximity of windows above and below. This would not have been done in a genuine English Arts and Crafts house, but may be considered tolerable here in the “colonies”. Large paired timber brackets that support the gable bay are structural and appropriate for the design. Overall this is a very satisfying building, set in a beautiful landscape.

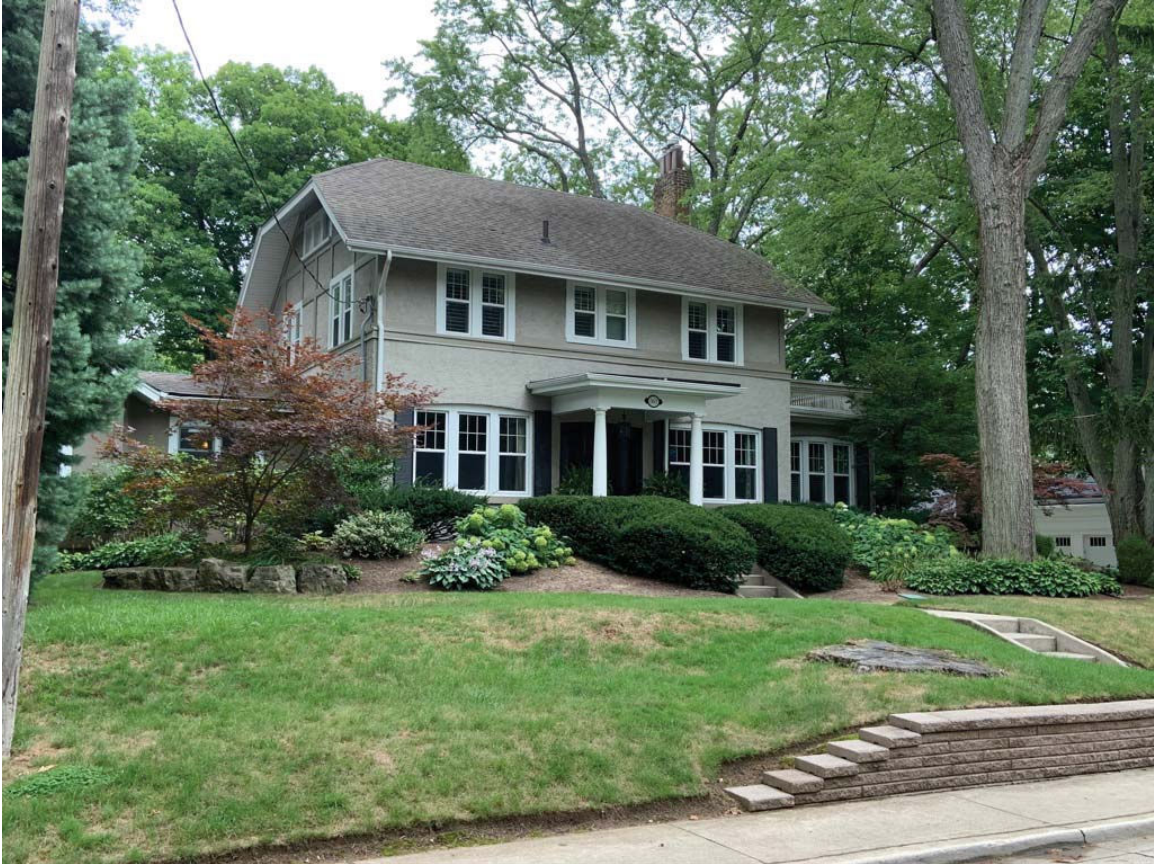
6.1.40 # 305 Hart Avenue, Burlington. Built 1925, Class "A", Burlington Heritage list. Symmetrical façade with large entry canopy, Germanic style hipped gable ends, and unusual brick string course at the level of the second floor window sills rather than the second floor. The single hung sash have six pane transoms at both main and second floors, and for windows in the sunroom. The masonry walls below have been parged with a coarse stucco that retains the slight impression of the projecting arch over the ganged windows. At the second floor the street façade is also stucco but of a finer texture. On the gable walls faux half-timber was used with similar fine stucco. The roof eaves project three feet from the walls producing a the image of a house protected by a massive roof, almost as impressive as thatching. This is Arts and Crafts drawn from new, European roots, rather than successive generations of North American derivatives. The very broad eaves of the flat roofed portico are in keeping with the main roof. Perhaps the only defect in this image is that the two portico columns have excessive entasis (taper) which detracts from their confidence. The diameter of the column bases is correct, but the capitals should have been at least four inches broader to reduce the taper at the top by two inches. This is a very fine example of Arts and Crafts as interpreted in a well built house contemporary with #110 Chisholm.

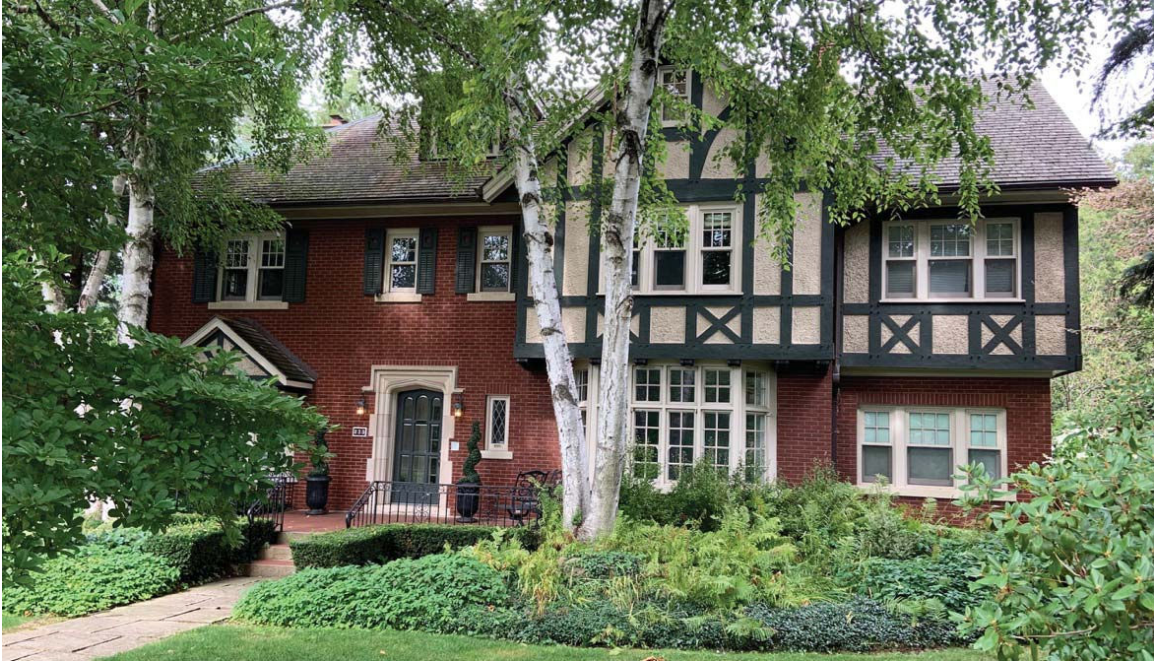
6.1.41 # 233 Rossmore Boulevard, Burlington. This example of a large house built in 1927 might be considered Arts and Crafts since the second floor is differentiated, at least partially, by projecting bays of faux half timber and stucco. The designer or architect has, however, opted for using much more formal and pretentious features such as the spectacular “Late Perpendicular Gothic” dressed limestone entry surround. The refinement of this stonework is fitting for the best church or college construction with a gorgeous panelized glass entry door that uses beveled plate panes even for the arched heads at the top of the door. The leaded glass sidelight suggests that it has an Elizabethan date. The “half timber” would be convincing as late medieval vernacular, except for the fussy “cross braces” that were used slavishly under both sets of ganged windows even though the bays project different distances from the wall. Arts and Crafts designers sought to use more authentic details that would have included single braces in a less symmetrical arrangement. While this is ostensibly Arts and Crafts and built at considerable expense with fine materials, it does not represent the most successful interpretation of a style. The two storey brick wall weakens the case that this is related to #110 Chisholm as a two part (i.e. shingle over brick) design, but this house is more significant as representative of a “type”, and worthy of designation.

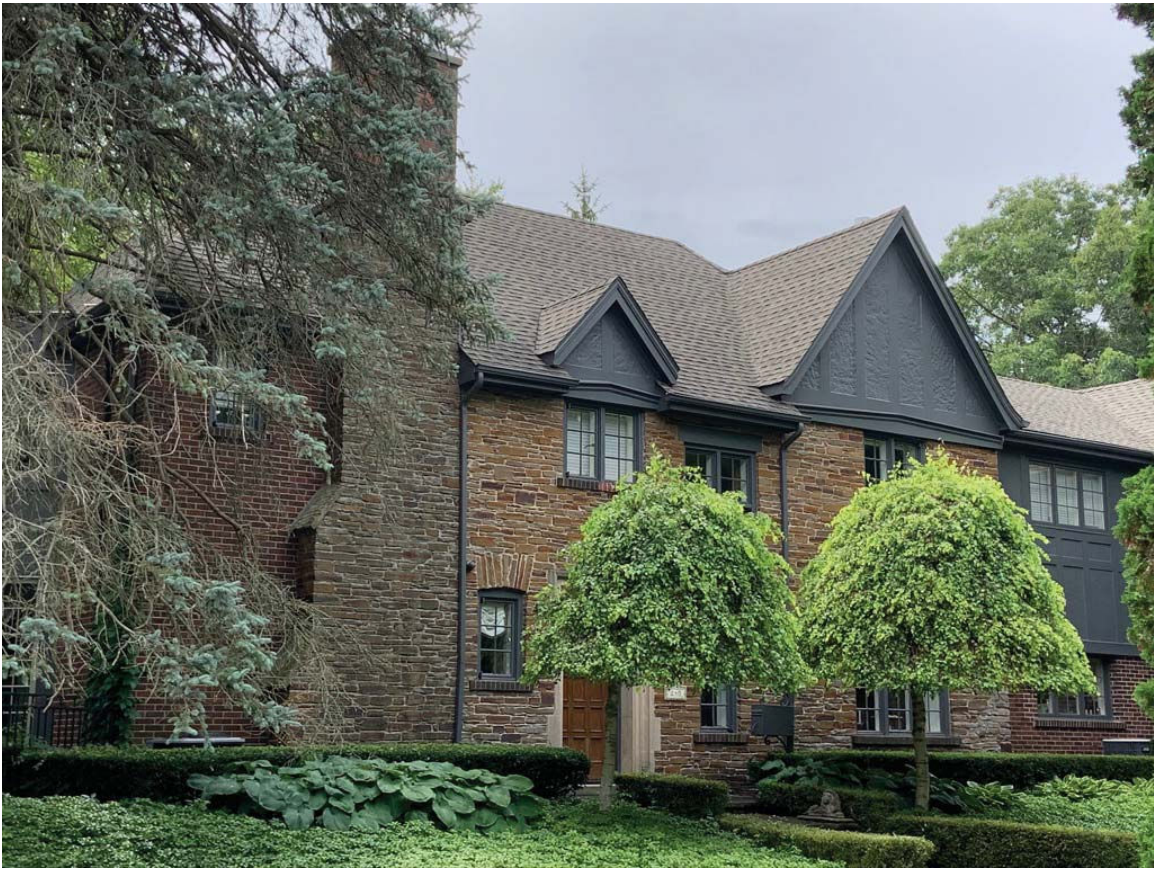
6.1.42 # 240 Rossmore Boulevard, Burlington. This house is not designated or listed but is an exceptional example of Arts and Crafts just after WW1. This substantial house combines three materials for the walls; random rubble sandstone for the chimney and central portion of the house, brick for the ground floor of the north wing, and two floors of the south wing, and faux half-timber and stucco for the north bay, gables, and south extension, and random rubble limestone for the central walls. This gives the impression that the house is very old and has been extended several times but is a masterful conceit by the architect of the original design. The house is ostensibly Arts and Crafts but the complexity of the wings and various stylistic inventions make it exceptional. This house succeeds in the most subtle and comprehensive way to be ancient. The lower eaves of the gables are slightly “swept” into little bellcast curves. Window heights vary slightly between the pair above the entry, and others along the façade. The varnished oak “Tudor” entry door is again framed with dressed limestone, in the late Perpendicular style. The prominence of the two gables on the street, is reminiscent of # 110 Chisholm but within a far more elaborate and high quality assembly of parts. There are no shingles in this case, except what would have been on the roof.
