20 BELVEDERE DRIVE

COMMITTEE OF ADJUSTMENT

TITLE SHEET

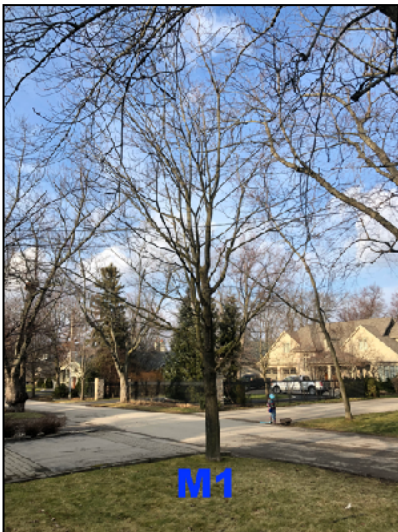
Tree M1 is a 29cm dbh Red Maple that is growing near the street in front of the house. This tree is in fair condition and requires a tree protection zone of 2.4m.

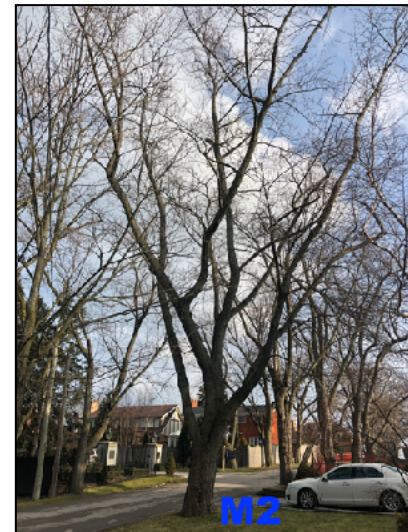
Tree M2 is a 92cm dbh Silver Maple that is growing near the street in front of the house. This tree is in fair condition and requires a tree protection zone of 6m.

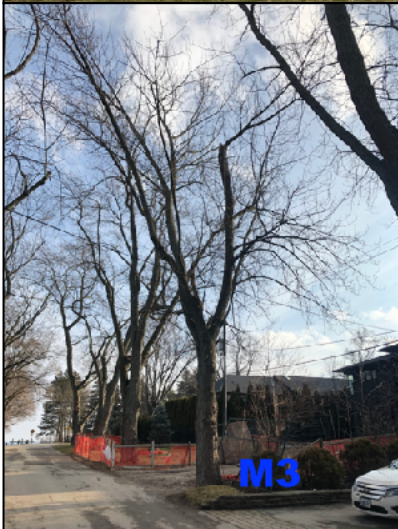
Tree M3 is a 63cm dbh Silver Maple that is growing near the street in front of 14 Belvedere Drive. This tree is in fair condition and requires a tree protection zone of 4.2m.

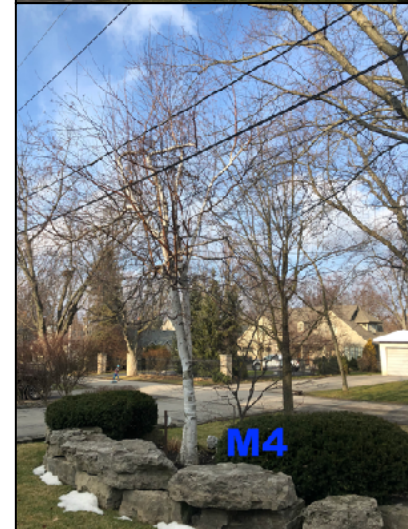
Tree M4 is a twin stemmed Paper Birch that is growing near the property line in front of the house. This tree is in poor condition and requires a tree protection zone of 2.4m.
