**Re: Supplemental Commentary regarding the Heritage Conservation Plan for  
2480 Old Bronte Road, Oakville, Ontario**

*APPENDIX 1*  
*EXISTING WINDOWS*

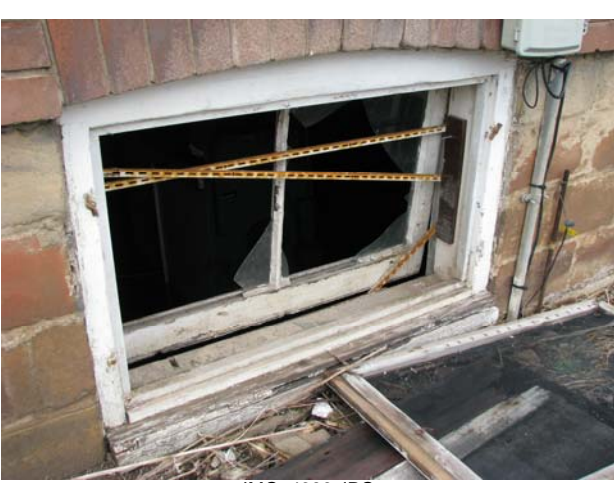
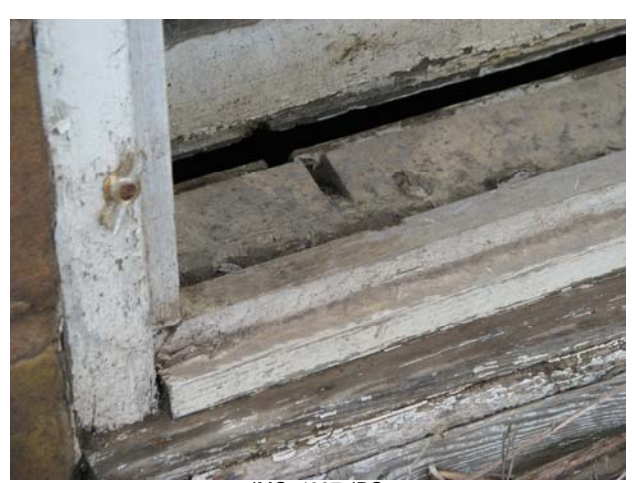
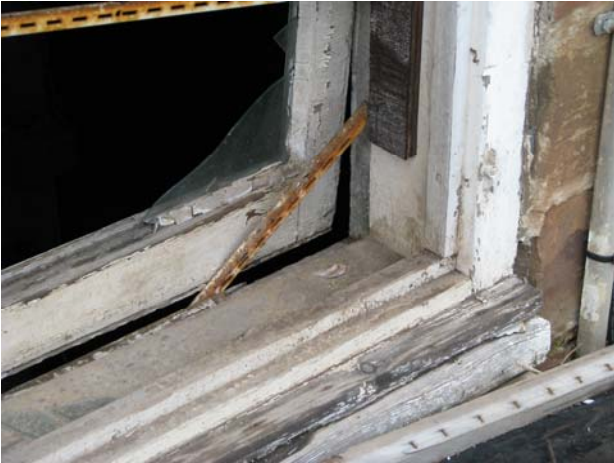
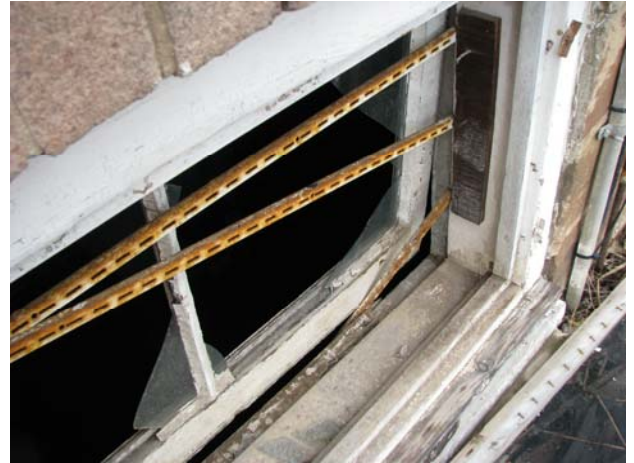
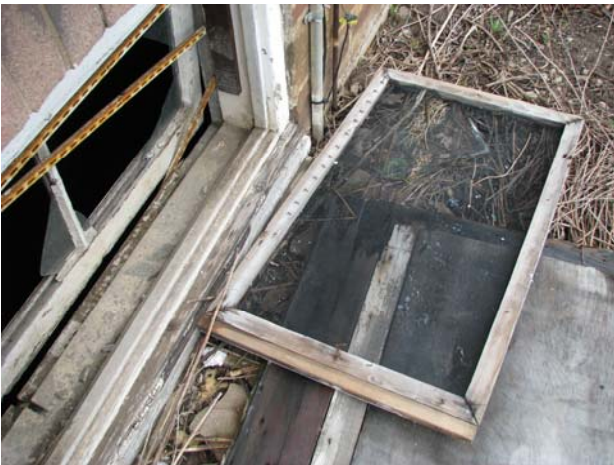
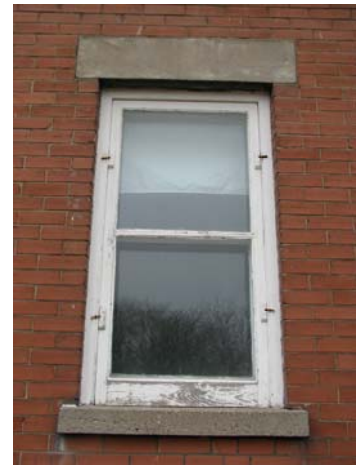
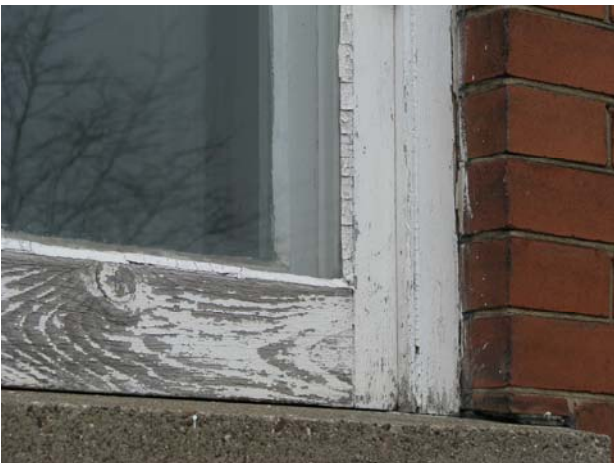
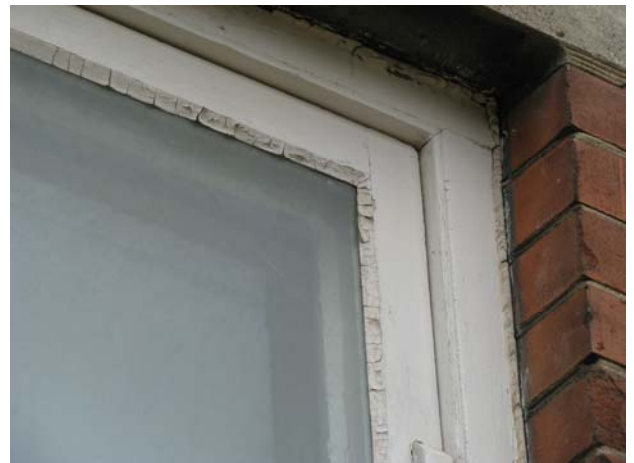
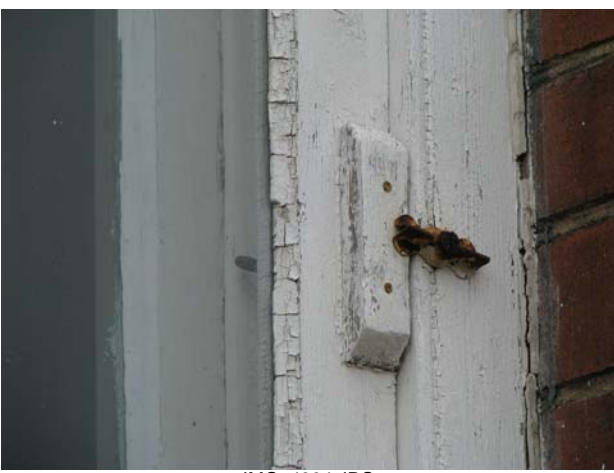
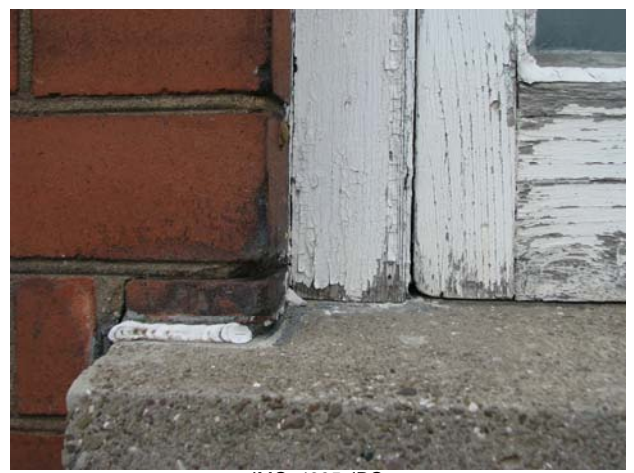
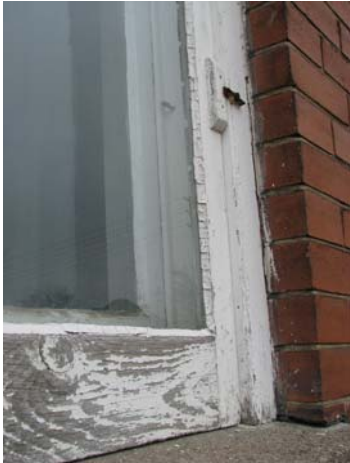
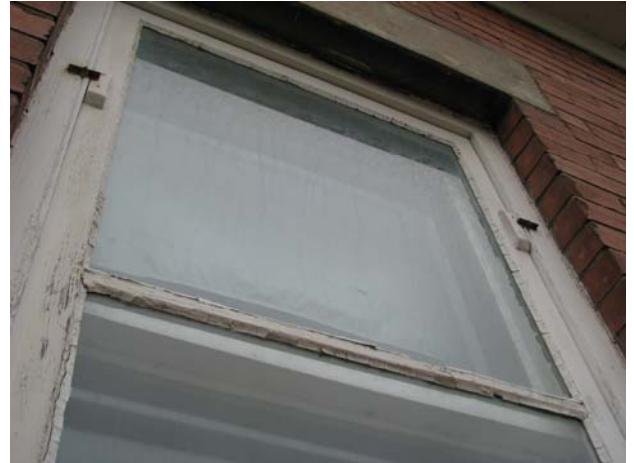
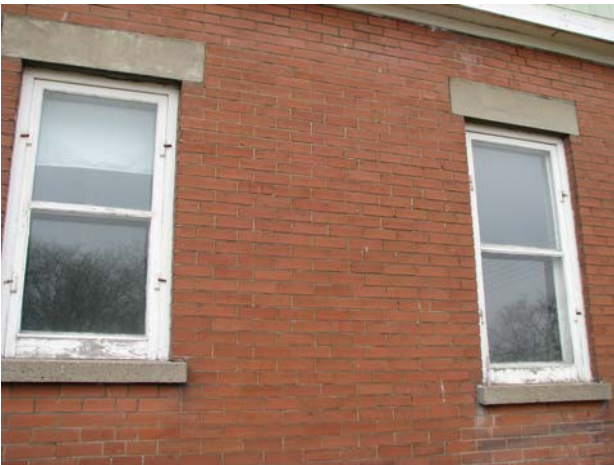
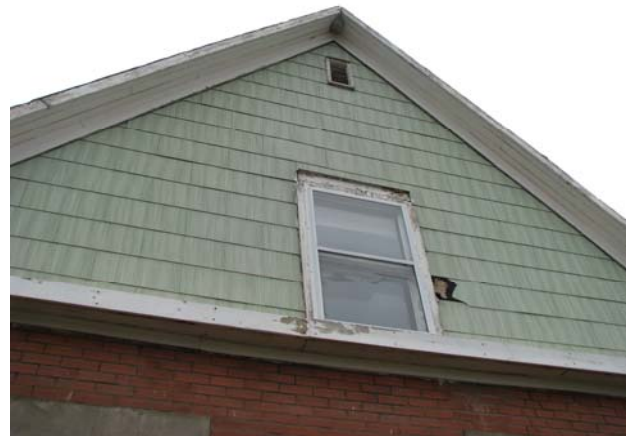
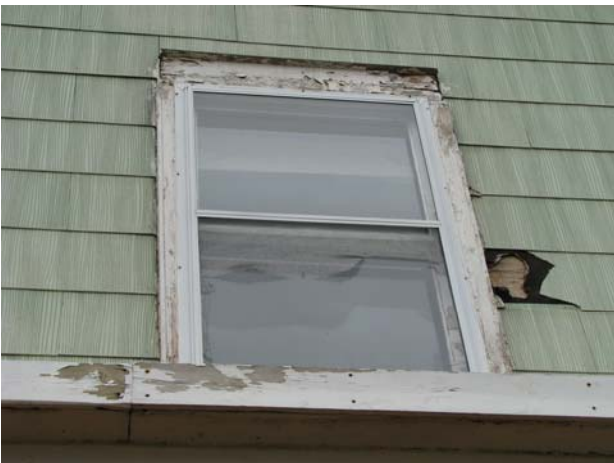
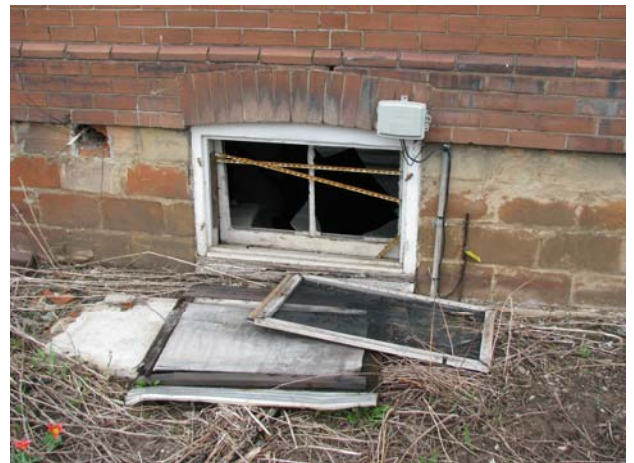
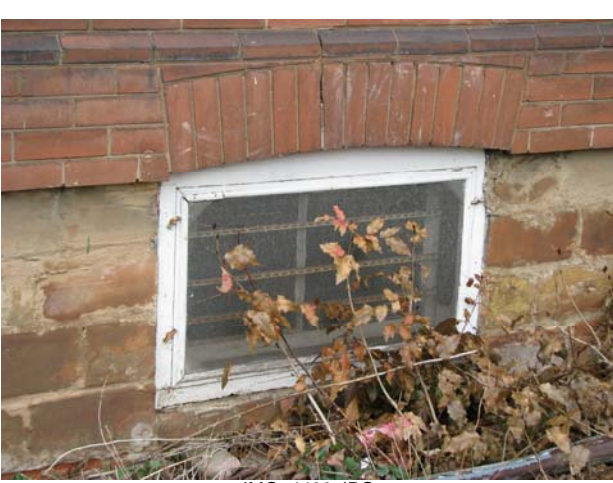
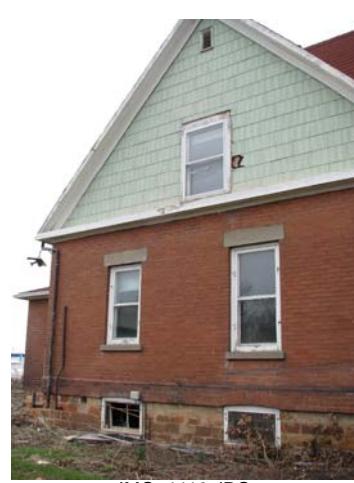
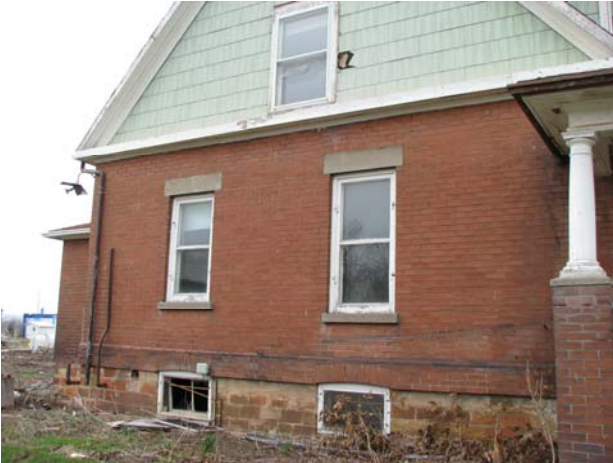
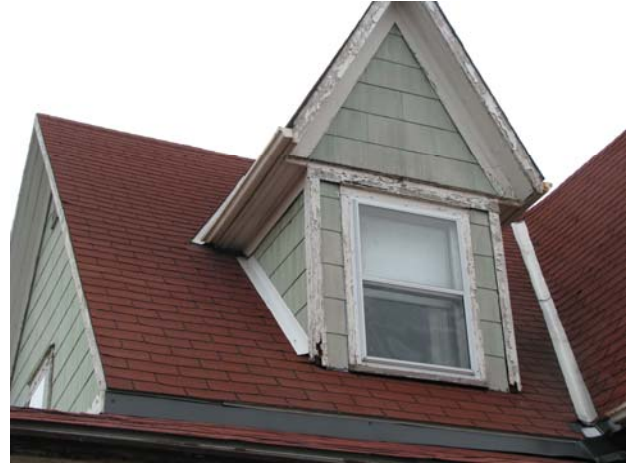
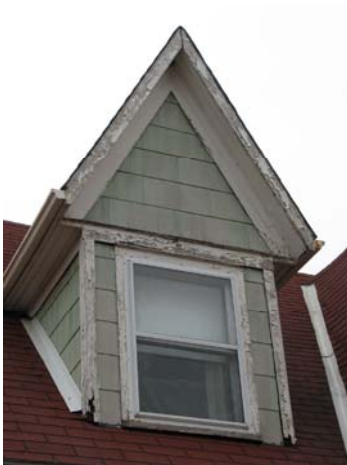
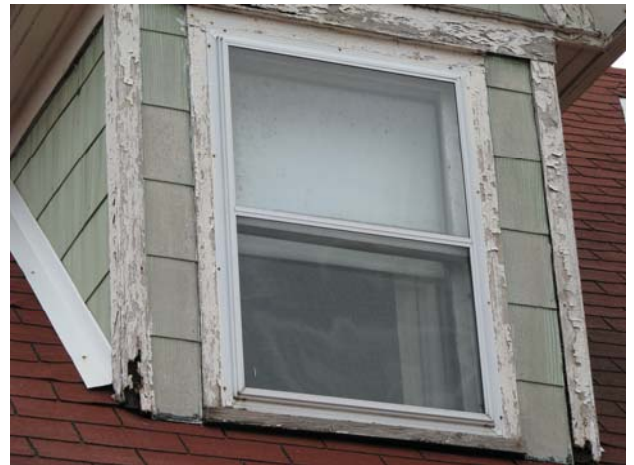
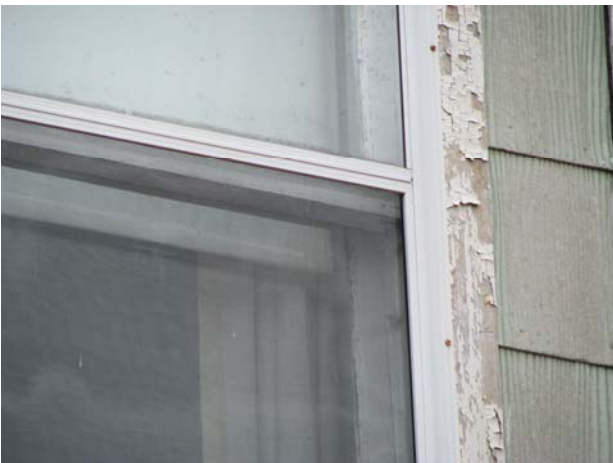
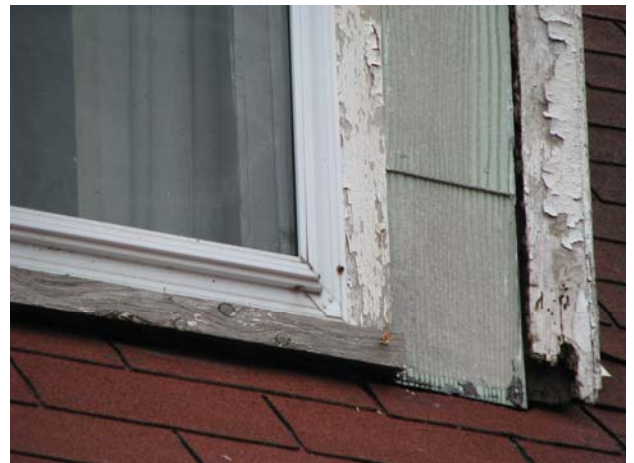
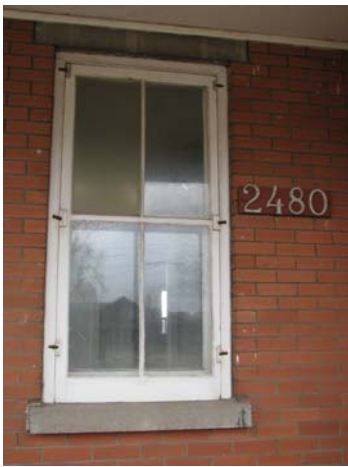
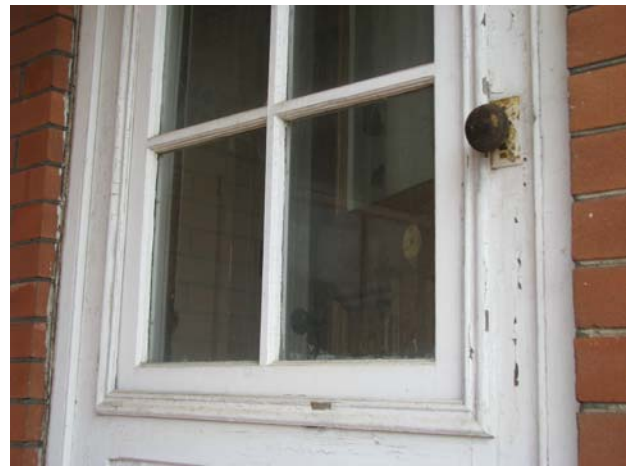
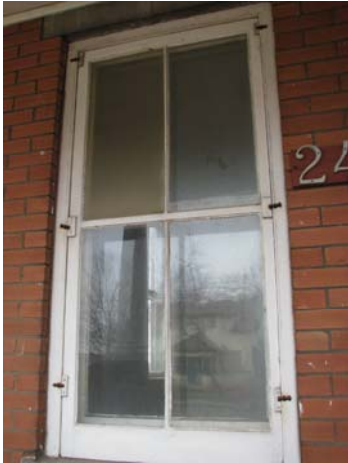
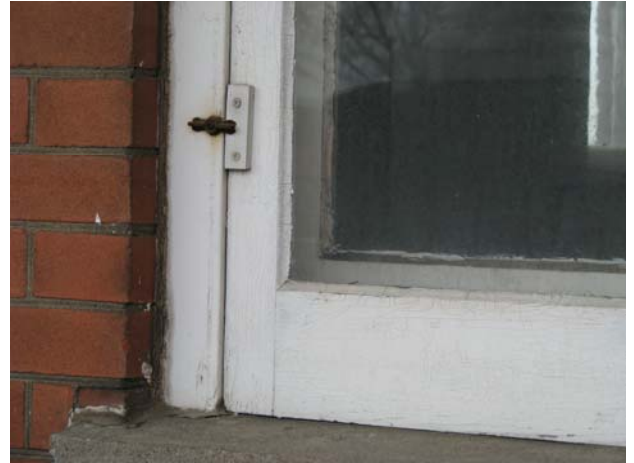
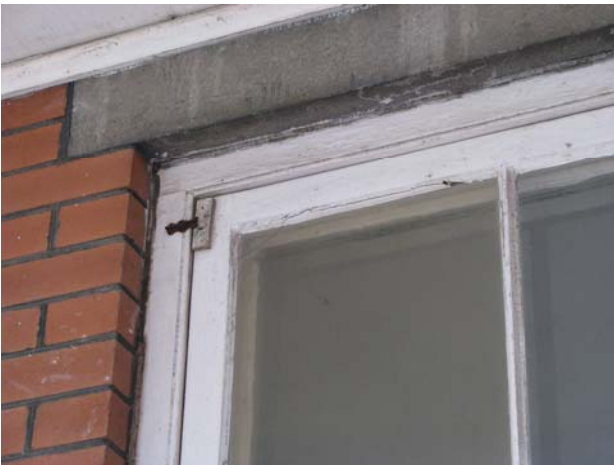
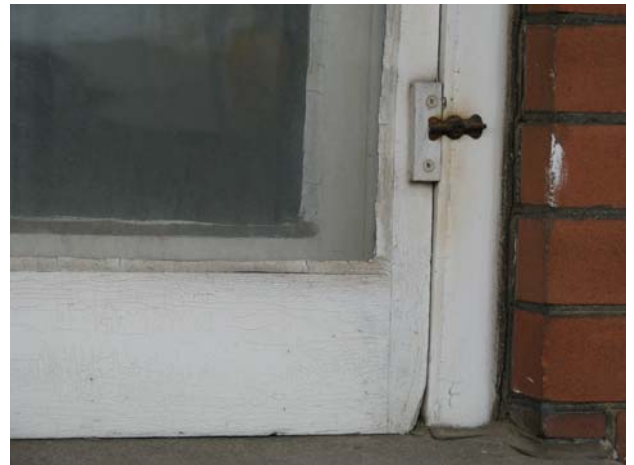
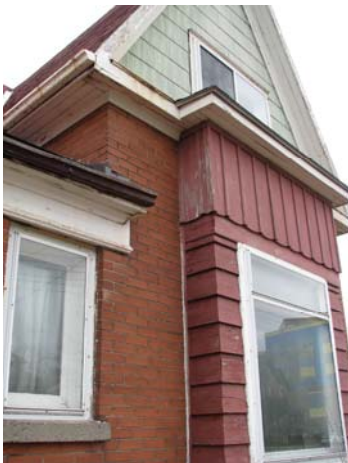
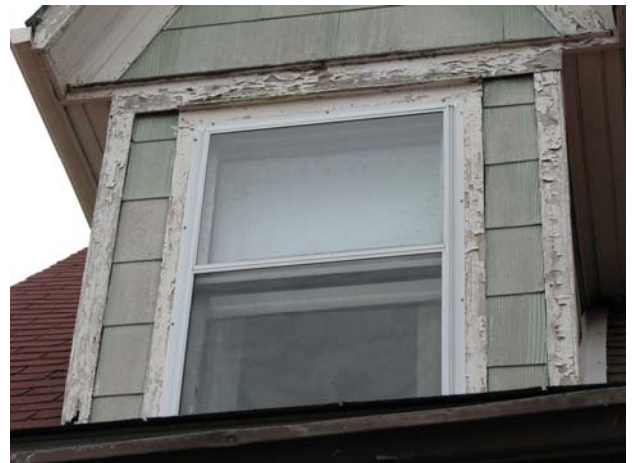
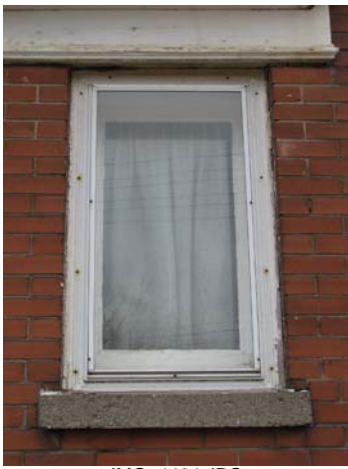
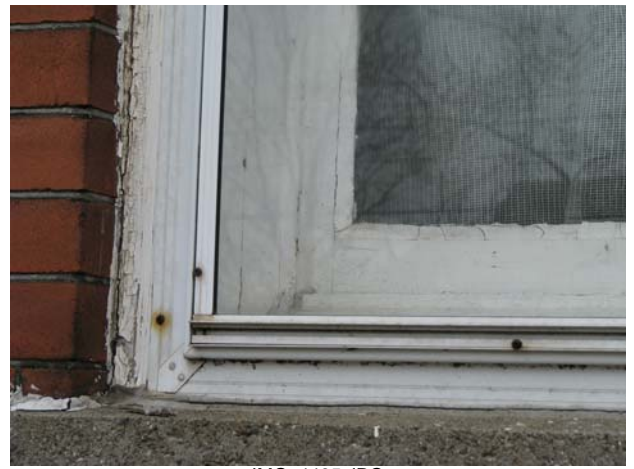
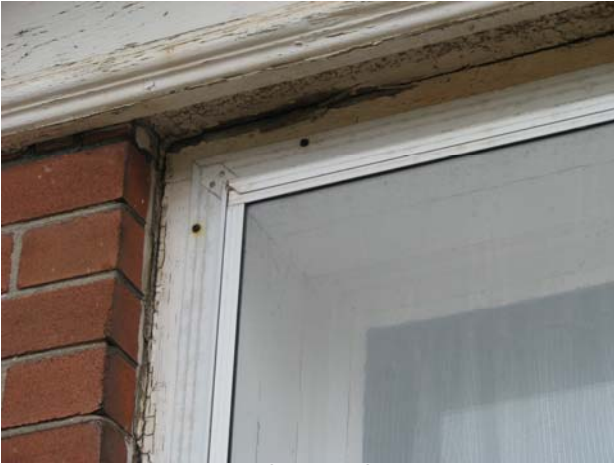
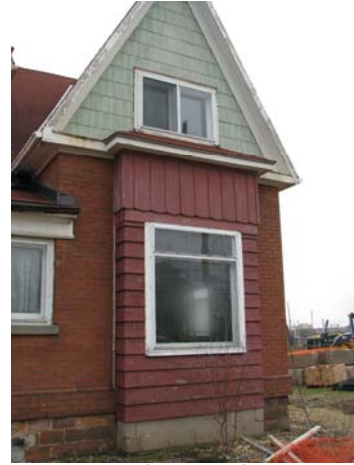
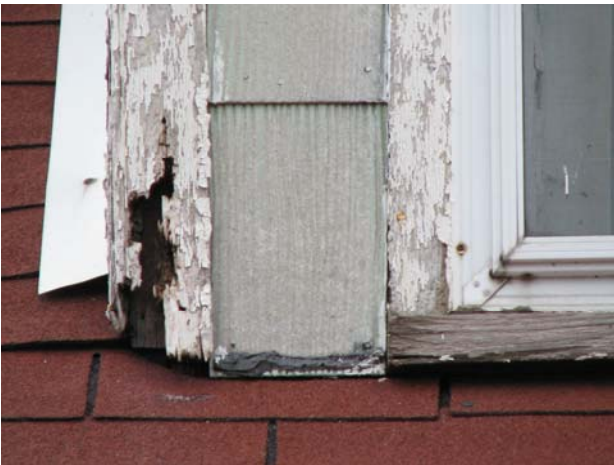
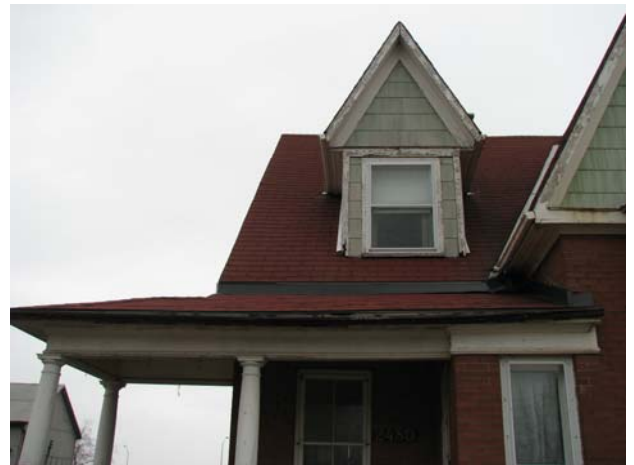
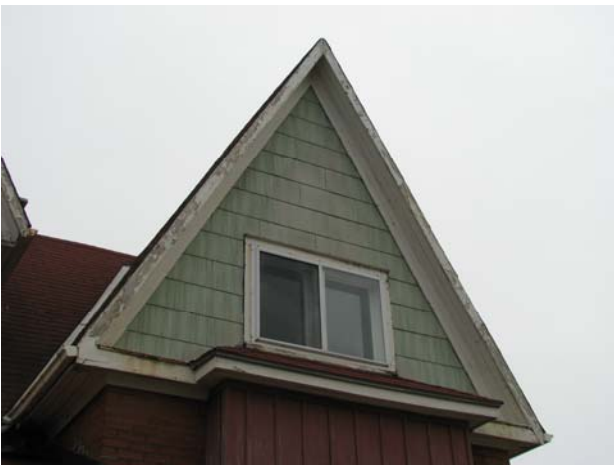
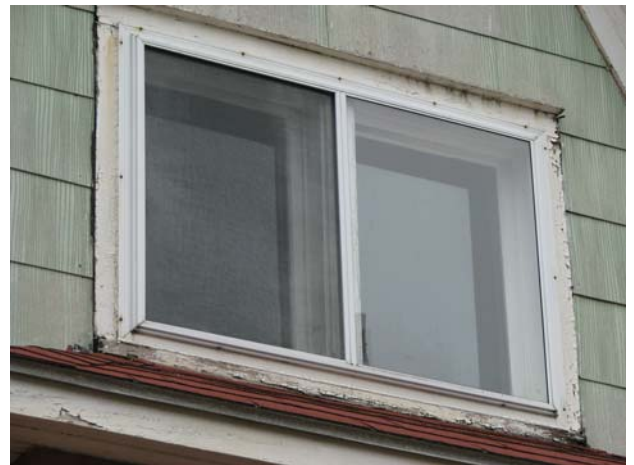
2480 Old Bronte Road currently has 19 windows to be reviewed, including the following:

14 of the total number of windows have been covered with modern storm windows.
